Australian Technology Park Movable Collection Management Plan

FINAL DRAFT

April 2015

Prepared for
Australian Technology Park Sydney Limited

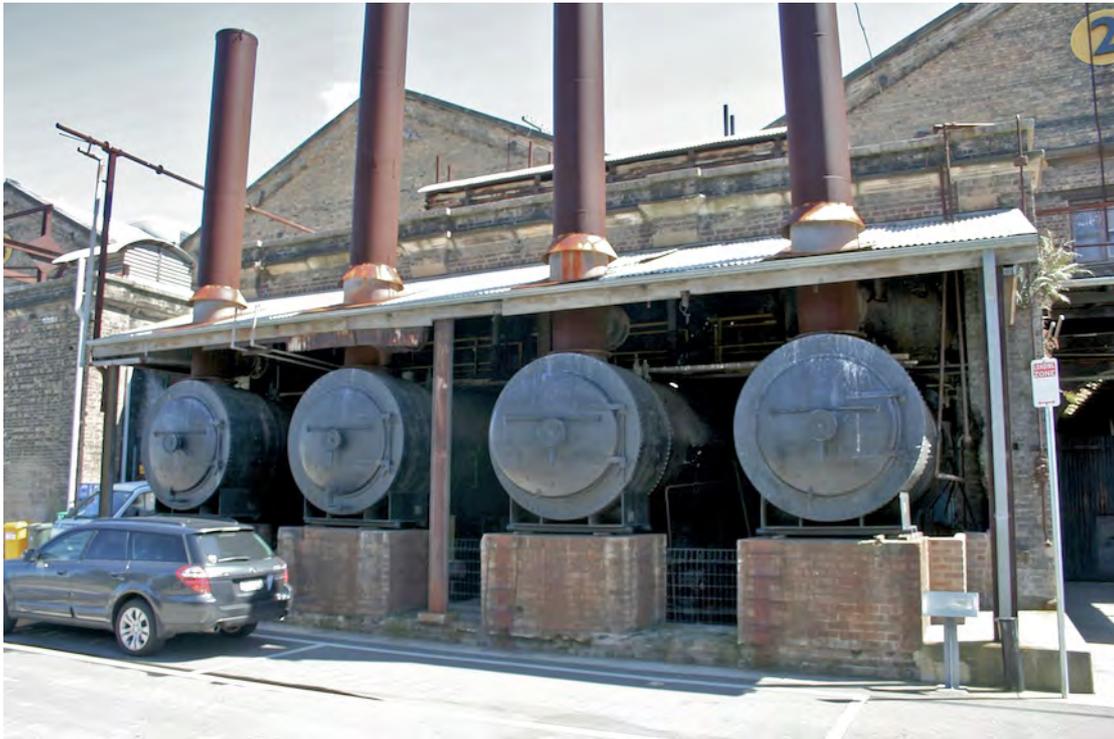
The Boiler Annex consists of a skillion-roofed structure open on three sides and housing 4 boilers and associated machinery. The Boiler Annex is fixed to the south wall of the Locomotive Workshops and supported on a combination of steel posts and masonry columns at the corners. The west wall of the Annex was originally enclosed but was opened with an irregular rectangular opening at some point in the past. This area has been partially infilled with modern brickwork.

Figure 3 – Looking north into the Boiler Area in front of Bay 2.

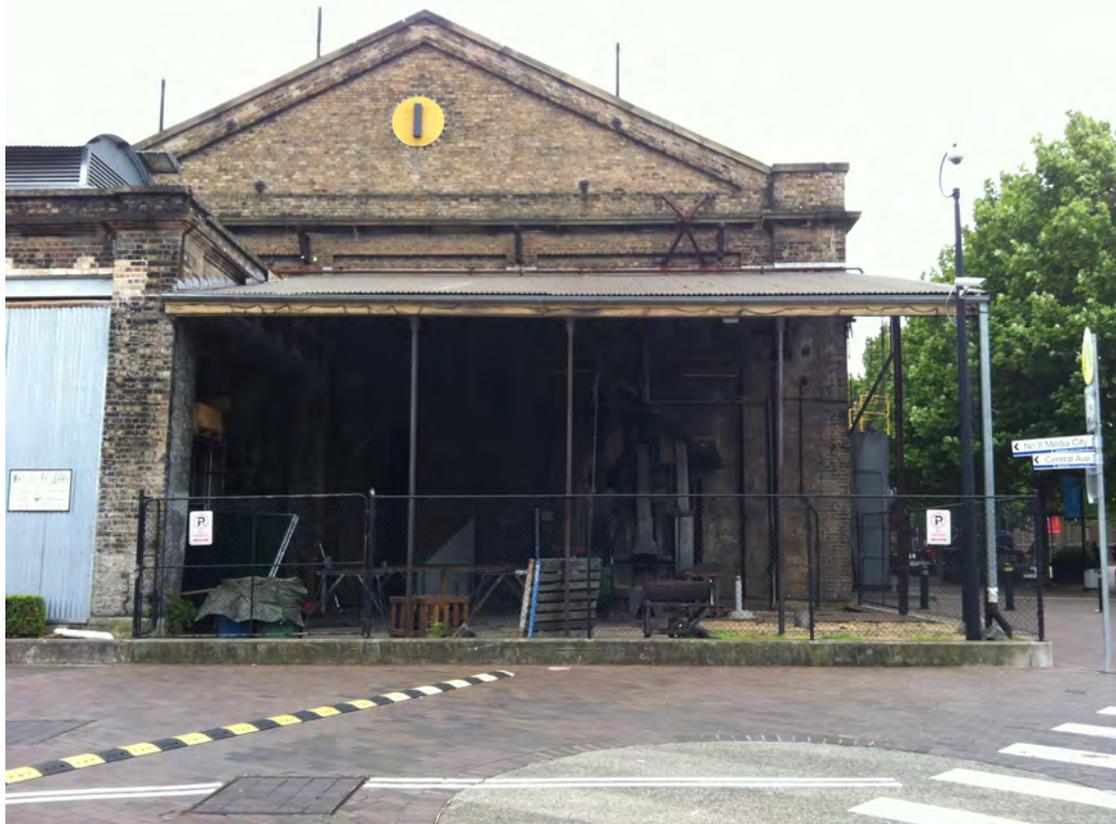
The subject area of the Bay 1 Annex is a simple skillion roofed structure supported by iron poles and open on two sides. It is attached to the wall of Bay 1 to the north, and to the east wall of the closed in annex section to the west.

Figure 4 – Looking north into the Bay 1 Annex. Innovation Plaza is visible on the very right of photograph.

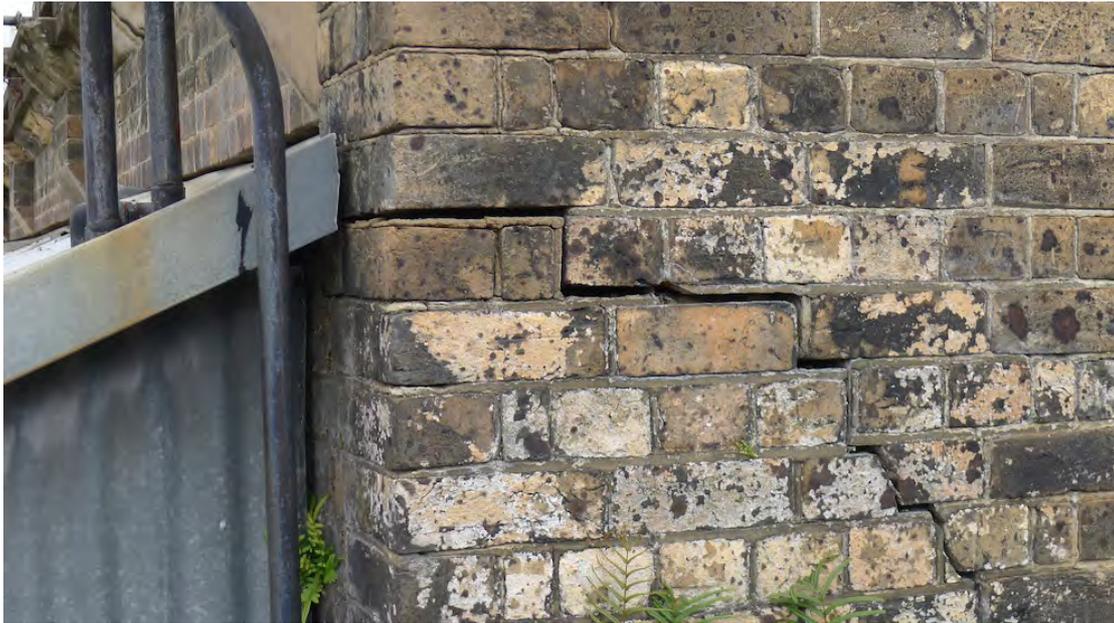
Figure 8 – Cracking of the brickwork caused by rust jacking.

The pattern of masonry cracking especially in the eastern elevation indicates rust jacking of the steel joist seating.

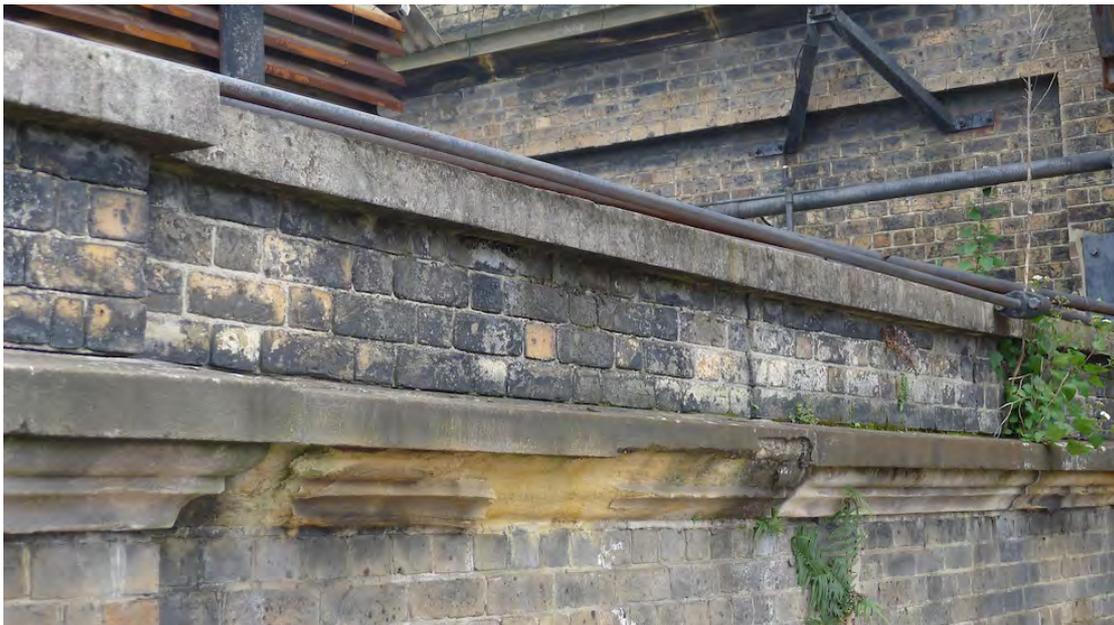
Figure 9 – Erosion of sandstone elements and plant growth on the Bay 2 Annex.

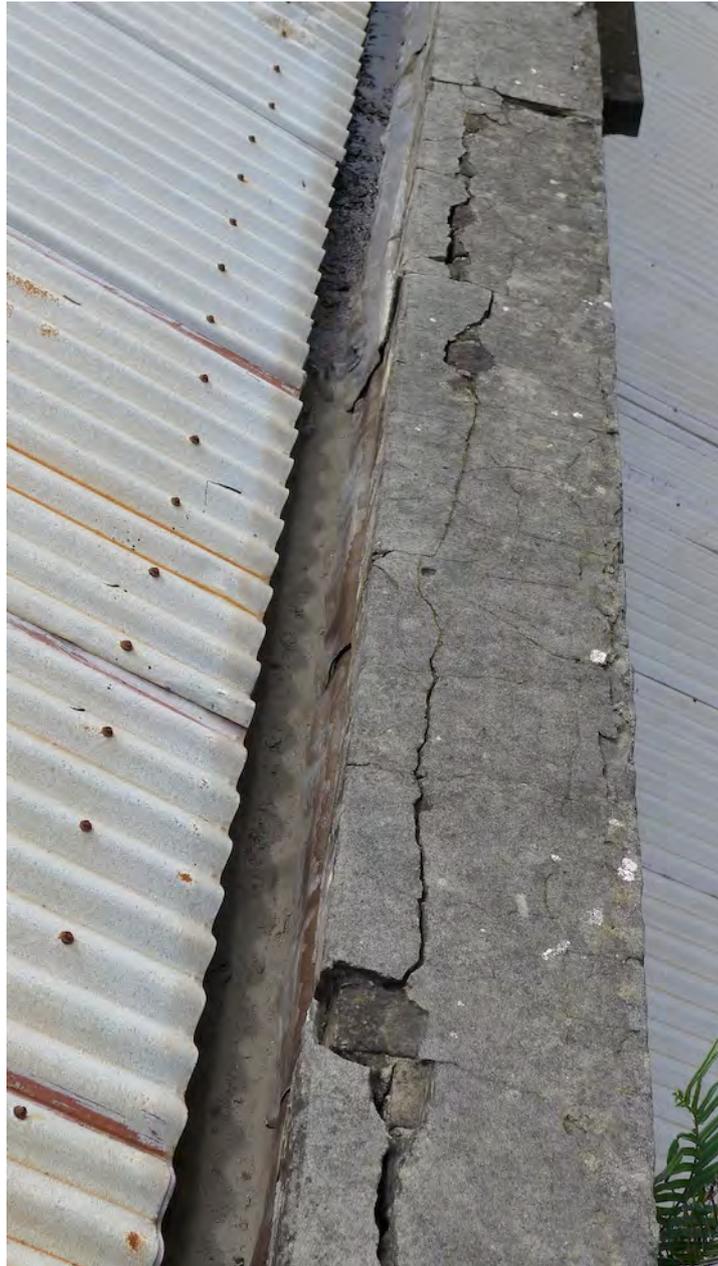
The sandstone coping of the parapet is in poor condition. Screeding of the sandstone is breaking down revealing the earlier underlying failure of the sandstone element (Figure 11).

Figure 11 – Note that the breakdown of the render is uncovering underlying fractures of the sandstone coping.

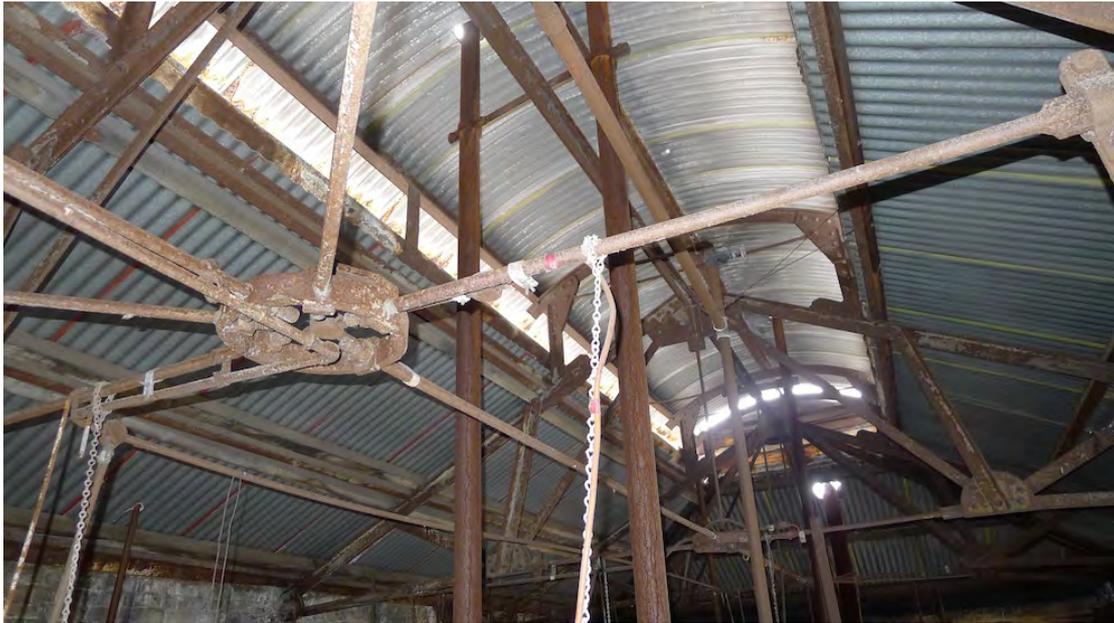
Figure 12 – Internal view of the roof structure of the Bay 2 Annex. Note the complex junction of tie rods at the hip apex.

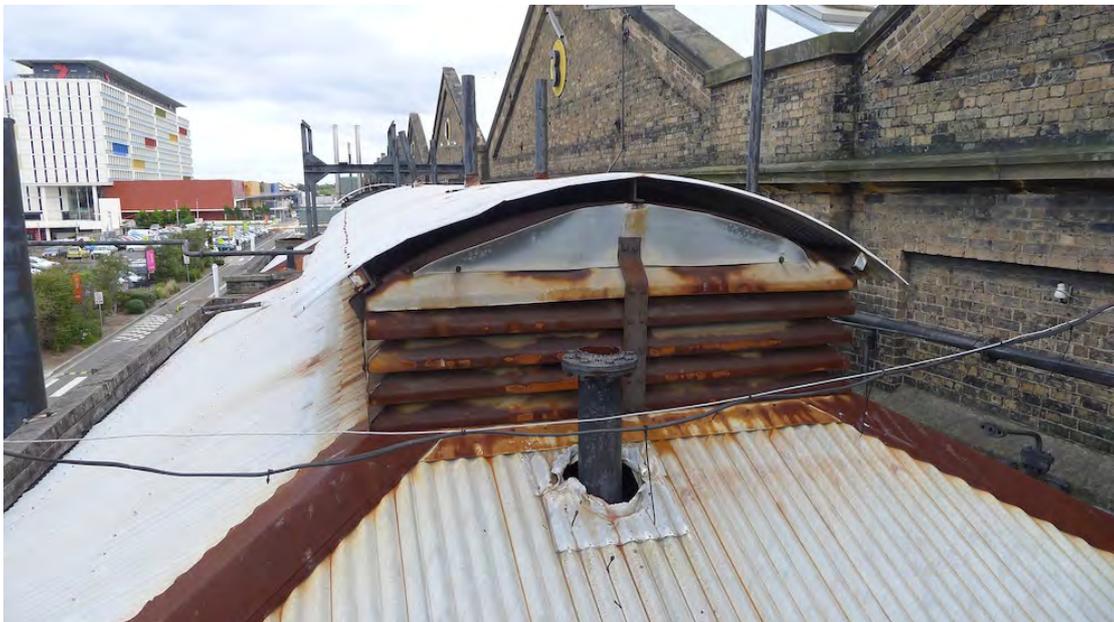
The roof covering and attendant flashings are in poor condition. The louver to the roof surmount is damaged, corroded and incomplete.

Figure 13 – The roof covering of the Bay 2 Annex. Note the rusting hip flashings, the damaged and corroded louvers, the distorted capping to the surmount and poorly flashed penetrations.

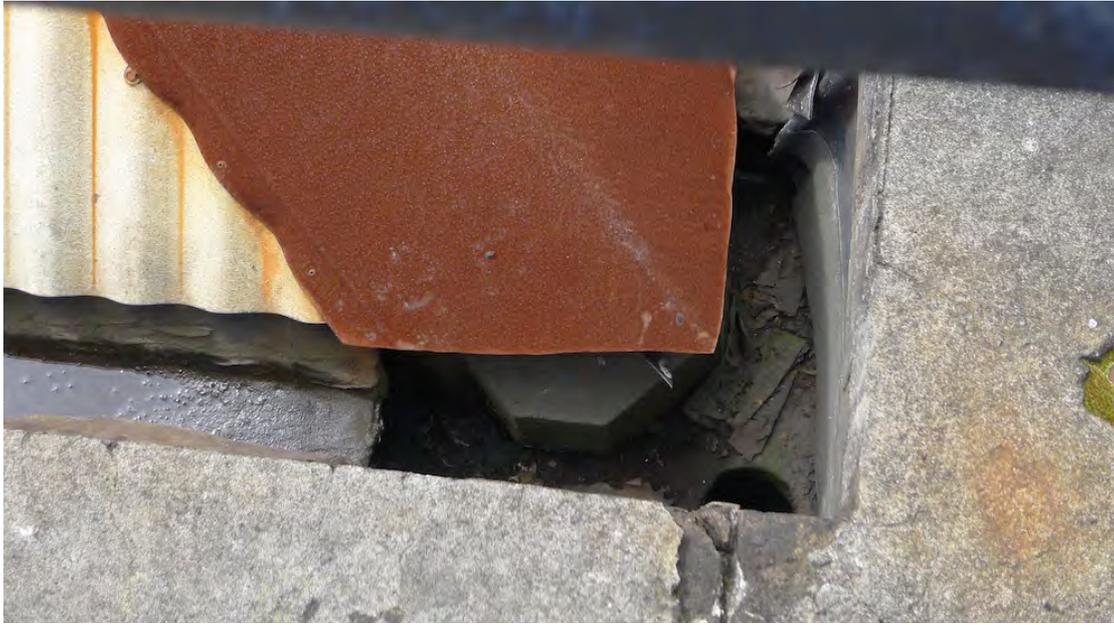
The guttering appears to be in fair to poor condition and has been partially flashed by lead and coated with bitumen. In places the guttering is cracked. The adaptation of the guttering has been poorly designed and executed and consequently surface water disposal is inadequate and causing accelerated deterioration of the structure.

Figure 14 – Detailed photograph of the guttering of the Bay 2 Annex. Note the downpipe appears to discharge into a concealed downpipe. The associated plant growth would suggest the drainage line no longer functions and the surface water saturates the masonry.

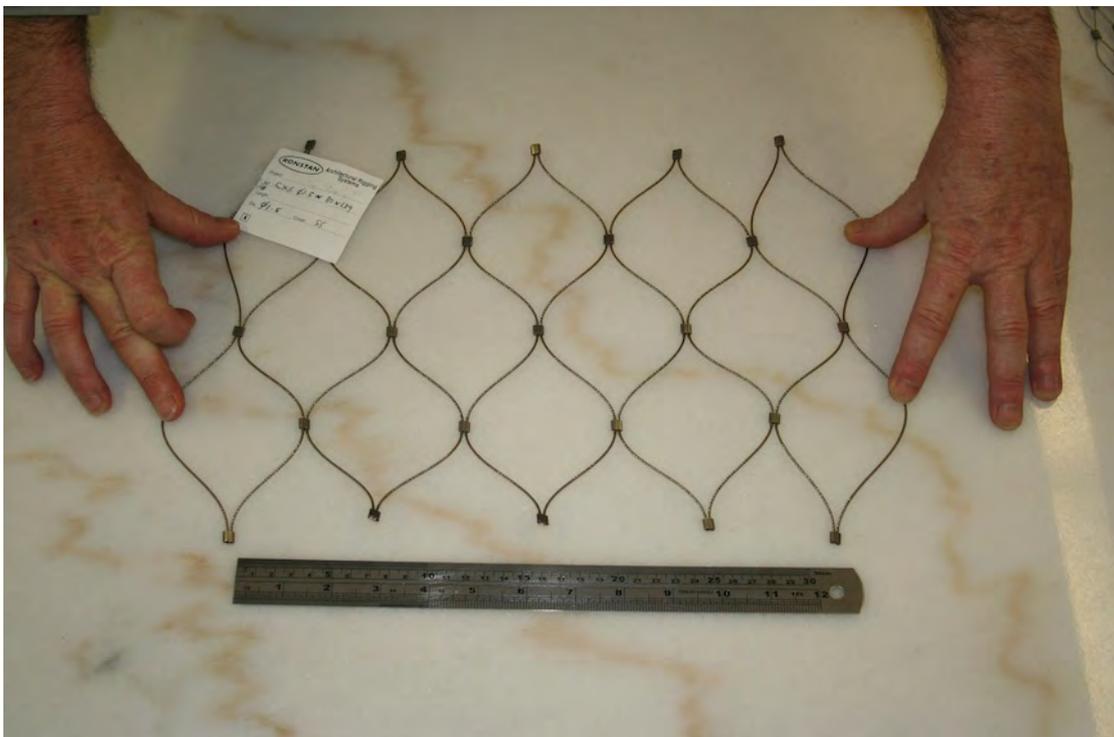
Figure 25 - Ronstan 80mm stainless steel mesh. This mesh is likely to be too open and may allow bird ingress.
