North-West Conservation Park - Rehabilitation Monitoring

Lot 1 RP48903

North-West Conservation Park
Gainsborough Greens

March 2020

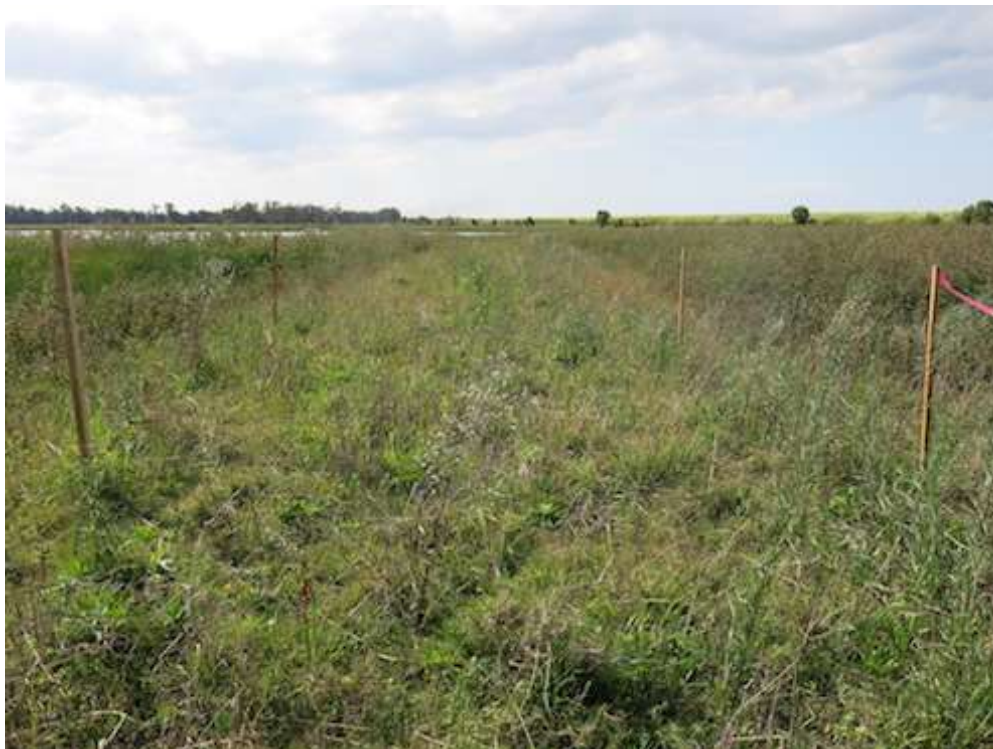
Photo Plate 1: Quadrat 1 - Month 1 (September 2015)

Now, the quadrat marker stakes are difficult to locate due to the density, height and overall biomass of *Casuarina glauca*. An obvious decline in weed growth and presence has been noted within this quadrat over the past number of years as *Casuarina glauca* became dominant. This is due to weed species being outcompeted and shaded out. This quadrat is continually shifting towards a native woodland with a grassy understorey of *Capillipedium*.

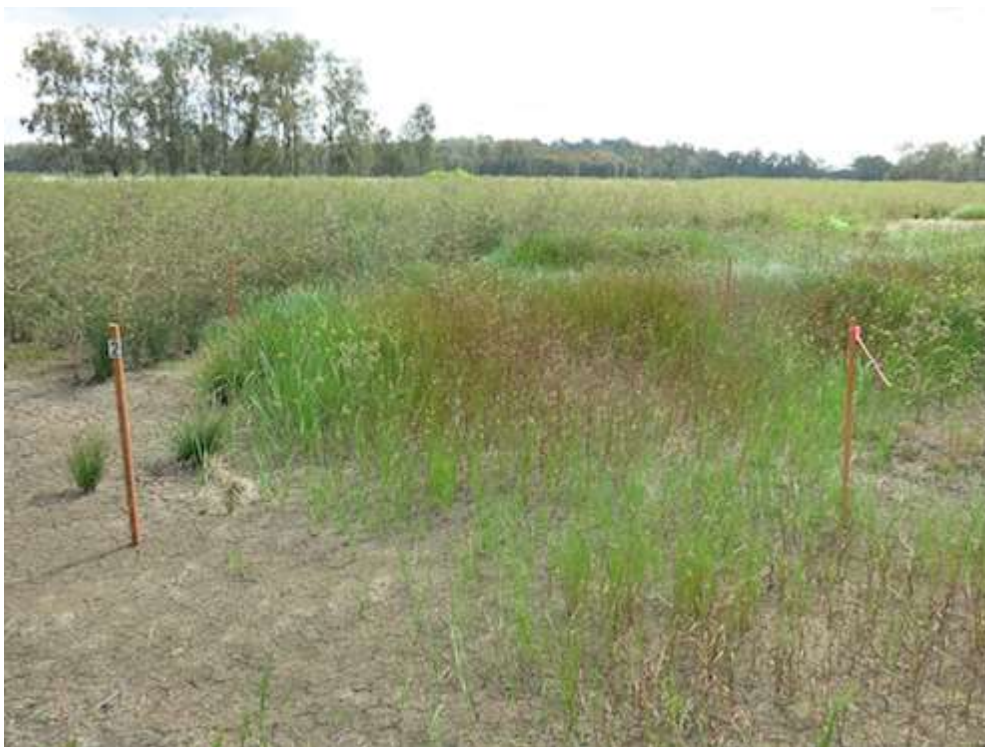
Photo Plate 3: Quadrat 2 - Month 1 (September 2015)

This quadrat began the five year monitoring period with a low vegetative cover of mostly native sedge and grass species. Native dominance did initially decline due to the invasion of weedy grass species.

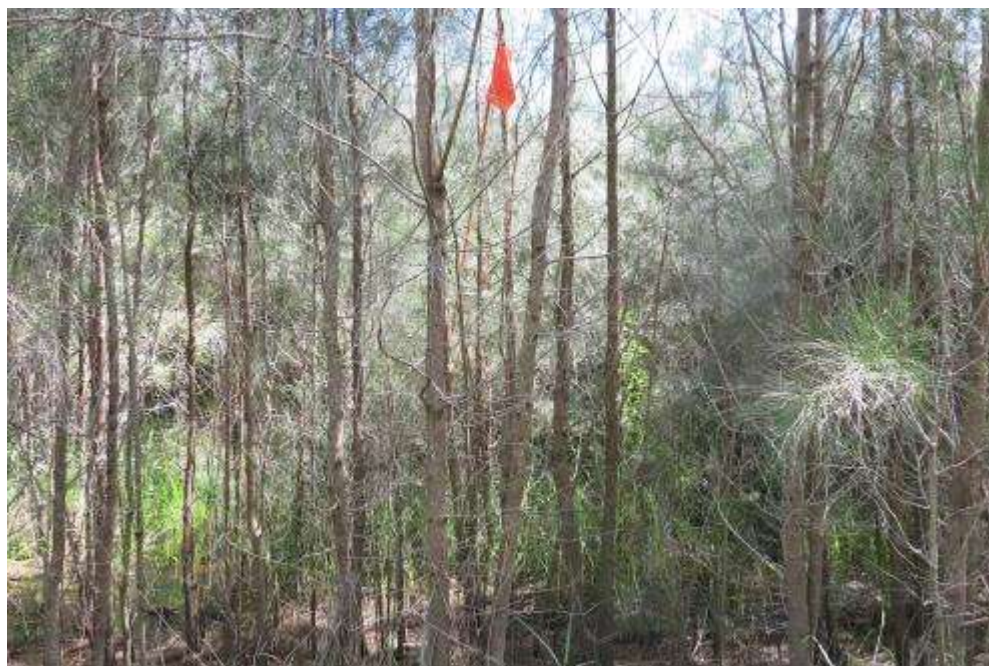
Photo Plate 4: Quadrat 2 - Month 54 (February 2020)

Now, this quadrat has established a canopy of *Casuarina glauca* with an understorey dominated by *Bolboschoenus cardwellii*.

This quadrat is subjected to periods of standing water post large rain events. This has allowed for the ongoing dominance of natives species, with the natural control of weeds through increased water levels and shading from native canopy trees.

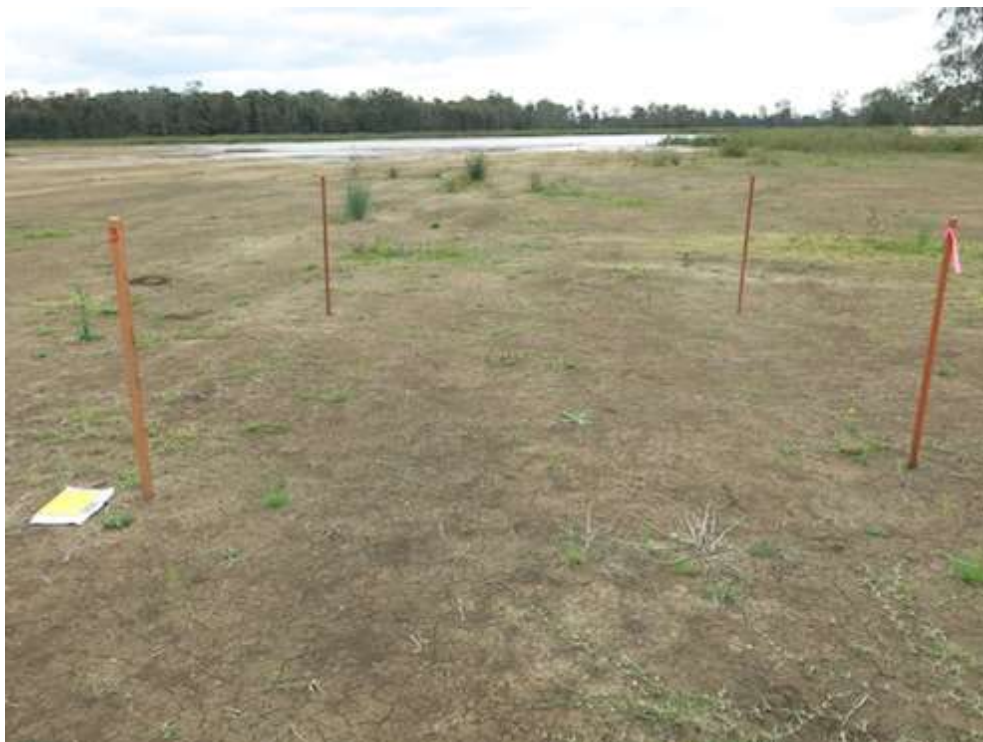
Photo Plate 5: Quadrat 3 - Month 1 (September 2015)

This quadrat began the five year monitoring period with little vegetative cover. The majority of vegetation consisted of weed species.

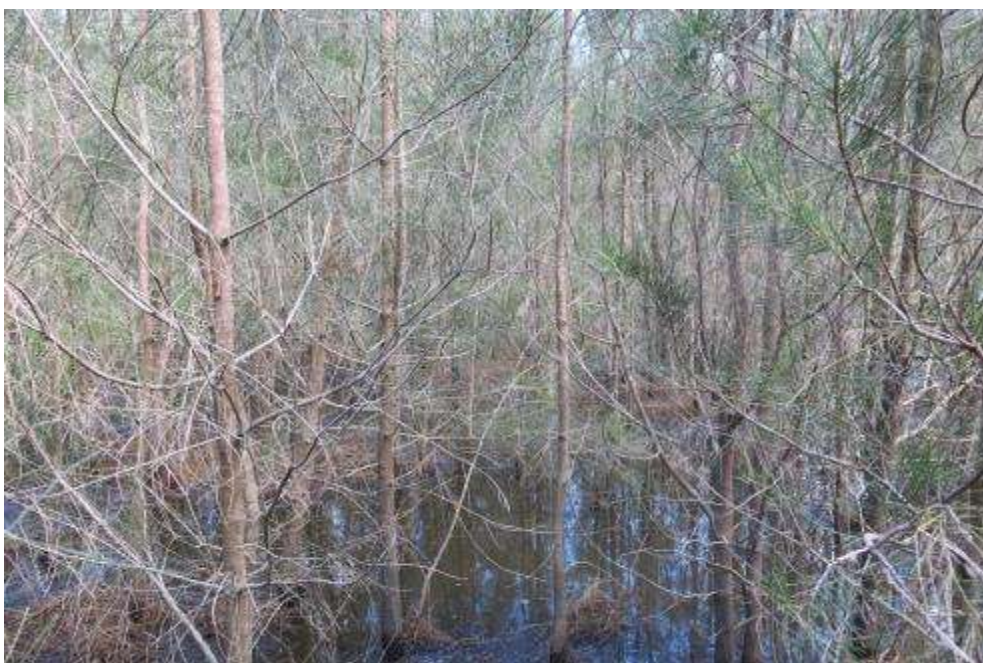
Photo Plate 6: Quadrat 3 - Month 54 (February 2020)

Now, the quadrat marker stakes are not visible due to the density and prolific growth of *Casuarina glauca*. As a continuous canopy now exists, weed species growth is limited.

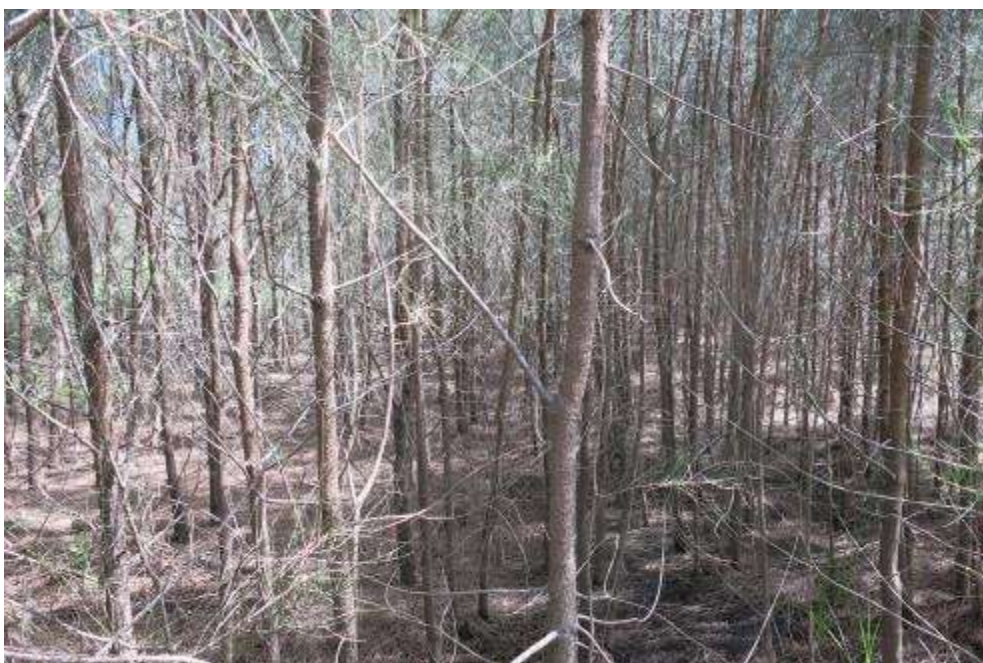
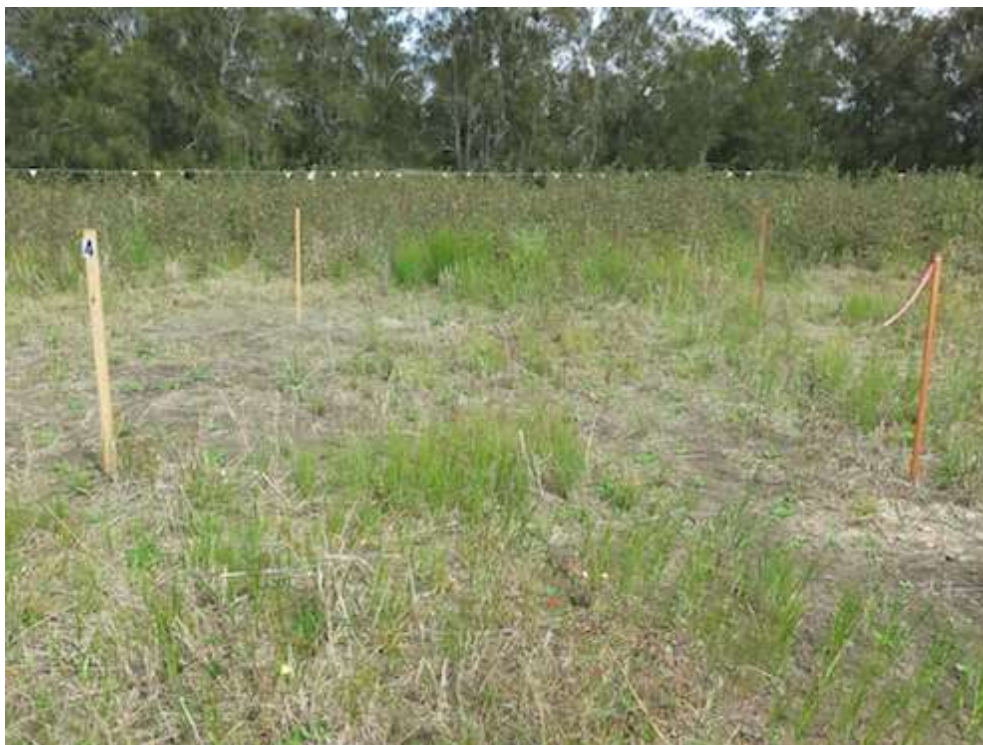
Contour banding of plant community assemblages are also becoming more predominant as wet conditions prevail.

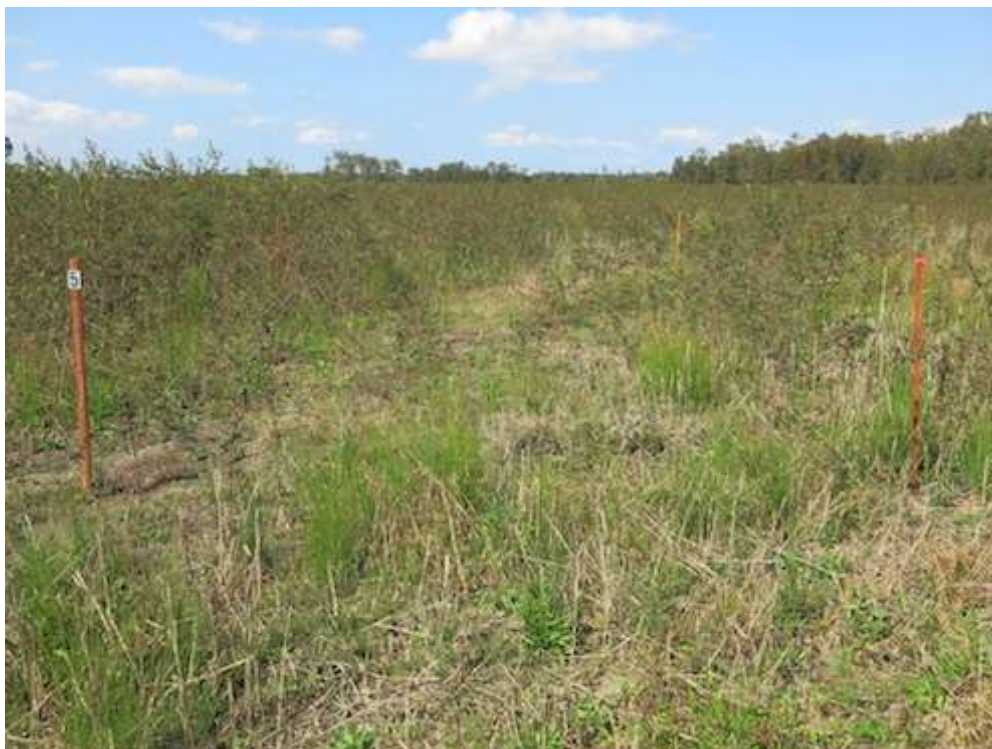
Photo Plate 9: Quadrat 5 - Month 1 (September 2015)

This quadrat began the five year monitoring period with little native vegetative cover.

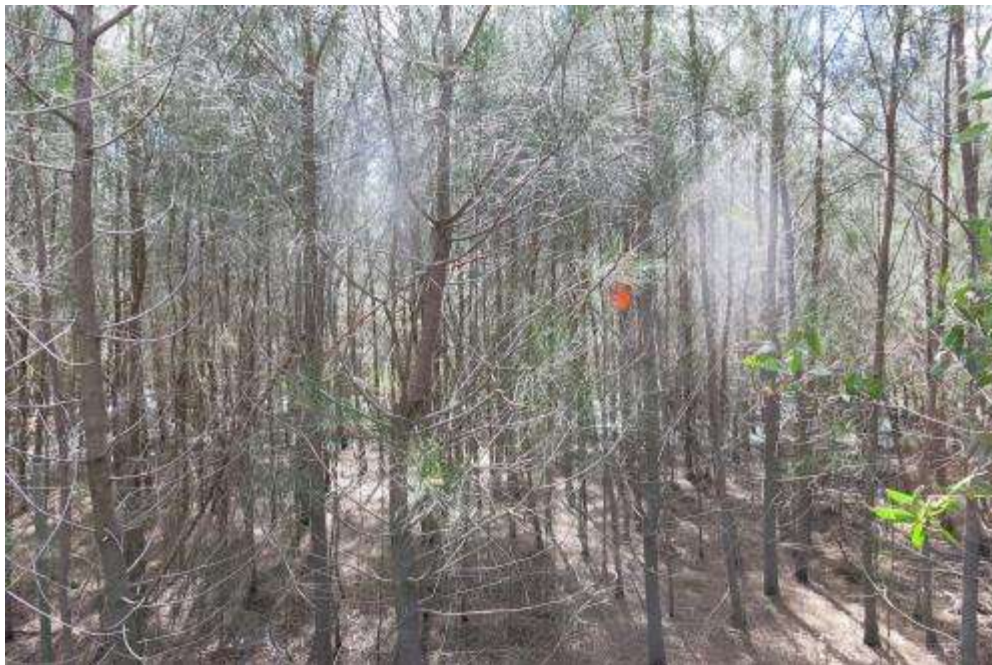
Photo Plate 10: Quadrat 5 - Month 54 (February 2020)

A canopy of *Casuarina glauca* and *Melaleuca quinquenervia* is now well formed and continuing to increase in biomass. Native groundcovers continue to surpass weed growth, with assistance from the canopy via shading.

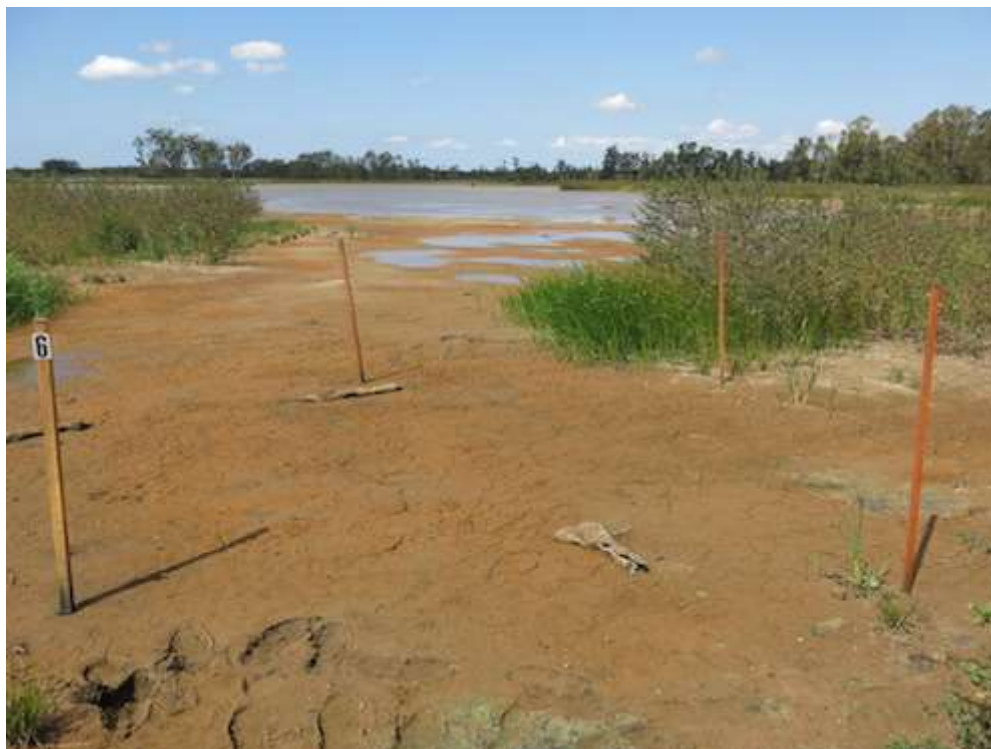
Photo Plate 11: Quadrat 6 - Month 1 (September 2015)

This quadrat began the five year monitoring period with no vegetative cover. It was predicted that due to the location of this quadrat, that is unlikely that any canopy species will emerge.

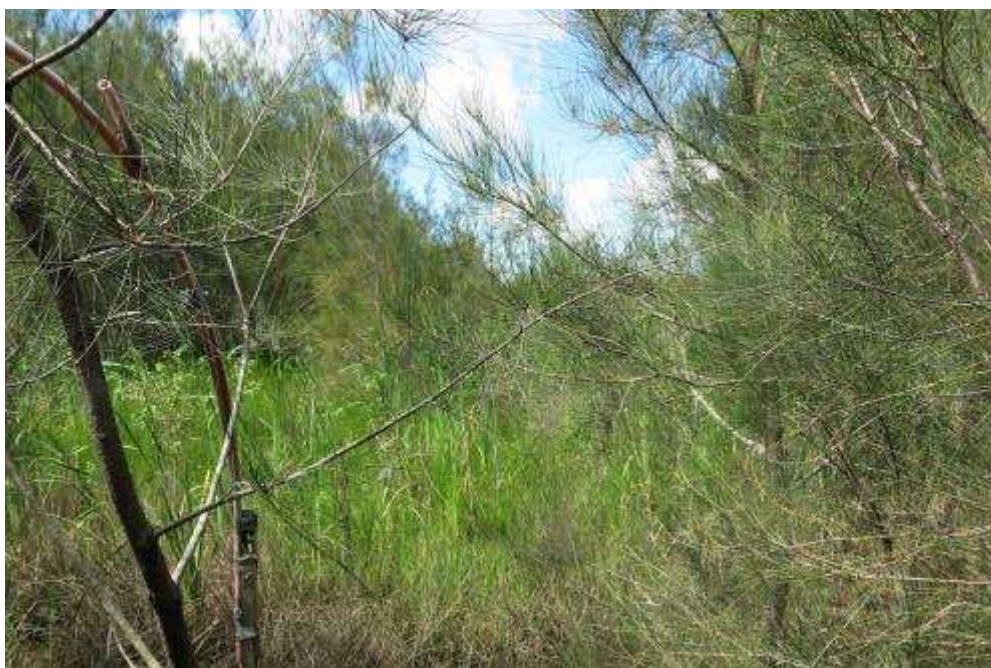
Photo Plate 12: Quadrat 6 - Month 54 (February 2020)

This quadrat has morphed into a perfect representation of a wetland community, dominated by sedges, rushes and cyperus species. This is a dynamic quadrat that shows significant changes between the wet and dry months as a direct result of the seasonal shifts in the hydrological regime of the area.

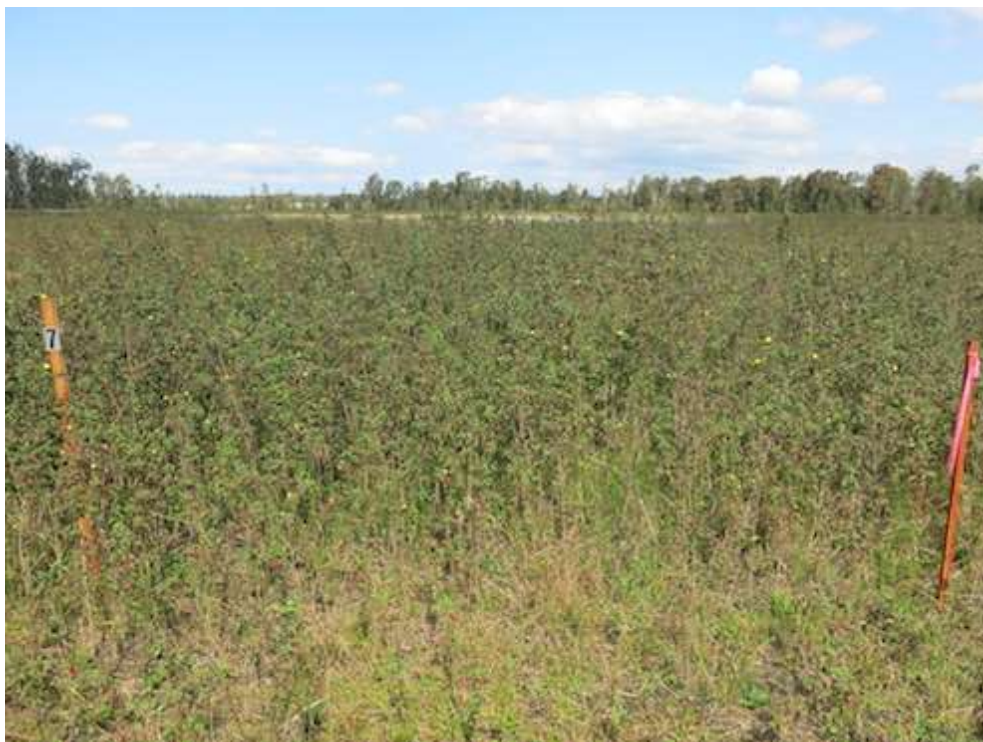
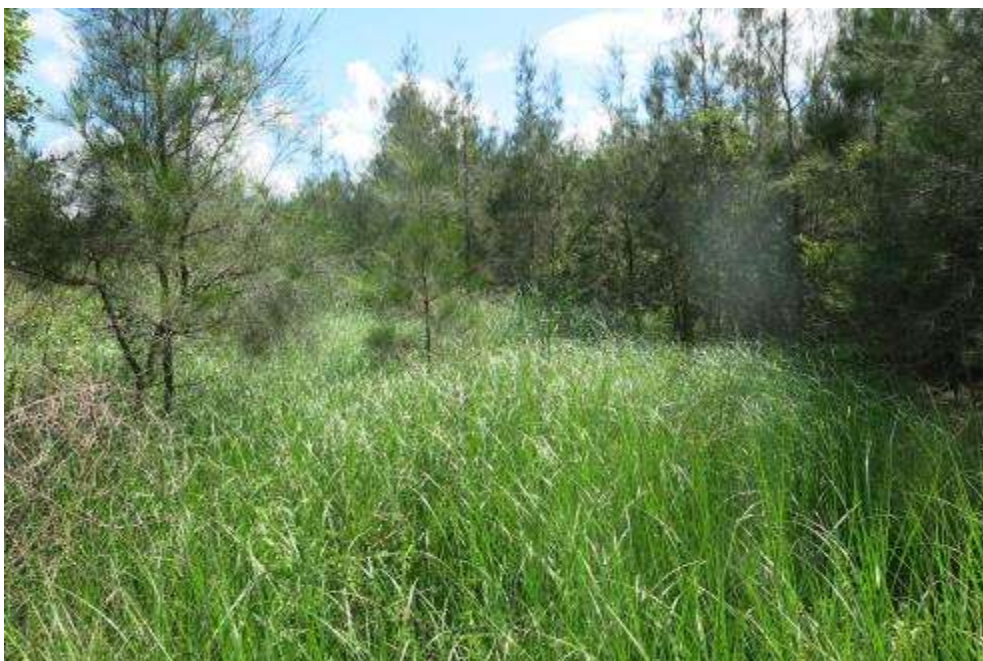
Native species diversity and abundance has continually increased, with this quadrat demonstrating the dynamic nature of the NWCP on the whole.

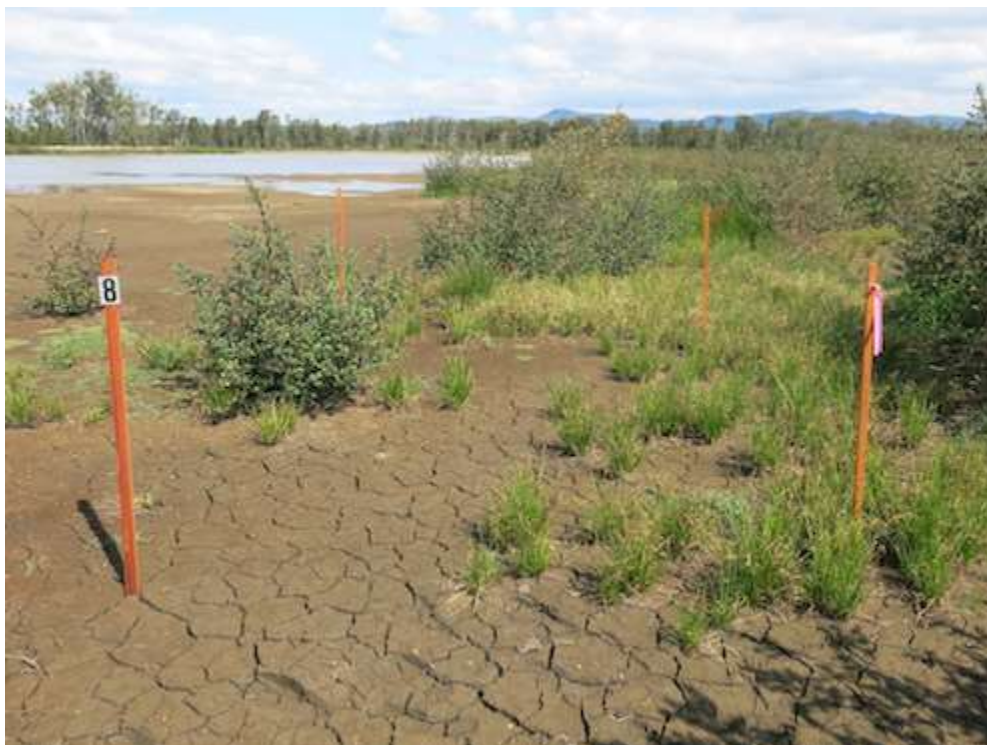
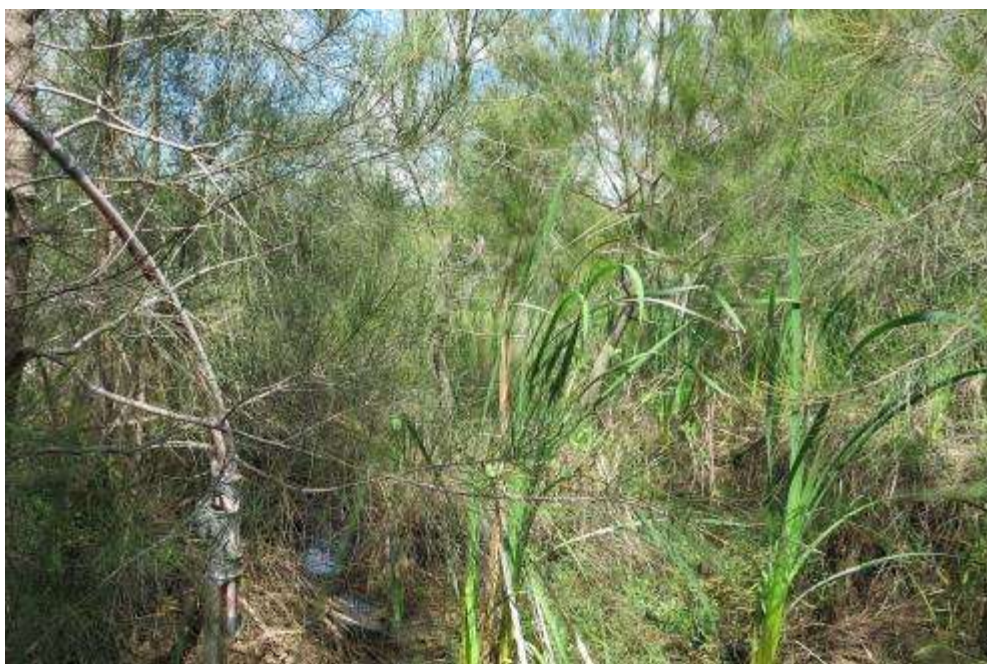
This quadrat is another example of the dynamic nature of the NWCP on the whole.

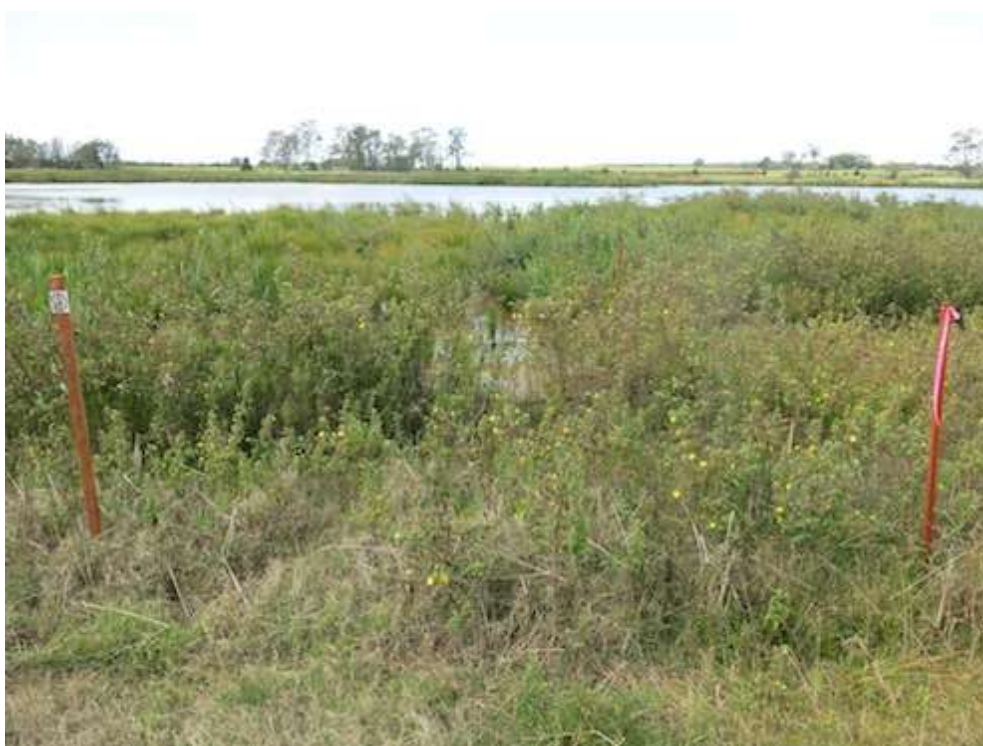
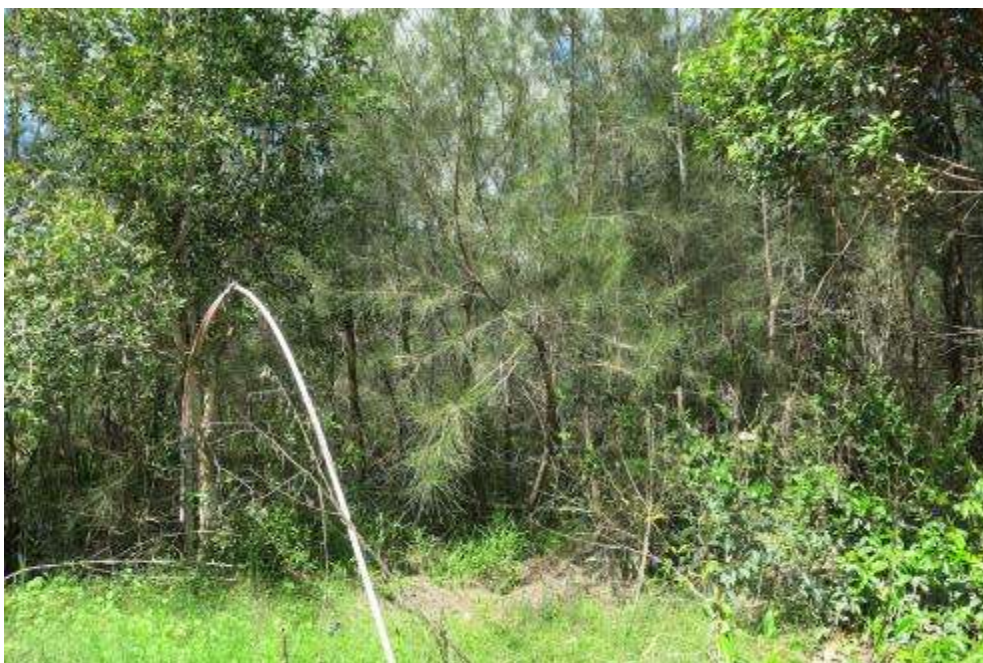
Despite this prediction, a thicket of casuarina and melaleucas have continued to develop around and within this quadrat. This continuing vegetative development continues to displace weed species. This vegetation community will continue to mature and diversify over the years to come.

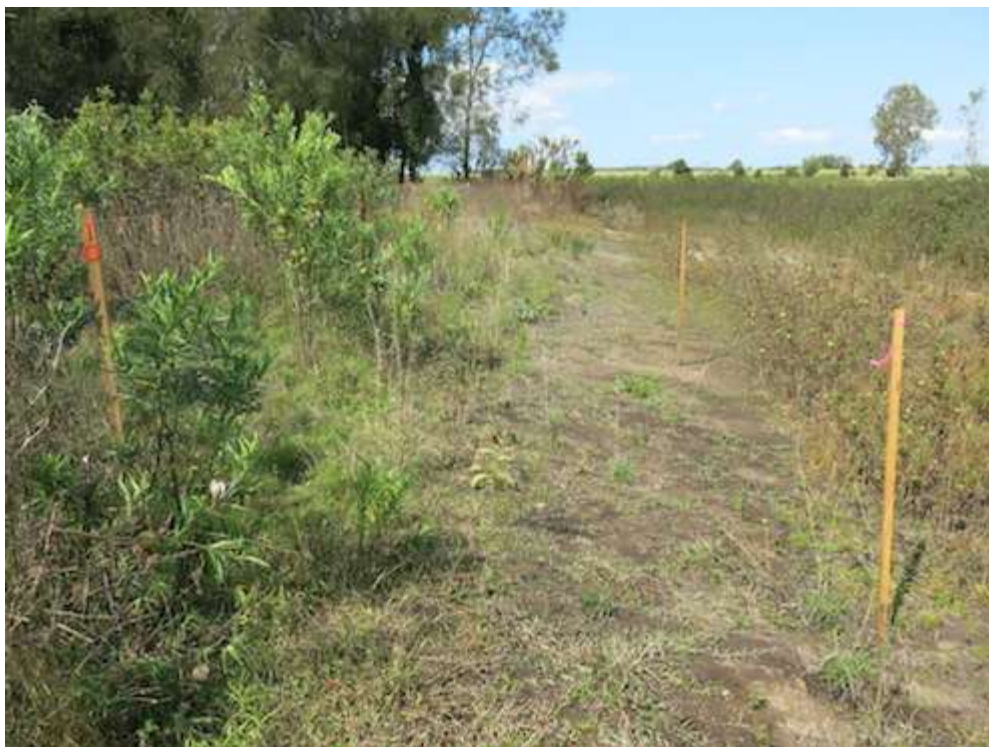
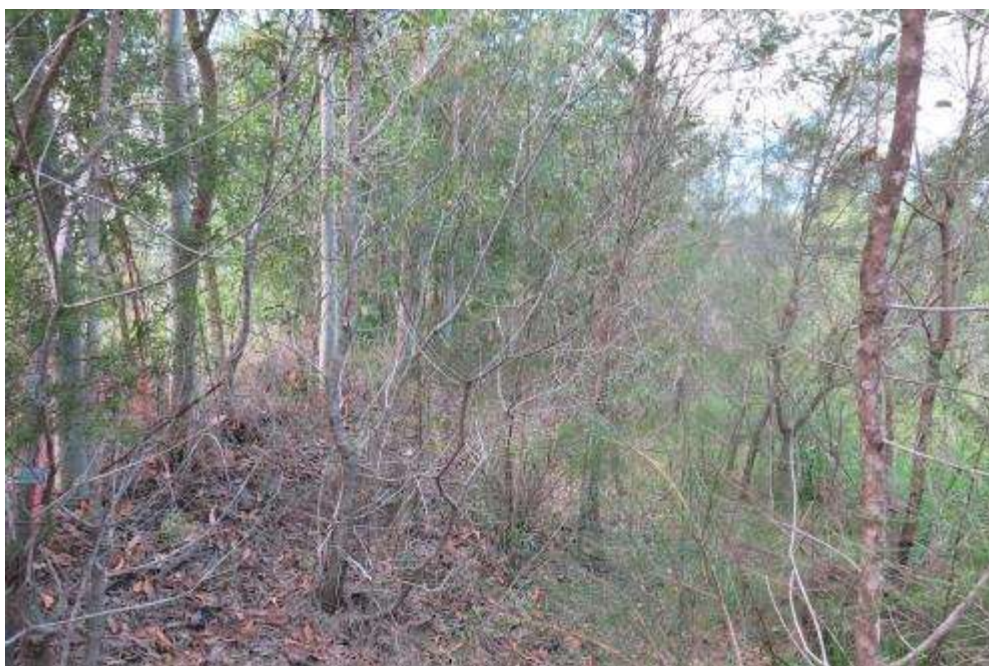
This quadrat, and the similar surrounding areas, has the highest diversity of canopy vegetation, including a number of eucalypts. This quadrat is the only one at a higher elevation therefore data is skewed to the moister communities.

As this quadrat is at a higher elevation, it does suffer the most from dry weather. This quadrat is progressively transitioning towards a grassy woodland structure with dominance of native grasses in the understorey.

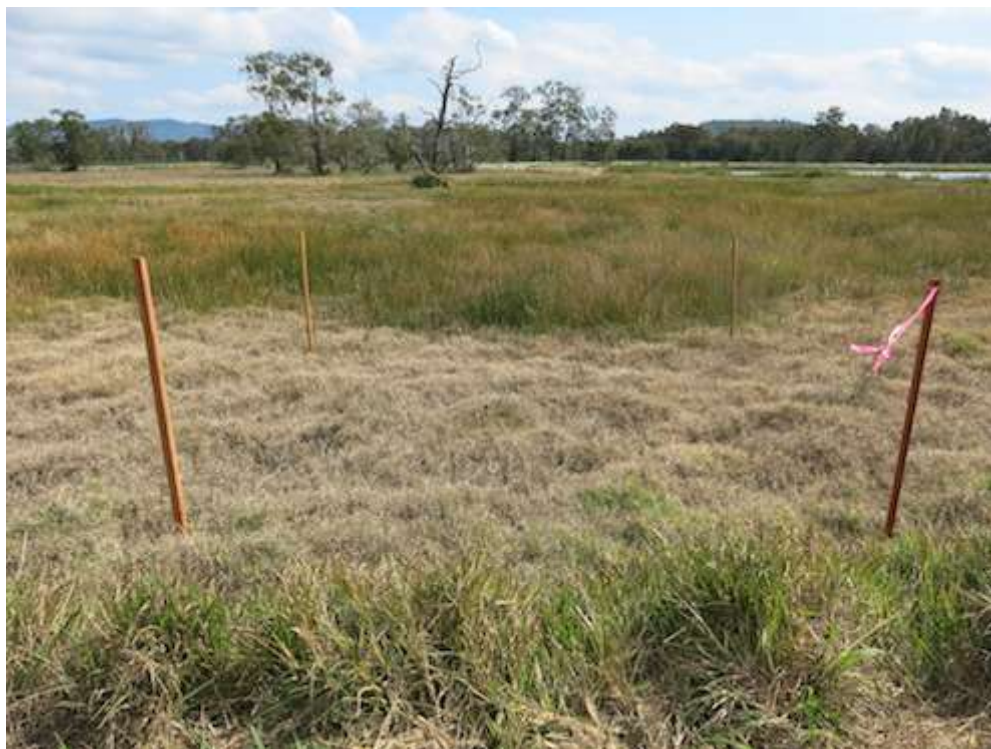
Photo Plate 21: Quadrat 11 - Month 1 (September 2015)

This quadrat is still degraded and struggling to achieve native dominance. The surrounding areas are increasing in wetland species.

It is predicted that this quadrat and surrounding area will eventually be dominated by sedges and rushes.

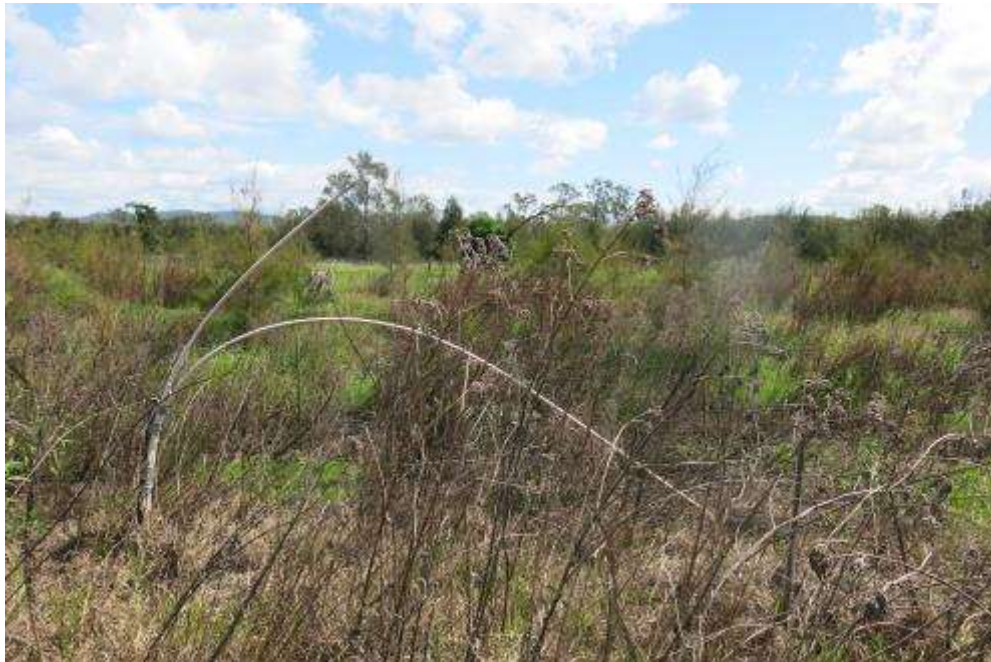
Photo Plate 22: Quadrat 11 - Month 54 (February 2020)

This quadrat began the five year monitoring period with a complete coverage with introduced grasses. This quadrat is highly susceptible to invasion by annual herbaceous weed species. Depending on the volume of rain and season this can alternate between aster and thistle species. These annual pasture weeds are not a significant environmental concern.

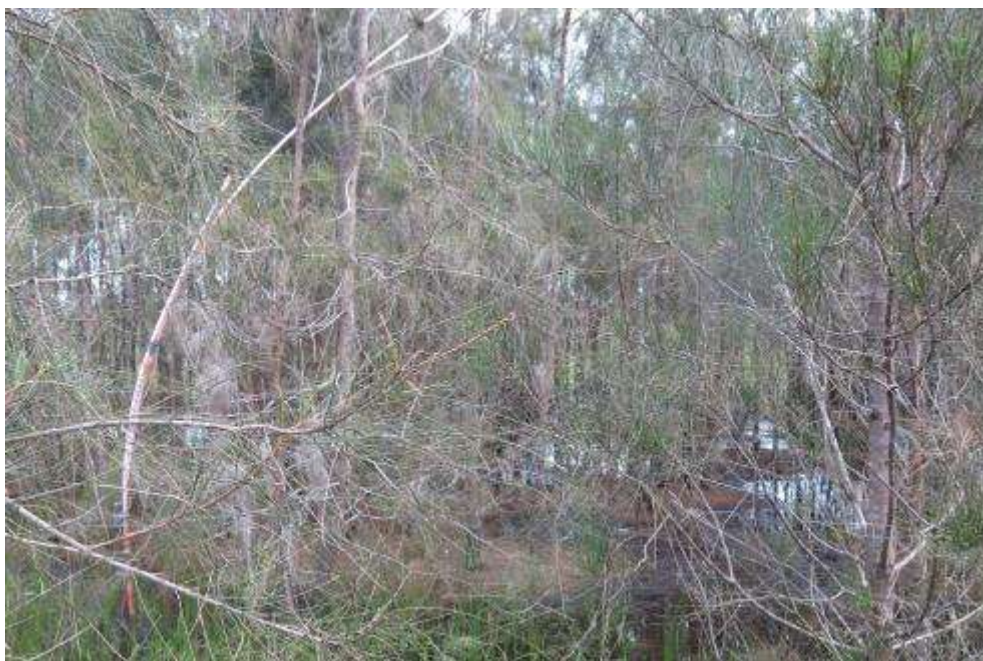
Photo Plate 24: Quadrat 12 - Month 54 (February 2020)

Now, a canopy of casuarina has formed and continues to grow in height and biomass. Due to the increase in shading and organic build up, weed species have shown a significant decline.

This quadrat is developing well into an open woodland community with a sparse understorey due to regular inundation. A number of wetland plants are present due to this inundation.

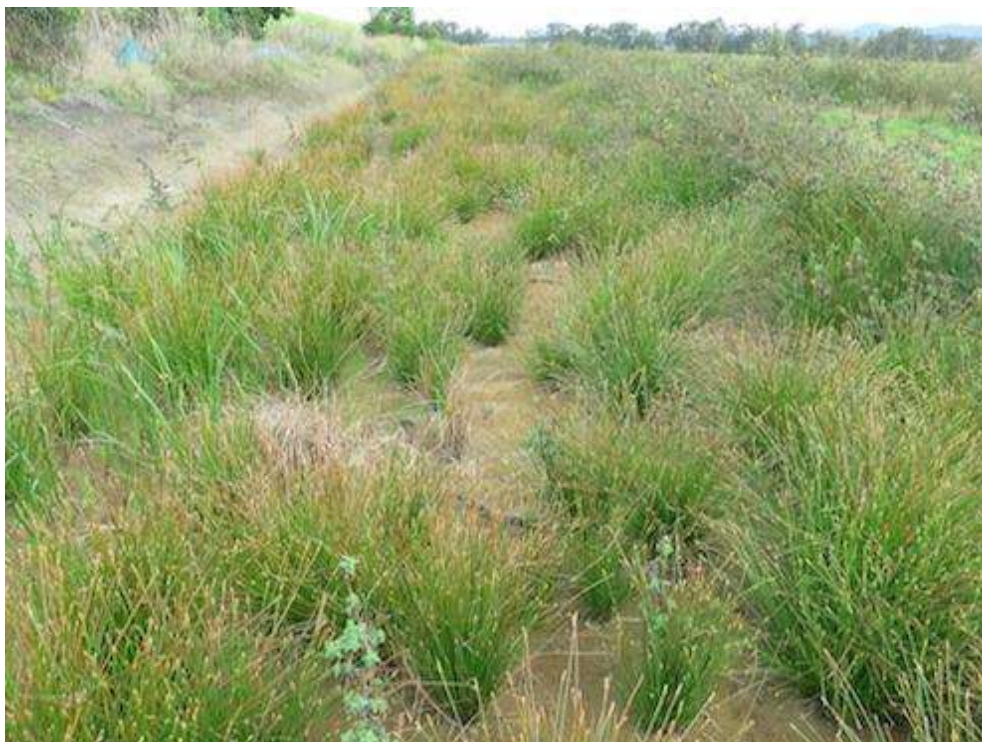
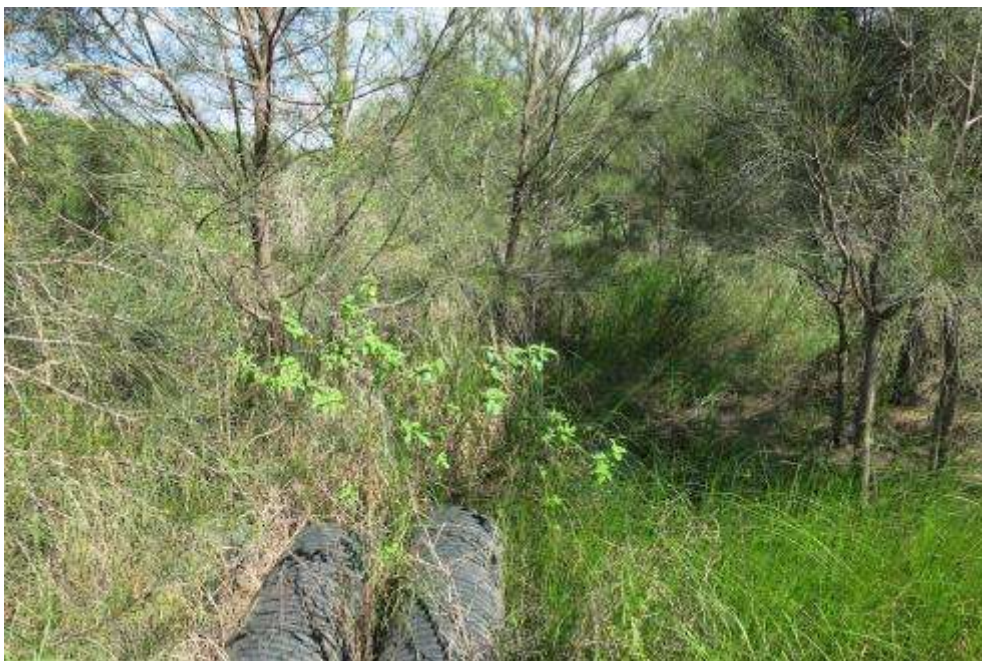
This quadrat began the five year monitoring period with a cover of native sedges, rushes and cyperus species. Due to a period of extended drought-like conditions, this quadrat became extremely distressed, resulting in the dieback of predominantly wetland species.

With the additional build-up of organic materials, conditions have improved greatly allowing for the rapid growth of native vegetation.

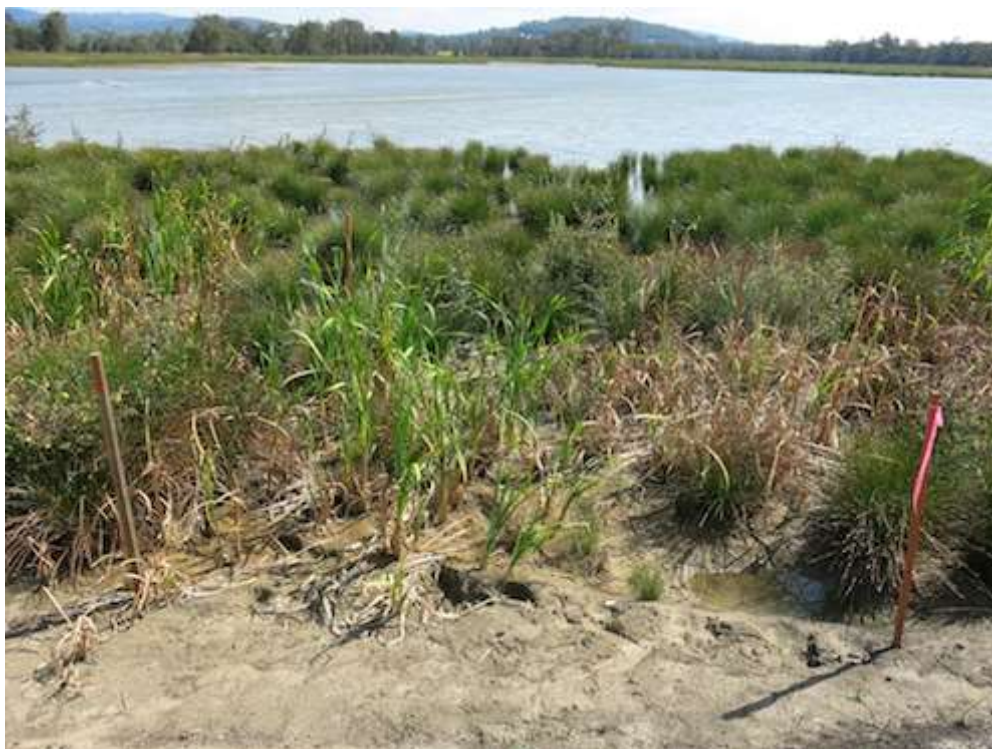
Photo Plate 27: Quadrat 14 - Month 1 (September 2015)

This quadrat began the five year monitoring period with a partial coverage of vegetation, dominated by Typha. This quadrat developed into a monoculture of Typha. Whilst this is a native species, it can often outcompete other wetland species. Control of typha was undertaken within the first 6 months of monitoring, however was not followed up and therefore had little effect.

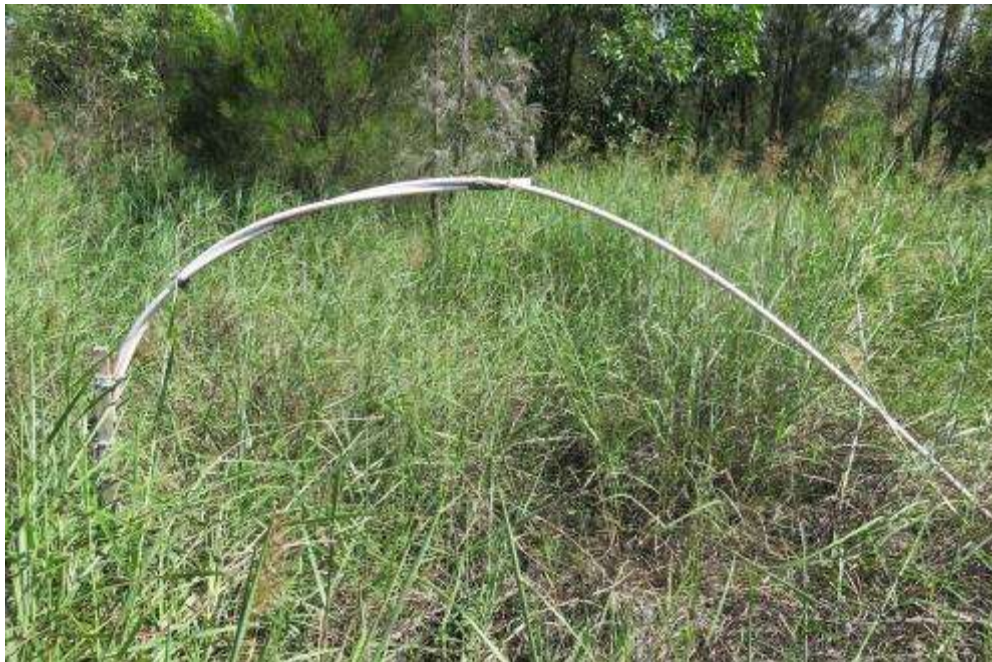
Photo Plate 28: Quadrat 14 - Month 54 (February 2020)

This monoculture has now almost completed a transition towards a grassy understory to a rapidly expanding casuarina canopy.

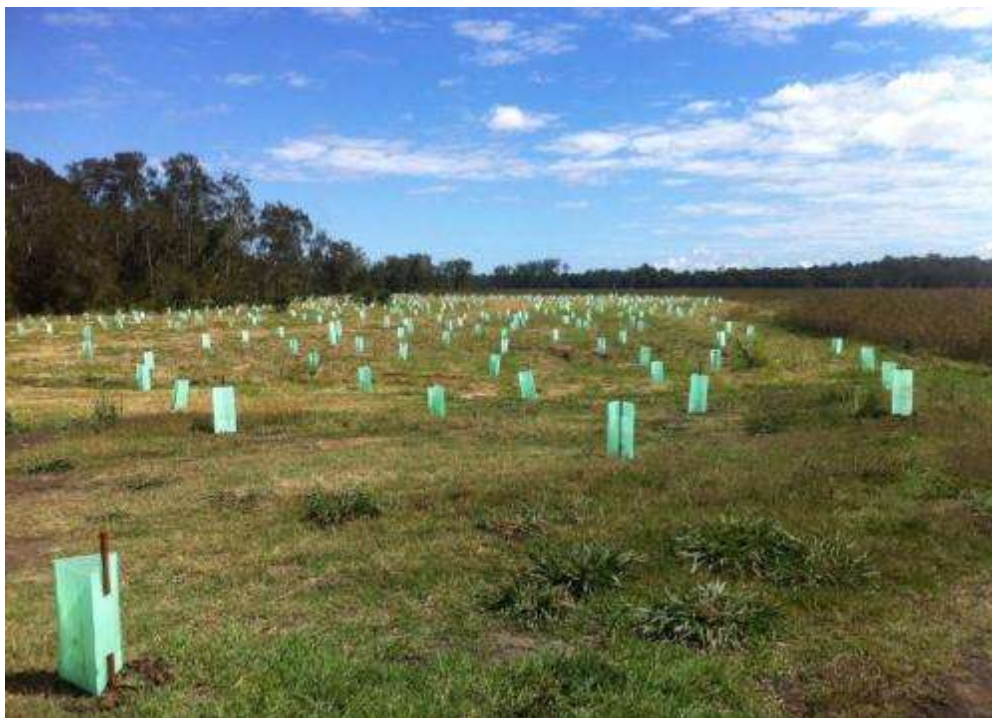
Photo Plate 29: A1 Eucalypt Plantings - Month 1 (September 2015)

Comparison Summary
Approximately 7,000 koala resource trees were planted adjacent to Hotham Creek and the Pimpama River. The site was previously degraded grazing pasture. Grasses were slashed prior to planting. Tree guards were removed at 5 months, once the stock had successfully established. Pasture grasses quickly regained their original height.

Canopy vegetation within this area continues to extend the overall percentage of cover, allowing for the increase of native species recruitment.

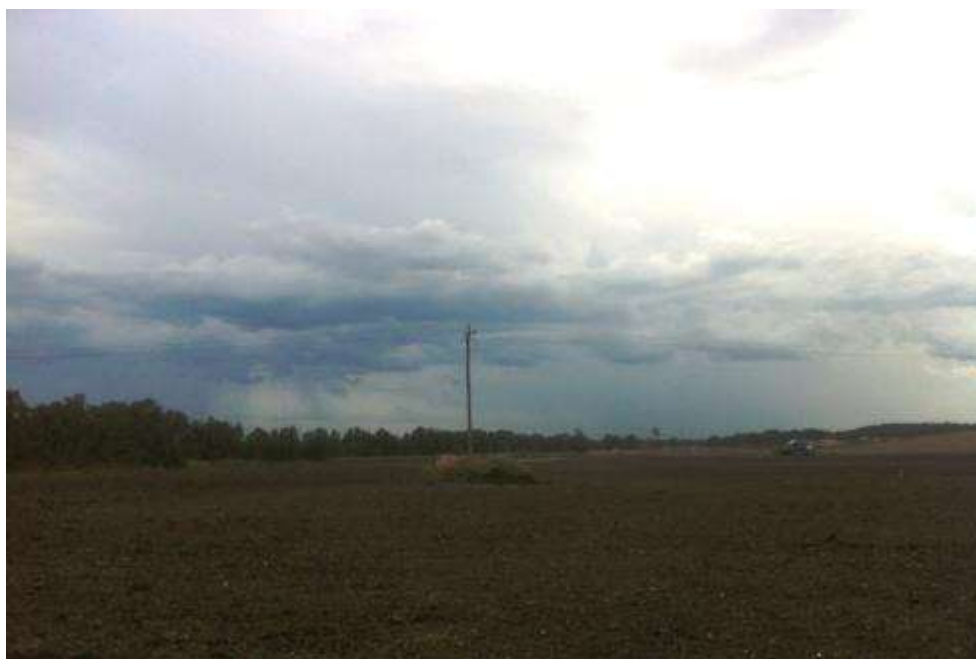
Photo Plate 31: A2 Eucalypt Plantings - Month 1 (September 2015)

This area was seeded and consisted of approximately 9ha. Immediately subsequent to the seeding, 8,000 koala resource trees were planted. The site is inundated more frequently, which is creating significantly different hydrological conditions to that of A1. This has resulted in a different progression of rehabilitation when compared to that of A1.

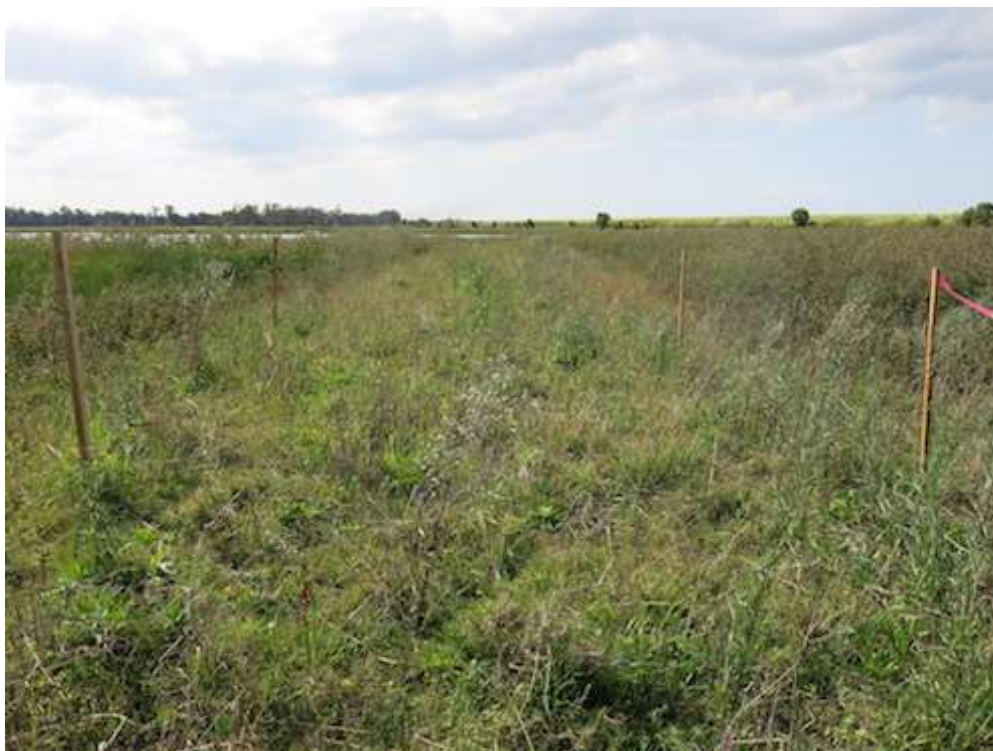
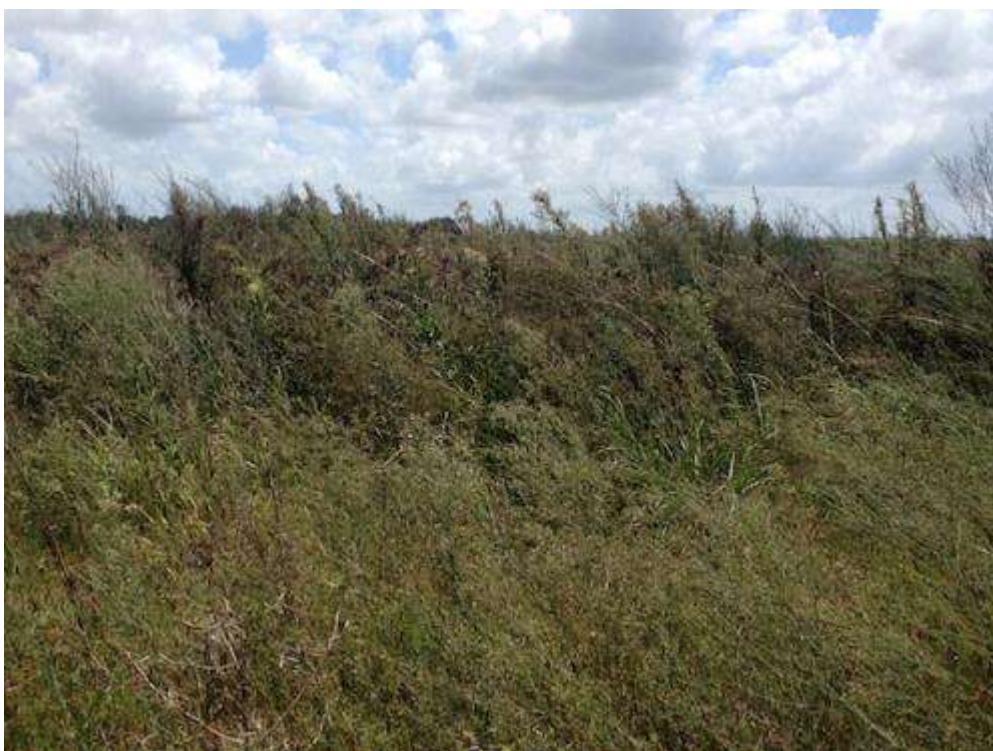
Weeds have remained dominant in this quadrat, however the native grasses have endured and Casuarinas have become common in surrounding areas. Overall there is a significant increase in biomass without a commensurate increase of native species. Native grass presence is noted however no tree species recorded and unlikely to appear.
