North-West Conservation Park - Rehabilitation Monitoring

Lot 1 RP48903

North-West Conservation Park
Gainsborough Greens

March 2020

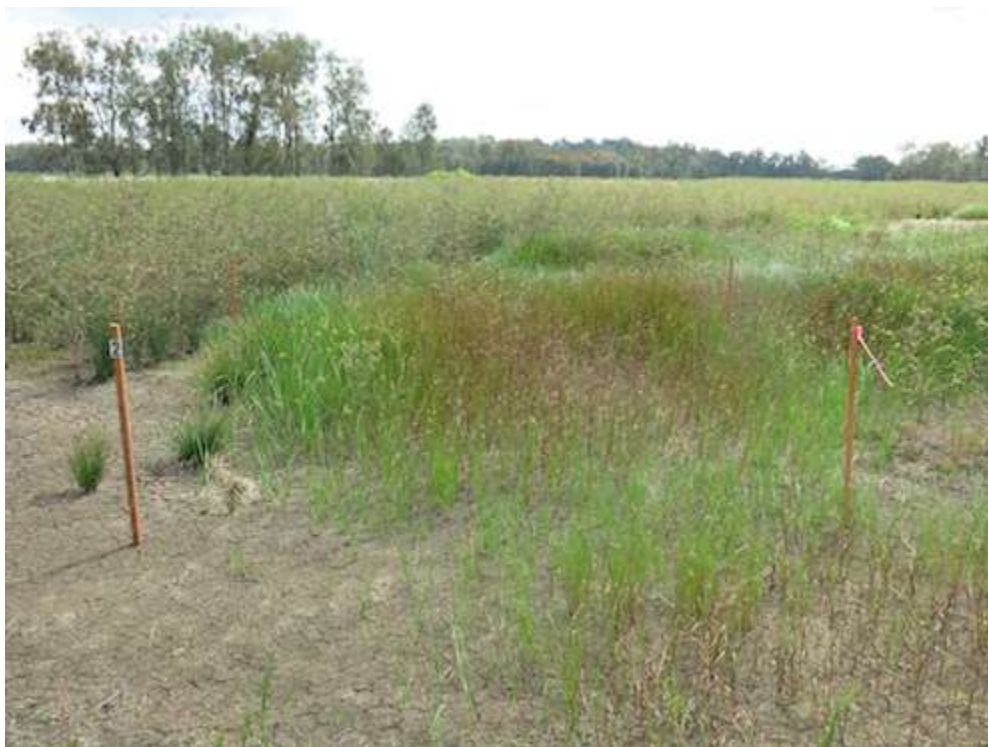
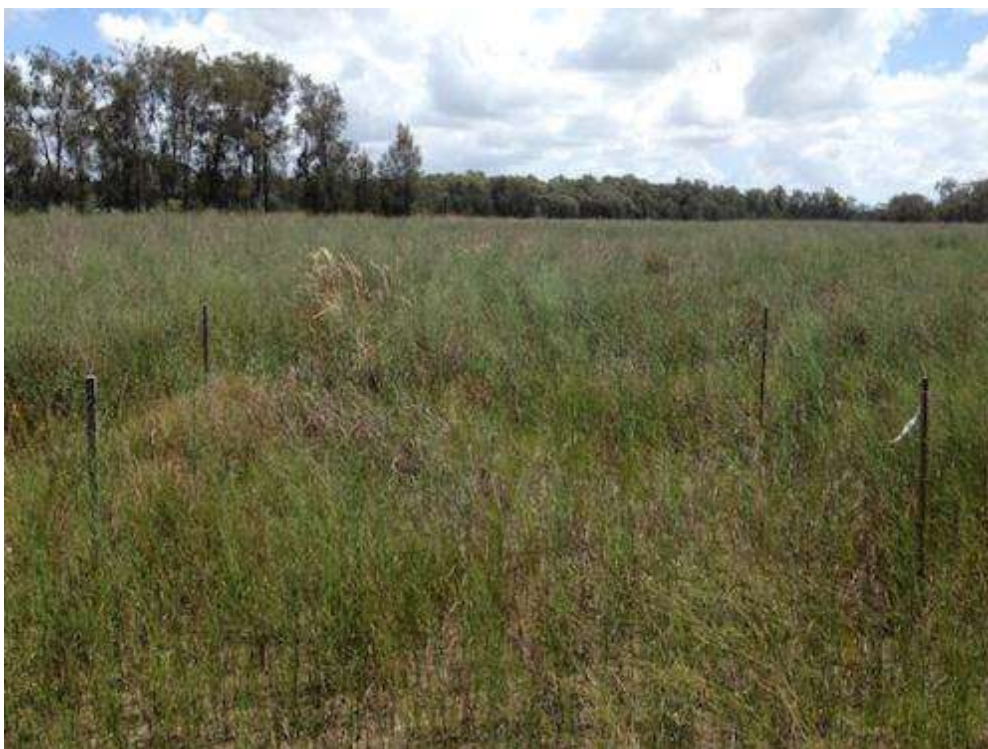
Comparison Summary
Native species have continued to dominate this quadrat and canopy trees have become common in surrounding areas up to 1.5m. Steady expansion of natives and setting of new seed has strengthened the ecological resilience of this quadrat, a solid result these past six months.

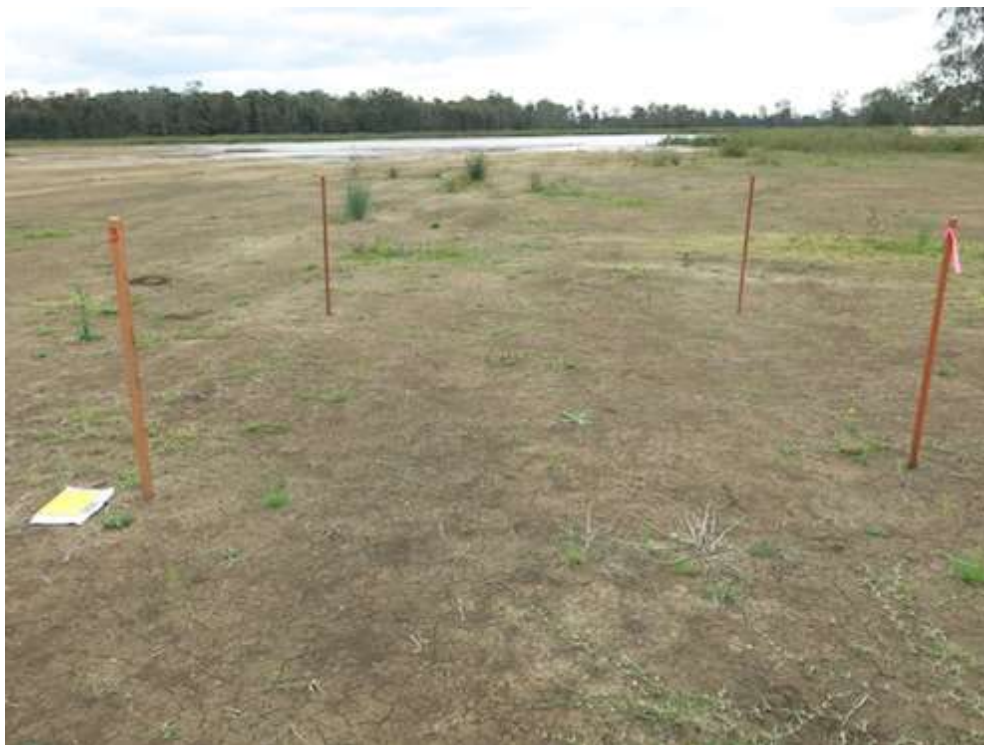
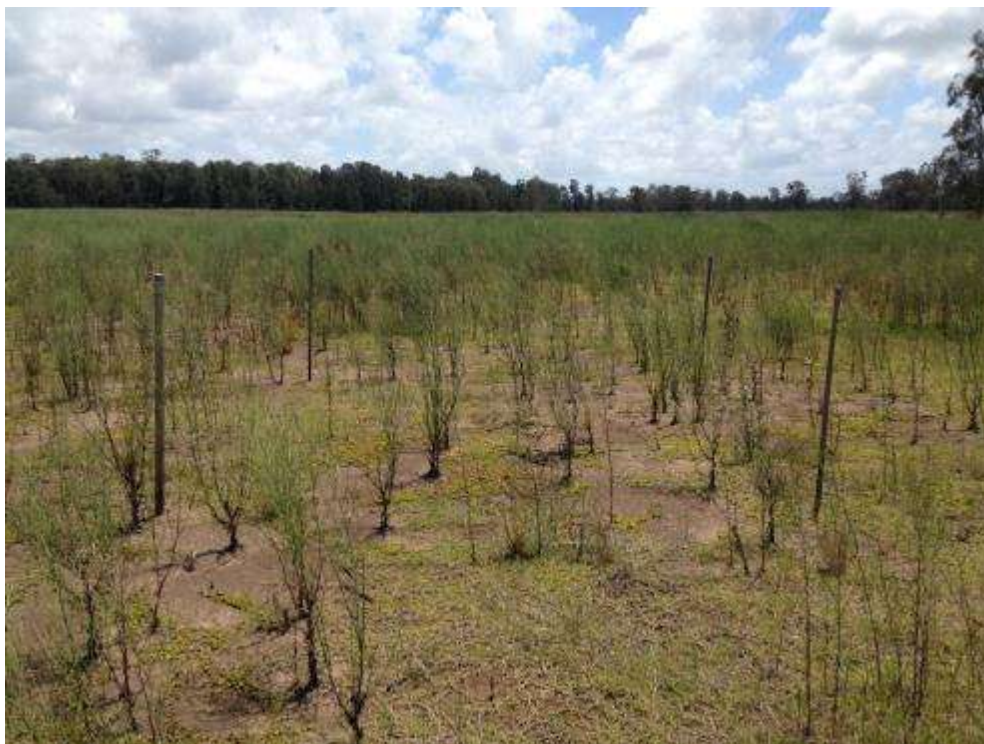
Comparison Summary
Four new weed species have colonised this quadrat, however canopy trees have become common in the surrounding areas although still in seedling form. These weeds are providing competition for the native seedlings. The author is confident that over time the native trees will outperform and out shade weed species present at this time. Hundreds of tree seedlings are within a 20m radius of this quadrat.

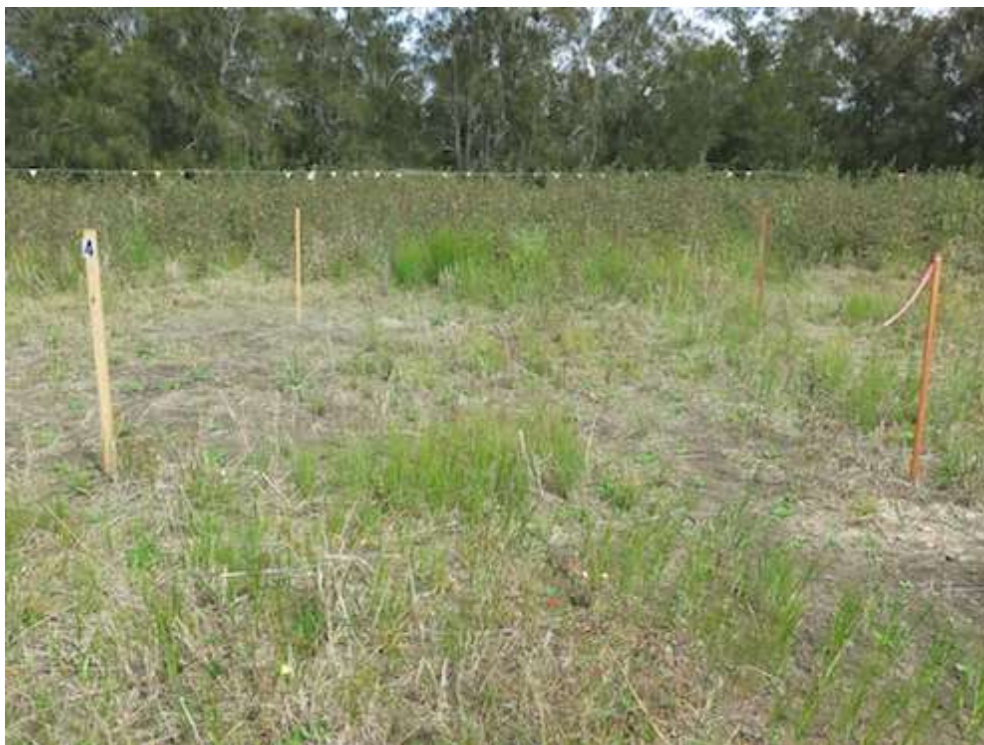
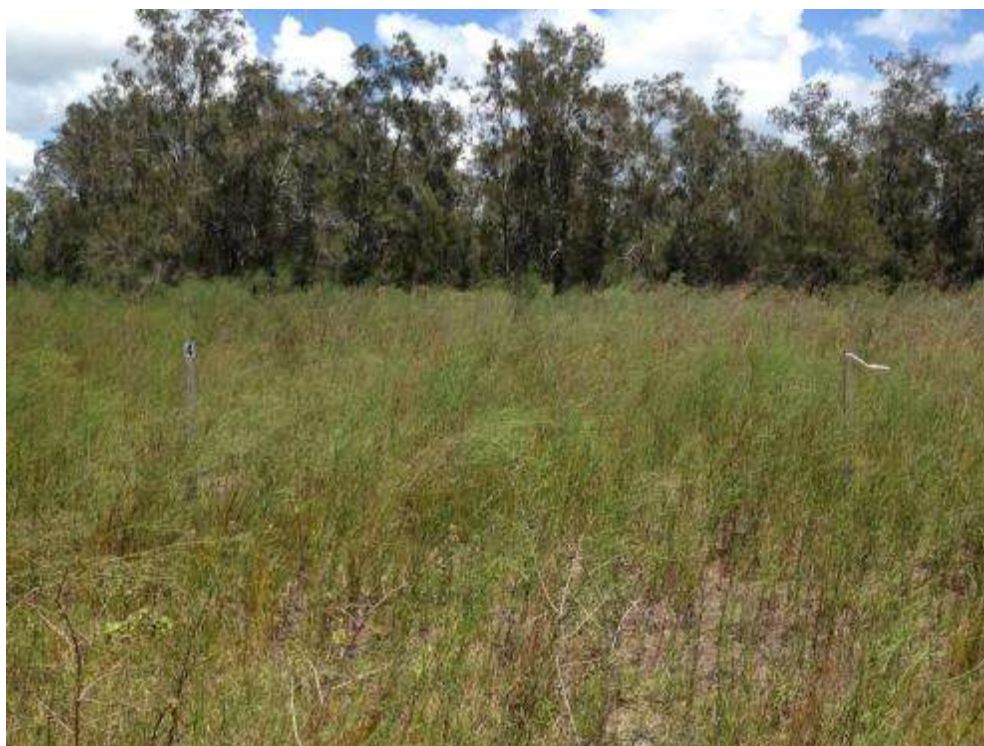
A number of new weeds have emerged however canopy trees occur within the quadrat and surrounding areas, although still in seedling form. Aster is also predominant in this quadrat. As found elsewhere, the aster is serving a useful function for competition and protection. Beyond this quadrat couch grass is encroaching toward the quadrat. Careful monitoring will continue to be required to determine what effect this will have in the future.

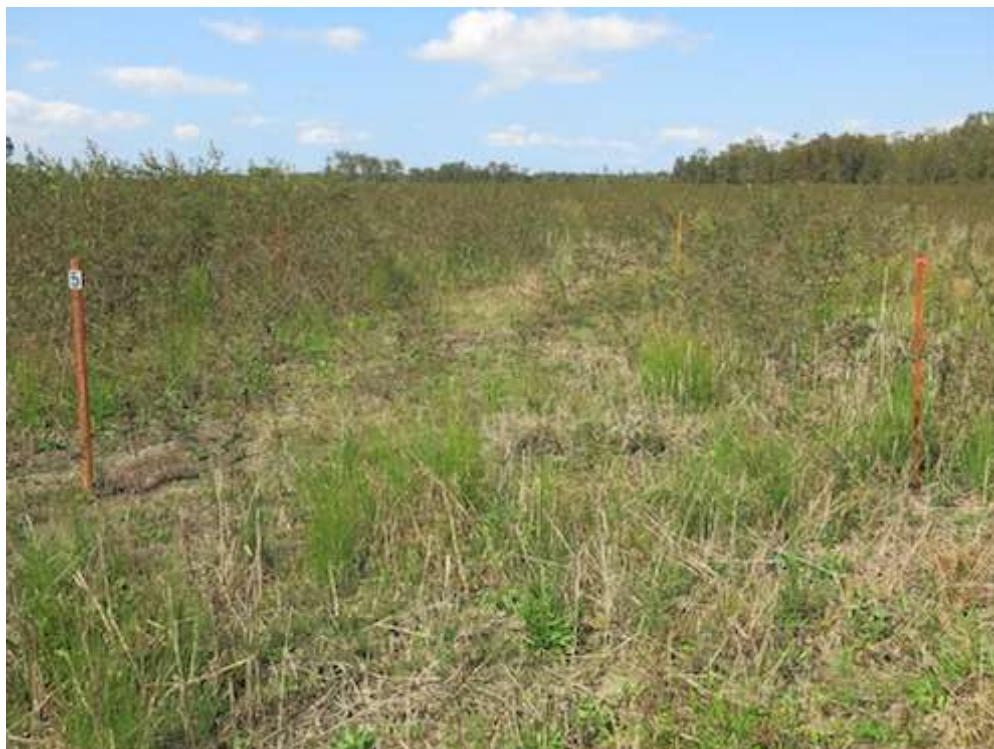
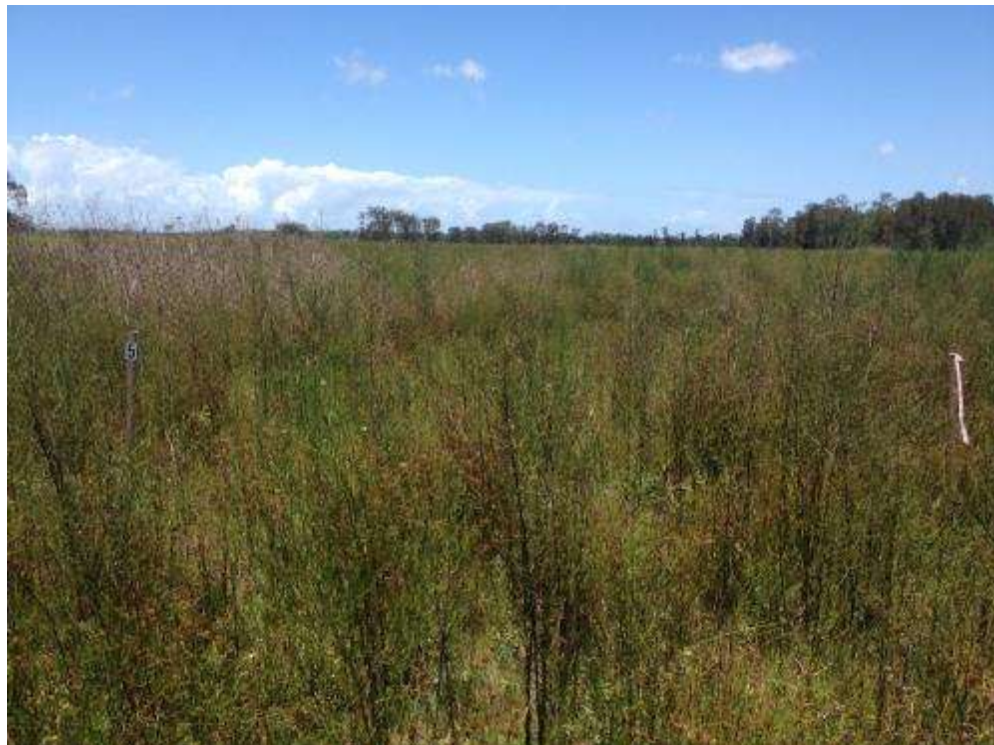
A number of new weeds have emerged, however canopy trees occur within the quadrat and surrounding areas up to 1.7m. An impressive increase in biomass is also noted in this quadrat.

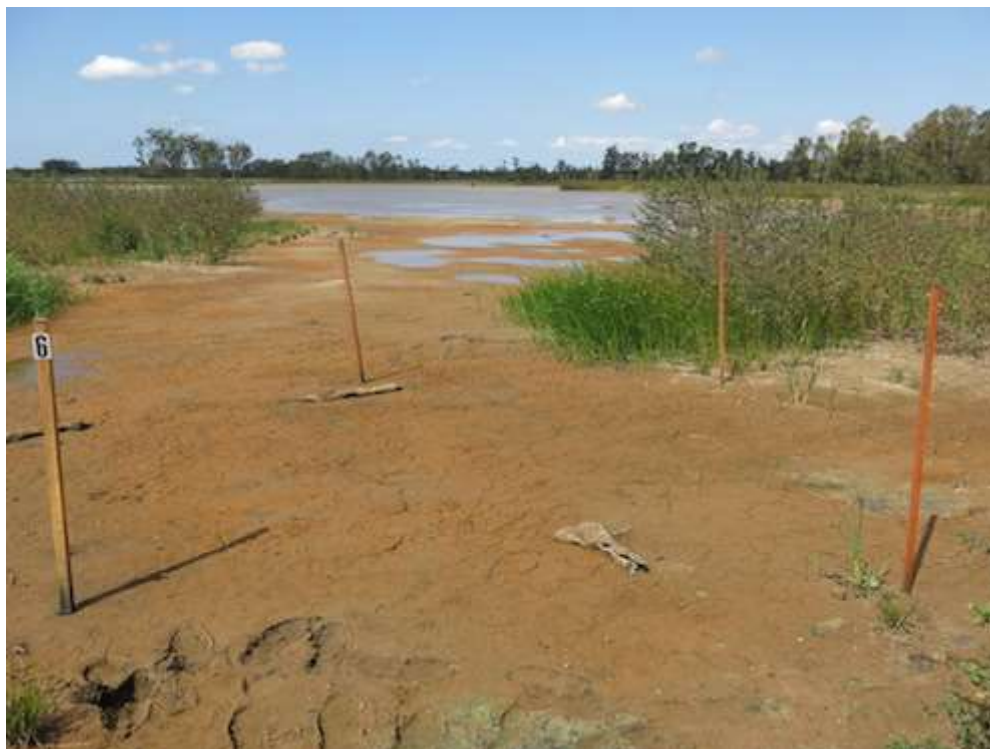
Photo Plate 43: Quadrat 6 - Month 1 (September 2015)

Comparison Summary
Vegetative cover has increased from 1% to 80%. A number of weed species have emerged, however a significant number of canopy trees occur in the surrounding areas. As per quadrat 5 it's expected that *Melaleuca spp.* will become more prevalent in the coming months. The physical change of this quadrat in six months is quite remarkable.

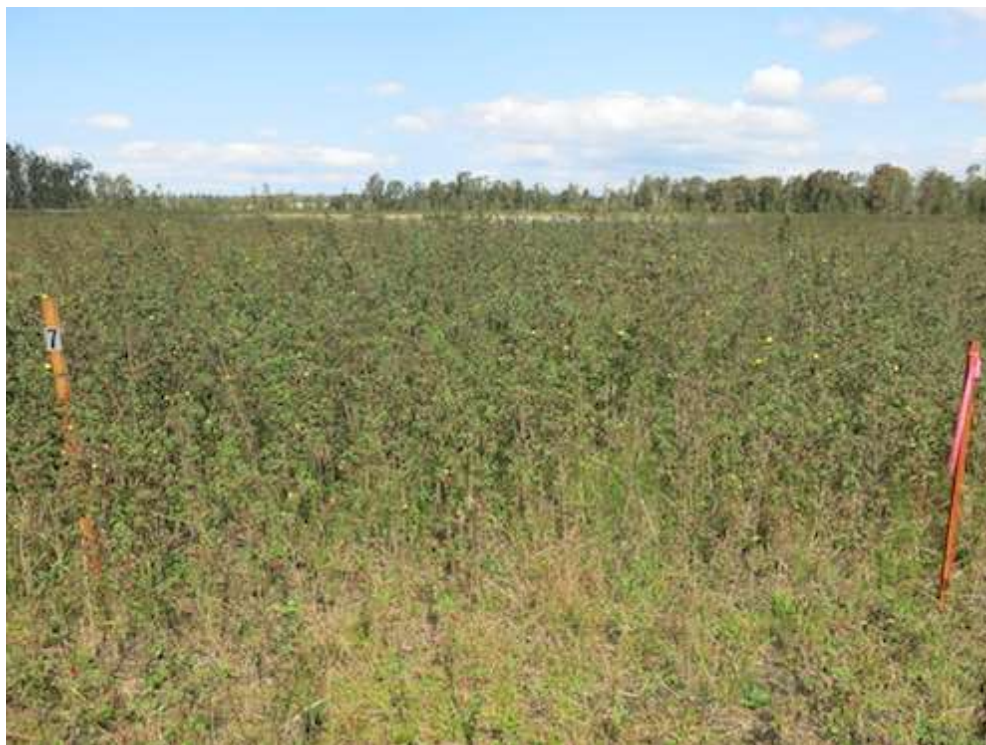
Photo Plate 45: Quadrat 7 - Month 1 (September 2015)

The number of canopy trees within this quadrat has increased from 1 to 6, and native species continue to dominate. It's likely that within 2 years this quadrat will be unrecognisable due to the presence and growth of these canopy trees. The 6 month picture doesn't reflect just how much native growth is occurring within this quadrat.

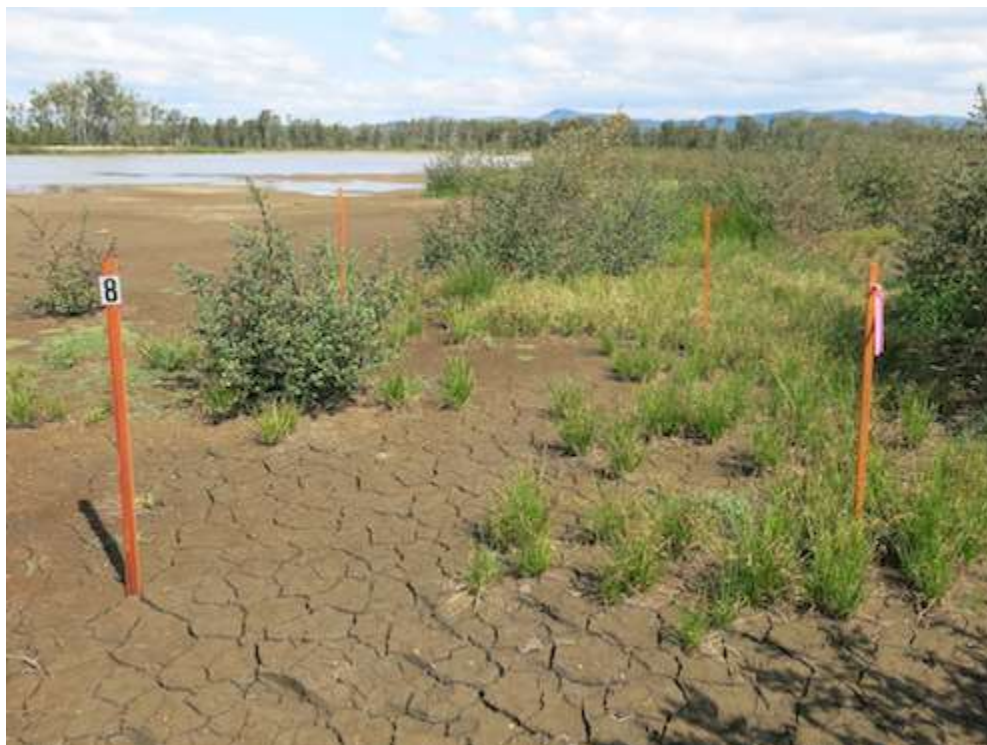
Photo Plate 47: Quadrat 8 - Month 1 (September 2015)

A number of new weed species have emerged, however a significant number of native canopy trees occur within the surrounding areas. This quadrat also represents an excellent example of how standing water can act as a weed suppressant in wetland conditions. Native dominance has been reduced by approximately one third over the past 6 months due to weed incursion. This said, it's expected that seasonal inundation will be effective in reducing the proliferation of exotic species in the future.

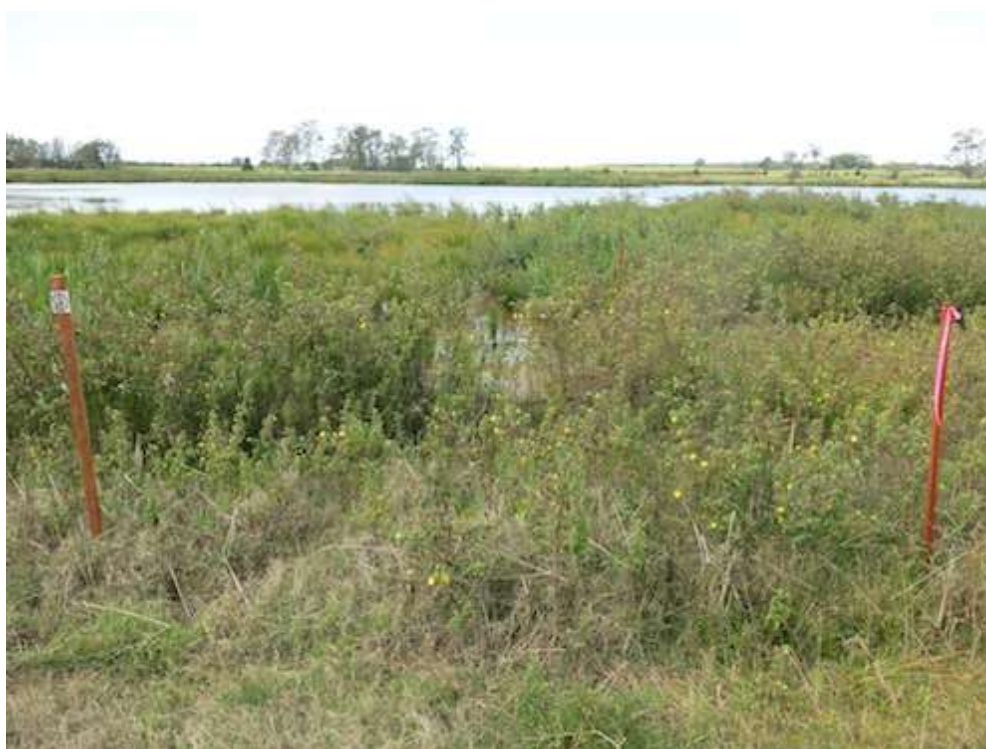
Photo Plate 49: Quadrat 9 - Month 1 (September 2015)

An additional canopy species has emerged and native species remain dominant. This quadrat is clearly suffering the effects of extended drought. Native plant vigour has been reduced, particularly in the last 3 months. This trend is expected to reverse once seasonal rainfall occurs.

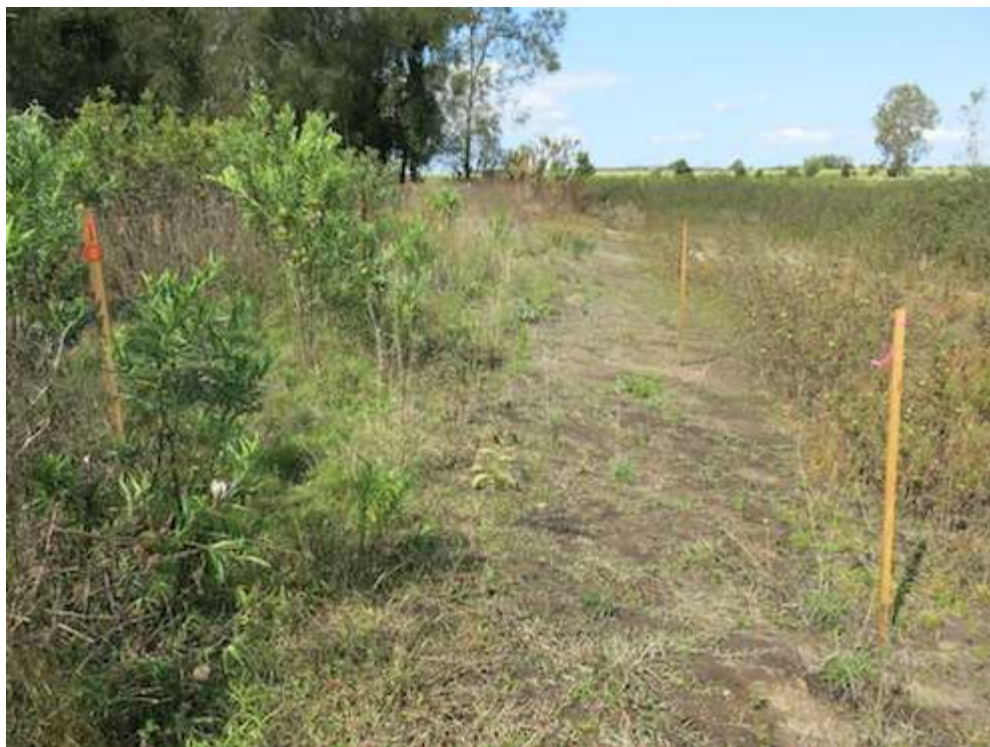
Photo Plate 51: Quadrat 10 - Month 1 (September 2015)

This quadrat displays an increase in diversity and native dominance has increased from 76%-90%. Canopy trees occur within the quadrat up to 3.2m. The quadrat is the most diverse site in the entire monitoring precinct at this time. Diversity can be attributed to the differing soil profiles and inundation experienced across the quadrat.

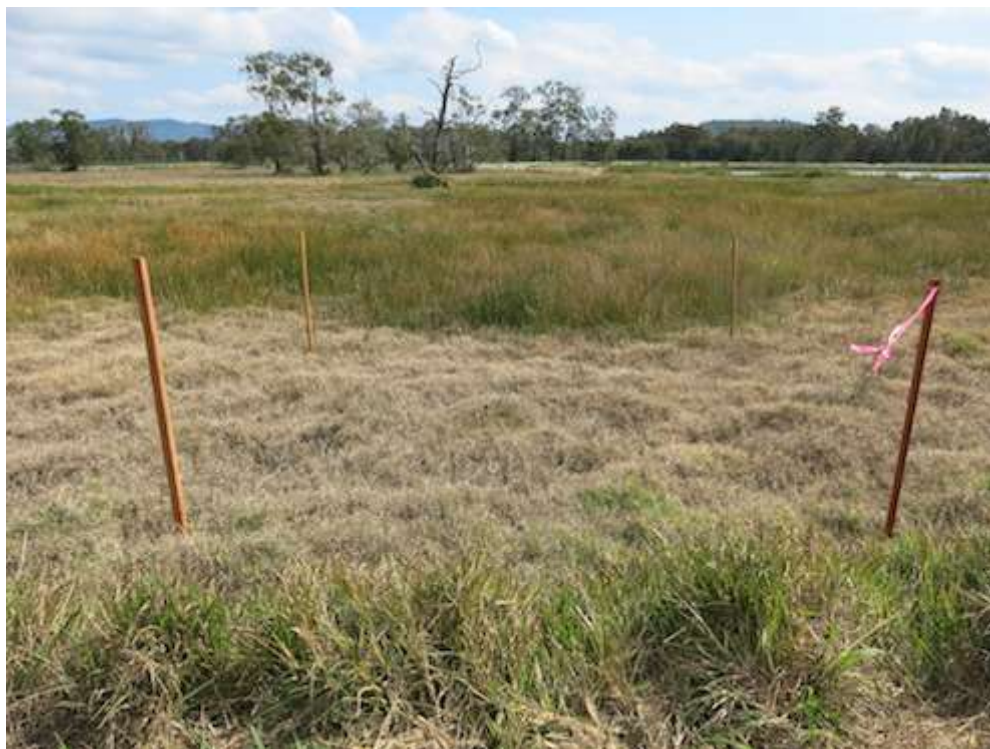
Photo Plate 53: Quadrat 11 - Month 1 (September 2015)

Additional species have emerged including both native and exotic. Native species remain dominant. Seasonal growth of exotic annuals can be witnessed in the background (Aster, Common Sow Thistle). This has also been a consequence of an extended drought where inundation has not been present and assisting with weed control.

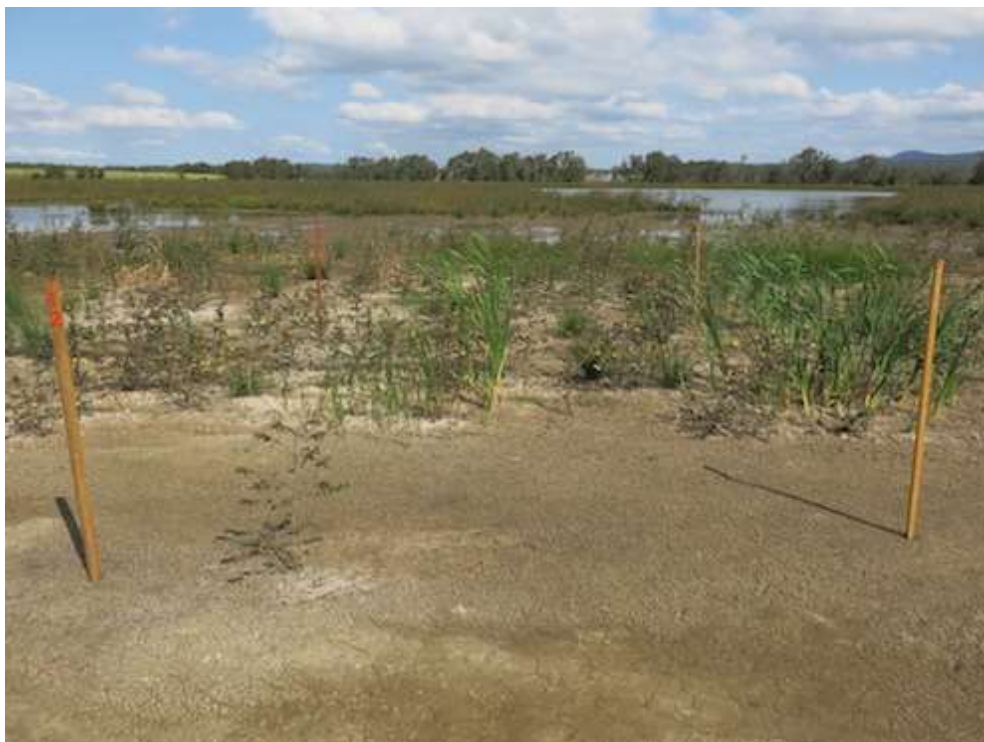
Photo Plate 55: Quadrat 12 - Month 1 (September 2015)

The number of canopy trees within this quadrat has increased from 0 to 34 and native species continue to dominate. This quadrat is another site that will be unrecognisable within 24 months.

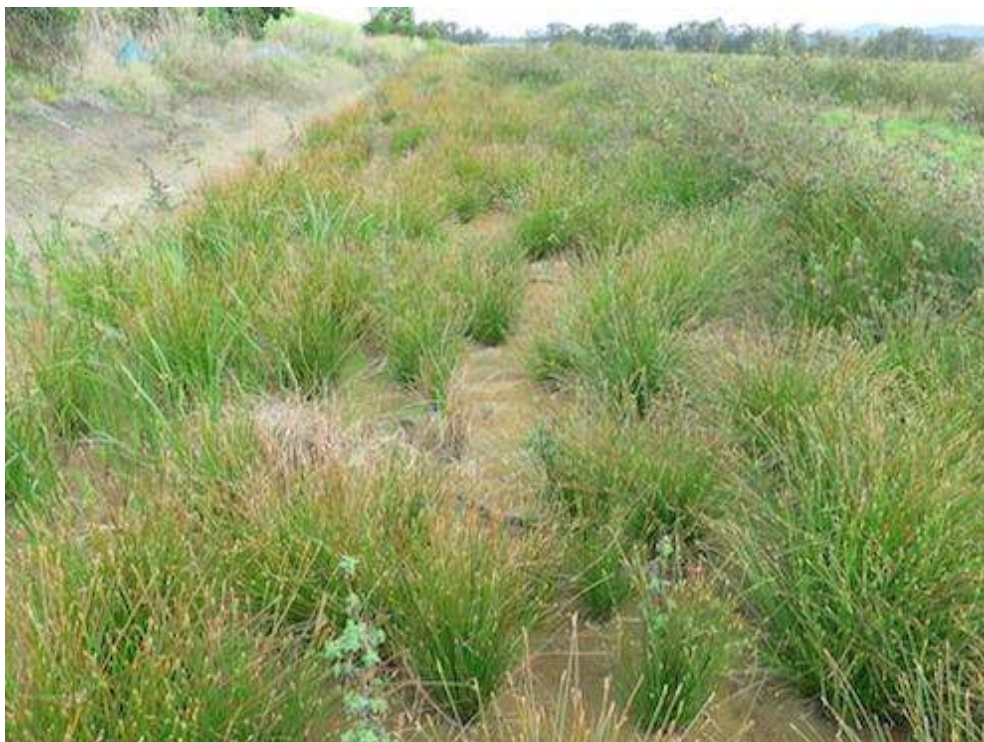
Photo Plate 57: Quadrat 13 - Month 1 (September 2015)

A number of weed species have emerged as a consequence of the extended drought. The earthworks profile will allow for significant inundation when seasonal rain arrives upon which the dry land dependant exotics will suffer and the wetland natives will continue to prosper.

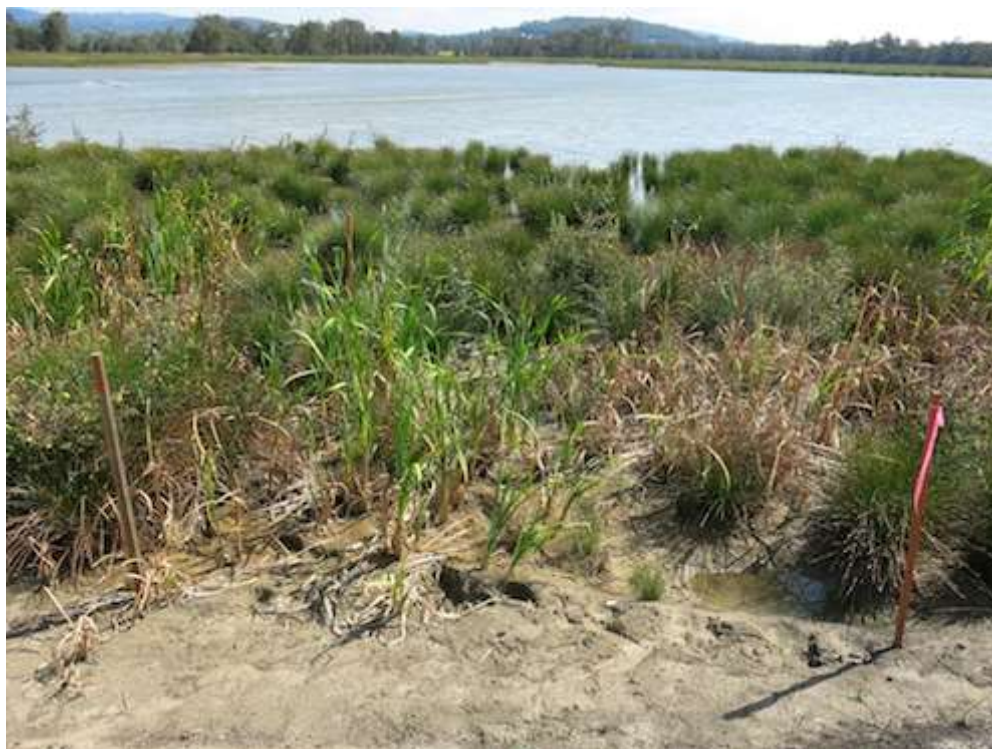
Photo Plate 59: Quadrat 14 - Month 1 (September 2015)

Comparison Summary
Vegetative cover has increased from 50% to 80%. A number of weed species have emerged, however native species remain dominant. The soil profile here is similar to quadrat 13. Therefore it's equally expected that dry land weed species will suffer when seasonal rainfall occurs. Native wetland species are clearly in a state of moderate distress at this time due to extended drought conditions.

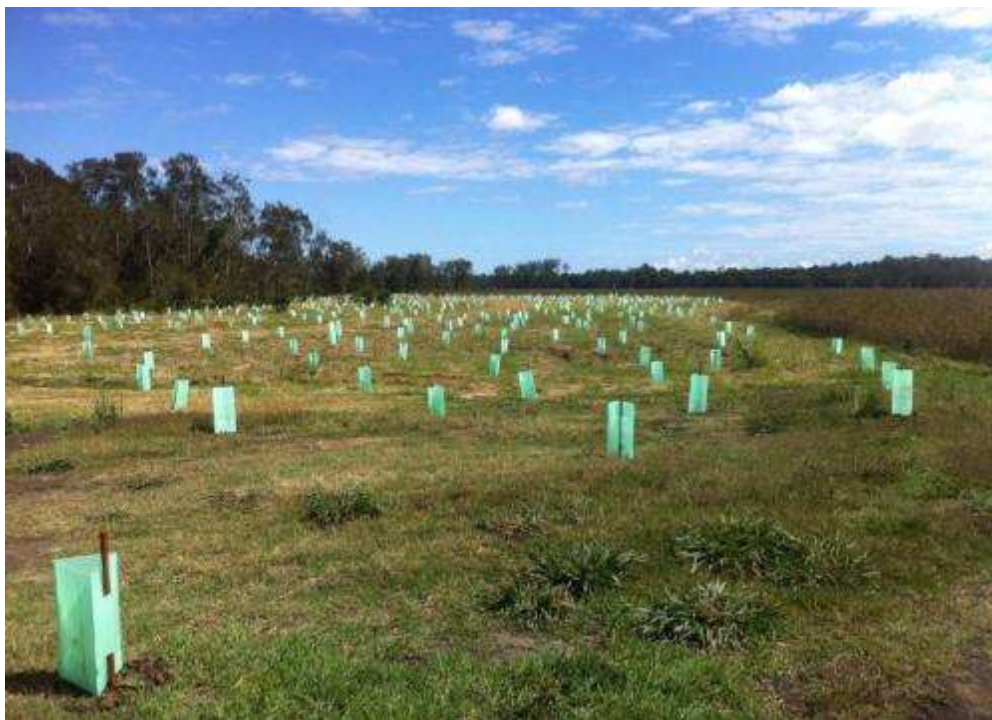
Photo Plate 61: A1 Eucalypt Plantings - Month 1 (September 2015)

Comparison Summary
Approximately 7,000 koala resource trees were planted adjacent to Hotham Creek and the Pimpama River. The site was previously degraded grazing pasture. Grasses were slashed prior to planting. Tree guards were removed at 5 months after approval from Habitat that the stock had successfully established. Pasture grasses quickly regained their original height. At this time the tubestock is starting to grow above the pasture grasses. Average height of tubestock throughout is 600-800mm and all stock is now hardened and performing well. It's expected these plantings will have an average height of 2 metres within the next 18-24 months.

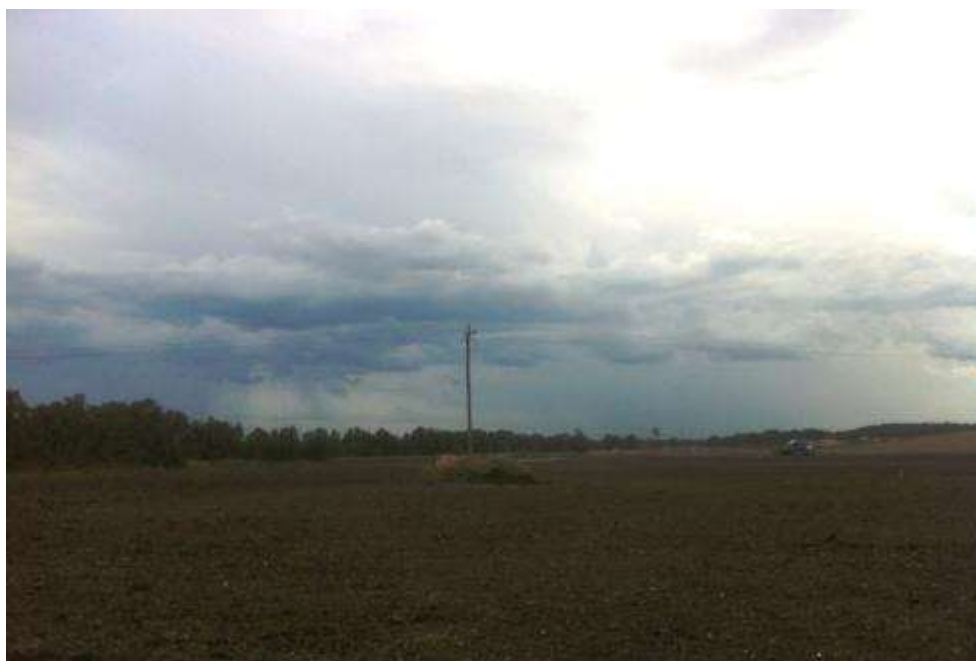
Photo Plate 63: A2 Eucalypt Plantings - Month 1 (September 2015)

This area was seeded in September/October 2015 and consisted of approximately 9ha. Immediately subsequent to the seeding, 8,000 eucalypt koala resource tubes were planted. After 5 months the results are very positive. All tubstock is performing well (average height 1 mtr) and 69% of native seed species have successfully germinated. The site is periodically inundated, reflected by standing water observed in the lower photo.

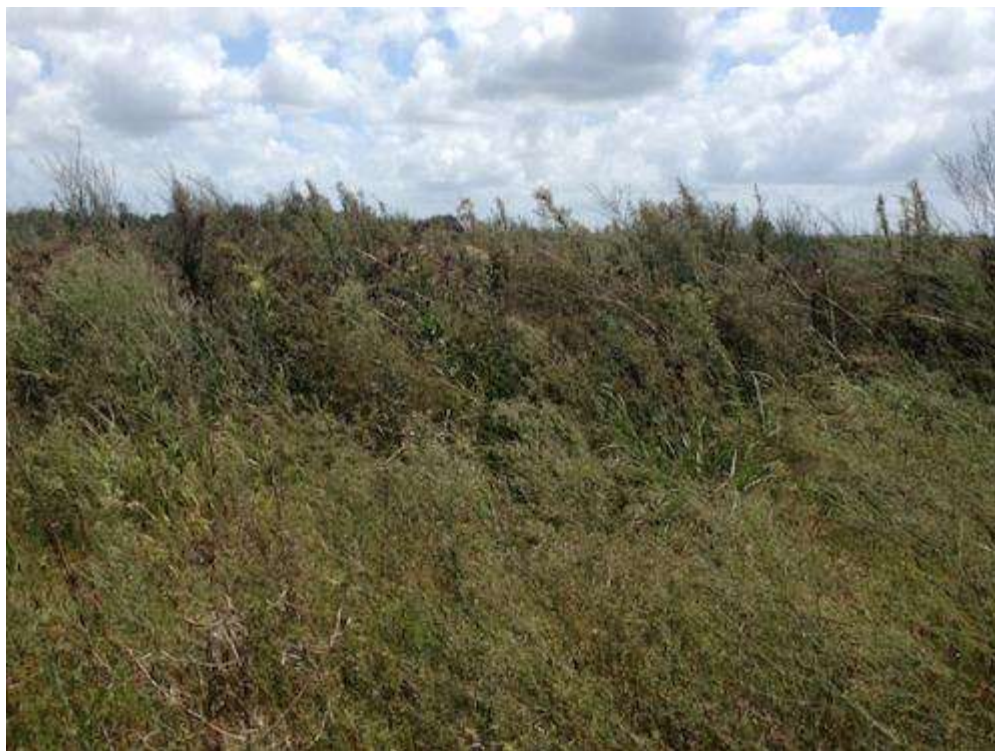
Photo Plate 65: Quadrat 1 - Month 6 (February 2016)

This is the most degraded quadrant. Having said that, the native grass *Capillipedium spicigerum* is common within the quadrant. There is a native dominance of 37%, which is an upward trend of 33% since month 6.

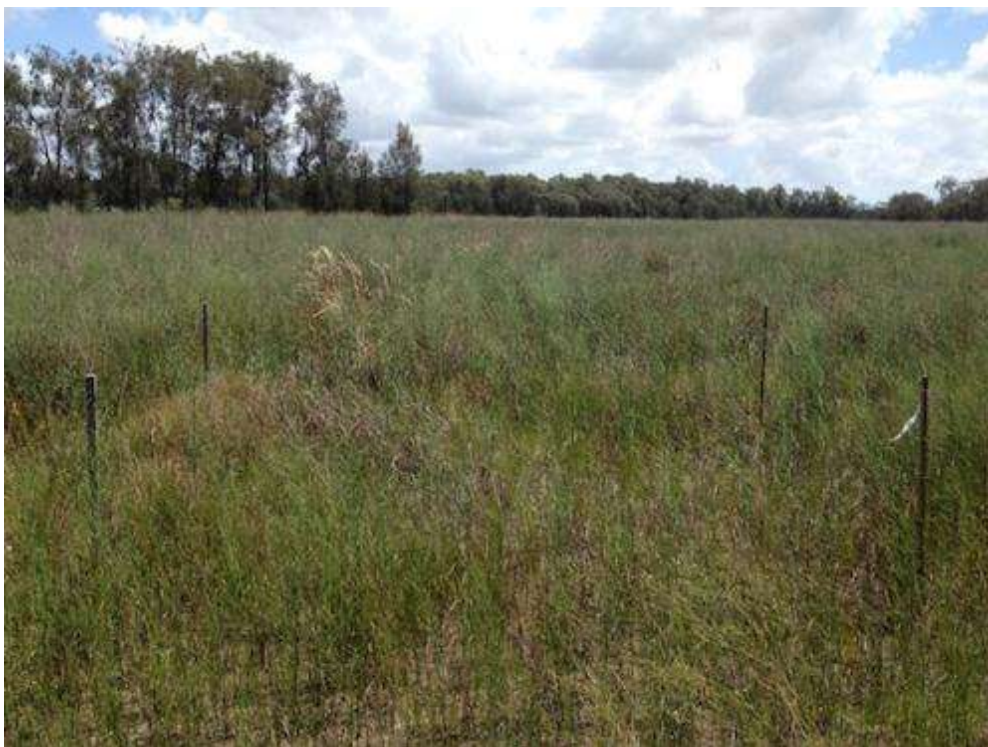
Photo Plate 67: Quadrat 2 - Month 6 (February 2016)

The Aster has died off over winter and reveals a dormant *Bolboschoenus cardwellii*. *Casuarina glauca* is also viable in the foreground.

Both *Melaleuca quinquenervia*, some measuring 1.5m in height, and *Casuarina glauca* surround this quadrat in the hundreds. The entire surrounds are very weed free.

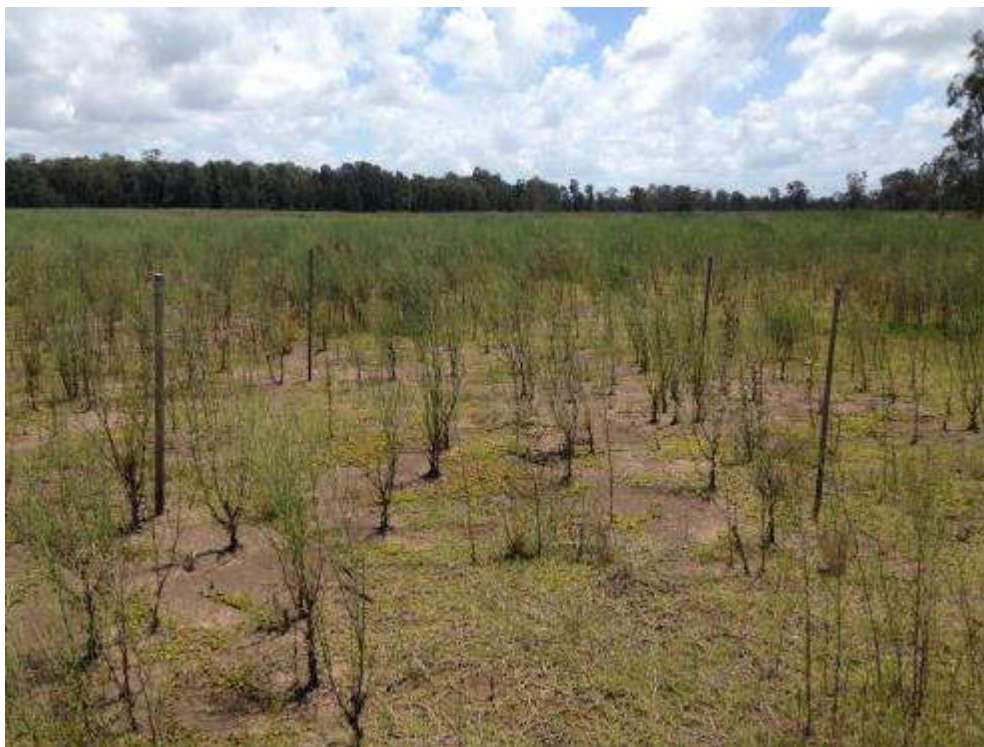
Photo Plate 69: Quadrat 3 - Month 6 (February 2016)

The evidence of dormancy and wintering is obvious. The *Livistona* palm within the quad is still alive but struggling, this can be common with *Livistona*'s.

Lomandra longifolia is becoming common in the surrounds; however, they are struggling with lack of oxygen to the root zone.

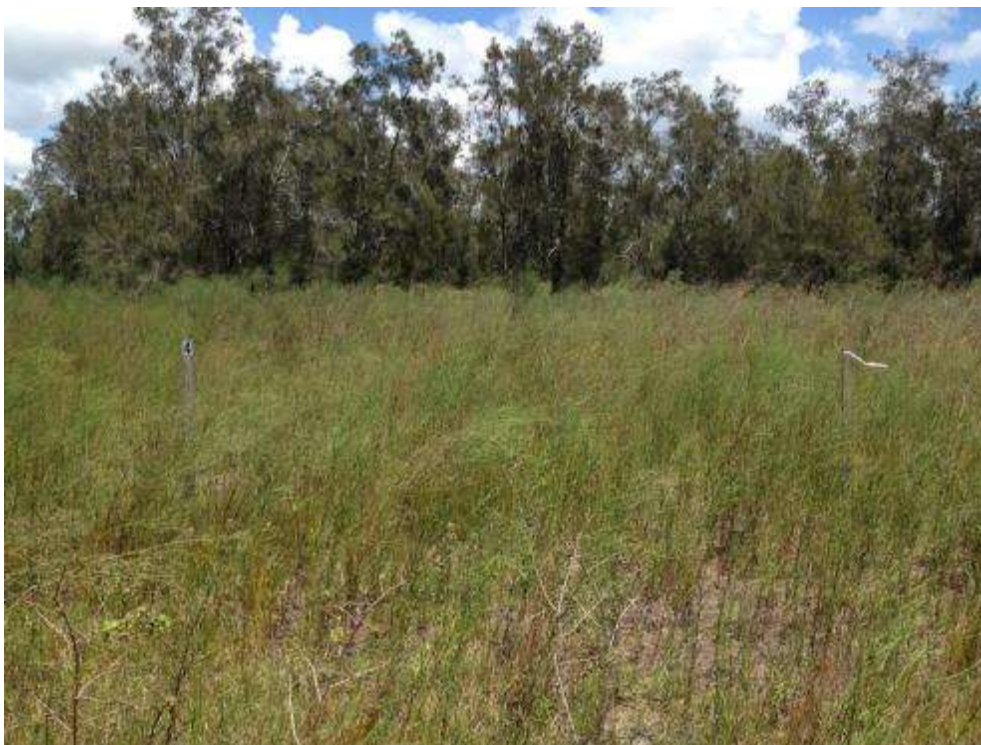
Photo Plate 71: Quadrat 4 - Month 6 (February 2016)

Comparison Summary
Canopy trees that were in seedling form in this quadrant are now over 1m high. There has been no change in native dominance, however vegetation cover has increased by 10%.

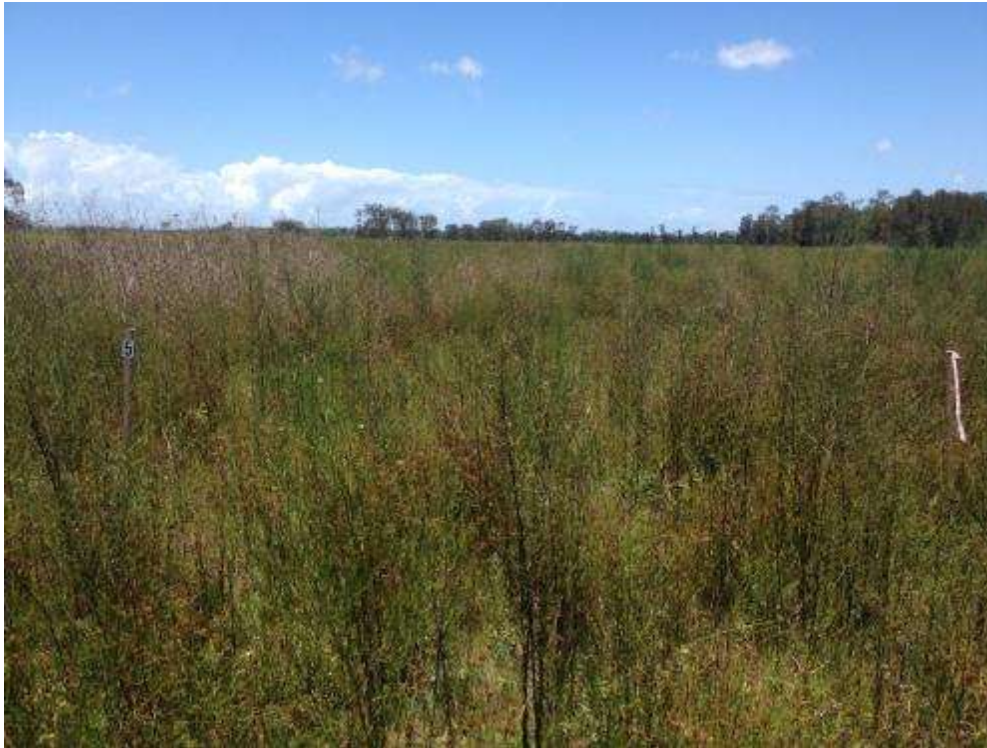
Photo Plate 73: Quadrat 5 - Month 6 (February 2016)

Comparison Summary
Melaleuca and Casuarina are forming impressive thickets in areas between quadrants 4, 5, 6 and 7. Despite the changes surrounding the quadrants, no significant change is noted within this quadrat.

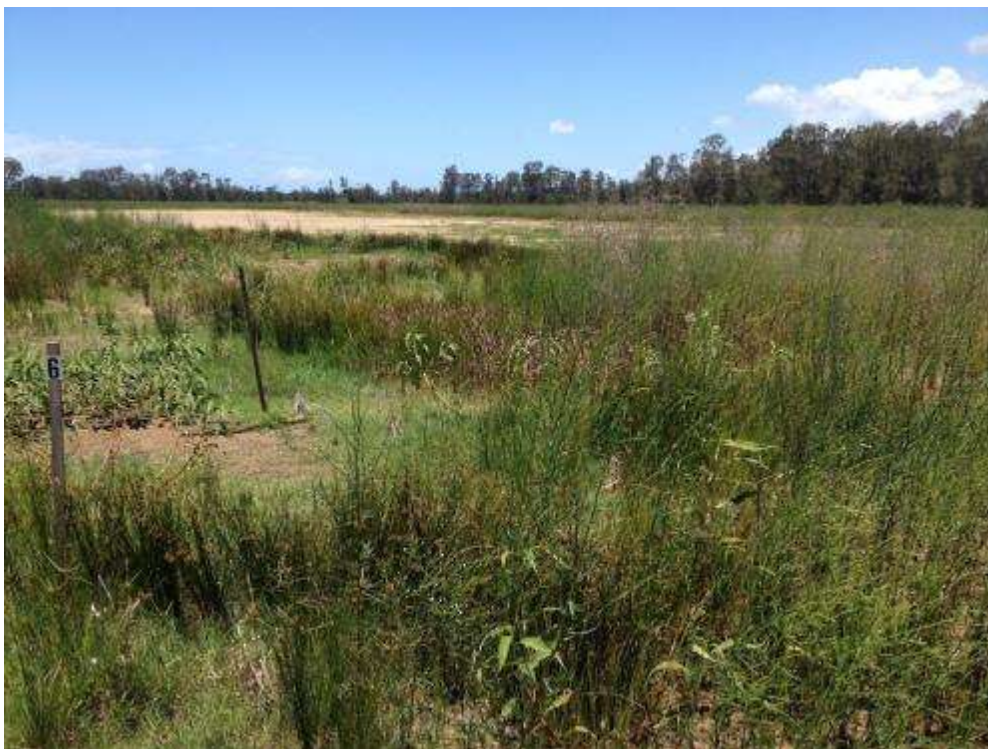
Photo Plate 75: Quadrat 6 - Month 6 (February 2016)

This quadrat has retained native dominance during the entire monitoring phase to date, and continues to do so with many species of sedges in the area. There are significant numbers of canopy trees in the surrounding area to this quadrant. *Parsonsia straminea* is seeding abundantly in the surrounding trees abutting the project area.

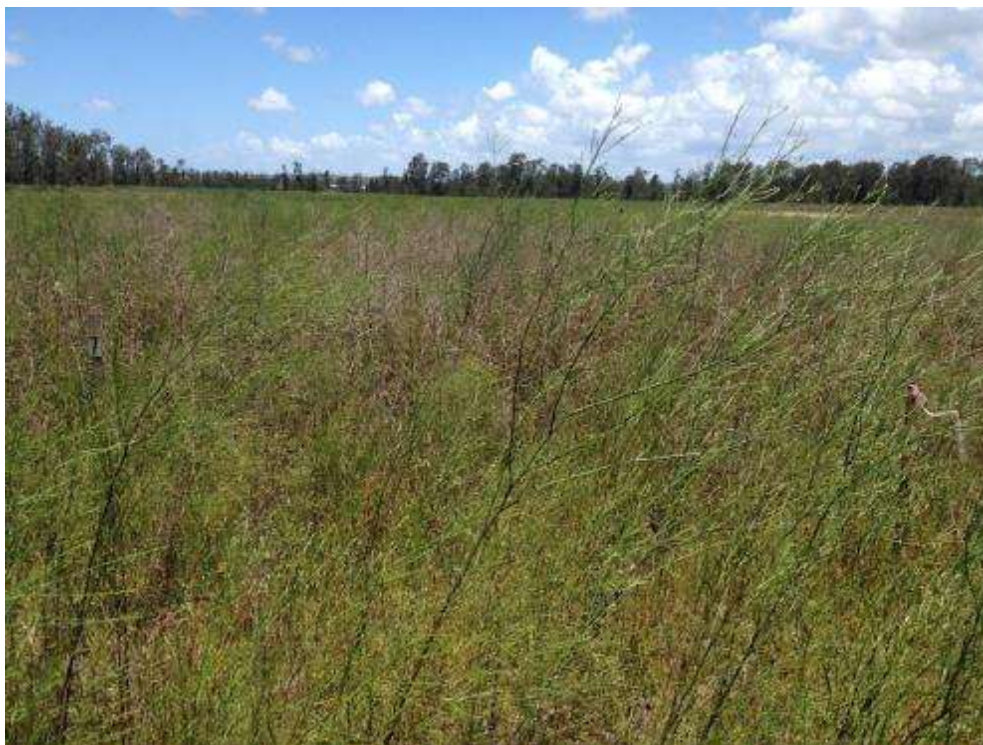
Photo Plate 77: Quadrat 7 - Month 6 (February 2016)

Native canopy vegetation continues to increase in diversity within this quadrat. During month 1, 6 individuals were identified, now there are significant numbers present. This is also representative of the surrounding area, and an overall upwards trend common over much of the site.

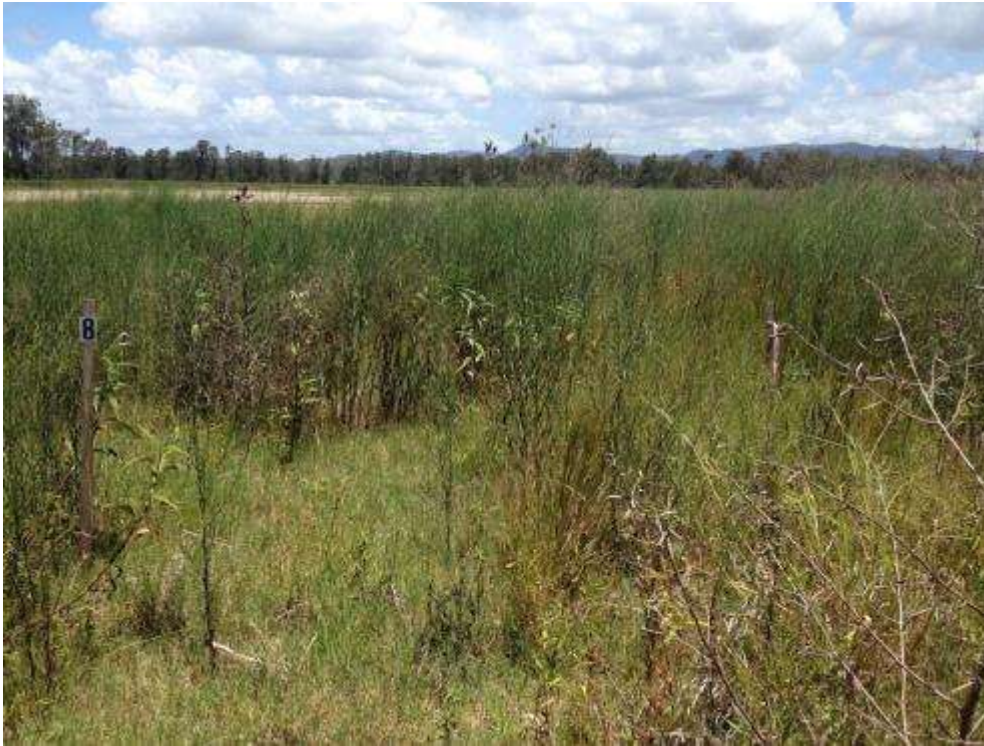
Photo Plate 79: Quadrat 8 - Month 6 (February 2016)

This quadrat still remains relatively weed free. The first canopy tree within the quadrat was recorded in month 12, indicating canopy trees are still emerging.

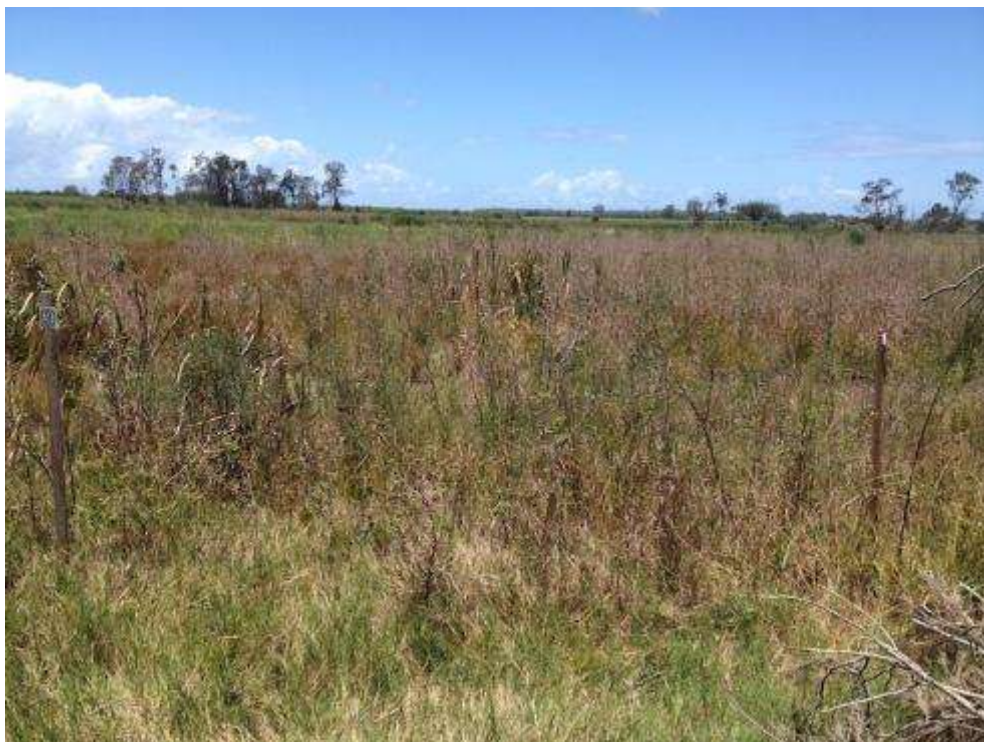
Photo Plate 81: Quadrat 9 - Month 6 (February 2016)

There has been an increase in canopy species in this quadrat from one, to two species. This area will benefit well from the next inundation event.
