North-West Conservation Park - Rehabilitation Monitoring

Lot 1 RP48903

North-West Conservation Park
Gainsborough Greens

March 2020

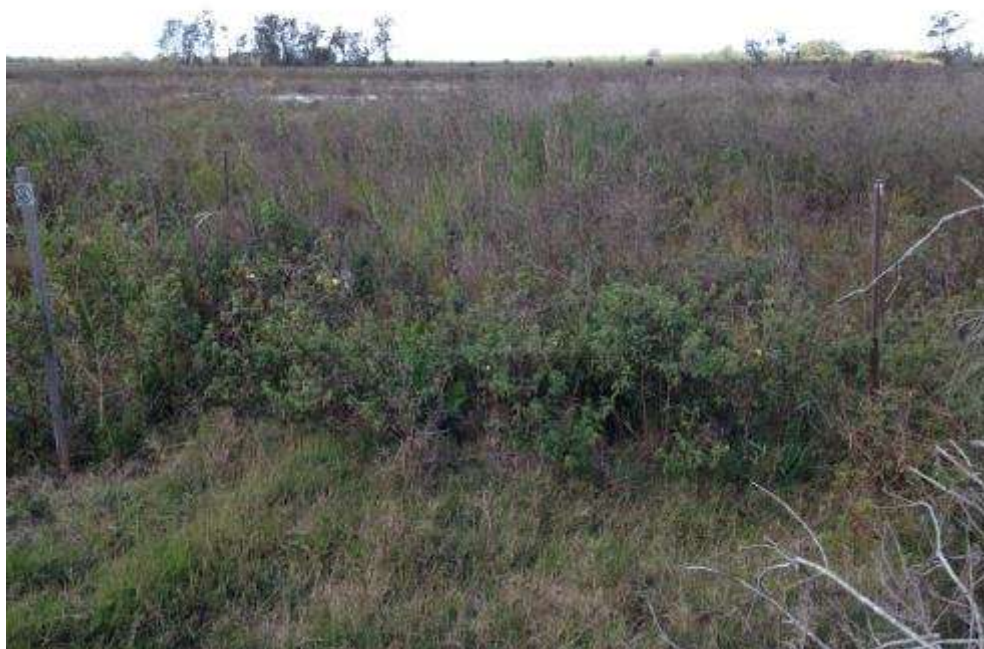
Photo Plate 82: Quadrat 9 - Month 12 (August 2016)

There has been an increase in canopy species in this quadrat from one, to two species. This area will benefit well from the next inundation event.

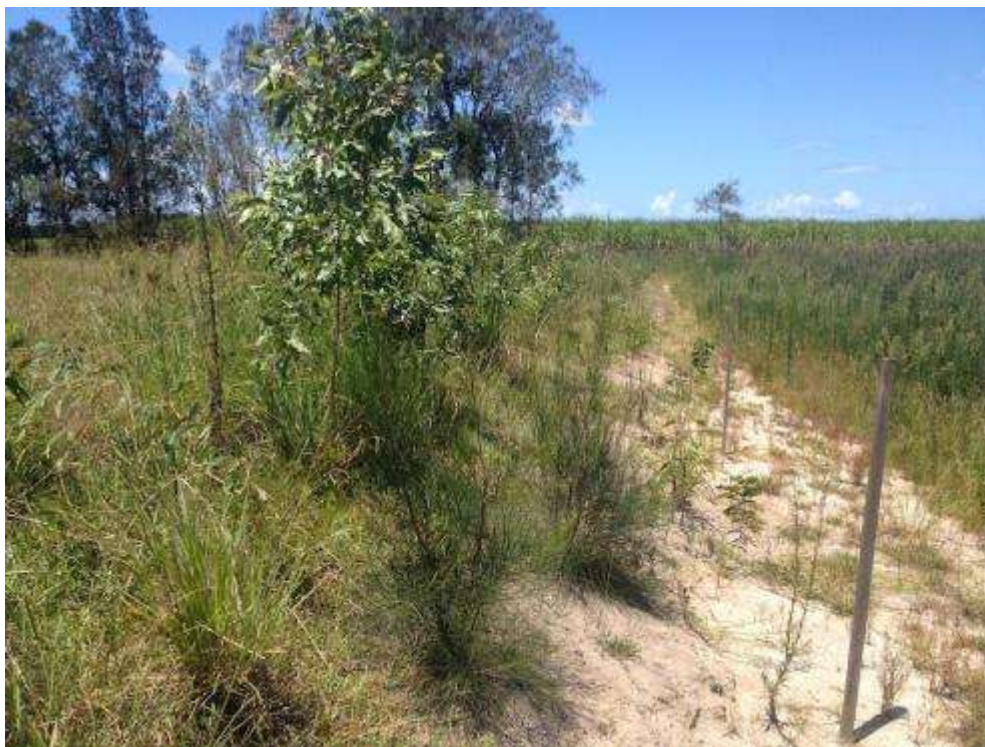
Photo Plate 83: Quadrat 10 - Month 6 (February 2016)

Comparison Summary
This is one of two dry and sloping quadrats where the contour highlights the impact of improved drainage on terrestrial plant success. This is evident both in diversity and structure, where 5 canopy species are present. *Capillipedium spicigerum* is still a dominant grass in the background even though dormant over this period.

The growth within this quadrant is quite representative of the broader site, with some Eucalyptus reaching 5m or more.

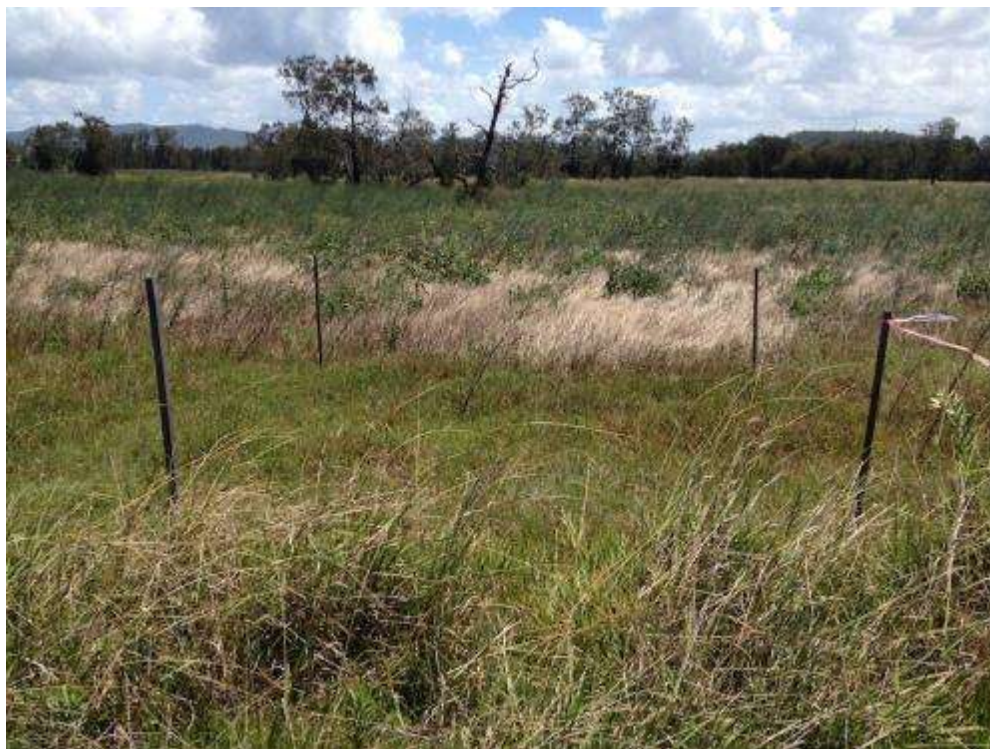
Photo Plate 85: Quadrat 11 - Month 6 (February 2016)

This is a very stable quadrat. Comparing this winter photo (month 12) to the last summer photo (month 6), it is very interesting, and highlights the change in abundance and dominance of the different species. This time (month 12), *Persicaria attenuata* located in the surrounding area can be seen taking advantage of the lack of competition, spreading rapidly.

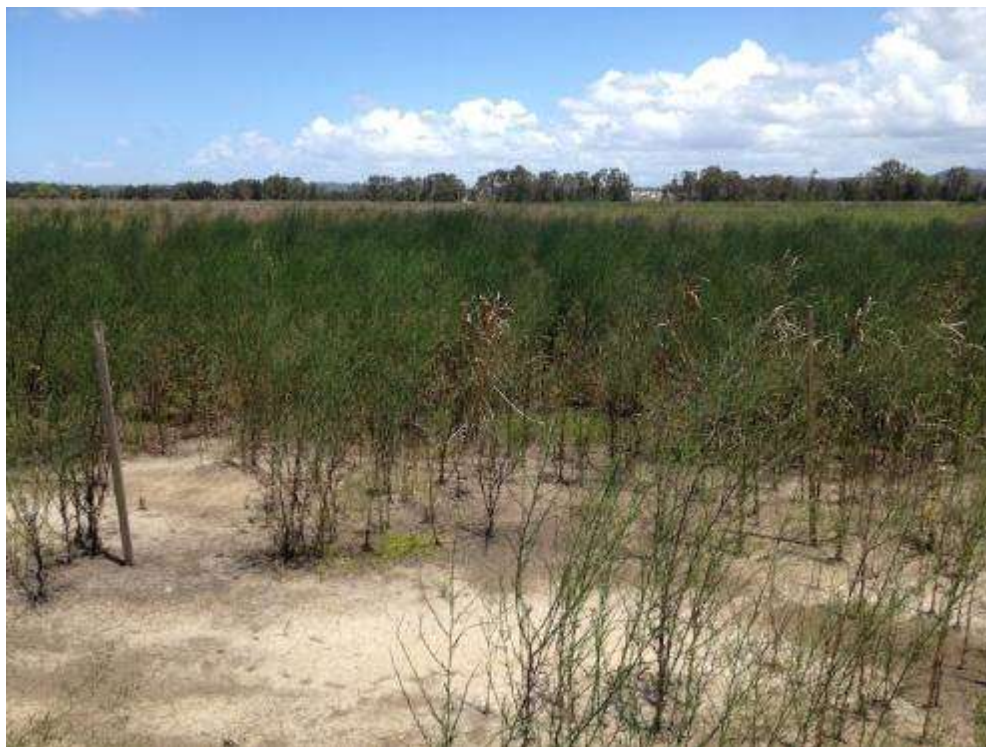
Photo Plate 87: Quadrat 12 - Month 6 (February 2016)

This quadrat is abundant with canopy tree species, which is also representative of the surrounding areas. The native grass *Capillipedium spicigerum* is dormant in the surrounding area. *Baumea articulata* was also observed in the surrounds, a sedge species not identified before within the area.

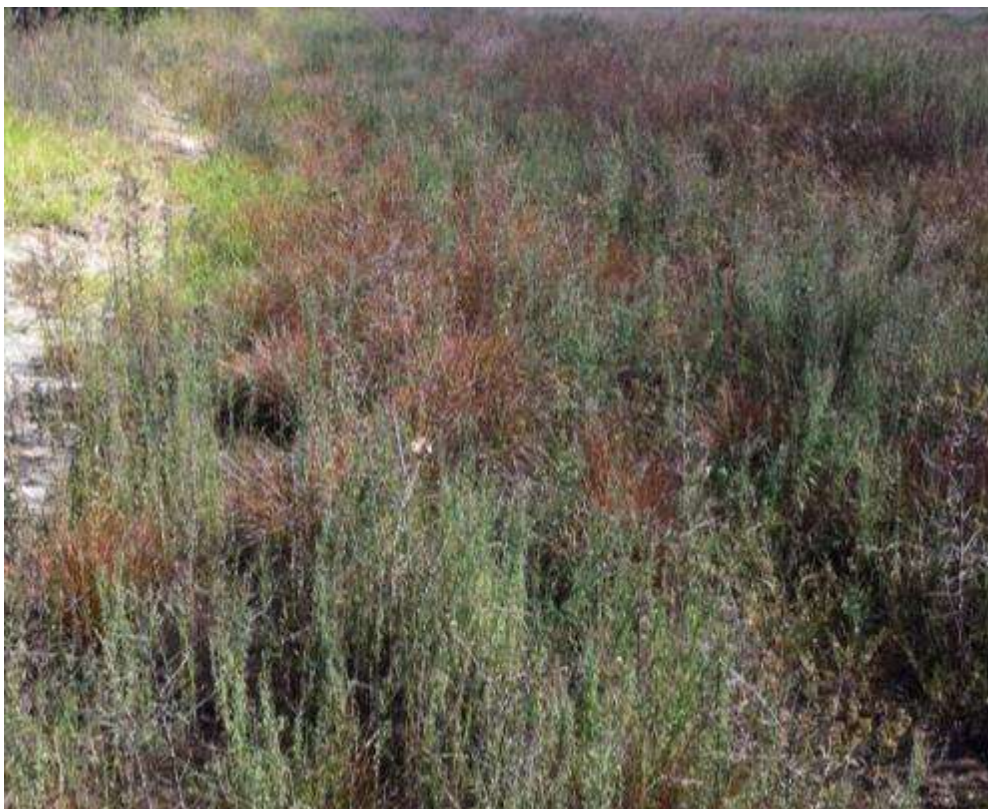
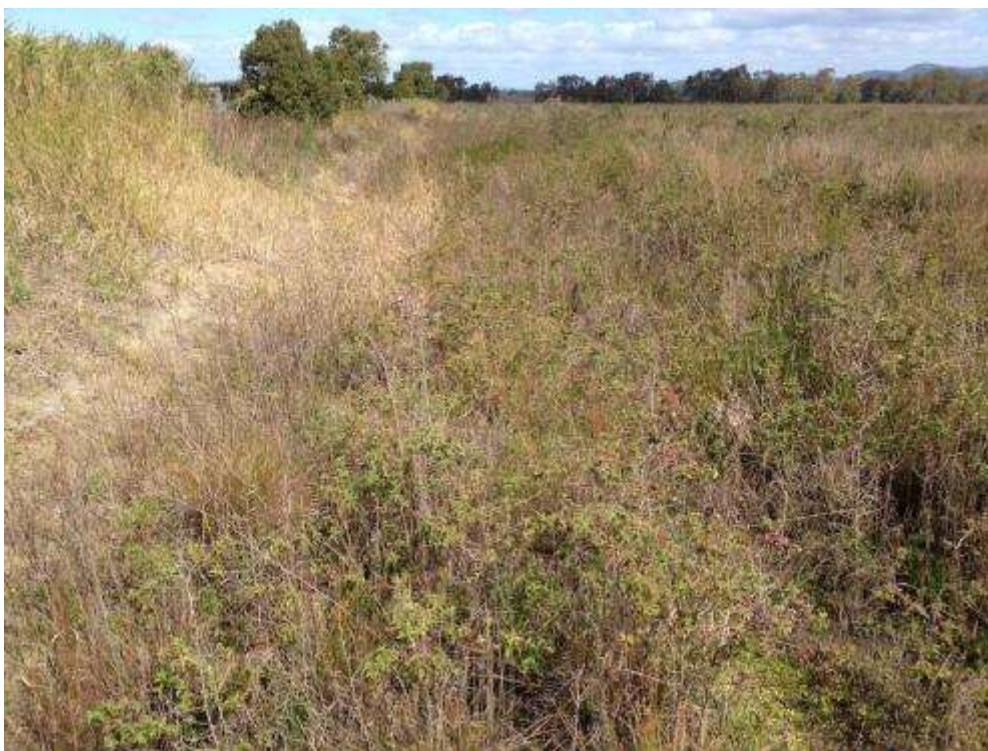
Photo Plate 90: Quadrat 13 - Month 12 (August 2016)

Comparison Summary
Summer temperatures will see *Eleocharis* recover its dominance in this area. There is a significant increase in canopy trees along this entire eastern edge adjacent to this quadrat. This has been the most concerning area due to exposure to winds, and lack of recruitment trees within windfall. This is the most vital aspect of change in these past 6 months.

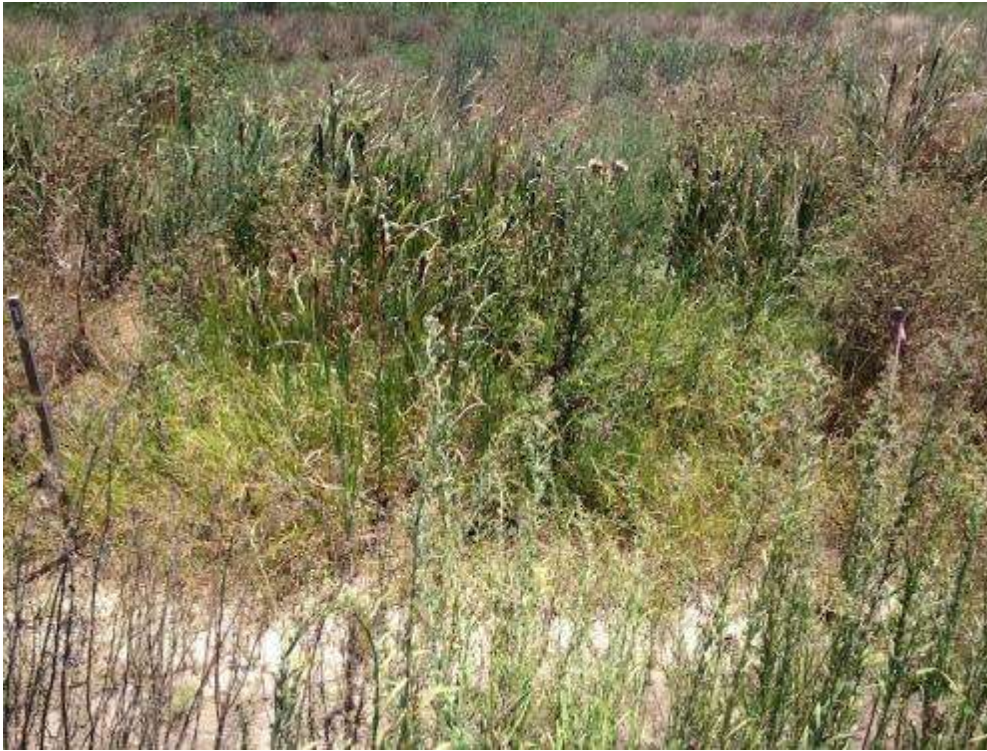
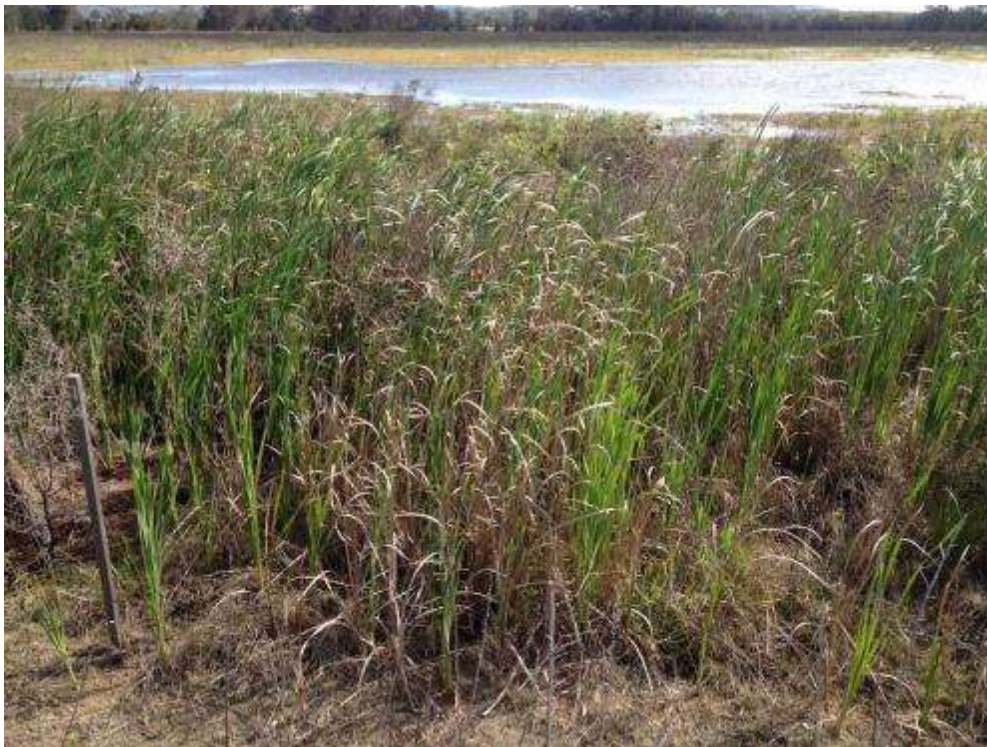
Photo Plate 92: Quadrat 14 - Month 12 (August 2016)

Comparison Summary
Typha is becoming dominant in the area. The positive aspect to this would be its nesting habitat value for water birds over the wet season.

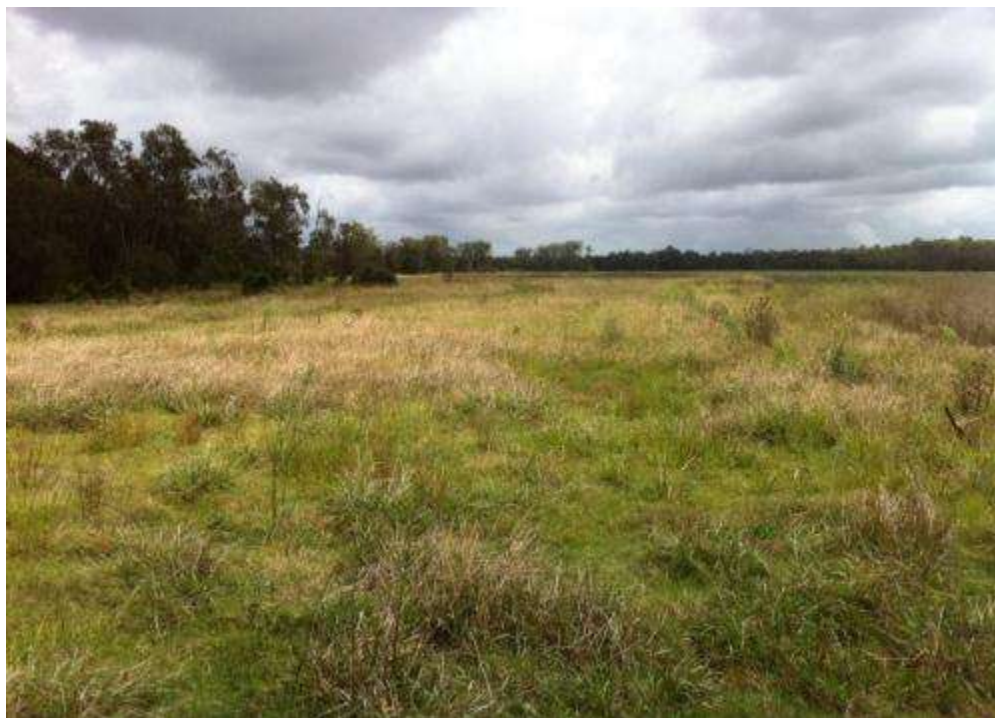
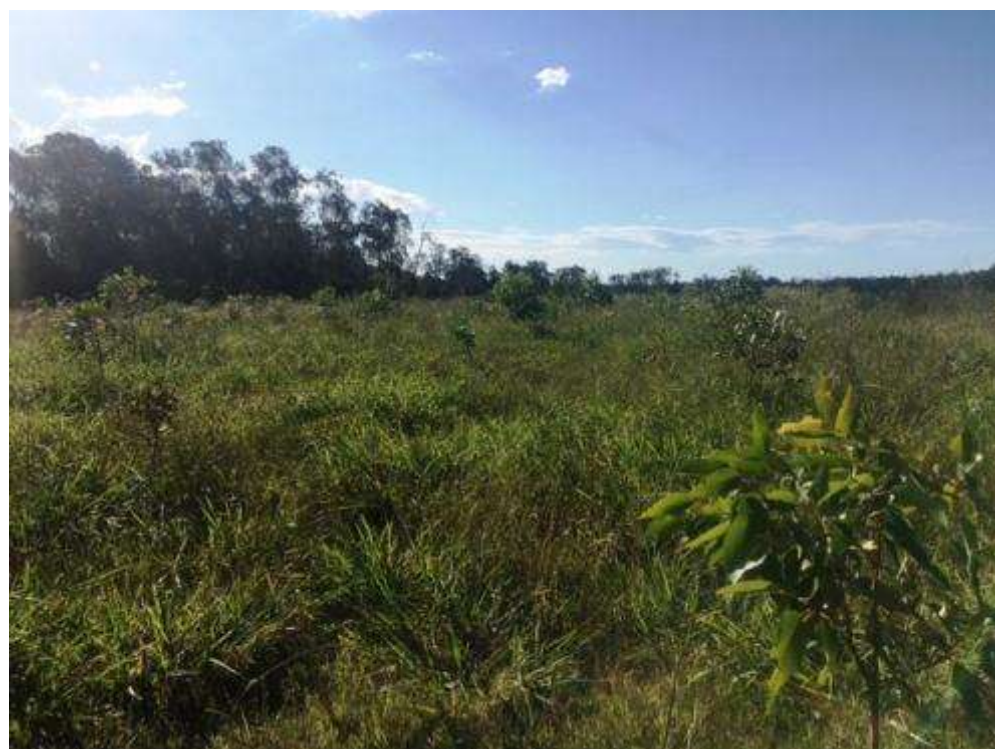
Photo Plate 94: A1 Eucalypt Plantings - Month 12 (August 2016)

Comparison Summary
Pasture grasses quickly regained their original height at the month 6 monitoring point. The average height of tubestock at that time was approximately 600-800mm, sun hardened and performing well. At the month 12 monitoring time, pasture grasses had continued to grow in height, however seedlings were clearly visible above the height of the grass. Stock averaged approximately 1200-1600mm in height.

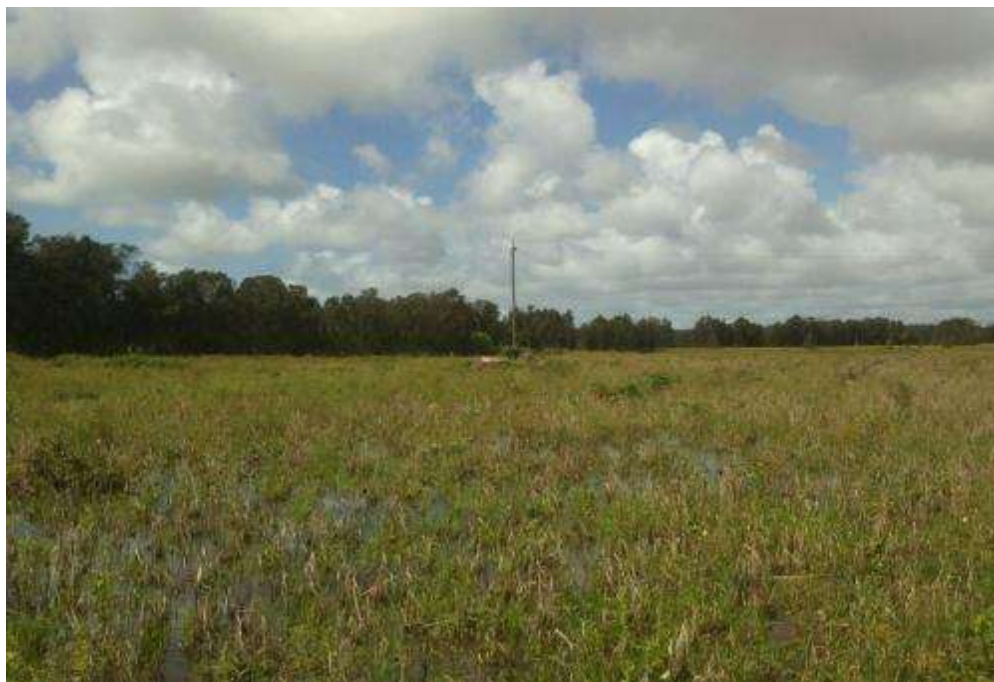
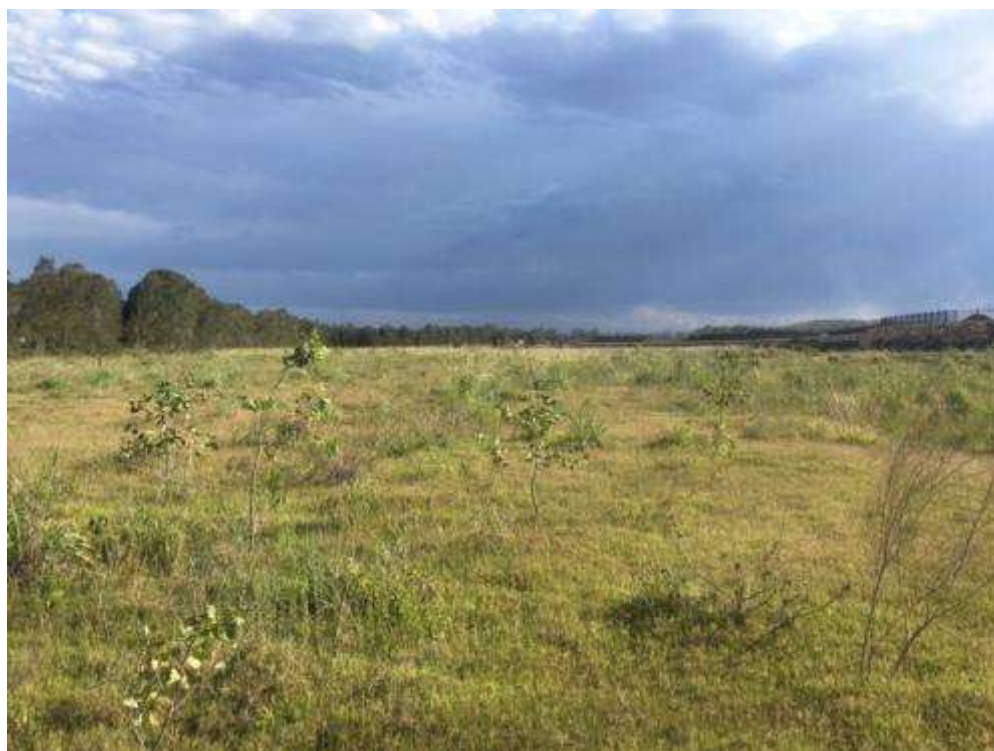
Photo Plate 96: A2 Eucalypt Plantings - Month 12 (August 2016)

Comparison Summary
The site is still periodically inundated, limiting the growth of a number of the seeded species. Nonetheless, tubes are growing well with an average height of 1600mm. Seedlings of seeded species are also emerging and growing well.

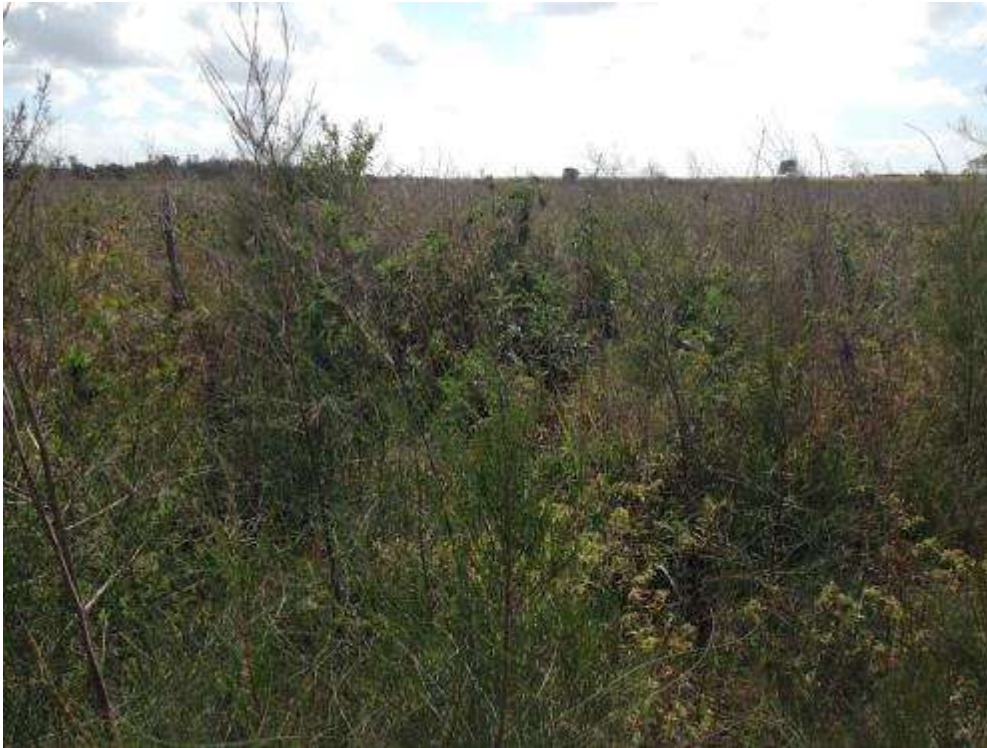
Photo Plate 97: Quadrat 1 - Month 12 (August 2016)

This is the most degraded quadrant. Having said that, the native grass *Capillipedium spicigerum* is common within the quadrant. *Casuarina glauca* is abundant within the quadrat and surrounding areas. *Acacia falcata* was also identified within the surrounding area at the month 18 monitoring event.

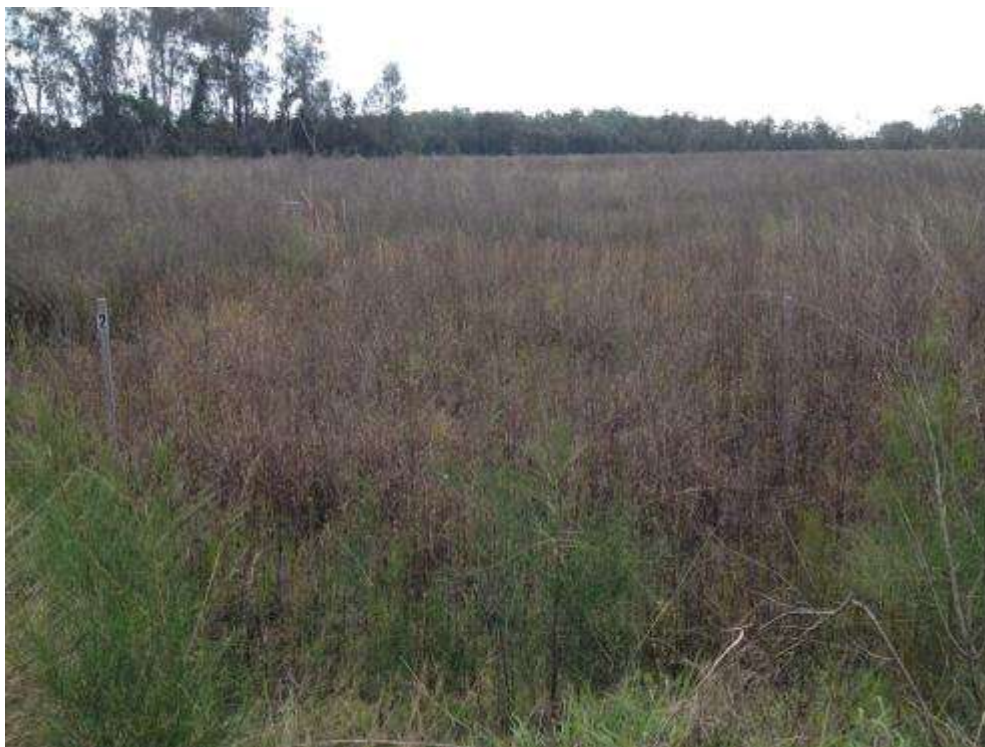
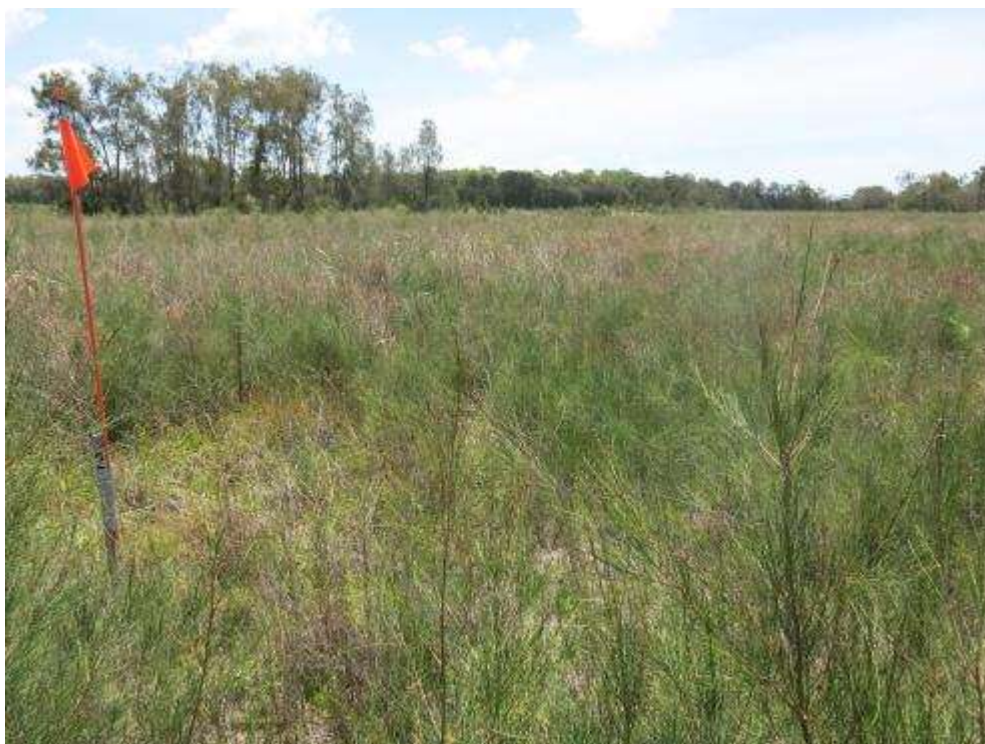
Photo Plate 100: Quadrat 2 - Month 18 (February 2017)

Traversing between quadrats 2 and 3 is becoming difficult due to the abundance of canopy trees.

Juncus usitatus has recently set abundant seed within the surrounding area.

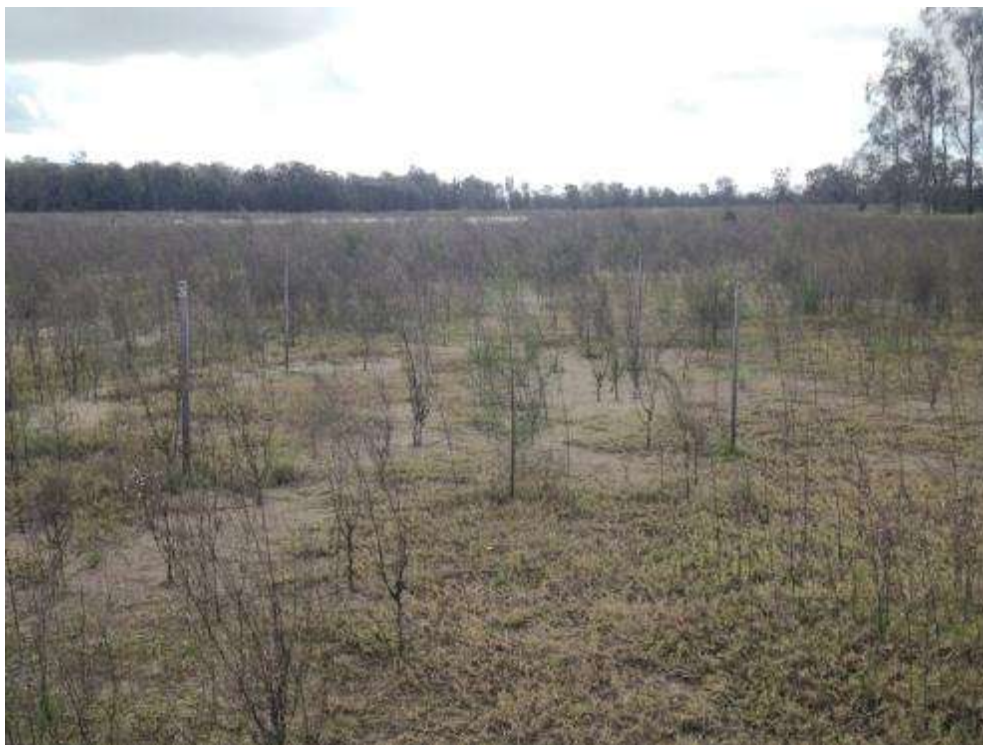
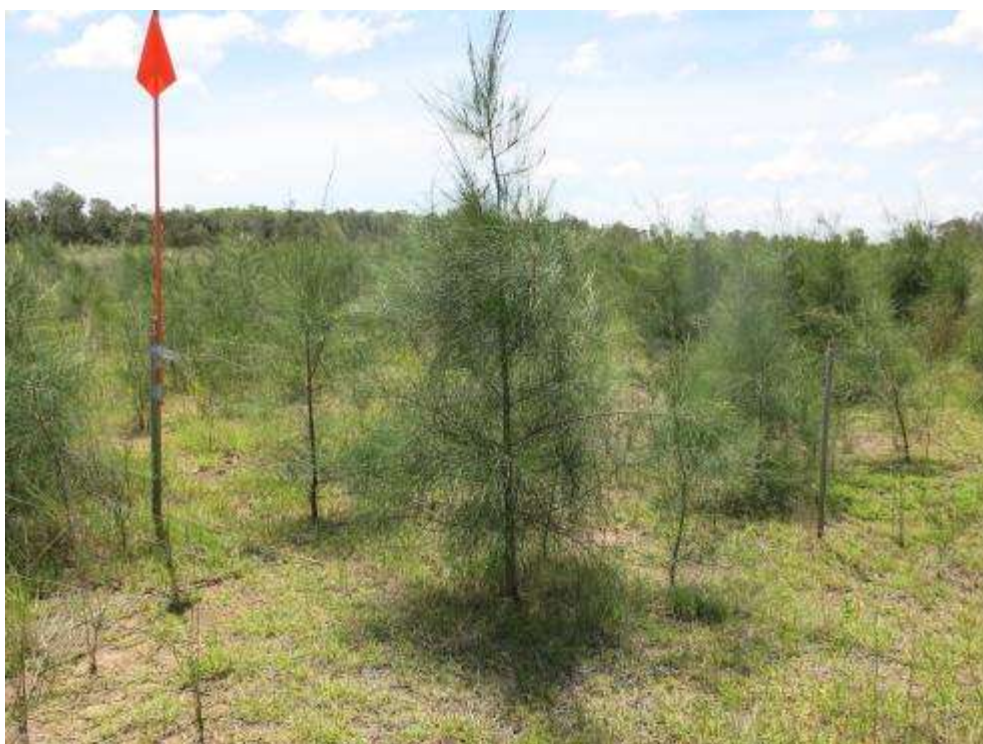
Photo Plate 102: Quadrat 3 - Month 18 (February 2017)

The growth of *Casuarina glauca* seedlings is phenomenal over this six month period.

Juncus kraussii has become common in the surrounds, along with other species diversity. This *Juncus* is a new species

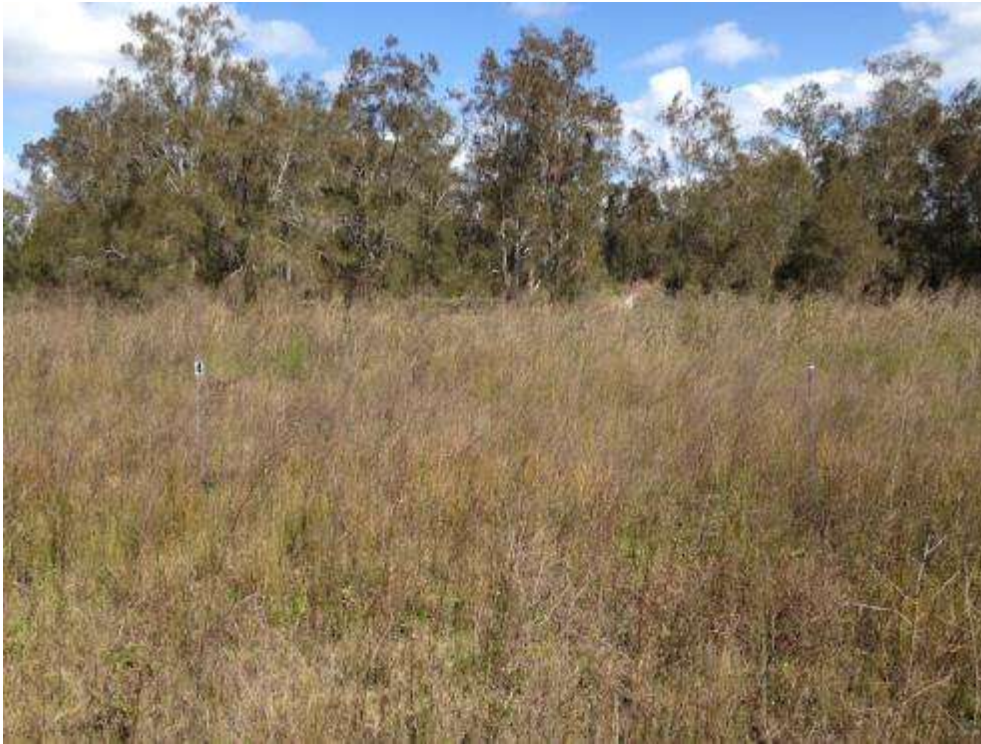
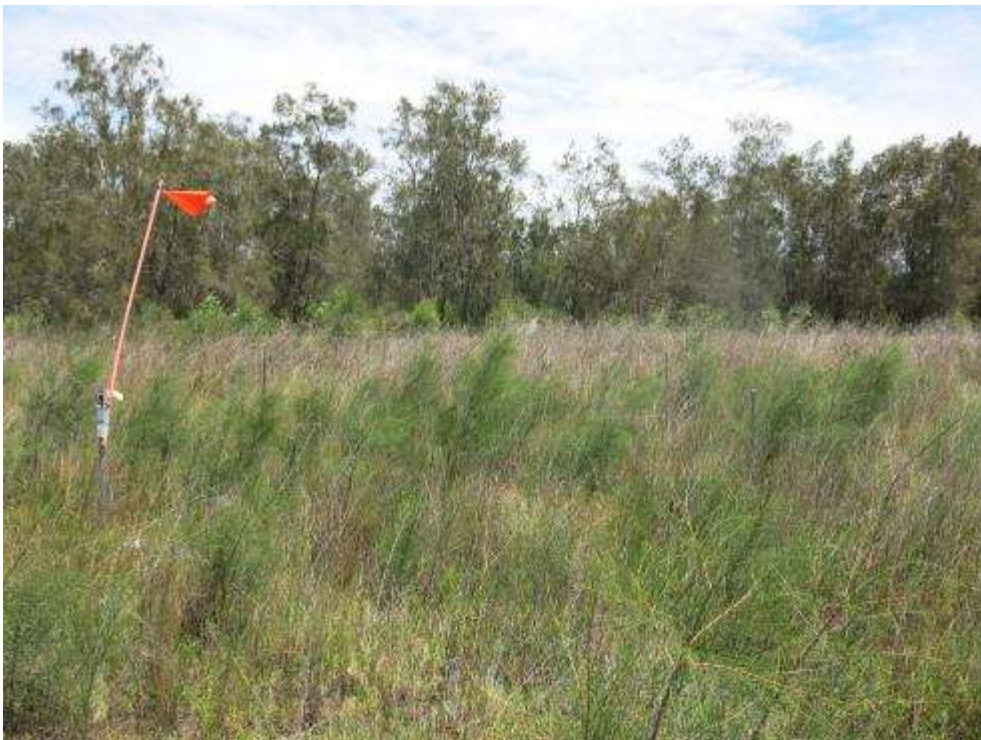
Photo Plate 104: Quadrat 4 - Month 18 (February 2017)

Comparison Summary
Casuarina glauca seedlings have also grown significantly within this quadrat over this six month period.

Melaleucas and Casuarinas are both thriving well within the surrounding area.

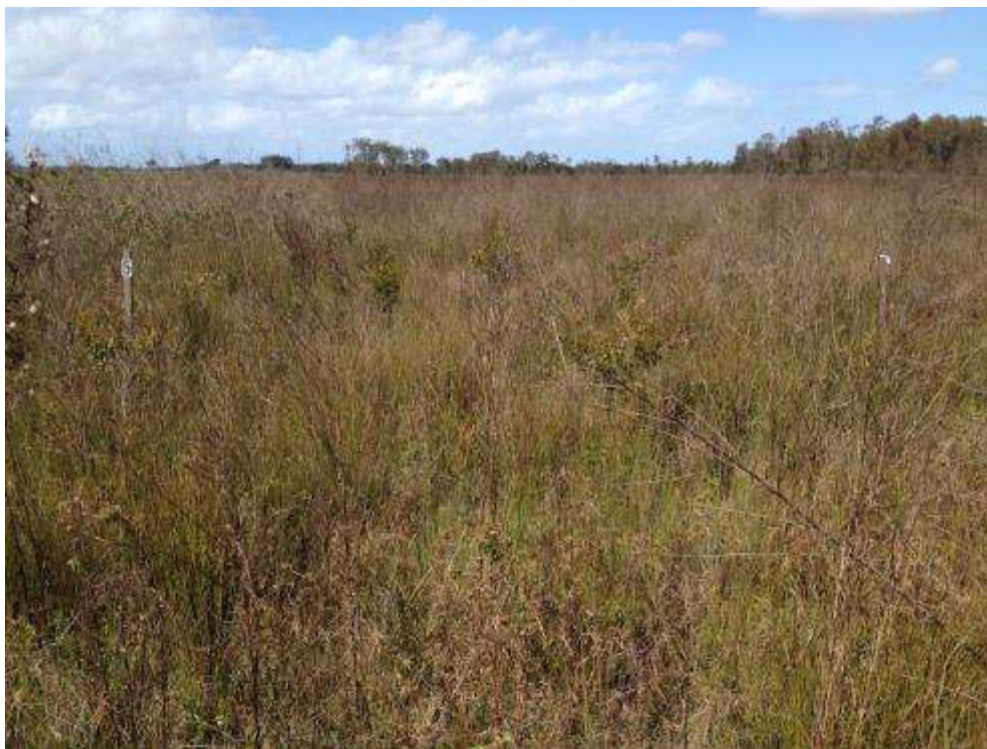
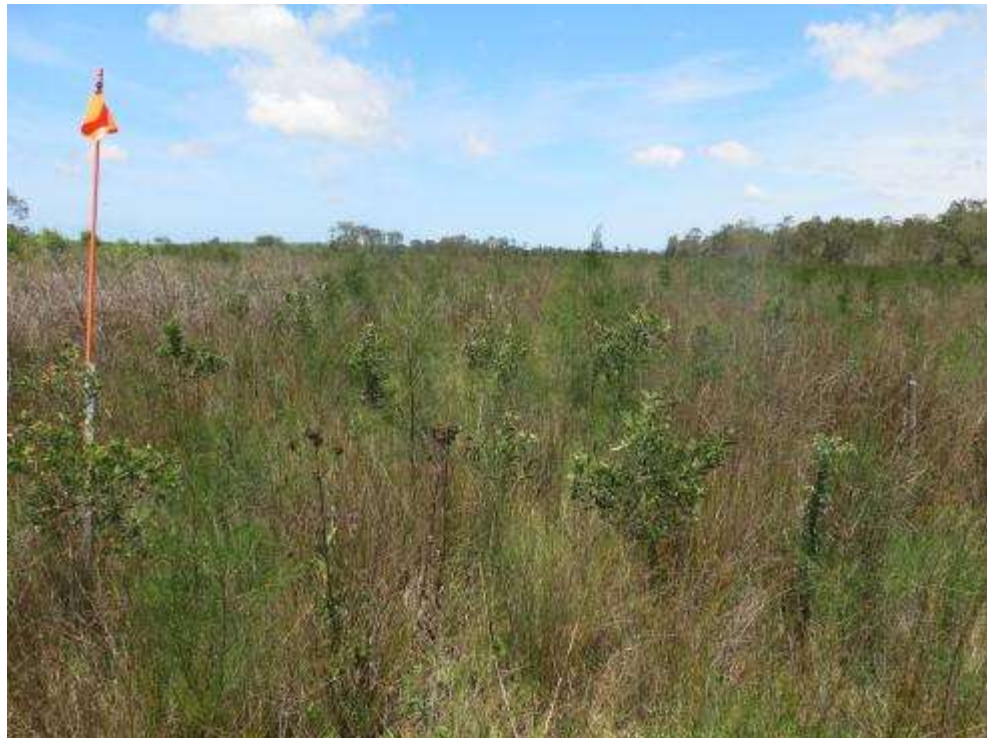
Photo Plate 106: Quadrat 5 - Month 18 (February 2017)

Melaleuca and Casuarina are forming impressive thickets in areas between quadrats 4, 5, 6 and 7. Myrtle rust is still obvious on the Melaleucas in the surrounding area, however it has not spread over this six month period.

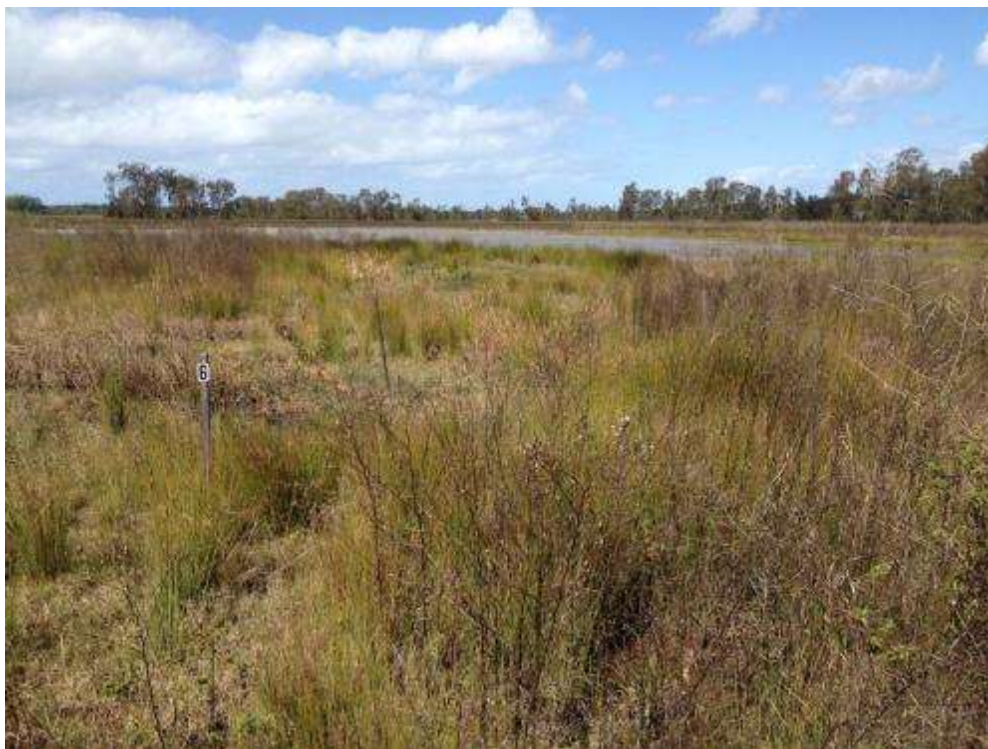
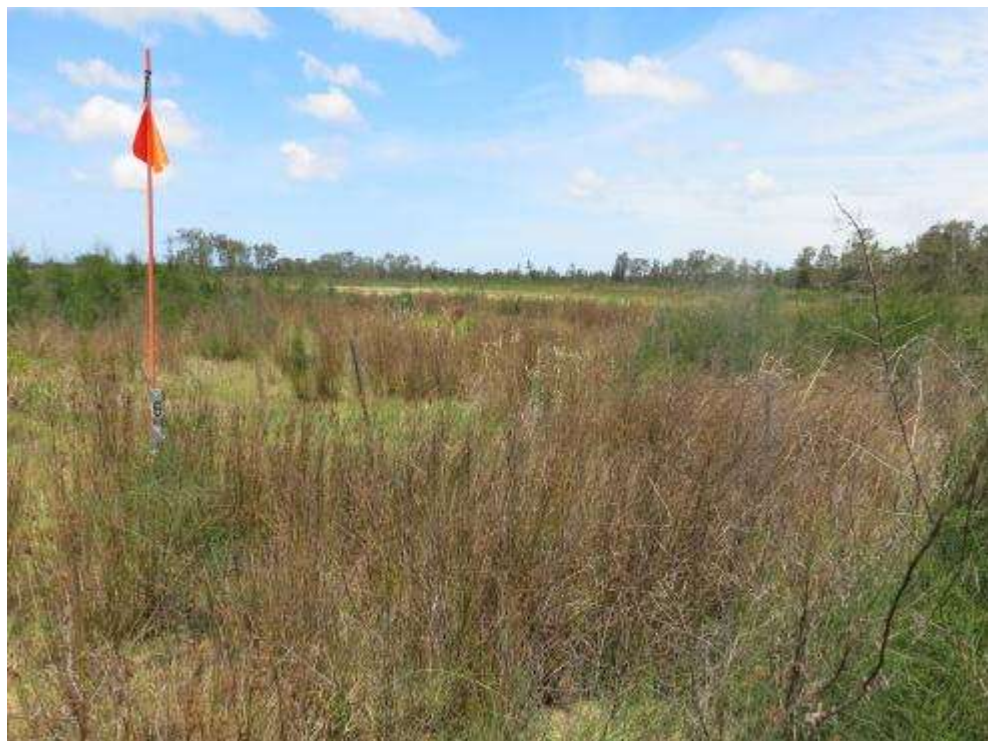
Photo Plate 108: Quadrat 6 - Month 18 (February 2017)

This quadrat has retained native dominance during the entire monitoring phase to date, and continues to do so with many species of sedges in the area. There are significant numbers of canopy trees in the surrounding area to this quadrant.

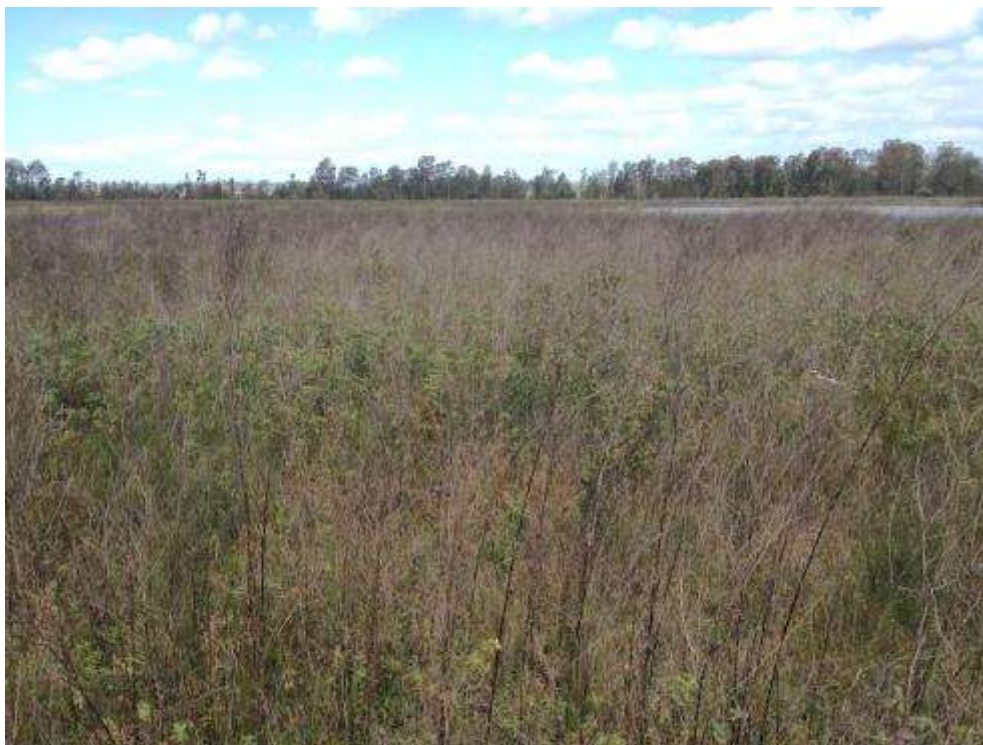
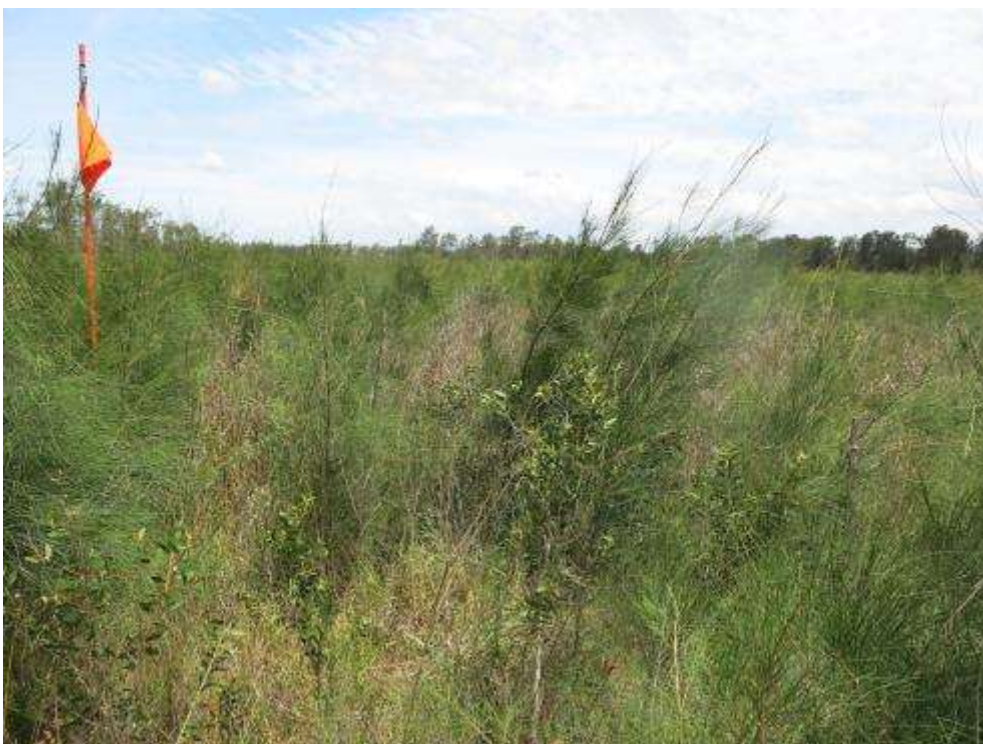
Photo Plate 110: Quadrat 7 - Month 18 (February 2017)

Native canopy vegetation continues to increase in diversity within this quadrat. During month 1, 6 individuals were identified, now there are significant numbers present. This is also representative of the surrounding area, and an overall upwards trend common over much of the site.

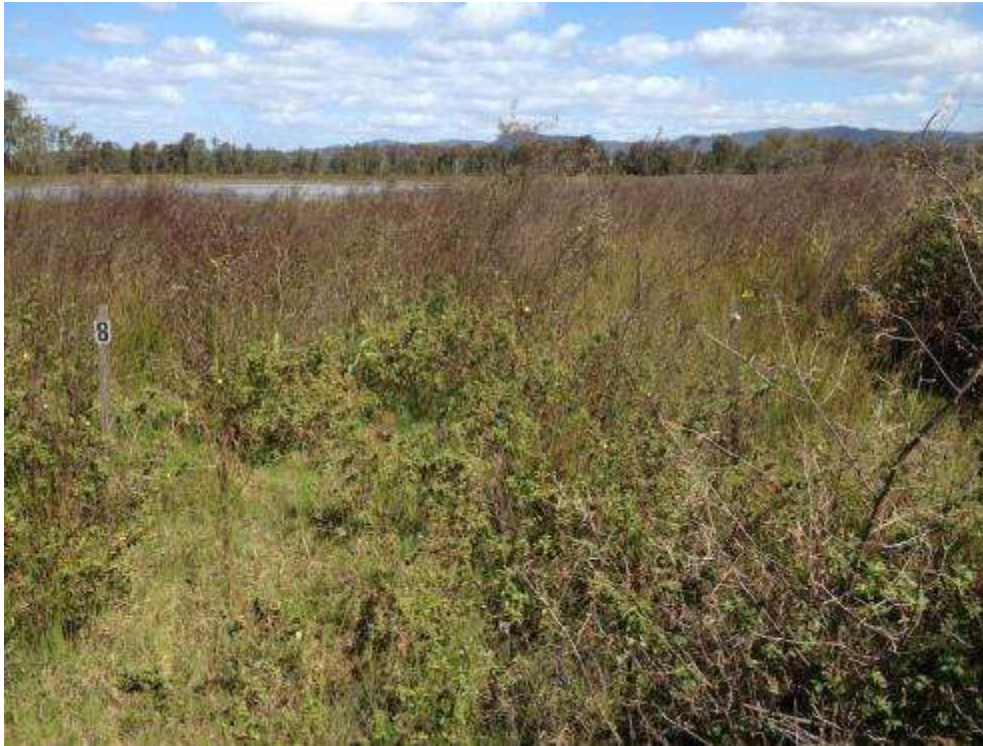
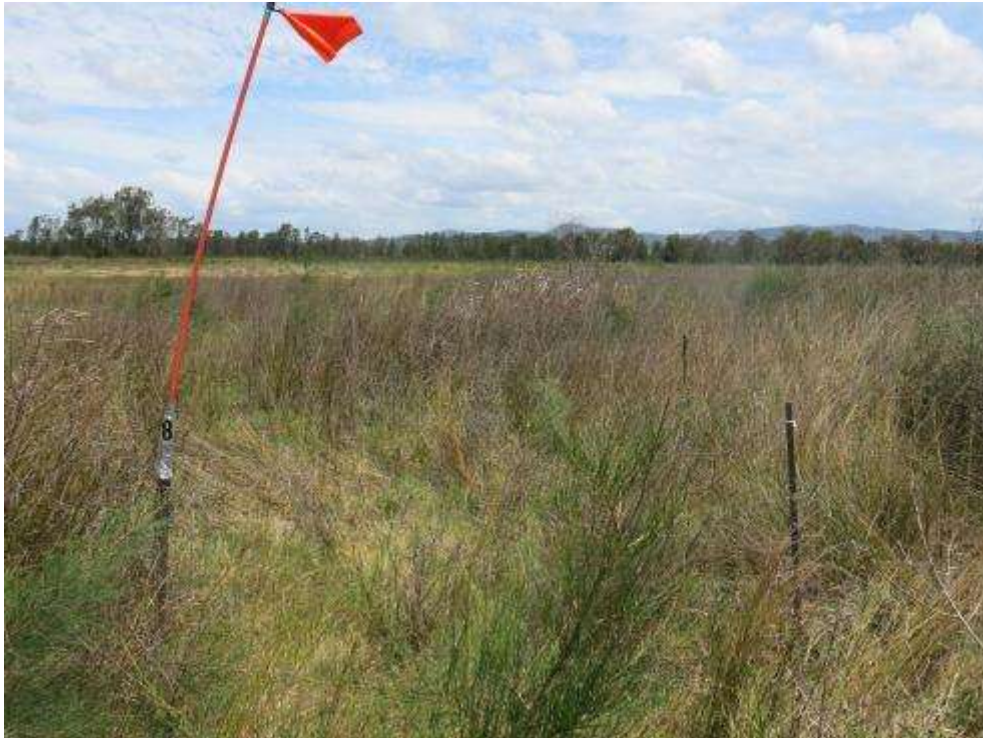
Photo Plate 112: Quadrat 8 - Month 18 (February 2017)

Comparison Summary
There are a significant number of canopy tree species within the surrounding areas of this quadrat, however are still not generating in great numbers within the quadrat boundaries. Sedges and grasses continue to grow and develop well.

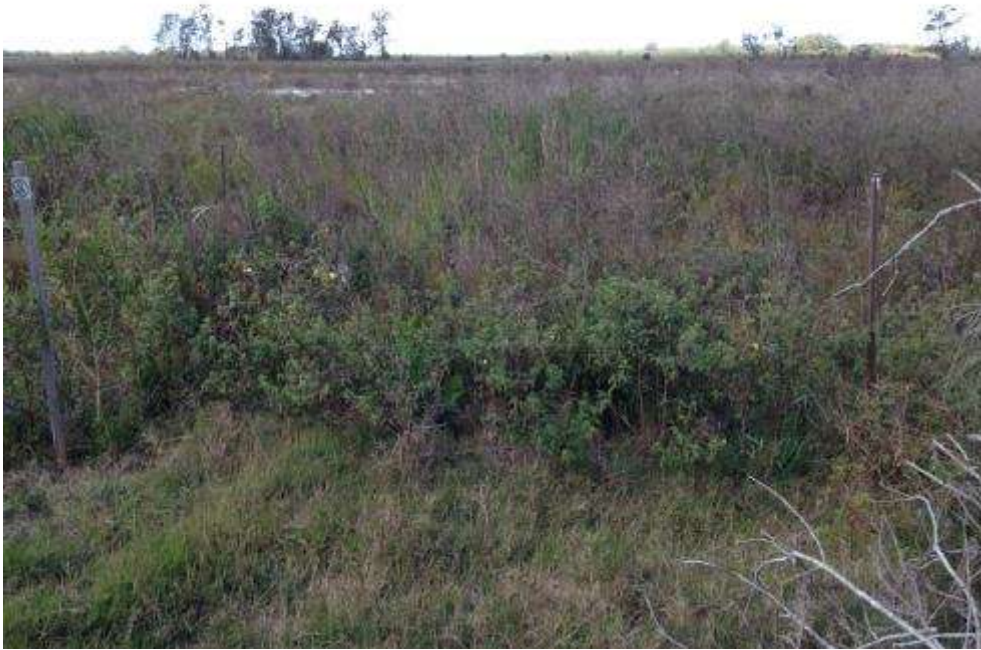
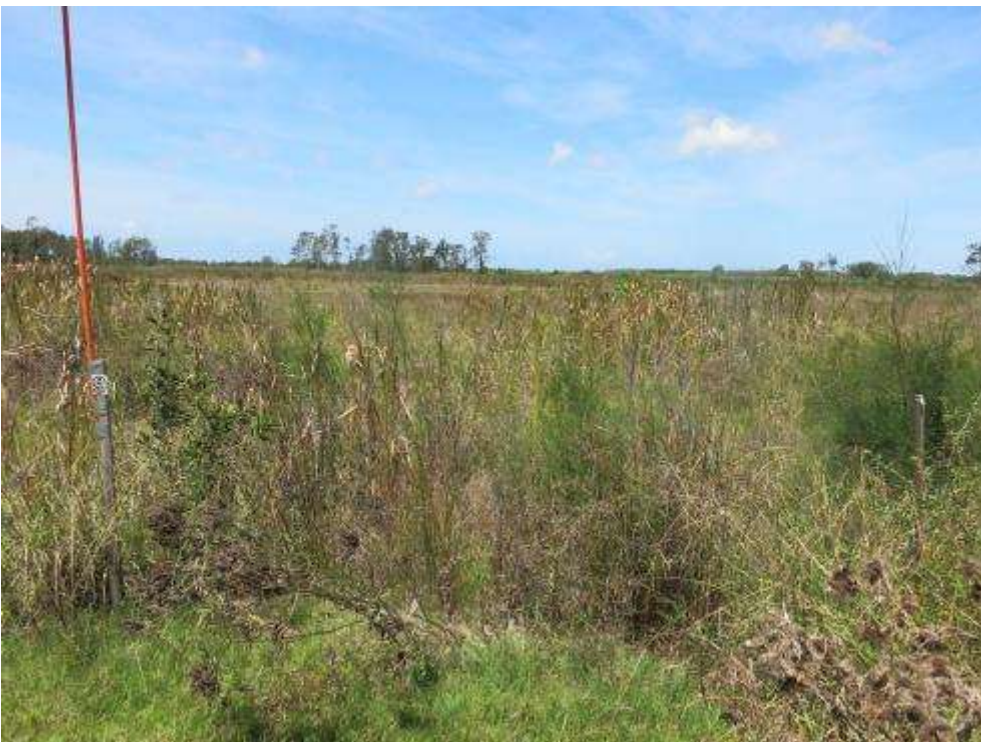
Photo Plate 114: Quadrat 9 - Month 18 (February 2017)

There has been an increase in canopy species abundance within this quadrat. A new sedge species was identified within the surrounding area. This is a positive sign for an increase of species diversity.
