North-West Conservation Park - Rehabilitation Monitoring

Lot 1 RP48903

North-West Conservation Park
Gainsborough Greens

March 2020

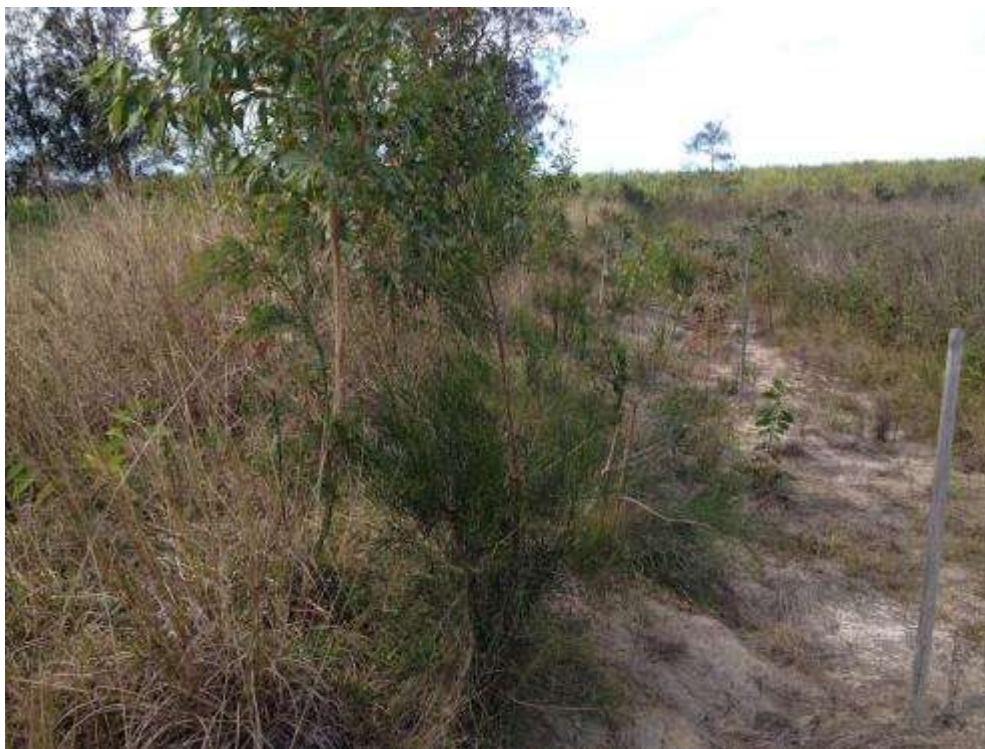
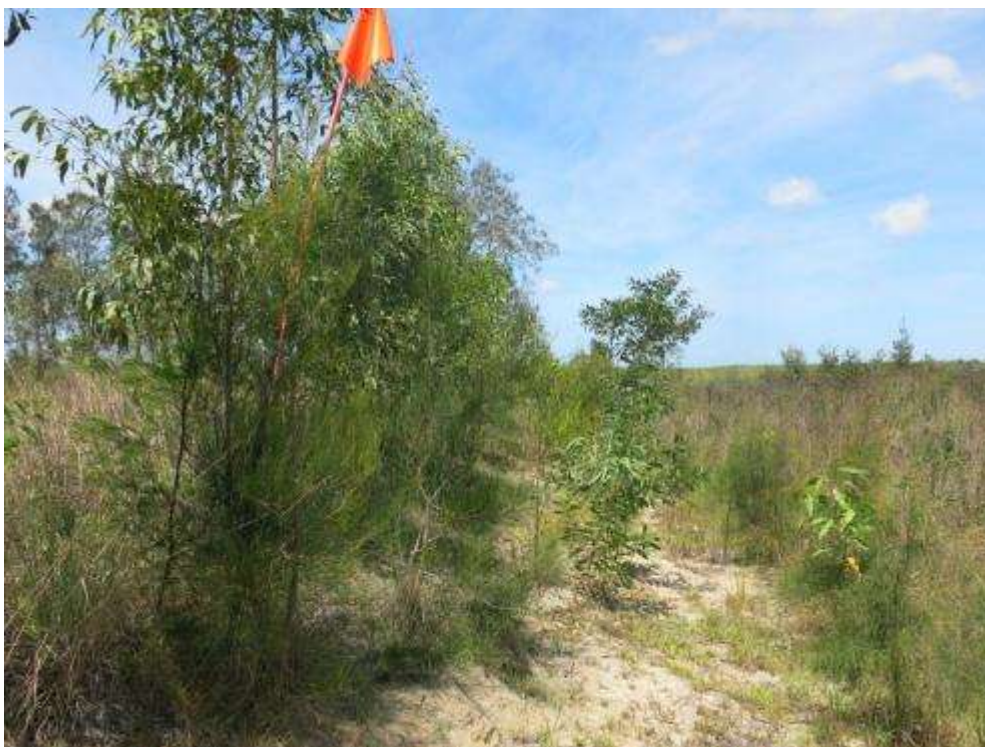
Photo Plate 116: Quadrat 10 - Month 18 (February 2017)

Comparison Summary
This is one of two dry and sloping quadrats where the contour highlights the impact of improved drainage on terrestrial plant success. A different species composition is recorded within this quadrat due to the differences in contour. *Capillipedium spicigerum* is still a dominant grass in the background even though dormant over this period.

The growth within this quadrant is quite representative of the broader site, with some Eucalypts reaching 5m or more, with a DBH of approximately 25cm.

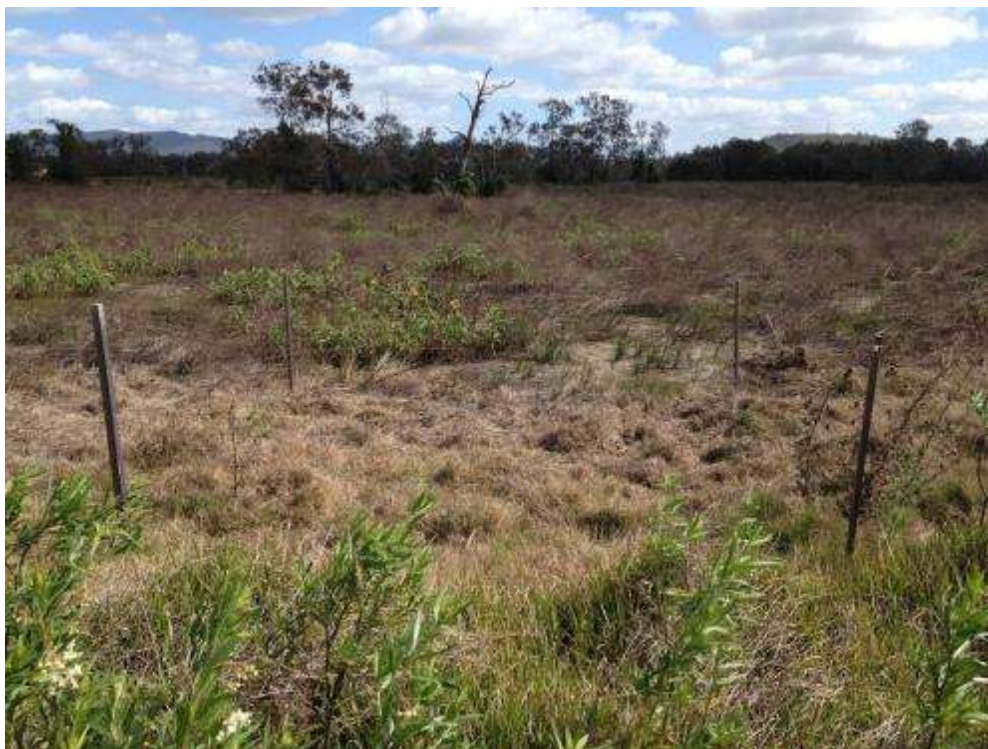
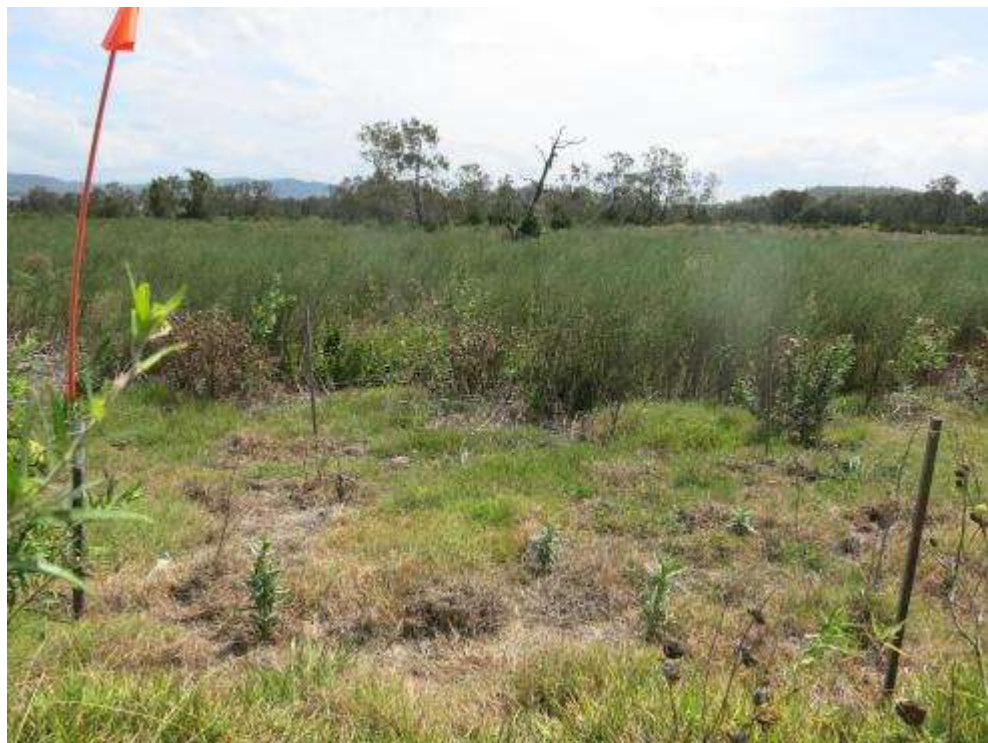
Photo Plate 118: Quadrat 11 - Month 18 (February 2017)

This is a very stable quadrat. Comparing month 12 and month 18 photos, there has been a significant change in Aster abundance behind this quadrat. This is an annual weed, therefore will die off.

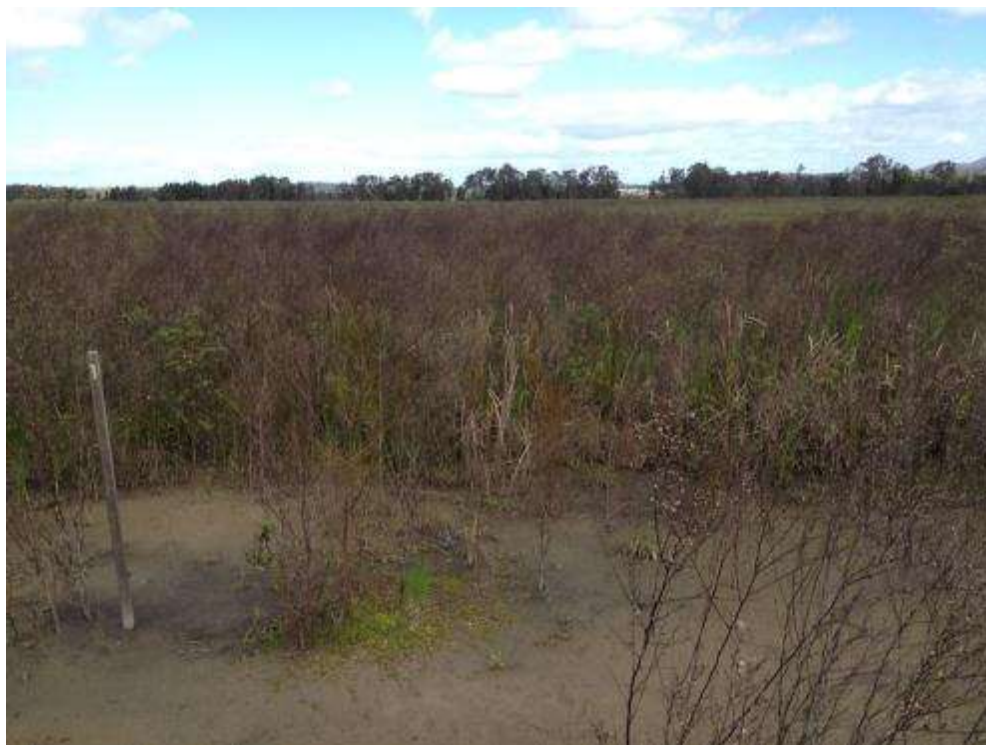
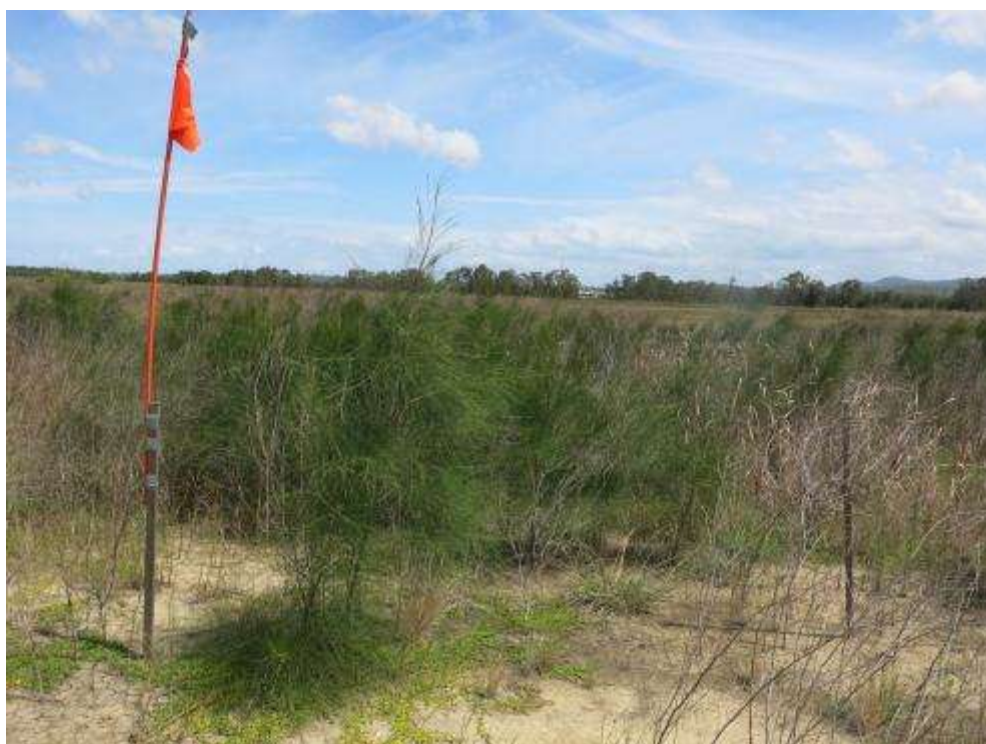
Photo Plate 120: Quadrat 12 - Month 18 (February 2017)

This quadrat is abundant with canopy tree species, which is also representative of the surrounding areas. These individuals continue to grow well. The surrounds of this quadrat appear to be lagging compared to other areas, however have grown significantly over this six month period.

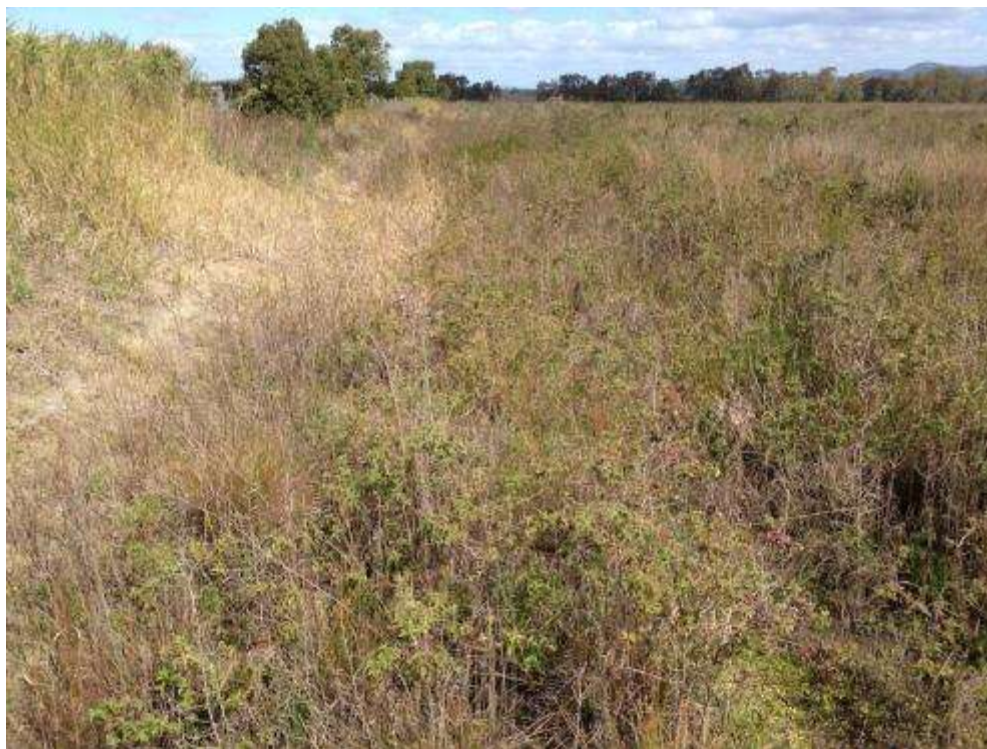
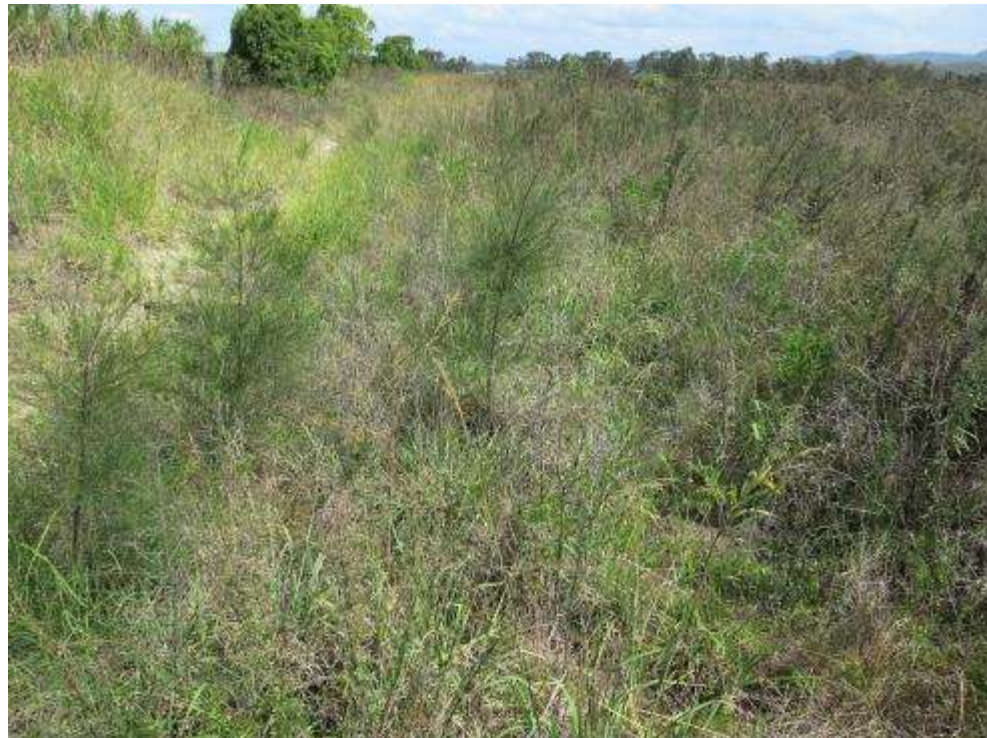
Photo Plate 122: Quadrat 13 - Month 18 (February 2017)

Comparison Summary
Canopy trees have grown significantly within this quadrat over the six month period. This growth is representative of the general areas, which has overall been a little slower to take off when compared to other areas of the site.

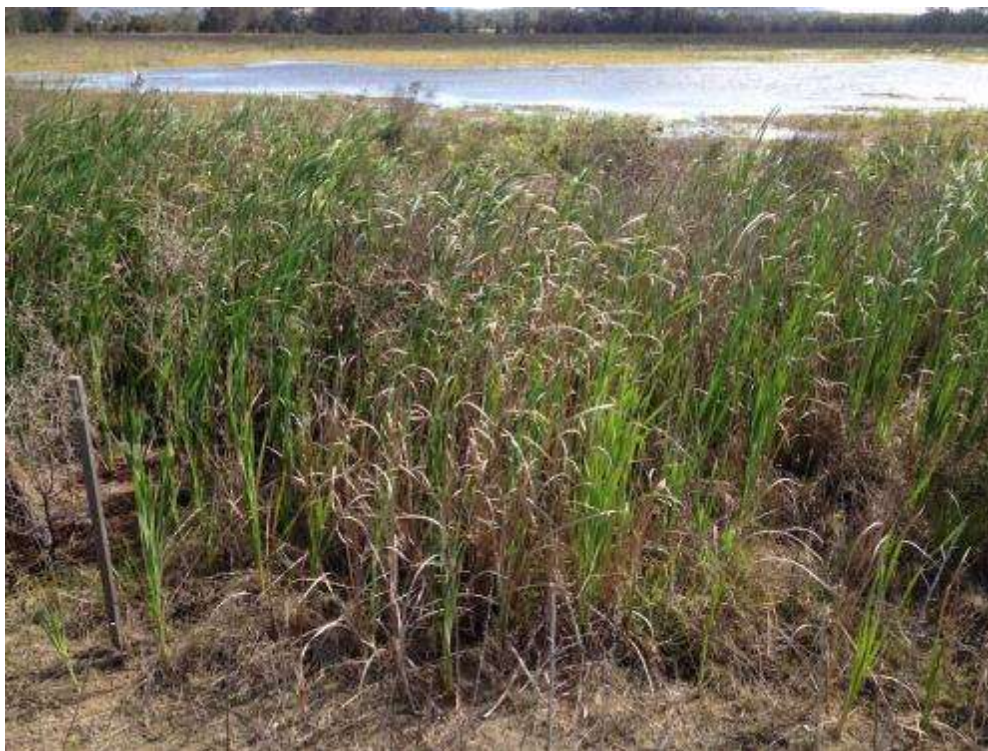
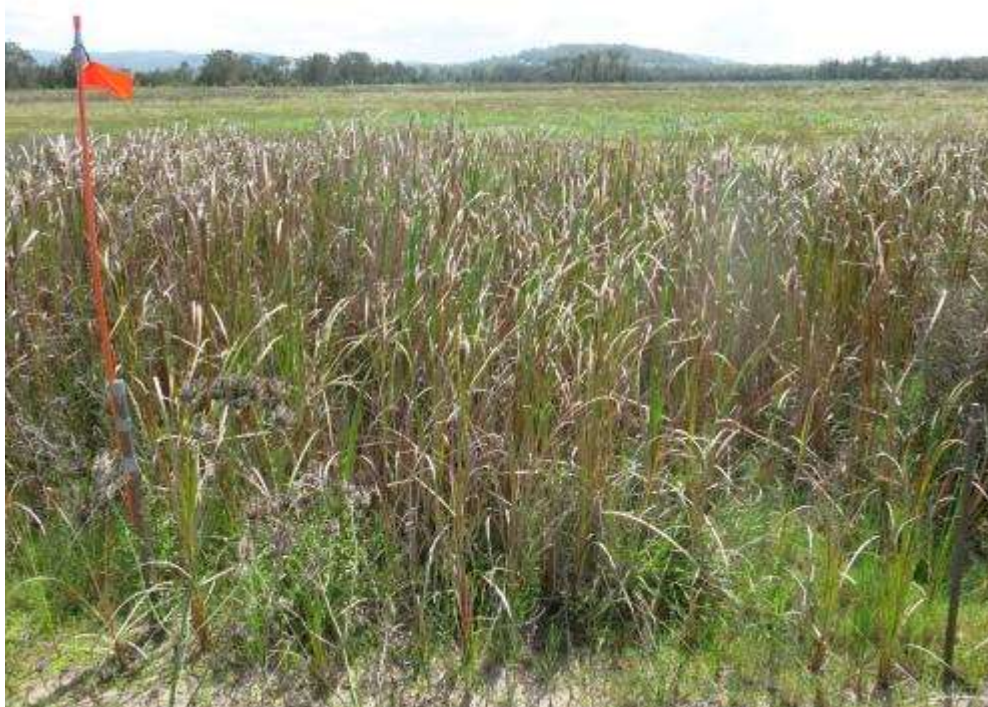
Photo Plate 124: Quadrat 14 - Month 18 (February 2017)

Typha is becoming dominant in the area. The positive aspect to this would be its nesting habitat value for water birds over the wet season. However, this species could, over a long period, degrade the diversity of the entire site. Interestingly enough, Typha was sprayed here in the very first visit.

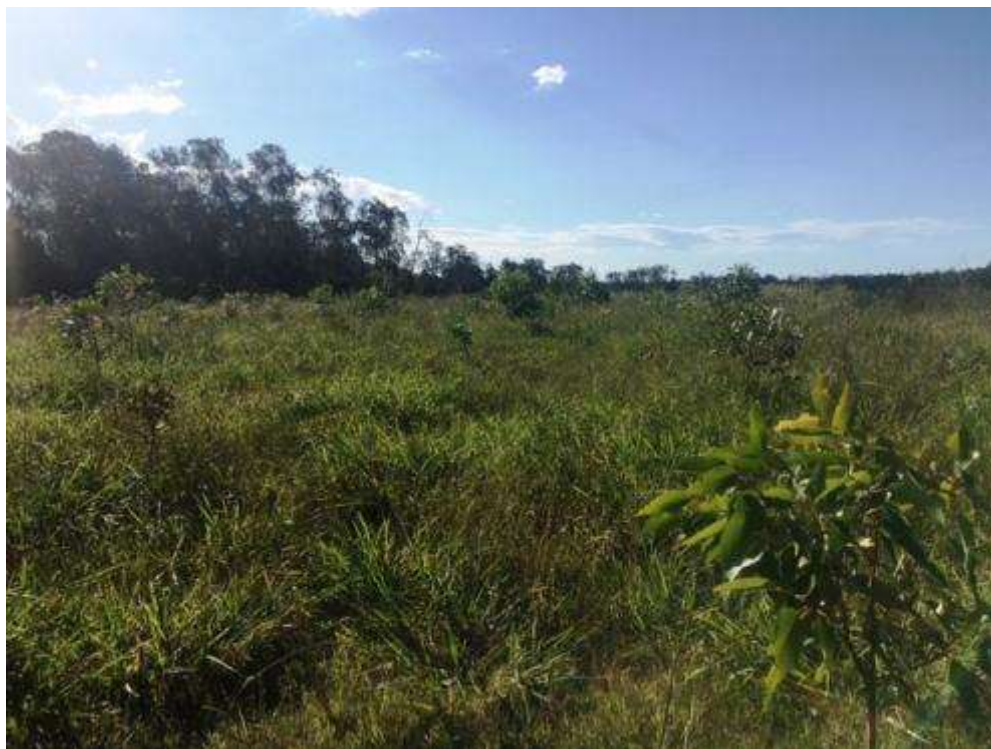
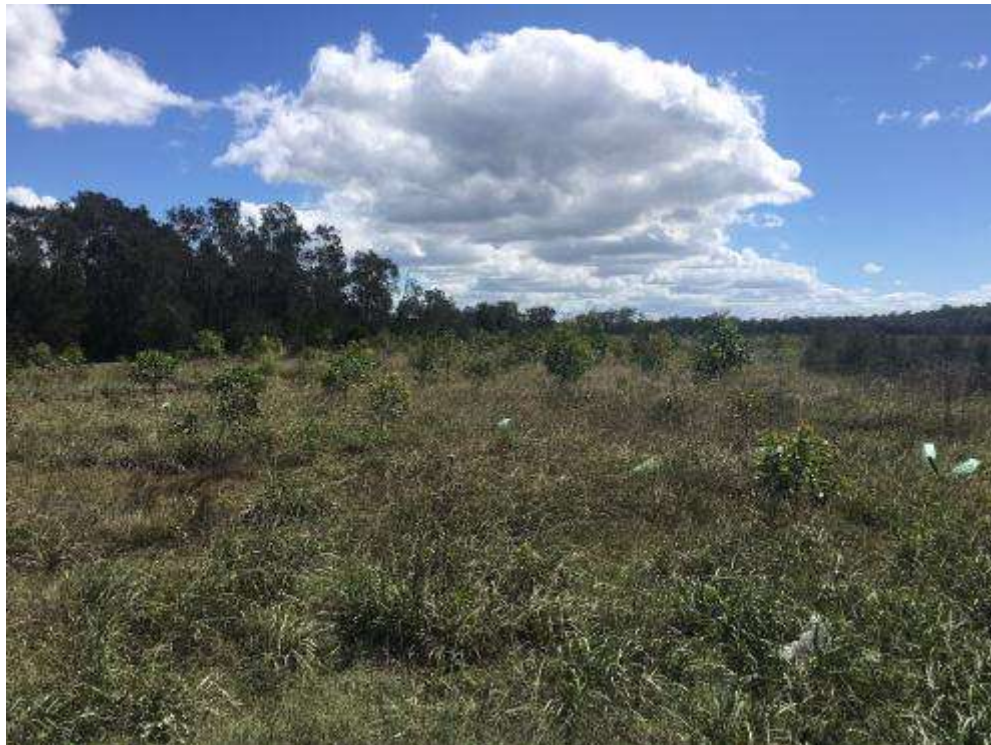
Photo Plate 126: A1 Eucalypt Plantings - Month 18 (February 2017)

At the month 12 monitoring time, pasture grasses were still dominant, however seedlings were becoming clearly visible above the height of the grass. During the month 18 monitoring event, grass height was comparable, however planted stock continued to grow and prosper. Stock averaged approximately 3.5m in height at this monitoring event. Additional new species were identified within the NWCP during the month 18 monitoring period.

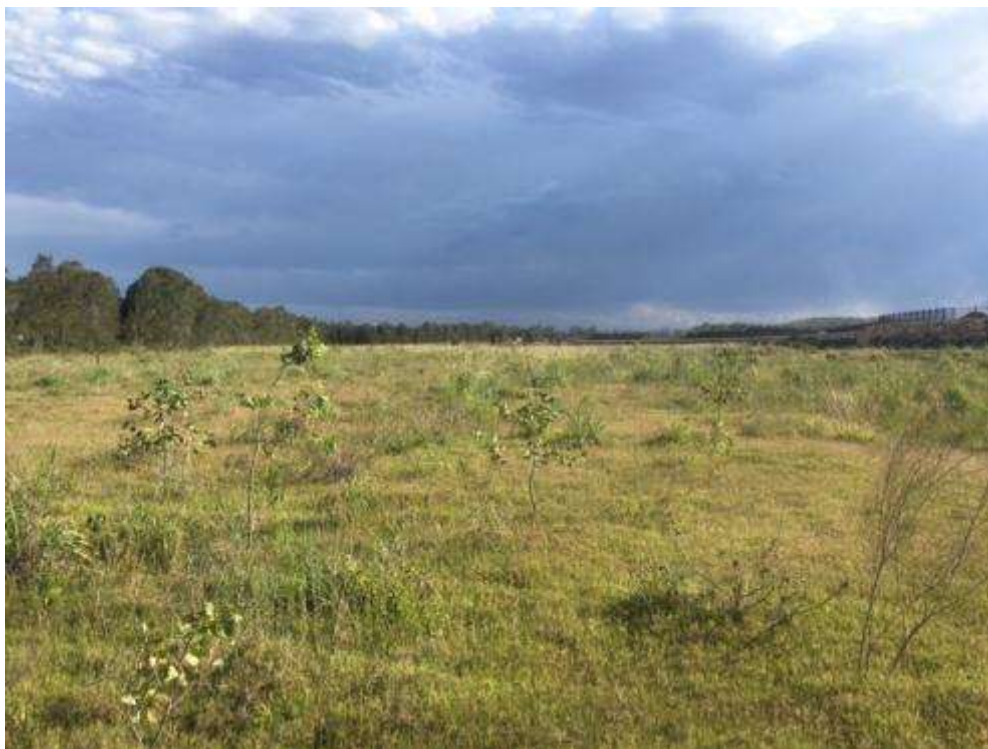
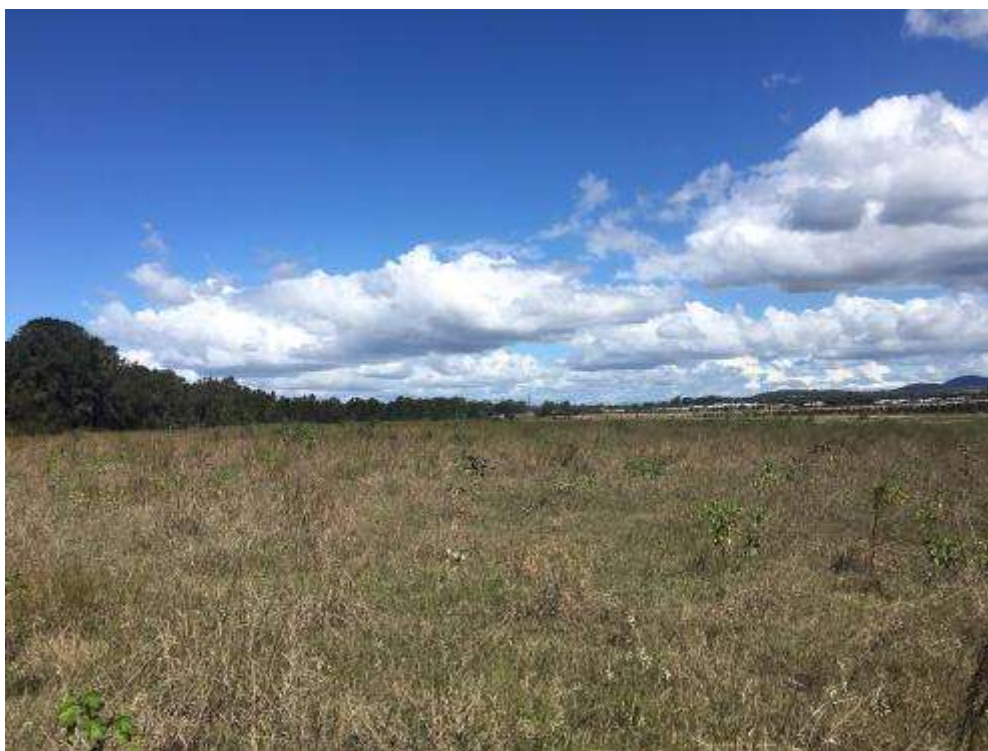
Photo Plate 128: A2 Eucalypt Plantings - Month 18 (February 2017)

The site is still periodically inundated, limiting the growth of a number of the seeded species. This area of tube stock planting is taking longer than the A1 plantings. It is anticipated that this stock will grow slower than other areas due to the geology and inundation.

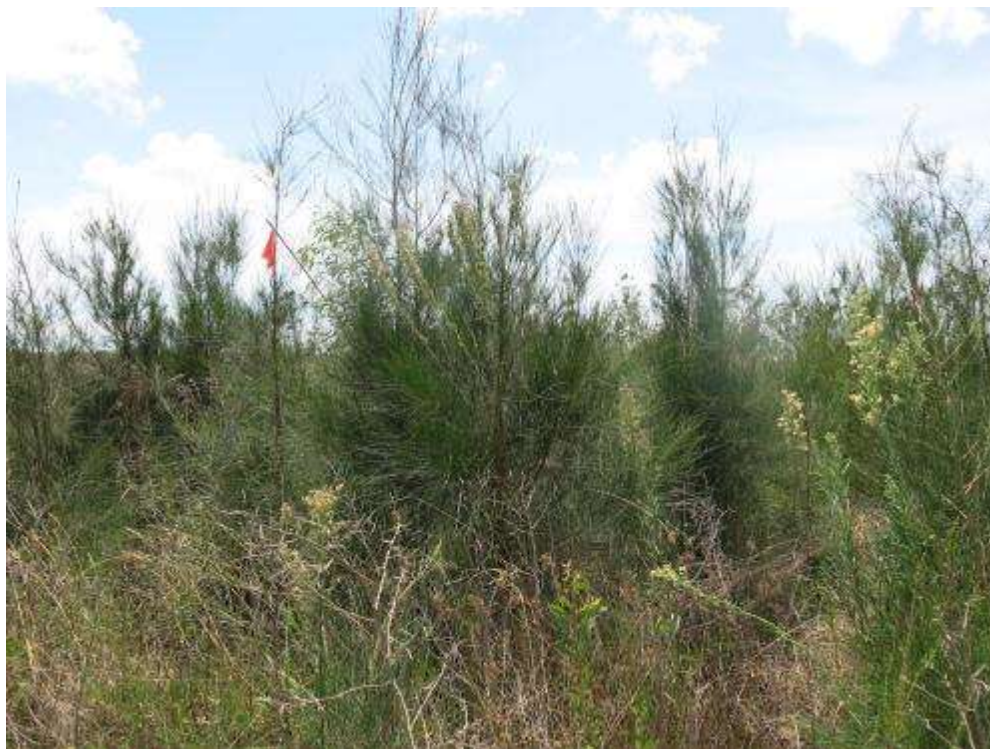
Photo Plate 129: Quadrat 1 - Month 18 (February 2017)

This quadrat was noted during Month 18 as being the most degraded quadrat. Over the past 6 months, growth of *Casuarina glauca* is has been exponential. This is clearly evident in the Month 24 monitoring photo. There has been no change in native plant dominance, however the biomass of native growth has significantly increased. This will greatly assist with shading out of weed species over the next 6 months.

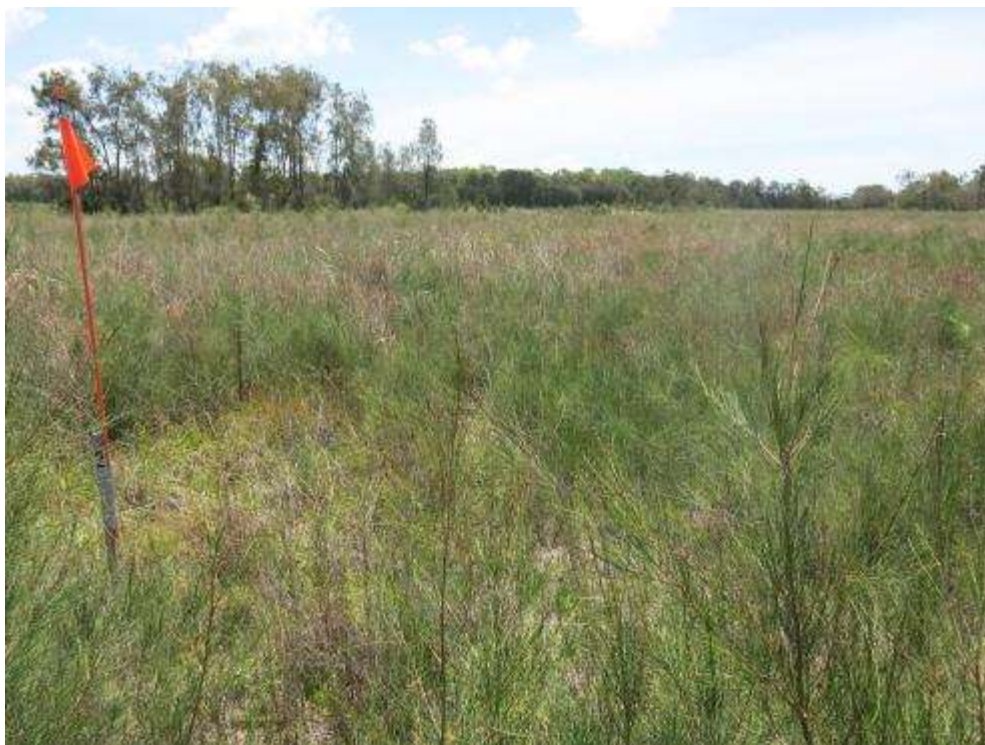
Photo Plate 131: Quadrat 2 - Month 18 (February 2017)

Comparison Summary
Weed growth is noted to be struggling against the growing dominance of native vegetation, especially casuarinas.

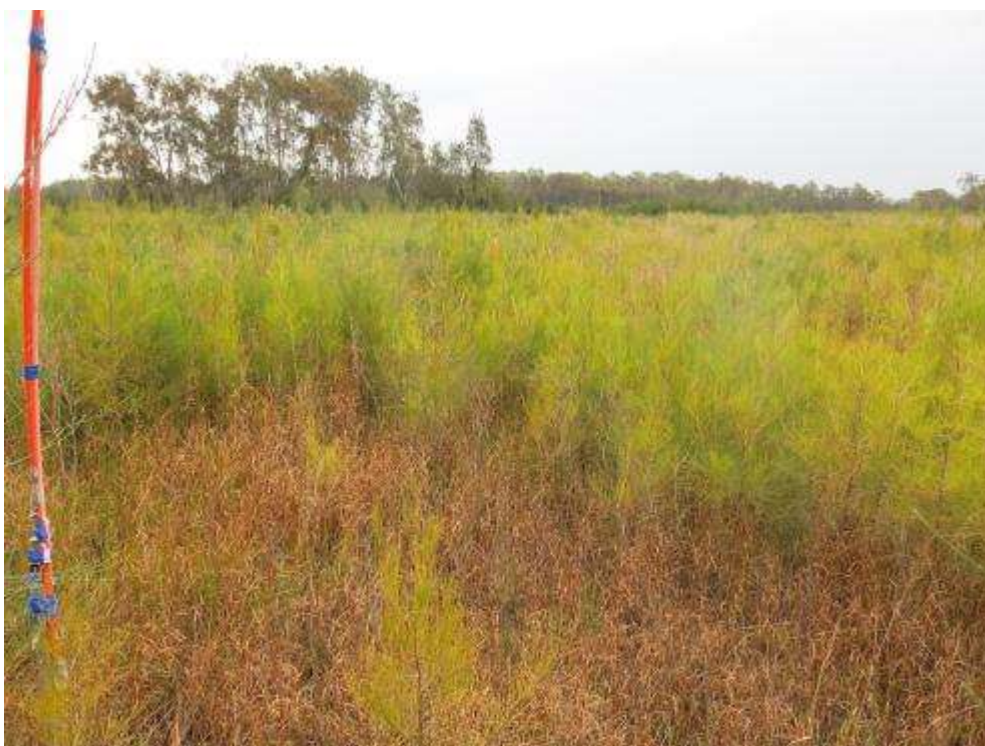
Photo Plate 132: Quadrat 2 - Month 24 (August 2017)

Both *Melaleuca quinquenervia*, some measuring 2m in height, and *Casuarina glauca* surround this quadrat in the hundreds. The entire surrounds are very weed free. Traversing between quadrats 2 and 3 is difficult due to the abundance of canopy trees.

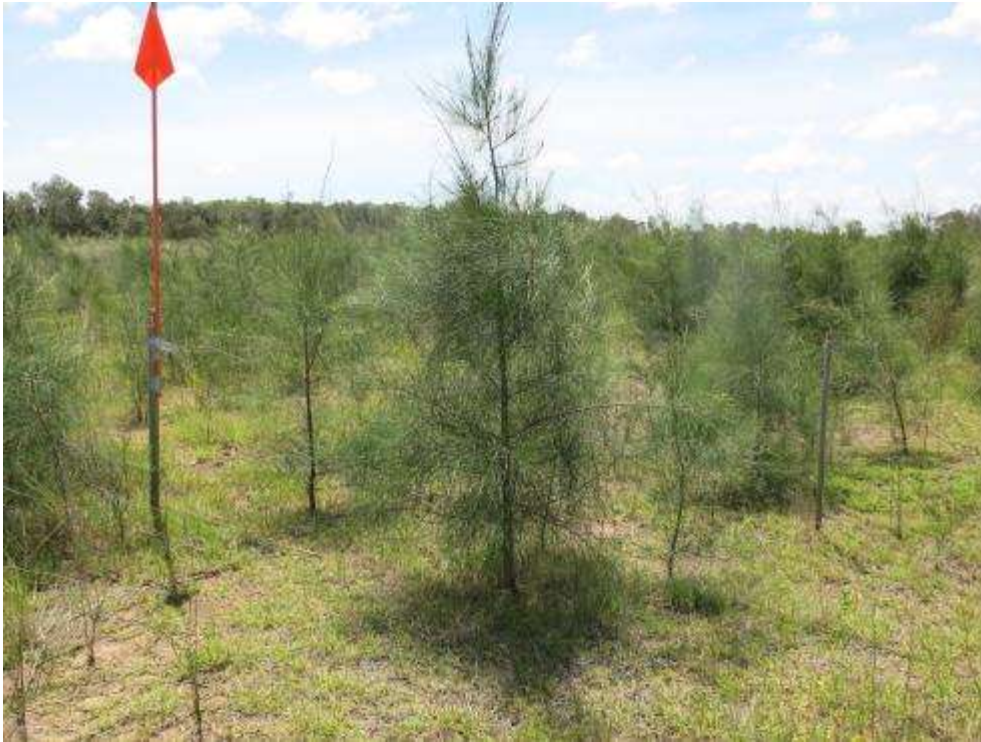
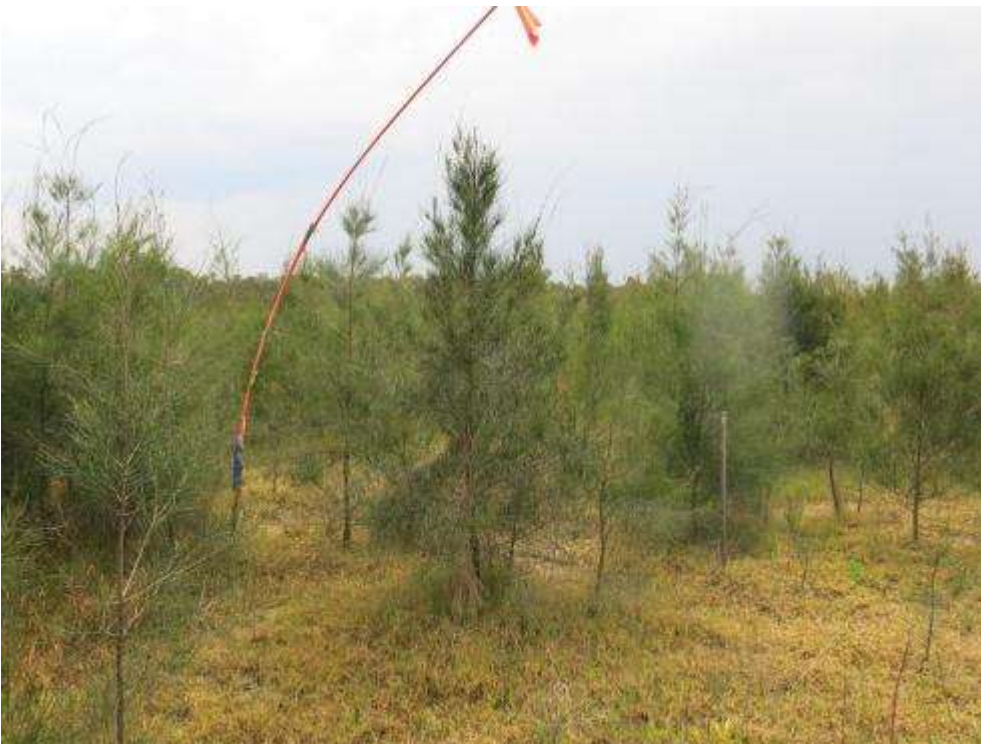
Photo Plate 133: Quadrat 3 - Month 18 (February 2017)

The growth in biomass and height of *Casuarina glauca* has been significant over the past 6 months. Also increasing in strength is the coverage and density of groundcovers. This has increased the soil coverage and stability within the quadrat and surrounds.

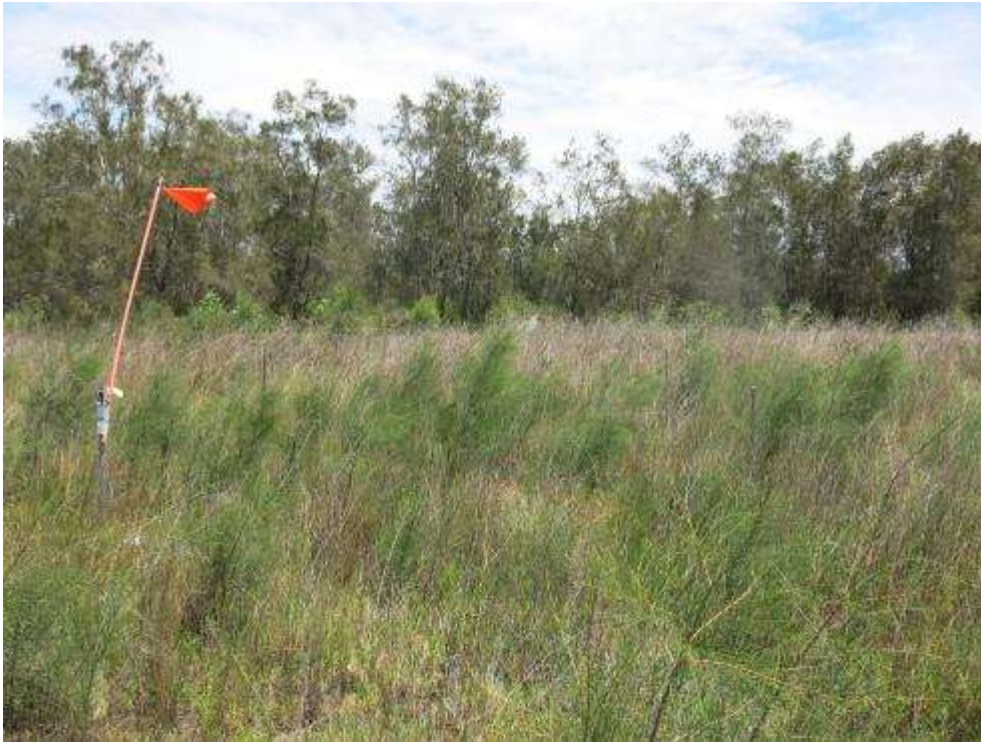
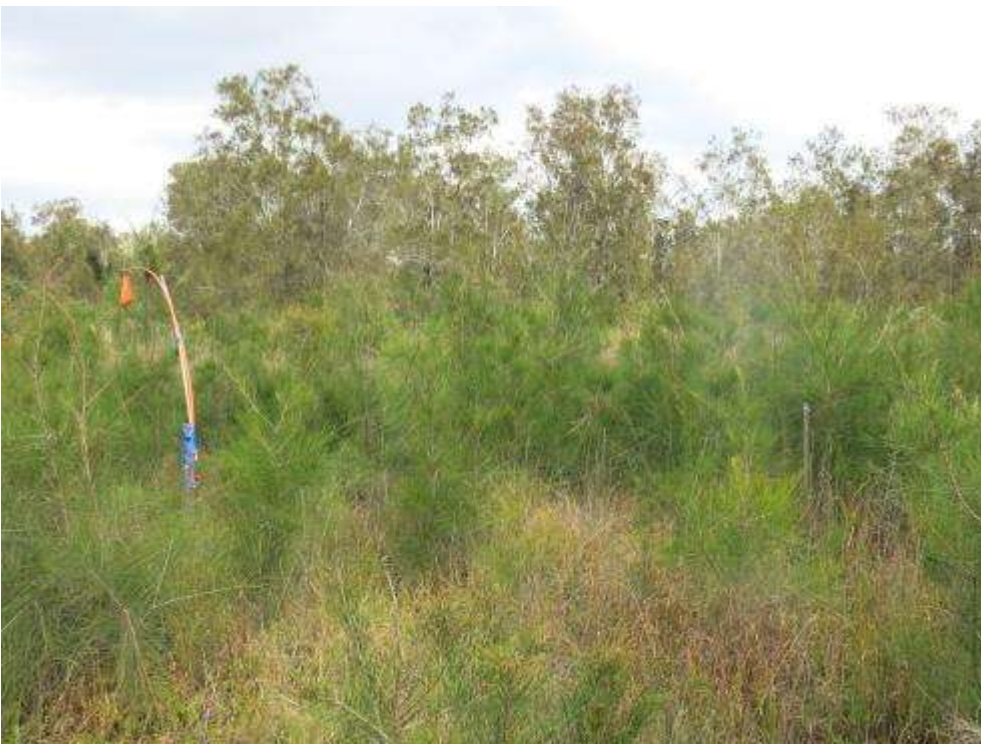
Photo Plate 135: Quadrat 4 - Month 18 (February 2017)

Casuarina glauca were recorded to be no more than seedlings during the Month 18 monitoring event. These seedlings are now over 2.5m in height.

Within the surrounds of this quadrat are a number of eucalypt and *Corymbia* seedlings that are also growing well. A new species, *Gahnia aspera*, was also identified in good numbers surrounding this area.

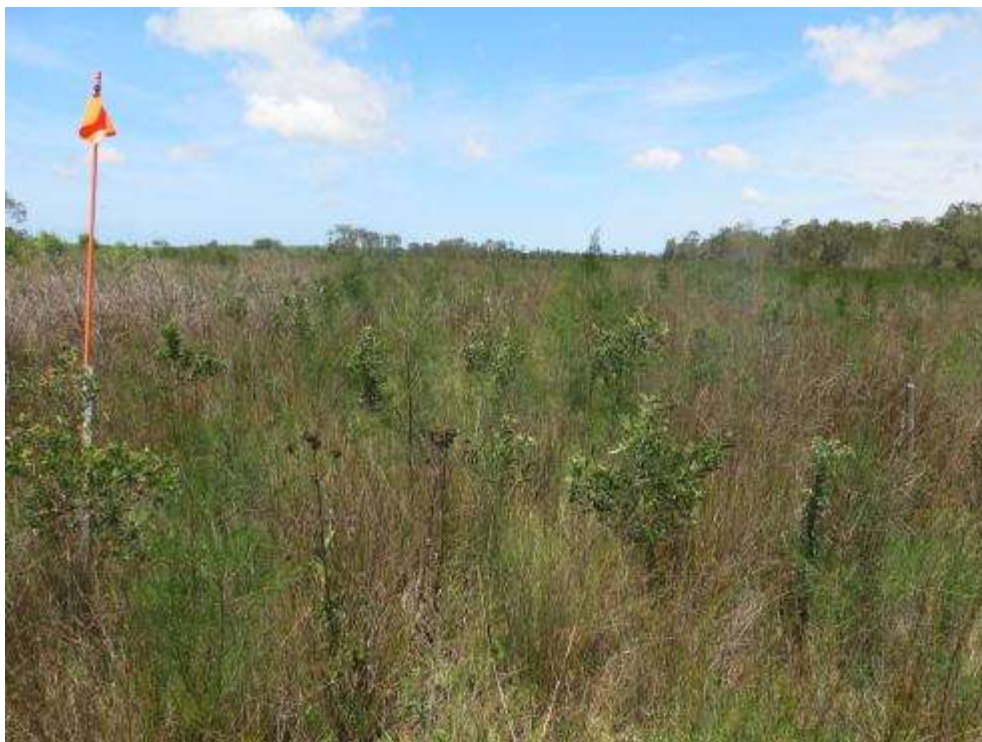
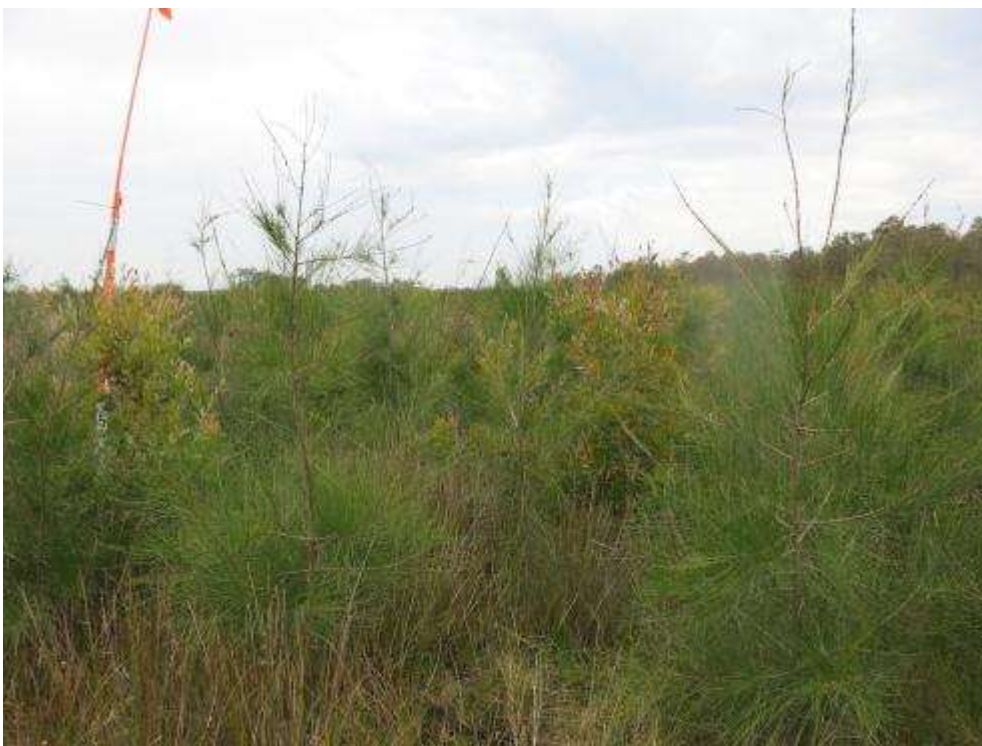
Photo Plate 137: Quadrat 5 - Month 18 (February 2017)

Melaleuca and Casuarina are forming impressive thickets in areas between quadrats 4, 5, 6 and 7. Myrtle rust is still present on some Melaleucas in the surrounding area, however is not spreading or degrading individuals.

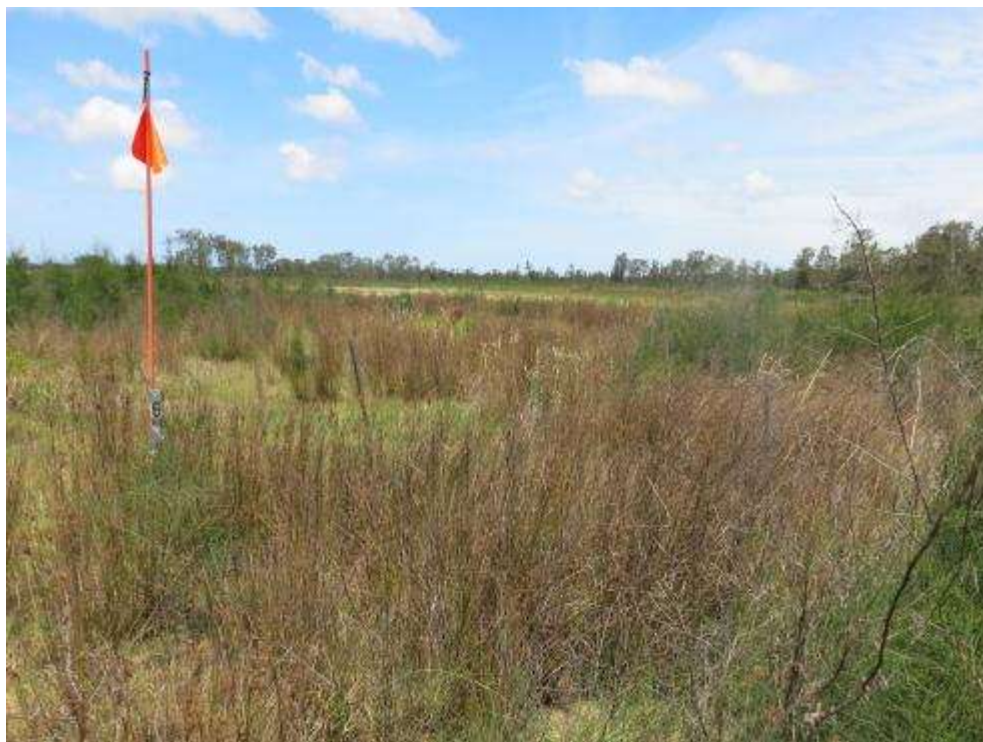
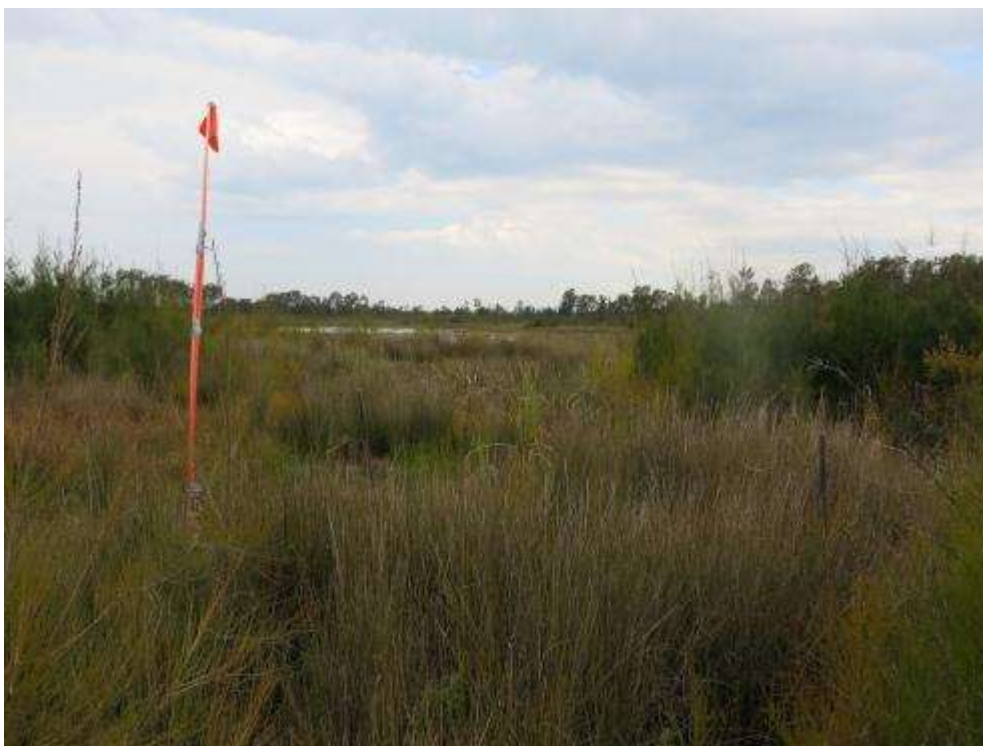
Photo Plate 139: Quadrat 6 - Month 18 (February 2017)

This quadrat has retained native dominance during the entire monitoring phase to date, and continues to do so with many species of sedges in the area. There are significant numbers of canopy trees in the surrounding area to this quadrant. This illustrates the habitat complexity and diversity within a small area of the site, with niche pockets such as this scattered throughout the NWCP.

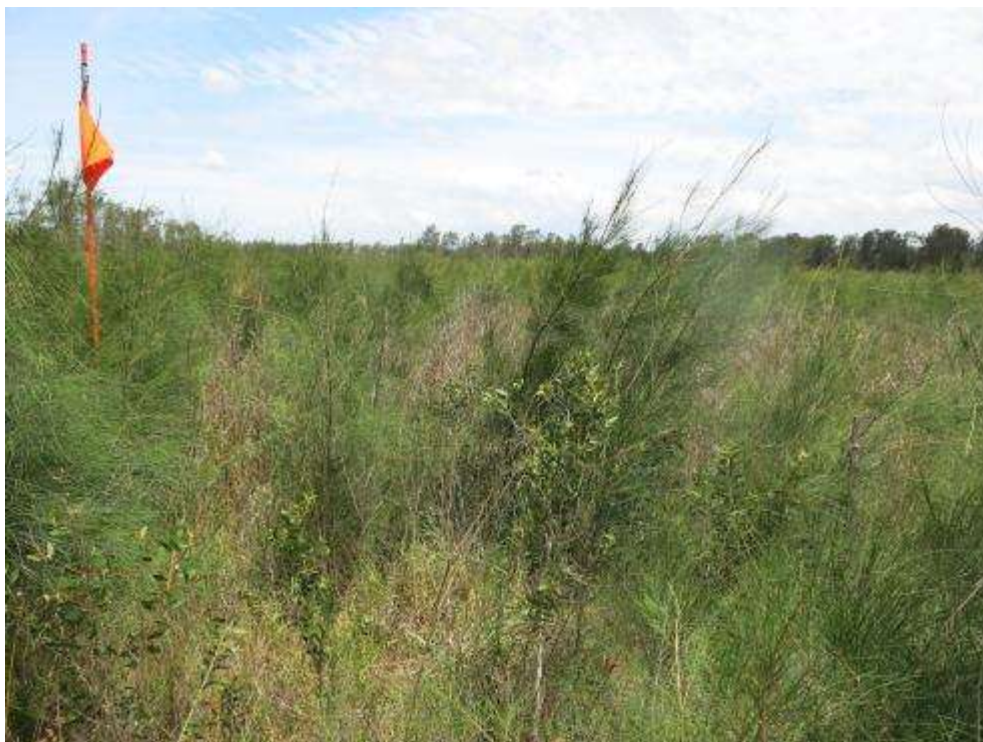
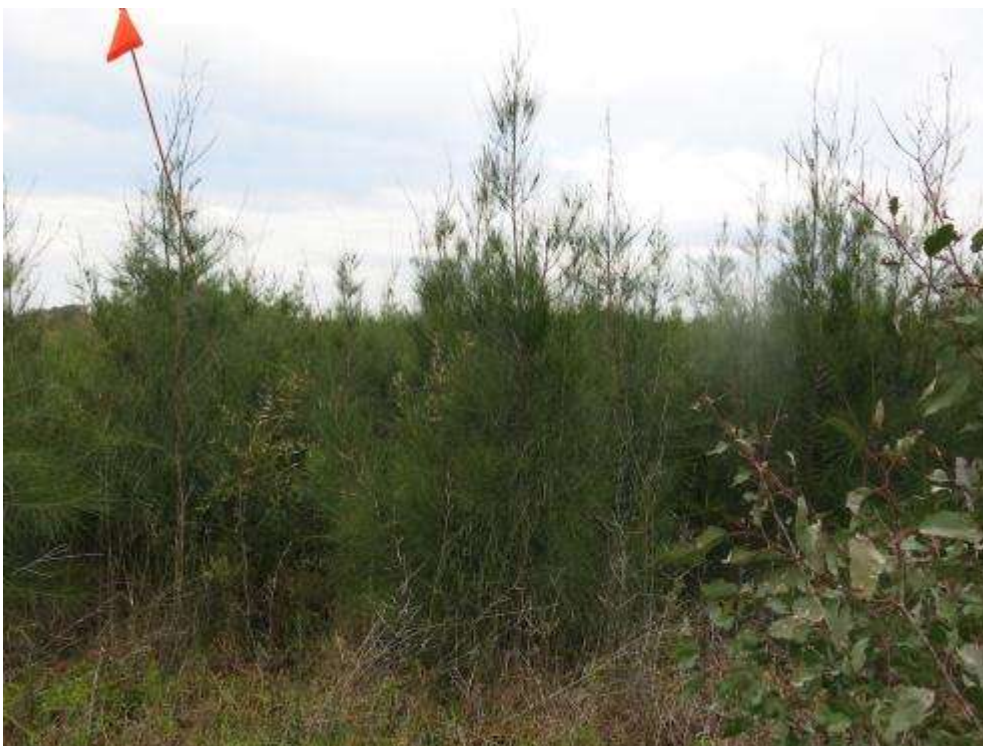
Photo Plate 141: Quadrat 7 - Month 18 (February 2017)

Comparison Summary
Native canopy vegetation continues to increase in height and biomass within this quadrat. Dominance of canopy species within the surrounding areas is variable, and includes a number of eucalypt and corymbia species. The increase in biomass of canopy vegetation has increased shading of the understorey. This has resulting in the eradication of one pasture weed species, *Conyza sumatrensis*.

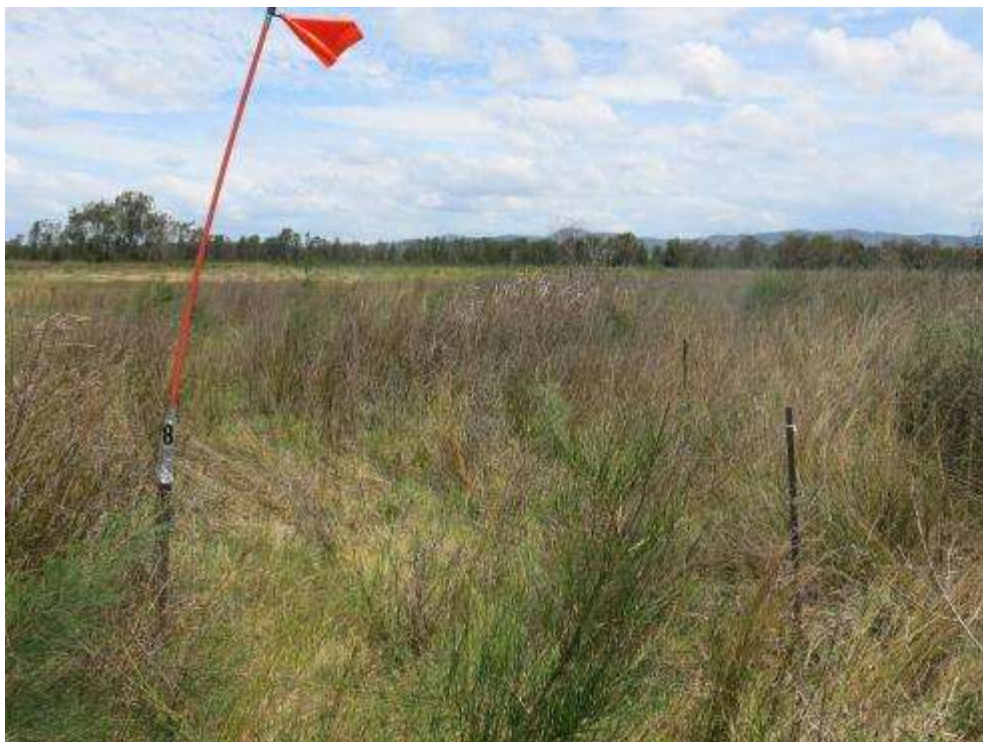
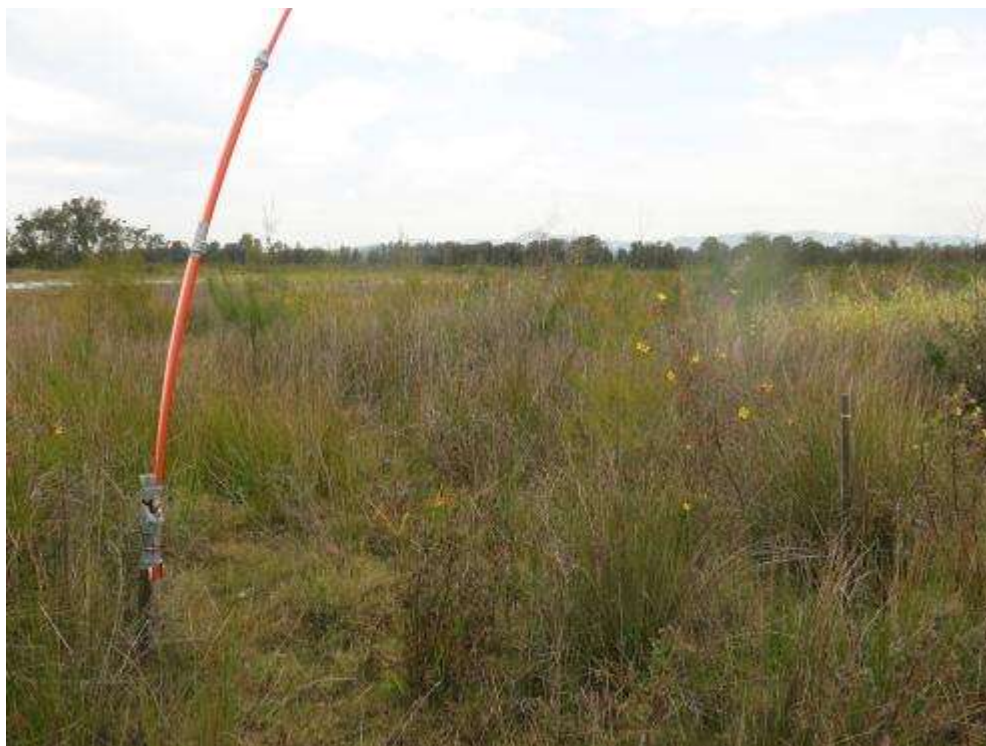
Photo Plate 143: Quadrat 8 - Month 18 (February 2017)

Comparison Summary
This is a stable quadrat dominated by freshwater wetland species, such as sedge, rush and cyperus species. A small number of casuarinas are scattered in and around this quadrat, however it will never be a dominant species within this area due to the hydrology.
