North-West Conservation Park - Rehabilitation Monitoring

Lot 1 RP48903

North-West Conservation Park
Gainsborough Greens

March 2020

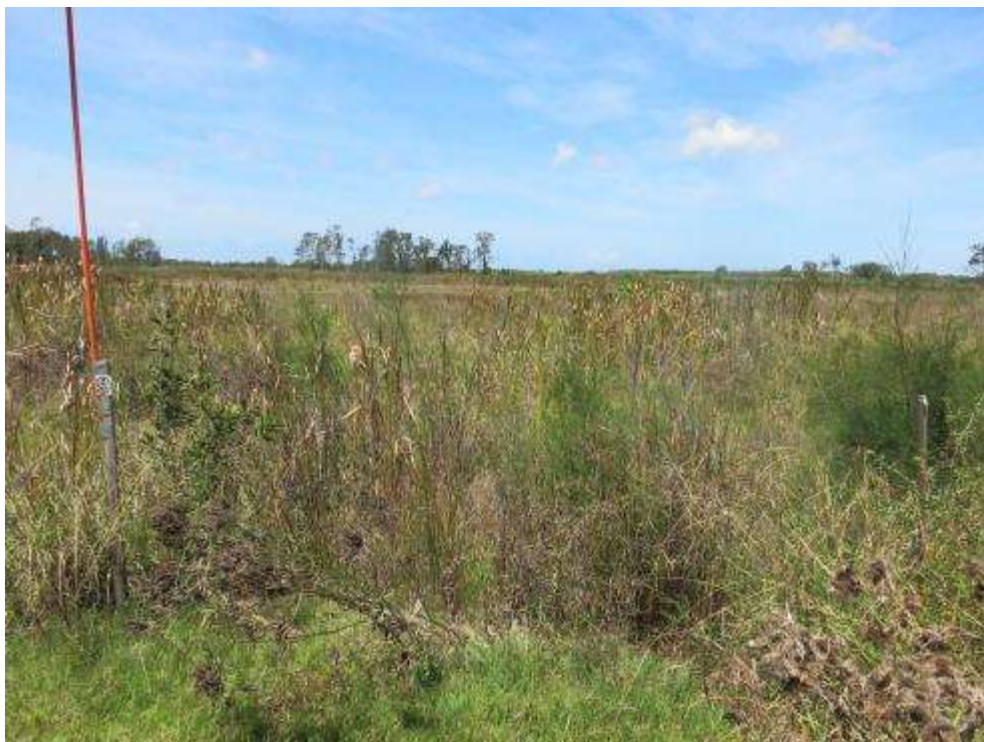
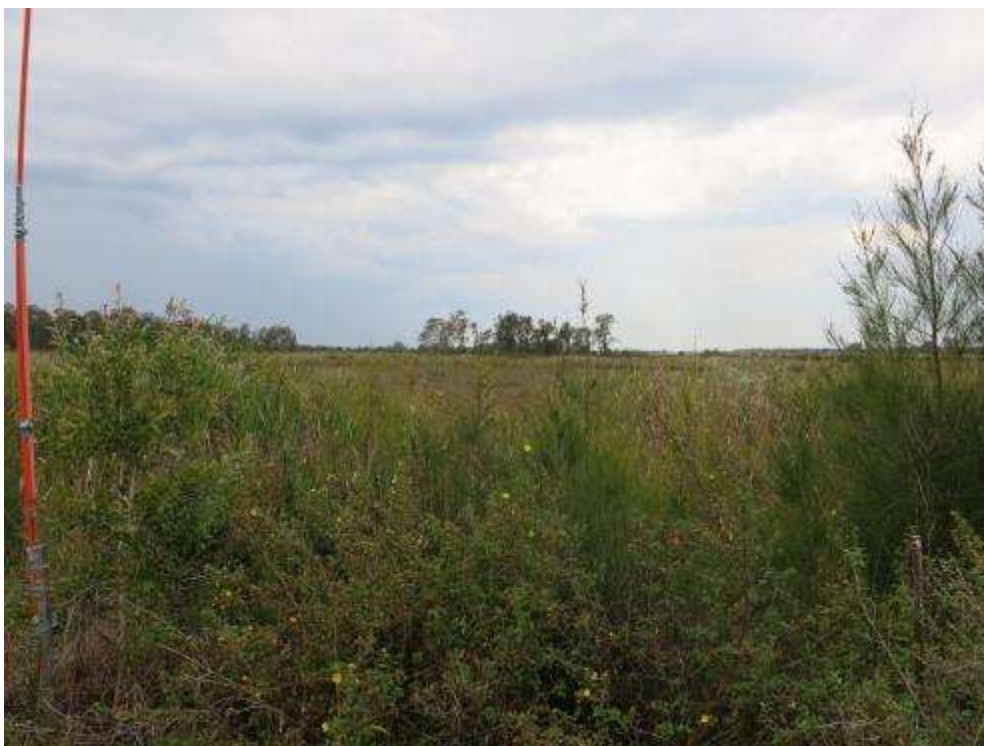
Photo Plate 145: Quadrat 9 - Month 18 (February 2017)

There are no major changes with this quadrat over the past 6 months. It has remained stable. Canopy vegetation growth within and surrounding this quadrat has increased. Native groundcover biomass has also increased slightly over this period.

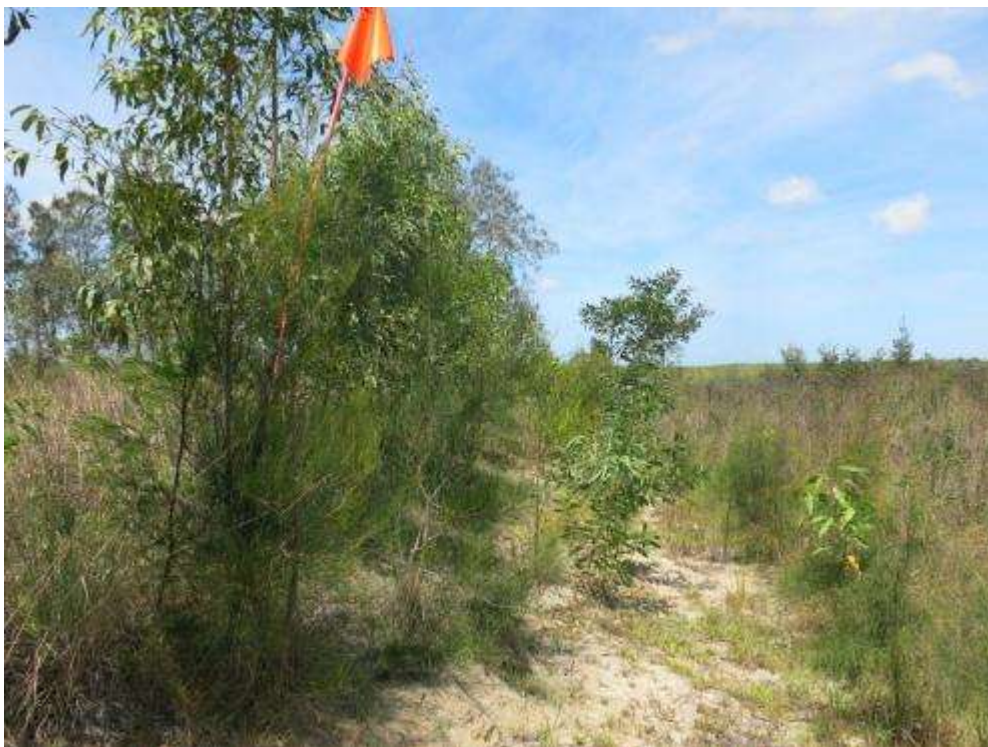
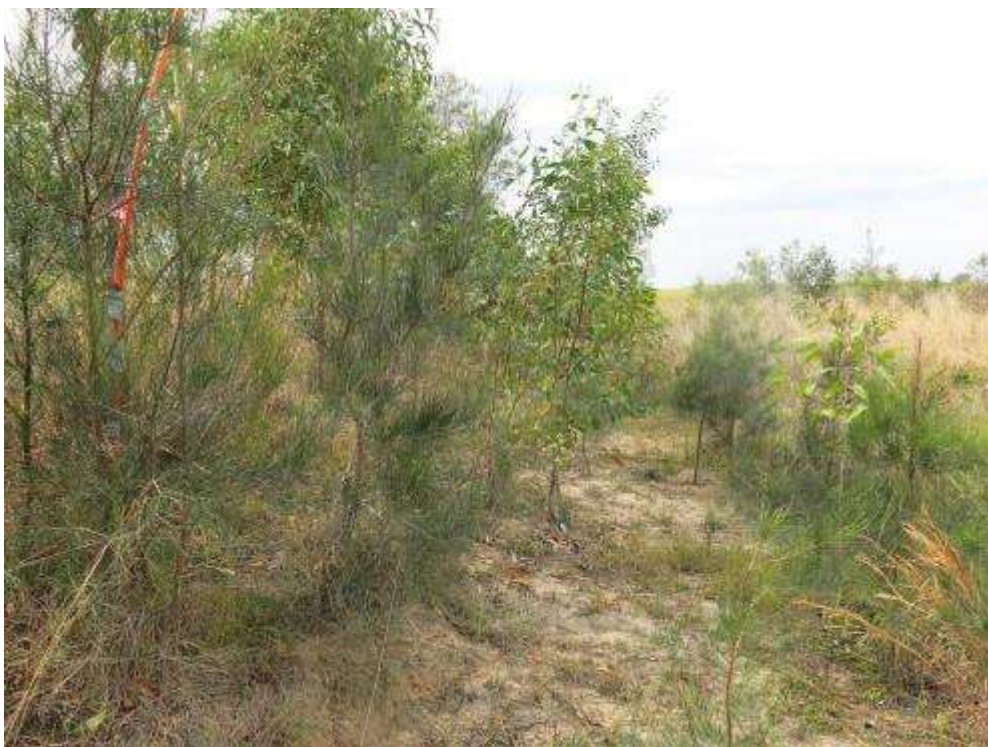
Photo Plate 147: Quadrat 10 - Month 18 (February 2017)

The extent of vegetation cover within this quadrat has not increased. It is considered unlikely that this will increase due to the topography of this quadrat.

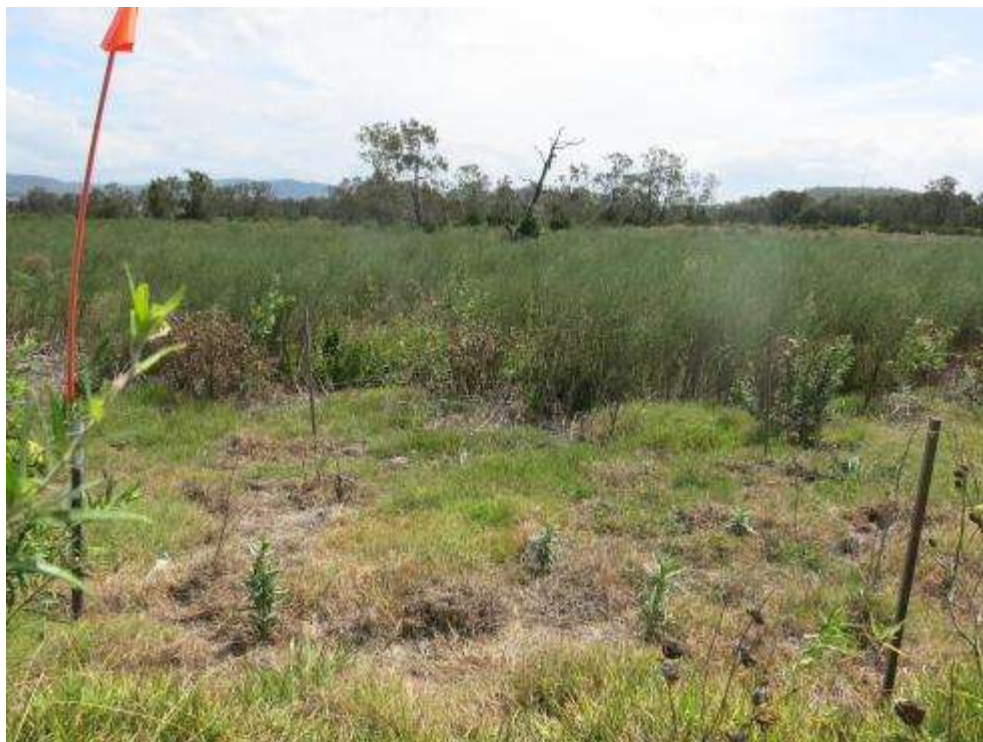
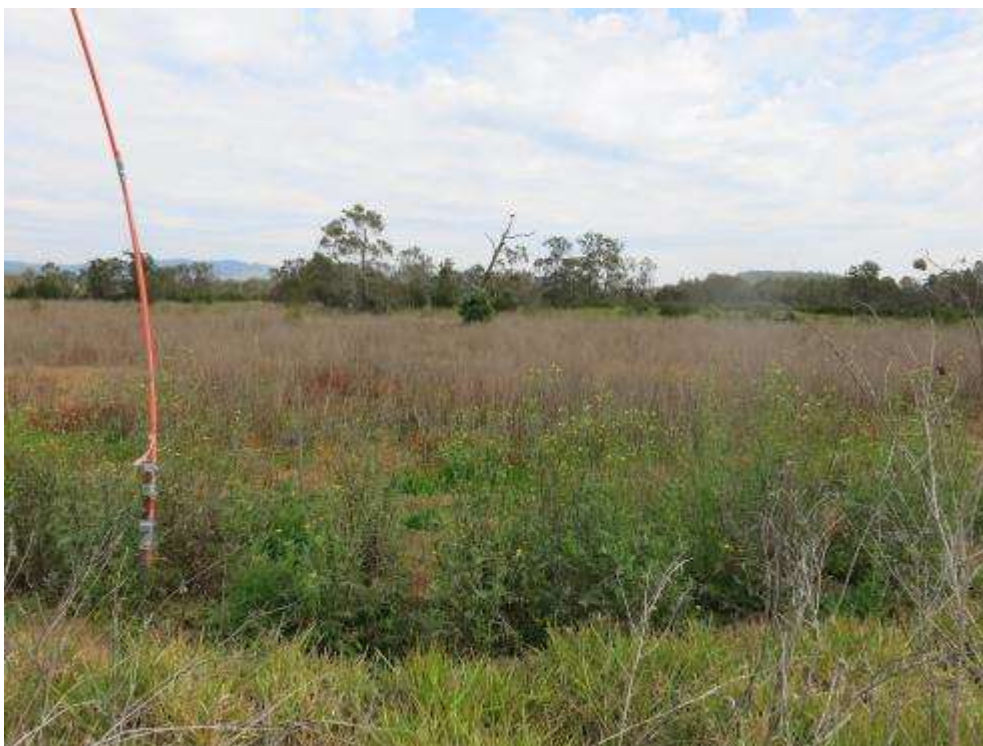
Photo Plate 149: Quadrat 11 - Month 18 (February 2017)

This quadrat provides an example of how dynamic this area can be. During Month 18, this area was noted as being very stable. Now at Month 24, the quadrat has decreased in native dominance due to an outbreak of Common Sow Thistle. It is noted that this pasture weed is not of concern and will be naturally controlled with the next large rain event, as standing water will smother this species.

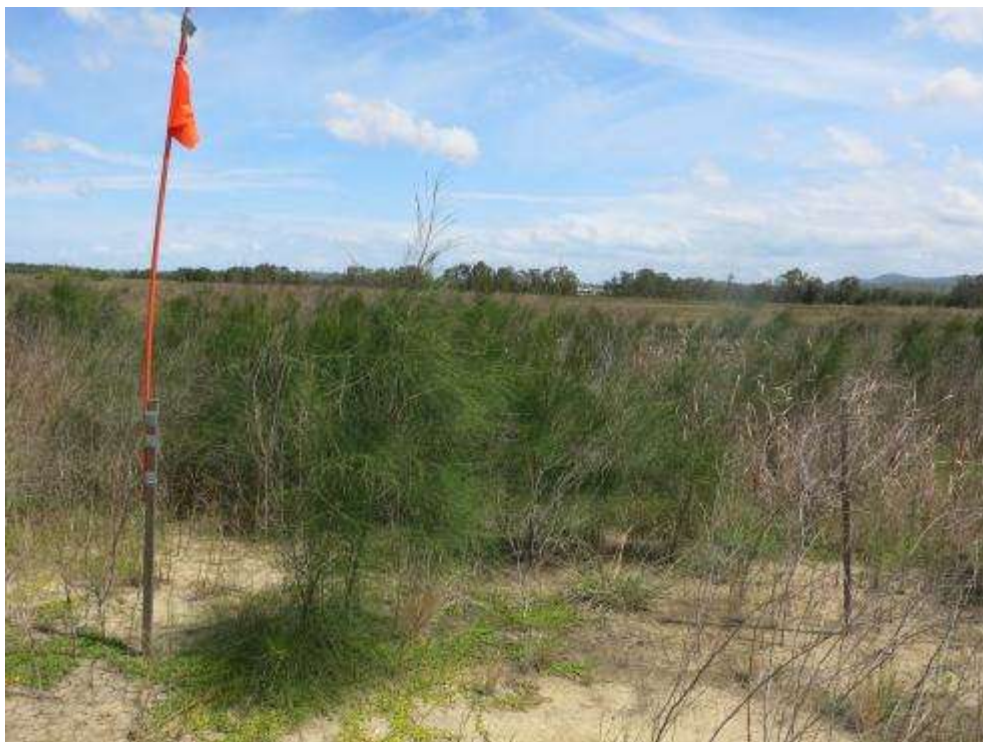
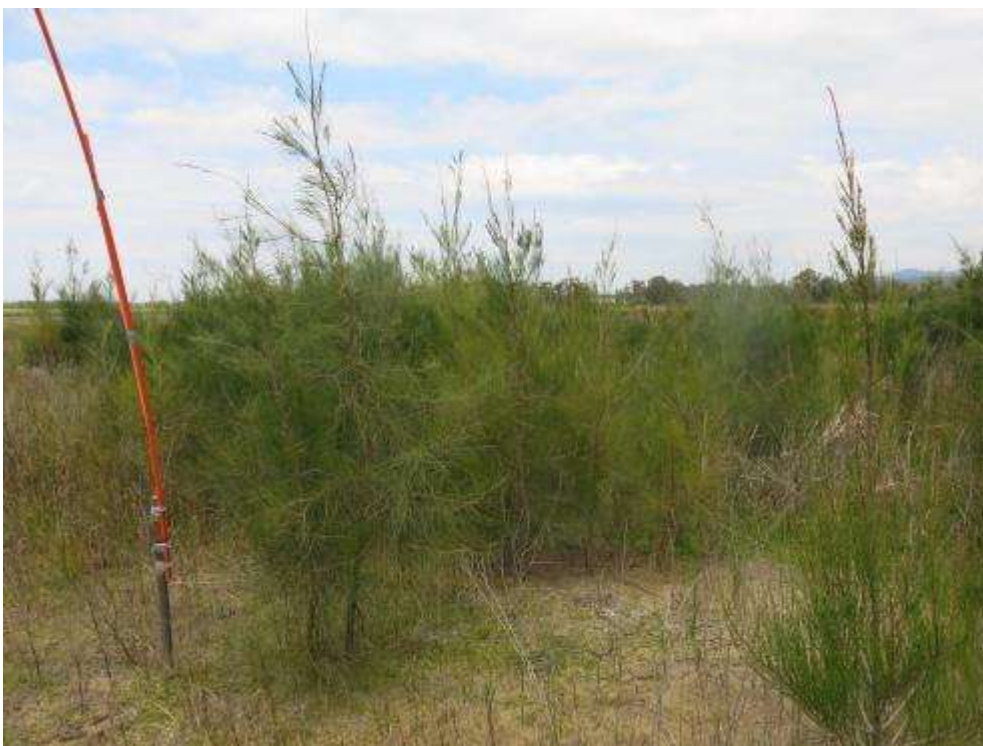
Photo Plate 151: Quadrat 12 - Month 18 (February 2017)

Comparison Summary
Whilst this quadrat is abundant with canopy tree species, there is still a lack in good soil coverage. Native grasses are common across the higher contours surrounding this quadrat.

This quadrat and the immediate surrounds appear to be lagging compared to other areas, however vegetation has still grown significantly over this six month period.

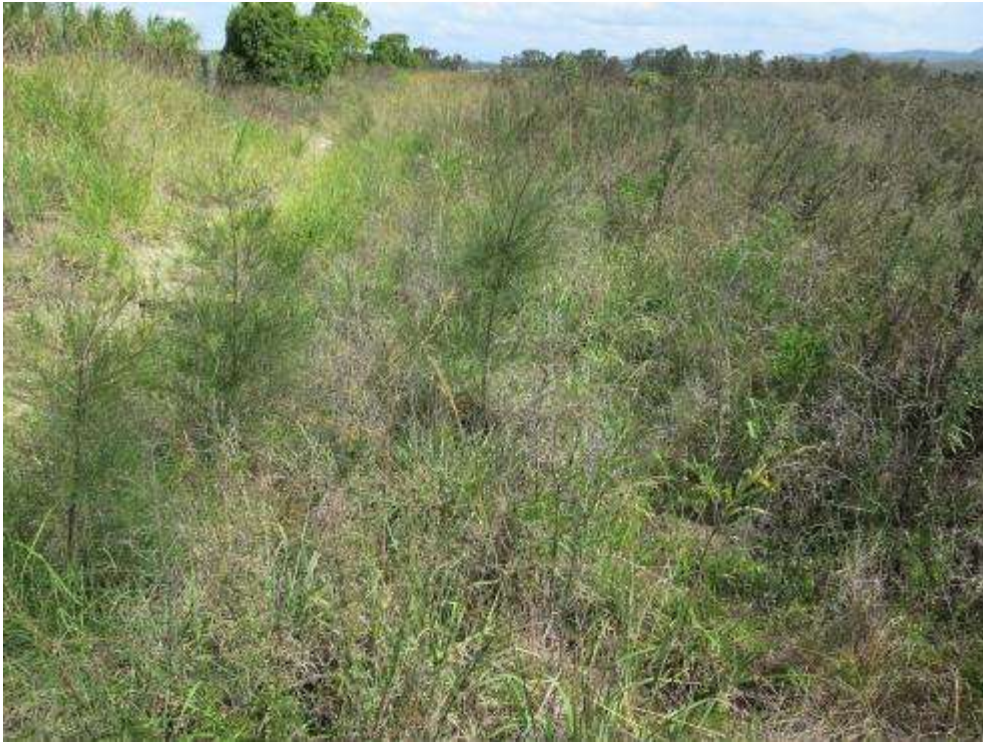
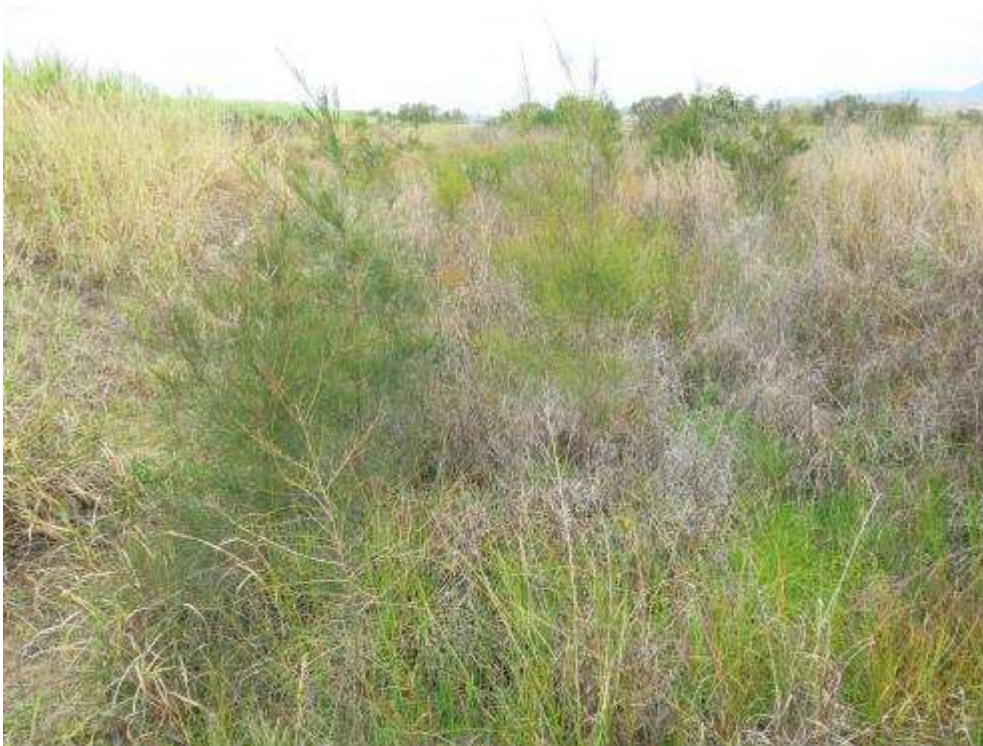
Photo Plate 153: Quadrat 13 - Month 18 (February 2017)

Canopy trees have grown in height and biomass within this quadrat over the six month period. Growth within this area of the NWCP has been significant, with canopy vegetation reaching above weedy grass species within the broader area. These weedy grass species are beginning to struggle under the shading of native canopy vegetation.

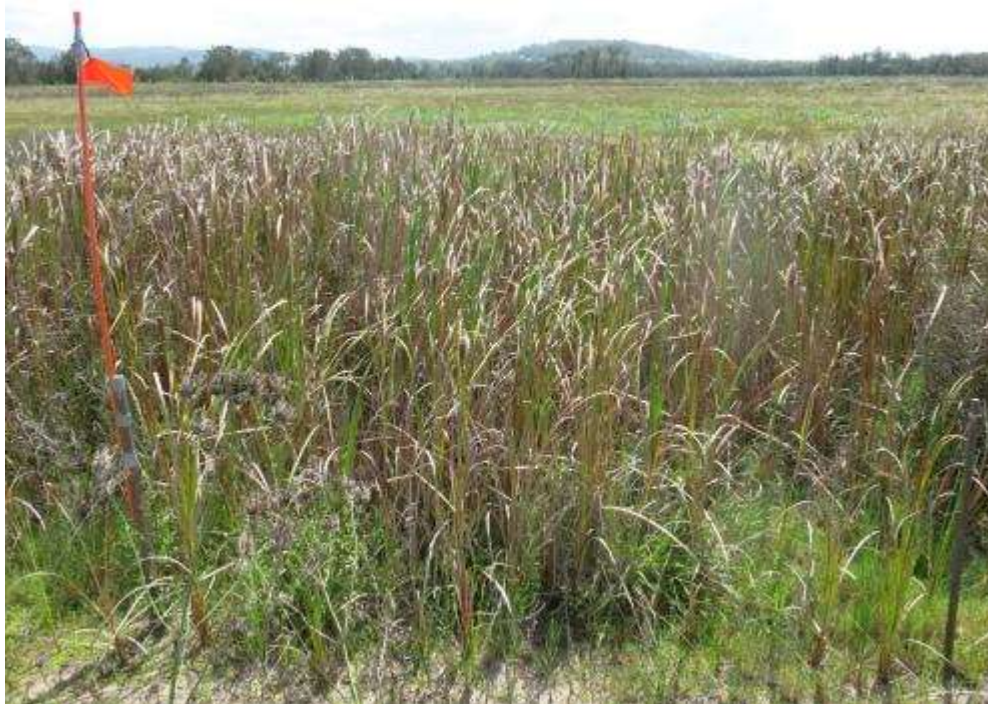
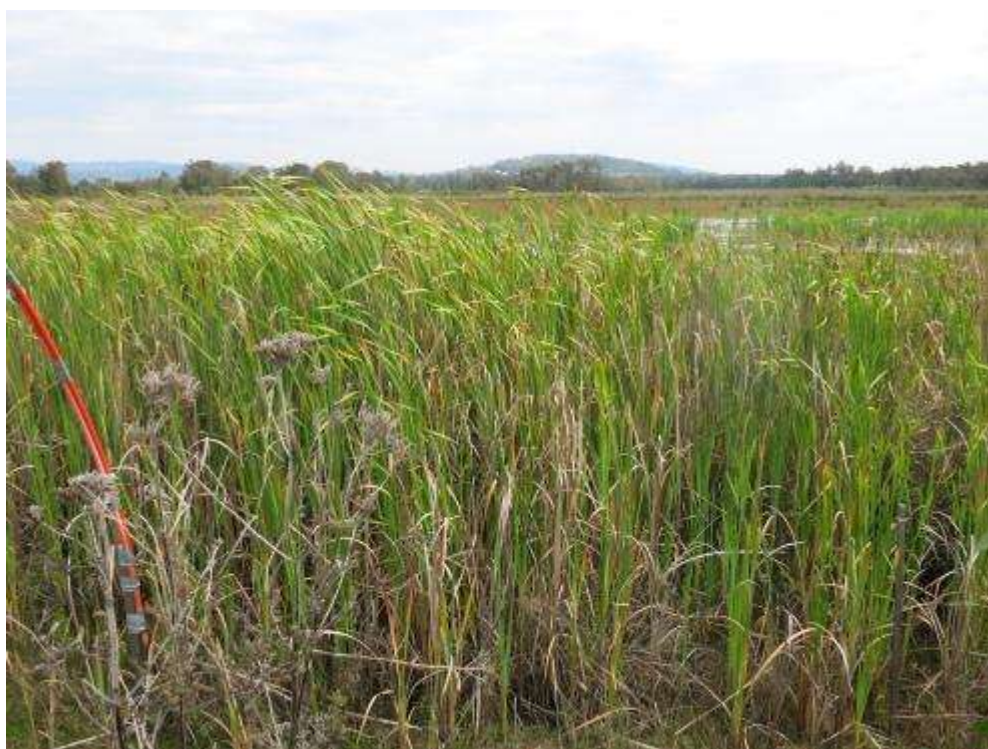
Photo Plate 155: Quadrat 14 - Month 18 (February 2017)

Native dominance of vegetation has now reached 100% within this quadrat, with almost complete coverage. It is noted that the diversity of native species is rapidly declining due to the dominance of Typha.

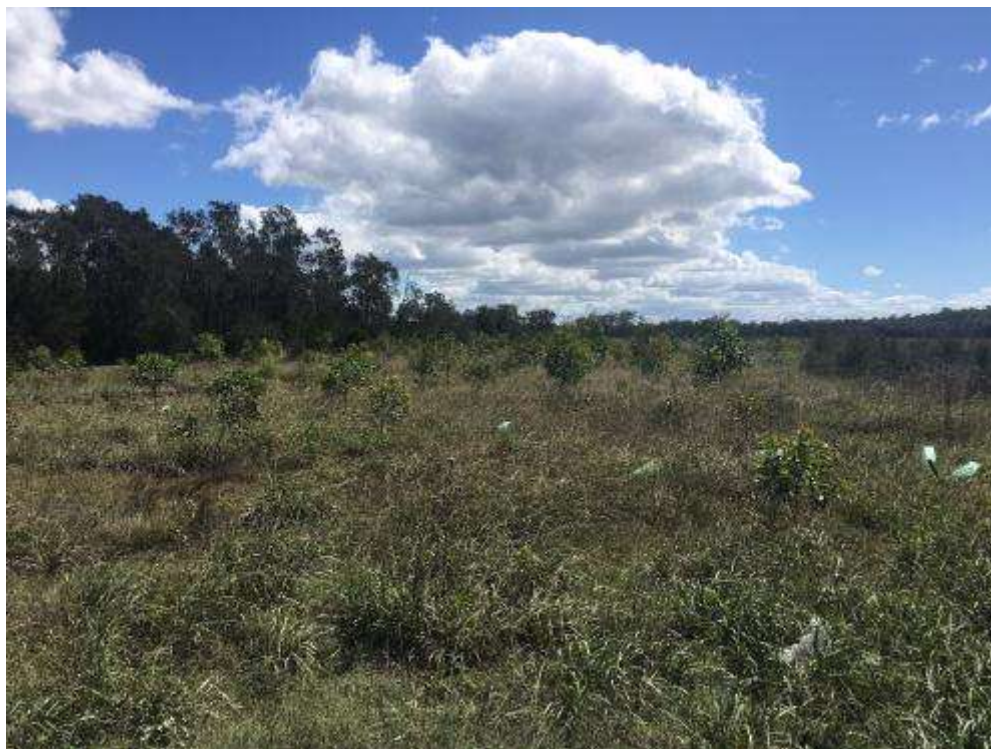
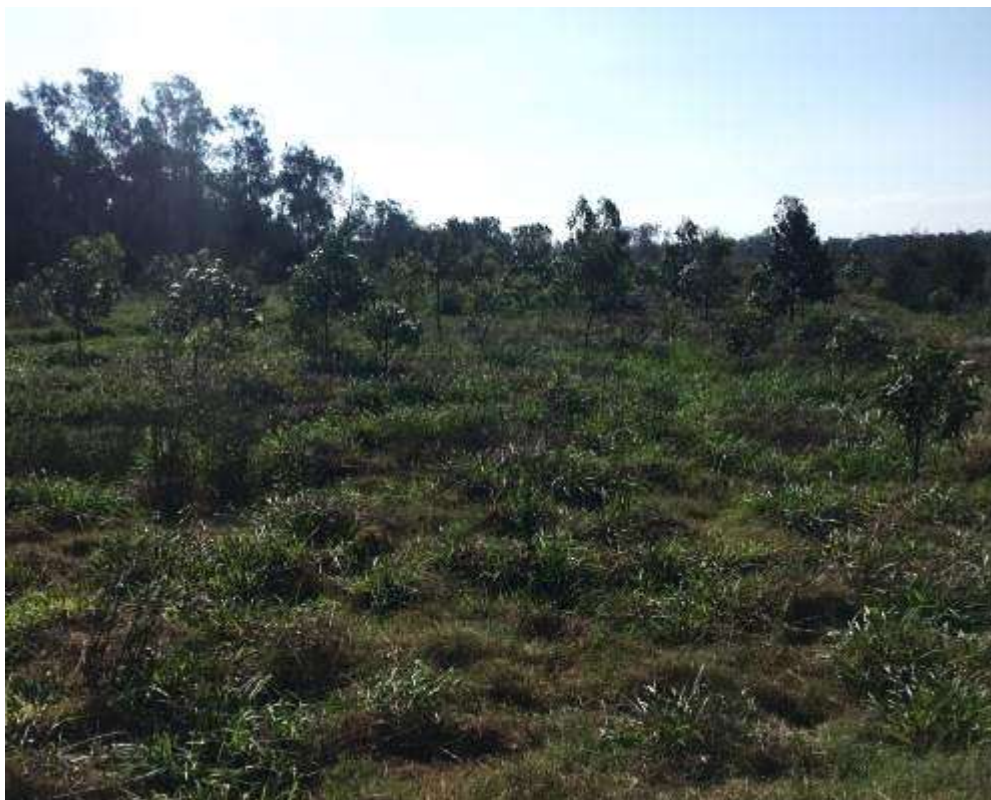
Photo Plate 157: A1 Eucalypt Plantings - Month 18 (February 2017)

Comparison Summary
Height and biomass of seedlings have both increased exponentially over this 6 month period. As the canopy continues to develop, weed growth will gradually be reduced. Stock averaged approximately 4m in height at this monitoring event.

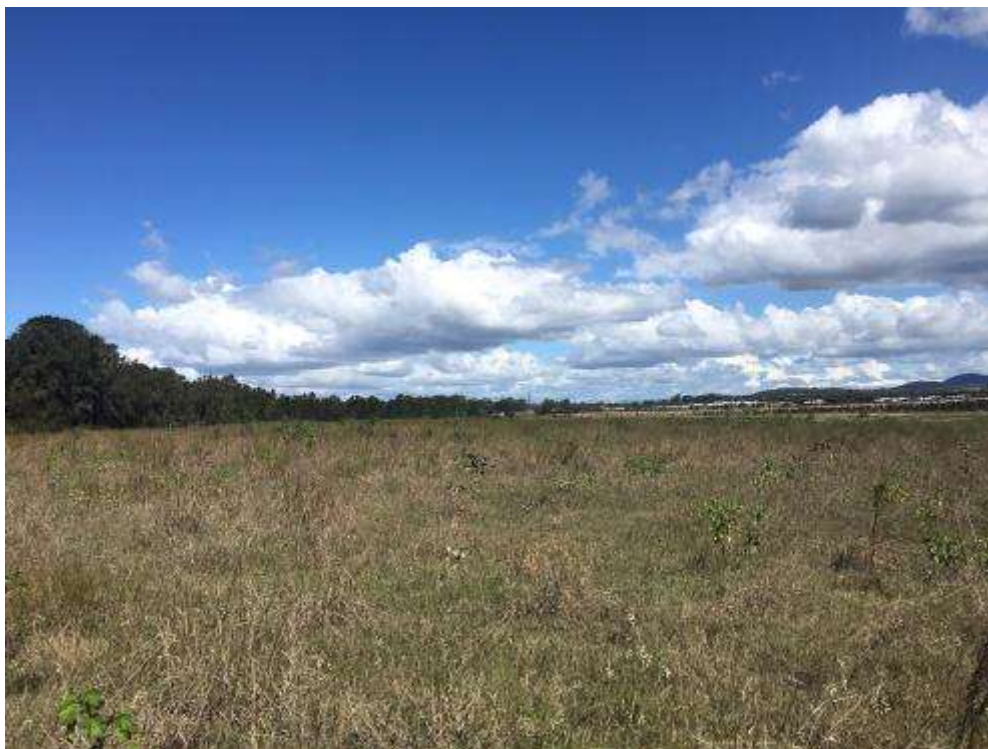
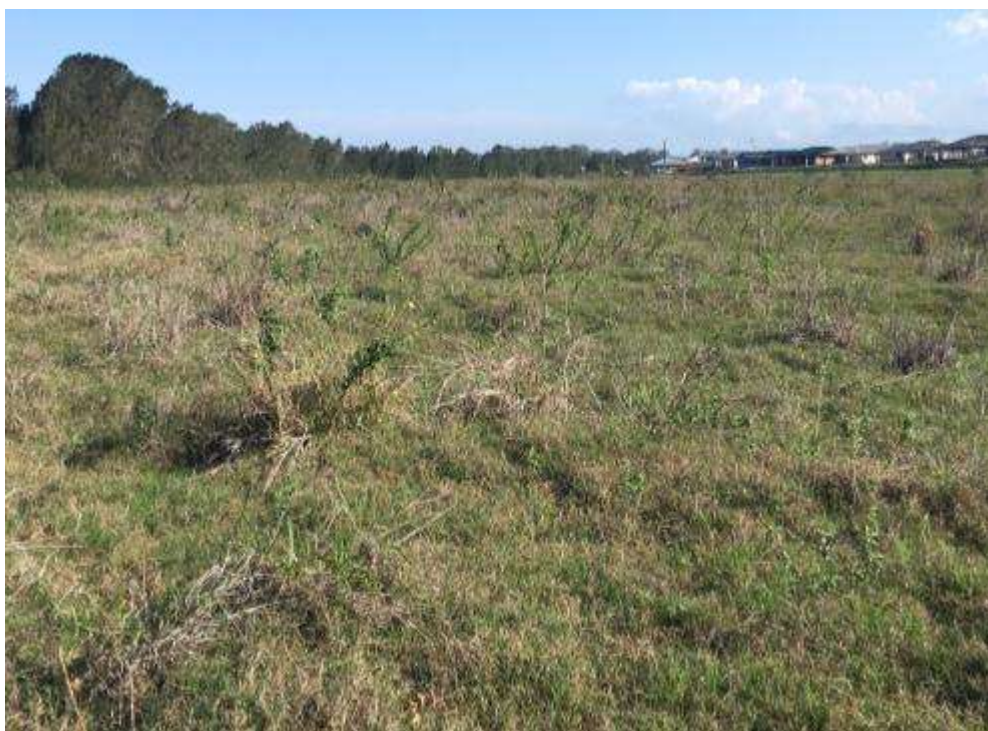
Photo Plate 159: A2 Eucalypt Plantings - Month 18 (February 2017)

The site is still periodically inundated, limiting the growth of a number of the seeded species. *Hibiscus diversifolius*, a species that requires high moisture levels, is dominant throughout this area. This area of tube stock planting is taking longer than the A1 plantings. It is anticipated that this stock will grow slower than other areas due to the geology and inundation.

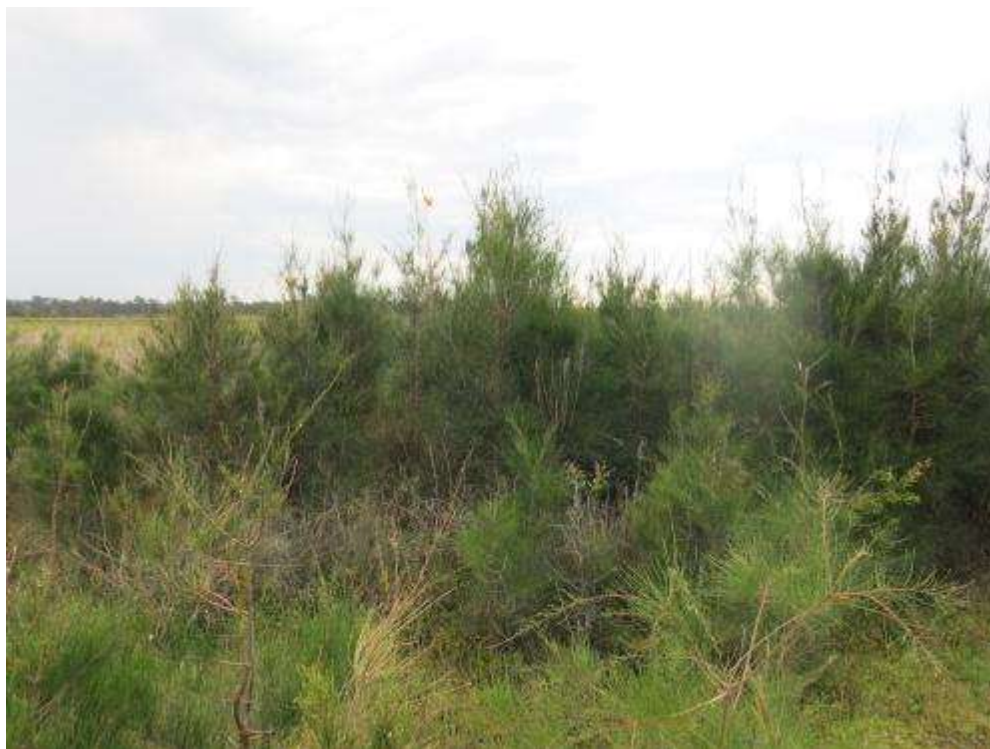
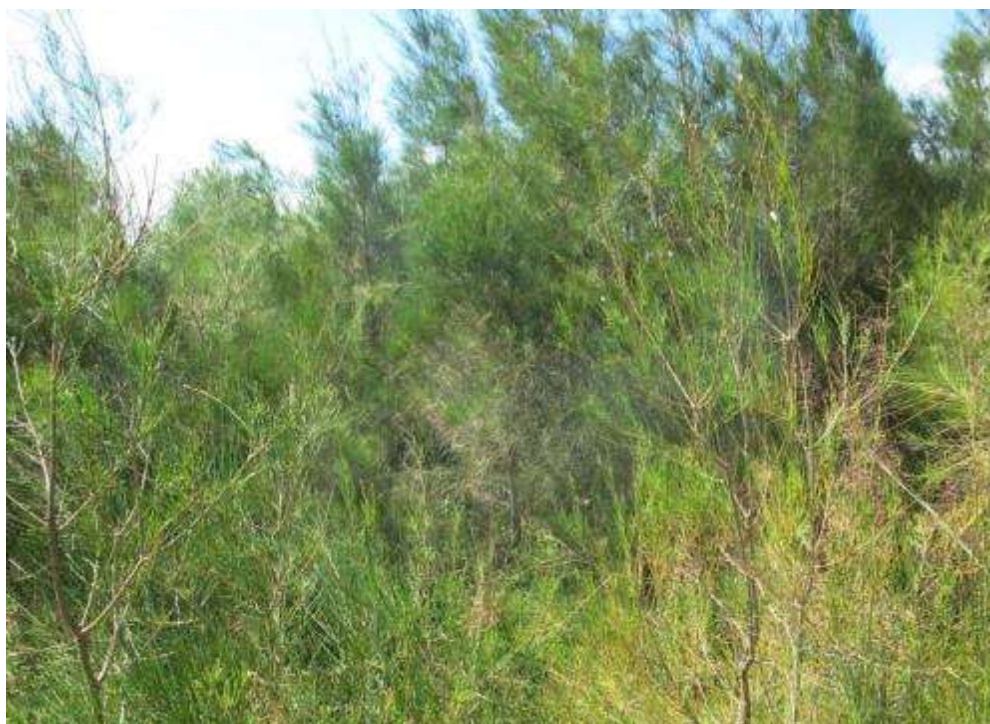
Photo Plate 161: Quadrat 1 - Month 24 (August 2017)

Over the past 6 months, growth of *Casuarina glauca* has again been exponential. This is clearly evident in the Month 30 monitoring photo. Native plant biomass has again significantly increased over this 6 month period. The diversity and abundance of weed species has been greatly reduced. This growth has assisted in reducing the weed biomass within this quadrat.

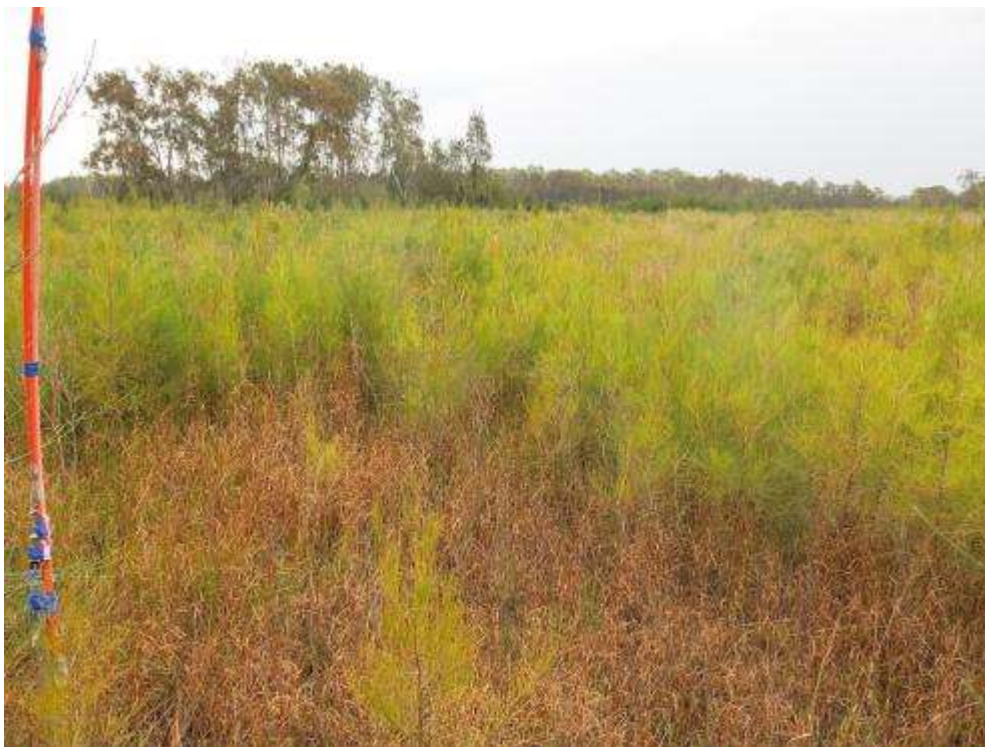
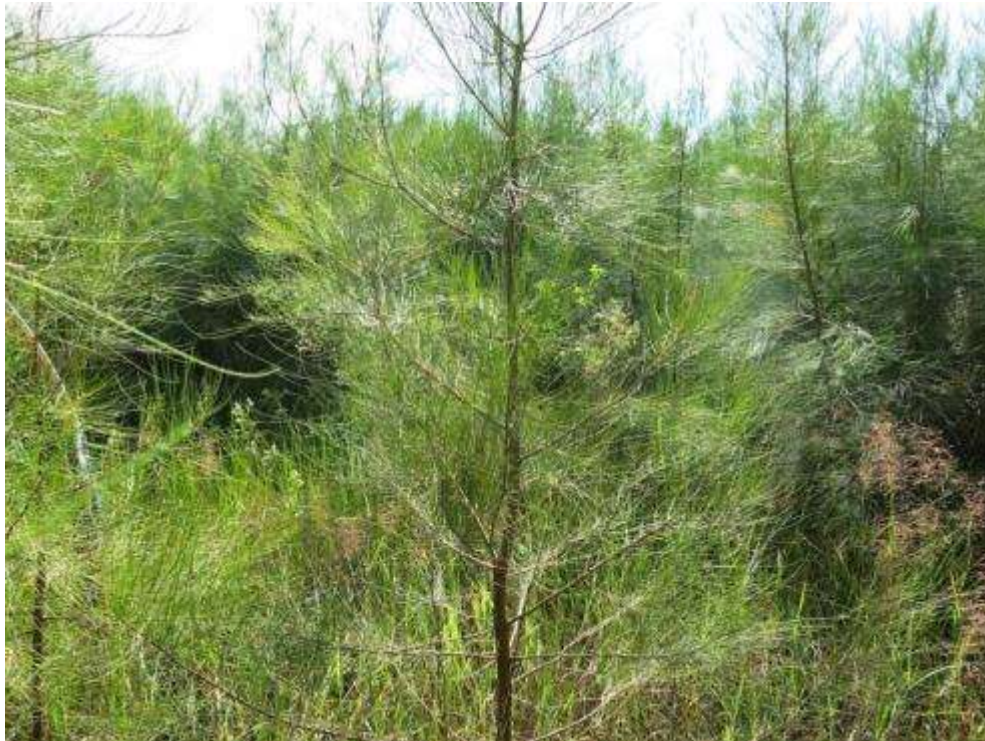
Photo Plate 163: Quadrat 2 - Month 24 (August 2017)

Over the past six months, *Casuarina glauca* and *Melaleuca quinquenervia* growth has made this quadrat unrecognisable.

The entire surrounds are still very weed free. Traversing between quadrats 2 and 3 is difficult due to the abundance of canopy trees.

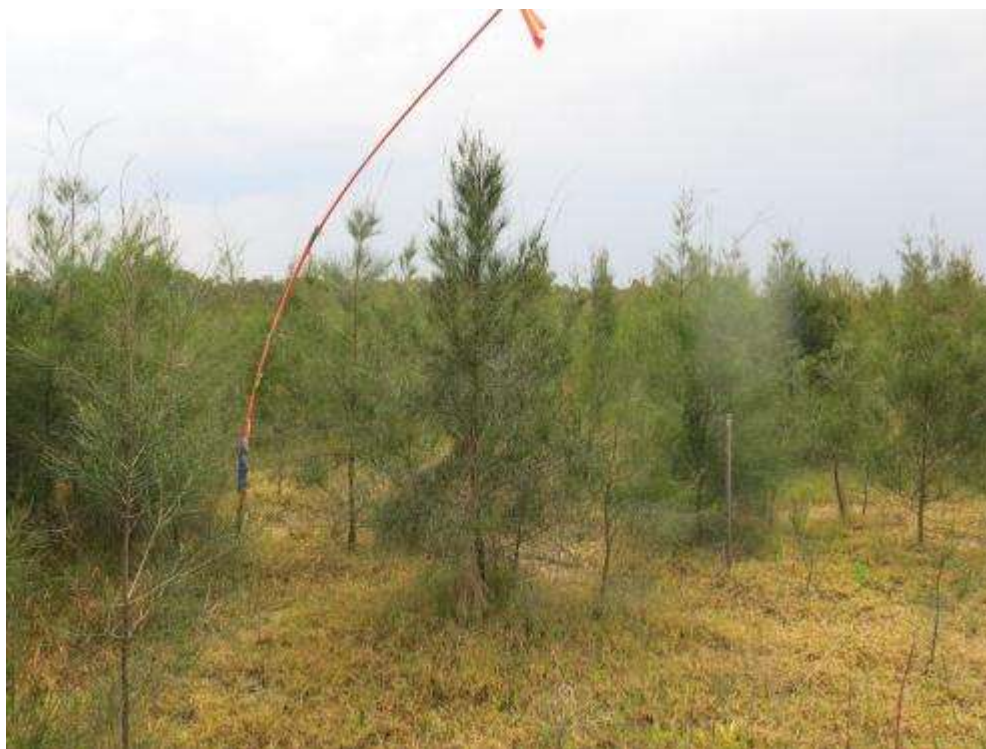
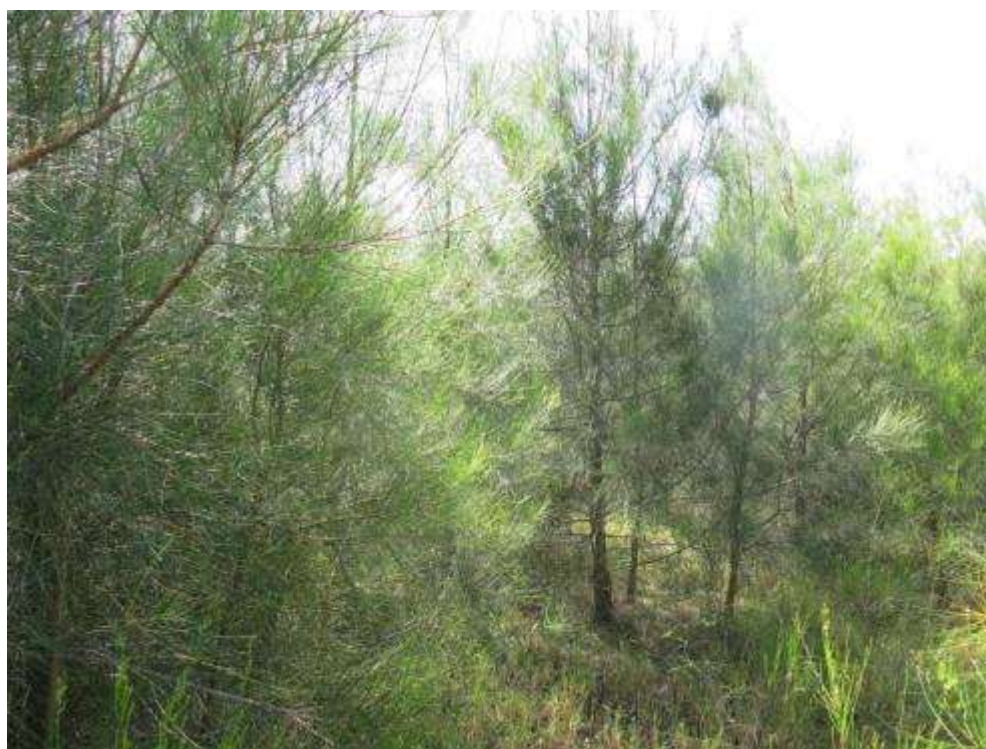
Photo Plate 165: Quadrat 3 - Month 24 (August 2017)

Comparison Summary
The growth in biomass and height of *Casuarina glauca* has been significant over the past six months. Of note is a positive colour change in the foliage, indicating the increase in soil health. Also increasing in strength is the coverage and density of native groundcovers. The diversity of ground cover species has increased over this period of time.

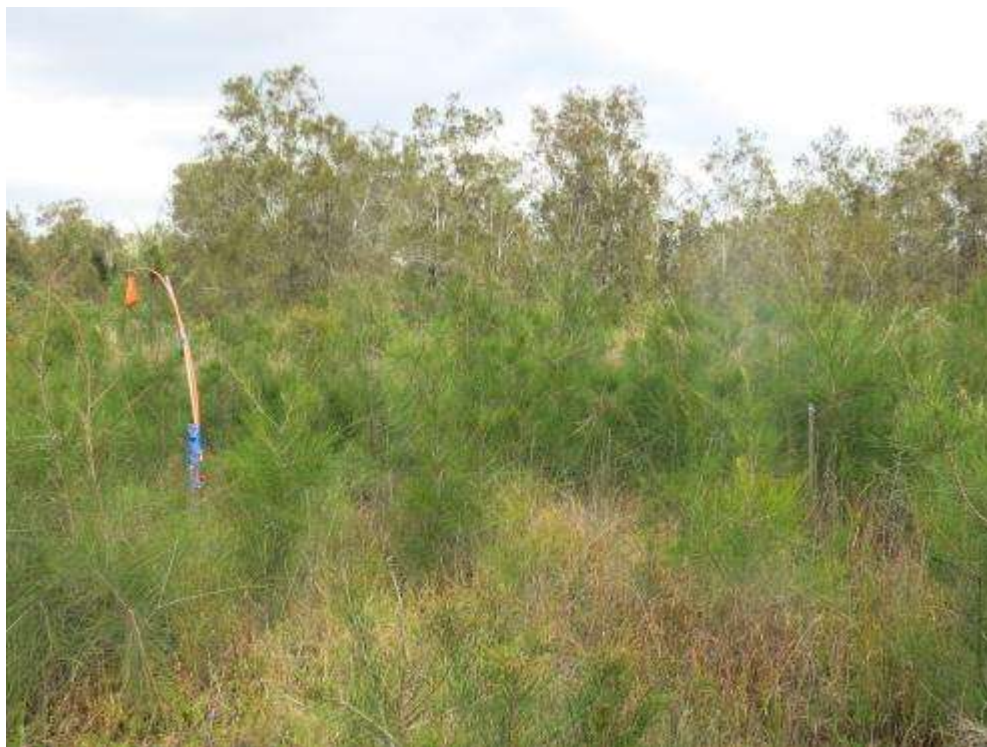
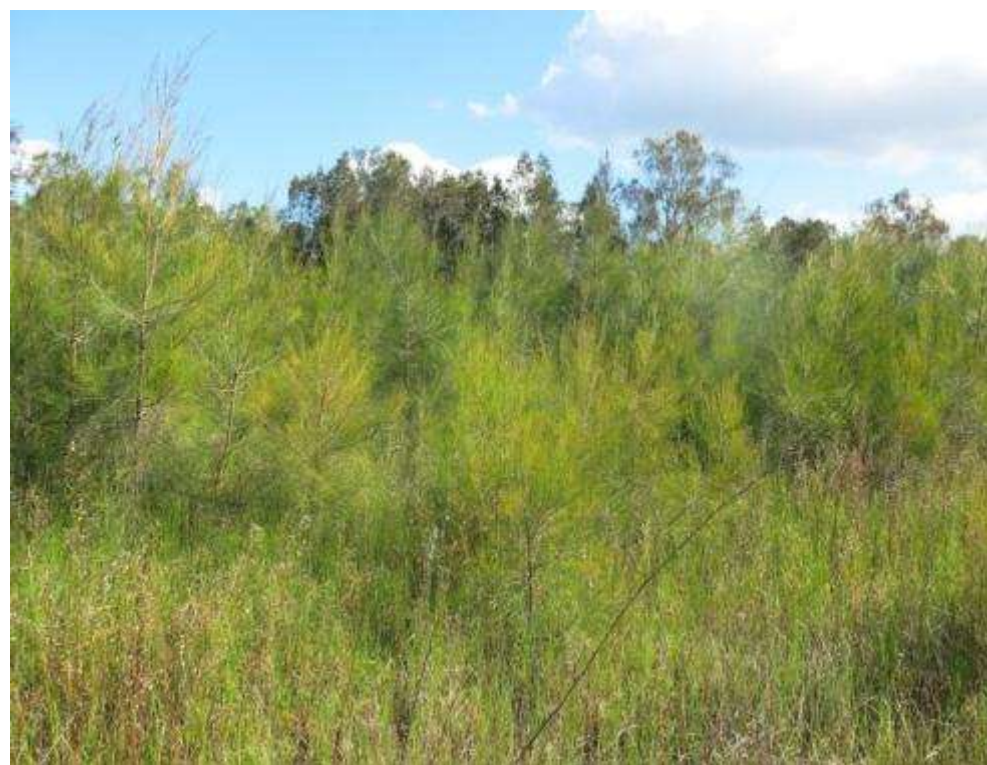
Photo Plate 167: Quadrat 4 - Month 24 (August 2017)

Comparison Summary
Casuarina glauca growth and biomass has continued to increase. This canopy formation has continued to suppress weed growth.

Vegetation growth in the surrounds also continues to gain biomass. Alternate routes between quadrats have to be utilised due to this growth. Also identified within the surrounds of this quadrat was *Melaleuca salignus*, which is a new species for this area.

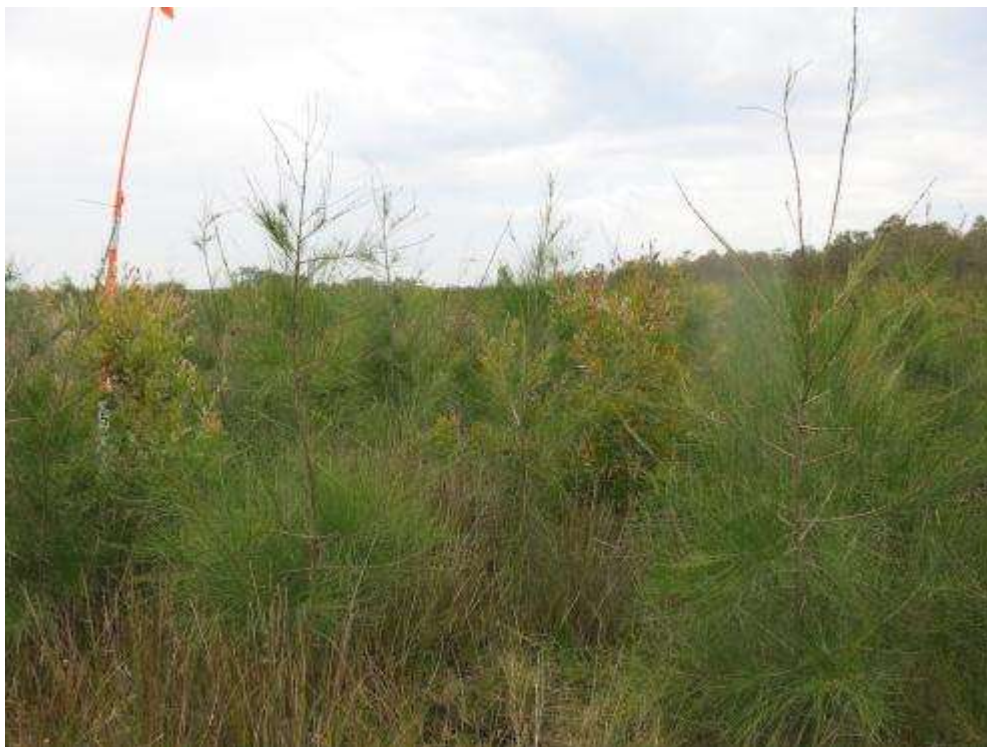
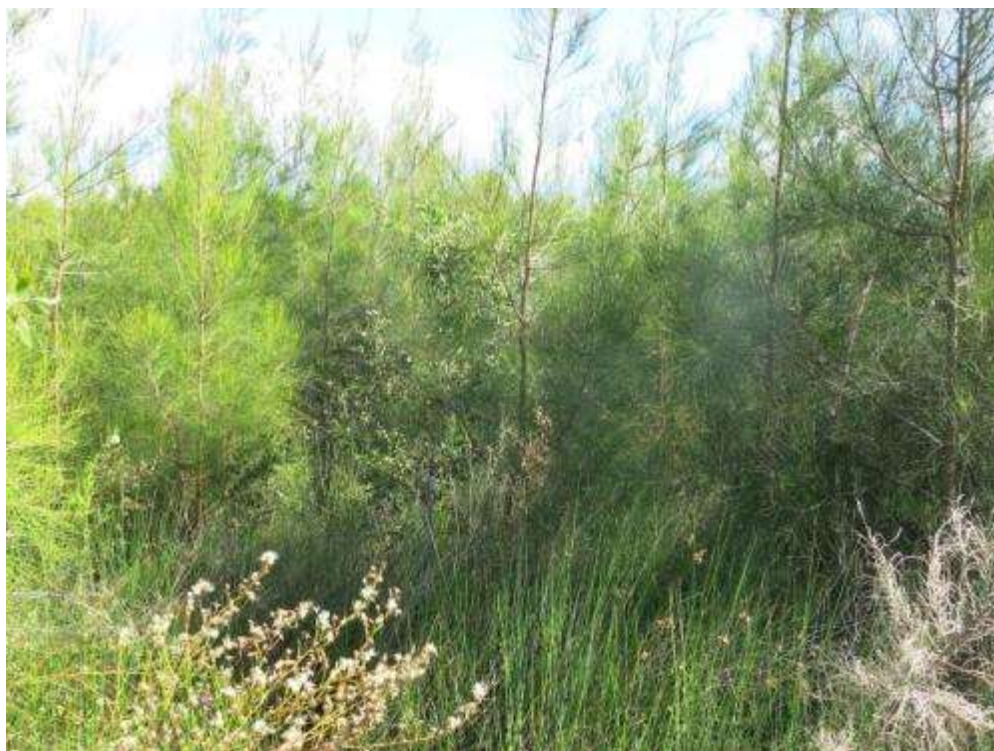
Photo Plate 169: Quadrat 5 - Month 24 (August 2017)

Growth within this quadrat over the past six months has been exponential. There has been no increase in soil coverage, however due to the growth and development of canopy species the overall shading of the soil has increased.

Myrtle rust is still being recorded within this area, however impacts on plant health is not significant.

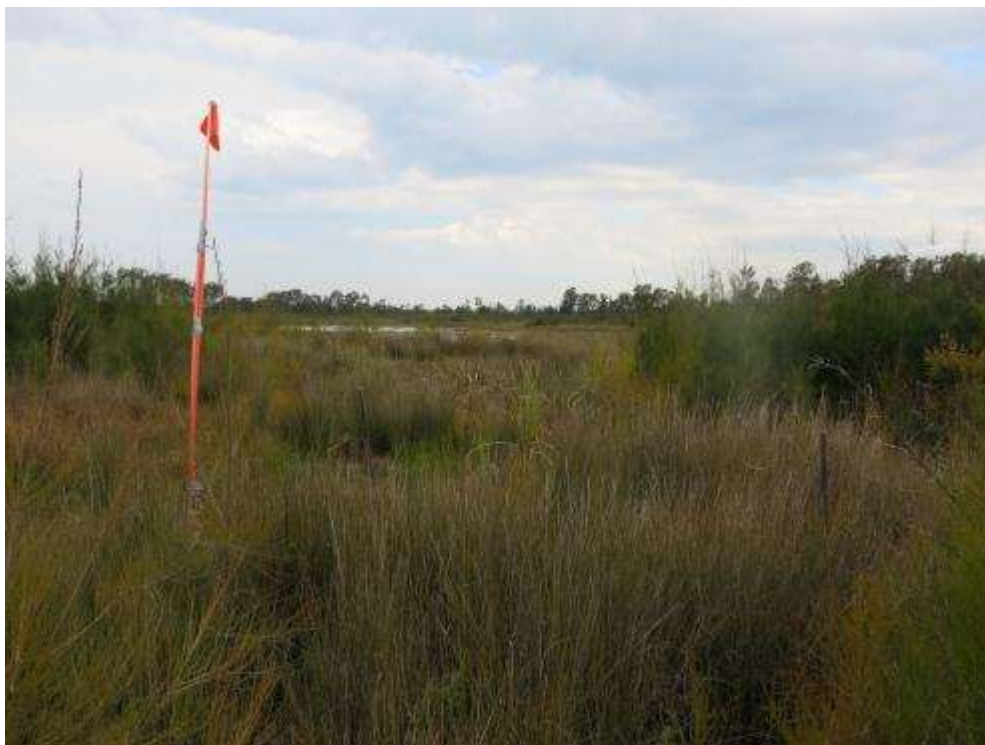
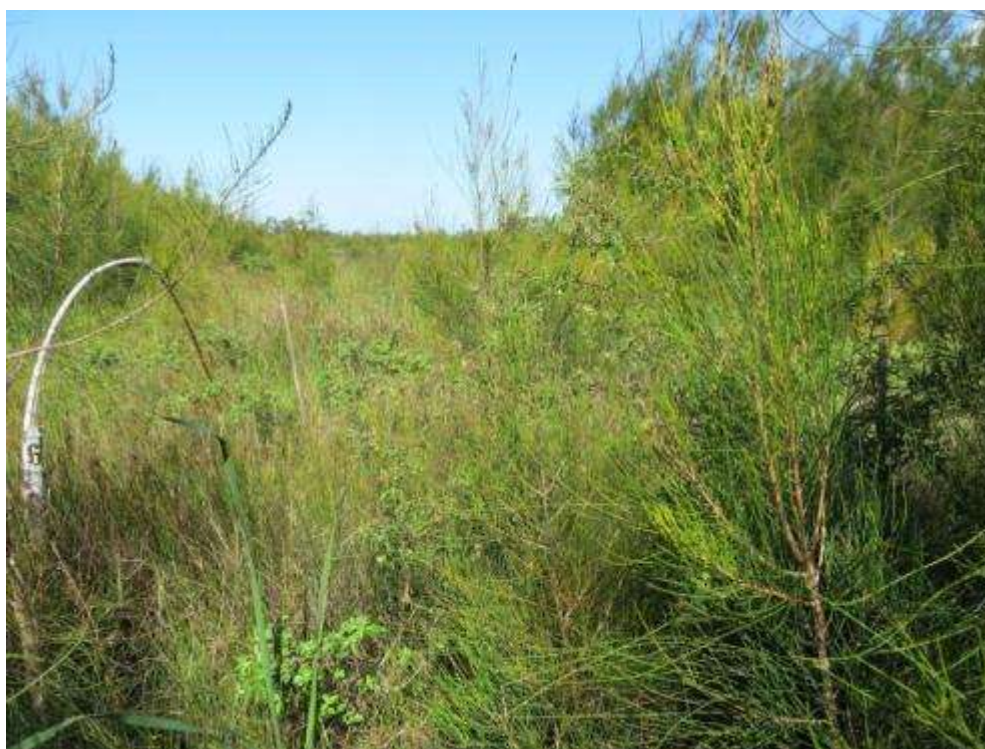
Photo Plate 171: Quadrat 6 - Month 24 (August 2017)

Comparison Summary
This quadrat has retained native dominance during the entire monitoring phase to date, and continues to do so with many species of sedges and rushes in the area. There are significant numbers of canopy trees in the surrounding area to this quadrant. This illustrates the habitat complexity and diversity within a small area of the site, with niche pockets such as this scattered throughout the NWCP.
