North-West Conservation Park - Rehabilitation Monitoring

Lot 1 RP48903

North-West Conservation Park
Gainsborough Greens

March 2020

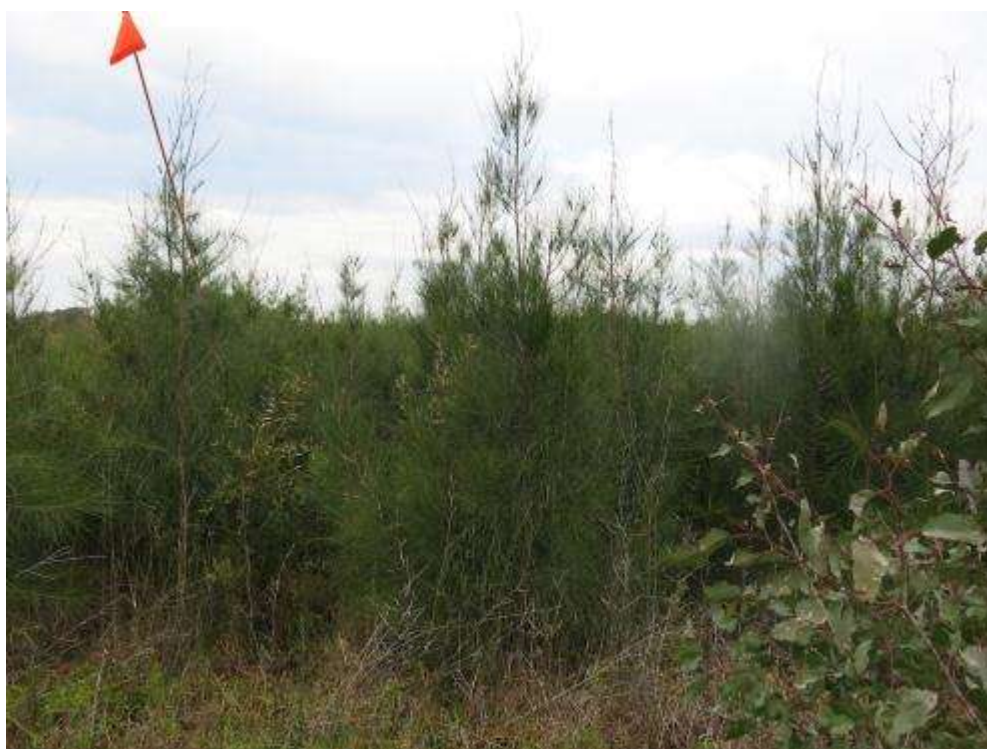
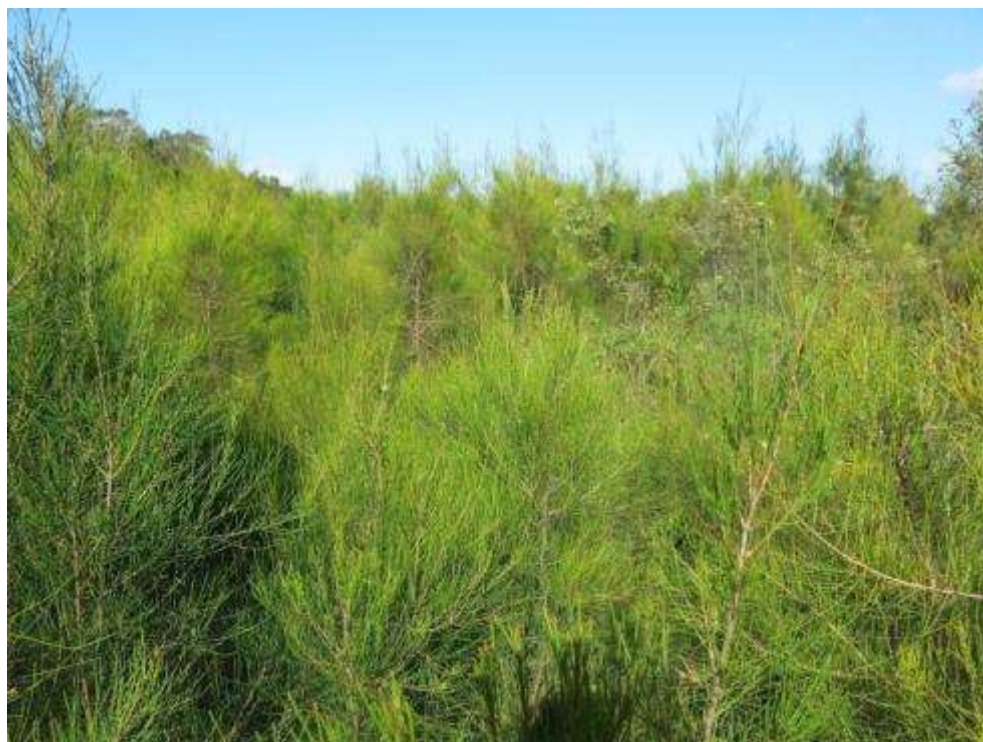
Photo Plate 173: Quadrat 7 - Month 24 (August 2017)

Native canopy vegetation continues to increase in height and biomass within this quadrat. The increase in biomass of canopy vegetation has increased shading of the understorey.

Dominance of canopy species within the surrounding areas is variable. Becoming more notable within this surrounds of this quadrat is *Melaleuca salignus*.

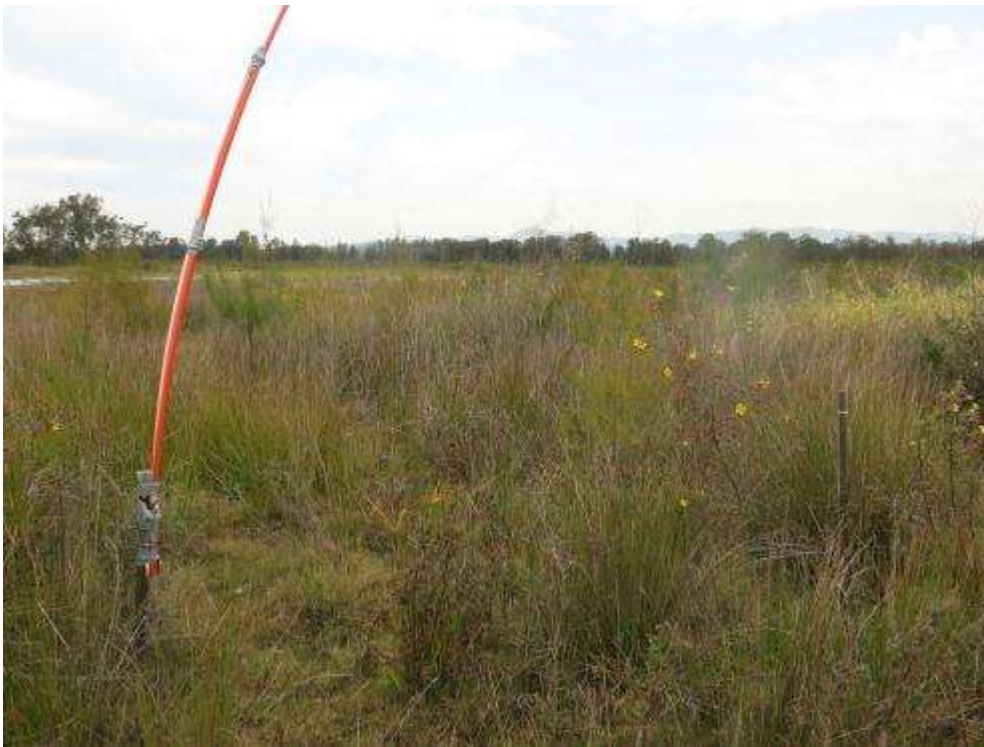
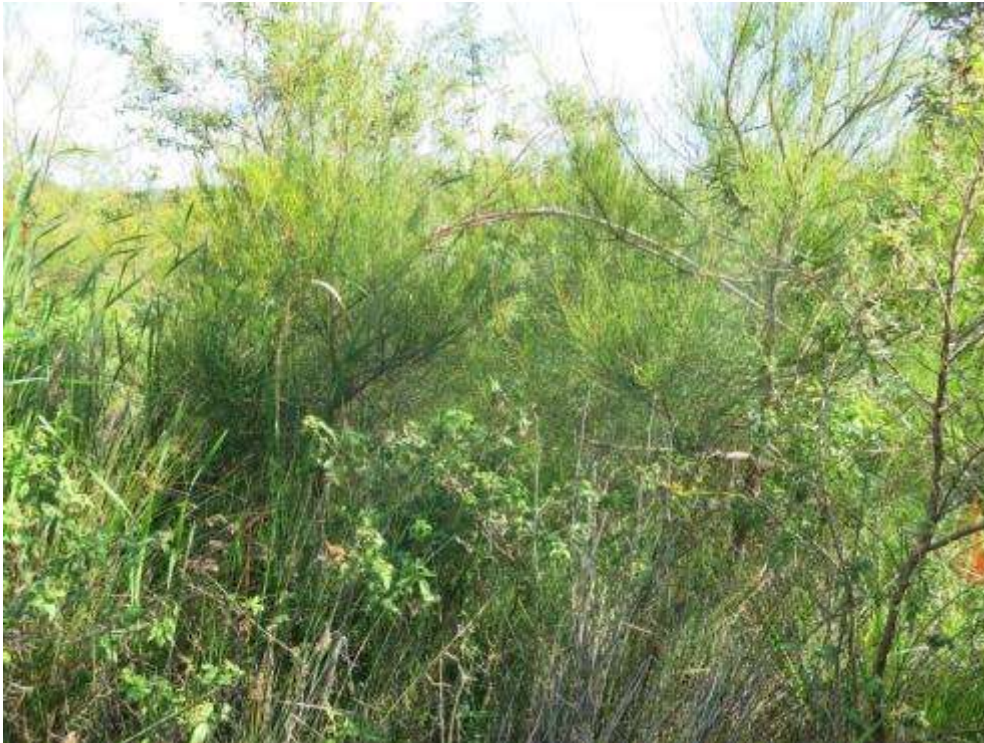
Photo Plate 175: Quadrat 8 - Month 24 (August 2017)

This is a stable quadrat dominated by freshwater wetland species, such as sedge, rush and cyperus species. A small number of casuarinas are scattered in and around this quadrat, however it will never be a dominant species within this area due to the hydrology. These casuarinas have grown exponentially over this six month period. This is demonstration of how optimal growth conditions contribute to successful growth.

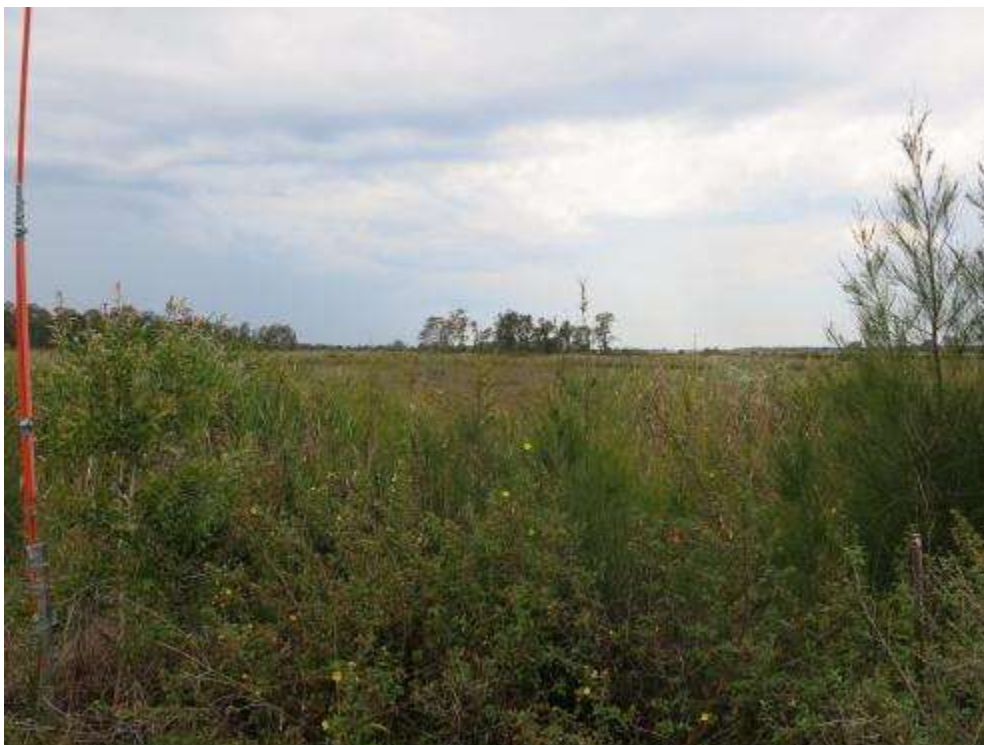
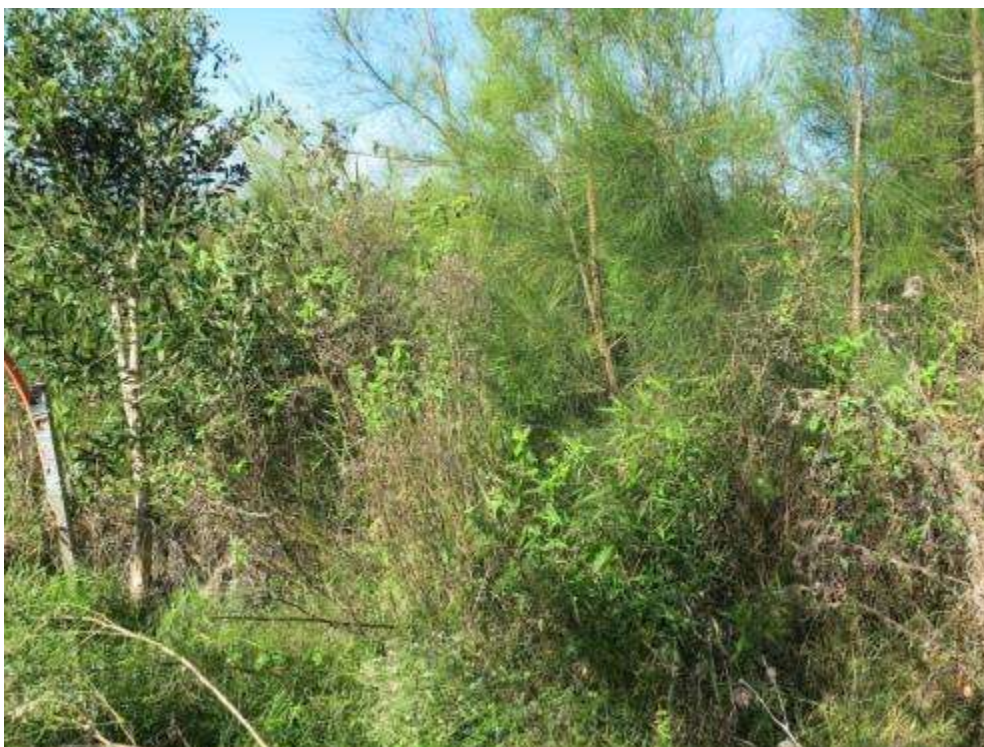
Photo Plate 177: Quadrat 9 - Month 24 (August 2017)

After remaining relatively dormant for the last six months, the casuarina and melaleuca seedlings have grown rapidly into small canopy trees. With the increase in canopy cover, two weed species have been outcompeted from this quadrat.

Within the surrounding area, casuarinas are noted to be in seed. Once these trees set viable seed, a second cohort will commence development.

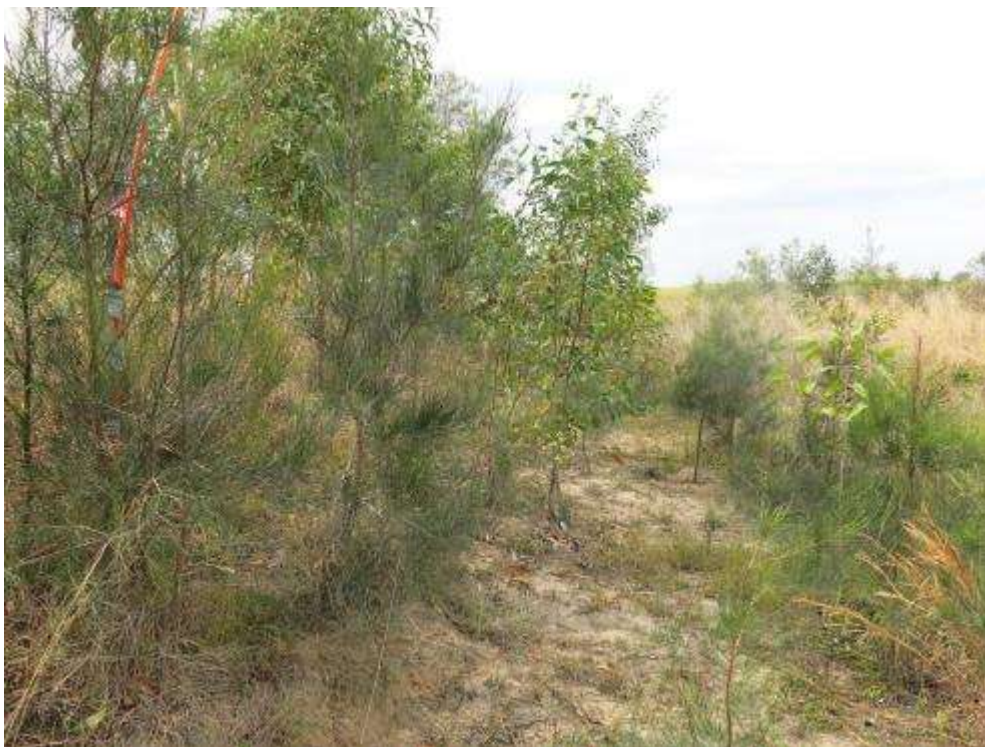
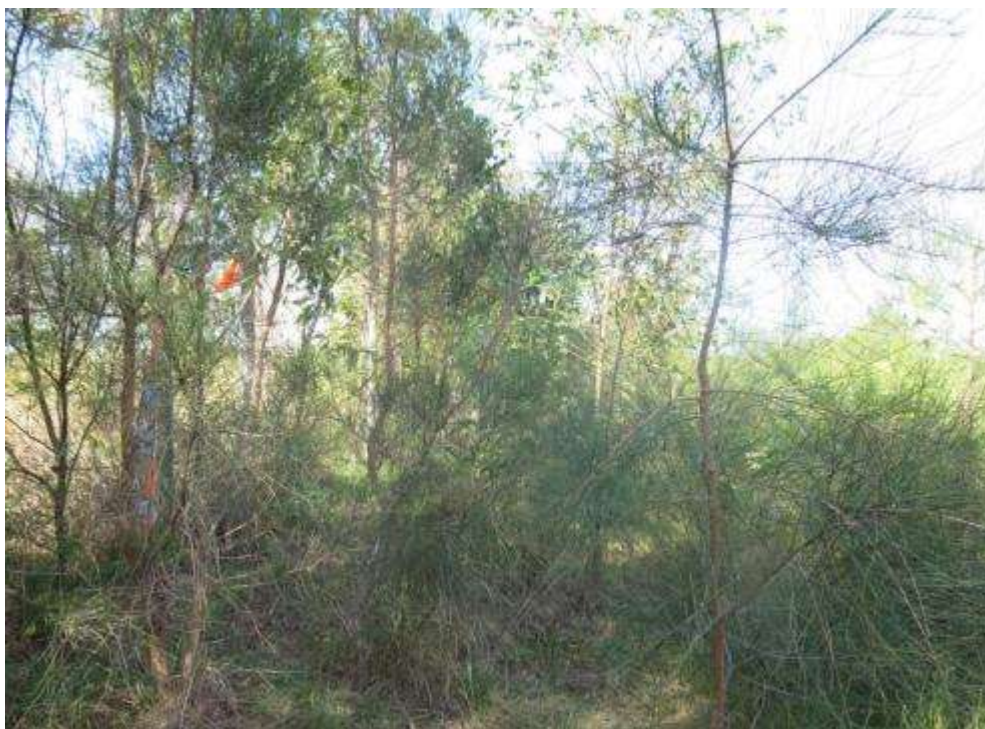
Photo Plate 179: Quadrat 10 - Month 24 (August 2017)

The native grass *Capillipedium spicigerum* has continued to seasonally outcompete weed species, with a significant decline in *Mimosa pudica* noted during this six month period.

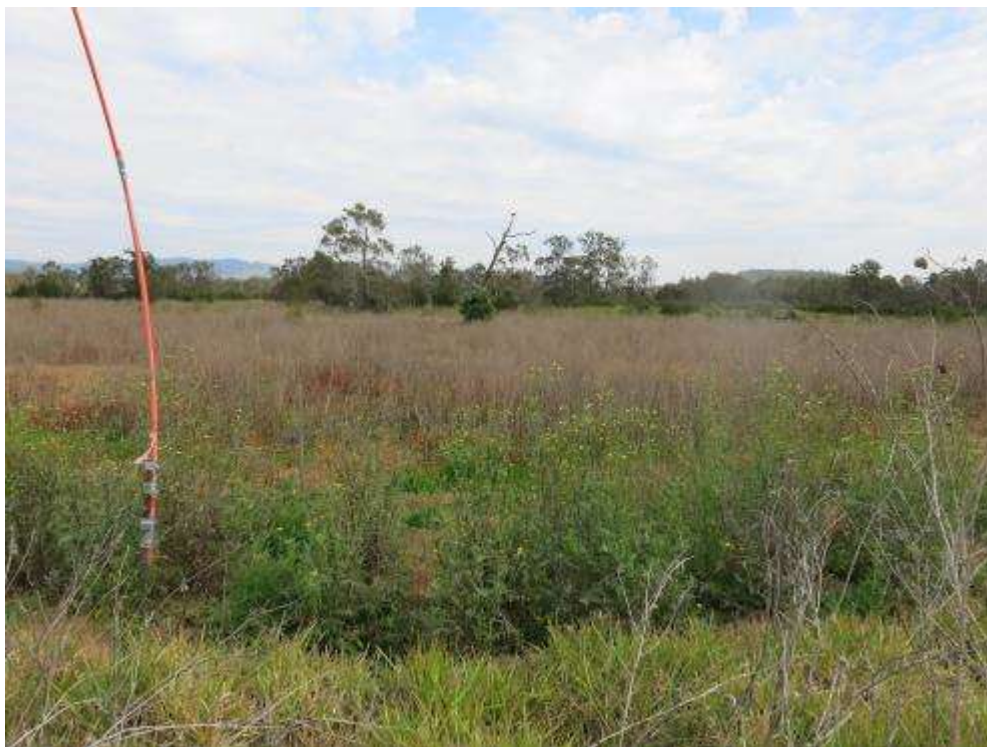
Photo Plate 181: Quadrat 11 - Month 24 (August 2017)

This quadrat provides an example of how dynamic this area can be. During Month 18, this area was noted as being very stable. In Month 24, the quadrat decreased in native dominance due to an outbreak of Common Sow Thistle. Now the quadrat is dominated by an introduced carpet grass.

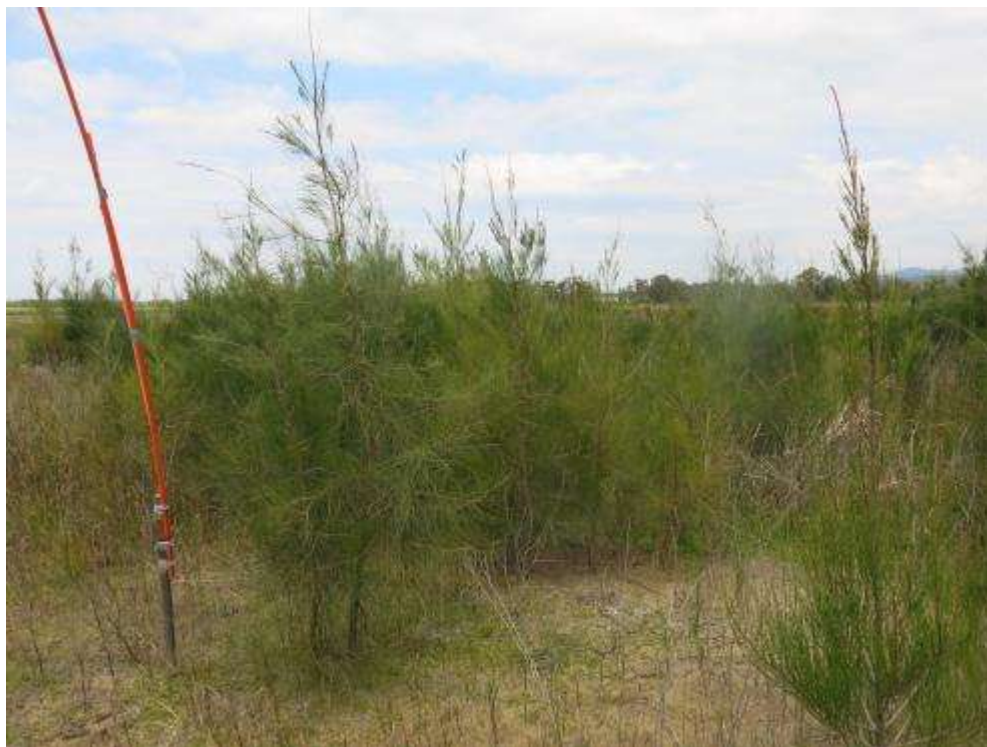
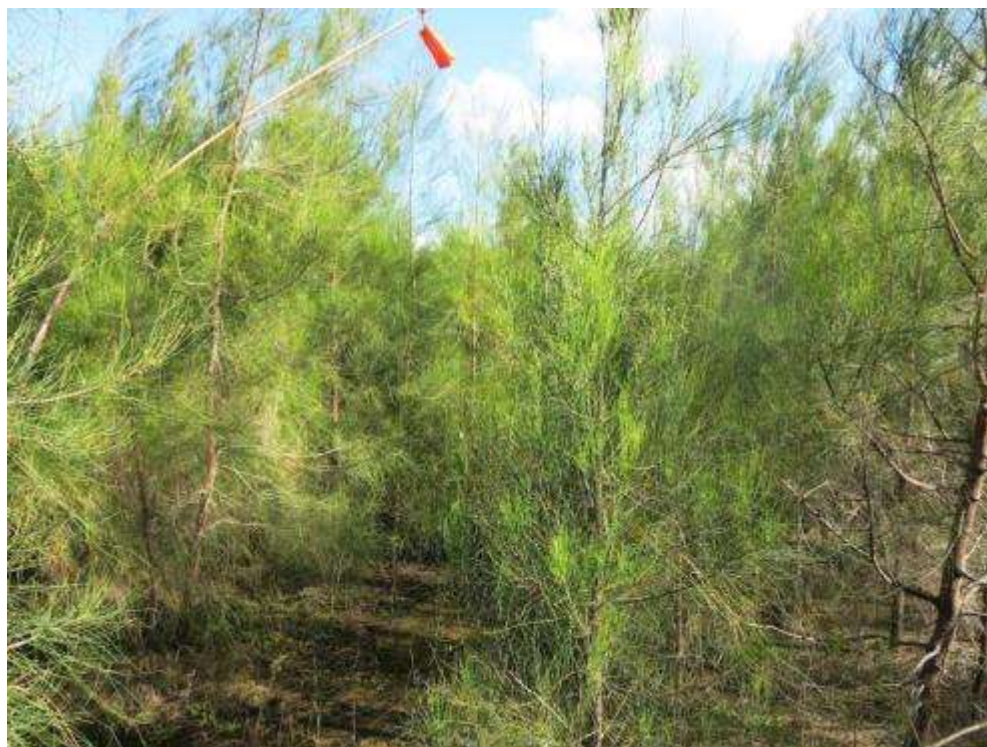
Photo Plate 183: Quadrat 12 - Month 24 (August 2017)

Comparison Summary
This quadrat and the immediate surrounds appeared to be lagging compared to other areas, however vegetation grown significantly over this six month period has been exponential. With the increased shading as a direct result of the increase in biomass, the extent of growth within this quadrat will rapidly increase. A significant decline in weed abundance has been recorded over this six month period.

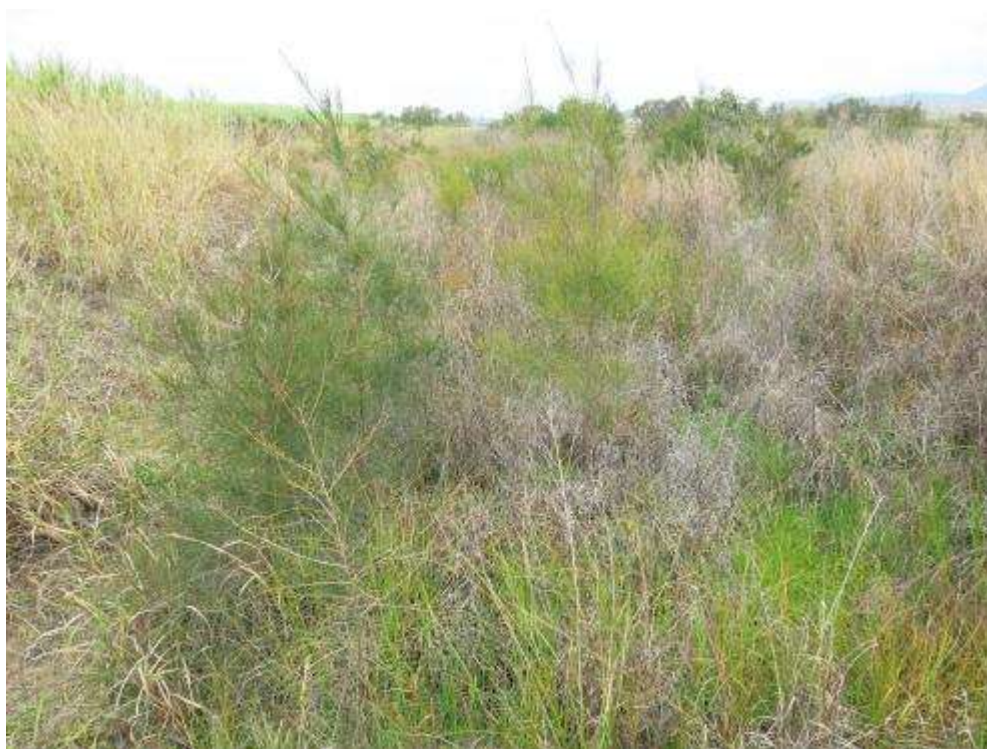
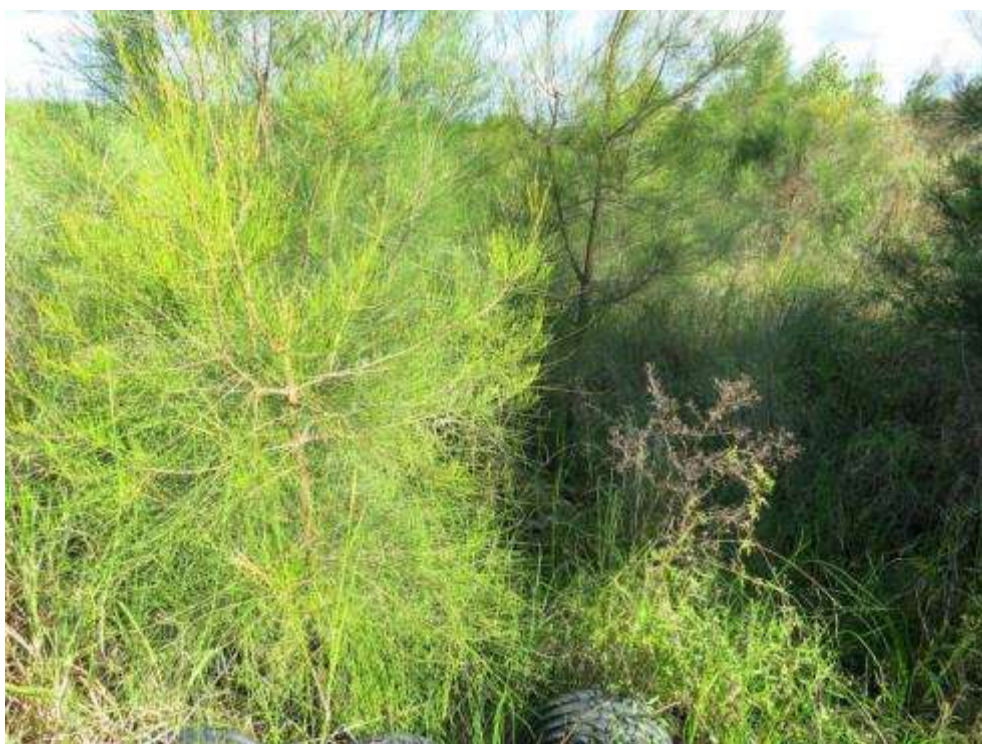
Photo Plate 185: Quadrat 13 - Month 24 (August 2017)

Comparison Summary
Canopy trees have grown significantly in height and biomass within this quadrat over the six month period. Growth within this area of the NWCP has been significant, with canopy vegetation having a positive impact on reducing the extent of weedy grass species due to shading.

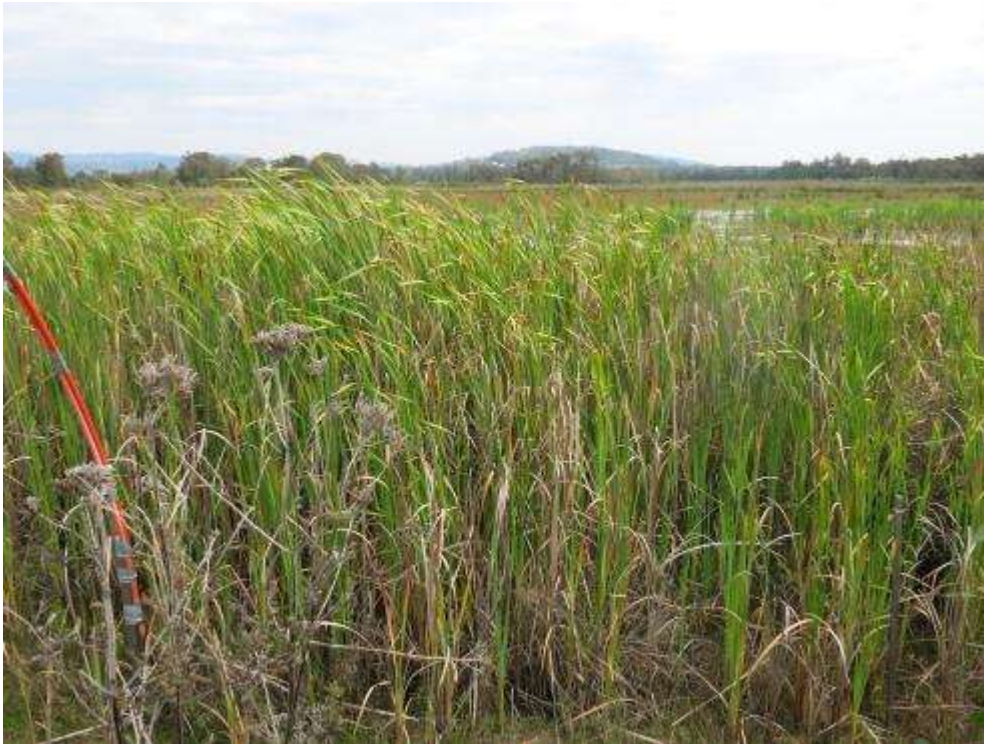
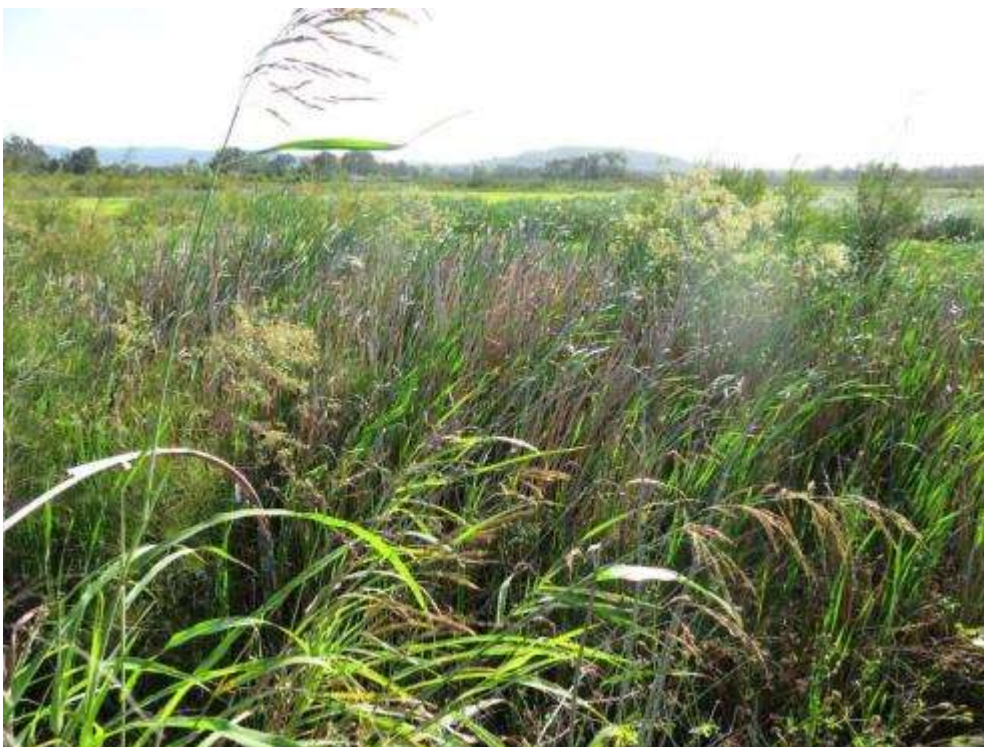
Photo Plate 187: Quadrat 14 - Month 24 (August 2017)

A number of small casuarina seedlings are developing and beginning to emerge over the tops of the typha. This marks the commencement of the diversification of this quadrat.

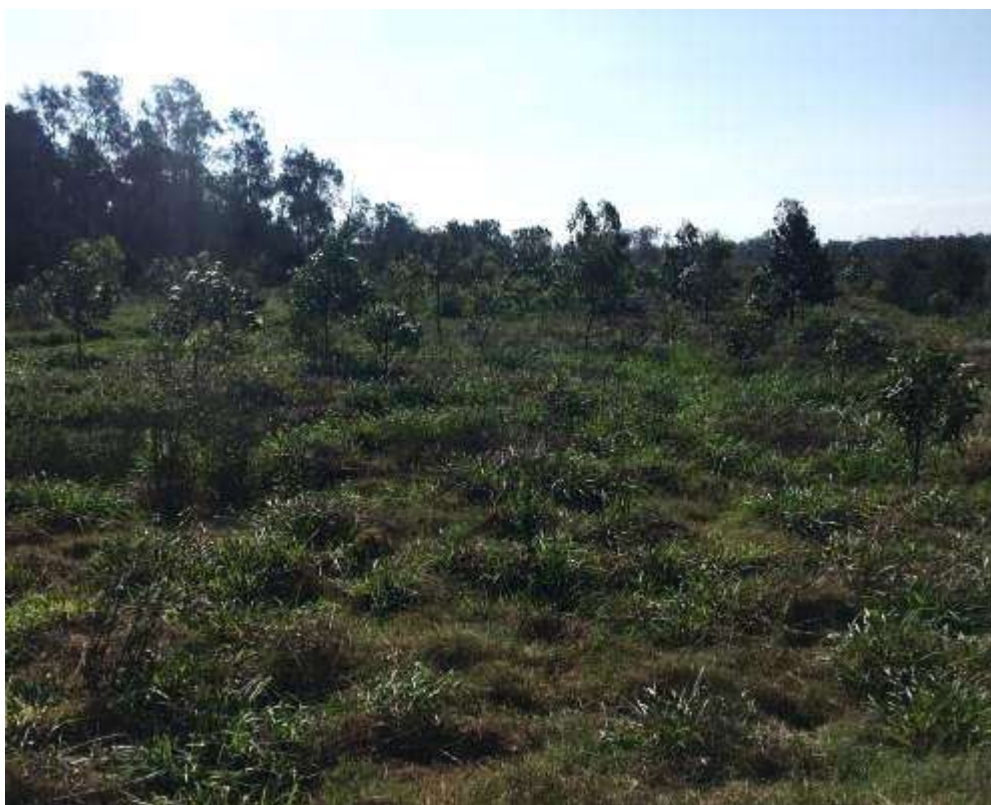
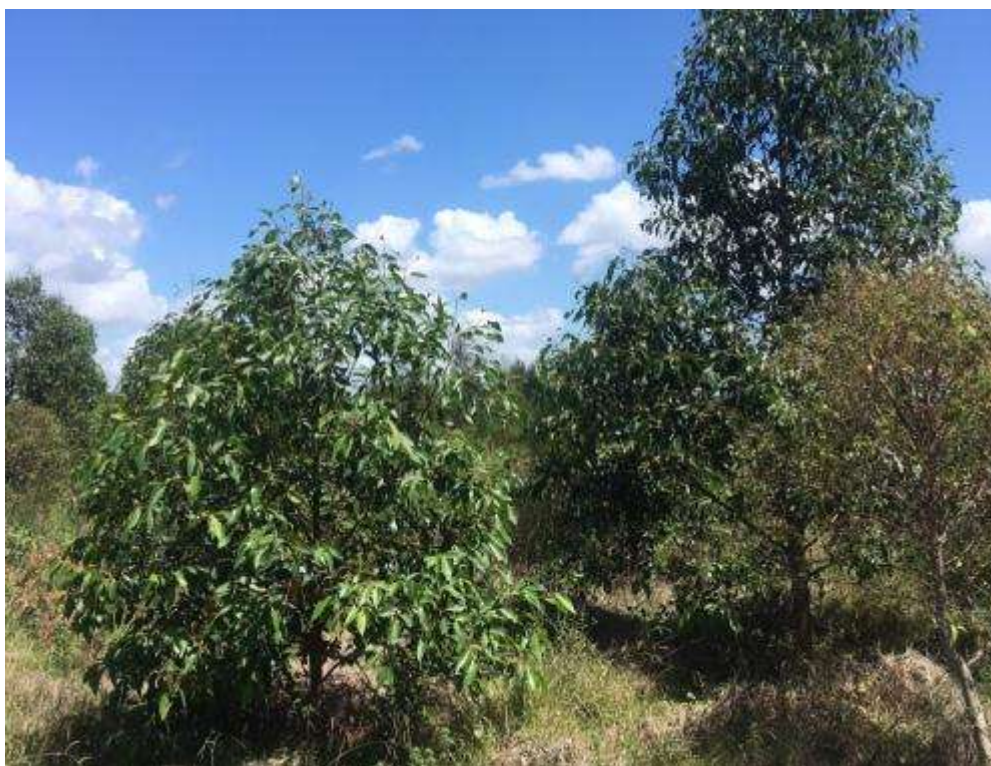
Photo Plate 189: A1 Eucalypt Plantings - Month 24 (August 2017)

Comparison Summary
Height and biomass of seedlings have both increased exponentially over this 6 month period. As the canopy continues to develop, weed growth will gradually be reduced. Stock averaged approximately 5m in height at this monitoring event.

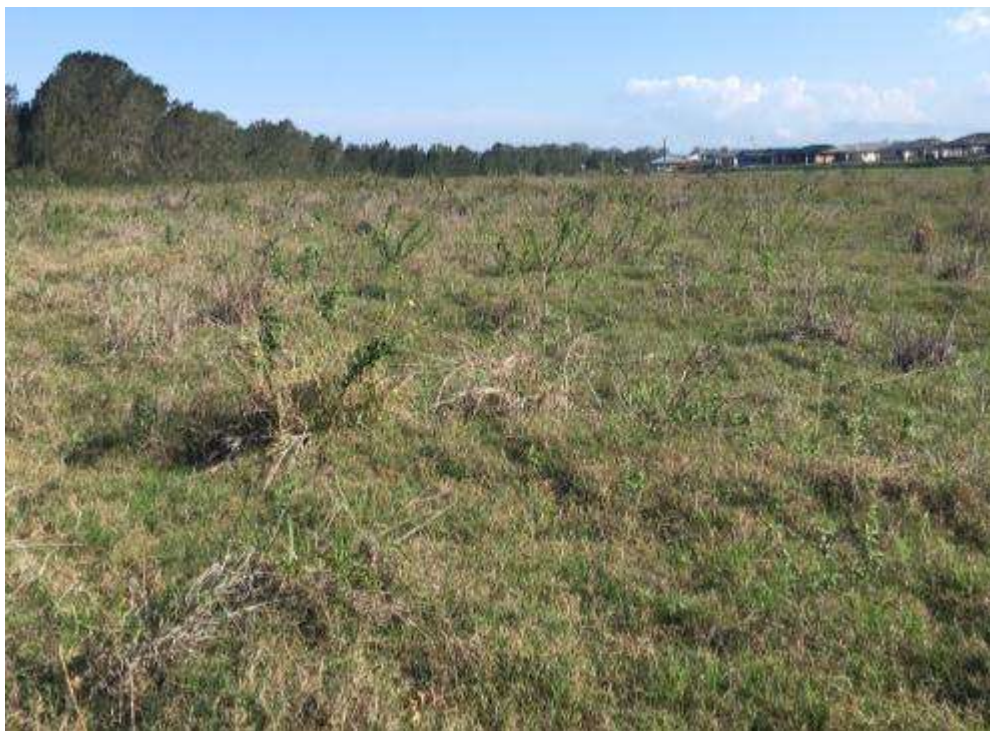
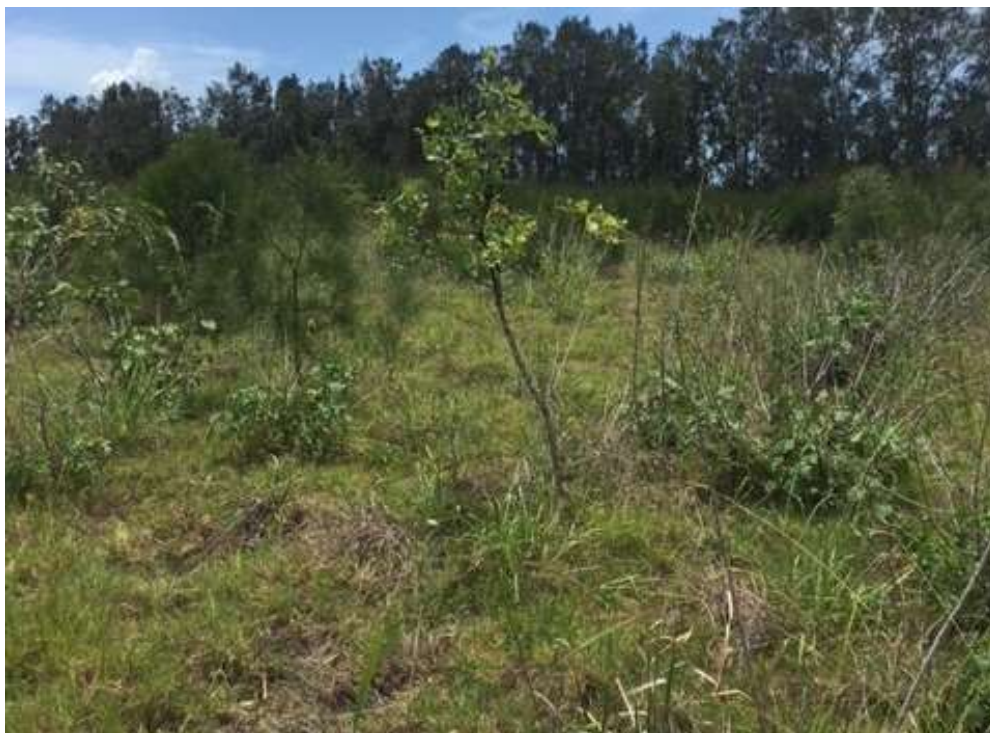
Photo Plate 191: A2 Eucalypt Plantings - Month 24 (August 2017)

The site is still periodically inundated, limiting the growth of a number of the seeded species. *Hibiscus diversifolius*, a species that requires high moisture levels, is dominant throughout this area. This area of tube stock planting is taking longer than the A1 plantings. It is anticipated that this stock will grow slower than other areas due to the geology and inundation.

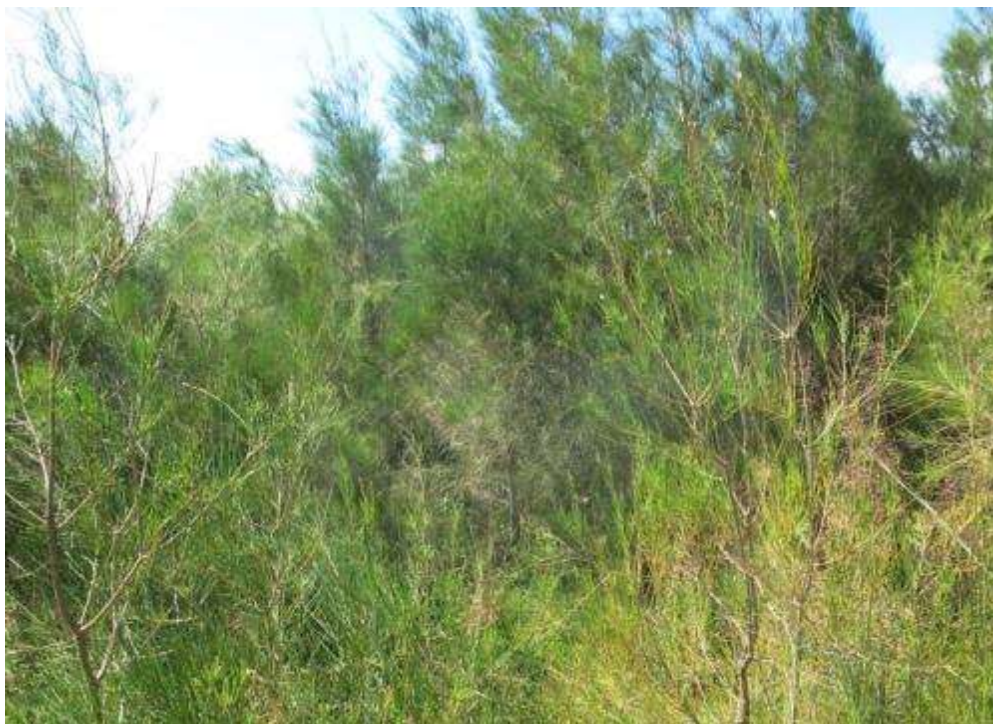
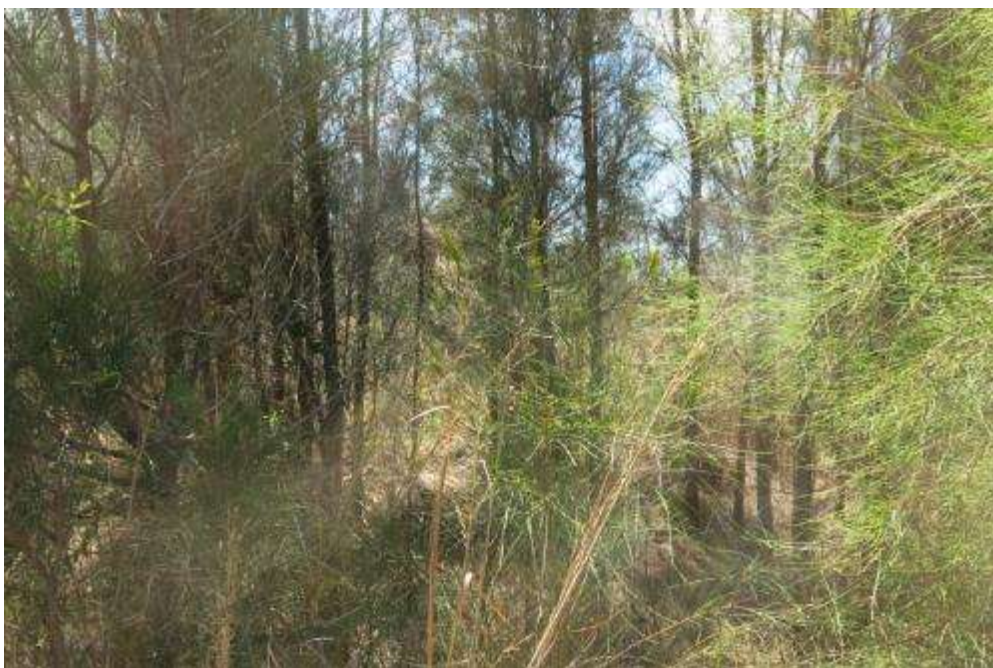
Photo Plate 193: Quadrat 1 - Month 30 (February 2018)

Comparison Summary
Over the past 6 months, growth of *Casuarina glauca* has again been exponential. Native plant biomass has again significantly increased over this 6 month period. The diversity and abundance of weed species has been greatly reduced, however aster is beginning to re-emerge from winter dormancy. As *Casuarina glauca* growth continues to increase and add biomass, this weed will be outcompeted. The balance of the understorey in this area continues to increase in diversity.

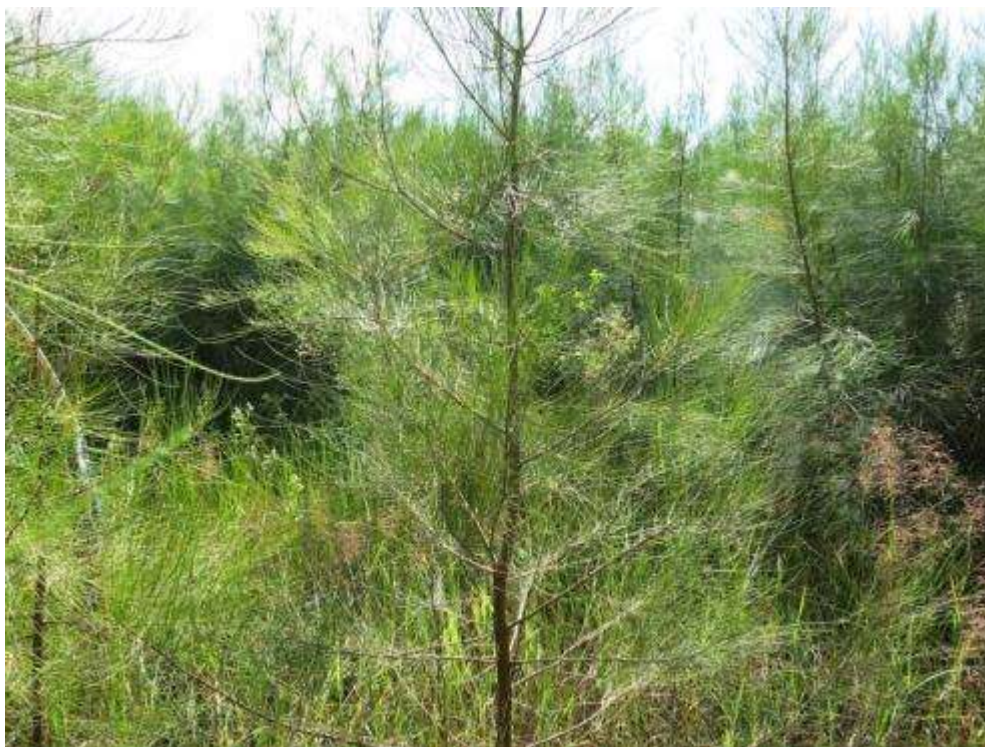
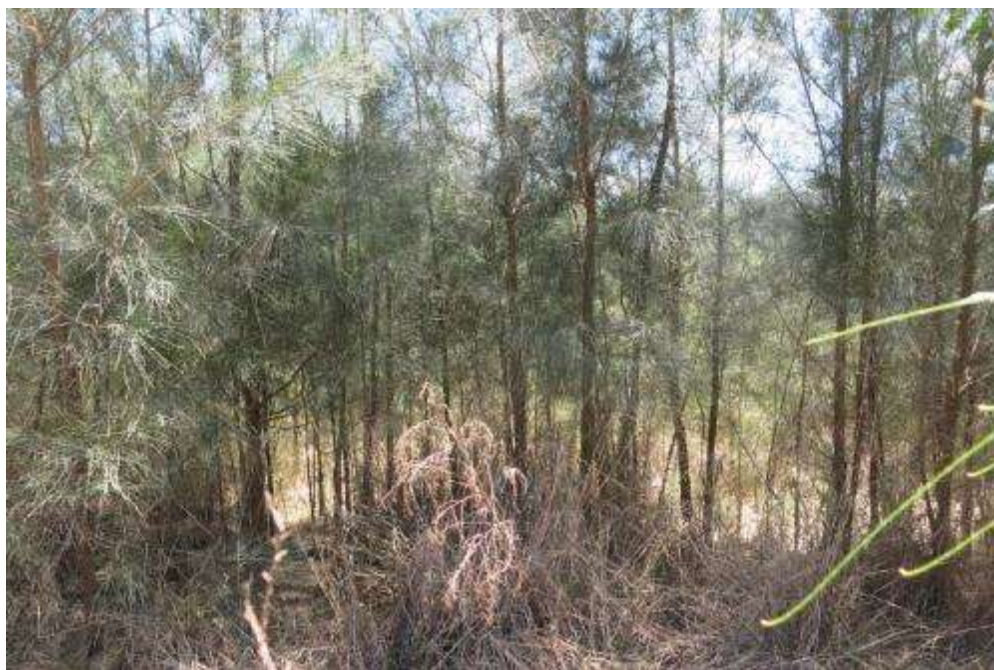
Photo Plate 195: Quadrat 2 - Month 30 (February 2018)

Comparison Summary
Over the past six months, *Casuarina glauca* and *Melaleuca quinquenervia* growth has made this quadrat unrecognisable.

This quadrat is rapidly establishing a canopy of *Casuarina glauca*. This is currently resulting in a short term reduction of diversity in the understory as the dynamic of this quadrat shifts.

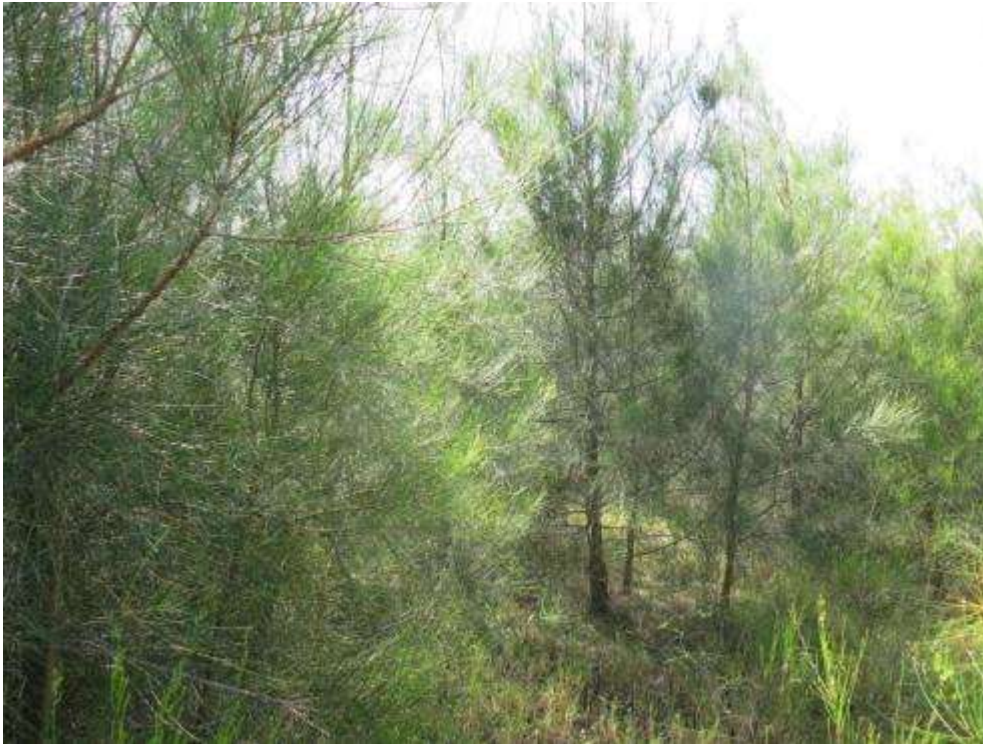
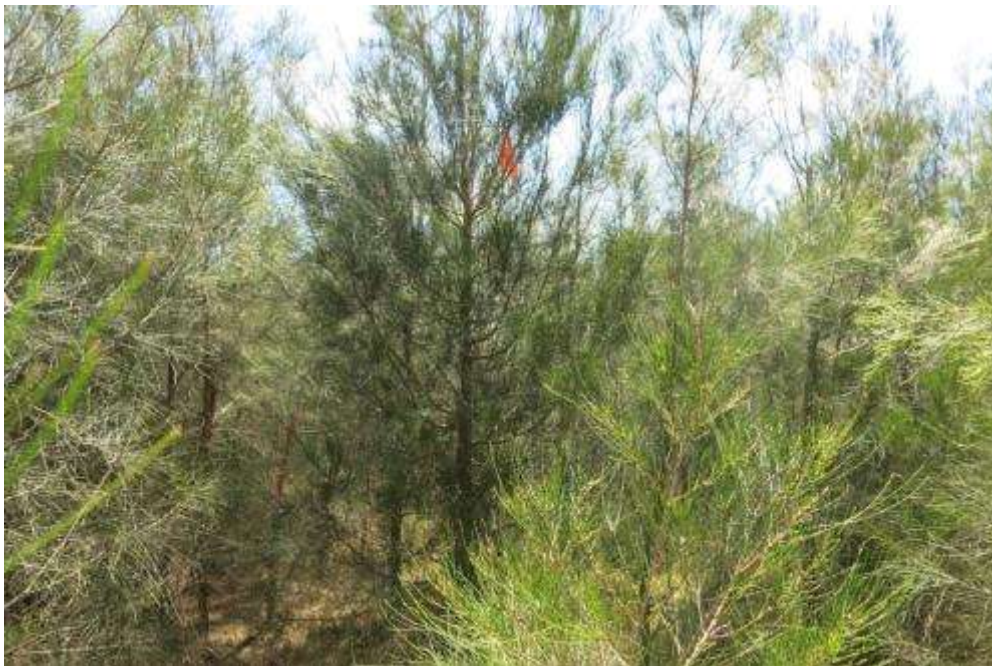
Photo Plate 197: Quadrat 3 - Month 30 (February 2018)

The growth in biomass and height of *Casuarina glauca* has been significant over the past six months. This growth and formation of a continuous canopy is resulting in the reduction of ground cover species. During month 36 *Casuarina glauca* was recorded as flowering and seeding for the first time. This will commence the processes for the growth of the second cohort of seedlings and canopy growth.

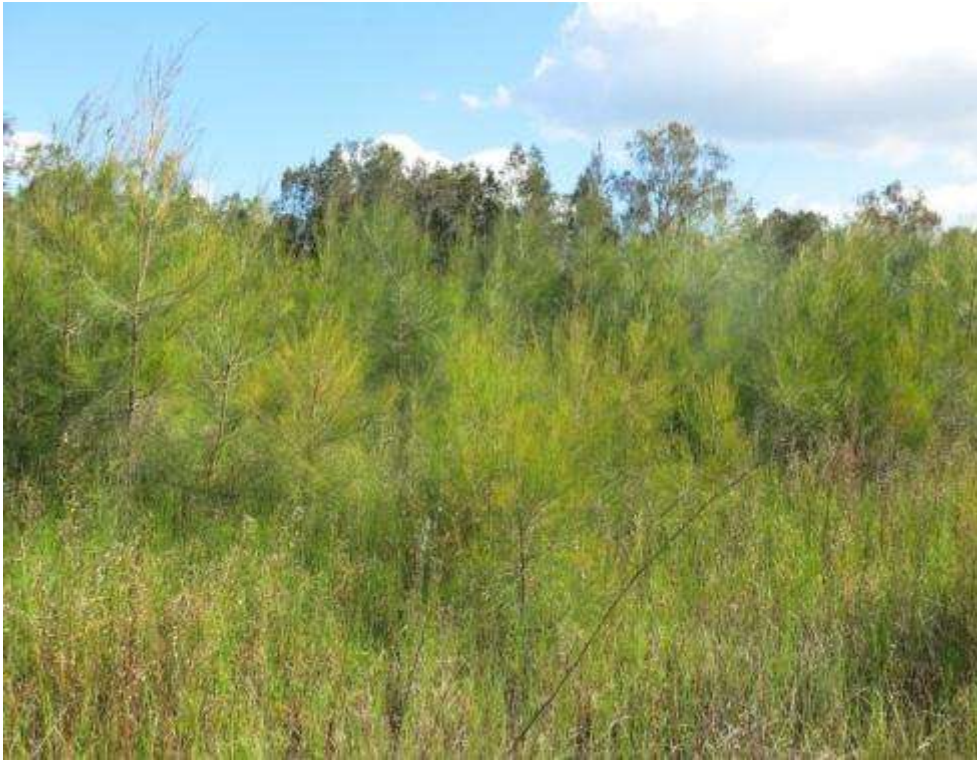
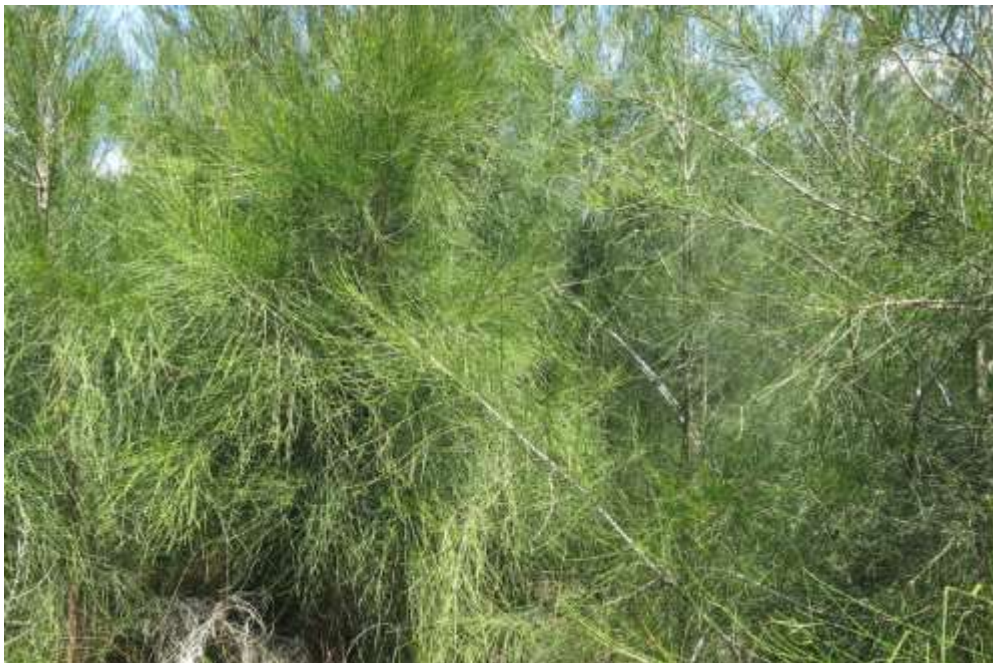
Photo Plate 199: Quadrat 4 - Month 30 (February 2018)

Comparison Summary
Casuarina glauca growth and biomass has continued to increase. This canopy formation has continued to suppress weed growth.

Vegetation growth in the surrounds also continues to gain biomass. Alternate routes between quadrats have to be utilised due to this growth.

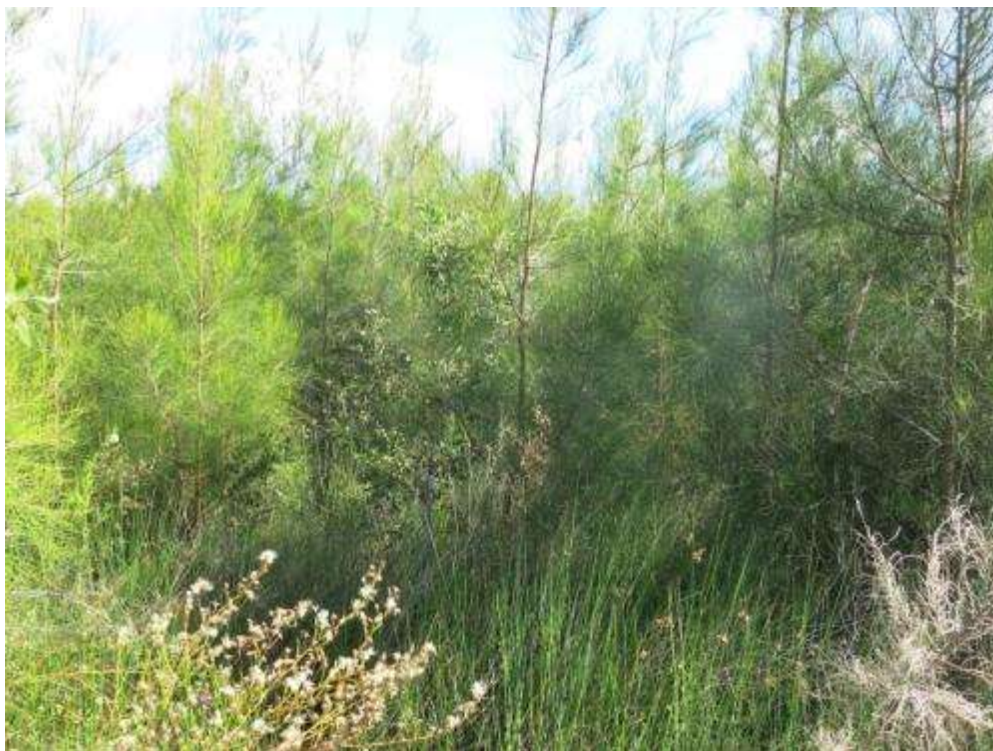
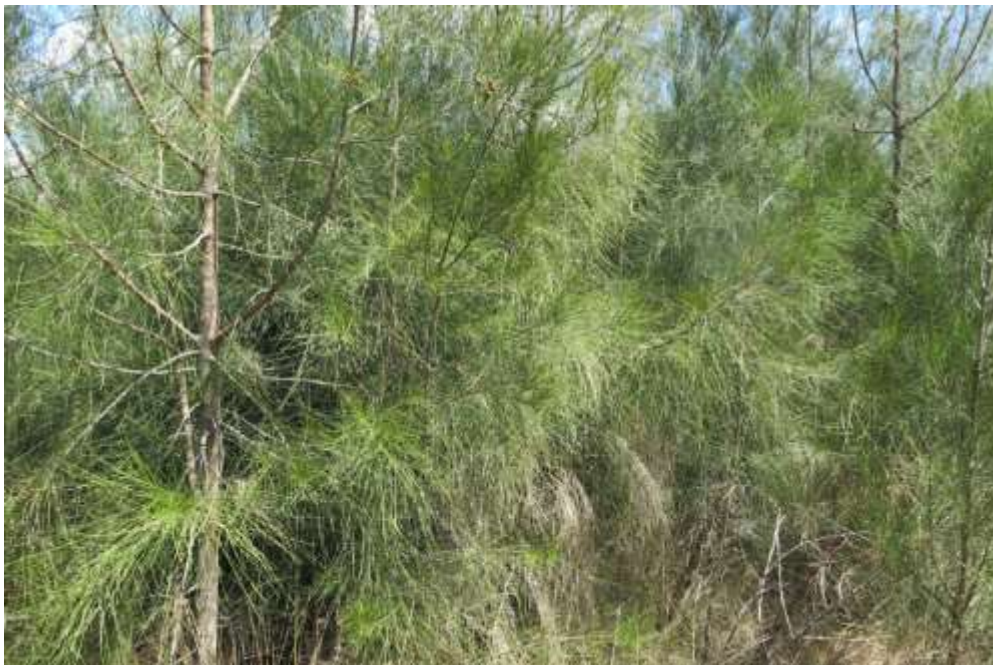
Photo Plate 201: Quadrat 5 - Month 30 (February 2018)

Growth within this quadrat over the past six months has again been exponential. A canopy of *Casuarina glauca* and *Melaleuca quinquenervia* is now well formed and continuing to increase in biomass. Native groundcovers continue to surpass weed growth, with assistance from the canopy via shading.

Myrtle rust is still being recorded within this area, with the growth of some individuals stunted; however this is not affecting all plants.
