North-West Conservation Park - Rehabilitation Monitoring

Lot 1 RP48903

North-West Conservation Park
Gainsborough Greens

March 2020

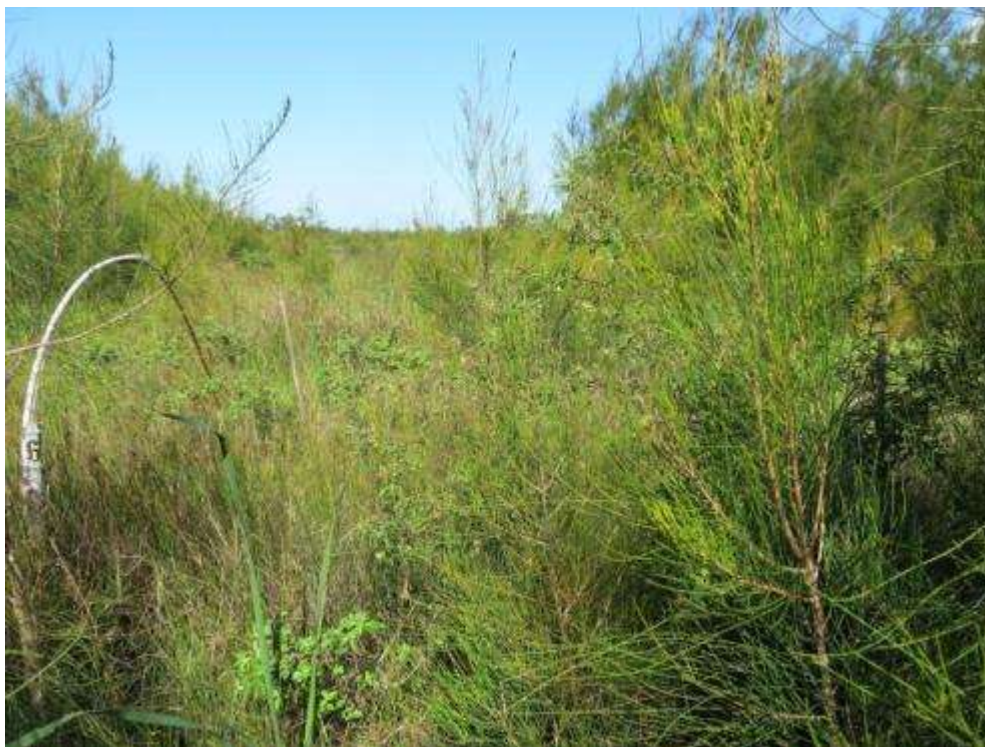
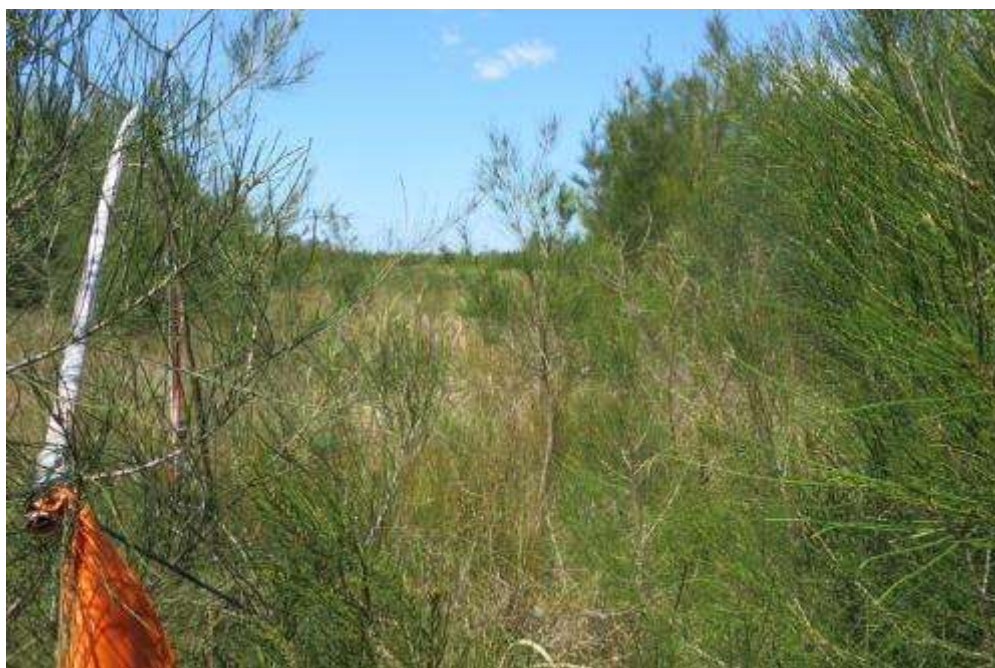
Photo Plate 203: Quadrat 6 - Month 30 (February 2018)

This quadrat has retained native dominance during the entire monitoring phase to date, and continues to do so with many species of sedges and rushes in the area. There are significant numbers of canopy trees in the surrounding area to this quadrant, with a few scattered individuals within the quadrat. Despite the lack of canopy, this quadrat has morphed into a perfect representation of a wetland community, dominated by sedges, rushes and cyperus species. This illustrates the habitat complexity and diversity within a small area of the site, with niche pockets such as this scattered throughout the NWCP.

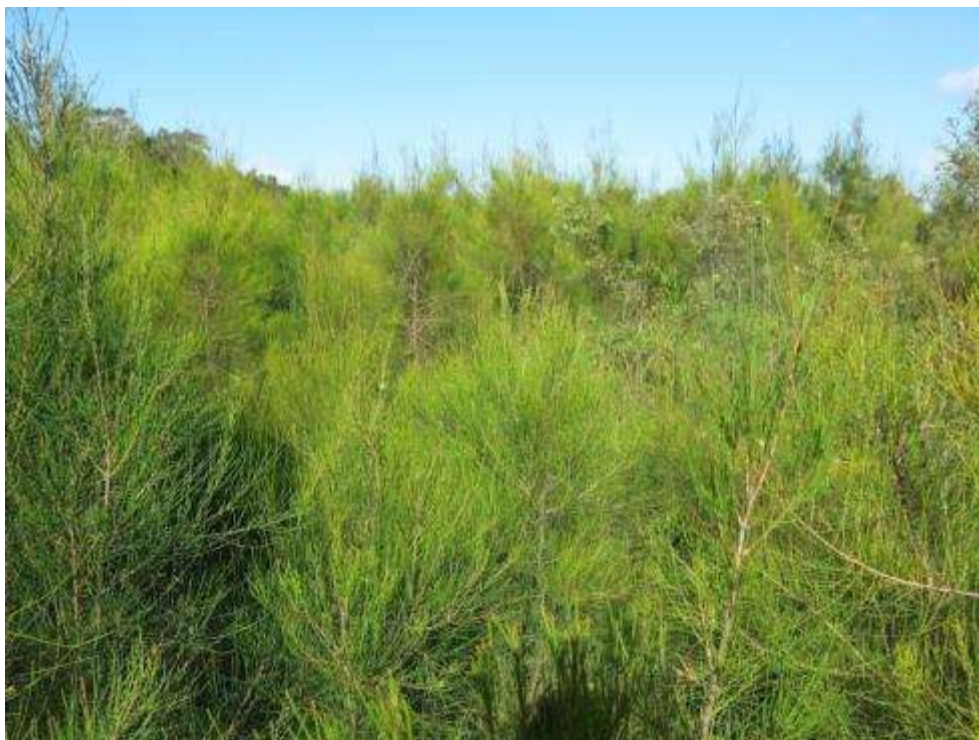
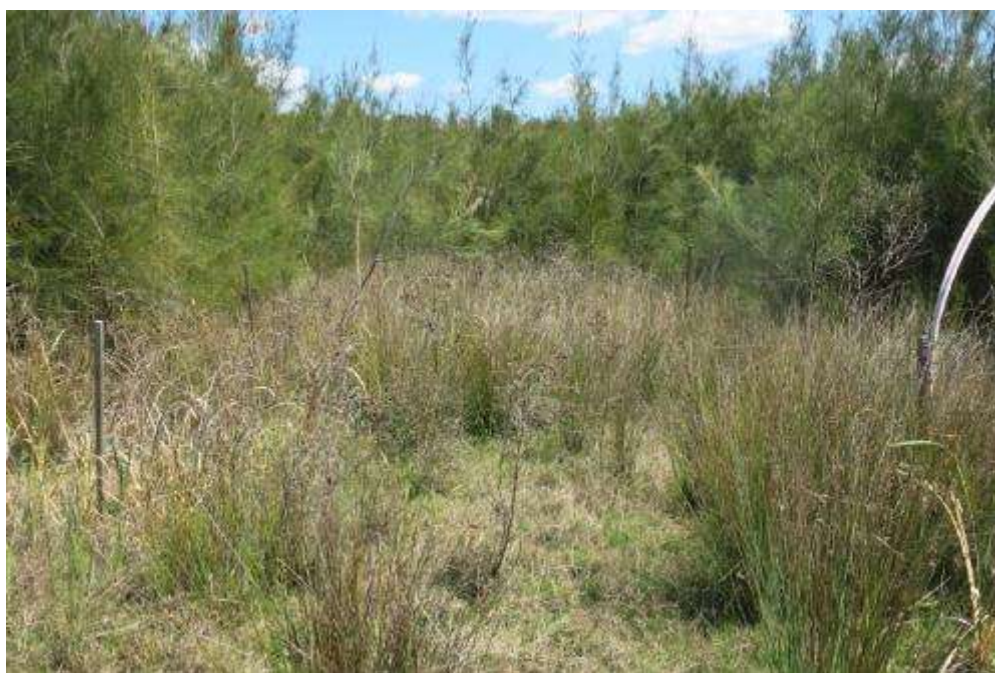
Photo Plate 205: Quadrat 7 - Month 30 (February 2018)

Native canopy vegetation continues to increase in height and biomass within the surrounds to this quadrat. Note that the month 30 monitoring photo appears different as it shows the surrounding vegetation. The actual quadrat was inaccessible at that time due to inundation.

Casuarina glauca was recorded flowering and seeding within the surrounding areas for the first time since monitoring commenced.

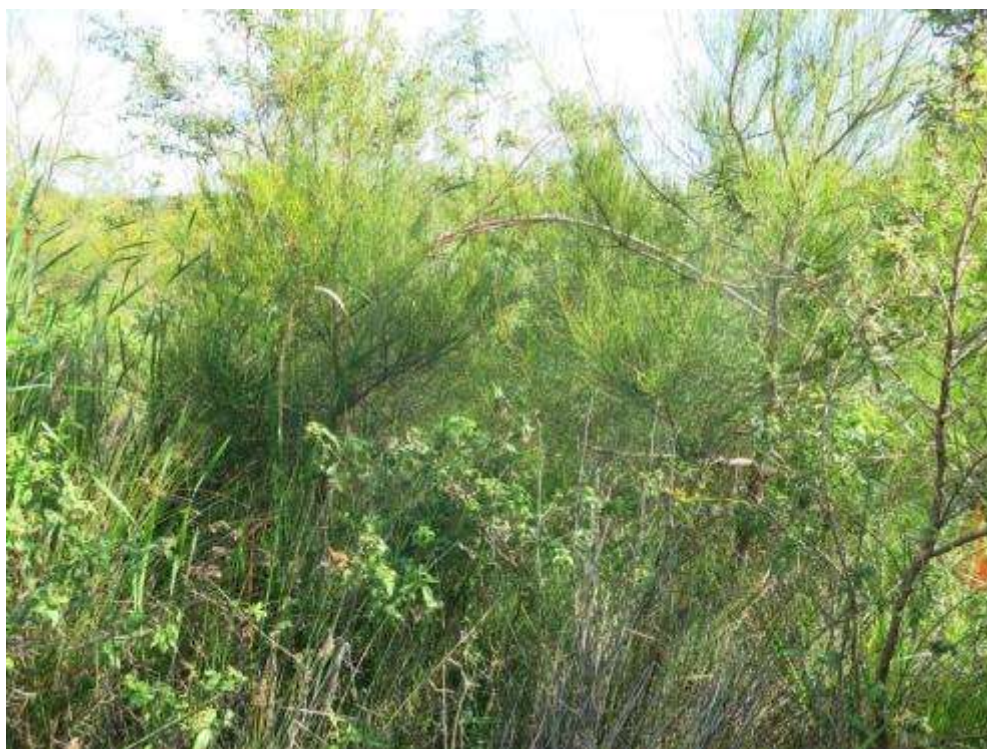
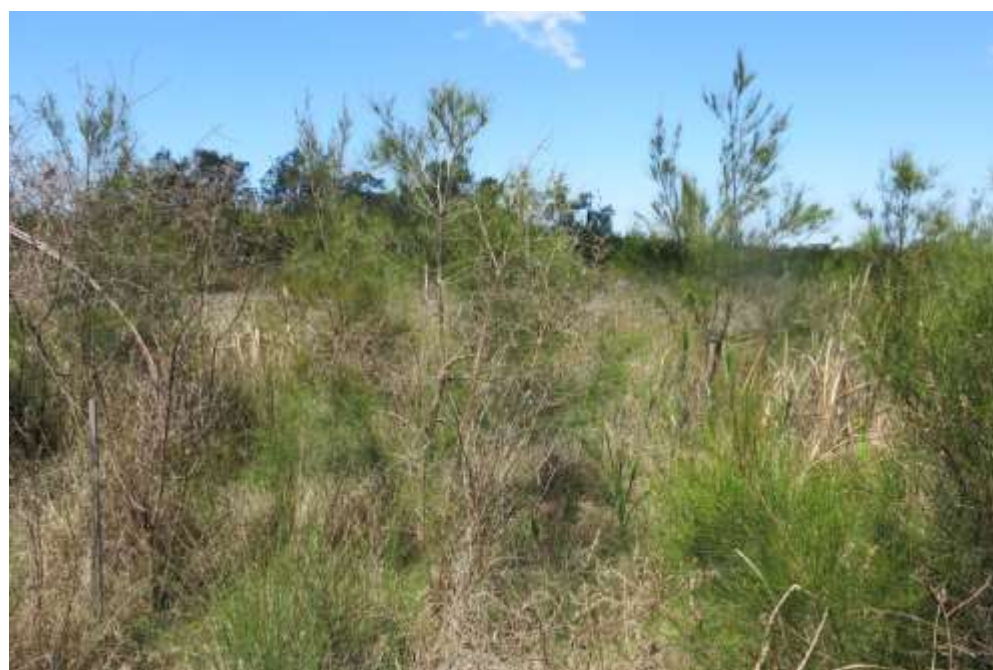
Photo Plate 207: Quadrat 8 - Month 30 (February 2018)

With the canopy establishment coupled with winter dormancies, this diversity of this quadrat has notably decreased between month 30 and month 36. A number of these species may re-emerge as growing conditions improve.

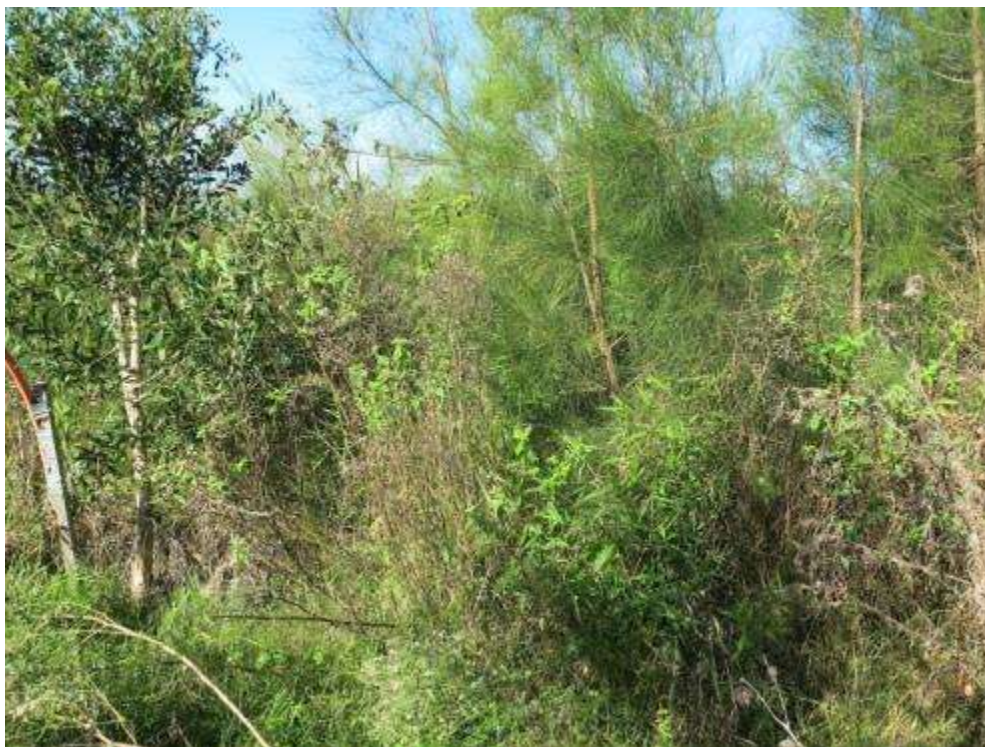
Photo Plate 209: Quadrat 9 - Month 30 (February 2018)

Within the surrounding area, casuarinas are noted to be in seed. Once these trees set viable seed, a second cohort will commence development.

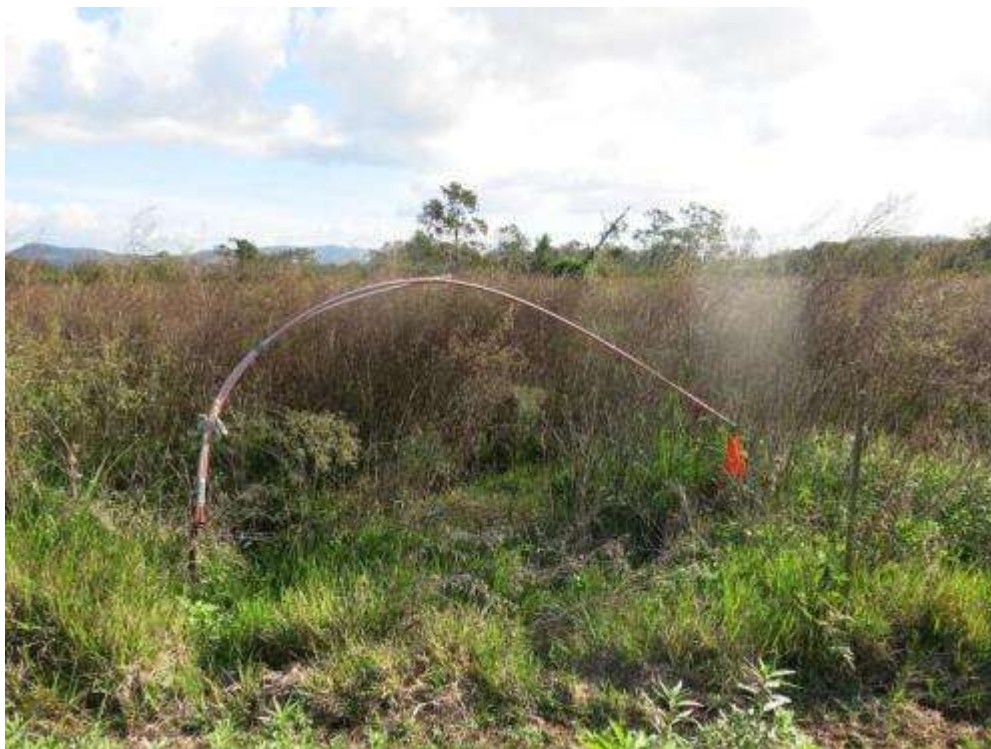
Photo Plate 213: Quadrat 11 - Month 30 (February 2018)

This quadrat provides an example of how dynamic this area can be. During Month 18, this area was noted as being very stable. In Month 24, the quadrat decreased in native dominance due to an outbreak of Common Sow Thistle. Over the past six months, there has been a shift in herbaceous weed species dominance.

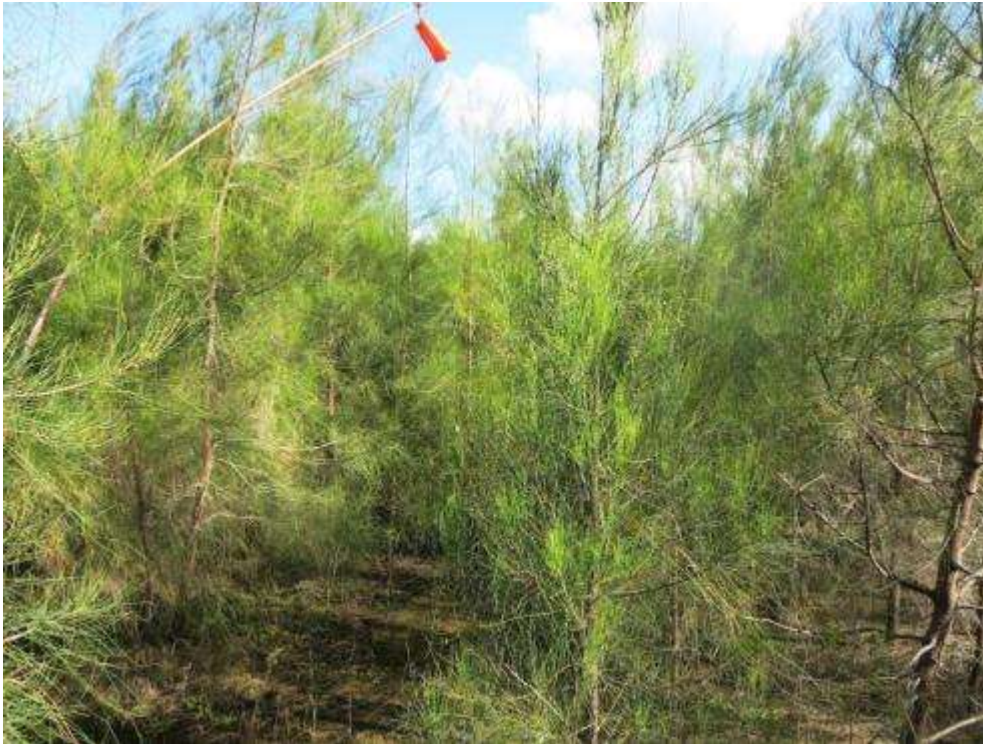
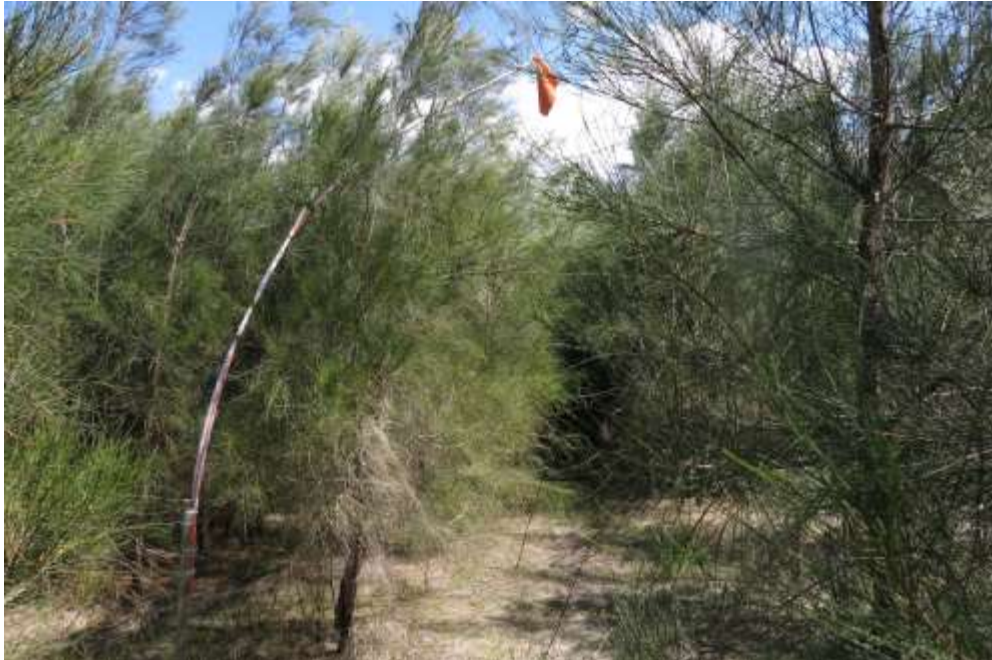
Photo Plate 216: Quadrat 12 - Month 36 (August 2018)

Due to the increase in shading and organic build up, weed species are continuing to decline. This quadrat is developing well into an open woodland community with a sparse understorey due to inundation.

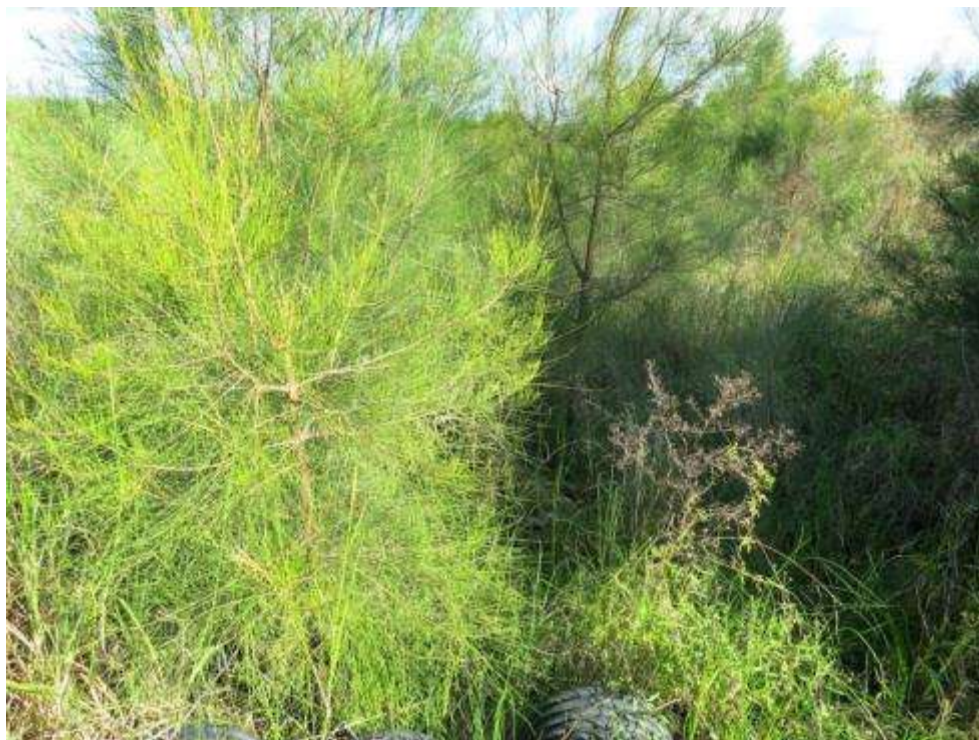
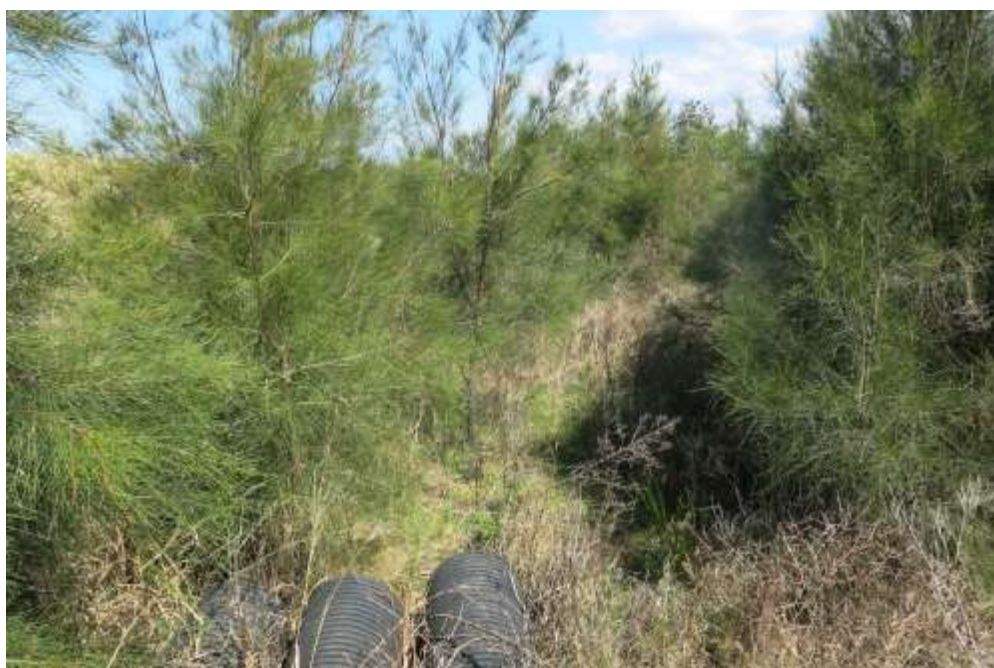
Photo Plate 217: Quadrat 13 - Month 30 (February 2018)

Canopy trees have grown significantly in height and biomass within this quadrat over the six month period.

This area has made a significant comeback with the change from sedges to casuarinas. A number of eucalypts are located on the fringes of this quadrat that are progressing well.

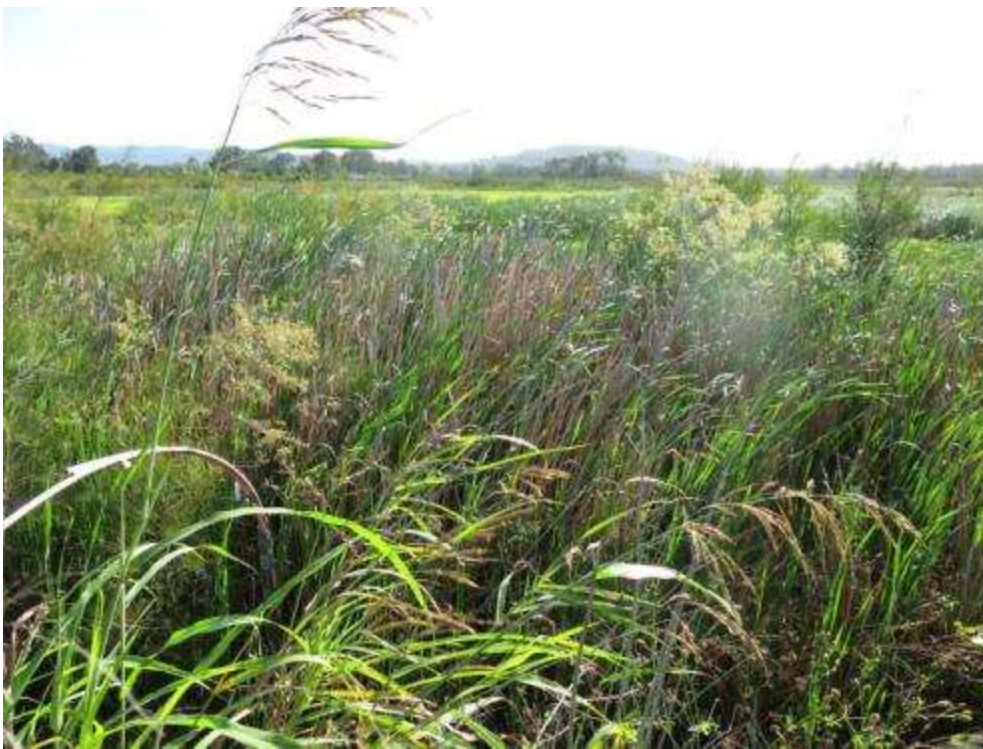
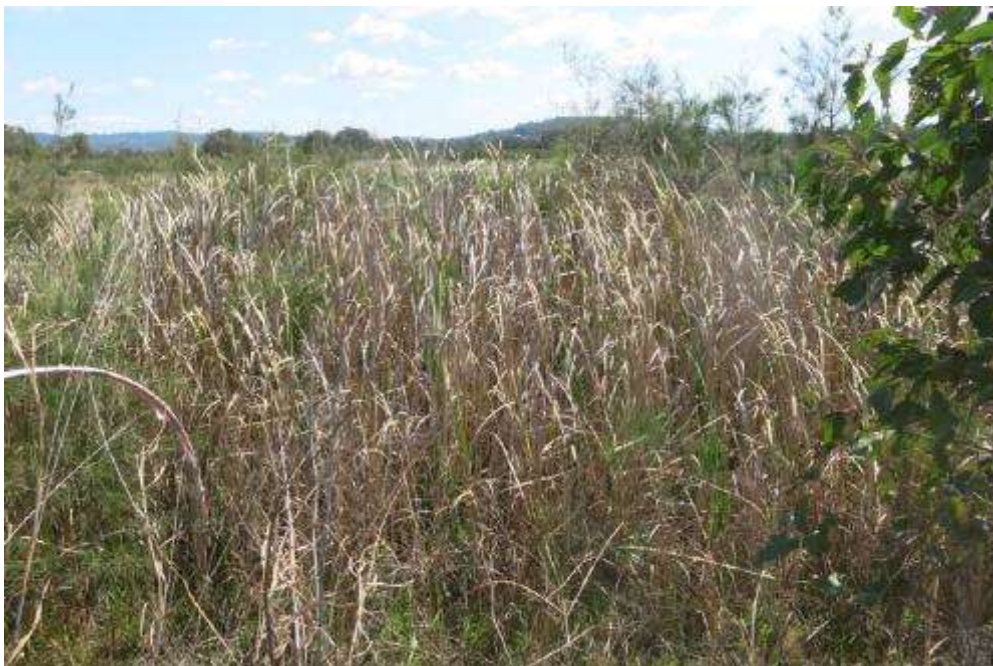
Photo Plate 219: Quadrat 14 - Month 30 (February 2018)

Comparison Summary
Typha is still quite dominant in this quadrat. A number of small casuarina seedlings are developing and have clearly emerged over the tops of the typha. This marks the commencement of the diversification of this quadrat.

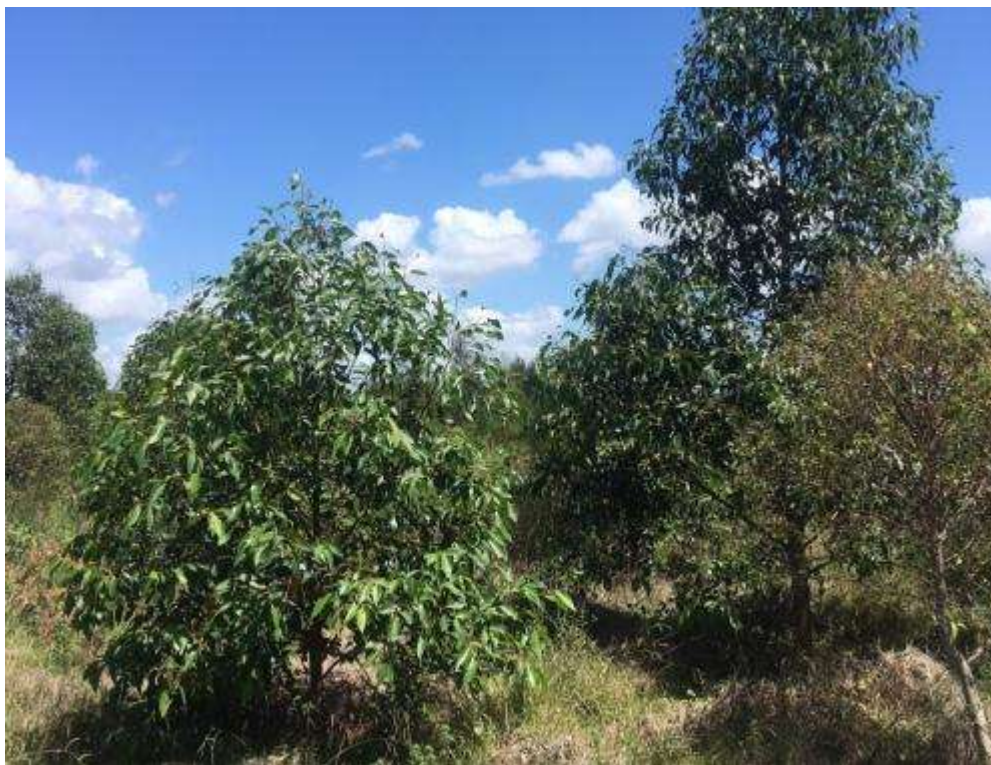
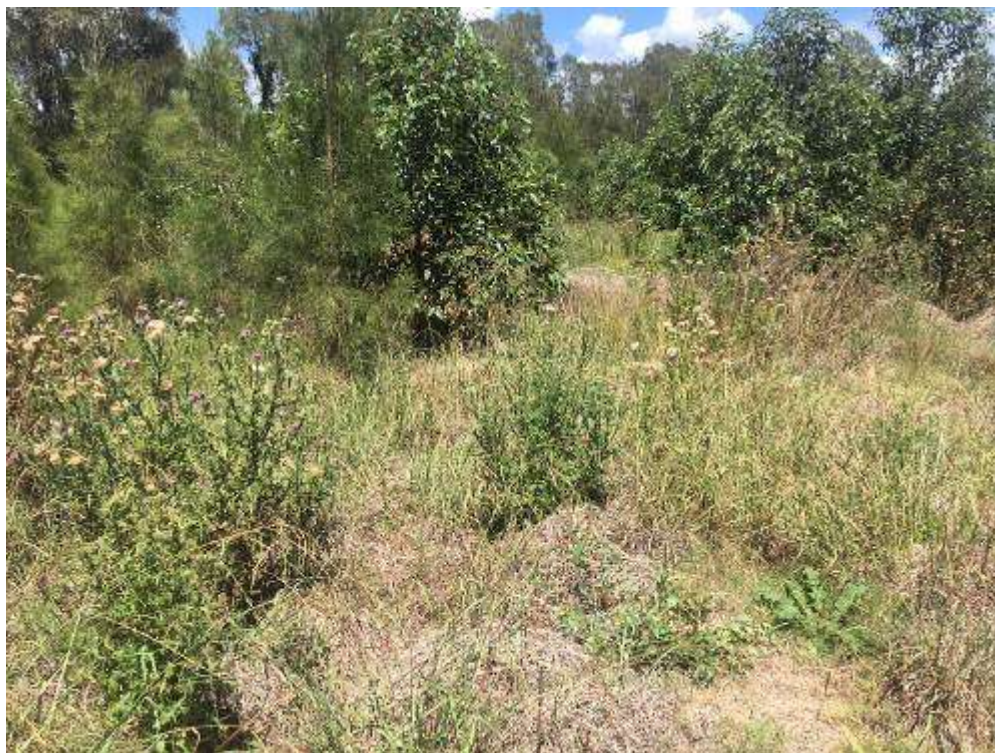
Photo Plate 221: A1 Eucalypt Plantings - Month 30 (February 2018)

Comparison Summary
Height and biomass of seedlings have both increased exponentially over this 6 month period. As the canopy continues to develop, weed growth will gradually be reduced. Stock averaged approximately 7m in height at this monitoring event.

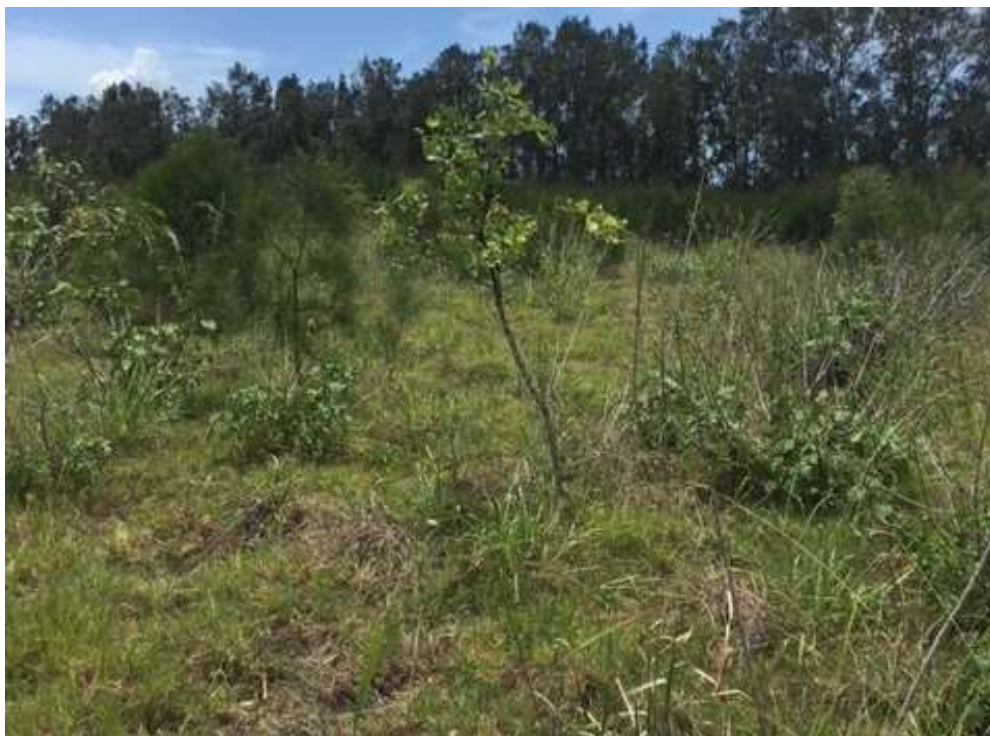
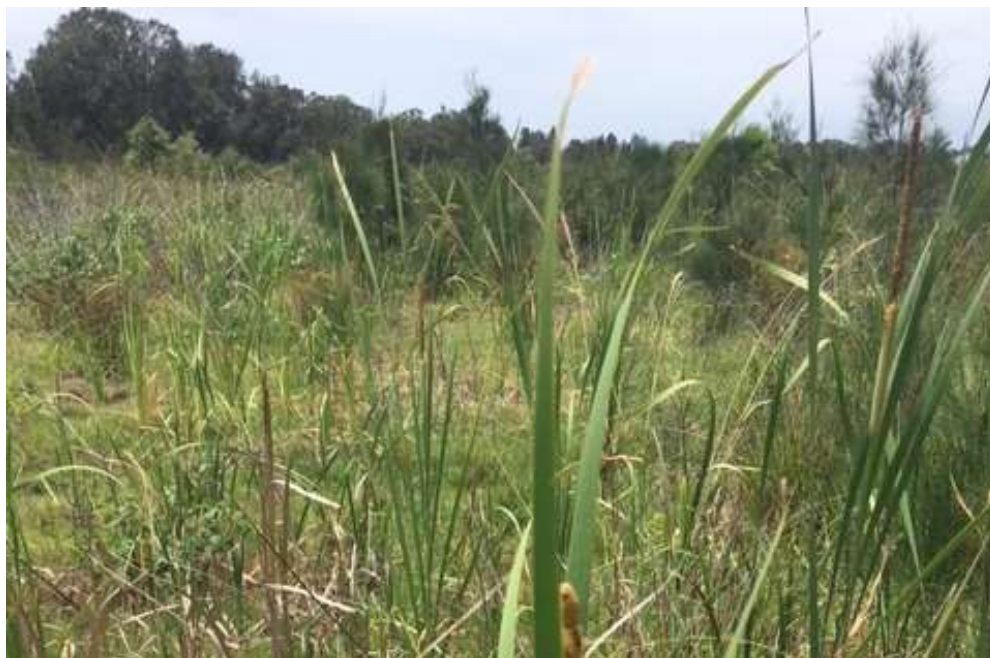
Photo Plate 223: A2 Eucalypt Plantings - Month 30 (February 2018)

The site is still periodically inundated, limiting the growth of a number of the seeded species. *Hibiscus diversifolius*, a species that requires high moisture levels, is dominant throughout this area. This area of tube stock planting is taking longer than the A1 plantings. It is anticipated that this stock will grow slower than other areas due to the geology and inundation.

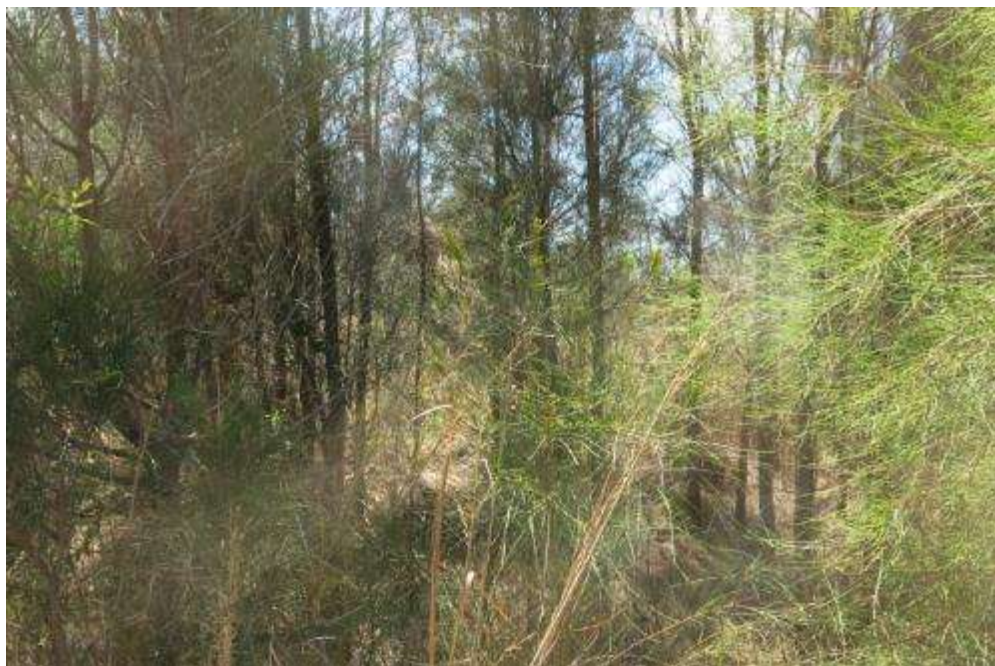
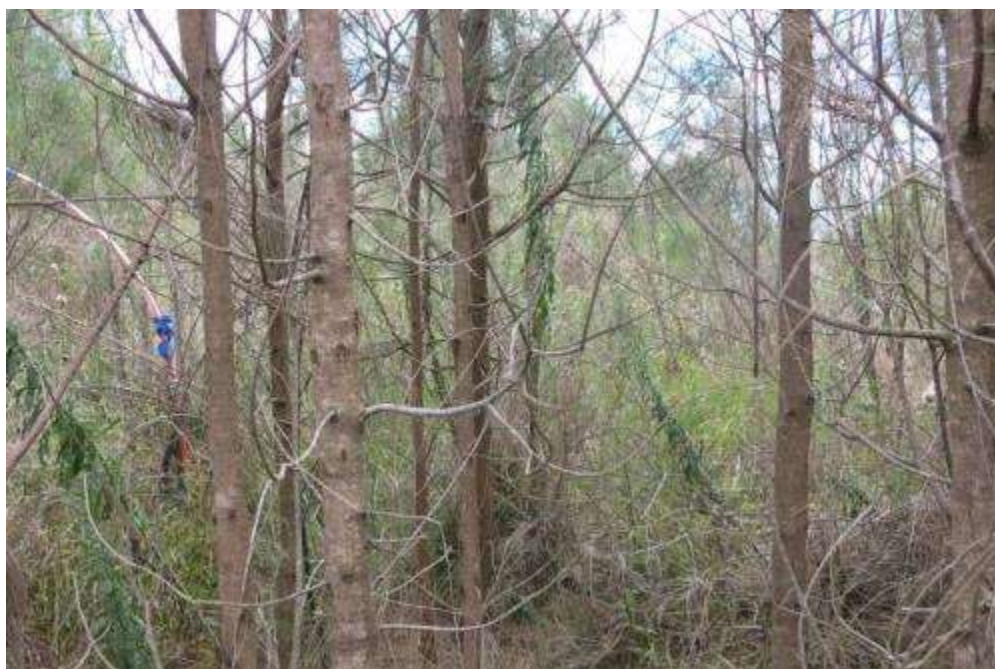
Photo Plate 225: Quadrat 1 - Month 36 (August 2018)

Over the past 6 months, growth of *Casuarina glauca* has continued to increase in biomass, especially girth. The diversity and abundance of weed species has been greatly reduced. As *Casuarina glauca* growth continues to increase and add biomass, this weed will be outcompeted. The balance of the understorey in this area continues to trend towards a native grassy understorey.

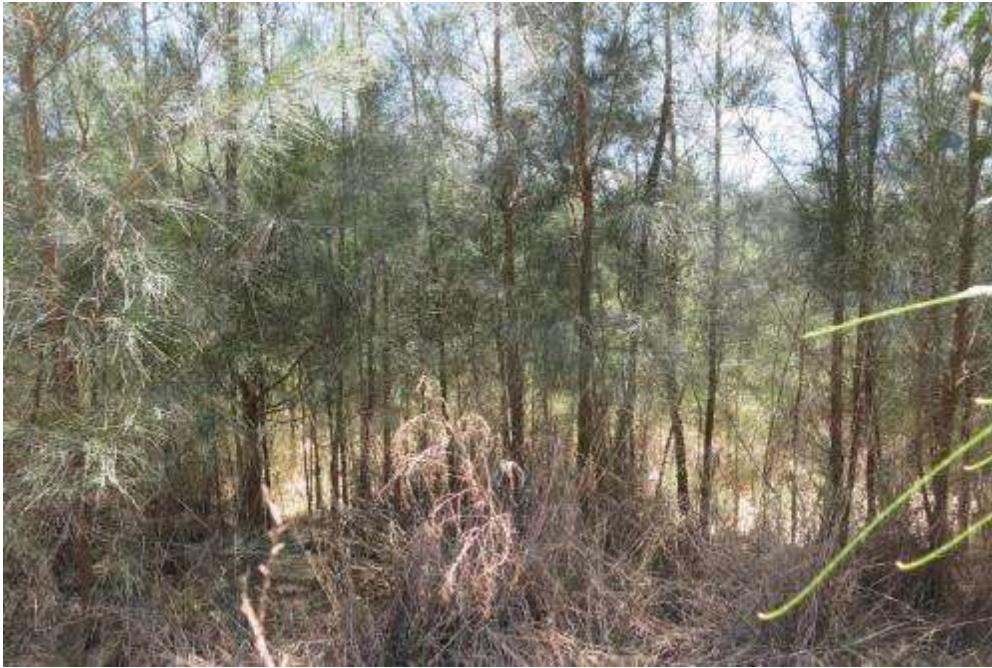
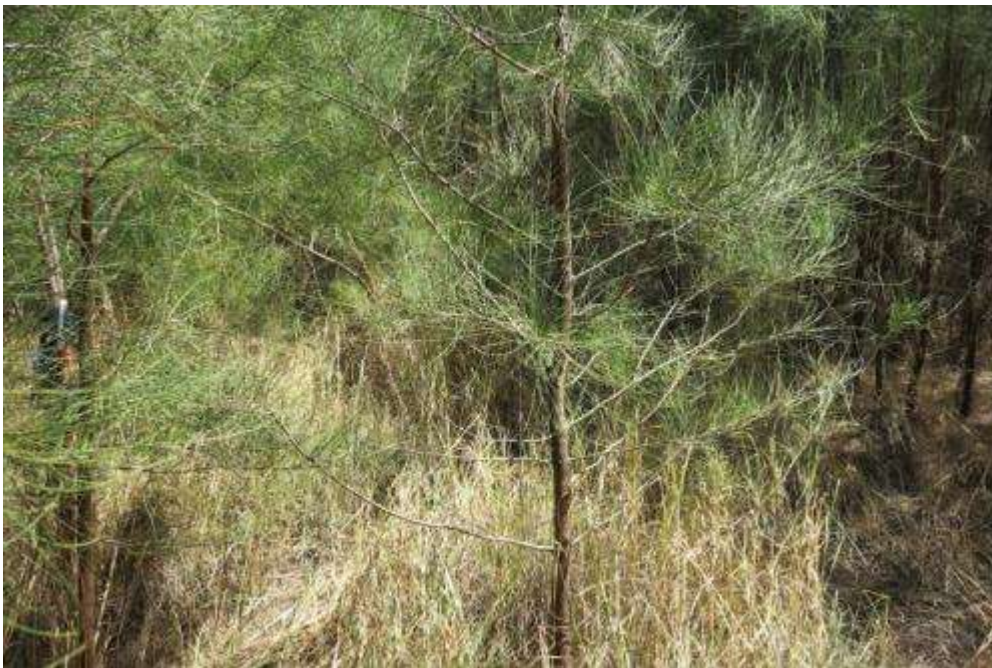
Photo Plate 227: Quadrat 2 - Month 36 (August 2018)

Over the past six months, *Casuarina glauca* and *Melaleuca quinquenervia* growth has made this quadrat unrecognisable.

This quadrat is rapidly establishing a canopy of *Casuarina glauca*. This is currently resulting in a short term reduction of diversity in the understory as the dynamic of this quadrat shifts.

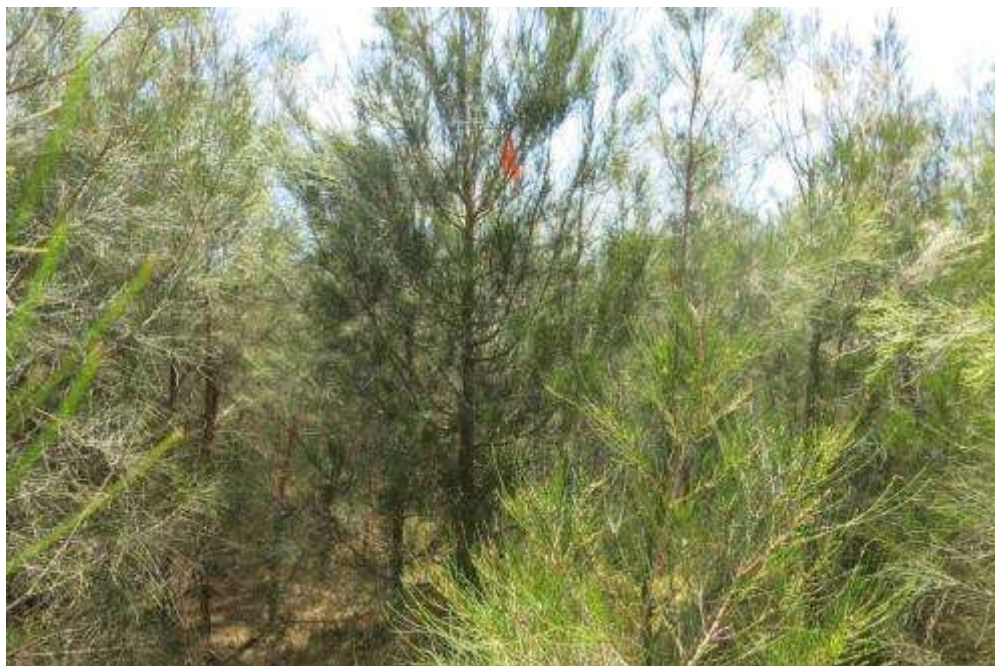
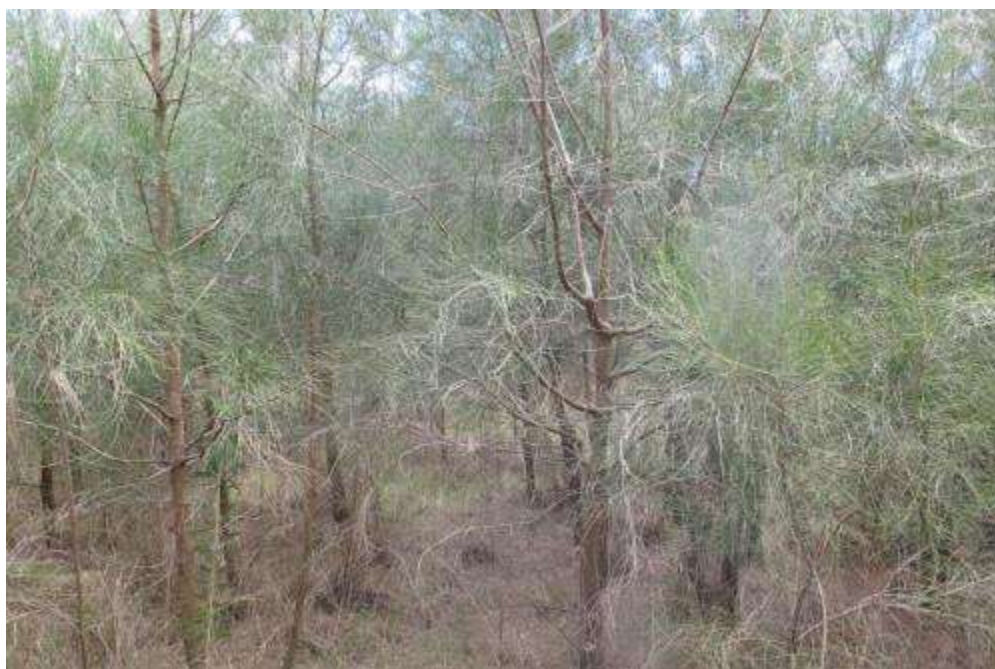
Photo Plate 229: Quadrat 3 - Month 36 (August 2018)

The growth in biomass and height of *Casuarina glauca* has again been significant over the past six months. The quadrat markers are now completely obscured from view. *Juncus kraussii* within the surrounds of this quadrat continues to multiply, creating many small colonies throughout the area. Myrtle Rust is still present in the area and impacted on melaleucas

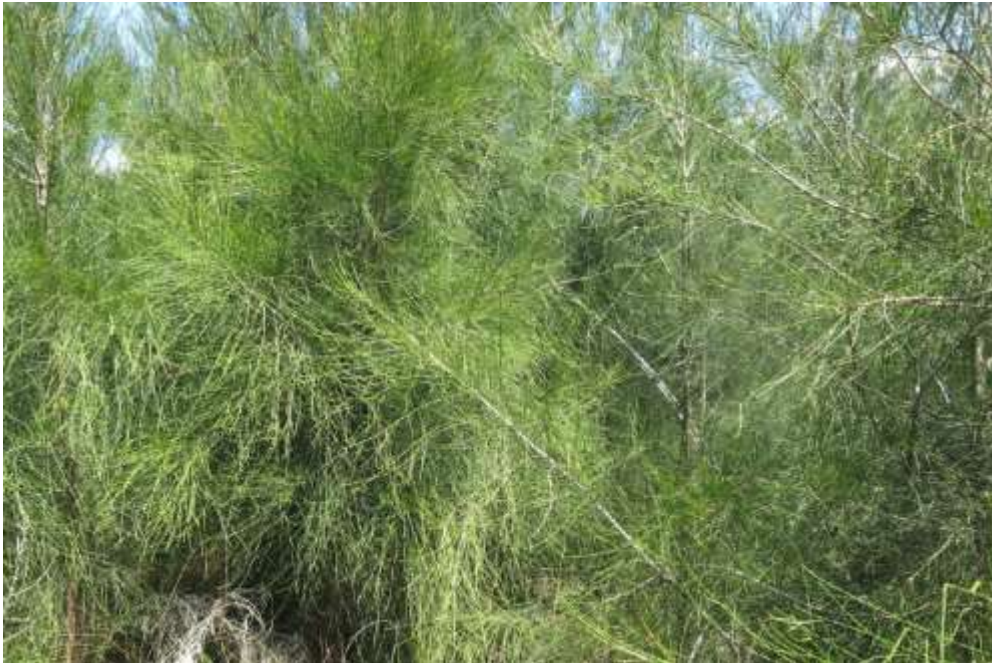
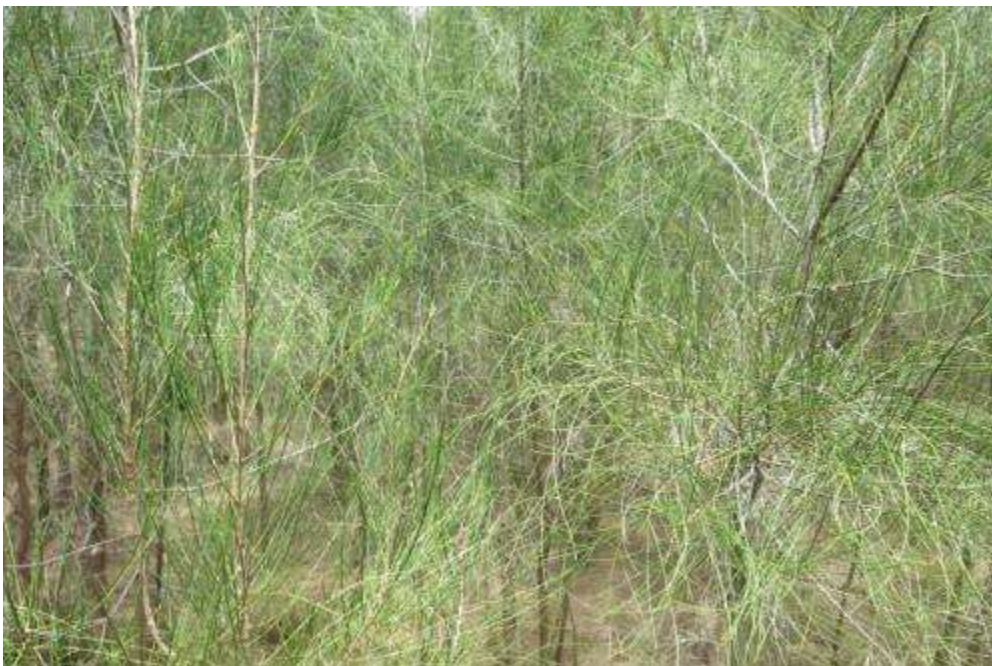
Photo Plate 231: Quadrat 4 - Month 36 (August 2018)

Comparison Summary
Casuarina glauca growth and biomass has continued to increase. This canopy formation has continued to suppress weed growth.

Contour bands in the surrounding area edging onto quadrats 4, 5, 6 and 7 continue to develop with *Juncus kraussii* and will fringe the small lake that will form in the wet season.

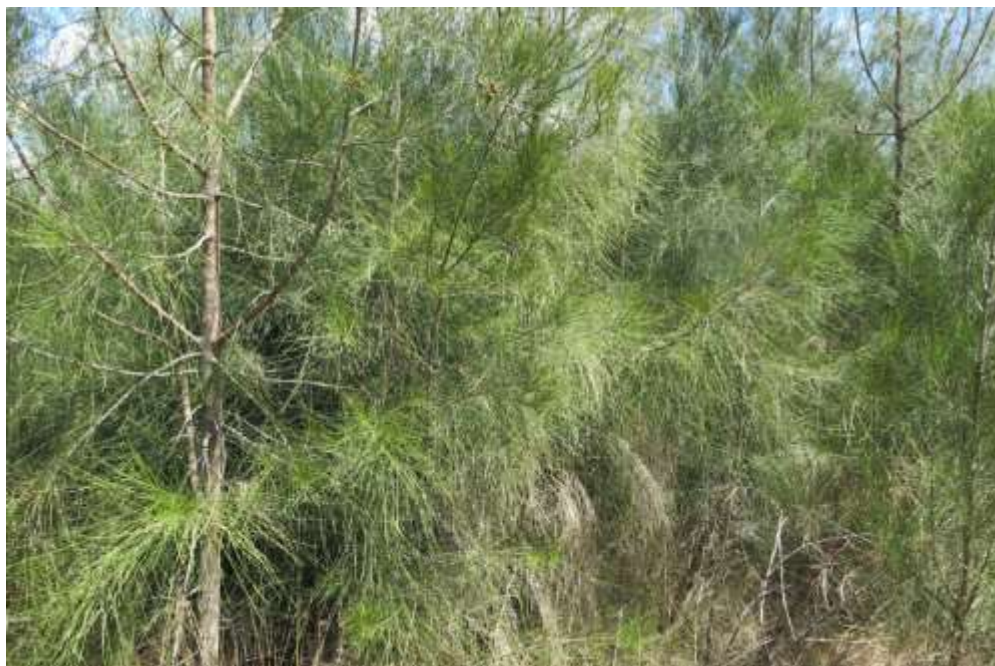
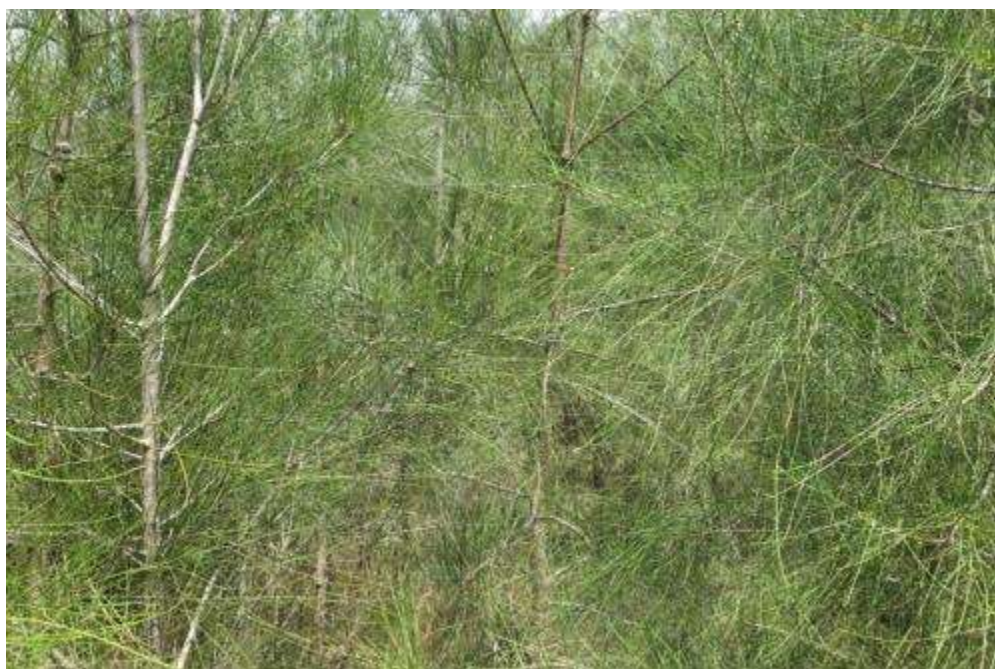
Photo Plate 233: Quadrat 5 - Month 36 (August 2018)

Growth within this quadrat over the past six months has been steady. A canopy of *Casuarina glauca* and *Melaleuca quinquenervia* is now well formed and continuing to increase in biomass. Native groundcovers continue to surpass weed growth, with assistance from the canopy via shading.

Myrtle rust is still being recorded within this area, with the growth of some individuals stunted; however this is not affecting all plants.

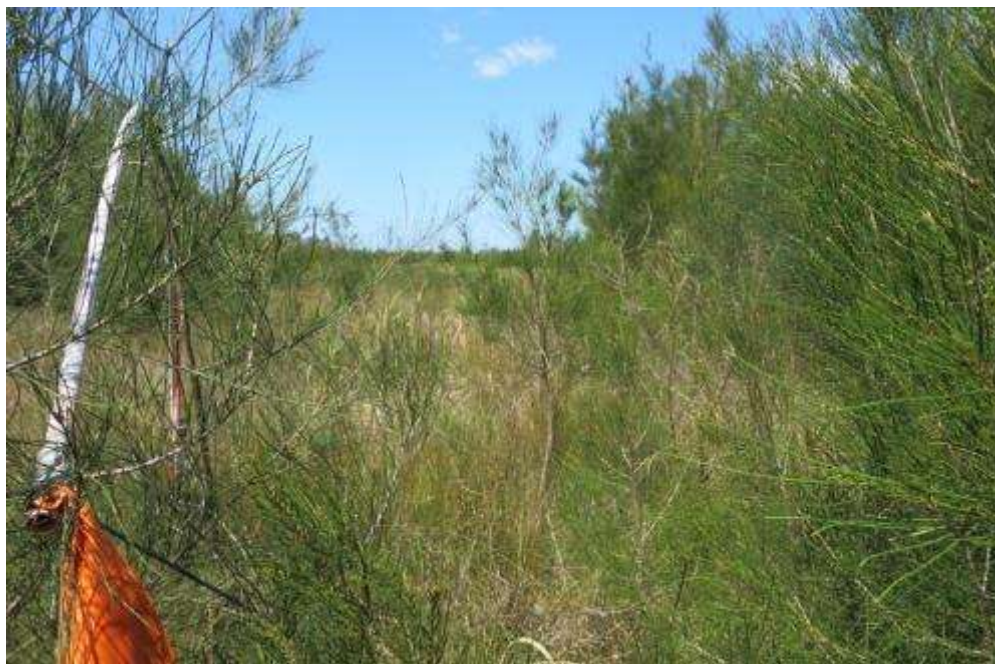
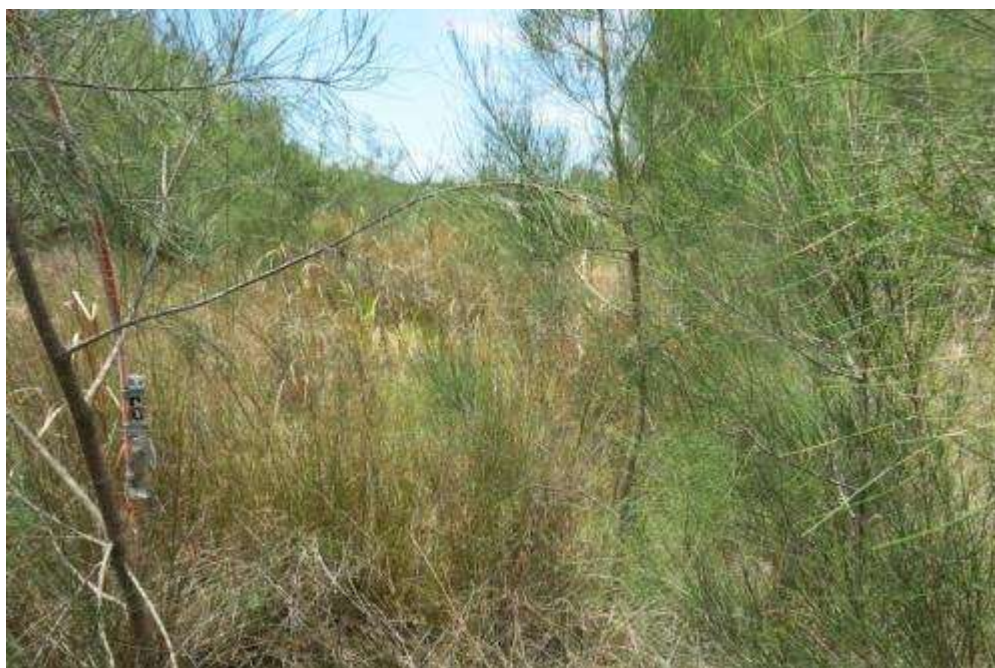
Photo Plate 235: Quadrat 6 - Month 36 (August 2018)

This quadrat has retained native dominance during the entire monitoring phase to date, and continues to do so with many species of sedges and rushes in the area.

This is a dynamic quadrat that shows significant changes between the wet and dry months as a direct result of the seasonal shifts in the hydrological regime of the area. This illustrates the habitat complexity and diversity within a small area of the site, with niche pockets such as this scattered throughout the NWCP.
