North-West Conservation Park - Rehabilitation Monitoring

Lot 1 RP48903

North-West Conservation Park
Gainsborough Greens

March 2020

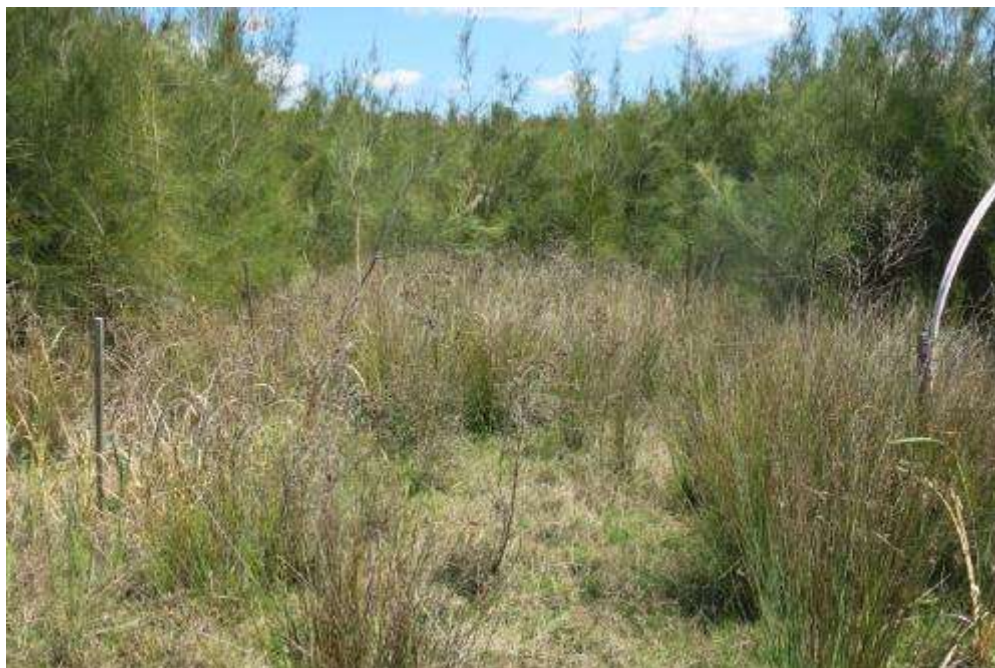
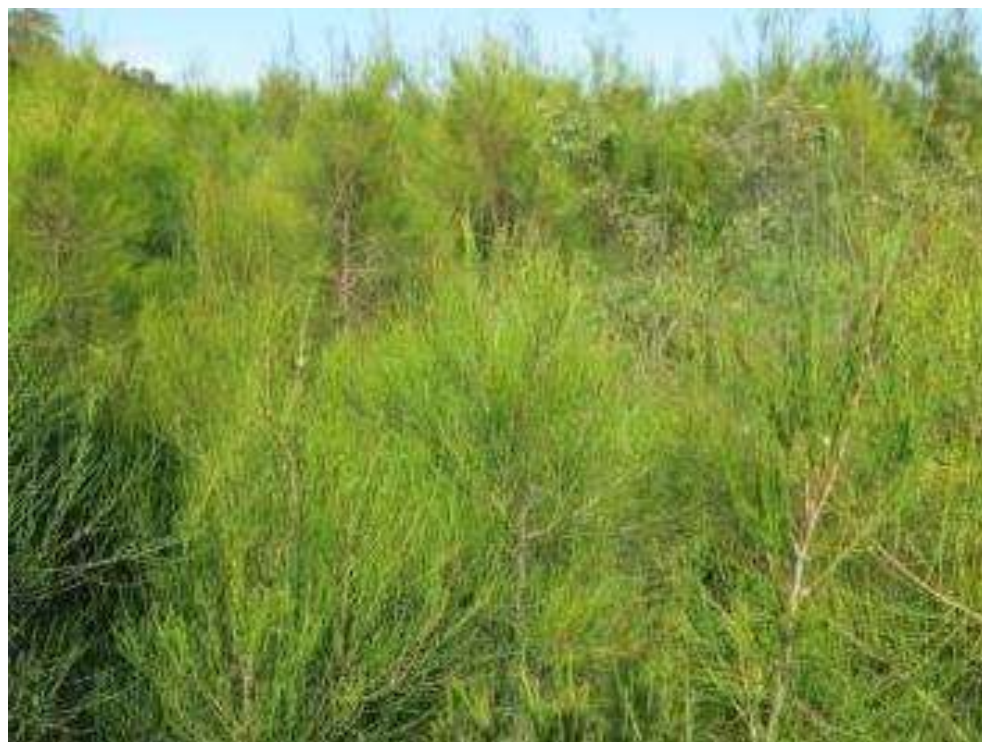
Photo Plate 237: Quadrat 7 - Month 36 (August 2018)

Native canopy vegetation continues to increase in height and biomass within the surrounds to this quadrat. Note that the month 42 monitoring photo appears different as it shows the surrounding vegetation. The actual quadrat was again inaccessible at that time due to inundation.

Casuarina glauca within this area continues to grow exponentially. Wetland species diversity within this area of the NWCP continues to increase.

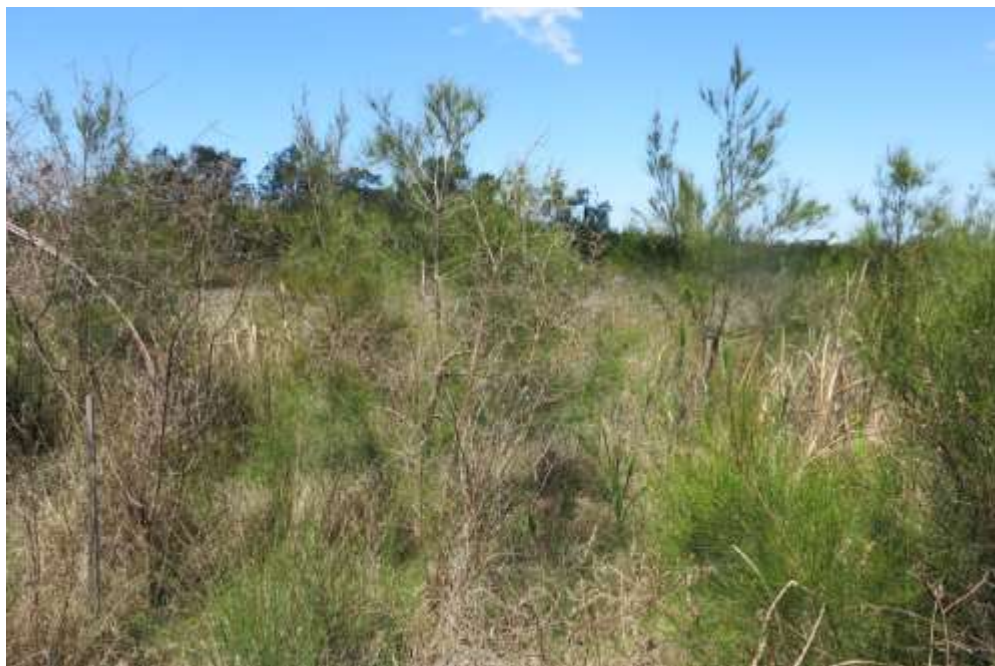
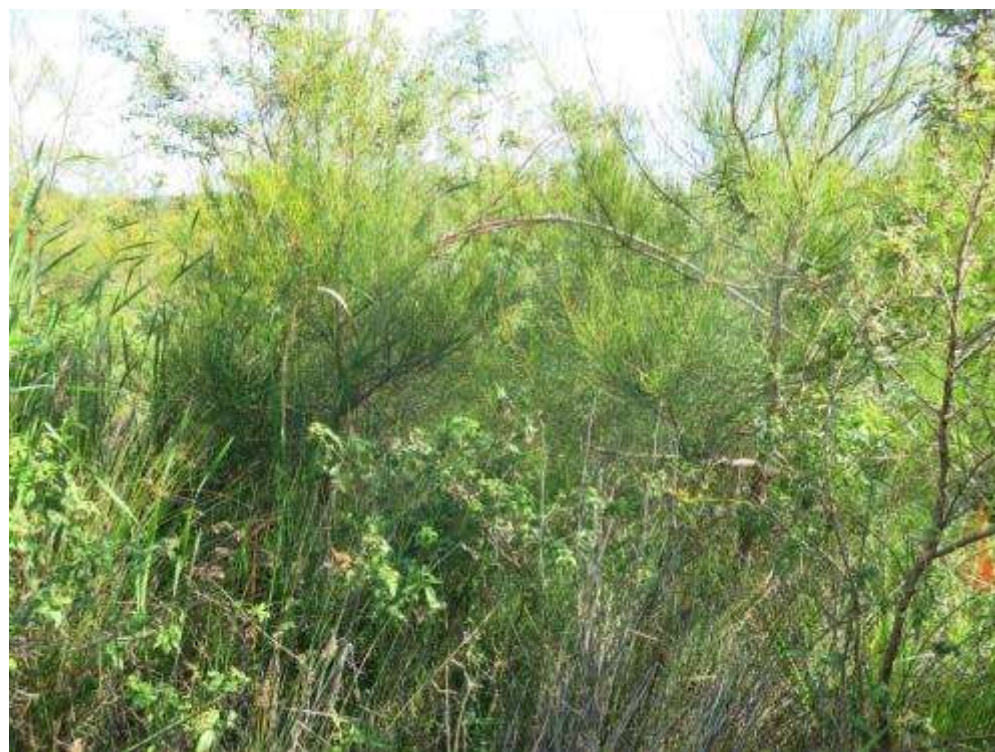
Photo Plate 239: Quadrat 8 - Month 36 (August 2018)

Species diversity was previously recorded as declining due to the increase in shading from the rapidly establishing canopy. Diversity has stabilised and is predicted to increase again over the next 12 months as the ecotone shift becomes more settled.

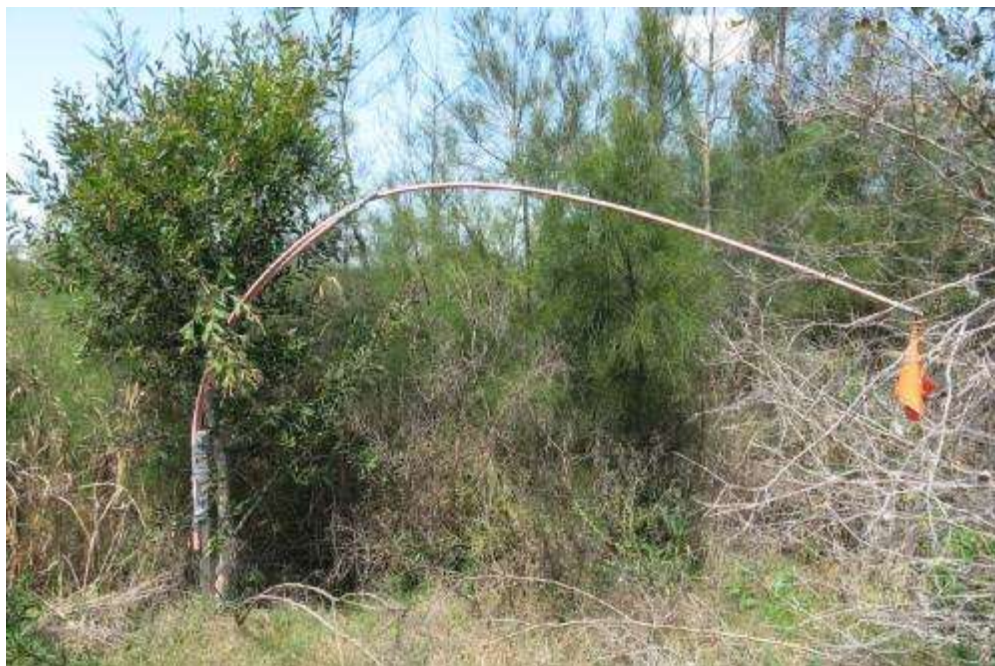
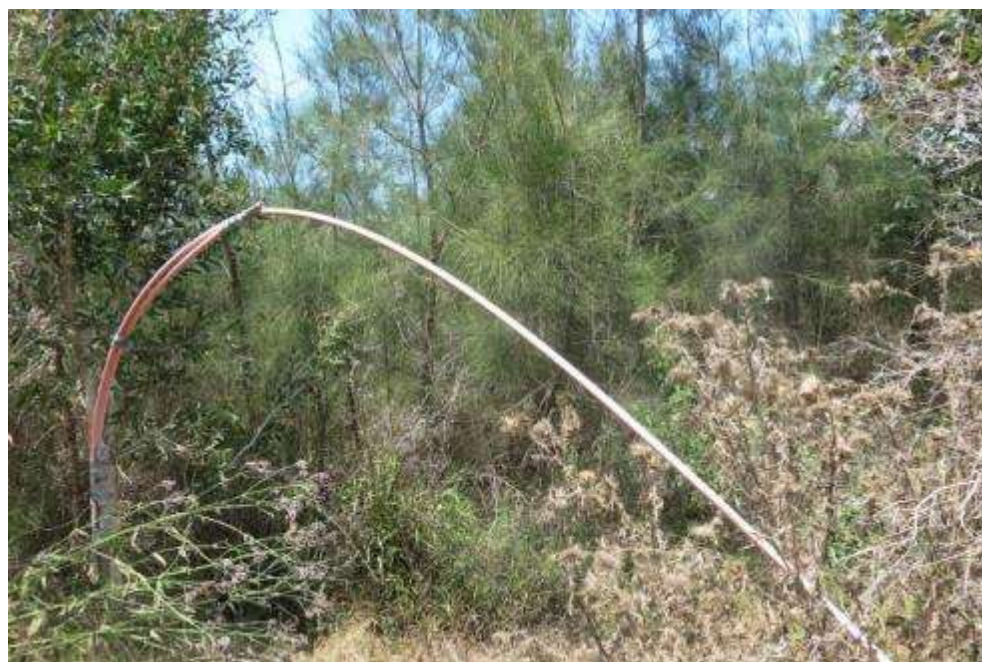
Photo Plate 241: Quadrat 9 - Month 36 (August 2018)

Kangaroo activity is noted to be high within the surrounding area with multiple sunning/ loafing pads sighted.

There is also evidence of stunted casuarinas between this quadrat and quadrat 10 due to grazing.

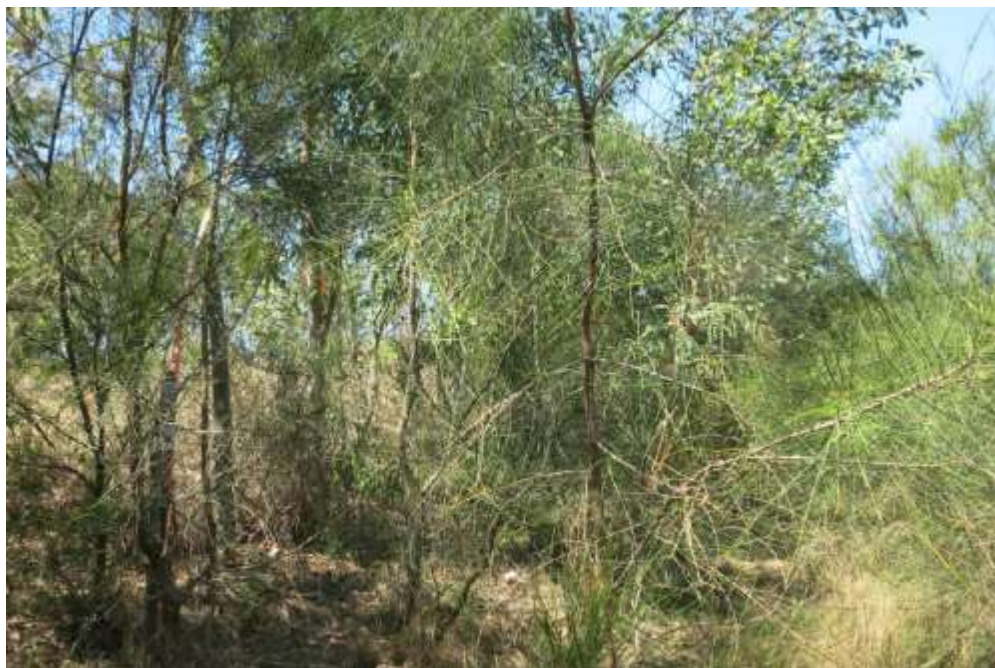
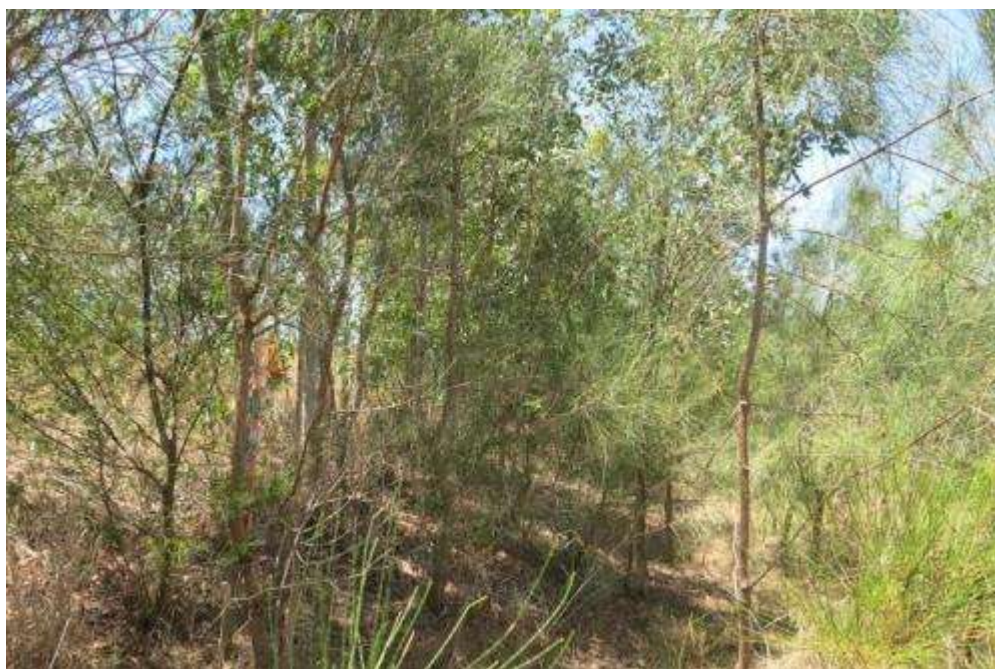
Photo Plate 243: Quadrat 10 - Month 36 (August 2018)

The growth within this quadrat is quite representative of the broader site. The extent of vegetation cover within this quadrat has not increased. It is considered unlikely that this will increase due to the topography of this quadrat. However, soil shading has increased due to the overall increase of biomass of the canopy. This continual increase in shading will continue to alter species composition and abundance.

This quadrat is progressively transitioning towards a grassy woodland structure with dominance of native grasses in the understorey.

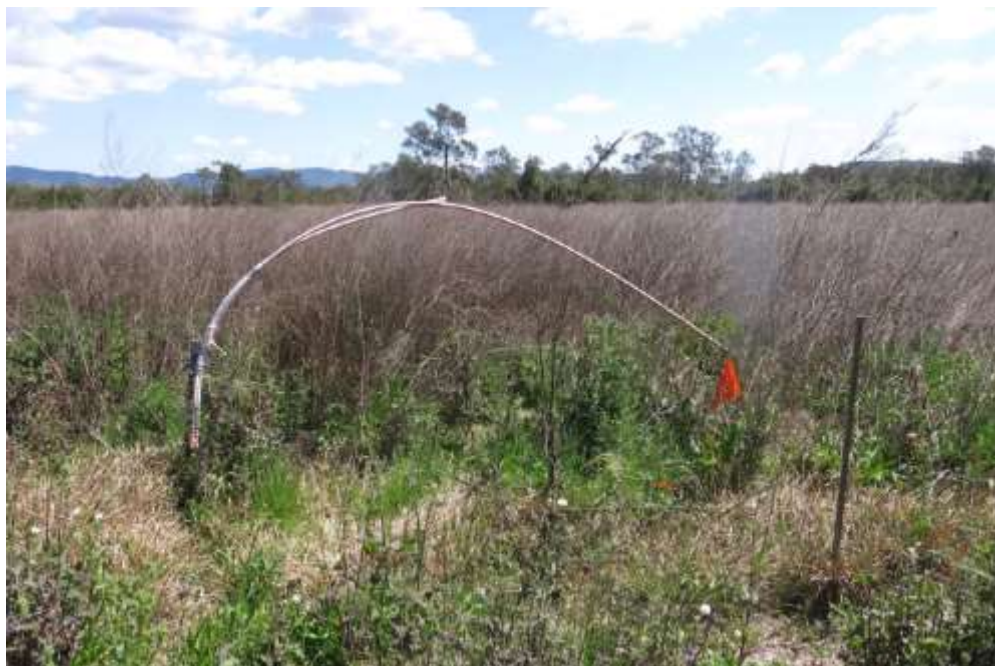
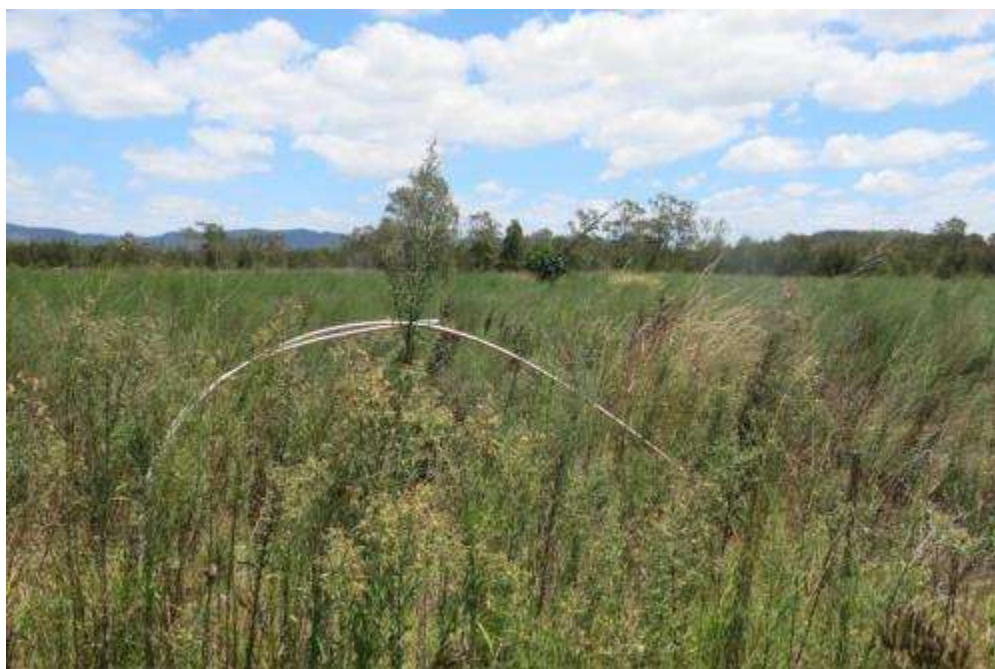
Photo Plate 245: Quadrat 11 - Month 36 (August 2018)

Native dominance has decreased between months 36 and 42 due to the annual summer growth of Aster. As the season transitions, native grasses such as *Capillipedium spicigerum* should increase in dominance.

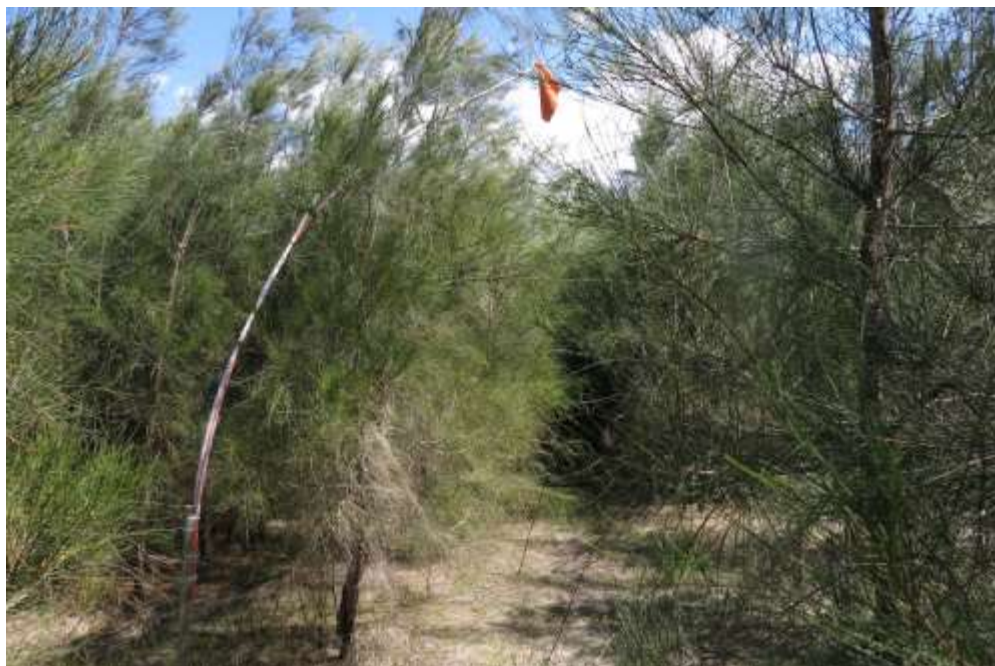
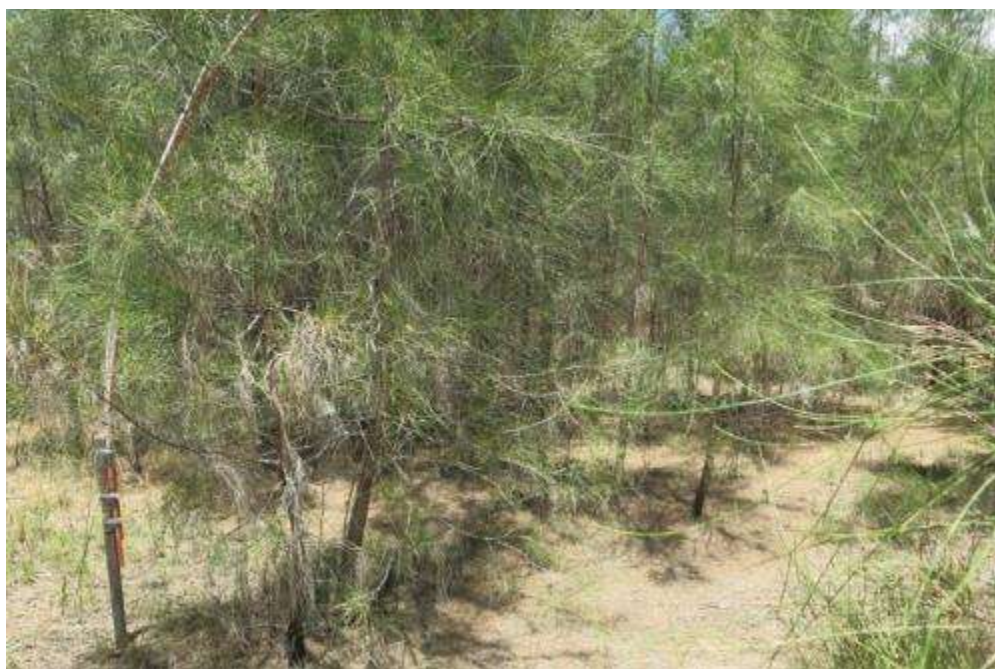
Photo Plate 247: Quadrat 12 - Month 36 (August 2018)

In previous six monthly comparisons this quadrat and the immediate surrounds appeared to be lagging compared to other areas, however vegetation has grown significantly over the past 12 months.

Due to the increase in shading and organic build up, weed species are continuing to decline. This quadrat is developing well into an open woodland community with a sparse understorey due to inundation.

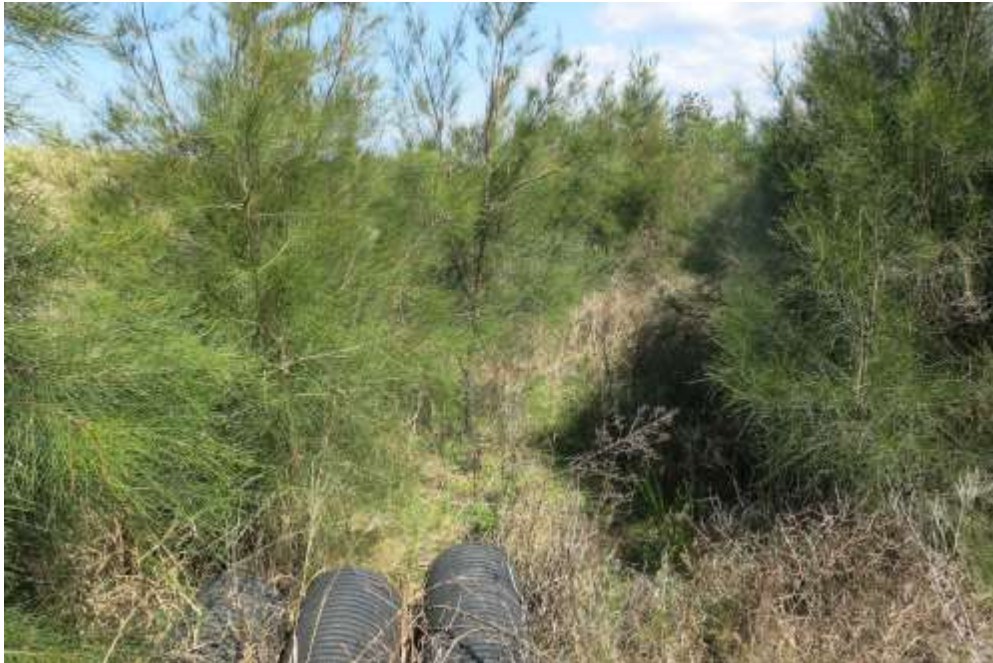
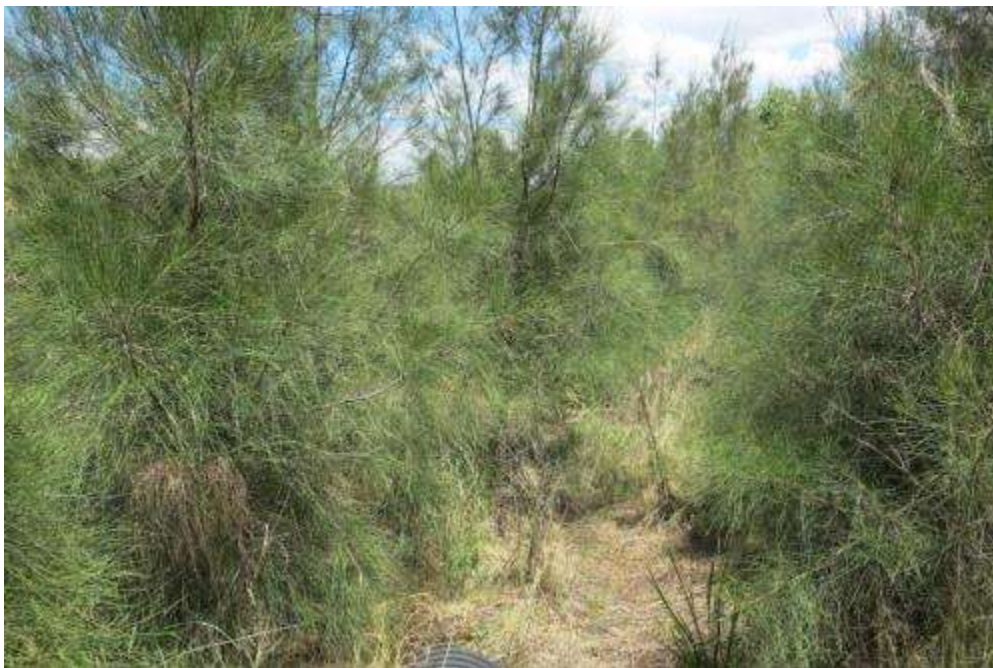
Photo Plate 249: Quadrat 13 - Month 36 (August 2018)

Comparison Summary
Canopy trees have grown significantly in height and biomass within this quadrat over the six month period.

This area has made a significant comeback with the change from sedges to casuarinas. A number of eucalypts are located on the fringes of this quadrat that are progressing well.

With the additional build-up of organic materials over the past six months, conditions have improved greatly allowing for the rapid growth of species such as *Lomandra longifolia*.

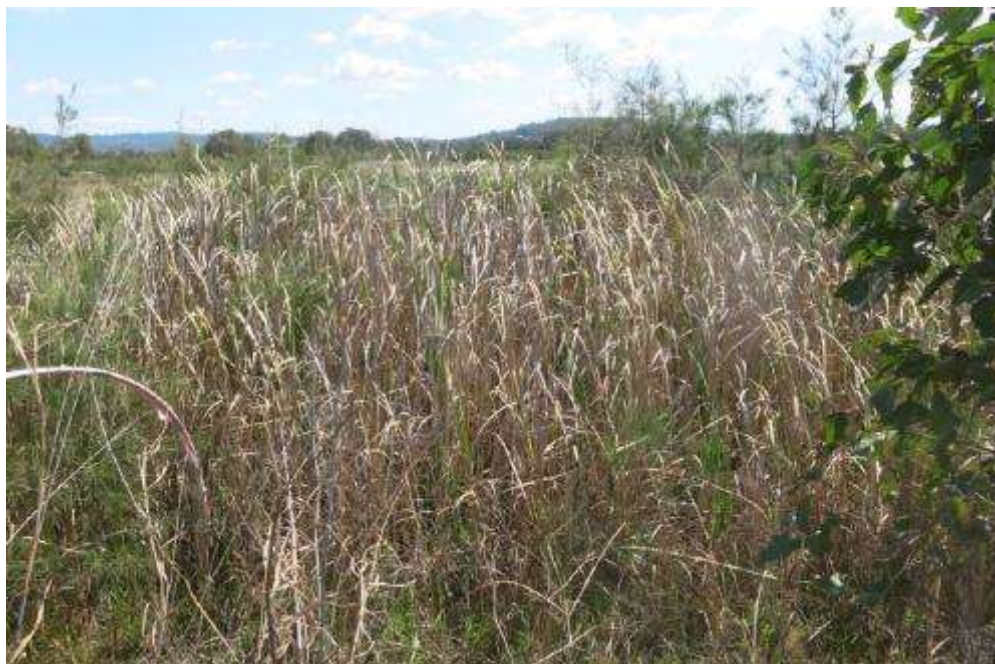
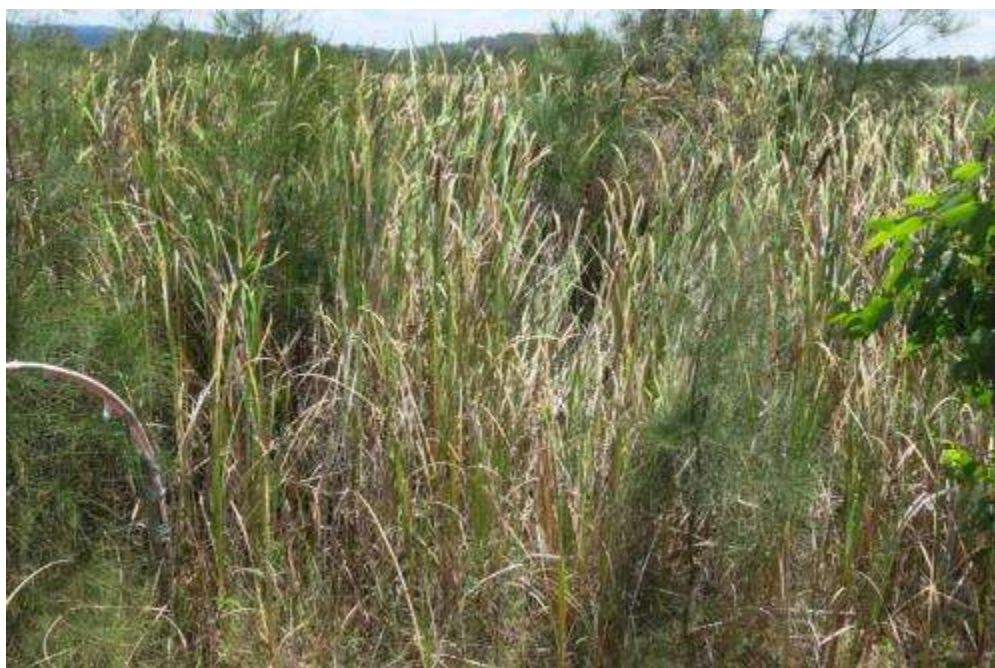
Photo Plate 251: Quadrat 14 - Month 36 (August 2018)

Typha is still quite dominant in this quadrat. A number of small casuarina seedlings are developing well and continue to add biomass. This is a positive trend for the diversification of this quadrat.

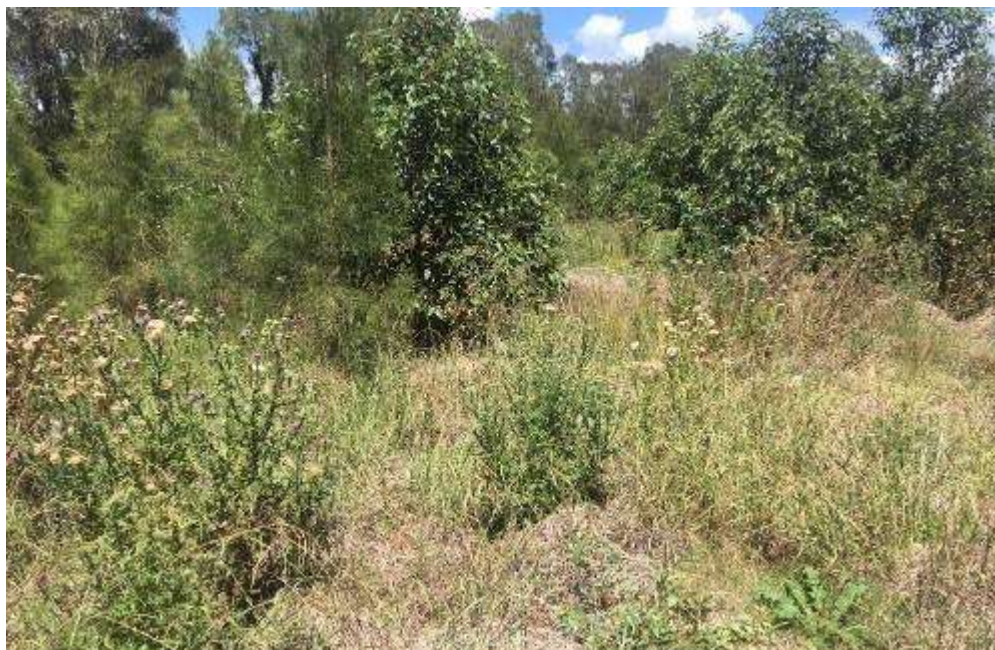
Photo Plate 253: A1 Eucalypt Plantings - Month 36 (August 2018)

Comparison Summary
Height and biomass of seedlings have both increased exponentially over this 6 month period. Canopy vegetation within this area continues to extend the overall percentage of cover, allowing for the increase of native species recruitment.

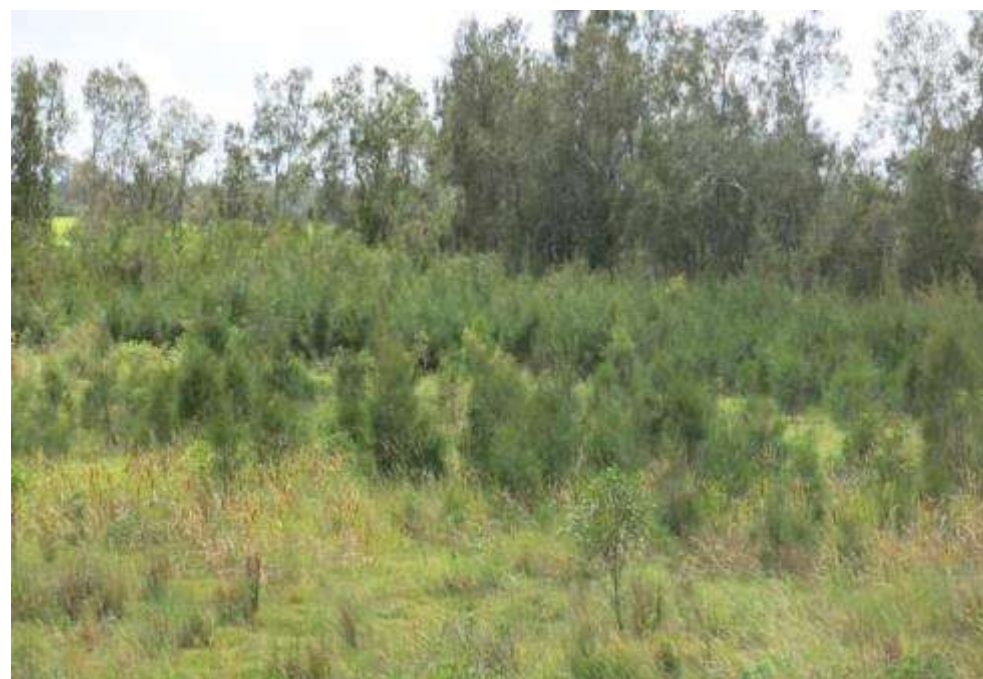
Photo Plate 255: A2 Eucalypt Plantings - Month 36 (August 2018)

The site is still periodically inundated, limiting the growth of a number of the seeded species. This area of tube stock planting is taking longer than the A1 plantings. It is anticipated that this stock will grow slower than other areas due to the geology and inundation.

Hibiscus diversifolius, a species that requires high moisture levels, is dominant throughout this area. Then spread of casuarina has been significant over the past six months with many small copses now linked together.

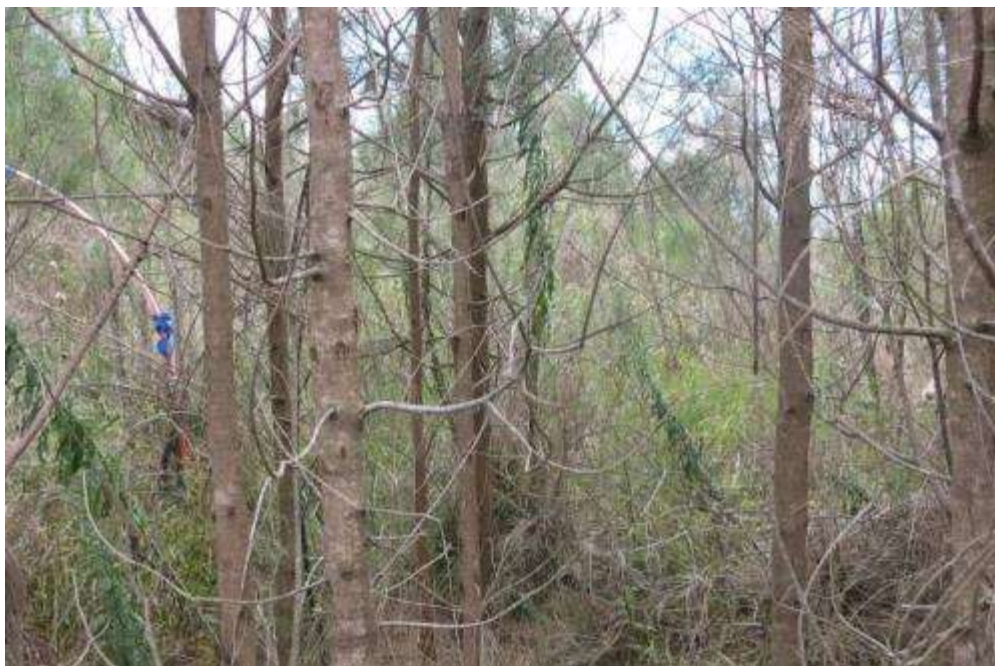
Photo Plate 257: Quadrat 1 - Month 42 (February 2019)

Over the past 6 months, growth of *Casuarina glauca* has continued to increase in biomass, especially girth. The diversity and abundance of weed species has been greatly reduced. As *Casuarina glauca* growth continues to increase and add biomass, this weed will be outcompeted. The balance of the understorey in this area continues to trend towards a native grassy understorey.

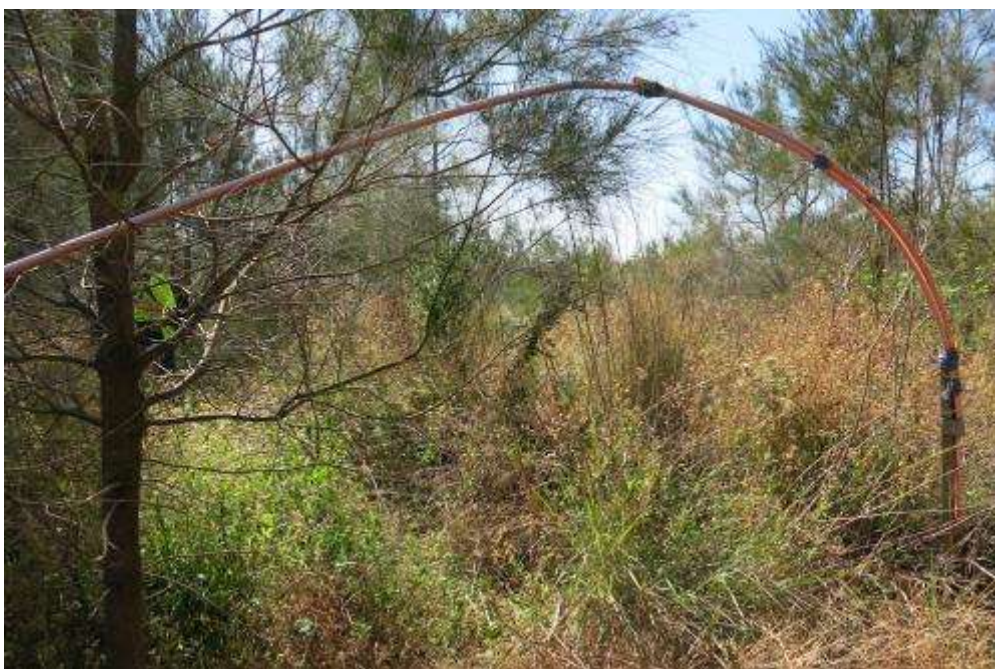
Photo Plate 258: Quadrat 1 - Month 48 (August 2019)

Note that the Month 48 photo is taken from a different angle due to lack of visibility through casuarina forest.

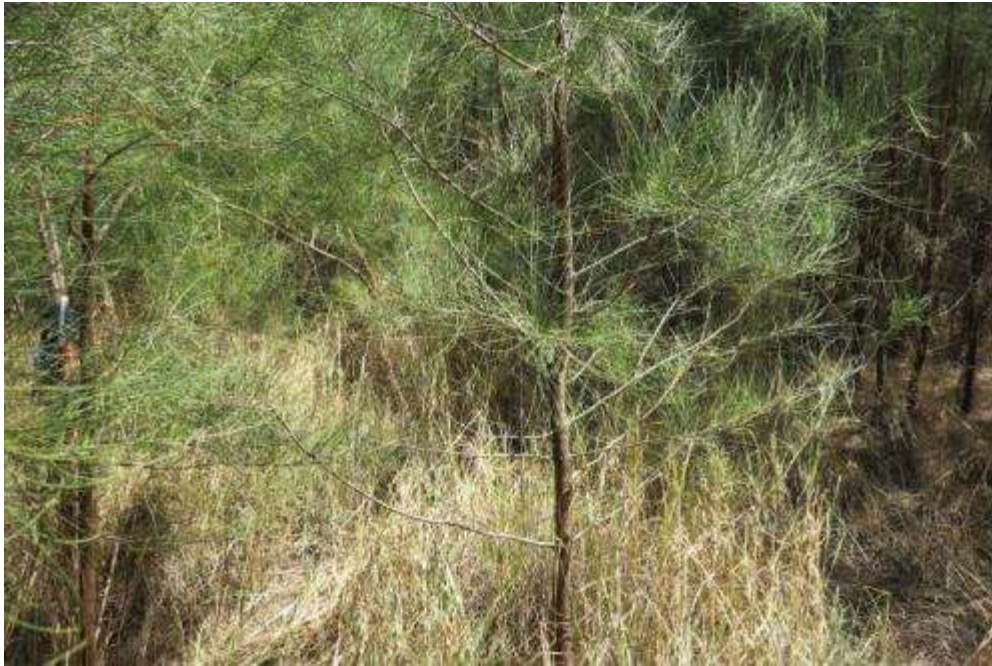
Photo Plate 259: Quadrat 2 - Month 42 (February 2019)

Over the past six months, *Casuarina glauca* and *Melaleuca quinquenervia* growth has made this quadrat unrecognisable.

This quadrat is rapidly establishing a canopy of *Casuarina glauca*. This is currently resulting in a short term reduction of diversity in the understory as the dynamic of this quadrat shifts. The quadrat and surrounds remain relatively weed free.

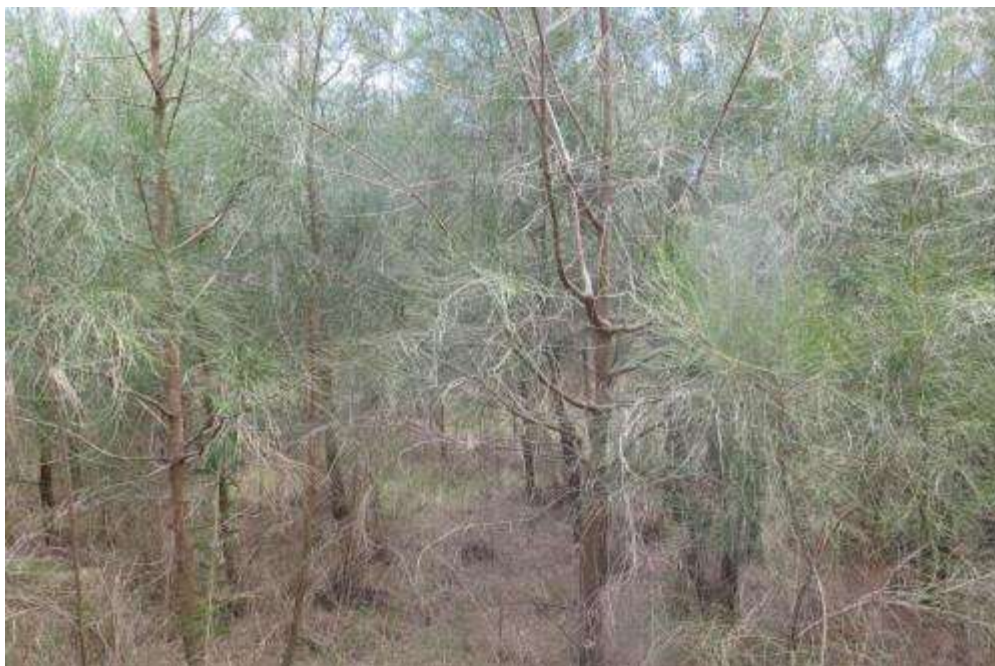
Photo Plate 261: Quadrat 3 - Month 42 (February 2019)

The growth in biomass and height of *Casuarina glauca* has again been significant over the past six months. The quadrat markers are now completely obscured from view. *Juncus kraussii* within the surrounds of this quadrat continues to multiply, creating many small colonies throughout the area. *Eucalyptus robusta* is setting seed in the surrounding area.

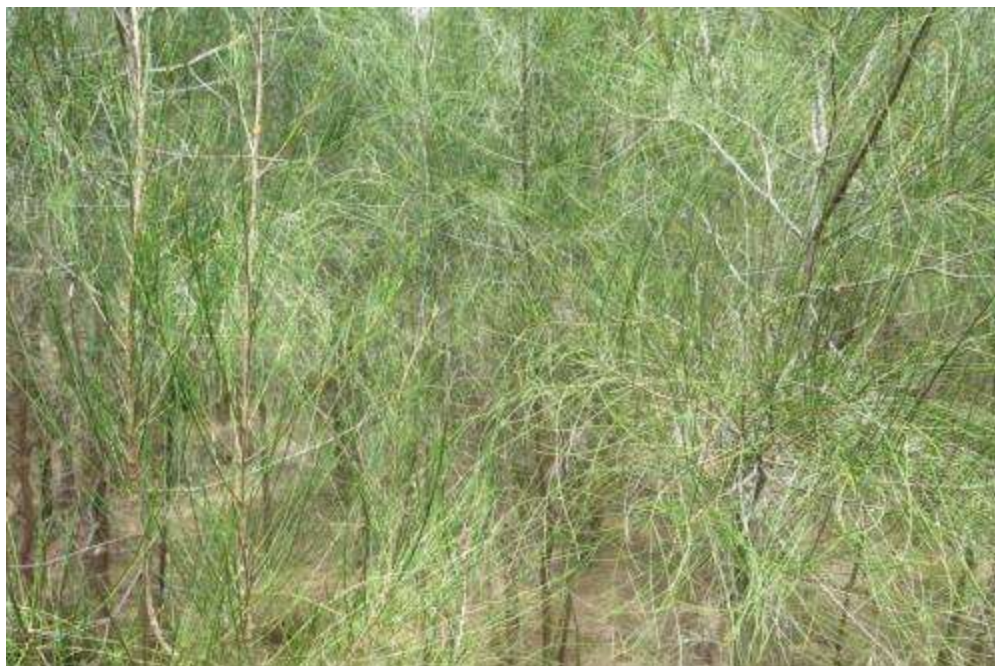
Photo Plate 263: Quadrat 4 - Month 42 (February 2019)

Comparison Summary
Casuarina glauca growth and biomass has continued to increase. This canopy formation has continued to suppress weed growth.

As the height of vegetation continues to increase, the physical height of the canopy is being lifted. This is slowly allowing for the opening up of the understorey. This opening up of the understorey is allowing more breathing room for the diversification of this quadrat.

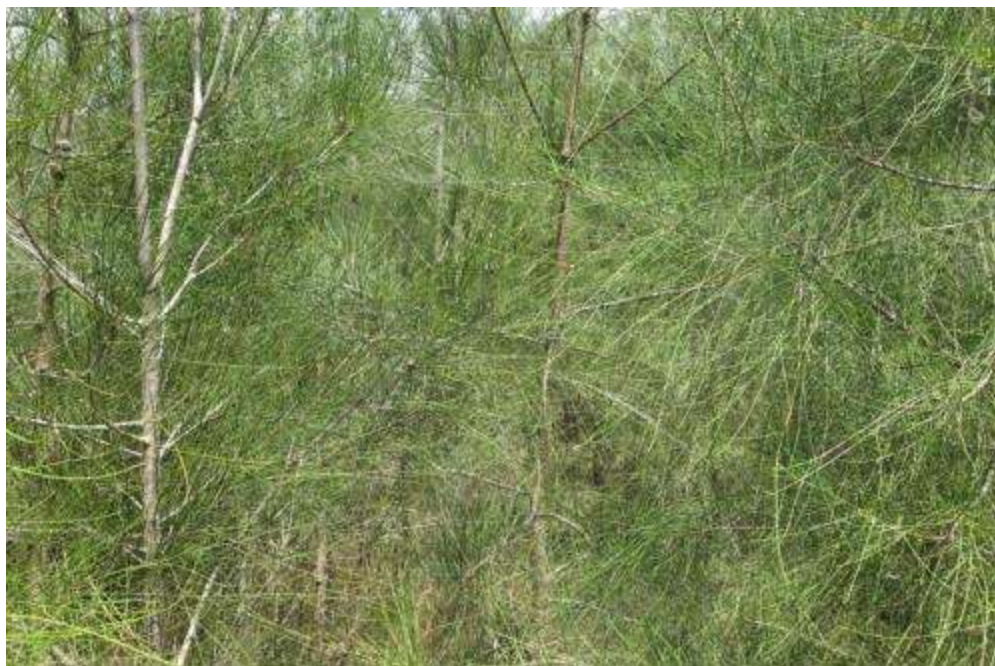
Photo Plate 265: Quadrat 5 - Month 42 (February 2019)

Growth within this quadrat over the past six months has been steady. A canopy of *Casuarina glauca* and *Melaleuca quinquenervia* is now well formed and continuing to increase in biomass. Native groundcovers continue to surpass weed growth, with assistance from the canopy via shading.

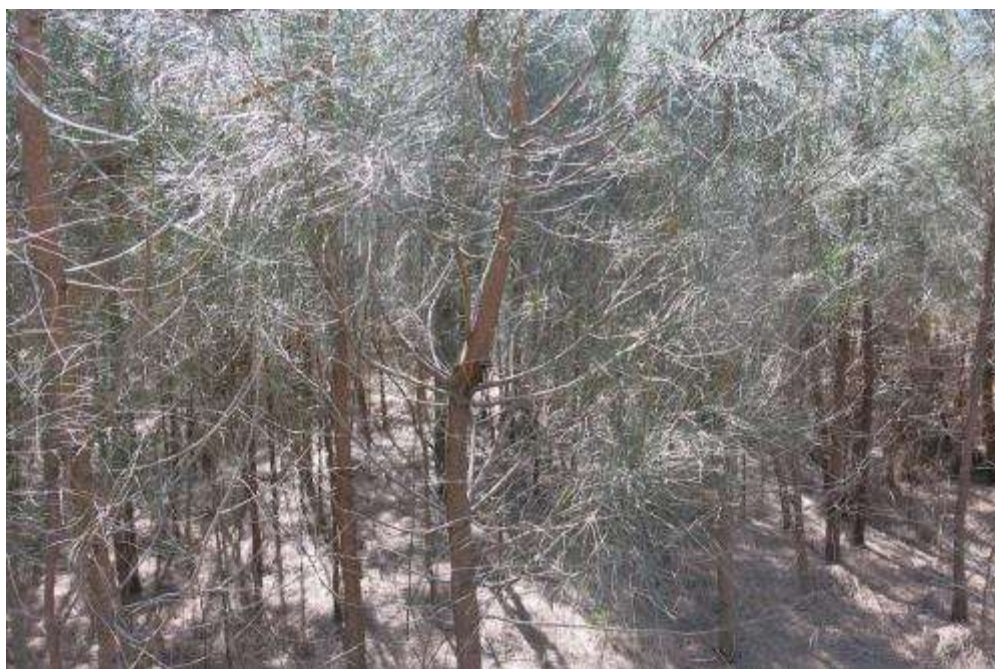
Photo Plate 266: Quadrat 5 - Month 48 (August 2019)

A build-up of leaf litter is occurring in this quadrat and the surrounds that support a similar canopy. These needles have a strong allelopathic effect on other plant species, inhibiting successful establishment of other plant species.

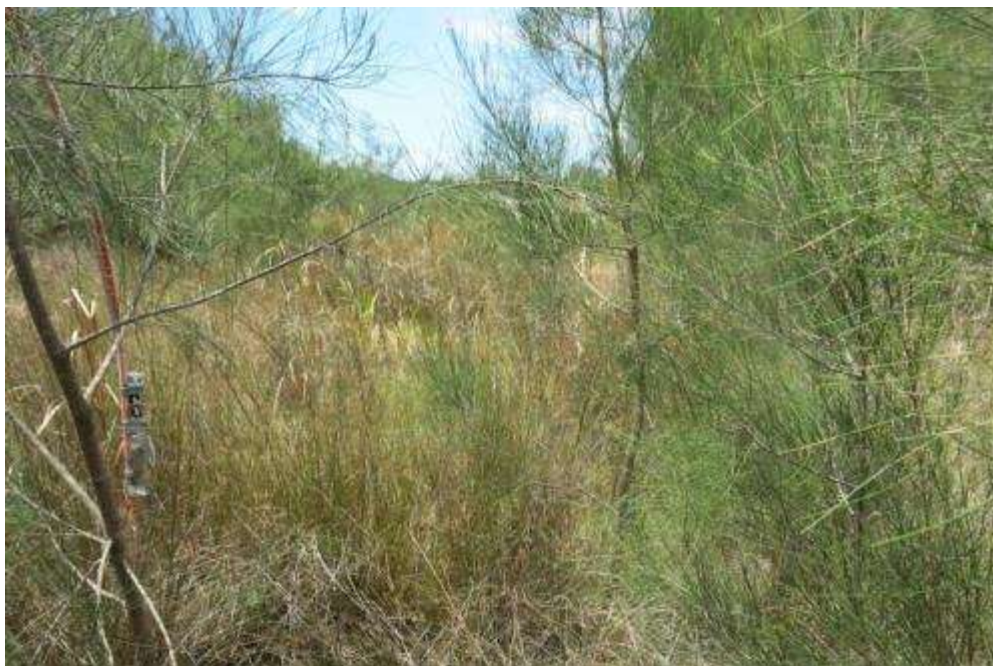
Photo Plate 267: Quadrat 6 - Month 42 (February 2019)

This is a dynamic quadrat that shows significant changes between the wet and dry months as a direct result of the seasonal shifts in the hydrological regime of the area.

This comparison provides a great representation of casuarina biomass and girth growth representative across the NWCP.

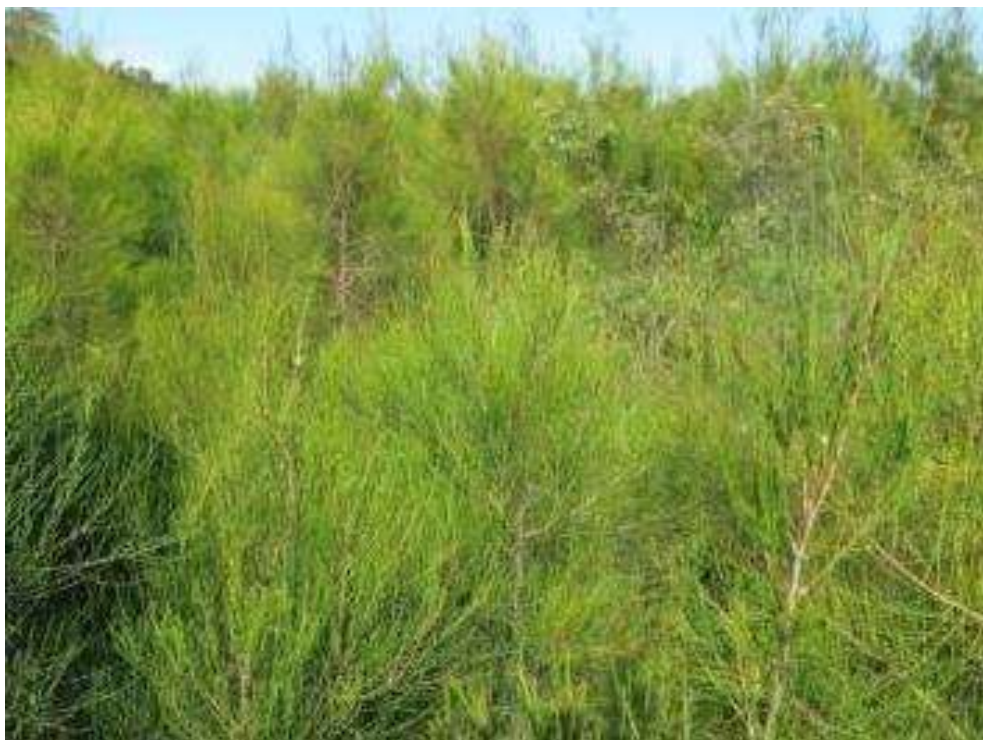
Photo Plate 269: Quadrat 7 - Month 42 (February 2019)

Casuarina glauca within this area continues to grow exponentially. Wetland species diversity within this area of the NWCP continues to increase.

Note that both monitoring photos are from the surrounding areas as quadrat location is physically inaccessible.

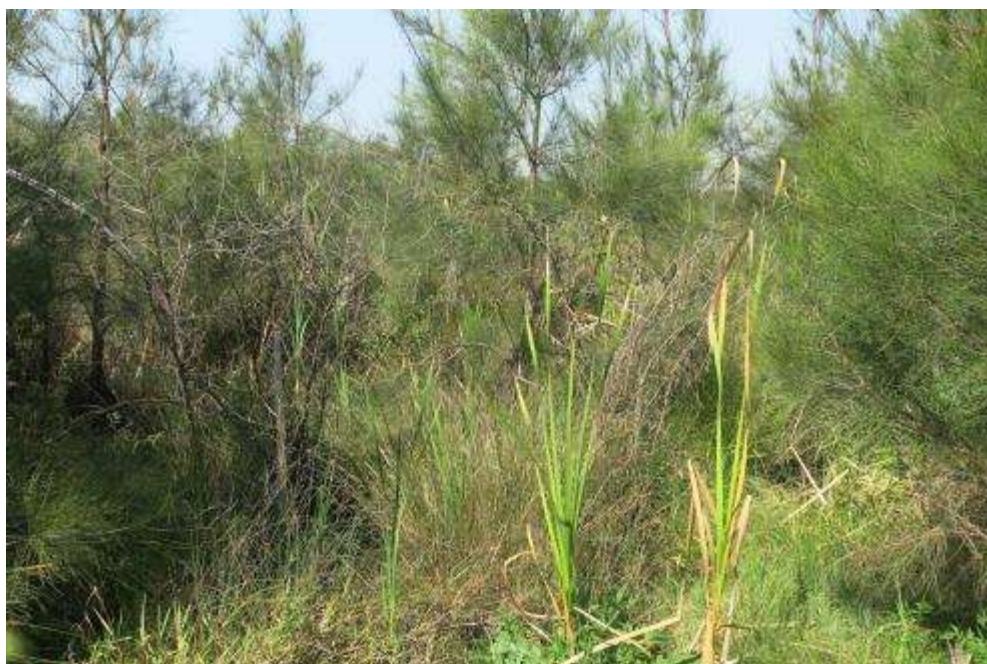
Photo Plate 272: Quadrat 8 - Month 48 (August 2019)

Comparison Summary
This is a stable quadrat dominated by freshwater wetland species, such as sedge, rush and cyperus species. A small number of casuarinas are scattered in and around this quadrat, however it will never be a dominant species within this area due to the hydrology.

Species diversity was previously recorded as declining due to the increase in shading from the rapidly establishing canopy. Diversity has stabilised and continues to show signs of maturation.

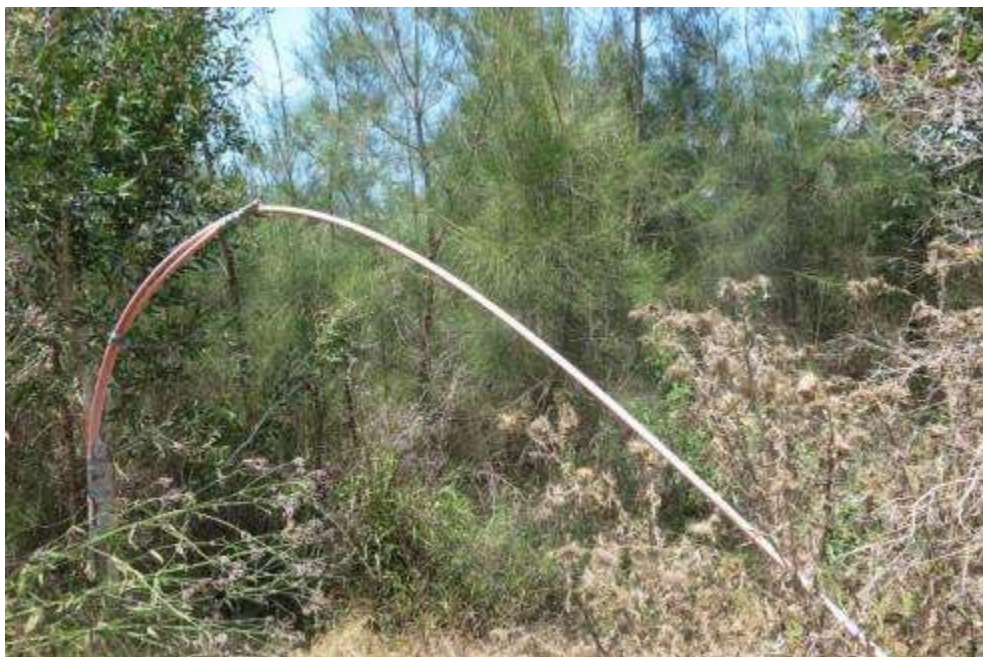
Photo Plate 273: Quadrat 9 - Month 42 (February 2019)

Understorey biodiversity is also becoming more prevalent throughout this quadrat and surrounding area.

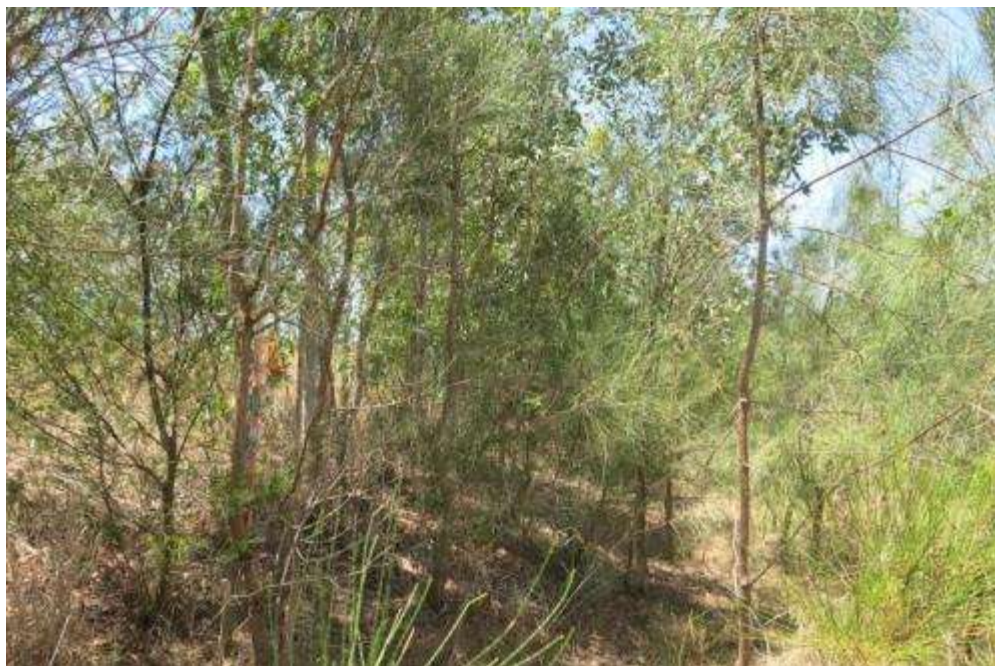
Photo Plate 275: Quadrat 10 - Month 42 (February 2019)

The growth within this quadrat is quite representative of the broader site. The extent of vegetation cover within this quadrat has not increased. It is considered unlikely that this will increase due to the topography of this quadrat. However, soil shading has increased due to the overall increase of biomass of the canopy.
