North-West Conservation Park - Rehabilitation Monitoring

Lot 1 RP48903

North-West Conservation Park
Gainsborough Greens

March 2020

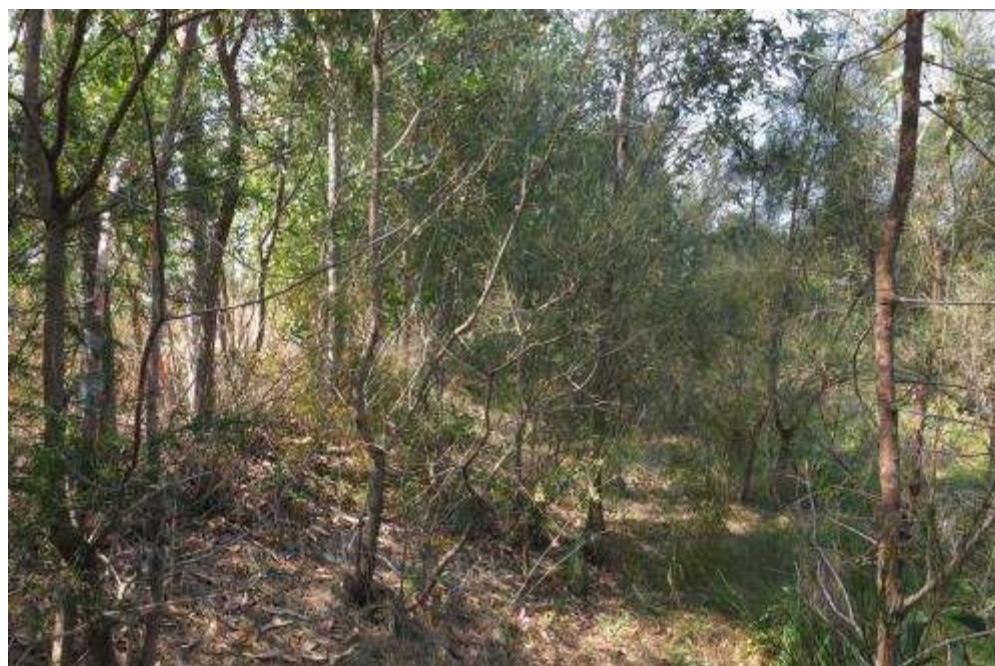
Photo Plate 276: Quadrat 10 - Month 48 (August 2019)

The growth within this quadrat is quite representative of the broader site. The extent of vegetation cover within this quadrat has not increased. It is considered unlikely that this will increase due to the topography of this quadrat. However, soil shading has increased due to the overall increase of biomass of the canopy.

This quadrat is progressively transitioning towards a grassy woodland structure with dominance of native grasses in the understorey.

During the Month 48 monitoring assessment, *Corymbia citriodora* was identified with mature seed.

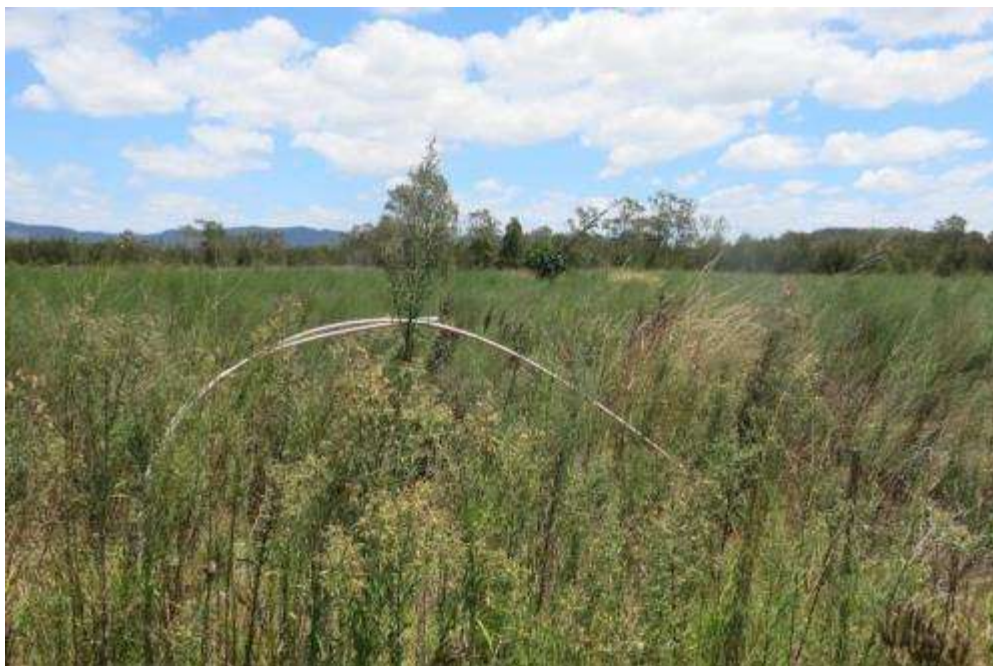
Photo Plate 277: Quadrat 11 - Month 42 (February 2019)

This quadrat provides an example of how dynamic this area can be. These dynamic changes are assumed to be associated with the fluctuating water table levels and levels of water inundation.

Native dominance of this quadrat fluctuates dramatically and frequently due to the variable nature of the annual pasture weeds.

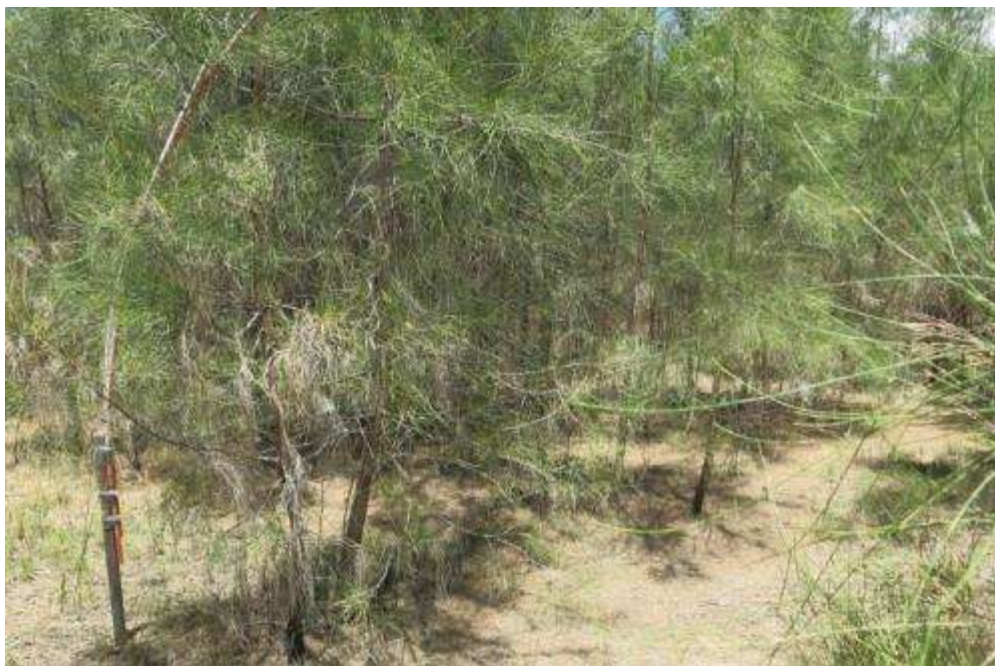
Photo Plate 279: Quadrat 12 - Month 42 (February 2019)

Due to the increase in shading and organic build up, weed species are continuing to decline. This quadrat is developing well into an open woodland community with a sparse understorey due to inundation. A number of wetland plants are present due to this inundation.

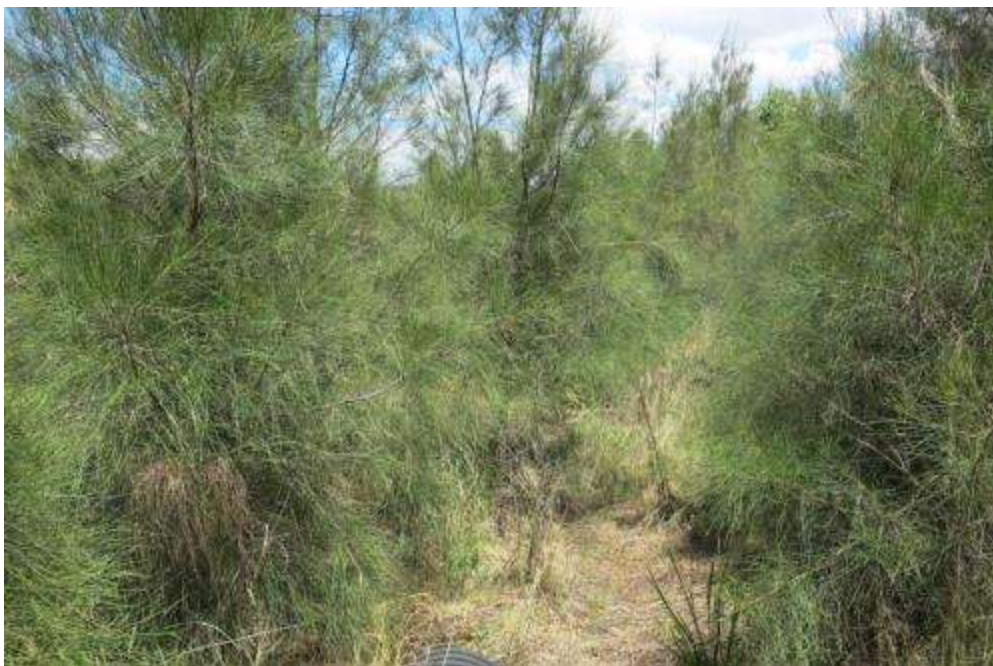
Photo Plate 281: Quadrat 13 - Month 42 (February 2019)

Canopy trees have grown significantly in height and biomass within this quadrat over the six month period.

This area has made a significant comeback with the change from sedges to casuarinas. A number of eucalypts are located on the fringes of this quadrat that are progressing well.

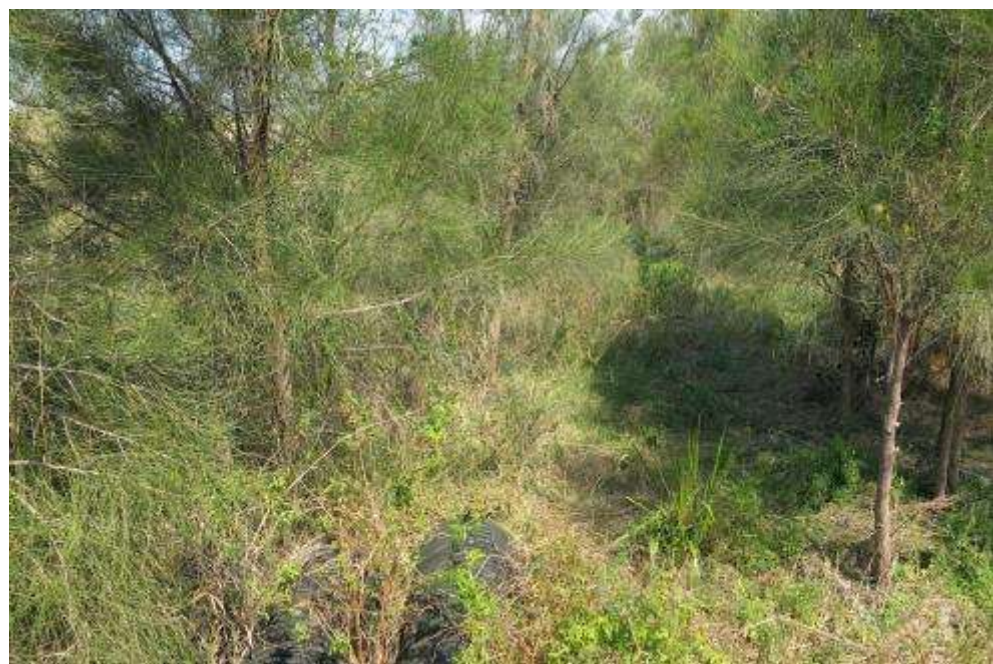
Photo Plate 282: Quadrat 13 - Month 48 (August 2019)

With the additional build-up of organic materials over the past six months, conditions have improved greatly allowing for the rapid growth of species such as *Lomandra longifolia*. Native grasses are forming positive buffer zones along this area.

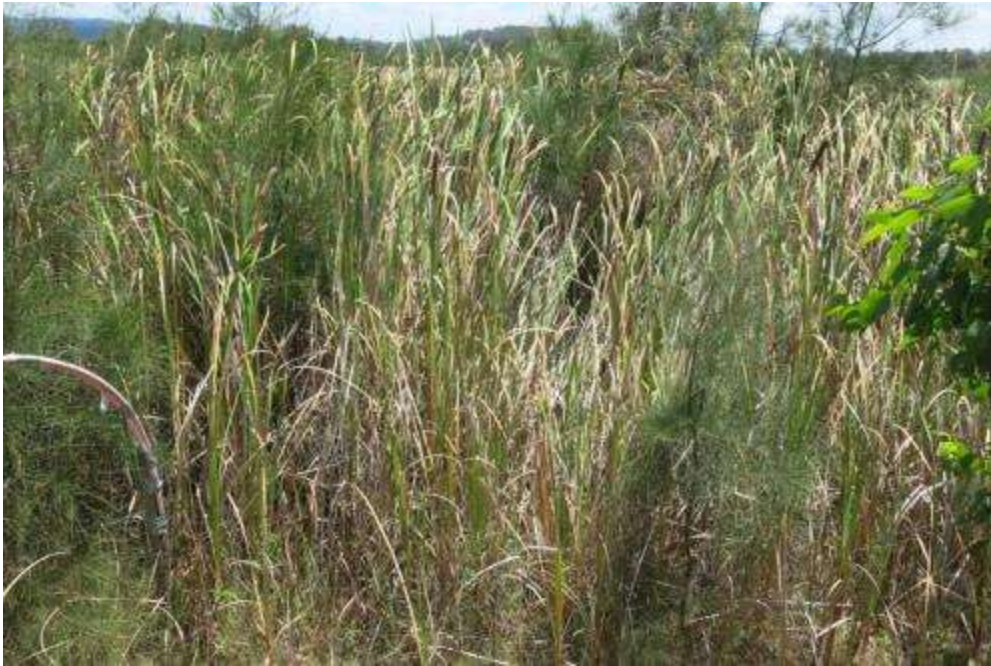
Photo Plate 283: Quadrat 14 - Month 42 (February 2019)

Comparison Summary
Typha is still quite dominant in this quadrat. A number of small casuarina seedlings are developing well and continue to add biomass. This is a positive trend for the diversification of this quadrat.

Imperata cylindrica is developing well along the the interface of this quadrat and the adjoining farmland.

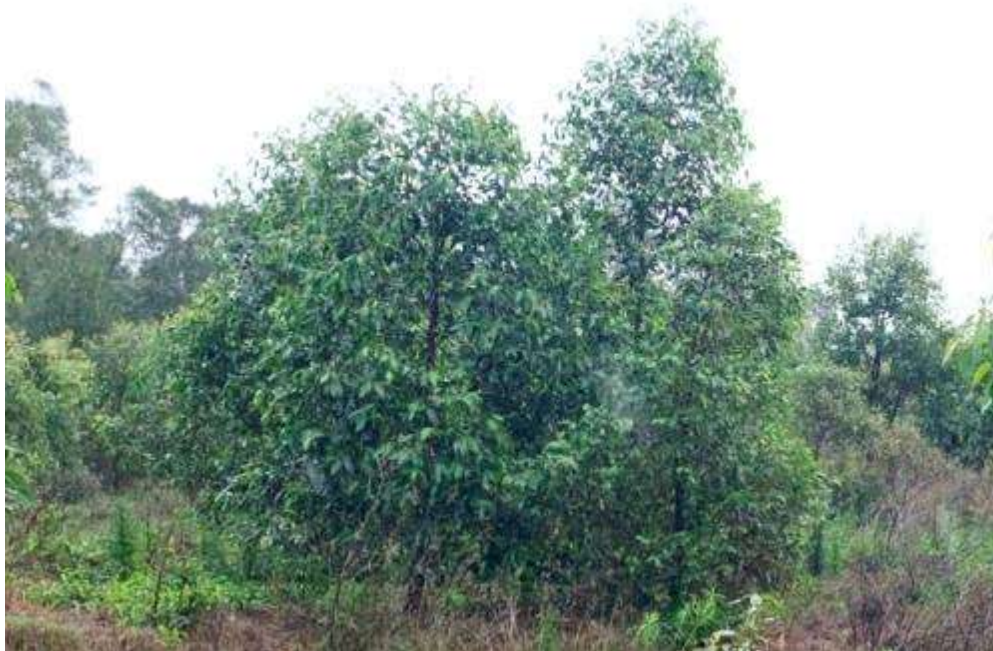
Photo Plate 285: A1 Eucalypt Plantings - Month 42 (February 2019)

Comparison Summary
Height and biomass of seedlings have both increased exponentially over this 6 month period. Canopy vegetation within this area continues to extend the overall percentage of cover, allowing for the increase of native species recruitment.

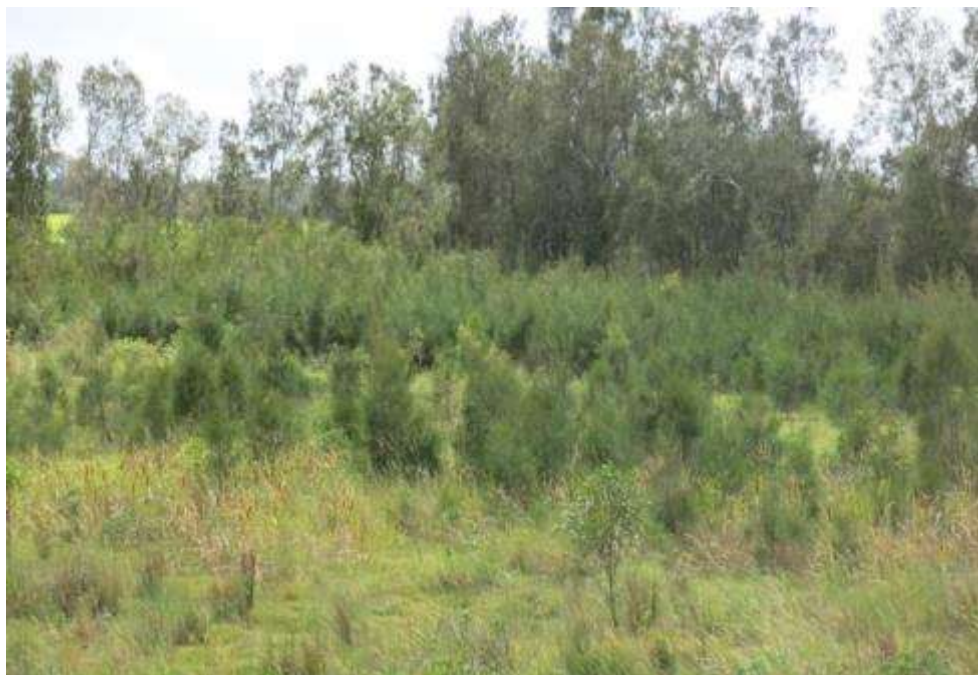
Photo Plate 287: A2 Eucalypt Plantings - Month 42 (February 2019)

The site is still periodically inundated, limiting the growth of a number of the seeded species. This area of tube stock planting is taking longer than the A1 plantings. It is anticipated that this stock will grow slower than other areas due to the geology and inundation.

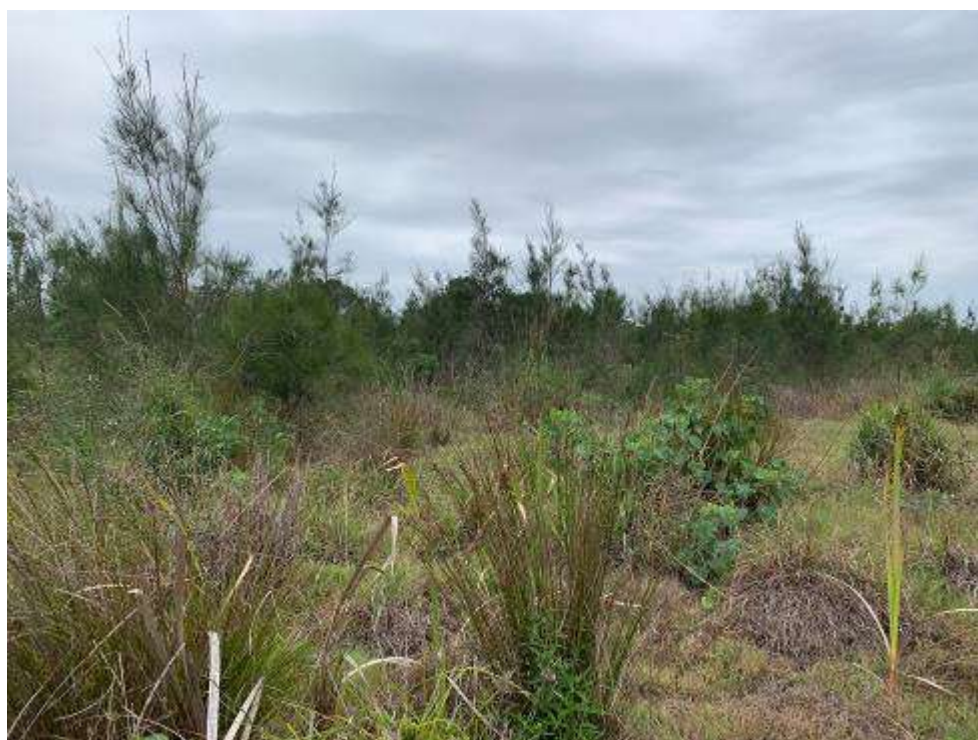
Photo Plate 288: A2 Eucalypt Plantings - Month 48 (August 2019)

Casuarina copses are beginning to close together, assisting with the strengthening of micro-niches within the rehabilitation area.

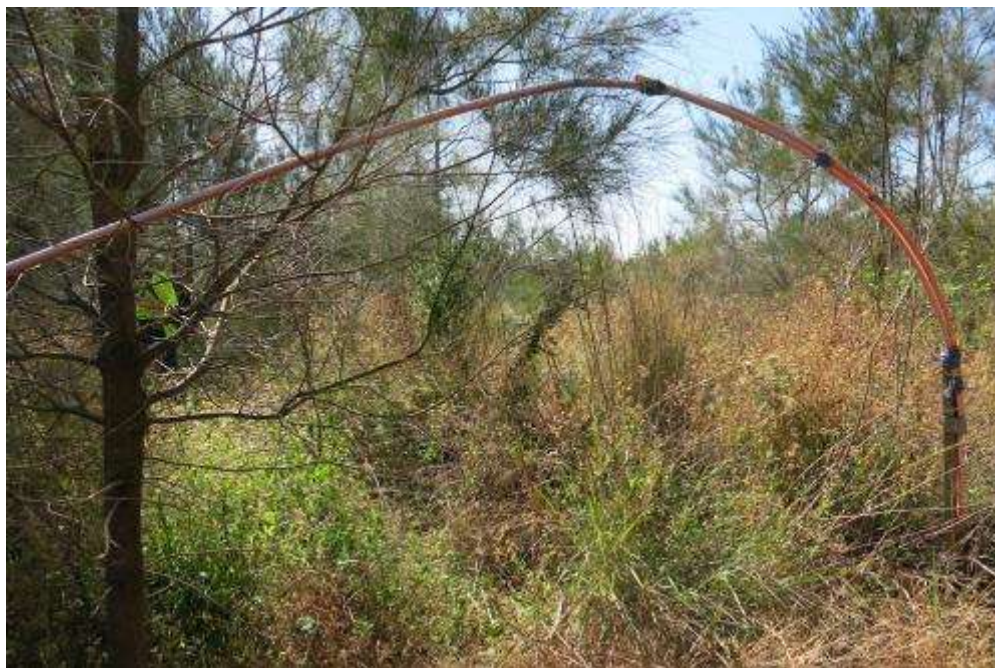
Photo Plate 289: Quadrat 1 - Month 48 (August 2019)

Comparison Summary
Over the past 6 months, growth of *Casuarina glauca* has continued to increase in biomass, especially girth. The recent heavy rainfall has assisted in reducing the signs of drought stress common throughout the entire NWCP area. The diversity and abundance of weed species has been greatly reduced. The balance of the understorey in this area continues to trend towards a native grassy understorey.

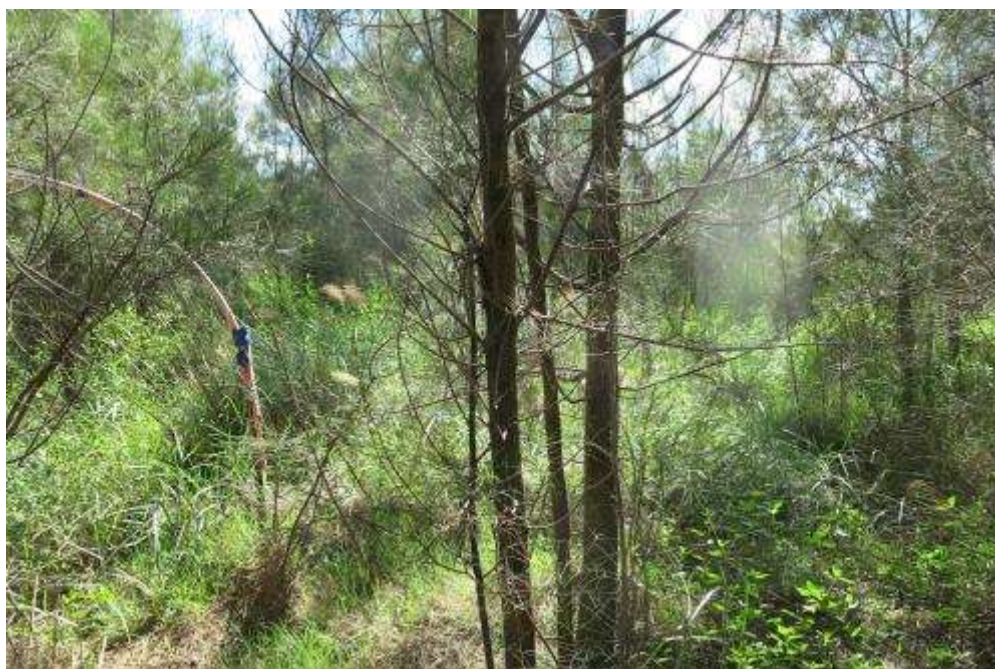
Photo Plate 290: Quadrat 1 - Month 54 (February 2020)

Note that the Month 48 photo is taken from a different angle due to lack of visibility through casuarina forest.

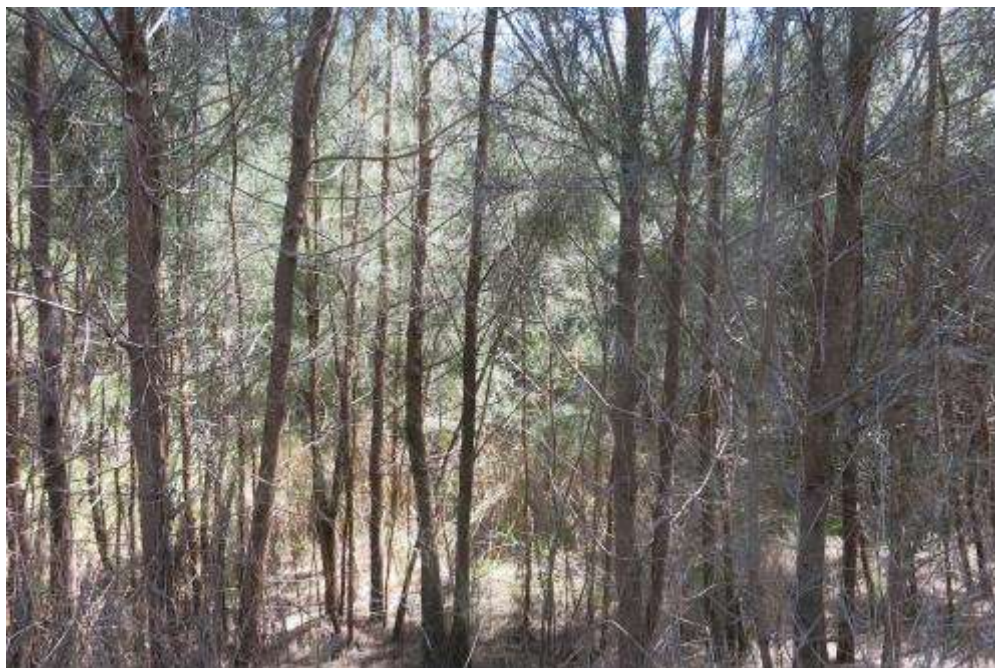
Photo Plate 291: Quadrat 2 - Month 48 (August 2019)

Over the past six months, the only significant change noted was the maturation of *Casuarina glauca* and *Melaleuca quinquenervia*. This is a sign of this vegetation community strengthening into a stable ecosystem.

Heavy rainfall periods over the last half of this six month period have resulted in standing water throughout this area. This has reduced weed presence and increased the dominance of native species, such as understorey dominated by *Bolboschoenus cardwellii*, in the understorey.

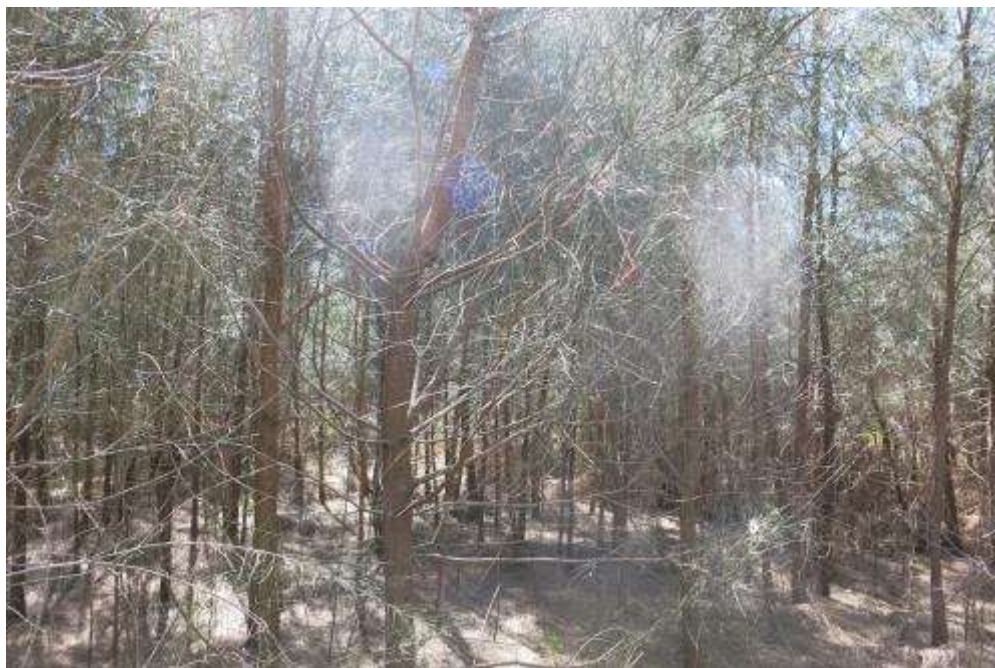
Photo Plate 293: Quadrat 3 - Month 48 (August 2019)

Over the past six months, the only significant change noted was the maturation of *Casuarina glauca*. This is a sign of this vegetation community strengthening into a stable ecosystem.

Heavy rainfall periods over the last half of this six month period have resulted in standing water throughout this area. Surface water is currently extensive throughout this area, however this will assist in relieving drought stress.

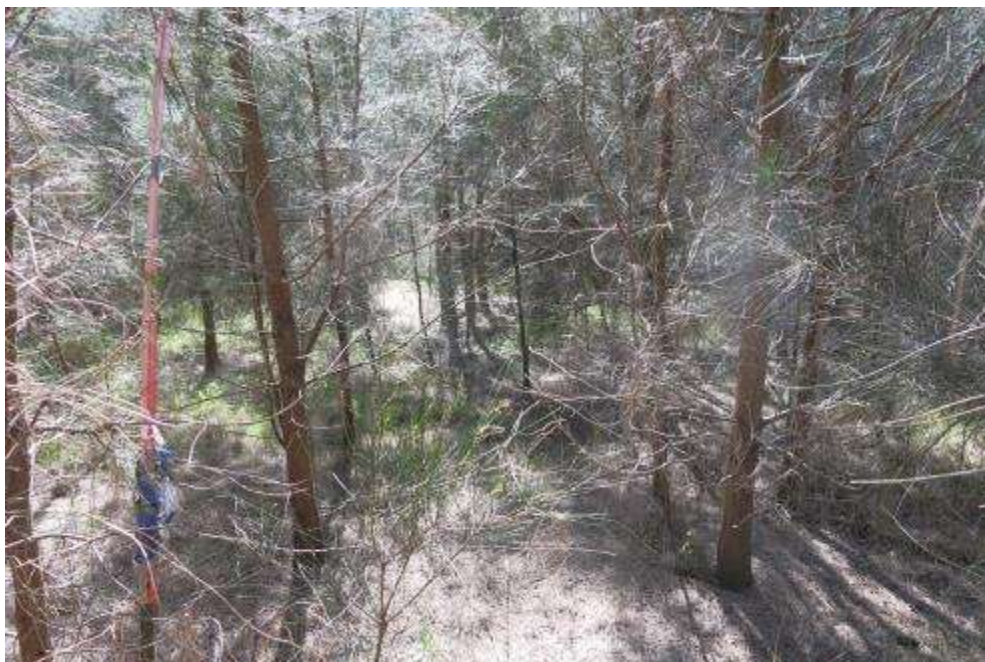
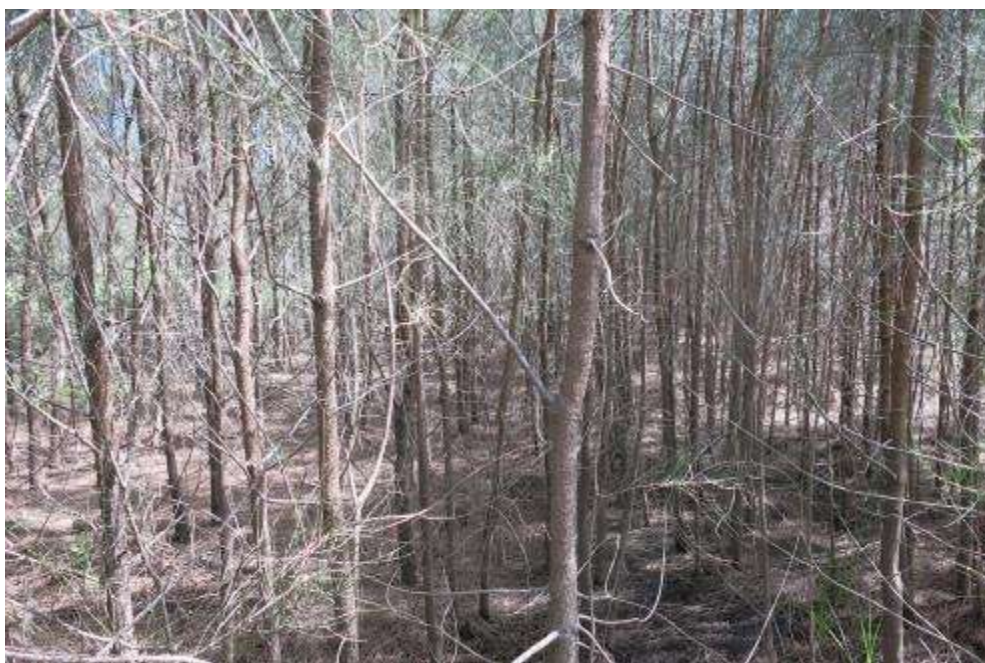
Photo Plate 295: Quadrat 4 - Month 48 (August 2019)

Comparison Summary
Over the past six months, the only significant change noted was the maturation of *Casuarina glauca* and *Melaleuca quinquenervia*. This is a sign of this vegetation community strengthening into a stable ecosystem.

Contour banding of plant community assemblages are also becoming more predominant as wet conditions prevail.

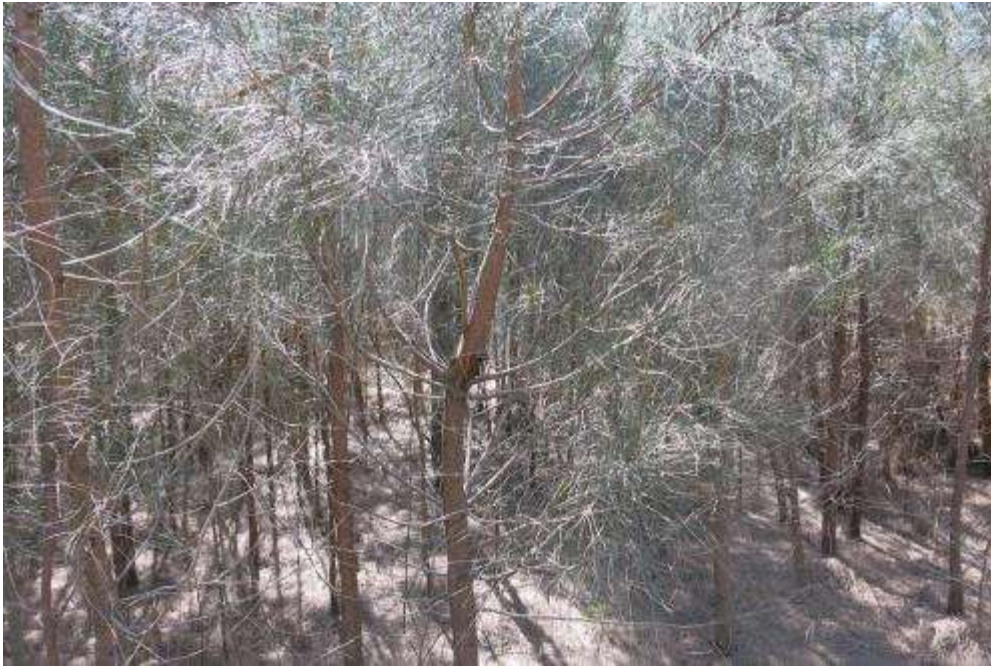
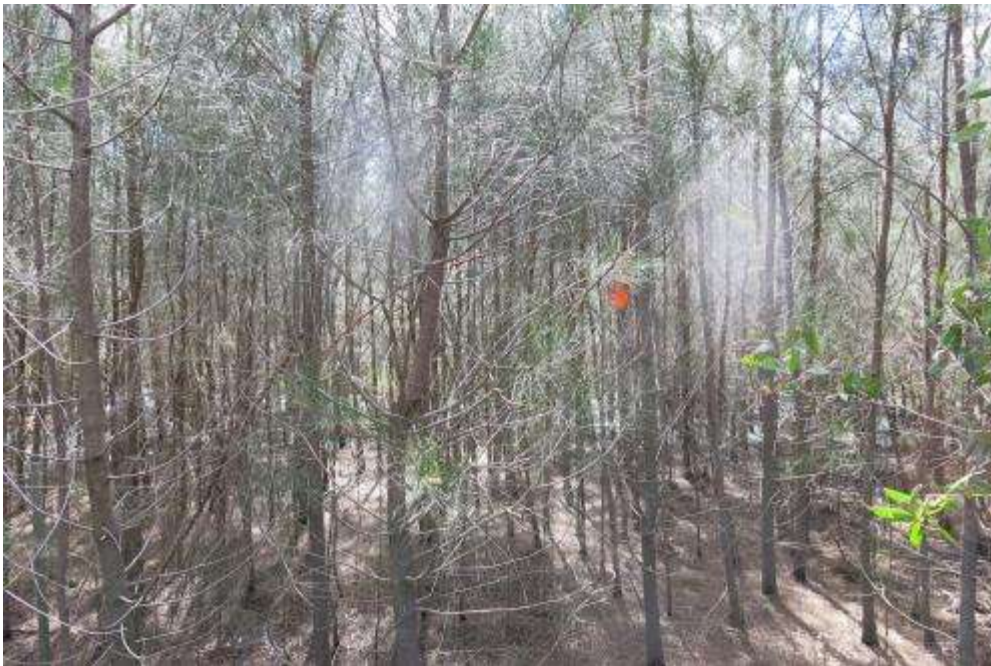
Photo Plate 297: Quadrat 5 - Month 48 (August 2019)

Comparison Summary
Over the past six months, the only significant change noted was the maturation of *Casuarina glauca* and *Melaleuca quinquenervia*. This is a sign of this vegetation community strengthening into a stable ecosystem.

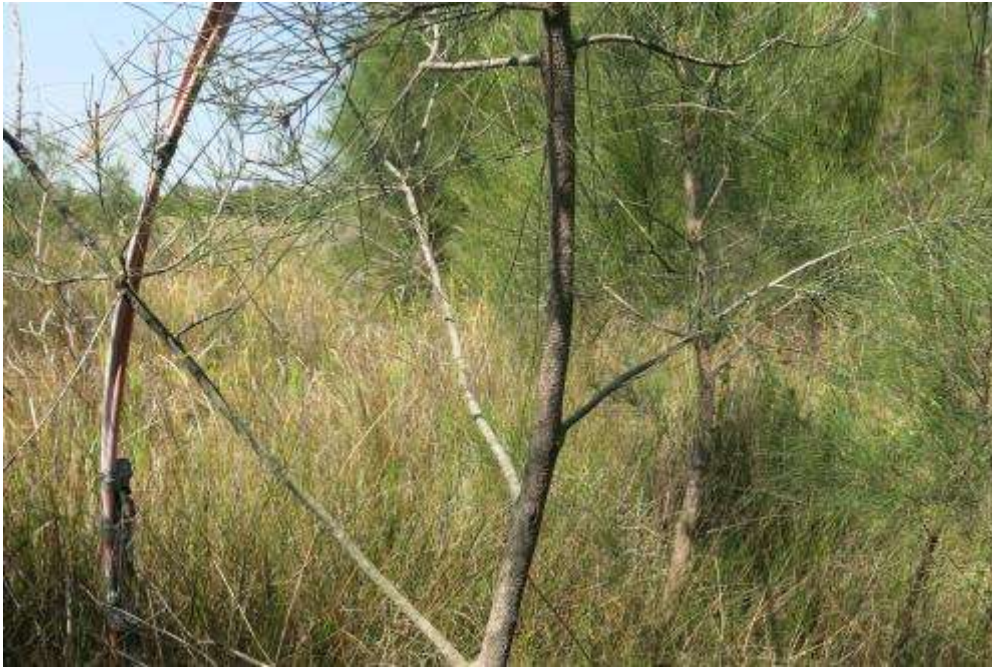
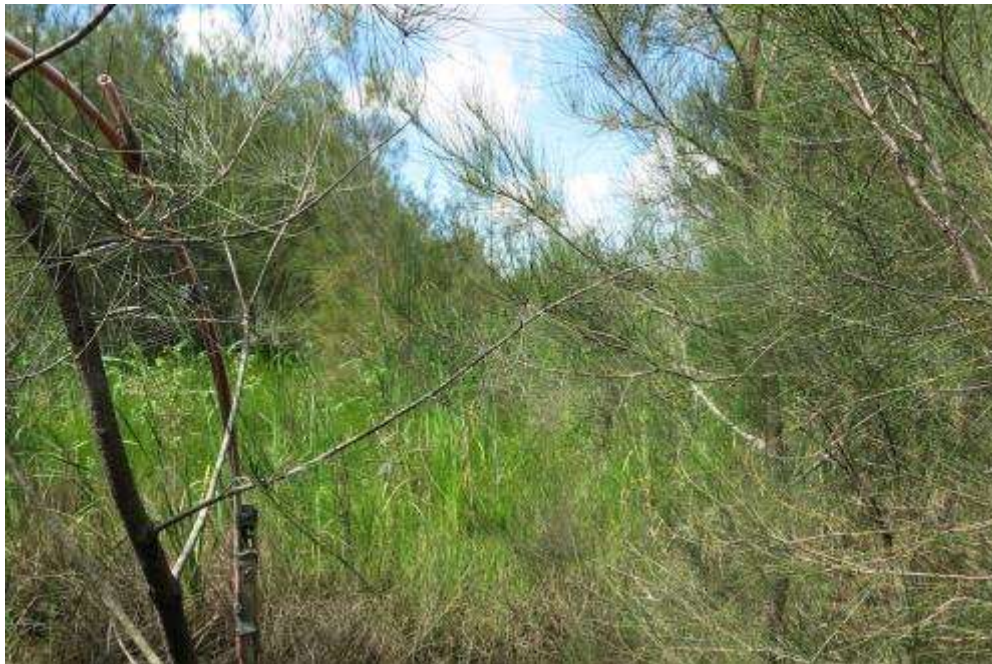
Photo Plate 299: Quadrat 6 - Month 48 (August 2019)

This is a dynamic quadrat that shows significant changes between the wet and dry months as a direct result of the seasonal shifts in the hydrological regime of the area. This is clearly evident comparing monitoring photos for this six month period.

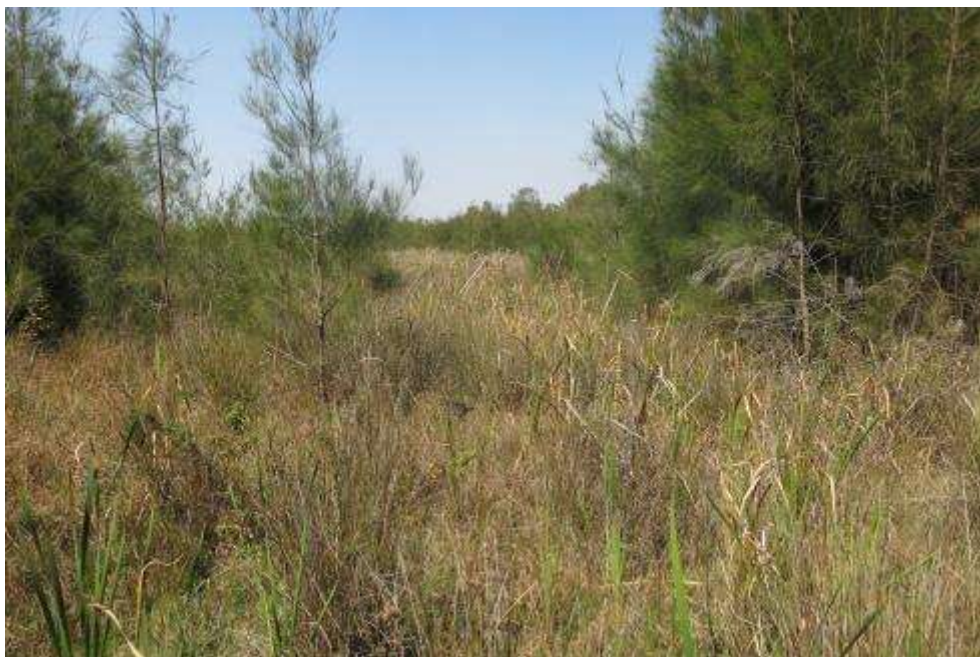
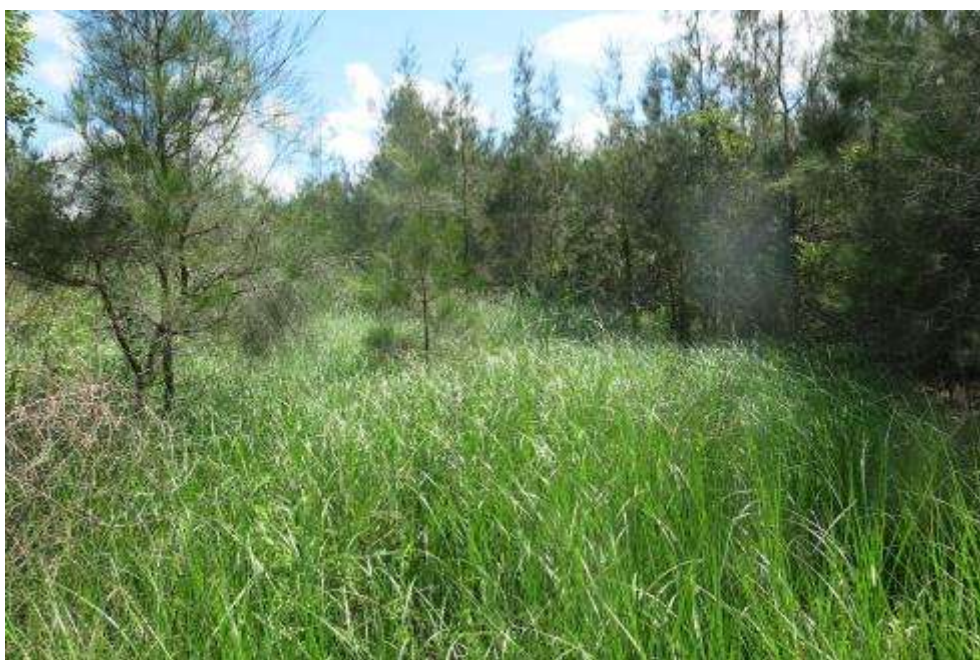
Photo Plate 301: Quadrat 7 - Month 48 (August 2019)

Note that both monitoring photos are from the surrounding areas as quadrat location is physically inaccessible.

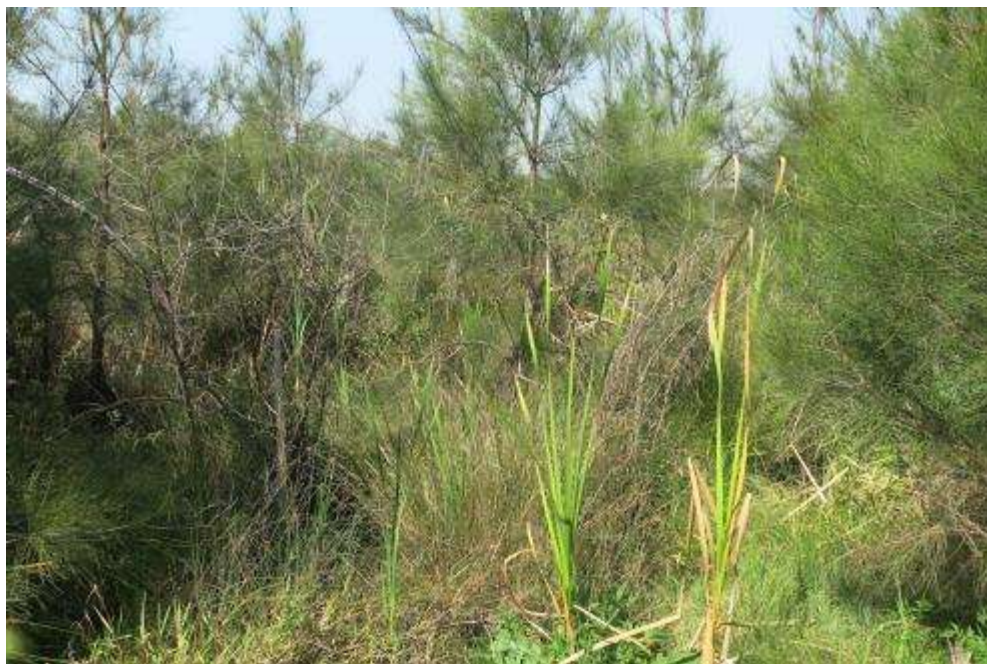
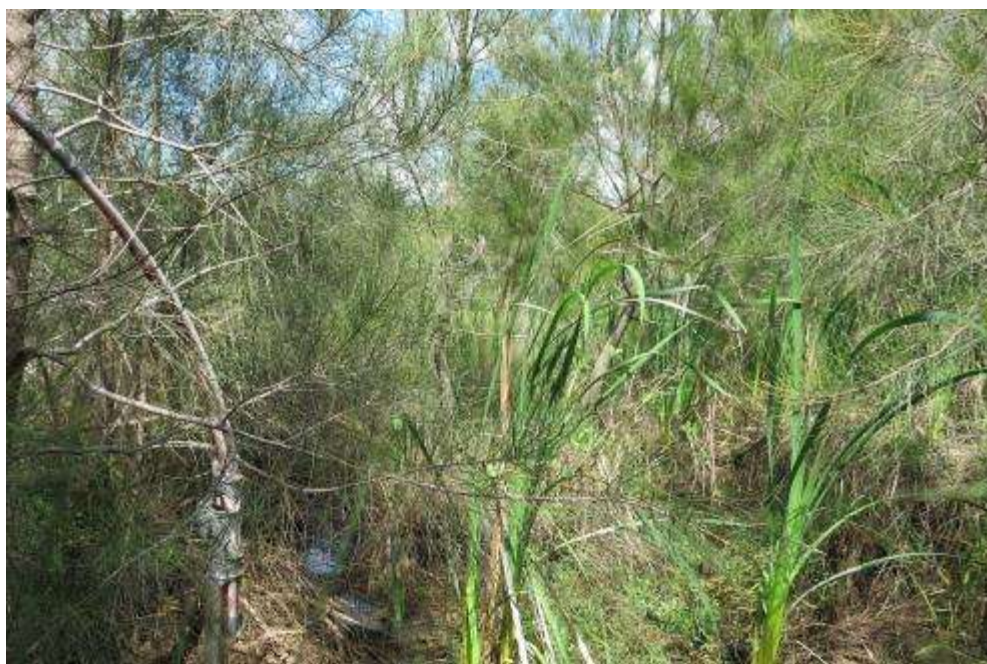
Photo Plate 303: Quadrat 8 - Month 48 (August 2019)

This is a stable quadrat dominated by freshwater wetland species, such as sedge, rush and cyperus species. A small number of casuarinas are also scattered in and around this quadrat.

Over the past six months, the only significant change noted was the general maturation of the quadrat and surrounding area.

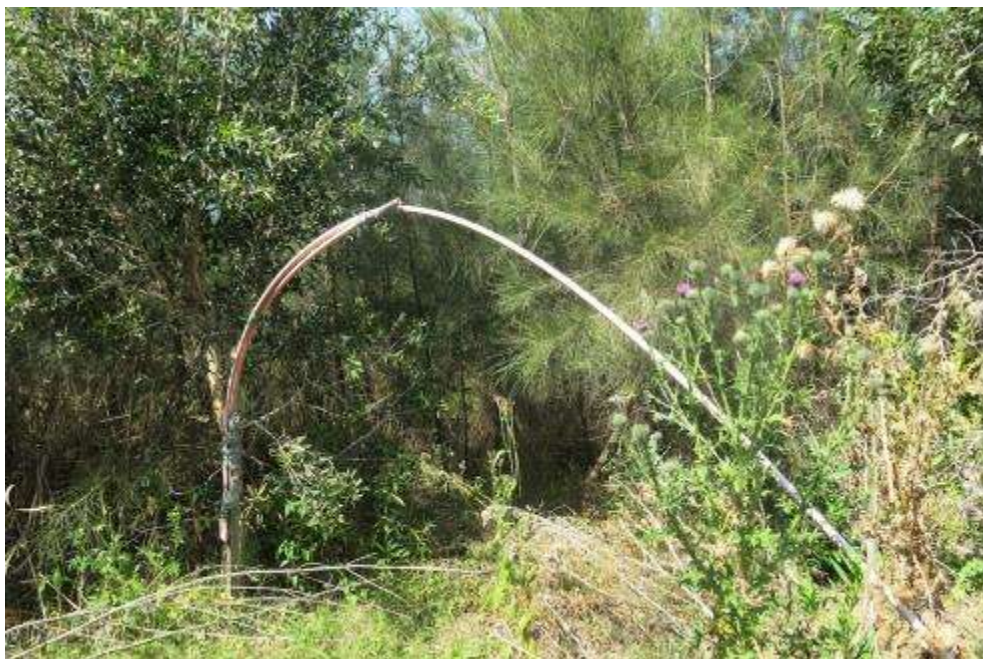
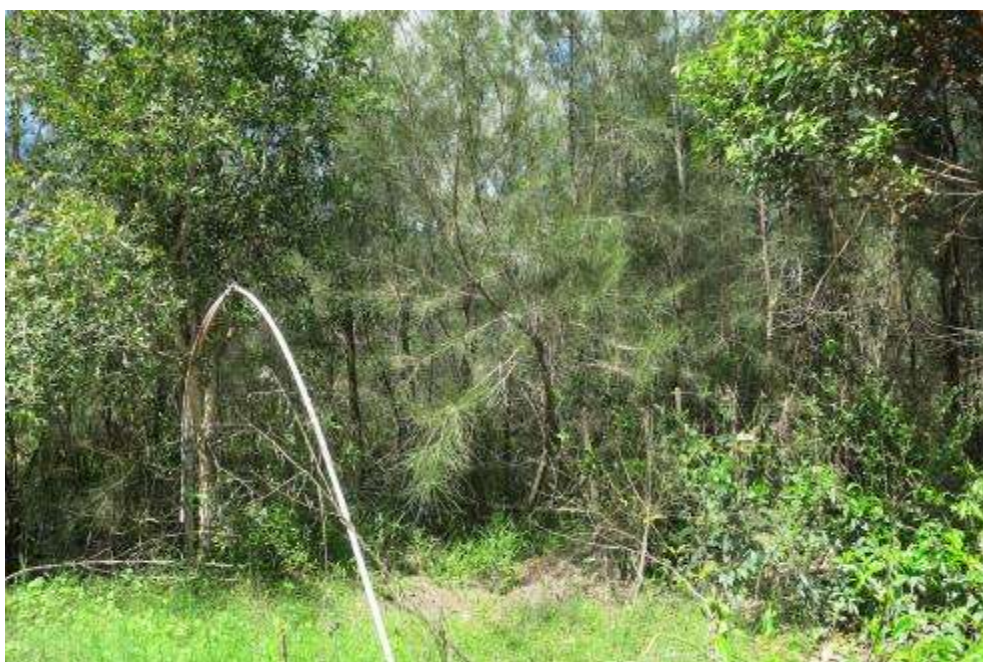
Photo Plate 305: Quadrat 9 - Month 48 (August 2019)

Scattered casuarina and melaleucas have continued to increase in biomass. This vegetative development continues to displace weed species.

The understorey within this area held standing water during the latter half of this six month period. This has assisted with drought stress and increased dominance of wetland species, such as *Carex appressa*.

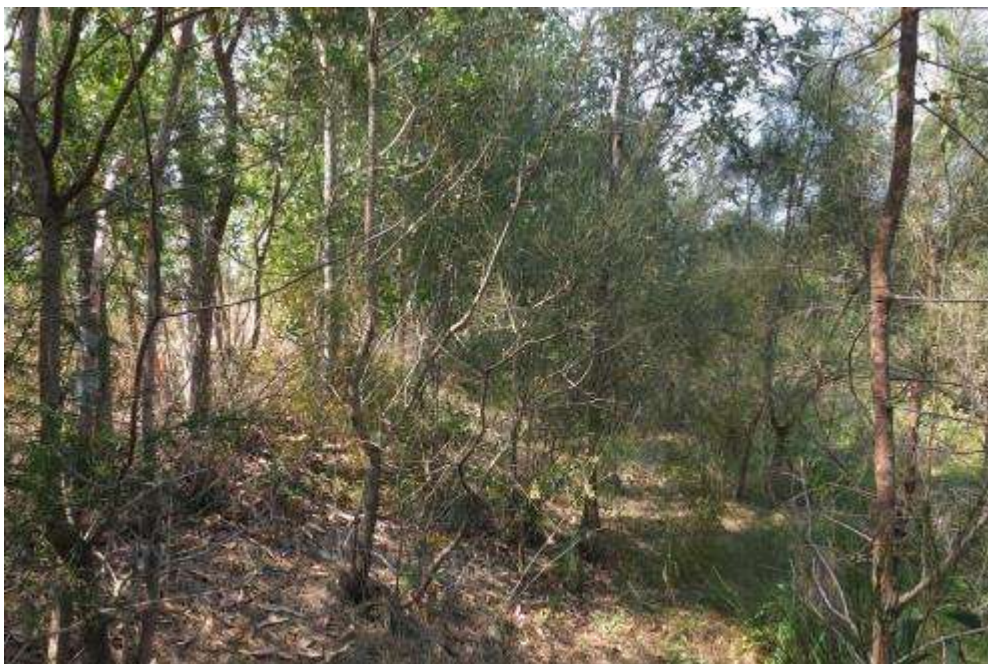
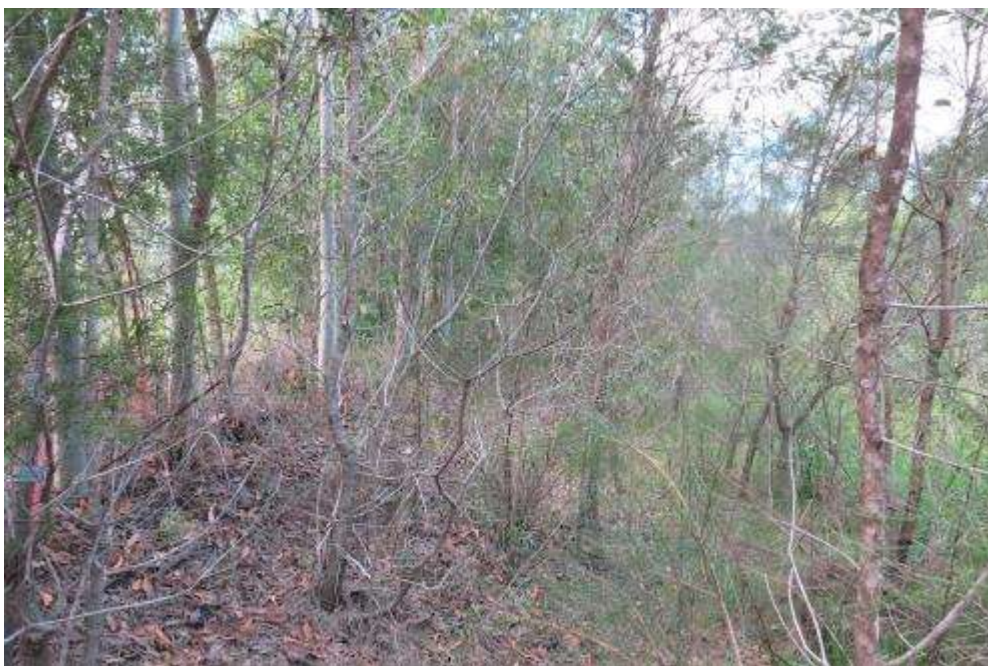
Photo Plate 307: Quadrat 10 - Month 48 (August 2019)

Comparison Summary
The growth within this quadrat is quite representative of the broader site. Over this six month period the biomass has continued to increase significantly.

This quadrat is progressively transitioning towards a grassy woodland structure with dominance of native grasses in the understorey.

Leaf litter now covers the entire soil surface here, which is a positive sign for the maturation of this vegetation community.

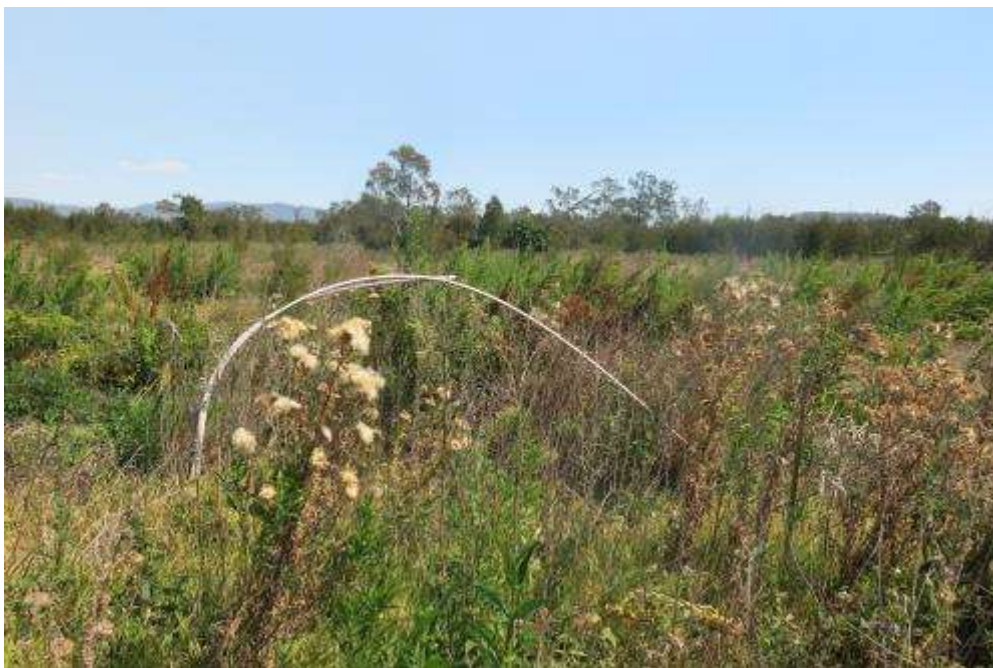
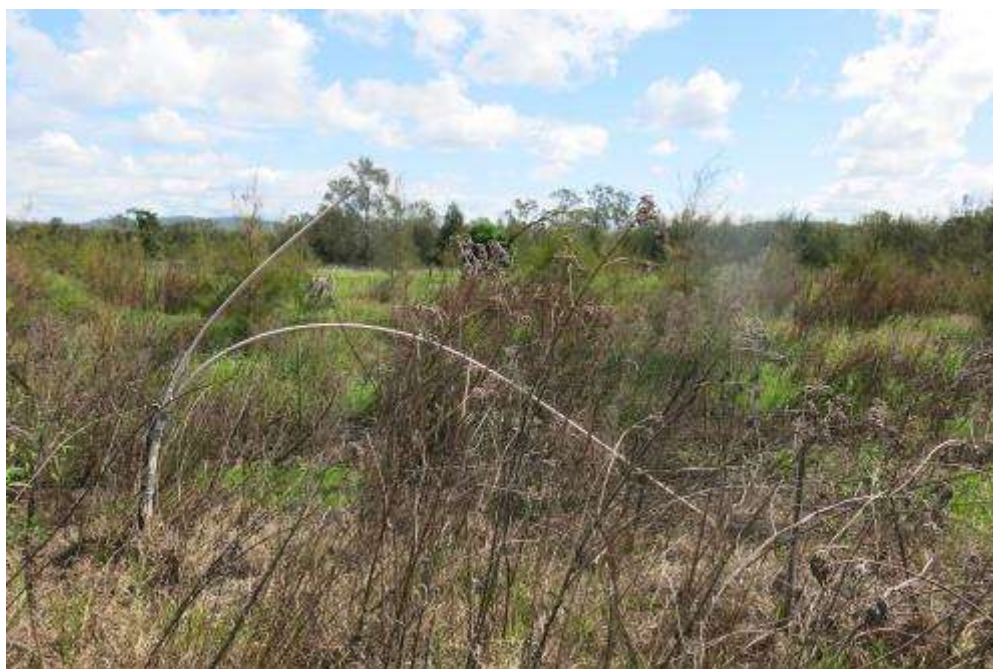
Photo Plate 309: Quadrat 11 - Month 48 (August 2019)

Native dominance of this quadrat fluctuates dramatically and frequently due to the variable nature of the annual pasture weeds. Recent heavy rains during the latter half of this six month period have started to impact these annual weed species via natural control measures from waterlogging.

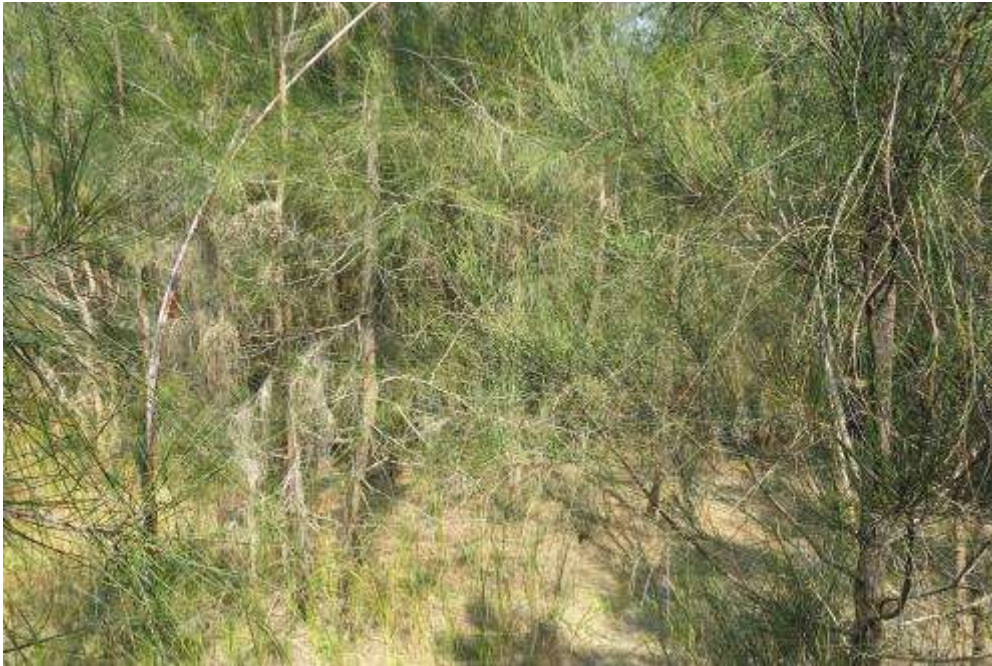
Photo Plate 311: Quadrat 12 - Month 48 (August 2019)

Comparison Summary
Over the past six months, the only significant change noted was the maturation of *Casuarina glauca*. This is a sign of this vegetation community strengthening into a stable ecosystem.
