North-West Conservation Park - Rehabilitation Monitoring

Lot 1 RP48903

North-West Conservation Park
Gainsborough Greens

March 2020

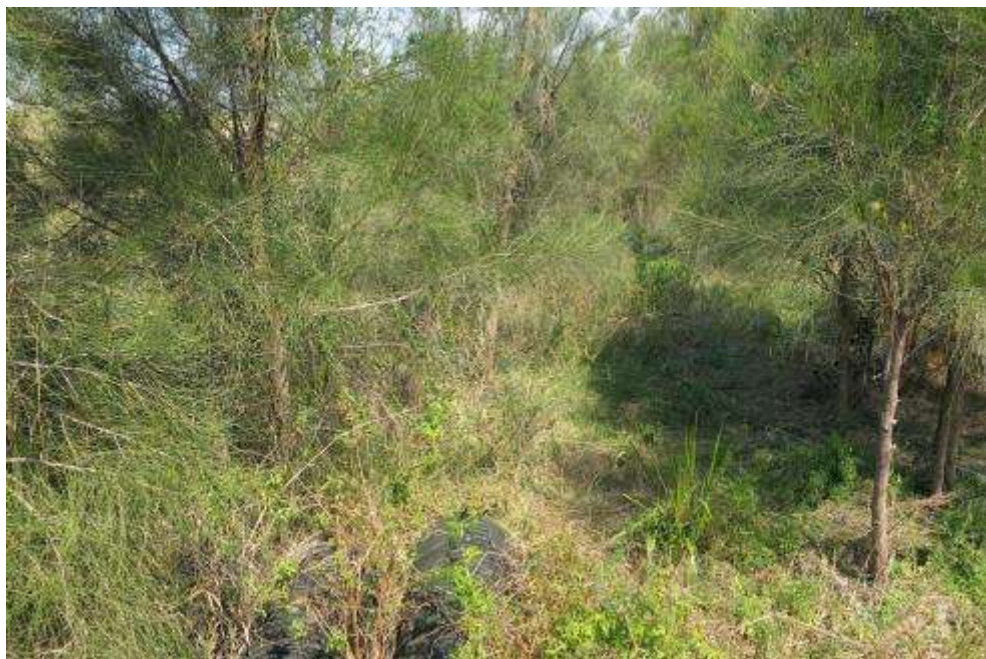
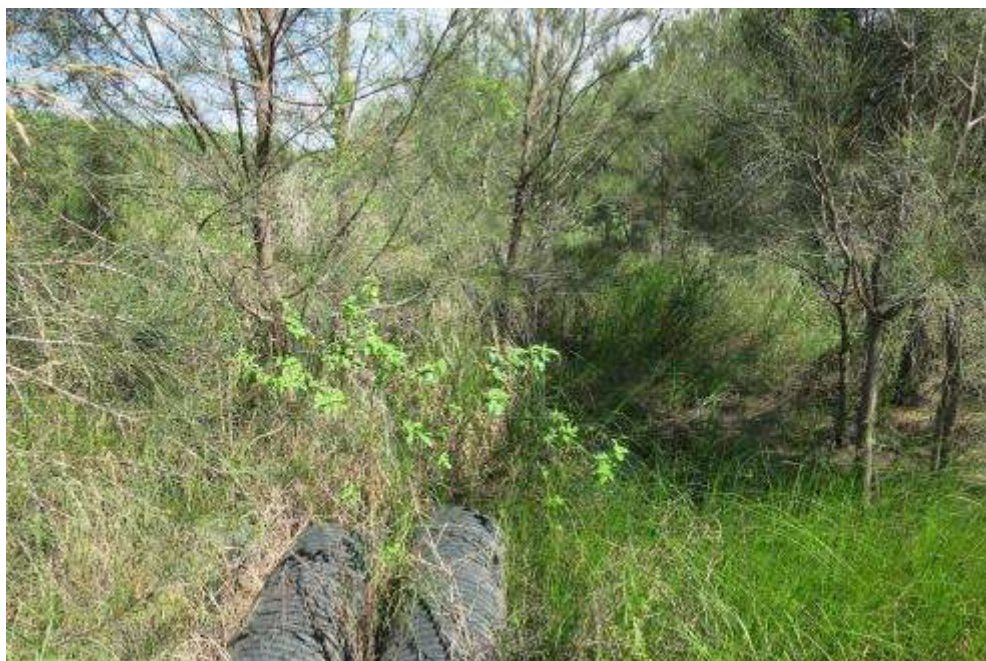
Photo Plate 313: Quadrat 13 - Month 48 (August 2019)

This area has made a significant comeback with the change from sedges to casuarinas. A number of eucalypts are located on the fringes of this quadrat that are progressing well. Vegetation within this quadrat and immediate surrounds continues to mature.

With the additional build-up of organic materials over the past six months, conditions have improved greatly allowing for the rapid growth of native species.

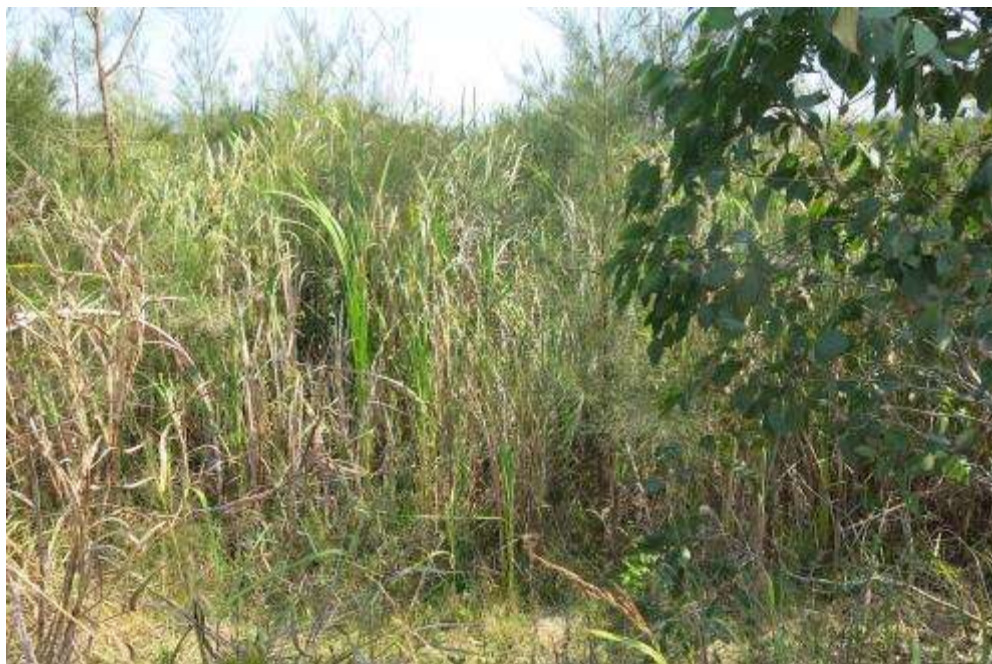
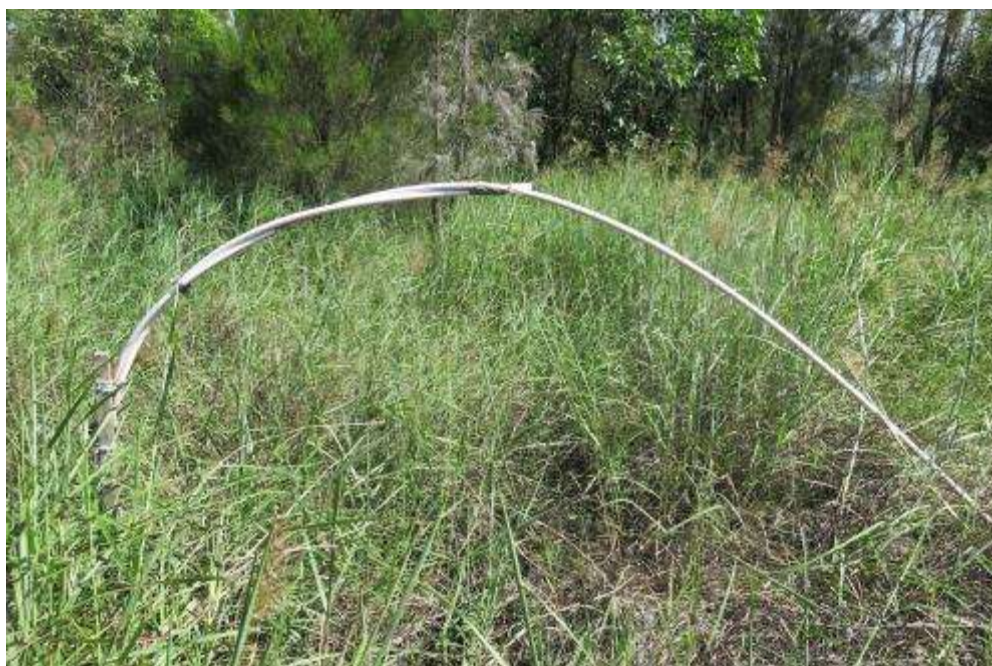
Photo Plate 315: Quadrat 14 - Month 48 (August 2019)

Comparison Summary
Over this six month period, Typha numbers have declined significantly. A positive sign is the native grass, such as *Capillipedium* that is now dominating this quadrat. This grassy understorey is growing well in conjunction with the expanding casuarina canopy.

Imperata cylindrica is also developing well along the interface of this quadrat and the adjoining farmland.

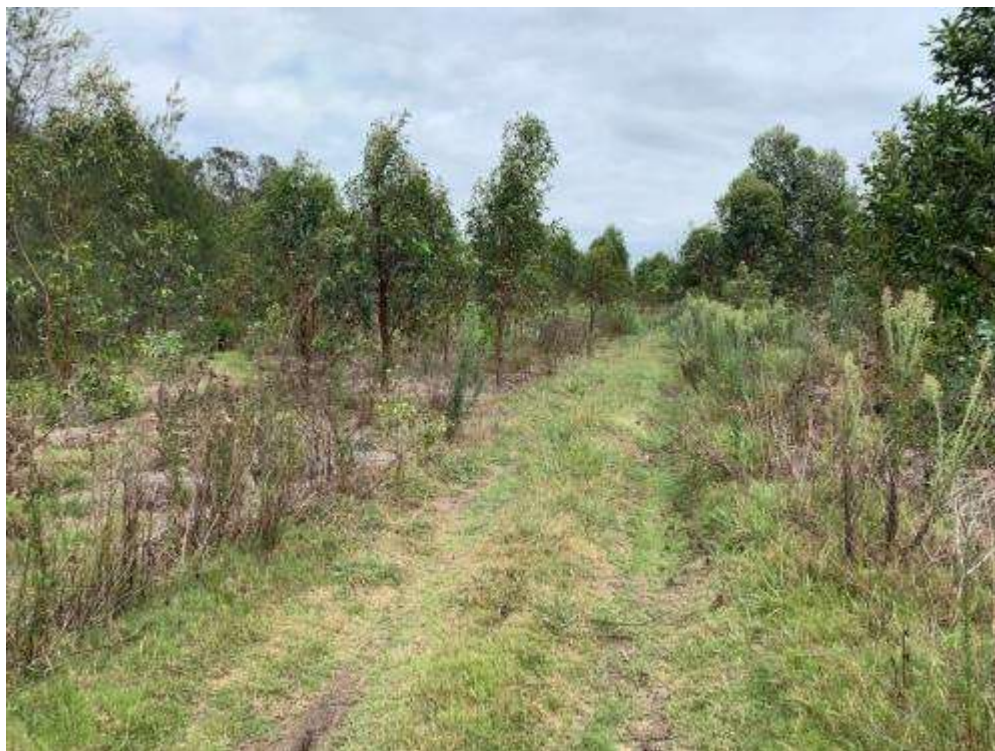
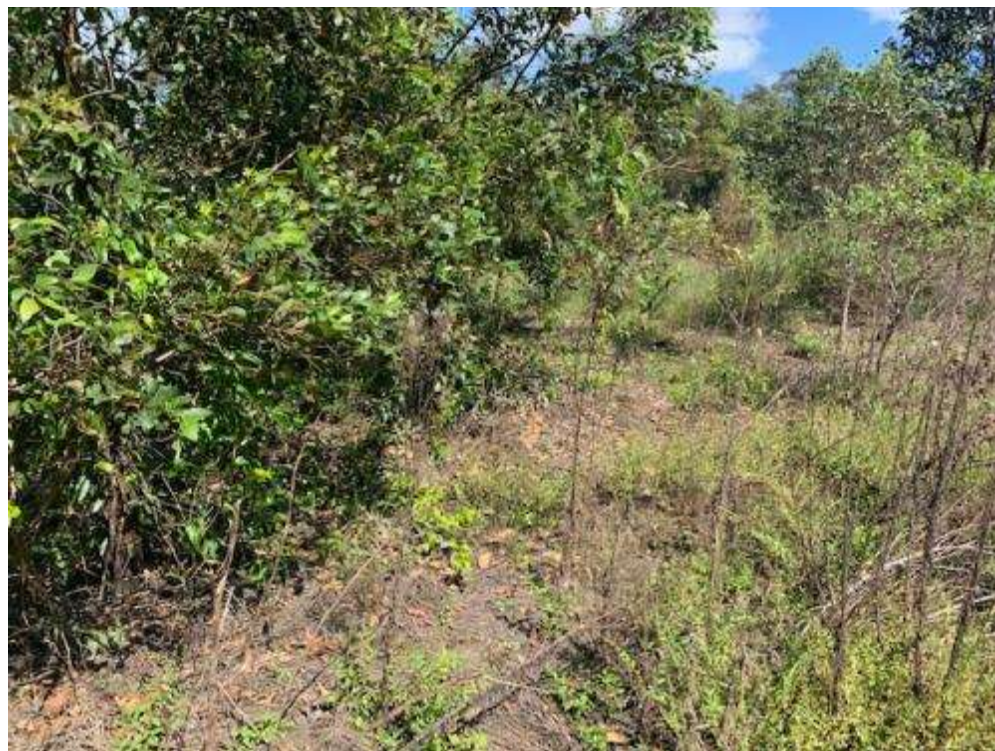
Photo Plate 317: A1 Eucalypt Plantings - Month 48 (August 2019)

Comparison Summary
Height and biomass of seedlings have both increased exponentially over this 6 month period. Canopy vegetation within this area continues to extend the overall percentage of cover, allowing for the increase of native species recruitment.

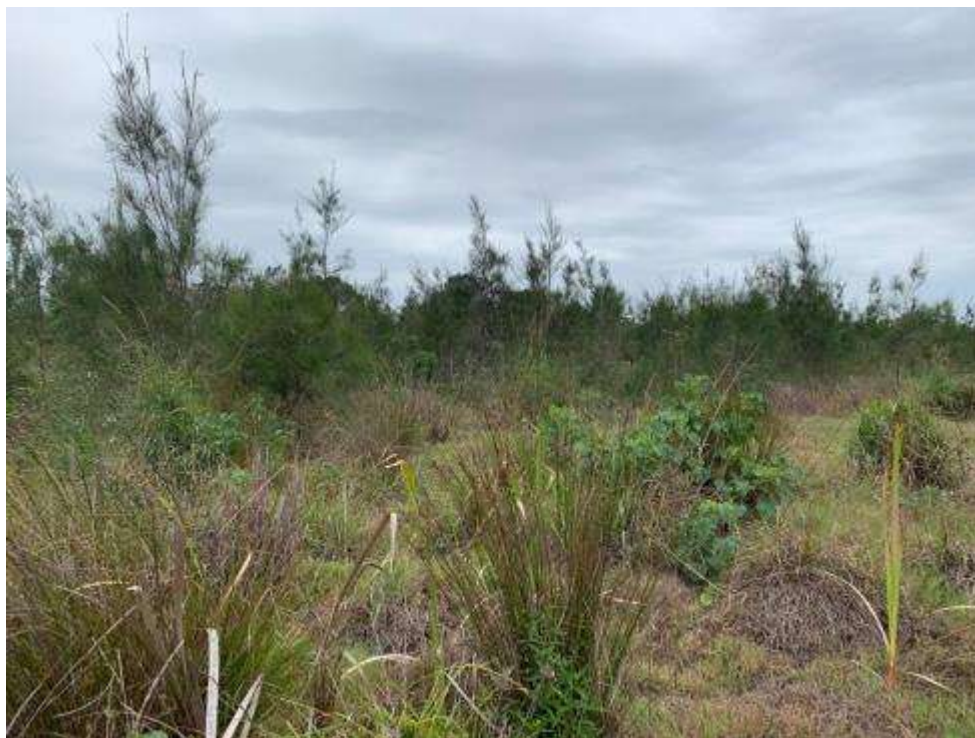
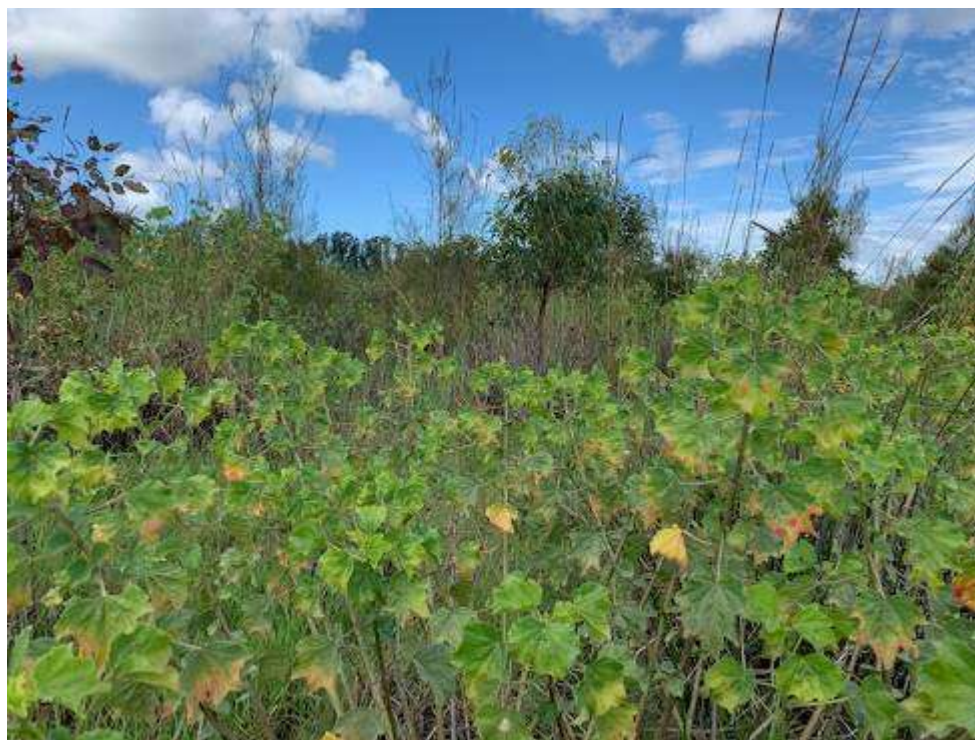
Photo Plate 319: A2 Eucalypt Plantings - Month 48 (August 2019)

The site is still periodically inundated, limiting the growth of a number of the seeded species. This area of tube stock planting is taking longer than the A1 plantings. It is anticipated that this stock will grow slower than other areas due to the geology and inundation.

Casuarina copses are beginning to close together, assisting with the strengthening of micro-niches within the rehabilitation area. A number of eucalypts are also becoming more prominent, however have been slow to establish.

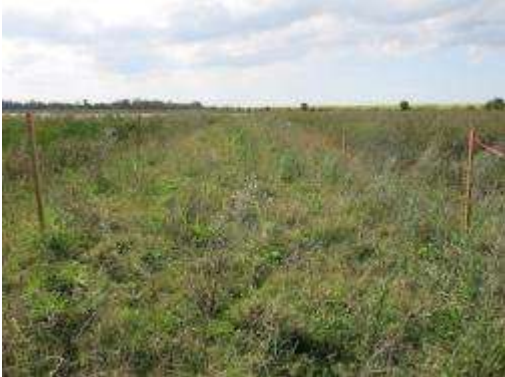
Monitoring month:	1	Months since direct seeding:	6
Date:	September 2015		
Comments:	This is the most degraded quadrat. It is not expected that this quadrat will perform well. The quadrat sits on an elevated area and was not subject to flooding. The quadrat was selected as it will serve as a good opportunity to observe whether a native seedbank can eventually overcome a significant existing exotic weed presence. This quadrat contains many more unidentified grasses and flat weeds than listed due to dormancy or immaturity.		
Native species:	<i>Capillipedium spicigerum</i>		
Weed species:	<i>Gomphocarpus physocarpus</i> , <i>Senecio sp.</i> , <i>Cynodon dactylon</i>		
Damage:	Nil		
Native dominance:	5%	Percentage vegetation cover:	100%
Photo:

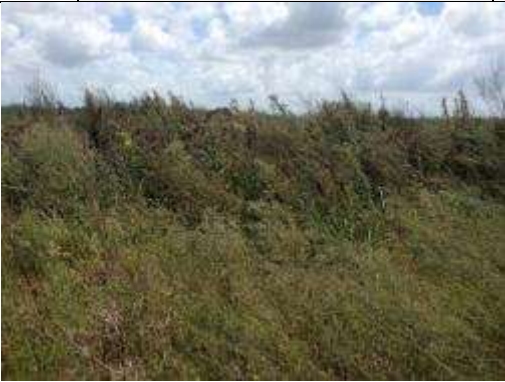
Monitoring month:	6	Months since direct seeding:	11
Date:	February 2016		
Comments:	Weed biomass has increased significantly since last month. Average height of weeds is 500mm approx. New <i>Casuarina glauca</i> have been found adjacent to the quad and one of these measured 1.3 metres in height. Native grasses continue to be outcompeted by exotics. No tree species recorded yet and hopes are fading of potential in this regard. This quadrat contains more unidentified grasses and flat weeds than listed due to dormancy or immaturity.		
Native species:	<i>Capillipedium spicigerum</i>		
Weed species:	<i>Gomphocarpus physocarpus</i> , <i>Aster subulatus</i> , <i>Paspalum dilatatum</i> , <i>Cuphea carthagenesis</i> , <i>Cirsium vulgare</i> , <i>Cynodon dactylon</i>		
Damage:	Nil		
Native dominance:	5%	Percentage vegetation cover:	100%
Photo:

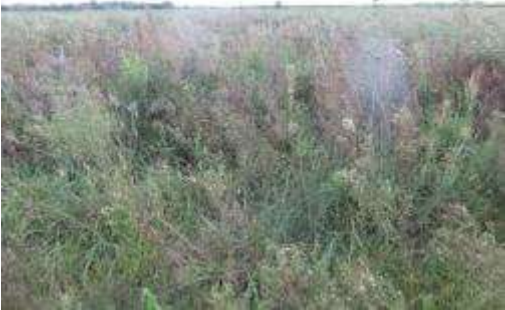
Monitoring month:	7	Months since direct seeding:	12
Date:	March 2016		
Comments:	<i>Casuarina glauca</i> are becoming very common around this area, some measured at 1.5 metres. This quadrat contains more unidentified grasses and flat weeds than listed due to dormancy or immaturity.		
Native species:	<i>Capillipedium spicigerum</i>		
Weed species:	<i>Gomphocarpus physocarpus</i> , <i>Aster subulatus</i> , <i>Paspalum dilatatum</i> , <i>Cuphea carthagenesis</i> , <i>Cirsium vulgare</i> , <i>Cynodon dactylon</i>		
Damage:	Nil		
Native dominance:	5%	Percentage vegetation cover:	100%
Photo:

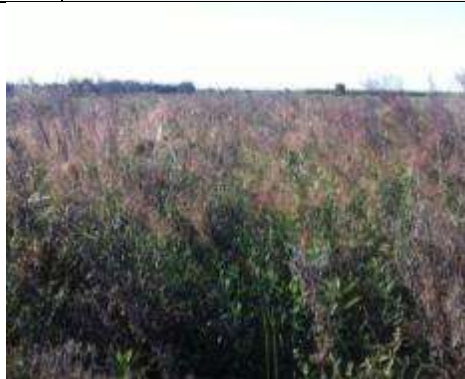
Monitoring month:	8	Months since direct seeding:	13
Date:	April 2016		
Comments:	The native grass <i>Capillipedium spicigerum</i> is common within the quadrat and currently setting seed. <i>Casuarina glauca</i> are very common around this area, some measured at 1.5 metres.		
Native species:	<i>Capillipedium spicigerum</i>		
Weed species:	<i>Gomphocarpus fruticosus</i> , <i>Aster subulatus</i> , <i>Paspalum dilatatum</i> , <i>Cuphea carthagenesis</i> , <i>Cirsium vulgare</i> , <i>Cynodon dactylon</i>		
Damage:	Nil		
Native dominance:	10%	Percentage vegetation cover:	100%
Photo:

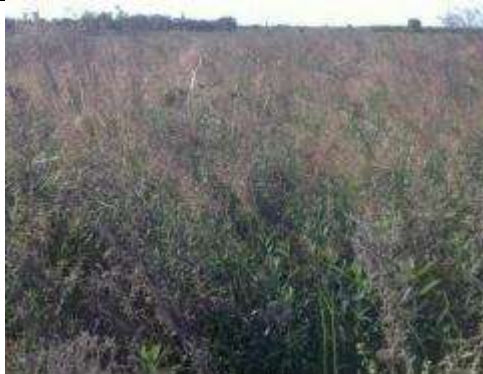
Monitoring month:	9	Months since direct seeding:	14
Date:	May 2016		
Comments:	There has been no significant change in this quadrat.		
Native species:	<i>Capillipedium spicigerum</i>		
Weed species:	<i>Gomphocarpus physocarpus</i> , <i>Aster subulatus</i> , <i>Paspalum dilatatum</i> , <i>Cuphea carthagenesis</i> , <i>Cirsium vulgare</i> , <i>Cynodon dactylon</i>		
Damage:	Nil		
Native dominance:	15%	Percentage vegetation cover:	100%
Photo:

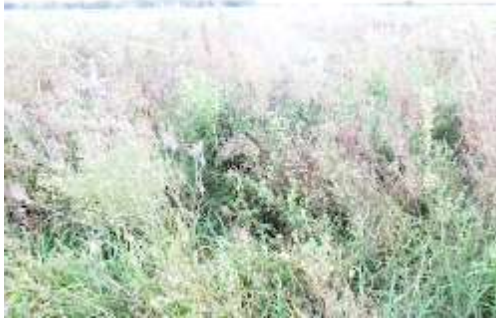
Monitoring month:	10	Months since direct seeding:	15
Date:	June 2016		
Comments:	Aster die-back in the lead up to winter is becoming notable within this month's monitoring of this quadrat.		
Native species:	<i>Capillipedium spicigerum</i>		
Weed species:	<i>Gomphocarpus physocarpus</i> , <i>Aster subulatus</i> , <i>Paspalum dilatatum</i> , <i>Cuphea carthagenesis</i> , <i>Cirsium vulgare</i> , <i>Cynodon dactylon</i>		
Damage:	Nil		
Native dominance:	20%	Percentage vegetation cover:	100%
Photo:

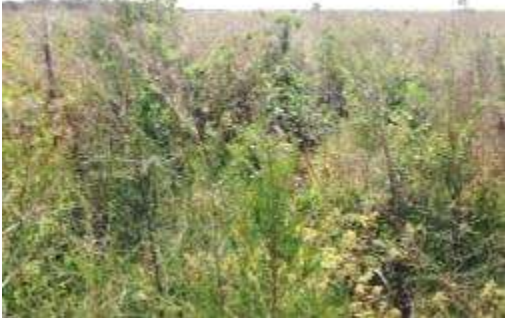
Monitoring month:	11	Months since direct seeding:	16
Date:	July 2016		
Comments:	Due to the die-back of Aster, <i>Casuarina glauca</i> seedlings are becoming visible and are becoming emergent over the Aster. The native grass <i>Capillipedium spicigerum</i> is still common within the quadrant.		
Native species:	<i>Capillipedium spicigerum</i> , <i>Casuarina glauca</i>		
Weed species:	<i>Gomphocarpus physocarpus</i> , <i>Aster subulatus</i> , <i>Paspalum dilatatum</i> , <i>Cuphea carthagenesis</i> , <i>Cirsium vulgare</i> , <i>Cynodon dactylon</i>		
Damage:	Nil		
Native dominance:	35%	Percentage vegetation cover:	100%
Photo:

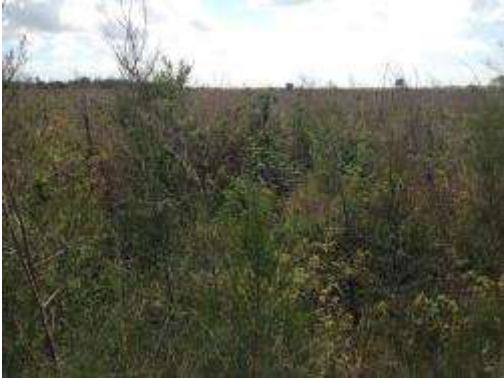
Monitoring month:	12	Months since direct seeding:	17
Date:	August 2016		
Comments:	The native grass <i>Capillipedium spicigerum</i> is common within the quadrant.		
Native species:	<i>Capillipedium spicigerum</i> , <i>Casuarina glauca</i>		
Weed species:	<i>Gomphocarpus physocarpus</i> , <i>Aster subulatus</i> , <i>Paspalum dilatatum</i> , <i>Cuphea carthagenesis</i> , <i>Cirsium vulgare</i> , <i>Cynodon dactylon</i>		
Damage:	Nil		
Native dominance:	37%	Percentage vegetation cover:	100%
Photo:

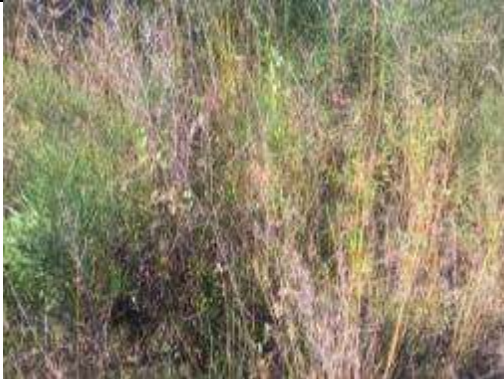
Monitoring month:	13	Months since direct seeding:	18
Date:	September 2016		
Comments:	The native grass <i>Capillipedium spicigerum</i> is common within the quadrant. <i>Casuarina</i> seedlings are progressing steadily.		
Native species:	<i>Capillipedium spicigerum</i> , <i>Casuarina glauca</i>		
Weed species:	<i>Gomphocarpus physocarpus</i> , <i>Aster subulatus</i> , <i>Paspalum dilatatum</i> , <i>Cuphea carthagenesis</i> , <i>Cirsium vulgare</i> , <i>Cynodon dactylon</i>		
Damage:	Nil		
Native dominance:	40%	Percentage vegetation cover:	100%
Photo:

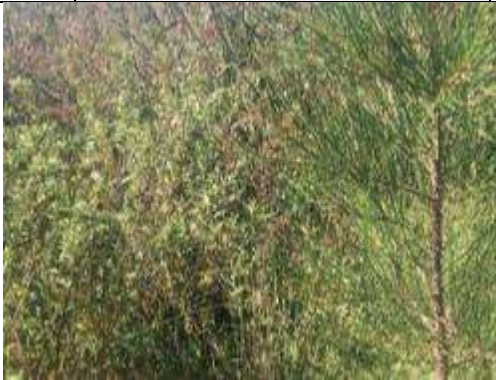
Monitoring month:	14	Months since direct seeding:	19
Date:	October 2016		
Comments:	<i>Casuarina glauca</i> seedlings continue to prosper, with some individuals reaching over 1m in height.		
Native species:	<i>Capillipedium spicigerum</i> , <i>Casuarina glauca</i>		
Weed species:	<i>Gomphocarpus physocarpus</i> , <i>Aster subulatus</i> , <i>Paspalum dilatatum</i> , <i>Cuphea carthagenesis</i> , <i>Cirsium vulgare</i> , <i>Cynodon dactylon</i>		
Damage:	Nil		
Native dominance:	40%	Percentage vegetation cover:	100%
Photo:

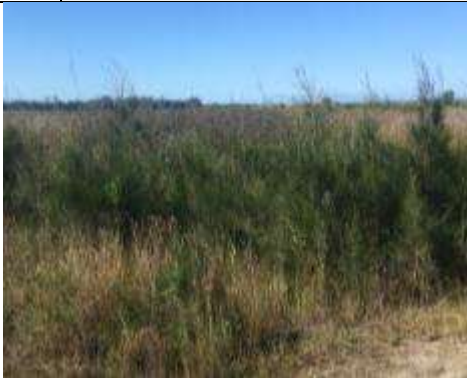
Monitoring month:	15	Months since direct seeding:	20
Date:	November 2016		
Comments:	Native dominance continues to increase with the increased growth of Casuarinas and <i>Capillipedium spicigerum</i> .		
Native species:	<i>Capillipedium spicigerum</i> , <i>Casuarina glauca</i>		
Weed species:	<i>Gomphocarpus physocarpus</i> , <i>Aster subulatus</i> , <i>Paspalum dilatatum</i> , <i>Cuphea carthagenesis</i> , <i>Cirsium vulgare</i> , <i>Cynodon dactylon</i>		
Damage:	Nil		
Native dominance:	45%	Percentage vegetation cover:	100%
Photo:

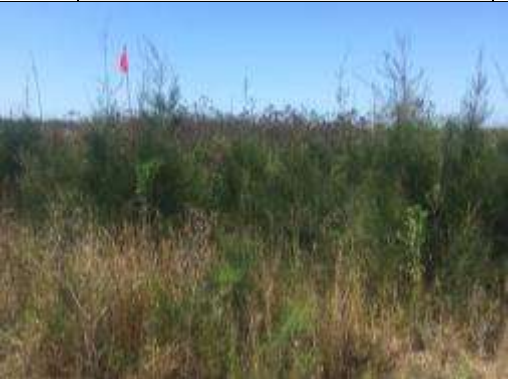
Monitoring month:	16	Months since direct seeding:	21
Date:	December 2016		
Comments:	A high visibility flag and extended pole was added to the quadrat stake this month for ease of identification. Casuarinas continue to grow, averaging approx. 1.8m in height.		
Native species:	<i>Capillipedium spicigerum</i> , <i>Casuarina glauca</i>		
Weed species:	<i>Gomphocarpus physocarpus</i> , <i>Aster subulatus</i> , <i>Paspalum dilatatum</i> , <i>Cuphea carthagenesis</i> , <i>Cirsium vulgare</i> , <i>Cynodon dactylon</i>		
Damage:	Nil		
Native dominance:	45%	Percentage vegetation cover:	100%
Photo:

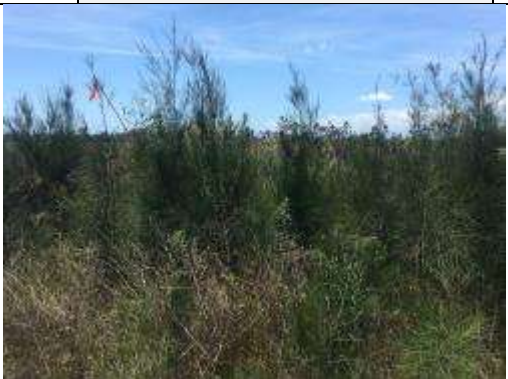
Monitoring month:	17	Months since direct seeding:	22
Date:	January 2017		
Comments:	Casuarinas continue to dominant and grow, still averaging approx. 1.8m in height. Melaleuca was recorded on the periphery of the quadrat.		
Native species:	<i>Capillipedium spicigerum</i> , <i>Casuarina glauca</i>		
Weed species:	<i>Gomphocarpus physocarpus</i> , <i>Aster subulatus</i> , <i>Paspalum dilatatum</i> , <i>Cuphea carthagenesis</i> , <i>Cirsium vulgare</i> , <i>Cynodon dactylon</i>		
Damage:	Nil		
Native dominance:	50%	Percentage vegetation cover:	100%
Photo:

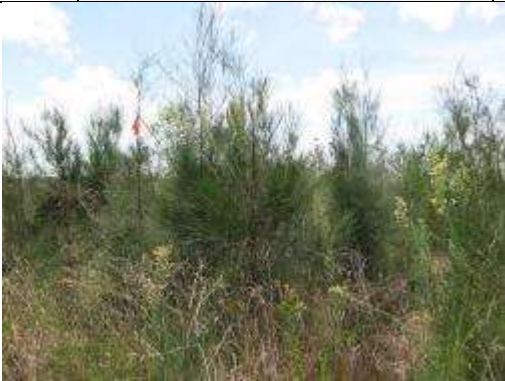
Monitoring month:	18	Months since direct seeding:	23
Date:	February 2017		
Comments:	Casuarinas continue to grow well within and surrounding this quadrat. <i>Capillipedium spicigerum</i> is still common. <i>Acacia falcata</i> was recorded on the periphery of the quadrat.		
Native species:	<i>Capillipedium spicigerum</i> , <i>Casuarina glauca</i> , <i>Ludwigia octovalvis</i>		
Weed species:	<i>Gomphocarpus physocarpus</i> , <i>Aster subulatus</i> , <i>Paspalum dilatatum</i> , <i>Cuphea carthagenesis</i> , <i>Cirsium vulgare</i> , <i>Cynodon dactylon</i>		
Damage:	Nil		
Native dominance:	50%	Percentage vegetation cover:	100%
Photo:

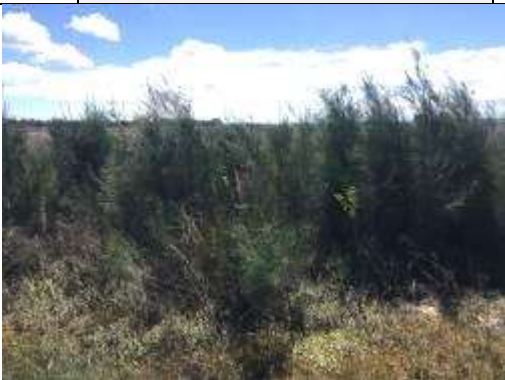
Monitoring month:	19	Months since direct seeding:	24
Date:	March 2017 (NB: monitoring event occurred early April due to inaccessibility)		
Comments:	During the last half of this month, the NWCP received significant rainfall. Access to the area was limited. Much of the area is waterlogged and functioning as the wetland it is designed to be. Casuarinas continue to grow well within and surrounding this quadrat, averaging 3m in height.		
Native species:	<i>Capillipedium spicigerum</i> , <i>Casuarina glauca</i> , <i>Ludwigia octovalvis</i>		
Weed species:	<i>Gomphocarpus physocarpus</i> , <i>Aster subulatus</i> , <i>Paspalum dilatatum</i> , <i>Cuphea carthagenesis</i> , <i>Cirsium vulgare</i> , <i>Cynodon dactylon</i>		
Damage:	Nil - large weather event associated with Ex-Tropical Cyclone Debbie did not result in any damage		
Native dominance:	55%	Percentage vegetation cover:	100%
Photo:

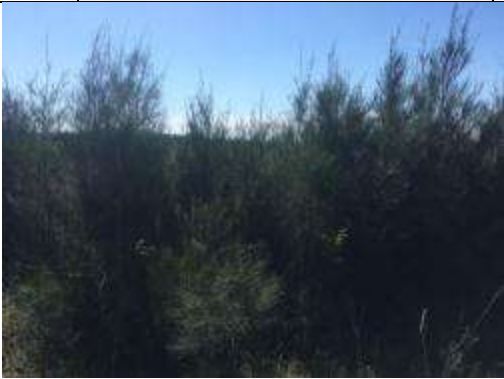
Monitoring month:	20	Months since direct seeding:	25
Date:	April 2017		
Comments:	Much of the area is still waterlogged and functioning as the wetland it is designed to be. Casuarinas continue to grow well within and surrounding this quadrat, averaging 3m in height.		
Native species:	<i>Capillipedium spicigerum, Casuarina glauca, Ludwigia octovalvis</i>		
Weed species:	<i>Gomphocarpus physocarpus, Aster subulatus, Paspalum dilatatum, Cuphea carthagenesis, Cirsium vulgare, Cynodon dactylon</i>		
Damage:	Nil		
Native dominance:	55%	Percentage vegetation cover:	100%
Photo:

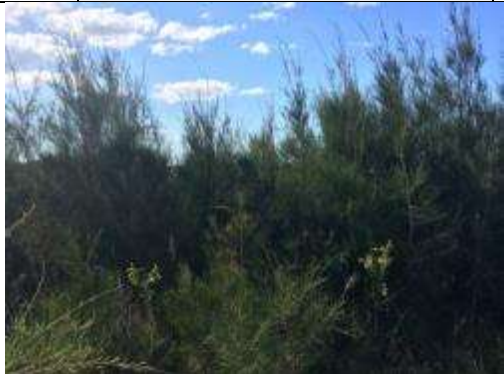
Monitoring month:	21	Months since direct seeding:	26
Date:	May 2017		
Comments:	Casuarinas continue to grow well within and surrounding this quadrat, averaging 4m in height. Melaleucas are becoming more notable at 1.5m		
Native species:	<i>Capillipedium spicigerum, Casuarina glauca, Ludwigia octovalvis</i>		
Weed species:	<i>Gomphocarpus physocarpus, Aster subulatus, Paspalum dilatatum, Cuphea carthagenesis, Cirsium vulgare, Cynodon dactylon</i>		
Damage:	Nil		
Native dominance:	60%	Percentage vegetation cover:	100%
Photo:

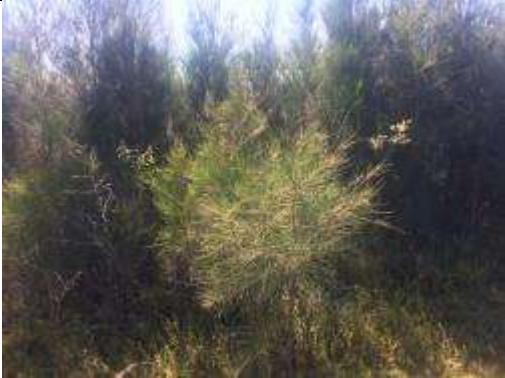
Monitoring month:	22	Months since direct seeding:	27
Date:	June 2017		
Comments:	No significant changes this month. It is anticipated growth will slow moving into the colder months.		
Native species:	<i>Capillipedium spicigerum, Casuarina glauca, Ludwigia octovalvis</i>		
Weed species:	<i>Gomphocarpus physocarpus, Aster subulatus, Paspalum dilatatum, Cuphea carthagenesis, Cirsium vulgare, Cynodon dactylon</i>		
Damage:	Nil		
Native dominance:	60%	Percentage vegetation cover:	100%
Photo:

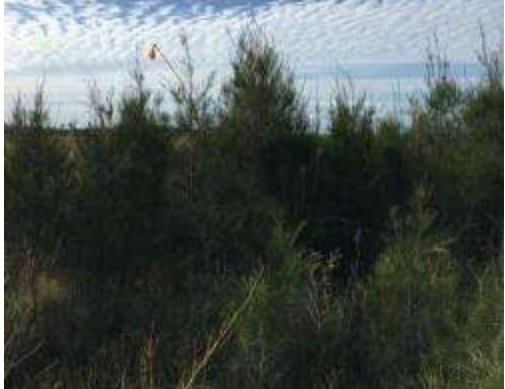
Monitoring month:	23	Months since direct seeding:	28
Date:	July 2017		
Comments:	An additional length of conduit was added to the flagging pole this month due to the increasing height of vegetation. Vegetation health is steady.		
Native species:	<i>Capillipedium spicigerum, Casuarina glauca, Ludwigia octovalvis</i>		
Weed species:	<i>Gomphocarpus physocarpus, Aster subulatus, Paspalum dilatatum, Cuphea carthagenesis, Cirsium vulgare, Cynodon dactylon</i>		
Damage:	Nil		
Native dominance:	60%	Percentage vegetation cover:	100%
Photo:

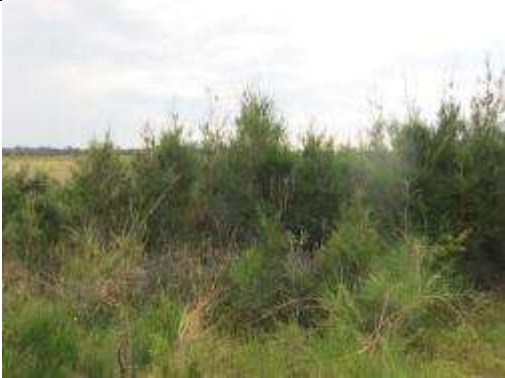
Monitoring month:	24	Months since direct seeding:	29
Date:	August 2017		
Comments:	Vegetation health is steady. <i>Casuarina glauca</i> growth continues to increase in height and biomass.		
Native species:	<i>Capillipedium spicigerum</i> , <i>Casuarina glauca</i> , <i>Ludwigia octovalvis</i>		
Weed species:	<i>Gomphocarpus physocarpus</i> , <i>Aster subulatus</i> , <i>Paspalum dilatatum</i> , <i>Cuphea carthagenesis</i> , <i>Cirsium vulgare</i> , <i>Cynodon dactylon</i> , <i>Verbena bonariensis</i>		
Damage:	Nil		
Native dominance:	60%	Percentage vegetation cover:	100%
Photo:

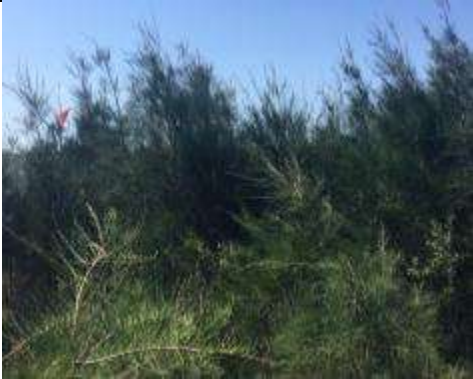
Monitoring month:	25	Months since direct seeding:	30
Date:	September 2017		
Comments:	<i>Casuarina glauca</i> growth continues to increase in height and biomass.		
Native species:	<i>Capillipedium spicigerum</i> , <i>Casuarina glauca</i> , <i>Ludwigia octovalvis</i>		
Weed species:	<i>Gomphocarpus physocarpus</i> , <i>Aster subulatus</i> , <i>Paspalum dilatatum</i> , <i>Cuphea carthagenesis</i> , <i>Cirsium vulgare</i> , <i>Cynodon dactylon</i> , <i>Verbena bonariensis</i>		
Damage:	Nil		
Native dominance:	60%	Percentage vegetation cover:	100%
Photo:

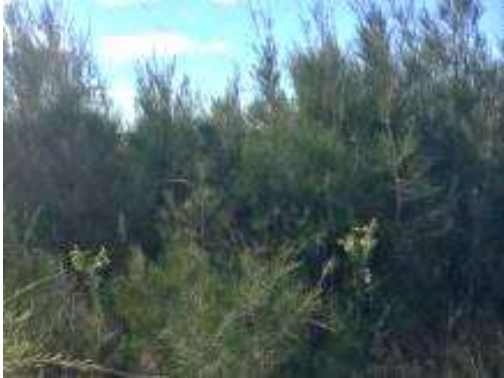
Monitoring month:	26	Months since direct seeding:	31
Date:	October 2017		
Comments:	<i>Casuarina glauca</i> growth continues to increase in height and biomass.		
Native species:	<i>Capillipedium spicigerum</i> , <i>Casuarina glauca</i> , <i>Ludwigia octovalvis</i>		
Weed species:	<i>Gomphocarpus physocarpus</i> , <i>Aster subulatus</i> , <i>Paspalum dilatatum</i> , <i>Cuphea carthagenesis</i> , <i>Cirsium vulgare</i> , <i>Cynodon dactylon</i> , <i>Verbena bonariensis</i>		
Damage:	Nil		
Native dominance:	60%	Percentage vegetation cover:	100%
Photo:

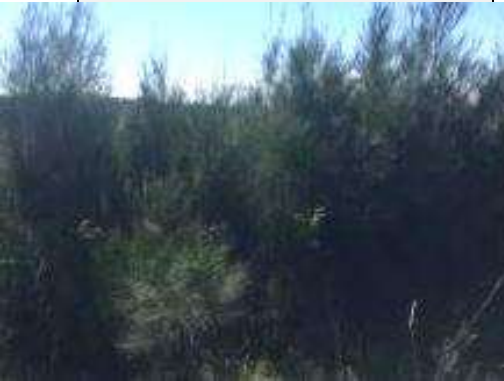
Monitoring month:	27	Months since direct seeding:	32
Date:	November 2017		
Comments:	A small amount of rain was received in the local area this month, assisting in growth of all species as the temperature rises.		
Native species:	<i>Capillipedium spicigerum</i> , <i>Casuarina glauca</i> , <i>Ludwigia octovalvis</i>		
Weed species:	<i>Gomphocarpus physocarpus</i> , <i>Aster subulatus</i> , <i>Paspalum dilatatum</i> , <i>Cuphea carthagenesis</i> , <i>Cirsium vulgare</i> , <i>Cynodon dactylon</i> , <i>Verbena bonariensis</i>		
Damage:	Nil		
Native dominance:	60%	Percentage vegetation cover:	100%
Photo:

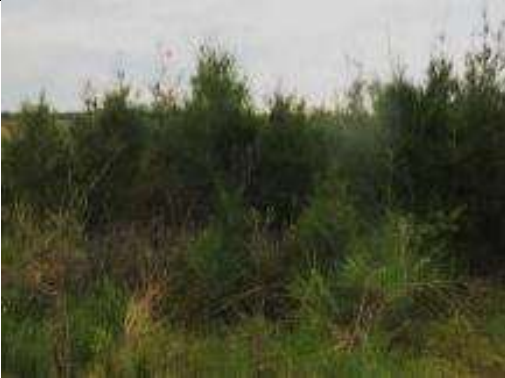
Monitoring month:	28	Months since direct seeding:	33
Date:	December 2017		
Comments:	Temperatures continue to climb, resulting in significant growth of <i>Casuarina glauca</i> . A moderate level of rain was received during the latter part of this month.		
Native species:	<i>Capillipedium spicigerum</i> , <i>Casuarina glauca</i> , <i>Ludwigia octovalvis</i>		
Weed species:	<i>Gomphocarpus physocarpus</i> , <i>Aster subulatus</i> , <i>Paspalum dilatatum</i> , <i>Cuphea carthagenesis</i> , <i>Cirsium vulgare</i> , <i>Cynodon dactylon</i> , <i>Verbena bonariensis</i>		
Damage:	Nil		
Native dominance:	60%	Percentage vegetation cover:	100%
Photo:

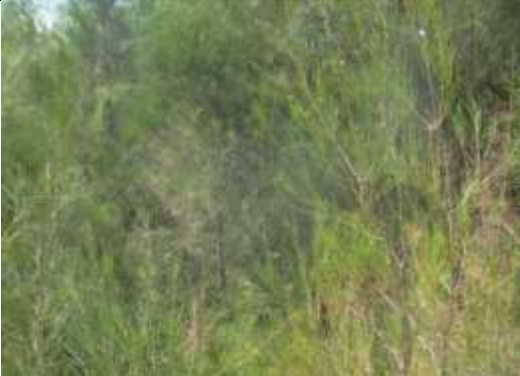
Monitoring month:	29	Months since direct seeding:	34
Date:	January 2018		
Comments:	Canopy growth continues to progressively shade out weed species, reducing diversity and abundance of weeds.		
Native species:	<i>Capillipedium spicigerum</i> , <i>Casuarina glauca</i> , <i>Ludwigia octovalvis</i>		
Weed species:	<i>Gomphocarpus physocarpus</i> , <i>Cuphea carthagenesis</i> , <i>Cirsium vulgare</i> , <i>Cynodon dactylon</i> , <i>Verbena bonariensis</i>		
Damage:	Nil		
Native dominance:	60%	Percentage vegetation cover:	100%
Photo:

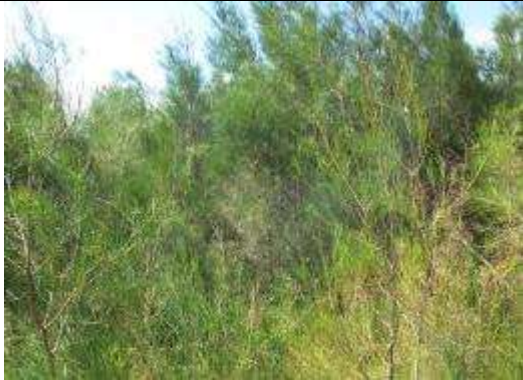
Monitoring month:	30	Months since direct seeding:	35
Date:	February 2018		
Comments:	<i>Casuarina glauca</i> growth continues to increase in height and biomass.		
Native species:	<i>Capillipedium spicigerum</i> , <i>Casuarina glauca</i> , <i>Ludwigia octovalvis</i>		
Weed species:	<i>Gomphocarpus physocarpus</i> , <i>Cuphea carthagenesis</i> , <i>Cirsium vulgare</i> , <i>Cynodon dactylon</i>		
Damage:	Nil		
Native dominance:	65%	Percentage vegetation cover:	100%
Photo:

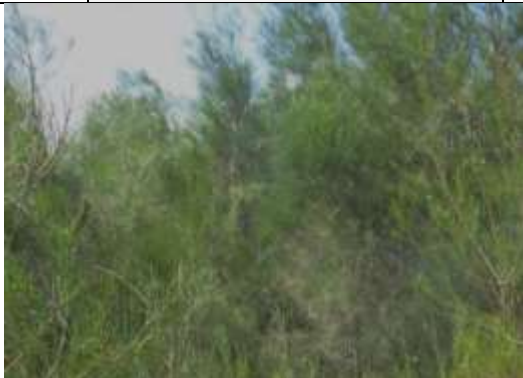
Monitoring month:	31	Months since direct seeding:	36
Date:	March 2018		
Comments:	A significant amount of rain fell at the end of last month resulting in standing water for approximately 3 weeks. This has acted as a natural weed control for a number of the weed species. Canopy growth and shading has also assisted in a reduction of weed growth.		
Native species:	<i>Capillipedium spicigerum</i> , <i>Casuarina glauca</i> , <i>Ludwigia octovalvis</i>		
Weed species:	<i>Gomphocarpus physocarpus</i> , <i>Cuphea carthagenesis</i> , <i>Cynodon dactylon</i> ,		
Damage:	Nil		
Native dominance:	65%	Percentage vegetation cover:	100%
Photo:

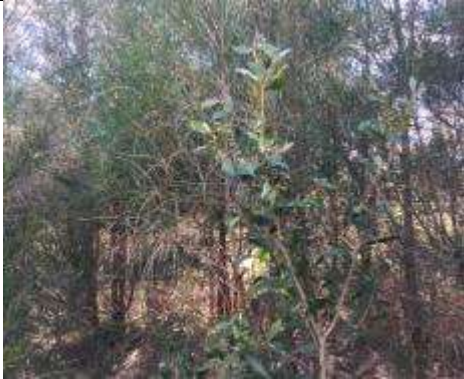
Monitoring month:	32	Months since direct seeding:	37
Date:	April 2018		
Comments:	<i>Casuarina glauca</i> growth continues to increase in height and biomass.		
Native species:	<i>Capillipedium spicigerum</i> , <i>Casuarina glauca</i> , <i>Ludwigia octovalvis</i>		
Weed species:	<i>Gomphocarpus physocarpus</i> , <i>Cuphea carthagenesis</i> , <i>Cynodon dactylon</i>		
Damage:	Nil		
Native dominance:	65%	Percentage vegetation cover:	100%
Photo:

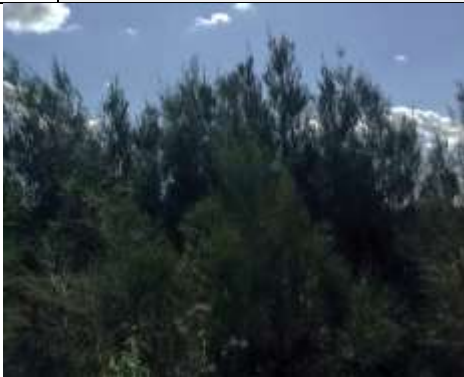
Monitoring month:	33	Months since direct seeding:	38
Date:	May 2018		
Comments:	Canopy growth continues to progressively shade out weed species, reducing diversity and abundance of weeds.		
Native species:	<i>Capillipedium spicigerum</i> , <i>Casuarina glauca</i> , <i>Ludwigia octovalvis</i>		
Weed species:	<i>Gomphocarpus physocarpus</i> , <i>Cuphea carthagenesis</i> , <i>Cynodon dactylon</i>		
Damage:	Nil		
Native dominance:	65%	Percentage vegetation cover:	100%
Photo:

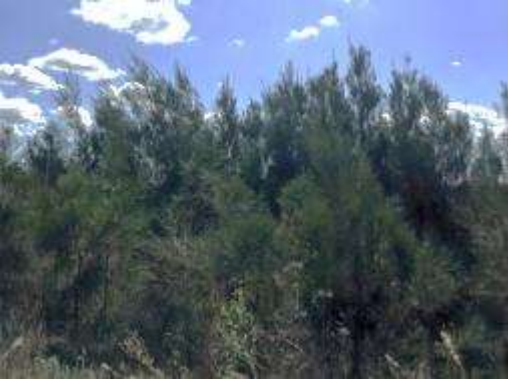
Monitoring month:	34	Months since direct seeding:	39
Date:	June 2018		
Comments:	No significant changes this month due to the slowing down of the growing season.		
Native species:	<i>Capillipedium spicigerum</i> , <i>Casuarina glauca</i> , <i>Ludwigia octovalvis</i>		
Weed species:	<i>Gomphocarpus physocarpus</i> , <i>Cuphea carthagenesis</i> , <i>Cynodon dactylon</i>		
Damage:	Nil		
Native dominance:	60%	Percentage vegetation cover:	100%
Photo:

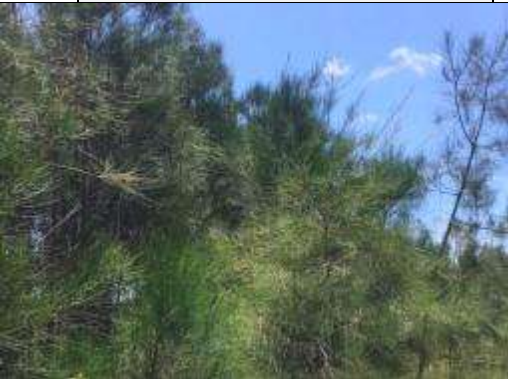
Monitoring month:	35	Months since direct seeding:	40
Date:	July 2018		
Comments:	Native dominance increased this month with the loss of a weed species and weed biomass. An additional native species, <i>Parsonsia straminea</i> , was also recorded.		
Native species:	<i>Capillipedium spicigerum</i> , <i>Casuarina glauca</i> , <i>Ludwigia octovalvis</i> , <i>Parsonsia straminea</i>		
Weed species:	<i>Gomphocarpus physocarpus</i> , <i>Cynodon dactylon</i>		
Damage:	Nil		
Native dominance:	75%	Percentage vegetation cover:	100%
Photo:

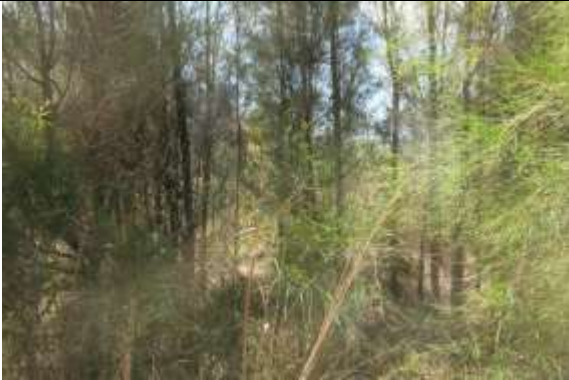
Monitoring month:	36	Months since direct seeding:	41
Date:	August 2018		
Comments:	Aster is beginning to re-emerge from winter dormancy. This may be its last season as competition from native trees eliminates its ability to reproduce.		
Native species:	<i>Capillipedium spicigerum, Casuarina glauca, Ludwigia octovalvis, Parsonsia straminea</i>		
Weed species:	<i>Gomphocarpus physocarpus, Cynodon dactylon</i>		
Damage:	Nil		
Native dominance:	80%	Percentage vegetation cover:	100%
Photo:

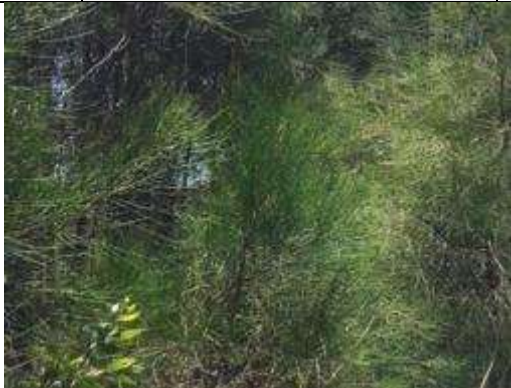
Monitoring month:	37	Months since direct seeding:	42
Date:	September 2018		
Comments:	No significant changes within the quadrat this month. Understorey and canopy of the surrounding area continues to develop with many new species emerging.		
Native species:	<i>Capillipedium spicigerum, Casuarina glauca, Ludwigia octovalvis</i>		
Weed species:	<i>Gomphocarpus physocarpus, Cuphea carthagenesis, Cynodon dactylon</i>		
Damage:	Nil		
Native dominance:	80%	Percentage vegetation cover:	100%
Photo:

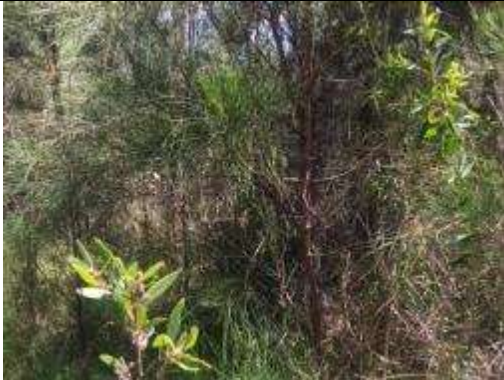
Monitoring month:	38	Months since direct seeding:	43
Date:	October 2018		
Comments:	Rainfall occurred throughout the area during this month which has assisted with the increase in biomass.		
Native species:	<i>Capillipedium spicigerum, Casuarina glauca, Ludwigia octovalvis</i>		
Weed species:	<i>Gomphocarpus physocarpus, Cuphea carthagenesis, Cynodon dactylon</i>		
Damage:	Nil		
Native dominance:	80%	Percentage vegetation cover:	100%
Photo:

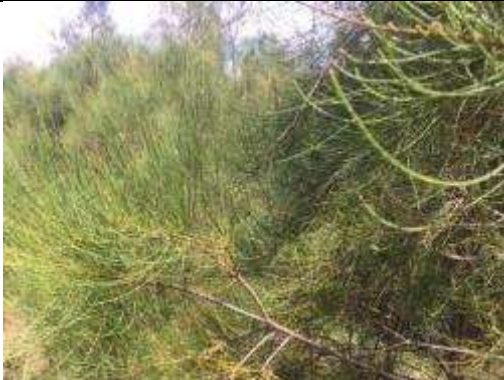
Monitoring month:	39	Months since direct seeding:	44
Date:	November 2018		
Comments:	Rapidly increasing temperatures were experienced this month resulting in the exponential growth of vegetation.		
Native species:	<i>Capillipedium spicigerum, Casuarina glauca, Ludwigia octovalvis</i>		
Weed species:	<i>Gomphocarpus physocarpus, Cuphea carthagenesis, Cynodon dactylon</i>		
Damage:	Nil		
Native dominance:	80%	Percentage vegetation cover:	100%
Photo:

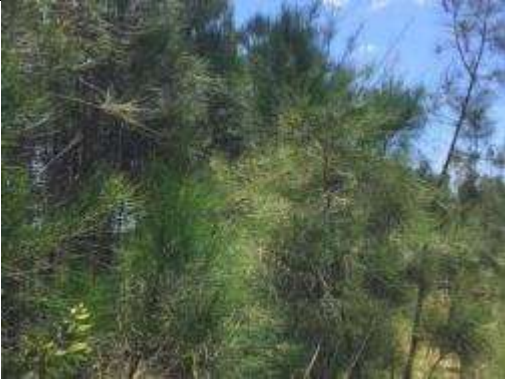
Monitoring month:	40	Months since direct seeding:	45
Date:	December 2018		
Comments:	Vegetation growth was steady this month.		
Native species:	<i>Capillipedium spicigerum</i> , <i>Casuarina glauca</i> , <i>Ludwigia octovalvis</i>		
Weed species:	<i>Gomphocarpus physocarpus</i> , <i>Cuphea carthagenesis</i> , <i>Cynodon dactylon</i>		
Damage:	Nil		
Native dominance:	80%	Percentage vegetation cover:	100%
Photo:

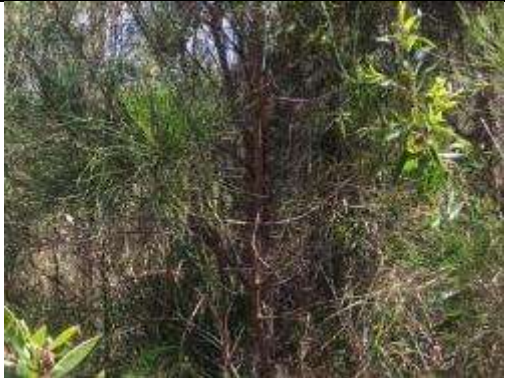
Monitoring month:	41	Months since direct seeding:	46
Date:	January 2019		
Comments:	Casuarinas continue to increase in biomass		
Native species:	<i>Capillipedium spicigerum</i> , <i>Casuarina glauca</i> , <i>Ludwigia octovalvis</i>		
Weed species:	<i>Gomphocarpus physocarpus</i> , <i>Cuphea carthagenesis</i> , <i>Cynodon dactylon</i>		
Damage:	Nil		
Native dominance:	80%	Percentage vegetation cover:	100%
Photo:

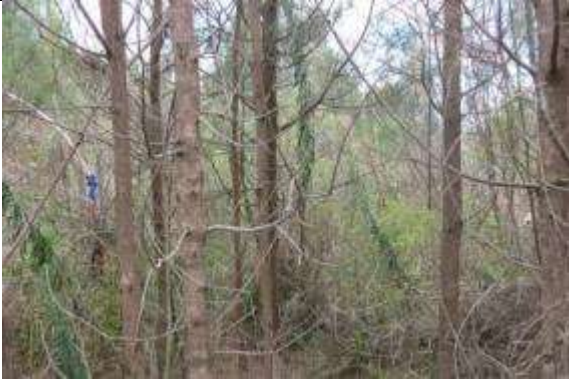
Monitoring month:	42	Months since direct seeding:	47
Date:	February 2019		
Comments:	Vegetation growth was steady this month. Aster re-emerging from winter dormancy.		
Native species:	<i>Capillipedium spicigerum</i> , <i>Casuarina glauca</i> , <i>Ludwigia octovalvis</i>		
Weed species:	<i>Gomphocarpus physocarpus</i> , <i>Cuphea carthagenesis</i> , <i>Cynodon dactylon</i>		
Damage:	Nil		
Native dominance:	80%	Percentage vegetation cover:	100%
Photo:

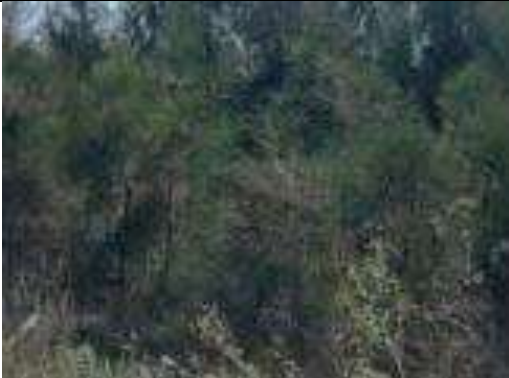
Monitoring month:	43	Months since direct seeding:	48
Date:	March 2019		
Comments:	No significant changes occurred this month		
Native species:	<i>Capillipedium spicigerum</i> , <i>Casuarina glauca</i> , <i>Ludwigia octovalvis</i>		
Weed species:	<i>Gomphocarpus physocarpus</i> , <i>Cuphea carthagenesis</i> , <i>Cynodon dactylon</i>		
Damage:	Nil		
Native dominance:	80%	Percentage vegetation cover:	100%
Photo:

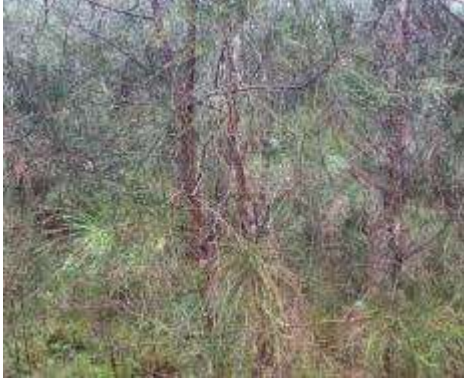
Monitoring month:	44	Months since direct seeding:	49
Date:	April 2019		
Comments:	Rainfall events increased late last month and continued this month giving the NWCP a much needed watering.		
Native species:	<i>Capillipedium spicigerum, Casuarina glauca, Ludwigia octovalvis</i>		
Weed species:	<i>Gomphocarpus physocarpus, Cuphea carthagenesis, Cynodon dactylon</i>		
Damage:	Nil		
Native dominance:	80%	Percentage vegetation cover:	100%
Photo:

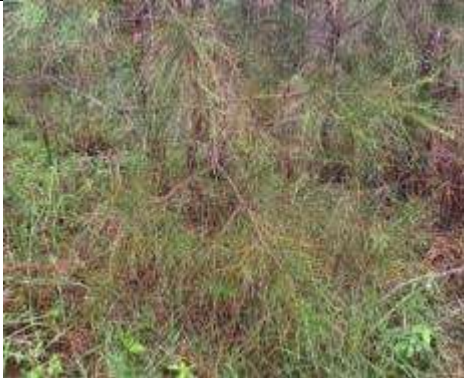
Monitoring month:	45	Months since direct seeding:	50
Date:	May 2019		
Comments:	<i>Casuarina glauca</i> continues to add biomass.		
Native species:	<i>Capillipedium spicigerum, Casuarina glauca, Ludwigia octovalvis</i>		
Weed species:	<i>Cuphea carthagenesis, Cynodon dactylon</i>		
Damage:	Nil		
Native dominance:	85%	Percentage vegetation cover:	100%
Photo:

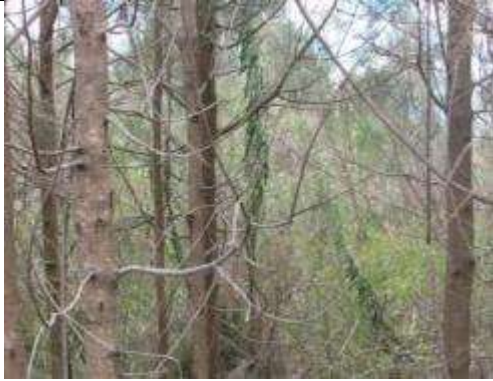
Monitoring month:	46	Months since direct seeding:	51
Date:	June 2019		
Comments:	Rainfall over the past few months has increased plant growth and vigour.		
Native species:	<i>Capillipedium spicigerum</i> , <i>Casuarina glauca</i> , <i>Ludwigia octovalvis</i>		
Weed species:	<i>Cuphea carthagenesis</i> , <i>Cynodon dactylon</i>		
Damage:	Nil		
Native dominance:	85%	Percentage vegetation cover:	100%
Photo:

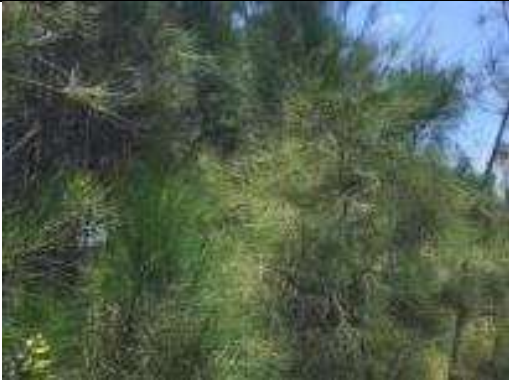
Monitoring month:	47	Months since direct seeding:	52
Date:	July 2019		
Comments:	Casuarina continues to grow well.		
Native species:	<i>Capillipedium spicigerum</i> , <i>Casuarina glauca</i> , <i>Ludwigia octovalvis</i>		
Weed species:	<i>Cuphea carthagenesis</i> , <i>Cynodon dactylon</i>		
Damage:	Nil		
Native dominance:	85%	Percentage vegetation cover:	100%
Photo:

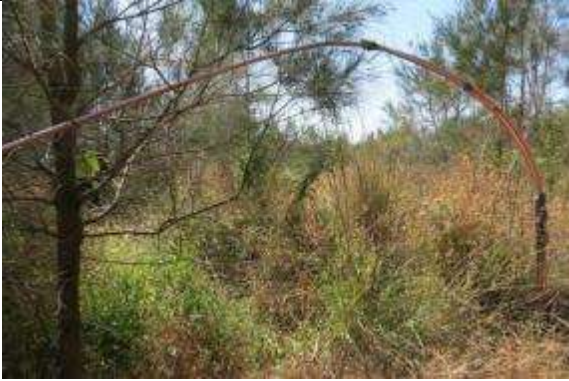
Monitoring month:	48	Months since direct seeding:	53
Date:	August 2019		
Comments:	<i>Livistona australis</i> is noted to be increasing in clusters surrounding this quadrat.		
Native species:	<i>Capillipedium spicigerum</i> , <i>Casuarina glauca</i> , <i>Ludwigia octovalvis</i>		
Weed species:	<i>Aster subulatus</i> , <i>Cuphea carthagenesis</i> , <i>Cynodon dactylon</i>		
Damage:	Nil		
Native dominance:	85%	Percentage vegetation cover:	100%
Photo:

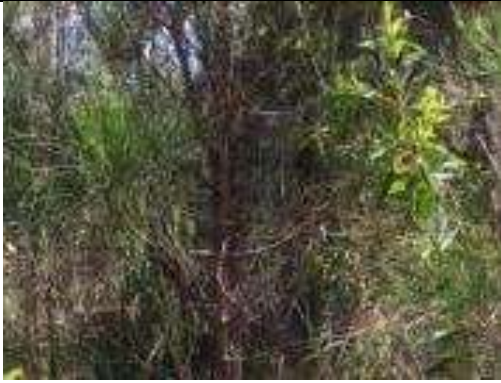
Monitoring month:	49	Months since direct seeding:	54
Date:	September 2019		
Comments:	Diversification within the surrounding areas continues.		
Native species:	<i>Capillipedium spicigerum</i> , <i>Casuarina glauca</i> , <i>Ludwigia octovalvis</i>		
Weed species:	<i>Aster subulatus</i> , <i>Cuphea carthagenesis</i> , <i>Cynodon dactylon</i>		
Damage:	Nil		
Native dominance:	85%	Percentage vegetation cover:	100%
Photo:

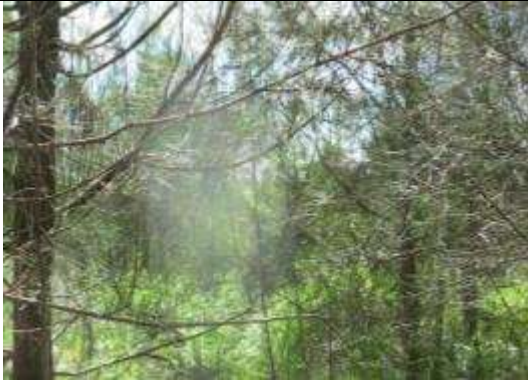
Monitoring month:	50	Months since direct seeding:	55
Date:	October 2019		
Comments:	Extended drought conditions are starting to take their toll with the extreme slowing of plant growth.		
Native species:	<i>Capillipedium spicigerum, Casuarina glauca, Ludwigia octovalvis</i>		
Weed species:	<i>Aster subulatus, Cuphea carthagenesis, Cynodon dactylon</i>		
Damage:	Nil		
Native dominance:	85%	Percentage vegetation cover:	100%
Photo:

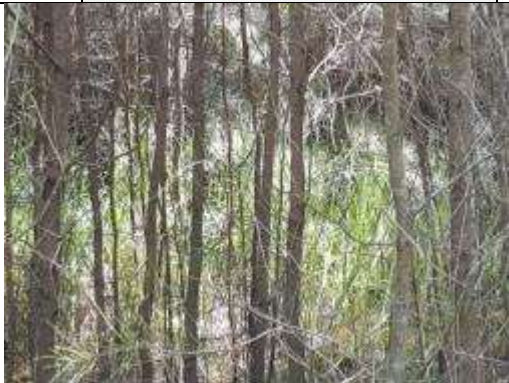
Monitoring month:	51	Months since direct seeding:	56
Date:	November 2019		
Comments:	Growth steady.		
Native species:	<i>Capillipedium spicigerum, Casuarina glauca, Parsonsia straminea</i>		
Weed species:	<i>Cuphea carthagenesis, Cynodon dactylon</i>		
Damage:	Nil		
Native dominance:	85%	Percentage vegetation cover:	100%
Photo:

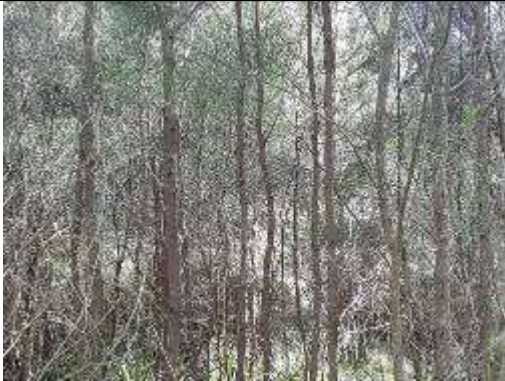
Monitoring month:	52	Months since direct seeding:	57
Date:	December 2019		
Comments:	<i>Capillipedium</i> still has a very strong presence within this quadrat.		
Native species:	<i>Capillipedium spicigerum</i> , <i>Casuarina glauca</i> , <i>Parsonsia straminea</i>		
Weed species:	<i>Cynodon dactylon</i>		
Damage:	Nil		
Native dominance:	90%	Percentage vegetation cover:	100%
Photo:

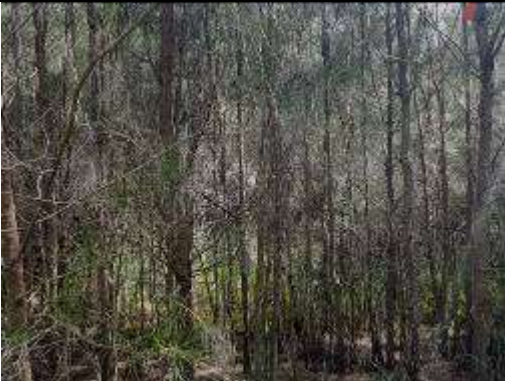
Monitoring month:	53	Months since direct seeding:	58
Date:	January 2020		
Comments:	Rainfall is assisting with increasing wetland species abundance.		
Native species:	<i>Capillipedium spicigerum</i> , <i>Casuarina glauca</i> , <i>Parsonsia straminea</i>		
Weed species:	<i>Cynodon dactylon</i>		
Damage:	Nil		
Native dominance:	90%	Percentage vegetation cover:	100%
Photo:
