North-West Conservation Park - Rehabilitation Monitoring

Lot 1 RP48903

North-West Conservation Park
Gainsborough Greens

March 2020

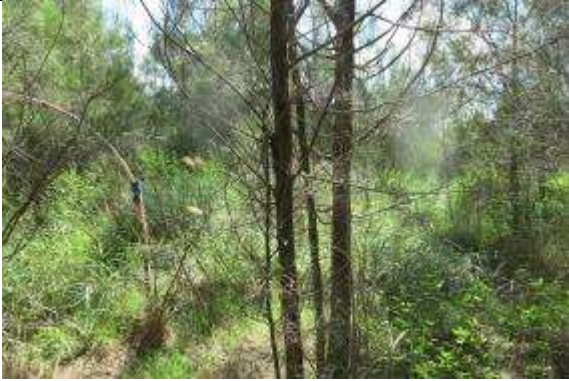
Monitoring month:	54	Months since direct seeding:	59
Date:	February 2020		
Comments:	The understorey within this quadrat continues to increase with vigour.		
Native species:	<i>Capillipedium spicigerum</i> , <i>Casuarina glauca</i> , <i>Parsonsia straminea</i>		
Weed species:	<i>Cynodon dactylon</i>		
Damage:	Nil		
Native dominance:	90%	Percentage vegetation cover:	100%
Photo:

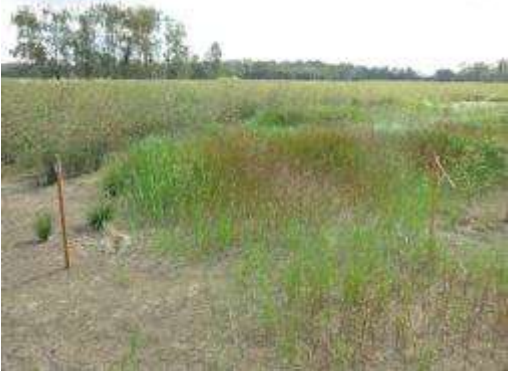
Monitoring month:	1	Months since direct seeding:	6
Date:	September 2015		
Comments:	All species are setting seed. This significantly increases the rate of native establishment, but more importantly, lays down a seed bank strengthening the ecological resilience of the area. This quadrat is performing very well.		
Native species:	<i>Bolboschoenus cardwellii</i> , <i>Eleocharis dulcis</i> , <i>Ludwigia octovalvis</i> , <i>Juncus prismatacarpa</i>		
Weed species:	Nil		
Damage:	Nil		
Native dominance:	100%	Percentage vegetation cover:	80%
Photo:

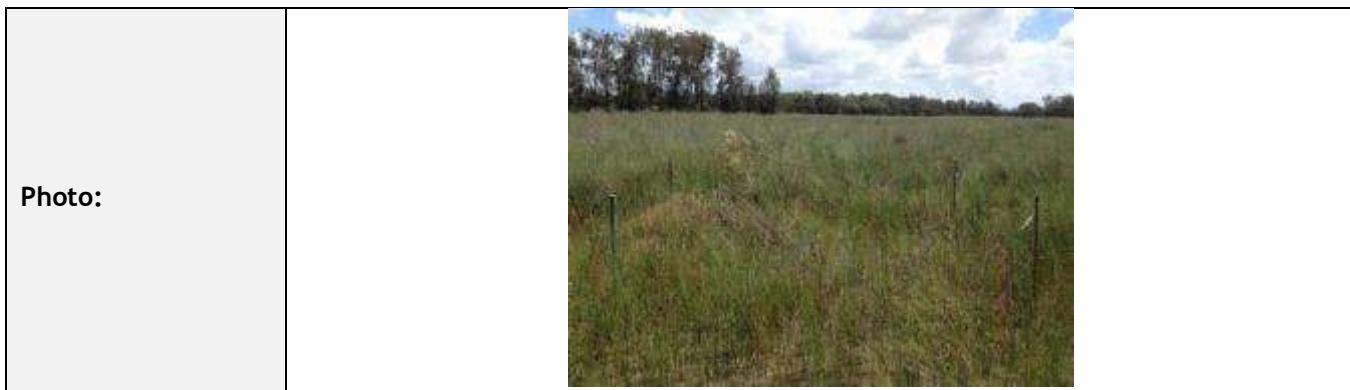
Monitoring month:	6	Months since direct seeding:	11
Date:	February 2016		
Comments:	All species have set seed. This significantly increases the rate of native establishment, but more importantly, lays down a seed bank strengthening the ecological resilience of the area. Starwort is common in the surrounding area, but so too are canopy trees, both <i>Melaleuca spp.</i> , some measuring 1.5m, and <i>Casuarina glauca</i> by the hundreds.		
Native species:	<i>Bolboschoenus cardwellii</i> , <i>Eleocharis dulcis</i> , <i>Ludwigia octovalvis</i> , <i>Juncus prismatacarpa</i> , <i>Fimbistylis furrugina</i>		
Weed species:	Nil		
Damage:	Nil		
Native dominance:	100%	Percentage vegetation cover:	80%

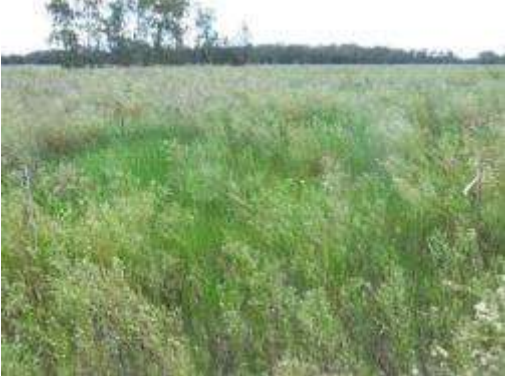
Monitoring month:	7	Months since direct seeding:	12
Date:	March 2016		
Comments:	The vigour in which the <i>Bolboschoenus cardwellii</i> is recovering and expanding in this area is impressive. Starwort is coming to the end of its life cycle. Many <i>Melaleuca</i> , some measuring over 1.5, and <i>Casuarina glauca</i> surround this quadrat.		
Native species:	<i>Bolboschoenus cardwellii</i> , <i>Eleocharis dulcis</i> , <i>Ludwigia octovalvis</i> , <i>Juncus prismatacarpa</i> , <i>Fimbistylis furruginea</i>		
Weed species:	Nil		
Damage:	Nil		
Native dominance:	100%	Percentage vegetation cover:	80%
Photo:

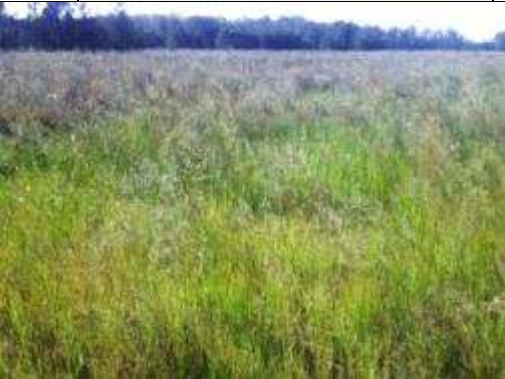
Monitoring month:	8	Months since direct seeding:	13
Date:	April 2016		
Comments:	The vigour in which the <i>Bolboschoenus cardwellii</i> is recovering and expanding in this area is impressive. Starwort is coming to the end of its life cycle. Native dominance continues to remain solid. Many <i>Melaleuca</i> and <i>Casuarina</i> surround this quadrat.		
Native species:	<i>Bolboschoenus cardwellii</i> , <i>Eleocharis dulcis</i> , <i>Ludwigia octovalvis</i> , <i>Juncus prismatacarpa</i> , <i>Fimbistylis furruginea</i>		
Weed species:	Nil		
Damage:	Nil		
Native dominance:	100%	Percentage vegetation cover:	80%
Photo:

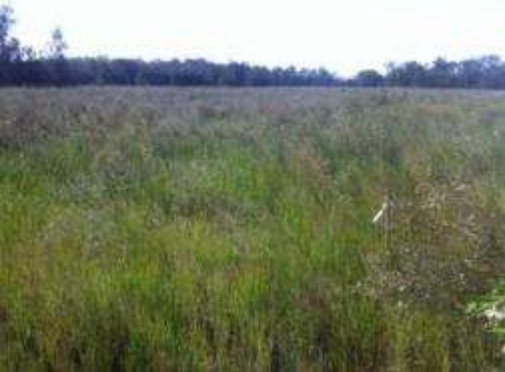
Monitoring month:	9	Months since direct seeding:	14
Date:	May 2016		
Comments:	Aster was recorded within this quadrat for the first time this month, decreasing the overall dominance by native species.		
Native species:	<i>Bolboschoenus cardwellii</i> , <i>Eleocharis dulcis</i> , <i>Ludwigia octovalvis</i> , <i>Juncus prismatacarpa</i> , <i>Fimbistylis furruginea</i> , <i>Casuarina glauca</i>		
Weed species:	<i>Aster subulatus</i>		
Damage:	Nil		
Native dominance:	75%	Percentage vegetation cover:	80%
Photo:

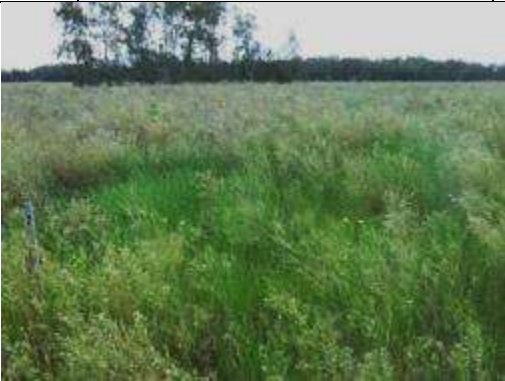
Monitoring month:	10	Months since direct seeding:	15
Date:	June 2016		
Comments:	No significant changes were recorded for this quadrant. This can be attributed to many species moving into a dormant growth period. Aster is still present, however has not spread any further.		
Native species:	<i>Bolboschoenus cardwellii</i> , <i>Eleocharis dulcis</i> , <i>Ludwigia octovalvis</i> , <i>Juncus prismatacarpa</i> , <i>Fimbistylis furruginia</i> , <i>Casuarina glauca</i>		
Weed species:	<i>Aster subulatus</i>		
Damage:	Nil		
Native dominance:	75%	Percentage vegetation cover:	80%
Photo:

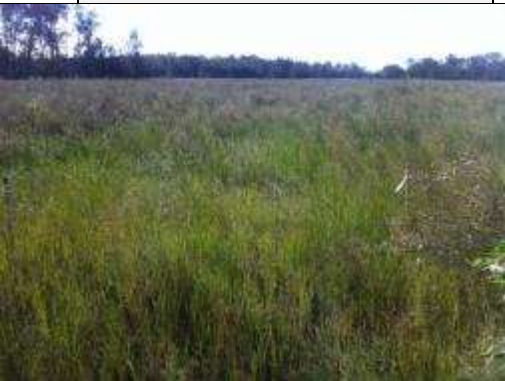
Monitoring month:	11	Months since direct seeding:	16
Date:	July 2016		
Comments:	The Aster is showing signs of die off as the temperatures decrease. Both <i>Melaleuca quinquenervia</i> and <i>Casuarina glauca</i> surround this quadrat in the hundreds.		
Native species:	<i>Bolboschoenus cardwellii</i> , <i>Eleocharis dulcis</i> , <i>Ludwigia octovalvis</i> , <i>Juncus prismatacarpa</i> , <i>Fimbistylis furruginia</i> , <i>Casuarina glauca</i>		
Weed species:	<i>Aster subulatus</i>		
Damage:	Nil		
Native dominance:	75%	Percentage vegetation cover:	80%
Photo:

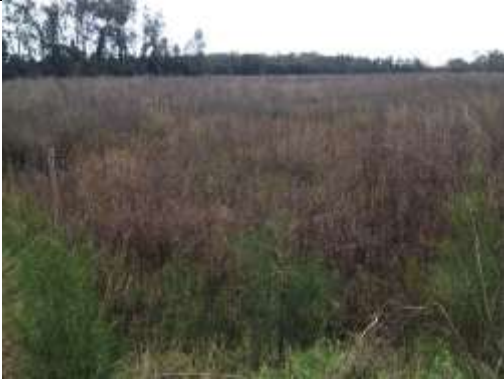
Monitoring month:	12	Months since direct seeding:	17
Date:	August 2016		
Comments:	The Aster has died off over winter and reveals a dormant <i>Bolboschoenus cardwellii</i> . <i>Casuarina glauca</i> is also viable in the foreground. Both <i>Melaleuca quinquenervia</i> , some measuring 1.5m in height, and <i>Casuarina glauca</i> surround this quadrat in the hundreds. The entire surrounds are very weed free.		
Native species:	<i>Bolboschoenus cardwellii</i> , <i>Eleocharis dulcis</i> , <i>Ludwigia octovalvis</i> , <i>Juncus prismatacarpa</i> , <i>Fimbistylis furruginia</i> , <i>Casuarina glauca</i>		
Weed species:	<i>Aster subulatus</i> , <i>Cuphea carthagenesis</i>		
Damage:	Nil		
Native dominance:	75%	Percentage vegetation cover:	80%
Photo:

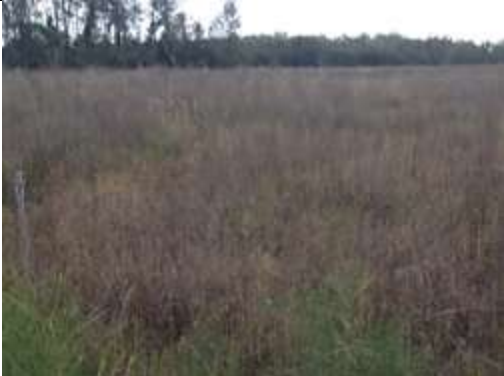
Monitoring month:	13	Months since direct seeding:	18
Date:	September 2016		
Comments:	Aster die-off is still evident this month. <i>Casuarina glauca</i> is also viable in the foreground. Both <i>Melaleuca quinquenervia</i> , and <i>Casuarina glauca</i> surround this quadrat in the hundreds.		
Native species:	<i>Bolboschoenus cardwellii</i> , <i>Eleocharis dulcis</i> , <i>Ludwigia octovalvis</i> , <i>Juncus prismatacarpa</i> , <i>Fimbistylis furruginia</i> , <i>Casuarina glauca</i>		
Weed species:	<i>Aster subulatus</i> , <i>Cuphea carthagenesis</i>		
Damage:	Nil		
Native dominance:	75%	Percentage vegetation cover:	80%
Photo:

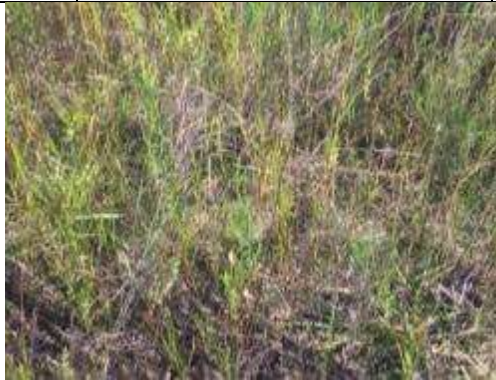
Monitoring month:	14	Months since direct seeding:	19
Date:	October 2016		
Comments:	Surrounding areas still remain relatively weed free. <i>Bolboschoenus cardwellii</i> still progressive in growth.		
Native species:	<i>Bolboschoenus cardwellii</i> , <i>Eleocharis dulcis</i> , <i>Ludwigia octovalvis</i> , <i>Juncus prismatacarpa</i> , <i>Fimbistylis furruginia</i> , <i>Casuarina glauca</i>		
Weed species:	<i>Aster subulatus</i> , <i>Cuphea carthagenesis</i>		
Damage:	Nil		
Native dominance:	75%	Percentage vegetation cover:	80%
Photo:

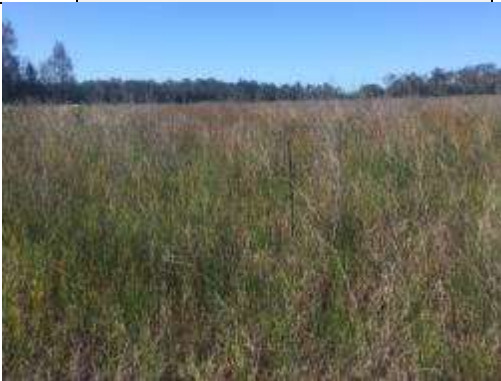
Monitoring month:	15	Months since direct seeding:	20
Date:	November 2016		
Comments:	Aster growth is starting to increase with the rise in temperatures.		
Native species:	<i>Bolboschoenus cardwellii</i> , <i>Eleocharis dulcis</i> , <i>Ludwigia octovalvis</i> , <i>Juncus prismatacarpa</i> , <i>Fimbistylis furruginia</i> , <i>Casuarina glauca</i>		
Weed species:	<i>Aster subulatus</i> , <i>Cuphea carthagenesis</i>		
Damage:	Nil		
Native dominance:	70%	Percentage vegetation cover:	90%
Photo:

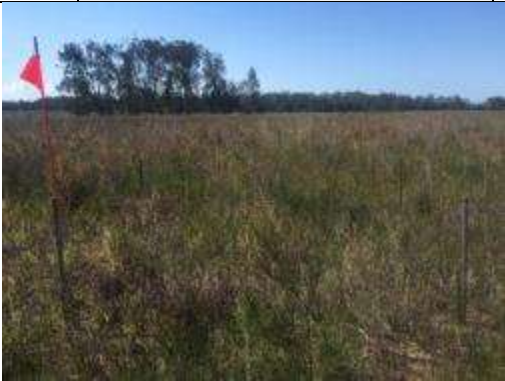
Monitoring month:	16	Months since direct seeding:	21
Date:	December 2016		
Comments:	A high visibility flag and extended pole was added to the quadrat stake this month for ease of identification. Groundsel has been identified within this quadrat this month.		
Native species:	<i>Bolboschoenus cardwellii</i> , <i>Eleocharis dulcis</i> , <i>Ludwigia octovalvis</i> , <i>Juncus prismatacarpa</i> , <i>Fimbistylis furruginia</i> , <i>Casuarina glauca</i>		
Weed species:	<i>Aster subulatus</i> , <i>Cuphea carthagenesis</i> , <i>Baccharis halimifolia</i> *		
Damage:	Nil		
Native dominance:	70%	Percentage vegetation cover:	90%
Photo:

* Weed species requires complete eradication to meet the Desired Environmental Outcomes.

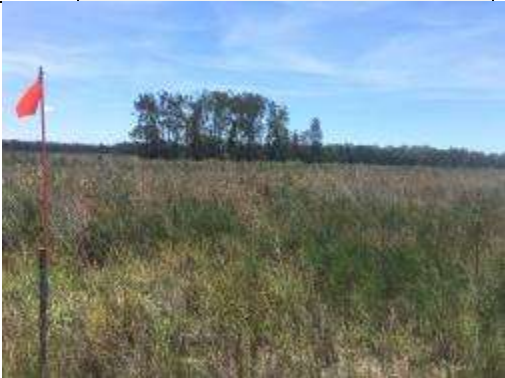
Monitoring month:	17	Months since direct seeding:	22
Date:	January 2017		
Comments:	Groundsel treatment within this quadrat has been successful. No living foliage was identified this month. Casuarina continues to dominate, approximately 1m in height.		
Native species:	<i>Bolboschoenus cardwellii</i> , <i>Eleocharis dulcis</i> , <i>Ludwigia octovalvis</i> , <i>Juncus prismatacarpa</i> , <i>Fimbistylis furruginia</i> , <i>Casuarina glauca</i>		
Weed species:	<i>Aster subulatus</i> , <i>Cuphea carthagenesis</i>		
Damage:	Nil		
Native dominance:	75%	Percentage vegetation cover:	90%
Photo:

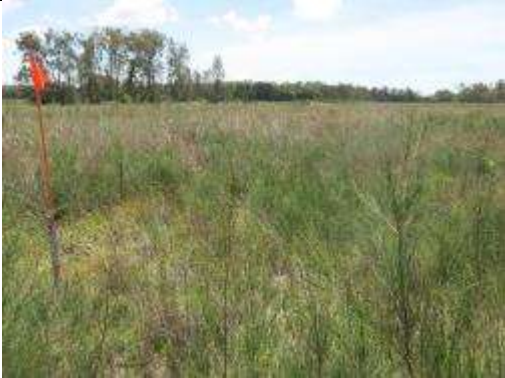
Monitoring month:	18	Months since direct seeding:	23
Date:	February 2017		
Comments:	The dominating weed species Aster has died down revealing the true abundance of <i>Casuarina glauca</i> in this area.		
Native species:	<i>Bolboschoenus cardwellii</i> , <i>Eleocharis dulcis</i> , <i>Ludwigia octovalvis</i> , <i>Juncus prismatacarpa</i> , <i>Fimbistylis furruginia</i> , <i>Casuarina glauca</i>		
Weed species:	<i>Cuphea carthagenesis</i> , <i>Paspalum dilatatum</i>		
Damage:	Nil		
Native dominance:	75%	Percentage vegetation cover:	90%
Photo:

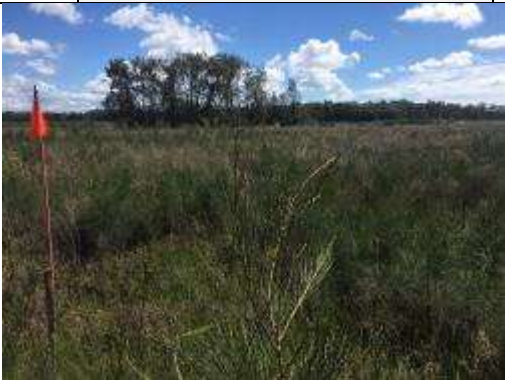
Monitoring month:	19	Months since direct seeding:	24
Date:	March 2017 (NB: monitoring event occurred early April due to inaccessibility)		
Comments:	During the last half of this month, the NWCP received significant rainfall. Access to the area was limited. Much of the area is waterlogged and functioning as the wetland it is designed to be. Whilst not visible within the photo, the entire quadrat is covered by approximately 2cm of water. Casuarinas continue to grow well, averaging 1.8m.		
Native species:	<i>Bolboschoenus cardwellii</i> , <i>Eleocharis dulcis</i> , <i>Ludwigia octovalvis</i> , <i>Juncus prismatacarpa</i> , <i>Fimbistylis furruginia</i> , <i>Casuarina glauca</i>		
Weed species:	<i>Cuphea carthagenesis</i> , <i>Paspalum dilatatum</i>		
Damage:	Nil		
Native dominance:	75%	Percentage vegetation cover:	90%
Photo:

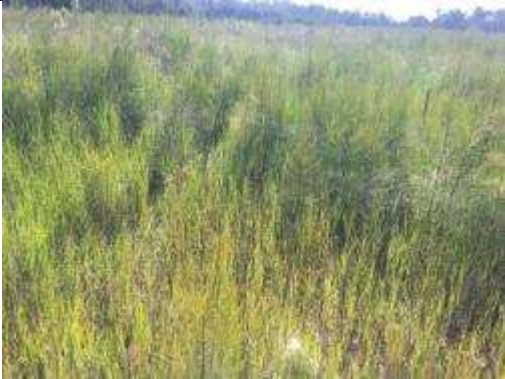
Monitoring month:	20	Months since direct seeding:	25
Date:	April 2017		
Comments:	Casuarinas continue to grow well, averaging 1.8m. Sedges continue to prosper and dominate the quadrat.		
Native species:	<i>Bolboschoenus cardwellii</i> , <i>Eleocharis dulcis</i> , <i>Ludwigia octovalvis</i> , <i>Juncus prismatacarpa</i> , <i>Fimbistylis furruginia</i> , <i>Casuarina glauca</i>		
Weed species:	<i>Cuphea carthagenesis</i> , <i>Paspalum dilatatum</i>		
Damage:	Nil		
Native dominance:	75%	Percentage vegetation cover:	90%
Photo:

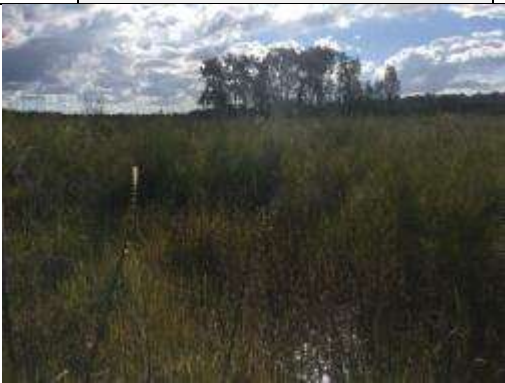
Monitoring month:	21	Months since direct seeding:	26
Date:	May 2017		
Comments:	Waterlogging is still evident during this monitoring month. No change in casuarina height. Wetland sedge species continue to prosper.		
Native species:	<i>Bolboschoenus cardwellii</i> , <i>Eleocharis dulcis</i> , <i>Ludwigia octovalvis</i> , <i>Juncus prismatacarpa</i> , <i>Fimbistylis furruginia</i> , <i>Casuarina glauca</i>		
Weed species:	<i>Cuphea carthagenesis</i> , <i>Paspalum dilatatum</i>		
Damage:	Nil		
Native dominance:	75%	Percentage vegetation cover:	90%
Photo:

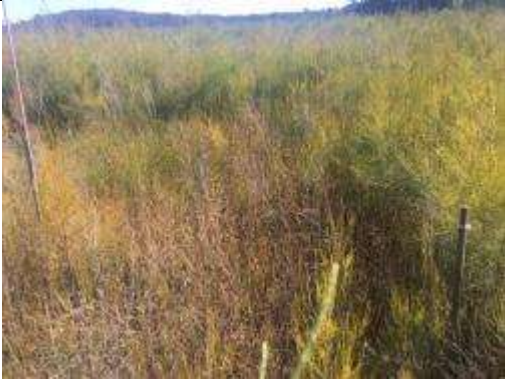
Monitoring month:	22	Months since direct seeding:	27
Date:	June 2017		
Comments:	No significant changes this month. It is anticipated growth will slow moving into the colder months.		
Native species:	<i>Bolboschoenus cardwellii</i> , <i>Eleocharis dulcis</i> , <i>Ludwigia octovalvis</i> , <i>Juncus prismatacarpa</i> , <i>Fimbistylis furruginea</i> , <i>Casuarina glauca</i>		
Weed species:	<i>Cuphea carthagenesis</i> , <i>Paspalum dilatatum</i>		
Damage:	Nil		
Native dominance:	75%	Percentage vegetation cover:	90%
Photo:

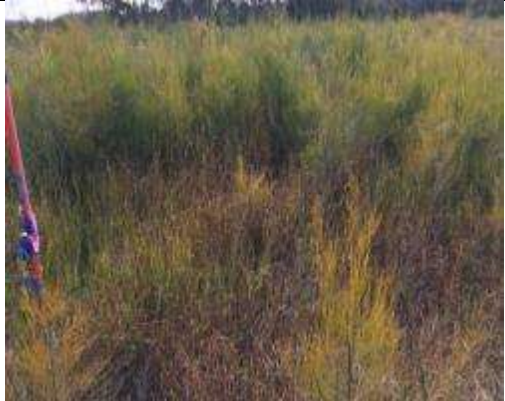
Monitoring month:	23	Months since direct seeding:	28
Date:	July 2017		
Comments:	An additional length of conduit was added to the flagging pole this month due to the increasing height of vegetation. Vegetation health is steady.		
Native species:	<i>Bolboschoenus cardwellii</i> , <i>Eleocharis dulcis</i> , <i>Ludwigia octovalvis</i> , <i>Juncus prismatacarpa</i> , <i>Fimbistylis furruginea</i> , <i>Casuarina glauca</i>		
Weed species:	<i>Cuphea carthagenesis</i> , <i>Paspalum dilatatum</i>		
Damage:	Nil		
Native dominance:	80%	Percentage vegetation cover:	90%
Photo:

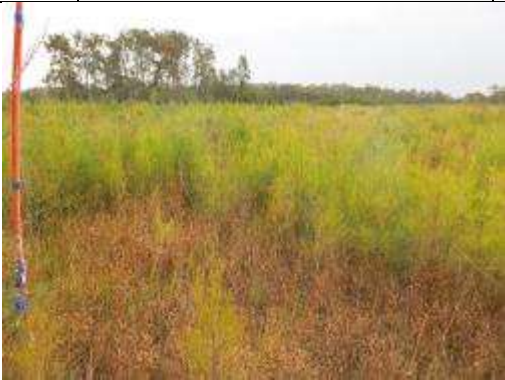
Monitoring month:	24	Months since direct seeding:	29
Date:	August 2017		
Comments:	Weed growth is struggling against the ongoing growth and dominance of native species, such as casuarina.		
Native species:	<i>Bolboschoenus cardwellii</i> , <i>Eleocharis dulcis</i> , <i>Ludwigia octovalvis</i> , <i>Juncus prismatacarpa</i> , <i>Fimbistylis furruginia</i> , <i>Casuarina glauca</i>		
Weed species:	<i>Cuphea carthagenesis</i> , <i>Paspalum dilatatum</i>		
Damage:	Nil		
Native dominance:	85%	Percentage vegetation cover:	90%
Photo:

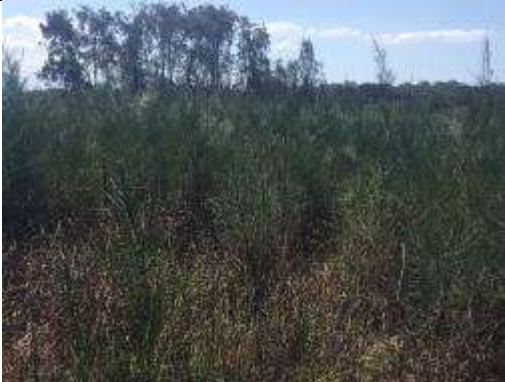
Monitoring month:	25	Months since direct seeding:	30
Date:	September 2017		
Comments:	Vegetation health is steady.		
Native species:	<i>Bolboschoenus cardwellii</i> , <i>Eleocharis dulcis</i> , <i>Ludwigia octovalvis</i> , <i>Juncus prismatacarpa</i> , <i>Fimbistylis furruginia</i> , <i>Casuarina glauca</i>		
Weed species:	<i>Cuphea carthagenesis</i> , <i>Paspalum dilatatum</i>		
Damage:	Nil		
Native dominance:	85%	Percentage vegetation cover:	90%
Photo:

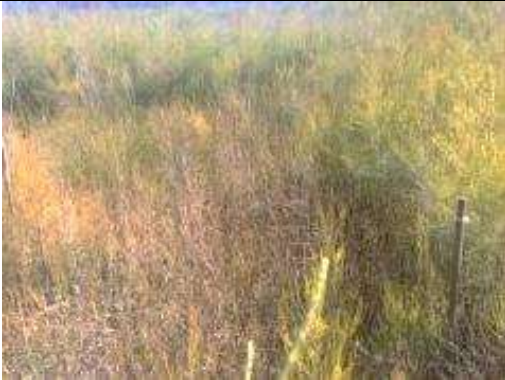
Monitoring month:	26	Months since direct seeding:	31
Date:	October 2017		
Comments:	Vegetation health is steady.		
Native species:	<i>Bolboschoenus cardwellii</i> , <i>Eleocharis dulcis</i> , <i>Ludwigia octovalvis</i> , <i>Juncus prismatacarpa</i> , <i>Fimbistylis furruginia</i> , <i>Casuarina glauca</i>		
Weed species:	<i>Cuphea carthagenesis</i> , <i>Paspalum dilatatum</i>		
Damage:	Nil		
Native dominance:	85%	Percentage vegetation cover:	90%
Photo:

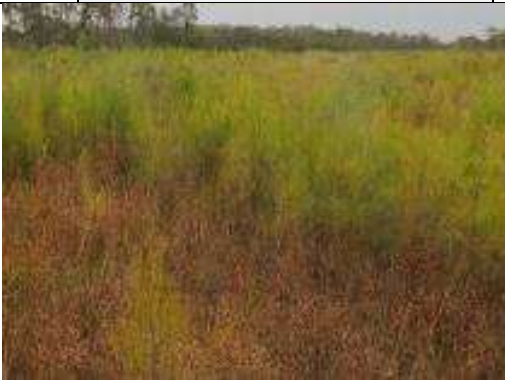
Monitoring month:	27	Months since direct seeding:	32
Date:	November 2017		
Comments:	<i>Casuarina glauca</i> continues to emerge, slowly increasing in dominance.		
Native species:	<i>Bolboschoenus cardwellii</i> , <i>Eleocharis dulcis</i> , <i>Ludwigia octovalvis</i> , <i>Juncus prismatacarpa</i> , <i>Fimbistylis furruginia</i> , <i>Casuarina glauca</i>		
Weed species:	<i>Cuphea carthagenesis</i> , <i>Paspalum dilatatum</i>		
Damage:	Nil		
Native dominance:	85%	Percentage vegetation cover:	90%
Photo:

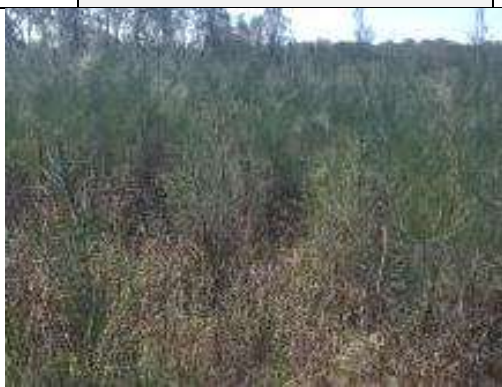
Monitoring month:	28	Months since direct seeding:	33
Date:	December 2017		
Comments:	A moderate level of rain was received at the end of last month and the end of this month. Coupled with the increasing temperatures, <i>Casuarina glauca</i> biomass has significantly increased.		
Native species:	<i>Bolboschoenus cardwellii</i> , <i>Eleocharis dulcis</i> , <i>Ludwigia octovalvis</i> , <i>Juncus prismatacarpa</i> , <i>Fimbistylis furruginia</i> , <i>Casuarina glauca</i>		
Weed species:	<i>Cuphea carthagenesis</i> , <i>Paspalum dilatatum</i>		
Damage:	Nil		
Native dominance:	85%	Percentage vegetation cover:	90%
Photo:

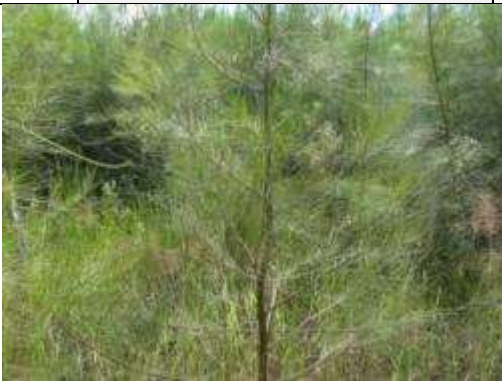
Monitoring month:	29	Months since direct seeding:	34
Date:	January 2018		
Comments:	Canopy growth continues to progressively shade out weed species, reducing diversity and abundance of weeds.		
Native species:	<i>Bolboschoenus cardwellii</i> , <i>Eleocharis dulcis</i> , <i>Ludwigia octovalvis</i> , <i>Juncus prismatacarpa</i> , <i>Fimbistylis furruginia</i> , <i>Casuarina glauca</i>		
Weed species:	<i>Paspalum dilatatum</i>		
Damage:	Nil		
Native dominance:	95%	Percentage vegetation cover:	95%
Photo:

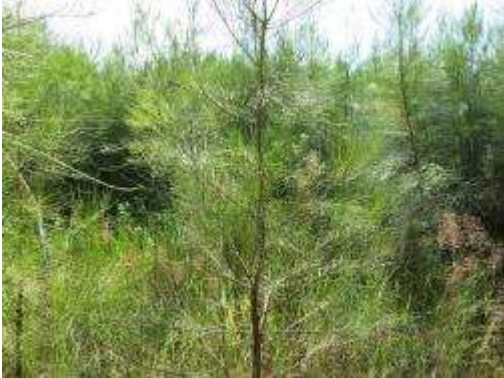
Monitoring month:	30	Months since direct seeding:	35
Date:	February 2018		
Comments:	<i>Casuarina glauca</i> growth continues to increase in height and biomass.		
Native species:	<i>Bolboschoenus cardwellii</i> , <i>Eleocharis dulcis</i> , <i>Ludwigia octovalvis</i> , <i>Juncus prismatacarpa</i> , <i>Fimbistylis furruginia</i> , <i>Casuarina glauca</i>		
Weed species:	<i>Paspalum dilatatum</i>		
Damage:	Nil		
Native dominance:	95%	Percentage vegetation cover:	95%
Photo:

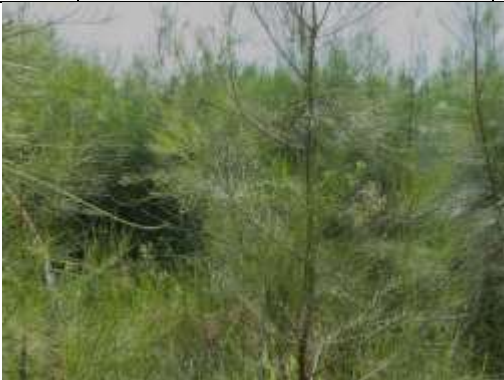
Monitoring month:	31	Months since direct seeding:	36
Date:	March 2018		
Comments:	A significant amount of rain fell at the end of last month resulting in standing water for approximately 3 weeks. This has acted as a natural weed control for a number of the weed species. Canopy growth and shading has also assisted in a reduction of weed growth.		
Native species:	<i>Bolboschoenus cardwellii</i> , <i>Eleocharis dulcis</i> , <i>Ludwigia octovalvis</i> , <i>Juncus prismatacarpa</i> , <i>Fimbistylis furruginia</i> , <i>Casuarina glauca</i>		
Weed species:	Nil		
Damage:	Nil		
Native dominance:	100%	Percentage vegetation cover:	100%
Photo:

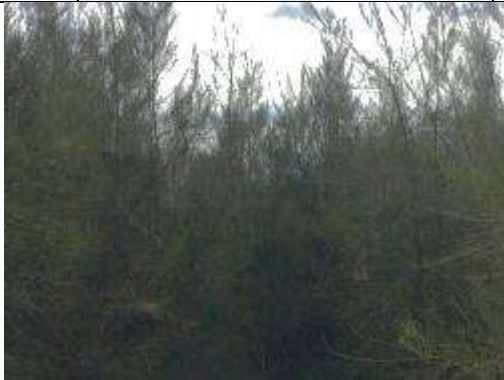
Monitoring month:	32	Months since direct seeding:	37
Date:	April 2018		
Comments:	Canopy growth continues to progressively shade out weed species, reducing diversity and abundance of weeds.		
Native species:	<i>Bolboschoenus cardwellii</i> , <i>Eleocharis dulcis</i> , <i>Ludwigia octovalvis</i> , <i>Juncus prismatacarpa</i> , <i>Fimbistylis furruginia</i> , <i>Casuarina glauca</i>		
Weed species:	Nil		
Damage:	Nil		
Native dominance:	100%	Percentage vegetation cover:	100%
Photo:

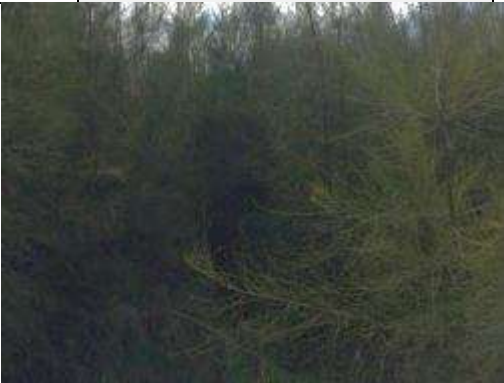
Monitoring month:	33	Months since direct seeding:	38
Date:	May 2018		
Comments:	<i>Casuarina glauca</i> growth continues to increase in height and biomass.		
Native species:	<i>Bolboschoenus cardwellii</i> , <i>Eleocharis dulcis</i> , <i>Ludwigia octovalvis</i> , <i>Juncus prismatacarpa</i> , <i>Fimbistylis furruginia</i> , <i>Casuarina glauca</i>		
Weed species:	Nil		
Damage:	Nil		
Native dominance:	100%	Percentage vegetation cover:	100%
Photo:

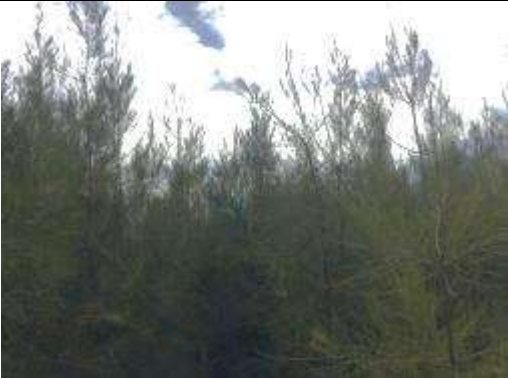
Monitoring month:	34	Months since direct seeding:	39
Date:	June 2018		
Comments:	No significant changes this month due to the slowing down of the growing season.		
Native species:	<i>Bolboschoenus cardwellii</i> , <i>Eleocharis dulcis</i> , <i>Ludwigia octovalvis</i> , <i>Juncus prismatacarpa</i> , <i>Fimbistylis furruginia</i> , <i>Casuarina glauca</i>		
Weed species:	Nil		
Damage:	Nil		
Native dominance:	100%	Percentage vegetation cover:	100%
Photo:

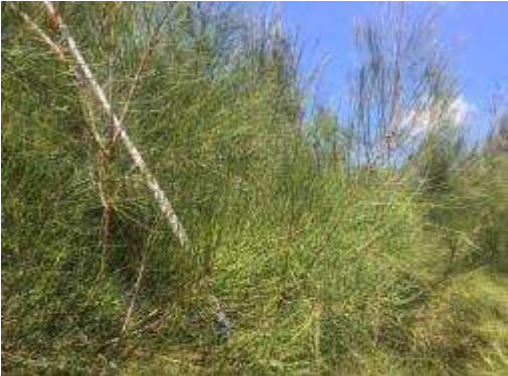
Monitoring month:	35	Months since direct seeding:	40
Date:	July 2018		
Comments:	Species diversity is declining due to the allelopathic properties of <i>Casuarina glauca</i> .		
Native species:	<i>Bolboschoenus cardwellii</i> , <i>Eleocharis dulcis</i> , <i>Ludwigia octovalvis</i> , <i>Juncus prismatacarpa</i> , <i>Casuarina glauca</i>		
Weed species:	Nil		
Damage:	Nil		
Native dominance:	100%	Percentage vegetation cover:	100%
Photo:

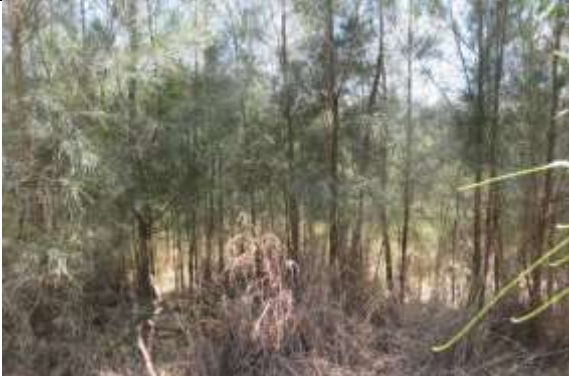
Monitoring month:	36	Months since direct seeding:	41
Date:	August 2018		
Comments:	A drop in diversity was notable this month as the canopy continues to develop. Native dominance remains unchanged as biomass has continued to increase.		
Native species:	<i>Bolboschoenus cardwellii</i> , <i>Eleocharis dulcis</i> , <i>Leersia hexandra</i> , <i>Juncus usitatus</i> , <i>Casuarina glauca</i>		
Weed species:	Nil		
Damage:	Nil		
Native dominance:	100%	Percentage vegetation cover:	100%
Photo:

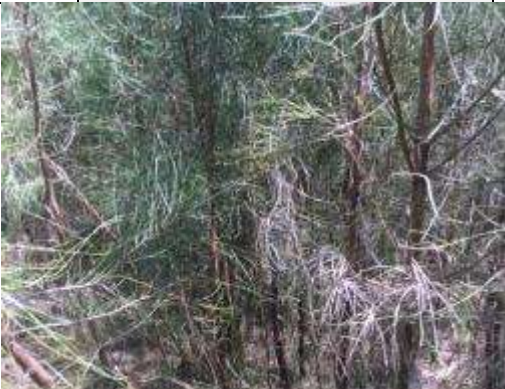
Monitoring month:	37	Months since direct seeding:	42
Date:	September 2018		
Comments:	No significant changes this month. Myrtle rust still evident in the surrounding area.		
Native species:	<i>Bolboschoenus cardwellii</i> , <i>Eleocharis dulcis</i> , <i>Leersia hexandra</i> , <i>Juncus usitatus</i> , <i>Casuarina glauca</i>		
Weed species:	Nil		
Damage:	Nil		
Native dominance:	100%	Percentage vegetation cover:	100%
Photo:

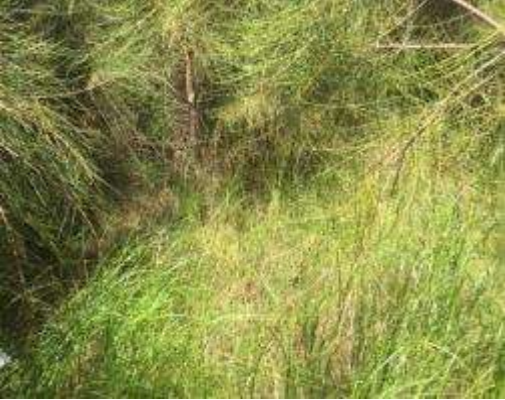
Monitoring month:	38	Months since direct seeding:	43
Date:	October 2018		
Comments:	Rainfall occurred throughout the area during this month which has assisted with the increase in biomass.		
Native species:	<i>Bolboschoenus cardwellii</i> , <i>Eleocharis dulcis</i> , <i>Leersia hexandra</i> , <i>Juncus usitatus</i> , <i>Casuarina glauca</i>		
Weed species:	Nil		
Damage:	Nil		
Native dominance:	100%	Percentage vegetation cover:	100%
Photo:

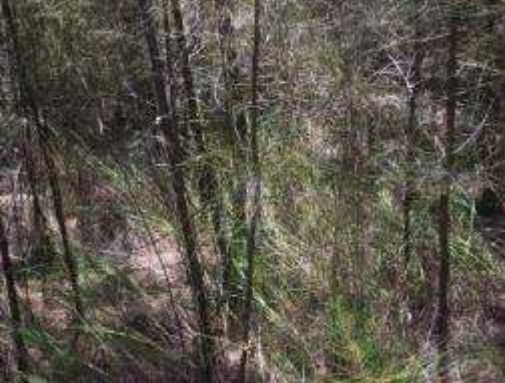
Monitoring month:	39	Months since direct seeding:	44
Date:	November 2018		
Comments:	Rapidly increasing temperatures were experienced this month resulting in the exponential growth of vegetation.		
Native species:	<i>Bolboschoenus cardwellii</i> , <i>Eleocharis dulcis</i> , <i>Leersia hexandra</i> , <i>Juncus usitatus</i> , <i>Casuarina glauca</i>		
Weed species:	Nil		
Damage:	Nil		
Native dominance:	100%	Percentage vegetation cover:	100%
Photo:

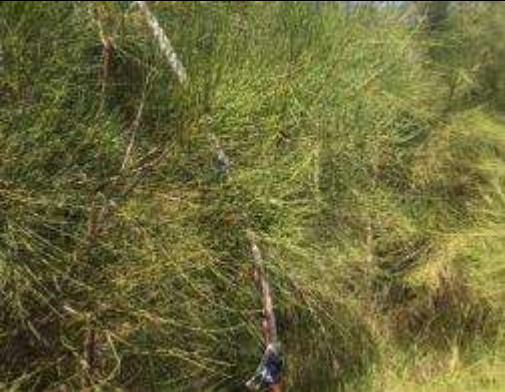
Monitoring month:	40	Months since direct seeding:	45
Date:	December 2018		
Comments:	Vegetation growth was steady this month.		
Native species:	<i>Bolboschoenus cardwellii</i> , <i>Eleocharis dulcis</i> , <i>Leersia hexandra</i> , <i>Juncus usitatus</i> , <i>Casuarina glauca</i>		
Weed species:	Nil		
Damage:	Nil		
Native dominance:	100%	Percentage vegetation cover:	100%
Photo:

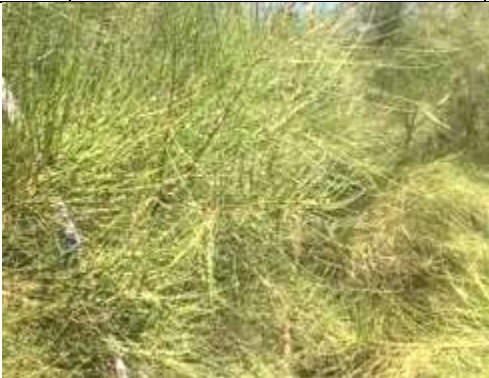
Monitoring month:	41	Months since direct seeding:	46
Date:	January 2019		
Comments:	No significant changes this month.		
Native species:	<i>Bolboschoenus cardwellii</i> , <i>Eleocharis dulcis</i> , <i>Leersia hexandra</i> , <i>Juncus usitatus</i> , <i>Casuarina glauca</i>		
Weed species:	Nil		
Damage:	Nil		
Native dominance:	100%	Percentage vegetation cover:	100%
Photo:

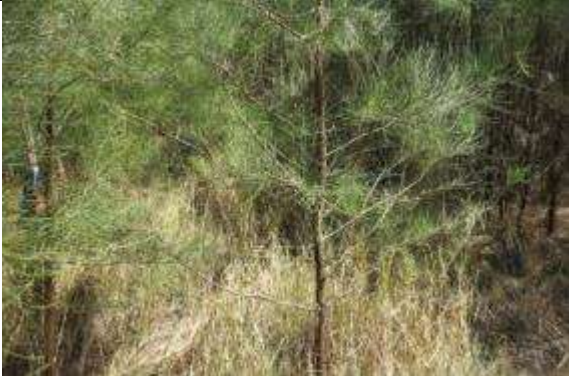
Monitoring month:	42	Months since direct seeding:	47
Date:	February 2019		
Comments:	There is no change in vegetation cover or native dominance; however there has been a decrease in native diversity.		
Native species:	<i>Bolboschoenus cardwellii</i> , <i>Eleocharis dulcis</i> , <i>Leersia hexandra</i> , <i>Juncus usitatus</i> , <i>Casuarina glauca</i>		
Weed species:	Nil		
Damage:	Nil		
Native dominance:	100%	Percentage vegetation cover:	100%
Photo:

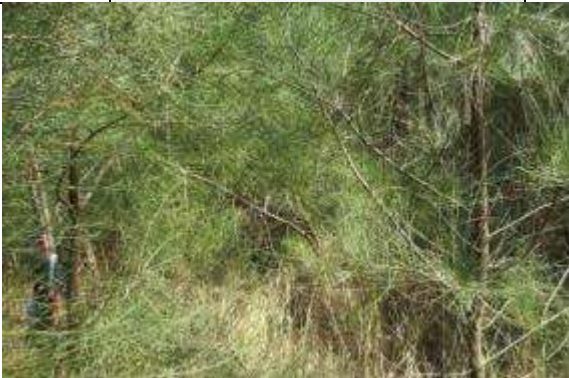
Monitoring month:	43	Months since direct seeding:	48
Date:	March 2019		
Comments:	Vegetation growth was steady this month.		
Native species:	<i>Bolboschoenus cardwellii</i> , <i>Eleocharis dulcis</i> , <i>Leersia hexandra</i> , <i>Juncus usitatus</i> , <i>Casuarina glauca</i>		
Weed species:	Nil		
Damage:	Nil		
Native dominance:	100%	Percentage vegetation cover:	100%
Photo:

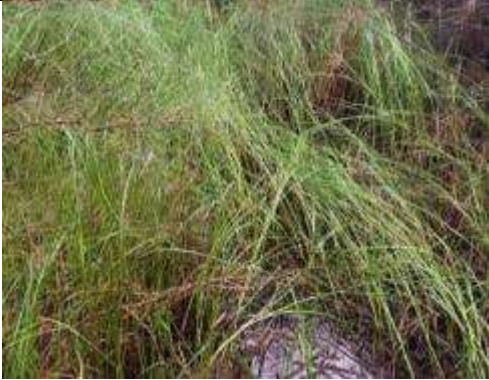
Monitoring month:	44	Months since direct seeding:	49
Date:	April 2019		
Comments:	Rainfall events increased late last month and continued this month giving the NWCP a much needed watering.		
Native species:	<i>Bolboschoenus cardwellii</i> , <i>Eleocharis dulcis</i> , <i>Leersia hexandra</i> , <i>Juncus usitatus</i> , <i>Casuarina glauca</i>		
Weed species:	Nil		
Damage:	Nil		
Native dominance:	100%	Percentage vegetation cover:	100%
Photo:

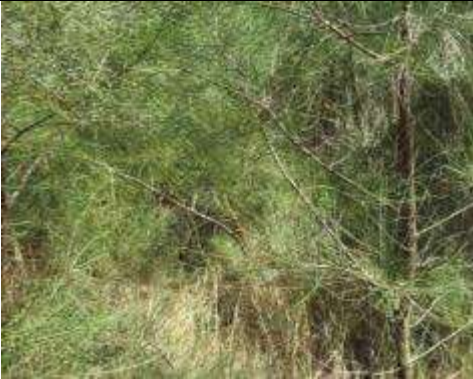
Monitoring month:	45	Months since direct seeding:	50
Date:	May 2019		
Comments:	<i>Casuarina glauca</i> continues to add biomass.		
Native species:	<i>Bolboschoenus cardwellii</i> , <i>Eleocharis dulcis</i> , <i>Leersia hexandra</i> , <i>Juncus usitatus</i> , <i>Casuarina glauca</i>		
Weed species:	Nil		
Damage:	Nil		
Native dominance:	100%	Percentage vegetation cover:	100%
Photo:

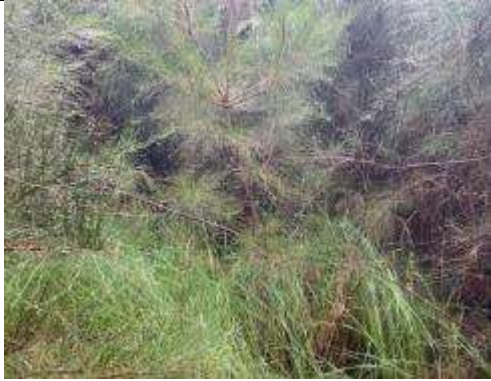
Monitoring month:	46	Months since direct seeding:	51
Date:	June 2019		
Comments:	Rainfall over the past few months has increased plant growth and vigour.		
Native species:	<i>Bolboschoenus cardwellii</i> , <i>Eleocharis dulcis</i> , <i>Juncus usitatus</i> , <i>Casuarina glauca</i>		
Weed species:	Nil		
Damage:	Nil		
Native dominance:	100%	Percentage vegetation cover:	100%
Photo:

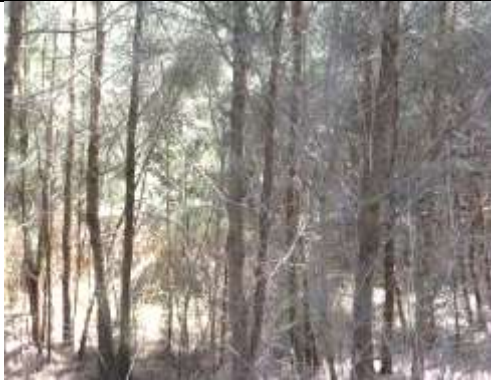
Monitoring month:	47	Months since direct seeding:	52
Date:	July 2019		
Comments:	Casuarina growth steady. One native species not identified during this assessment.		
Native species:	<i>Bolboschoenus cardwellii</i> , <i>Juncus usitatus</i> , <i>Casuarina glauca</i>		
Weed species:	Nil		
Damage:	Nil		
Native dominance:	100%	Percentage vegetation cover:	100%
Photo:

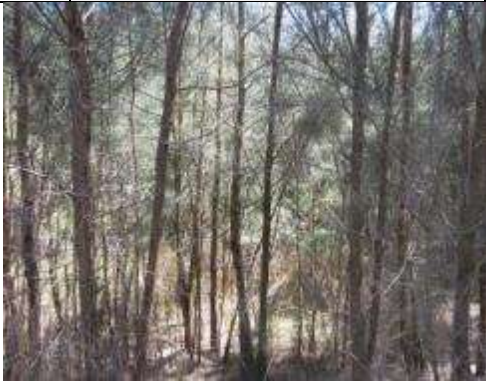
Monitoring month:	48	Months since direct seeding:	53
Date:	August 2019		
Comments:	Species diversity continues to decline as the depth of casuarina leaf litter increases and prevents the establishment of groundcovers. Whilst diversity has declined, dominance has remained unchanged.		
Native species:	<i>Bolboschoenus cardwellii</i> , <i>Casuarina glauca</i>		
Weed species:	Nil		
Damage:	Nil		
Native dominance:	100%	Percentage vegetation cover:	100%
Photo:

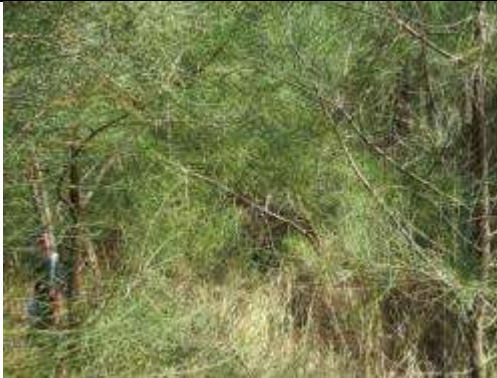
Monitoring month:	49	Months since direct seeding:	54
Date:	September 2019		
Comments:	Allelopathic properties of the casuarina leaf litter is still supressing species diversity.		
Native species:	<i>Bolboschoenus cardwellii</i> , <i>Casuarina glauca</i>		
Weed species:	Nil		
Damage:	Nil		
Native dominance:	100%	Percentage vegetation cover:	100%
Photo:

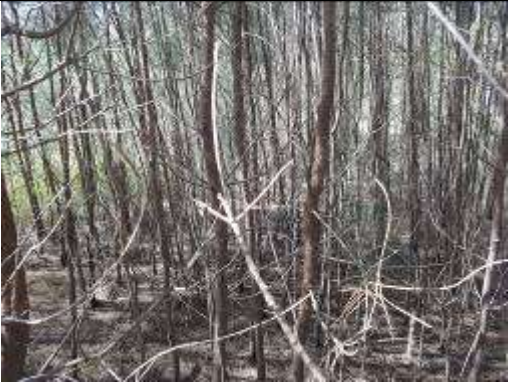
Monitoring month:	50	Months since direct seeding:	55
Date:	October 2019		
Comments:	Extended drought conditions are starting to take their toll with the extreme slowing of plant growth.		
Native species:	<i>Bolboschoenus cardwellii</i> , <i>Casuarina glauca</i>		
Weed species:	Nil		
Damage:	Nil		
Native dominance:	100%	Percentage vegetation cover:	100%
Photo:

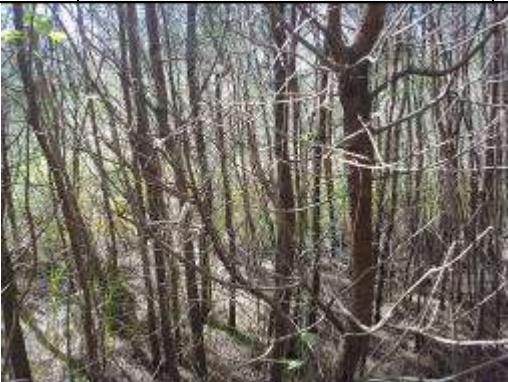
Monitoring month:	51	Months since direct seeding:	56
Date:	November 2019		
Comments:	Growth steady.		
Native species:	<i>Bolboschoenus cardwellii</i> , <i>Casuarina glauca</i>		
Weed species:	Nil		
Damage:	Nil		
Native dominance:	100%	Percentage vegetation cover:	100%
Photo:

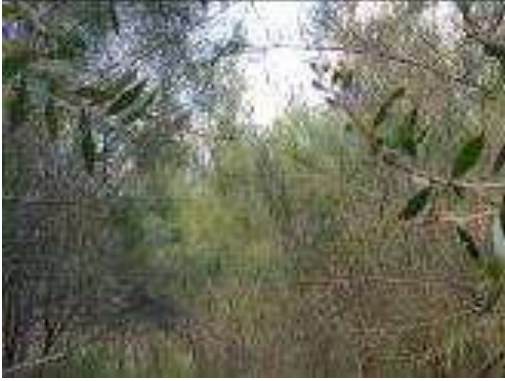
Monitoring month:	52	Months since direct seeding:	57
Date:	December 2019		
Comments:	Biomass of casuarina and melaleuca within and surrounding this quadrat continue to increase.		
Native species:	<i>Bolboschoenus cardwellii</i> , <i>Casuarina glauca</i>		
Weed species:	Nil		
Damage:	Nil		
Native dominance:	100%	Percentage vegetation cover:	100%
Photo:

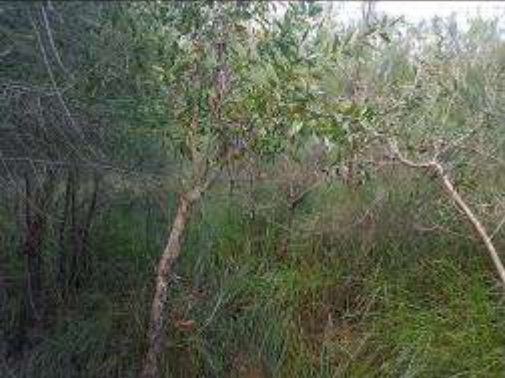
Monitoring month:	53	Months since direct seeding:	58
Date:	January 2020		
Comments:	Vegetation community structure continues to strengthen.		
Native species:	<i>Bolboschoenus cardwellii</i> , <i>Casuarina glauca</i>		
Weed species:	Nil		
Damage:	Nil		
Native dominance:	100%	Percentage vegetation cover:	100%
Photo:

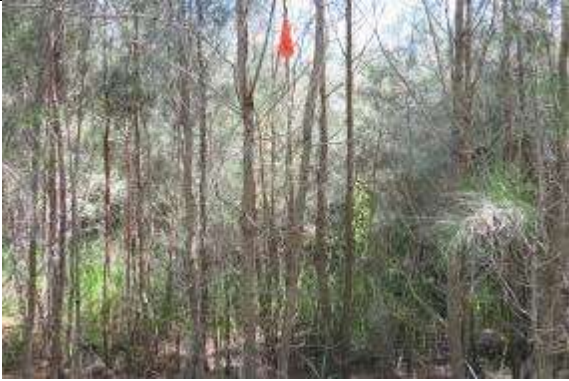
Monitoring month:	54	Months since direct seeding:	59
Date:	February 2020		
Comments:	<i>Bolboschoenus cardwellii</i> has increased in biomass due to rainfall during this month.		
Native species:	<i>Bolboschoenus cardwellii</i> , <i>Casuarina glauca</i>		
Weed species:	Nil		
Damage:	Nil		
Native dominance:	100%	Percentage vegetation cover:	100%
Photo:

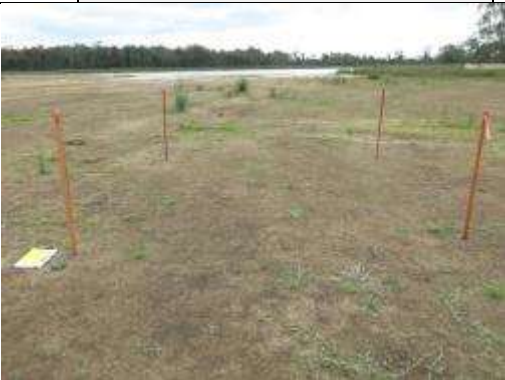
Monitoring month:	1	Months since direct seeding:	6
Date:	September 2015		
Comments:	There are literally hundreds of tree seedlings (predominately <i>Casuarina glauca</i>) surrounding this quadrat. The one exotic species is rye grass, not of concern. A <i>Livistona</i> seedling exists in the centre of the quadrat.		
Native species:	<i>Microleana stipoides</i> , <i>Ludwigia octovalvis</i> , <i>Livistona australis</i>		
Weed species:	<i>Lolium multiflorum</i> , <i>Cynodon dactylon</i>		
Damage:	Nil		
Native dominance:	80%	Percentage vegetation cover:	3%
Photo:

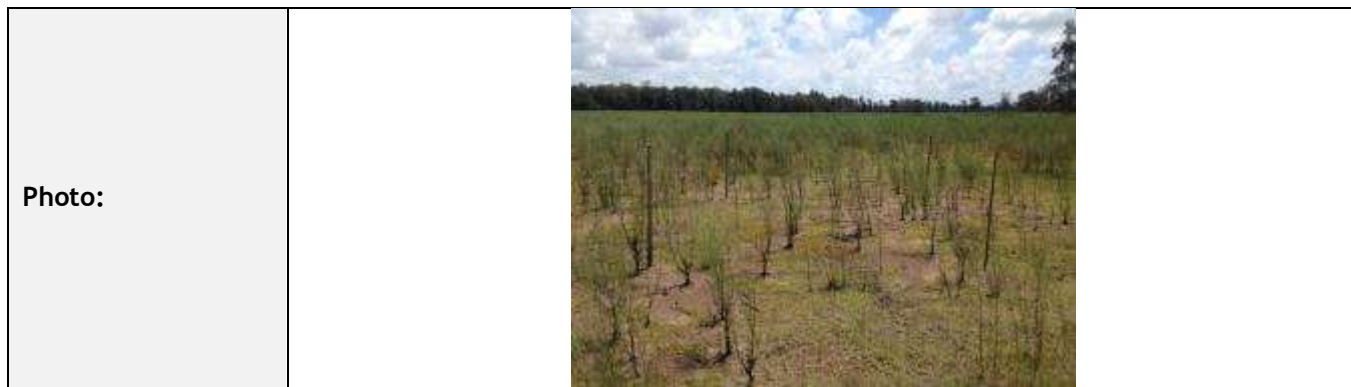
Monitoring month:	6	Months since direct seeding:	11
Date:	February 2016		
Comments:	There are literally hundreds of tree seedlings surrounding this quadrat. In surrounding areas several new species were observed germinating, small clusters of Eucalyptus, also <i>Canavalia rosea, Acacia concurrens, Hibiscus diversifolium, Corymbia intermedia</i> . These may be vulnerable if the area is inundated for long periods. This increase in eucalypts and the like can be attributed to over-seeding works undertaken in October. Conditions since then have been dry and this has allowed for the eucalypt seed to prosper.		
Native species:	<i>Microleana stipoides, Ludwigia octovalvis, Livistona australis, Persicaria sp.</i>		
Weed species:	<i>Baccharis halimifolia*</i> , <i>Aster subulatus, Centella asiatica, Cynodon dactylon</i>		
Damage:	Nil		
Native dominance:	50%	Percentage vegetation cover:	18%

* Weed species requires complete eradication to meet the Desired Environmental Outcomes.

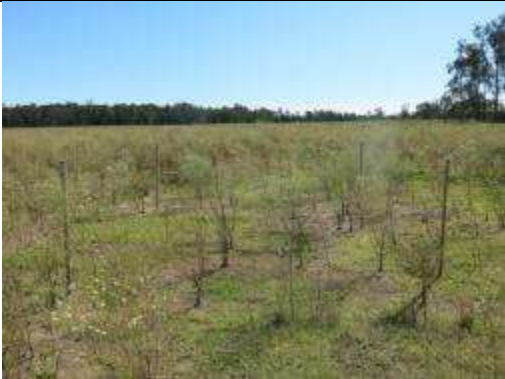
Photo:

Monitoring month:	7	Months since direct seeding:	12
Date:	March 2016		
Comments:	There are literally hundreds of tree seedlings surrounding this quadrat. 11 <i>Casuarina glauca</i> seedlings exist within the quadrat, where there were none 6 weeks ago. <i>Lomandra longifolia</i> is becoming common in the surrounds, and small Groundsel (<i>Baccharis halimifolia</i>) plants were seen that had not been noticed before. The small <i>Livistona australis</i> seedlings in this area, a native canopy tree, seem to be struggling and lacking vigour.		
Native species:	<i>Microleana stipoides</i> , <i>Ludwigia octovalvis</i> , <i>Livistona australis</i> , <i>Persicaria sp.</i> , <i>Casuarina glauca</i>		
Weed species:	<i>Baccharis halimifolia</i> *, <i>Aster subulatus</i> . <i>Centella asiatica</i> , <i>Cuphea carthagenesis</i> , <i>Cynodon dactylon</i>		
Damage:	Nil		
Native dominance:	44%	Percentage vegetation cover:	18%

* Weed species requires complete eradication to meet the Desired Environmental Outcomes.

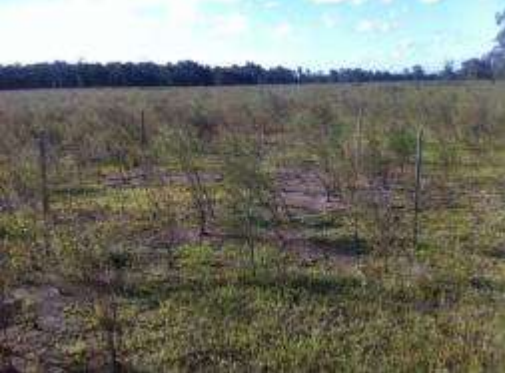
Monitoring month:	8	Months since direct seeding:	13
Date:	April 2016		
Comments:	There are literally hundreds of tree seedlings surrounding this quadrat. 11 <i>Casuarina glauca</i> seedlings exist within the quadrat. <i>Lomandra longifolia</i> is becoming common in the surrounds, and small Groundsel plants, <i>Baccharis halimifolia</i> . The small <i>Livistona australis</i> seedlings in this area, a native canopy tree, continue to progress slowly.		
Native species:	<i>Microleana stipoides</i> , <i>Ludwigia octovalvis</i> , <i>Livistona australis</i> , <i>Persicaria sp.</i> , <i>Casuarina glauca</i>		
Weed species:	<i>Baccharis halimifolia</i> *, <i>Aster subulatus</i> , <i>Centella asiatica</i> , <i>Cuphea carthagenesis</i> , <i>Cynodon dactylon</i>		
Damage:	Nil		
Native dominance:	44%	Percentage vegetation cover:	18%
Photo:

* Weed species requires complete eradication to meet the Desired Environmental Outcomes.

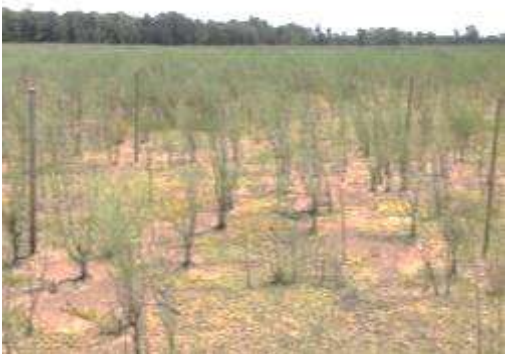
Monitoring month:	9	Months since direct seeding:	14
Date:	May 2016		
Comments:	There has been no significant change within this quadrat. Many <i>Casuarina glauca</i> seedlings are still emerging within the quadrat and surrounds		
Native species:	<i>Microleana stipoides</i> , <i>Ludwigia octovalvis</i> , <i>Livistona australis</i> , <i>Persicaria sp.</i> , <i>Casuarina glauca</i> , <i>Cynodon dactylon</i>		
Weed species:	<i>Baccharis halimifolia</i> *, <i>Aster subulatus</i> , <i>Centella asiatica</i> , <i>Cuphea carthagenesis</i>		
Damage:	Nil		
Native dominance:	44%	Percentage vegetation cover:	25%
Photo:

* Weed species requires complete eradication to meet the Desired Environmental Outcomes.

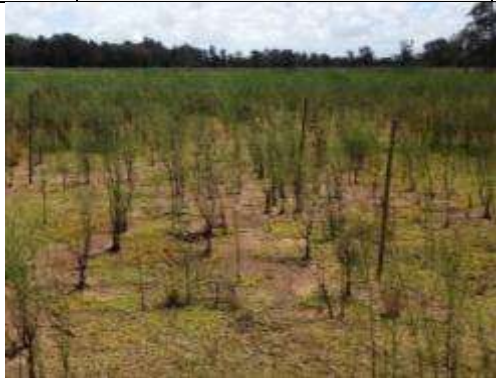
Monitoring month:	10	Months since direct seeding:	15
Date:	June 2016		
Comments:	Aster within this quadrat is showing signs of die-off due to the change in temperature.		
Native species:	<i>Microleana stipoides</i> , <i>Ludwigia octovalvis</i> , <i>Livistona australis</i> , <i>Persicaria sp.</i> , <i>Casuarina glauca</i>		
Weed species:	<i>Baccharis halimifolia</i> *, <i>Aster subulatus</i> , <i>Centella asiatica</i> , <i>Cuphea carthagenesis</i> , <i>Cynodon dactylon</i>		
Damage:	Nil		
Native dominance:	44%	Percentage vegetation cover:	20%
Photo:

* Weed species requires complete eradication to meet the Desired Environmental Outcomes.

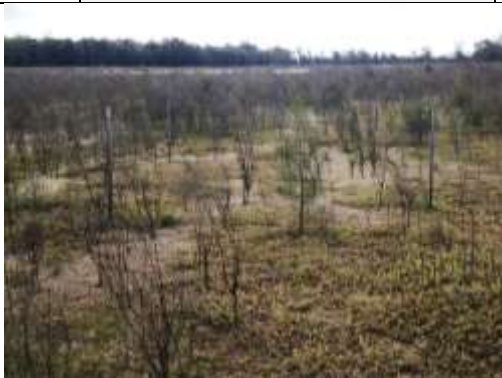
Monitoring month:	11	Months since direct seeding:	16
Date:	July 2016		
Comments:	Signs of winter are becoming more prevalent within this quadrat this month. Groundsel is still present within this quadrat, however is not spreading.		
Native species:	<i>Microleana stipoides</i> , <i>Ludwigia octovalvis</i> , <i>Livistona australis</i> , <i>Persicaria sp.</i> , <i>Casuarina glauca</i>		
Weed species:	<i>Baccharis halimifolia</i> *, <i>Aster subulatus</i> , <i>Centella asiatica</i> , <i>Cuphea carthagenesis</i> , <i>Cynodon dactylon</i>		
Damage:	Nil		
Native dominance:	44%	Percentage vegetation cover:	20%
Photo:

* Weed species requires complete eradication to meet the Desired Environmental Outcomes.

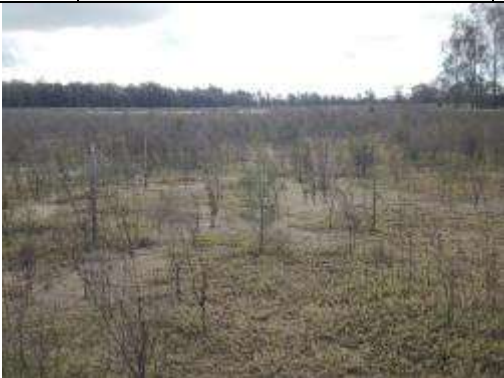
Monitoring month:	12	Months since direct seeding:	17
Date:	August 2016		
Comments:	The evidence of dormancy and wintering is obvious. The <i>Livistona</i> palm within the quad is still alive but struggling, this can be common with <i>Livistona</i> 's. <i>Lomandra longifolia</i> is becoming common in the surrounds; however, they are struggling with lack of oxygen to the root zone.		
Native species:	<i>Microleana stipoides</i> , <i>Ludwigia octovalvis</i> , <i>Livistona australis</i> , <i>Persicaria sp.</i> , <i>Casuarina glauca</i>		
Weed species:	<i>Baccharis halimifolia</i> *, <i>Aster subulatus</i> , <i>Centella asiatica</i> , <i>Cuphea carthagenesis</i> , <i>Cynodon dactylon</i>		
Damage:	Nil		
Native dominance:	44%	Percentage vegetation cover:	25%
Photo:

* Weed species requires complete eradication to meet the Desired Environmental Outcomes.

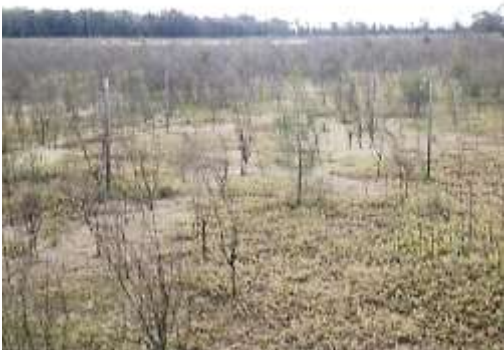
Monitoring month:	13	Months since direct seeding:	18
Date:	September 2016		
Comments:	There is no significant change within this quadrat. It is anticipated that plant growth will increase within the coming months, especially if temperatures continue to rise.		
Native species:	<i>Microleana stipoides</i> , <i>Ludwigia octovalvis</i> , <i>Livistona australis</i> , <i>Persicaria sp.</i> , <i>Casuarina glauca</i>		
Weed species:	<i>Baccharis halimifolia</i> *, <i>Aster subulatus</i> , <i>Centella asiatica</i> , <i>Cuphea carthagenesis</i> , <i>Cynodon dactylon</i>		
Damage:	Nil		
Native dominance:	44%	Percentage vegetation cover:	25%
Photo:

* Weed species requires complete eradication to meet the Desired Environmental Outcomes.

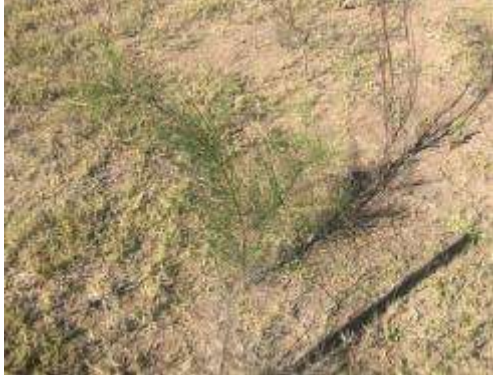
Monitoring month:	14	Months since direct seeding:	19
Date:	October 2016		
Comments:	Green growth on Casuarinas is increasing this month with the rise in temperatures. Overall cover is not increasing, with the area suffering from a lack of water.		
Native species:	<i>Microleana stipoides</i> , <i>Ludwigia octovalvis</i> , <i>Livistona australis</i> , <i>Persicaria sp.</i> , <i>Casuarina glauca</i>		
Weed species:	<i>Baccharis halimifolia</i> *, <i>Aster subulatus</i> , <i>Centella asiatica</i> , <i>Cuphea carthagenesis</i> , <i>Cynodon dactylon</i>		
Damage:	Nil		
Native dominance:	44%	Percentage vegetation cover:	25%
Photo:

* Weed species requires complete eradication to meet the Desired Environmental Outcomes.

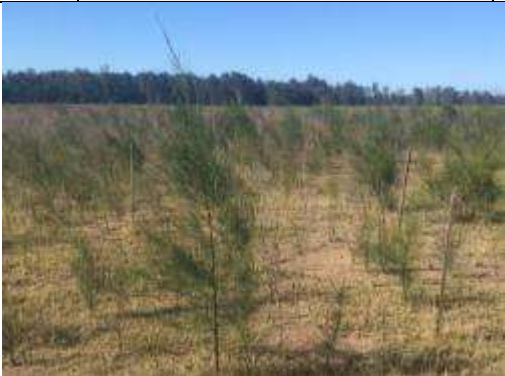
Monitoring month:	15	Months since direct seeding:	20
Date:	November 2016		
Comments:	Casuarina seedlings continue to prosper and grow this month, and remain the dominant native species.		
Native species:	<i>Microleana stipoides</i> , <i>Ludwigia octovalvis</i> , <i>Livistona australis</i> , <i>Persicaria sp.</i> , <i>Casuarina glauca</i>		
Weed species:	<i>Baccharis halimifolia</i> *, <i>Aster subulatus</i> , <i>Centella asiatica</i> , <i>Cuphea carthagenesis</i> , <i>Cynodon dactylon</i>		
Damage:	Nil		
Native dominance:	45%	Percentage vegetation cover:	25%
Photo:

* Weed species requires complete eradication to meet the Desired Environmental Outcomes.
