North-West Conservation Park - Rehabilitation Monitoring

Lot 1 RP48903

North-West Conservation Park
Gainsborough Greens

March 2020

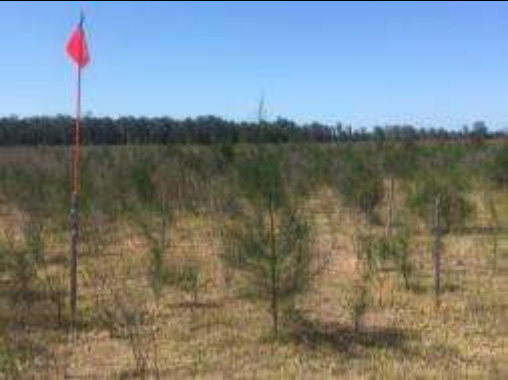
Monitoring month:	16	Months since direct seeding:	21
Date:	December 2016		
Comments:	A high visibility flag and extended pole was added to the quadrat stake this month for ease of identification. Casuarina seedlings continue to prosper and grow this month, and remain the dominant native species.		
Native species:	<i>Microleana stipoides</i> , <i>Ludwigia octovalvis</i> , <i>Livistona australis</i> , <i>Persicaria sp.</i> , <i>Casuarina glauca</i>		
Weed species:	<i>Baccharis halimifolia</i> *, <i>Aster subulatus</i> , <i>Centella asiatica</i> , <i>Cuphea carthagenesis</i> , <i>Cynodon dactylon</i>		
Damage:	Nil		
Native dominance:	45%	Percentage vegetation cover:	25%
Photo:

* Weed species requires complete eradication to meet the Desired Environmental Outcomes.

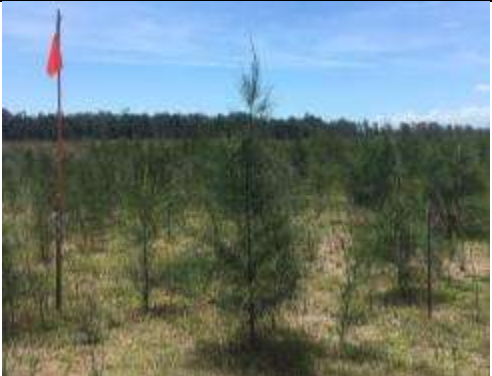
Monitoring month:	17	Months since direct seeding:	22
Date:	January 2017		
Comments:	Casuarina seedlings continue to prosper and grow this month with individuals up to approximately 2.5m in height. Casuarinas remain the dominant native species.		
Native species:	<i>Microleana stipoides</i> , <i>Ludwigia octovalvis</i> , <i>Livistona australis</i> , <i>Persicaria sp.</i> , <i>Casuarina glauca</i>		
Weed species:	<i>Baccharis halimifolia</i> *, <i>Aster subulatus</i> , <i>Centella asiatica</i> , <i>Cuphea carthagenesis</i> , <i>Cynodon dactylon</i>		
Damage:	Nil		
Native dominance:	50%	Percentage vegetation cover:	30%
Photo:

* Weed species requires complete eradication to meet the Desired Environmental Outcomes.

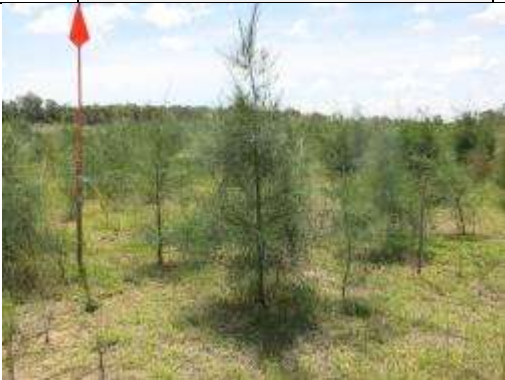
Monitoring month:	18	Months since direct seeding:	23
Date:	February 2017		
Comments:	Casuarina seedlings continue to prosper and grow this month. <i>Juncus krausii</i> (a new species for A1) has become common in the surrounds.		
Native species:	<i>Microleana stipoides</i> , <i>Ludwigia octovalvis</i> , <i>Livistona australis</i> , <i>Persicaria sp.</i> , <i>Casuarina glauca</i>		
Weed species:	<i>Baccharis halimifolia</i> *, <i>Aster subulatus</i> , <i>Centella asiatica</i> , <i>Cuphea carthagenesis</i> , <i>Cynodon dactylon</i>		
Damage:	Nil		
Native dominance:	50%	Percentage vegetation cover:	35%
Photo:

* Weed species requires complete eradication to meet the Desired Environmental Outcomes.

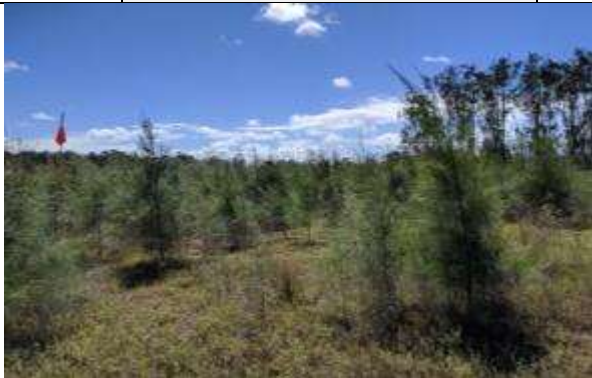
Photo:

Monitoring month:	19	Months since direct seeding:	24
Date:	March 2017 (NB: monitoring event occurred early April due to inaccessibility)		
Comments:	During the last half of this month, the NWCP received significant rainfall. Access to the area was limited. Much of the area is waterlogged (approximately 2cm of water across quadrat) and functioning as the wetland it is designed to be. Casuarina seedlings continue to prosper and grow this month, approximately 2-3m in height.		
Native species:	<i>Microleana stipoides</i> , <i>Ludwigia octovalvis</i> , <i>Livistona australis</i> , <i>Persicaria sp.</i> , <i>Casuarina glauca</i>		
Weed species:	<i>Baccharis halimifolia</i> *, <i>Aster subulatus</i> , <i>Centella asiatica</i> , <i>Cuphea carthagenesis</i> , <i>Cynodon dactylon</i>		
Damage:	Nil - large weather event associated with Ex-Tropical Cyclone Debbie did not result in any damage		
Native dominance:	50%	Percentage vegetation cover:	35%

* Weed species requires complete eradication to meet the Desired Environmental Outcomes.

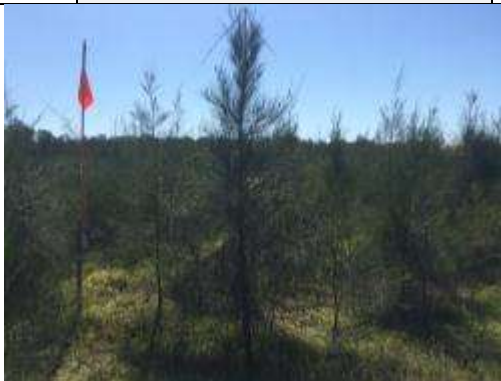
Monitoring month:	20	Months since direct seeding:	25
Date:	April 2017		
Comments:	Casuarina seedlings continue to prosper and grow this month, approximately 3m in height. Recommend additional weed control events for Groundsel. Individual plants are beginning to flower. Treatment is required before seed disperses.		
Native species:	<i>Microleana stipoides</i> , <i>Ludwigia octovalvis</i> , <i>Livistona australis</i> , <i>Persicaria sp.</i> , <i>Casuarina glauca</i>		
Weed species:	<i>Baccharis halimifolia</i> *, <i>Aster subulatus</i> , <i>Centella asiatica</i> , <i>Cuphea carthagenesis</i> , <i>Cynodon dactylon</i>		
Damage:	Nil		
Native dominance:	50%	Percentage vegetation cover:	35%
Photo:

* Weed species requires complete eradication to meet the Desired Environmental Outcomes.

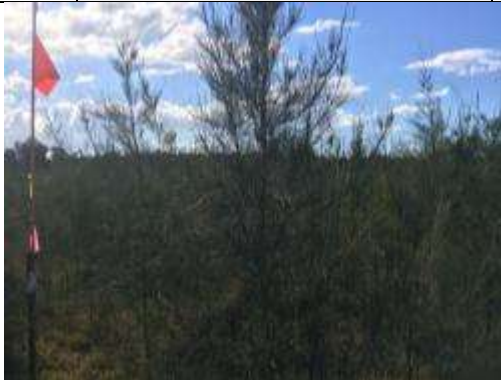
Monitoring month:	21	Months since direct seeding:	26
Date:	May 2017		
Comments:	Casuarina seedlings continue to prosper and grow this month, approximately 3m in height. Groundsel control has removed all seedlings from this quadrat and immediate surrounds.		
Native species:	<i>Microleana stipoides</i> , <i>Ludwigia octovalvis</i> , <i>Livistona australis</i> , <i>Persicaria sp.</i> , <i>Casuarina glauca</i>		
Weed species:	<i>Aster subulatus</i> , <i>Centella asiatica</i> , <i>Cuphea carthagenesis</i> , <i>Cynodon dactylon</i>		
Damage:	Nil		
Native dominance:	55%	Percentage vegetation cover:	35%
Photo:

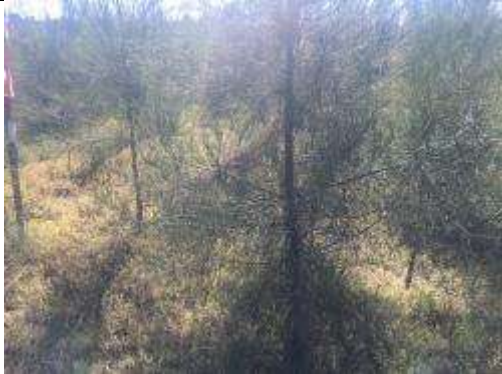
Monitoring month:	22	Months since direct seeding:	27
Date:	June 2017		
Comments:	No significant changes this month. It is anticipated growth will slow moving into the colder months. Groundsel remains under control.		
Native species:	<i>Microleana stipoides</i> , <i>Ludwigia octovalvis</i> , <i>Livistona australis</i> , <i>Persicaria sp.</i> , <i>Casuarina glauca</i>		
Weed species:	<i>Aster subulatus</i> , <i>Centella asiatica</i> , <i>Cuphea carthagenesis</i> , <i>Cynodon dactylon</i>		
Damage:	Nil		
Native dominance:	55%	Percentage vegetation cover:	35%
Photo:

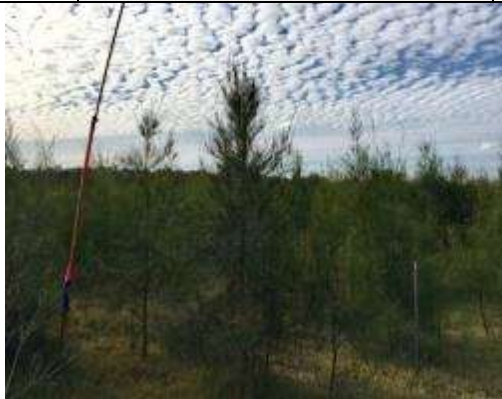
Monitoring month:	23	Months since direct seeding:	28
Date:	July 2017		
Comments:	An additional length of conduit was added to the flagging pole this month due to the increasing height of vegetation. Vegetation health is steady.		
Native species:	<i>Microleana stipoides</i> , <i>Ludwigia octovalvis</i> , <i>Livistona australis</i> , <i>Persicaria sp.</i> , <i>Casuarina glauca</i>		
Weed species:	<i>Aster subulatus</i> , <i>Centella asiatica</i> , <i>Cuphea carthagenesis</i> , <i>Cynodon dactylon</i>		
Damage:	Nil		
Native dominance:	60%	Percentage vegetation cover:	35%
Photo:

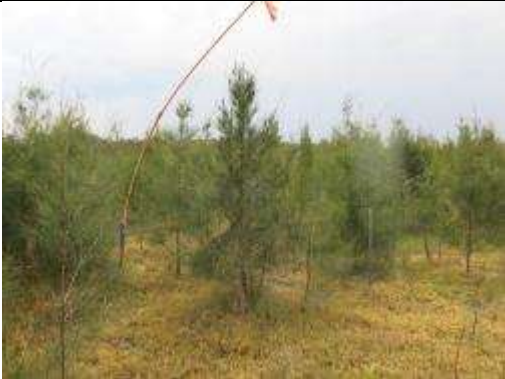
Monitoring month:	24	Months since direct seeding:	29
Date:	August 2017		
Comments:	Casuarina and grass biomass continues to increase.		
Native species:	<i>Microleana stipoides</i> , <i>Ludwigia octovalvis</i> , <i>Livistona australis</i> , <i>Persicaria sp.</i> , <i>Casuarina glauca</i>		
Weed species:	<i>Aster subulatus</i> , <i>Centella asiatica</i> , <i>Cuphea carthagenesis</i> , <i>Cynodon dactylon</i>		
Damage:	Nil		
Native dominance:	60%	Percentage vegetation cover:	35%
Photo:

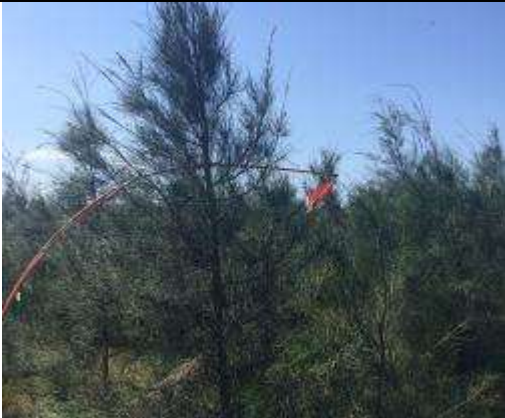
Monitoring month:	25	Months since direct seeding:	30
Date:	September 2017		
Comments:	Vegetation health and growth is steady.		
Native species:	<i>Microleana stipoides</i> , <i>Ludwigia octovalvis</i> , <i>Livistona australis</i> , <i>Persicaria sp.</i> , <i>Casuarina glauca</i>		
Weed species:	<i>Aster subulatus</i> , <i>Centella asiatica</i> , <i>Cuphea carthagenesis</i> , <i>Cynodon dactylon</i>		
Damage:	Nil		
Native dominance:	65%	Percentage vegetation cover:	35%
Photo:

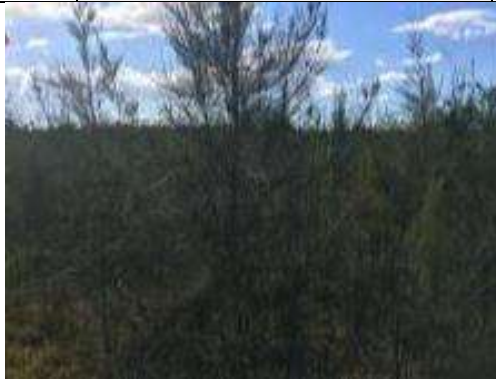
Monitoring month:	26	Months since direct seeding:	31
Date:	October 2017		
Comments:	Vegetation health and growth is steady. Groundsel noted again in low density within general proximity to this quadrat.		
Native species:	<i>Microleana stipoides</i> , <i>Ludwigia octovalvis</i> , <i>Livistona australis</i> , <i>Persicaria sp.</i> , <i>Casuarina glauca</i>		
Weed species:	<i>Aster subulatus</i> , <i>Centella asiatica</i> , <i>Cuphea carthagenesis</i> , <i>Cynodon dactylon</i> , <i>Baccharis halimifolia</i>*		
Damage:	Nil		
Native dominance:	65%	Percentage vegetation cover:	35%
Photo:

* Weed species requires complete eradication to meet the Desired Environmental Outcomes.

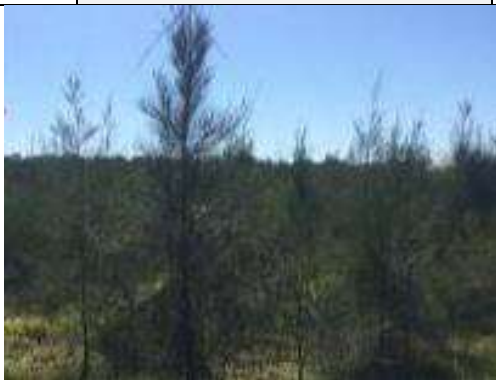
Monitoring month:	27	Months since direct seeding:	32
Date:	November 2017		
Comments:	Some rain was received in the local area at the end of this month assisting in the continued growth of <i>Casuarina glauca</i> . Groundsel still present in surrounding areas, but not spreading.		
Native species:	<i>Microleana stipoides</i> , <i>Ludwigia octovalvis</i> , <i>Livistona australis</i> , <i>Persicaria sp.</i> , <i>Casuarina glauca</i>		
Weed species:	<i>Aster subulatus</i> , <i>Centella asiatica</i> , <i>Cuphea carthagenesis</i> , <i>Cynodon dactylon</i>		
Damage:	Nil		
Native dominance:	65%	Percentage vegetation cover:	40%
Photo:

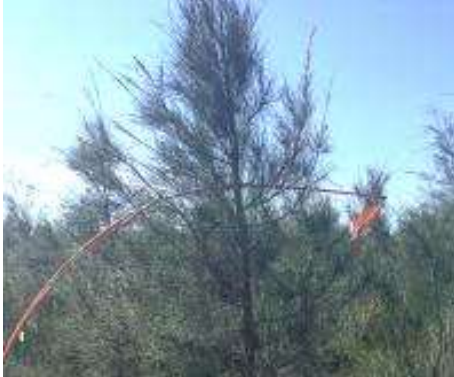
Monitoring month:	28	Months since direct seeding:	33
Date:	December 2017		
Comments:	Consistent light rainfall across the latter part of this month, coupled with increasing temperatures, has provided good growing conditions for vegetation. Treatment of groundsel required in surrounding areas, but access difficult due to rain.		
Native species:	<i>Microleana stipoides</i> , <i>Ludwigia octovalvis</i> , <i>Livistona australis</i> , <i>Persicaria sp.</i> , <i>Casuarina glauca</i>		
Weed species:	<i>Aster subulatus</i> , <i>Centella asiatica</i> , <i>Cuphea carthagenesis</i> , <i>Cynodon dactylon</i>		
Damage:	Nil		
Native dominance:	65%	Percentage vegetation cover:	60%
Photo:

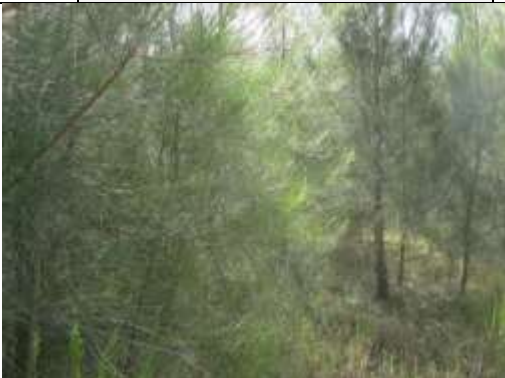
Monitoring month:	29	Months since direct seeding:	34
Date:	January 2018		
Comments:	Canopy growth continues to progressively shade out weed species, reducing diversity and abundance of weeds. Rainfall, temperatures and increased shading has resulted in a shift in species composition		
Native species:	<i>Ludwigia octovalvis</i> , <i>Persicaria sp.</i> , <i>Casuarina glauca</i> , <i>Leersia hexandra</i>		
Weed species:	<i>Cuphea carthagenesis</i> , <i>Cynodon dactylon</i>		
Damage:	Nil		
Native dominance:	80%	Percentage vegetation cover:	65%
Photo:

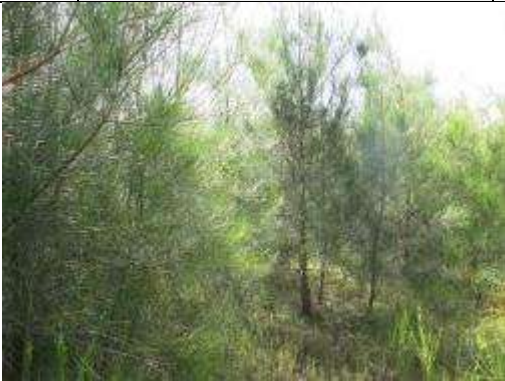
Monitoring month:	30	Months since direct seeding:	35
Date:	February 2018		
Comments:	<i>Casuarina glauca</i> growth continues to increase in height and biomass.		
Native species:	<i>Ludwigia octovalvis</i> , <i>Persicaria sp.</i> , <i>Casuarina glauca</i> , <i>Leersia hexandra</i>		
Weed species:	<i>Cuphea carthagenesis</i> , <i>Cynodon dactylon</i>		
Damage:	Nil		
Native dominance:	80%	Percentage vegetation cover:	65%
Photo:

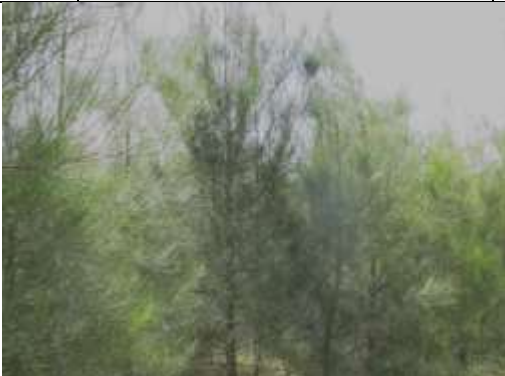
Monitoring month:	31	Months since direct seeding:	36
Date:	March 2018		
Comments:	A significant amount of rain fell at the end of last month resulting in standing water for approximately 3 weeks. This has acted as a natural weed control for a number of the weed species. Canopy growth and shading has also assisted in a reduction of weed growth. Groundsel treatment commenced in surrounding areas.		
Native species:	<i>Ludwigia octovalvis</i> , <i>Persicaria sp.</i> , <i>Casuarina glauca</i> , <i>Leersia hexandra</i>		
Weed species:	<i>Cuphea carthagenesis</i> , <i>Cynodon dactylon</i>		
Damage:	Nil		
Native dominance:	80%	Percentage vegetation cover:	70%
Photo:

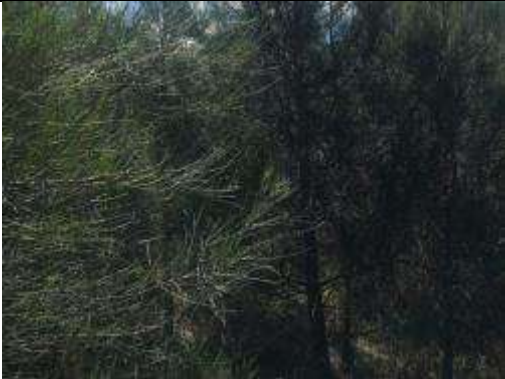
Monitoring month:	32	Months since direct seeding:	37
Date:	April 2018		
Comments:	Canopy growth continues to progressively shade out weed species, reducing diversity and abundance of weeds		
Native species:	<i>Ludwigia octovalvis</i> , <i>Persicaria sp.</i> , <i>Casuarina glauca</i> , <i>Leersia hexandra</i>		
Weed species:	<i>Cuphea carthagenesis</i> , <i>Cynodon dactylon</i>		
Damage:	Nil		
Native dominance:	80%	Percentage vegetation cover:	70%
Photo:

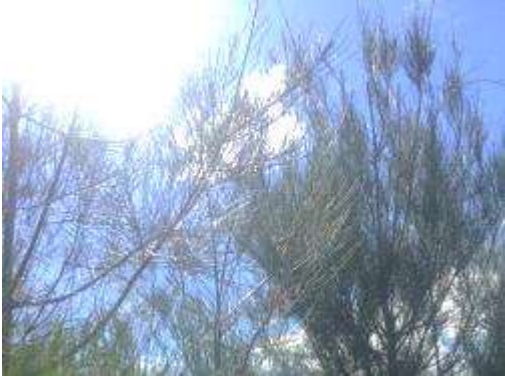
Monitoring month:	33	Months since direct seeding:	38
Date:	May 2018		
Comments:	<i>Casuarina glauca</i> growth continues to increase in height and biomass.		
Native species:	<i>Ludwigia octovalvis</i> , <i>Persicaria sp.</i> , <i>Casuarina glauca</i> , <i>Leersia hexandra</i>		
Weed species:	<i>Cuphea carthagenesis</i> , <i>Cynodon dactylon</i>		
Damage:	Nil		
Native dominance:	80%	Percentage vegetation cover:	70%
Photo:

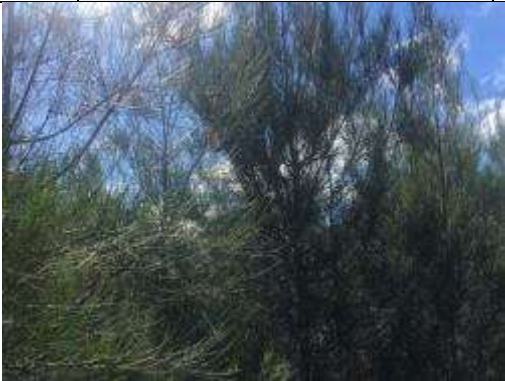
Monitoring month:	34	Months since direct seeding:	39
Date:	June 2018		
Comments:	No significant changes this month due to the slowing down of the growing season.		
Native species:	<i>Ludwigia octovalvis</i> , <i>Casuarina glauca</i> , <i>Leersia hexandra</i>		
Weed species:	<i>Cuphea carthagenesis</i> , <i>Cynodon dactylon</i>		
Damage:	Nil		
Native dominance:	80%	Percentage vegetation cover:	70%
Photo:

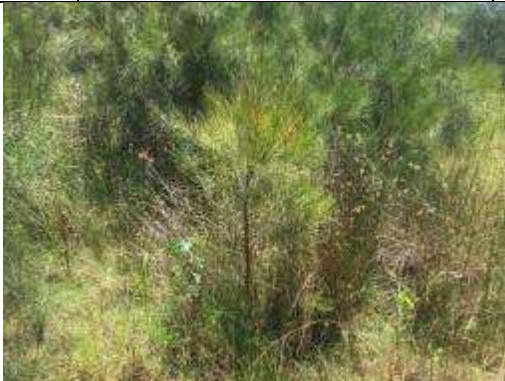
Monitoring month:	35	Months since direct seeding:	40
Date:	July 2018		
Comments:	Species diversity is declining due to the allelopathic properties of <i>Casuarina glauca</i> .		
Native species:	<i>Ludwigia octovalvis</i> , <i>Casuarina glauca</i>		
Weed species:	<i>Cynodon dactylon</i>		
Damage:	Nil		
Native dominance:	80%	Percentage vegetation cover:	70%
Photo:

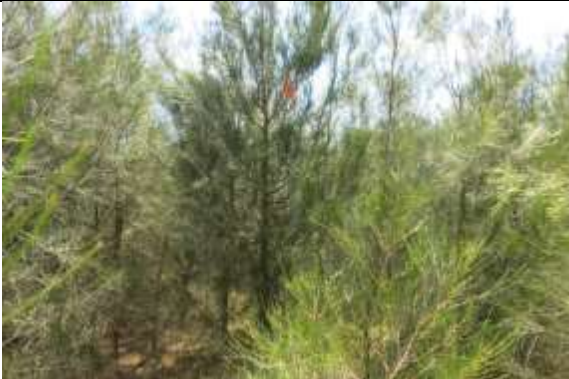
Monitoring month:	36	Months since direct seeding:	41
Date:	July 2018		
Comments:	A decline in diversity was notable this month due to the developing dominance of <i>Casuarina glauca</i> .		
Native species:	<i>Casuarina glauca</i>		
Weed species:	<i>Cynodon dactylon</i>		
Damage:	Nil		
Native dominance:	90%	Percentage vegetation cover:	70%
Photo:

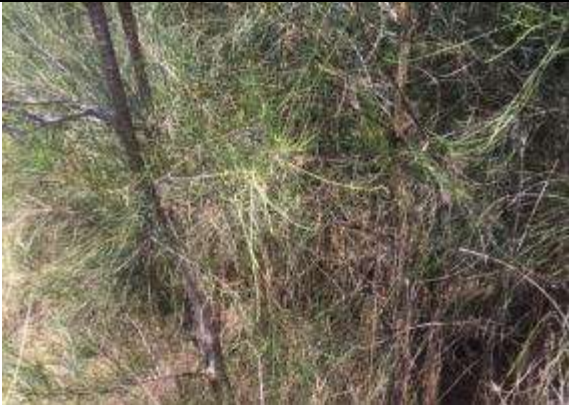
Monitoring month:	37	Months since direct seeding:	42
Date:	September 2018		
Comments:	No significant changes this month due. <i>Eucalyptus robusta</i> is setting seed in surrounding area.		
Native species:	<i>Casuarina glauca</i>		
Weed species:	<i>Cynodon dactylon</i>		
Damage:	Nil		
Native dominance:	90%	Percentage vegetation cover:	70%
Photo:

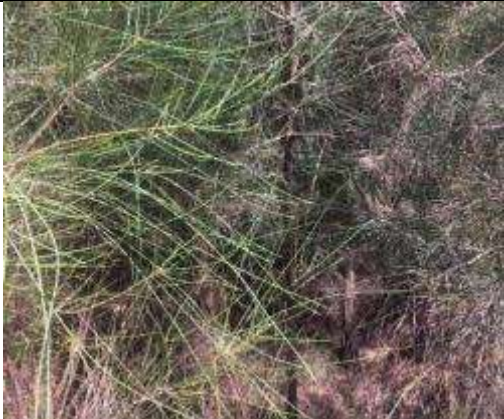
Monitoring month:	38	Months since direct seeding:	43
Date:	October 2018		
Comments:	Rainfall occurred throughout the area during this month which has assisted with the increase in biomass.		
Native species:	<i>Casuarina glauca</i>		
Weed species:	<i>Cynodon dactylon</i>		
Damage:	Nil		
Native dominance:	90%	Percentage vegetation cover:	70%
Photo:

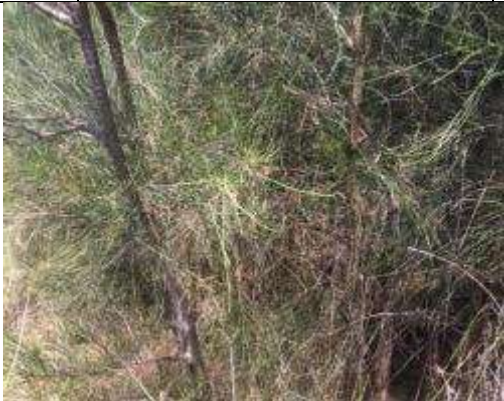
Monitoring month:	39	Months since direct seeding:	44
Date:	November 2018		
Comments:	Rapidly increasing temperatures were experienced this month resulting in the exponential growth of vegetation.		
Native species:	<i>Casuarina glauca</i>		
Weed species:	<i>Cynodon dactylon</i>		
Damage:	Nil		
Native dominance:	90%	Percentage vegetation cover:	70%
Photo:

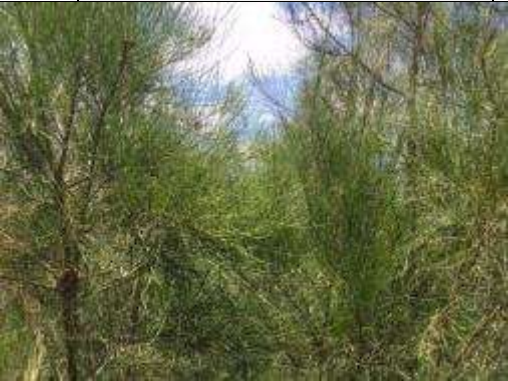
Monitoring month:	40	Months since direct seeding:	45
Date:	December 2018		
Comments:	Vegetation growth was steady this month.		
Native species:	<i>Casuarina glauca</i>		
Weed species:	<i>Cynodon dactylon</i>		
Damage:	Nil		
Native dominance:	90%	Percentage vegetation cover:	70%
Photo:

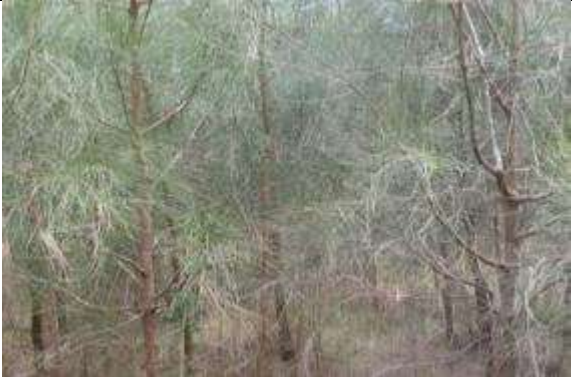
Monitoring month:	41	Months since direct seeding:	46
Date:	January 2019		
Comments:	No significant changes occurred this month.		
Native species:	<i>Casuarina glauca</i>		
Weed species:	<i>Cynodon dactylon</i>		
Damage:	Nil		
Native dominance:	90%	Percentage vegetation cover:	80%
Photo:

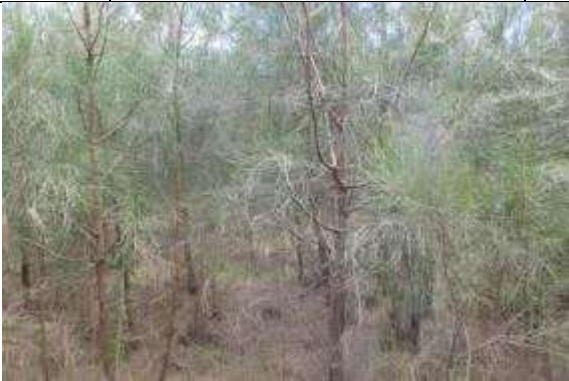
Monitoring month:	42	Months since direct seeding:	47
Date:	February 2019		
Comments:	Vegetation growth was steady this month.		
Native species:	<i>Casuarina glauca</i>		
Weed species:	<i>Cynodon dactylon</i>		
Damage:	Nil		
Native dominance:	90%	Percentage vegetation cover:	90%
Photo:

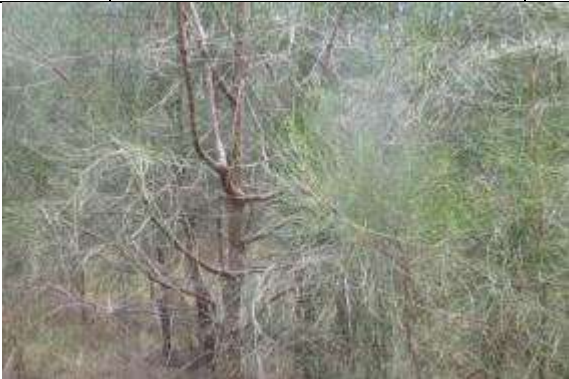
Monitoring month:	43	Months since direct seeding:	48
Date:	March 2019		
Comments:	Vegetation growth was steady this month.		
Native species:	<i>Casuarina glauca</i>		
Weed species:	<i>Cynodon dactylon</i>		
Damage:	Nil		
Native dominance:	90%	Percentage vegetation cover:	90%
Photo:

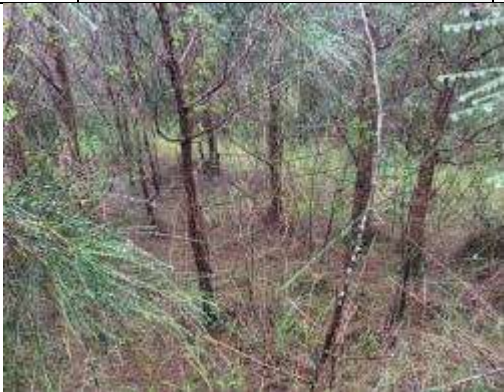
Monitoring month:	44	Months since direct seeding:	49
Date:	April 2019		
Comments:	Rainfall events increased late last month and continued this month giving the NWCP a much needed watering.		
Native species:	<i>Casuarina glauca</i>		
Weed species:	<i>Cynodon dactylon</i>		
Damage:	Nil		
Native dominance:	90%	Percentage vegetation cover:	100%
Photo:

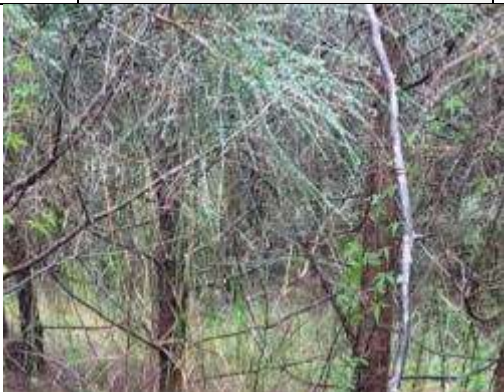
Monitoring month:	45	Months since direct seeding:	50
Date:	May 2019		
Comments:	<i>Casuarina glauca</i> continues to add biomass. A small amount of <i>Ipomea cairica</i> has been identified within this quadrat and will be treated. The presence of this weed is currently not a significant threat.		
Native species:	<i>Casuarina glauca</i>		
Weed species:	<i>Cynodon dactylon</i> , <i>Ipomea cairica</i> *		
Damage:	Nil		
Native dominance:	90%	Percentage vegetation cover:	100%
Photo:

* Weed species requires complete eradication to meet the Desired Environmental Outcomes.

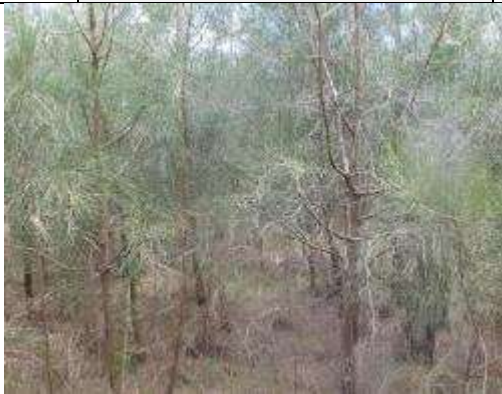
Monitoring month:	46	Months since direct seeding:	51
Date:	June 2019		
Comments:	Rainfall over the past few months has increased plant growth and vigour. <i>Ipomea cairica</i> has been successfully treated within this quadrat.		
Native species:	<i>Casuarina glauca</i>		
Weed species:	<i>Cynodon dactylon</i>		
Damage:	Nil		
Native dominance:	90%	Percentage vegetation cover:	100%
Photo:

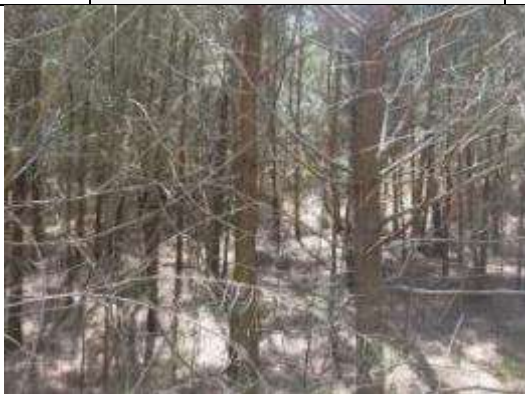
Monitoring month:	47	Months since direct seeding:	52
Date:	July 2019		
Comments:	<i>Cynodon dactylon</i> is continuing to lose vigour.		
Native species:	<i>Casuarina glauca</i>		
Weed species:	<i>Cynodon dactylon</i>		
Damage:	Nil		
Native dominance:	90%	Percentage vegetation cover:	100%
Photo:

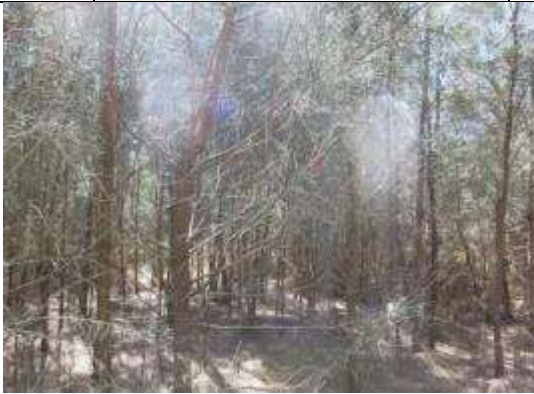
Monitoring month:	48	Months since direct seeding:	53
Date:	August 2019		
Comments:	<i>Eucalyptus robusta</i> is setting seed in the surrounding.		
Native species:	<i>Casuarina glauca</i>		
Weed species:	<i>Cynodon dactylon</i>		
Damage:	Nil		
Native dominance:	90%	Percentage vegetation cover:	100%
Photo:

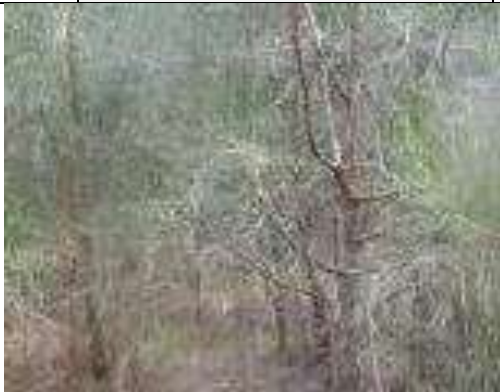
Monitoring month:	49	Months since direct seeding:	54
Date:	September 2019		
Comments:	Allelopathic properties of the casuarina leaf litter is still supressing species diversity.		
Native species:	<i>Casuarina glauca</i>		
Weed species:	<i>Cynodon dactylon</i>		
Damage:	Nil		
Native dominance:	90%	Percentage vegetation cover:	100%
Photo:

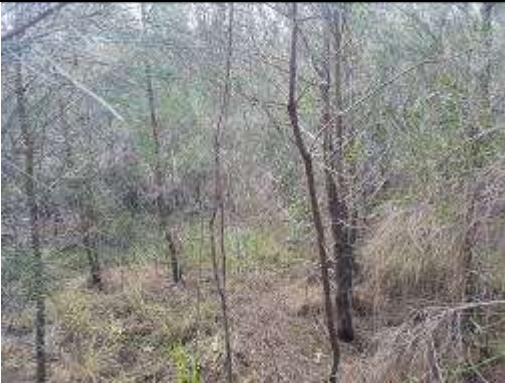
Monitoring month:	50	Months since direct seeding:	55
Date:	October 2019		
Comments:	Extended drought conditions are starting to take their toll with the extreme slowing of plant growth.		
Native species:	<i>Casuarina glauca</i>		
Weed species:	<i>Cynodon dactylon</i>		
Damage:	Nil		
Native dominance:	90%	Percentage vegetation cover:	100%
Photo:

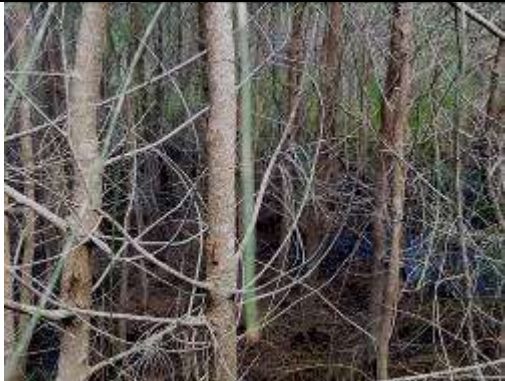
Monitoring month:	51	Months since direct seeding:	56
Date:	November 2019		
Comments:	Allelopathic properties of the casuarina leaf litter is still supressing other species growth, including <i>Cynodon dactylon</i> .		
Native species:	<i>Casuarina glauca</i>		
Weed species:	<i>Cynodon dactylon</i>		
Damage:	Nil		
Native dominance:	90%	Percentage vegetation cover:	100%
Photo:

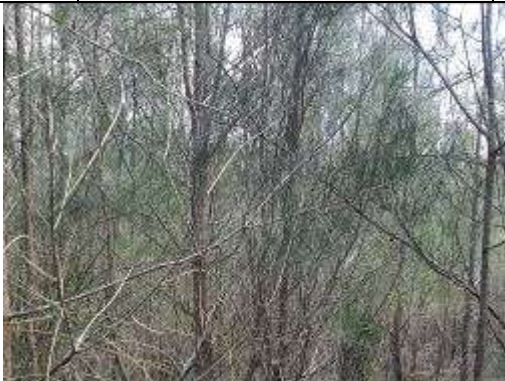
Monitoring month:	52	Months since direct seeding:	57
Date:	December 2019		
Comments:	Growth steady.		
Native species:	<i>Casuarina glauca</i>		
Weed species:	<i>Cynodon dactylon</i>		
Damage:	Nil		
Native dominance:	90%	Percentage vegetation cover:	100%
Photo:

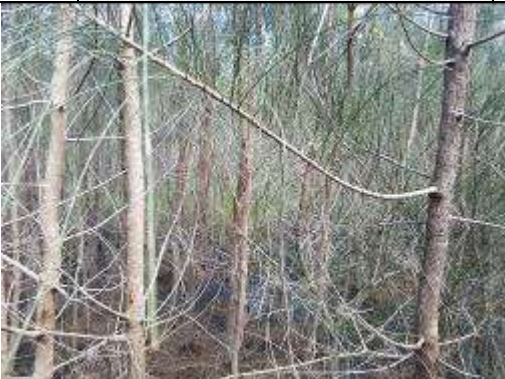
Monitoring month:	53	Months since direct seeding:	58
Date:	January 2020		
Comments:	No significant changes this month.		
Native species:	<i>Casuarina glauca</i>		
Weed species:	<i>Cynodon dactylon</i>		
Damage:	Nil		
Native dominance:	90%	Percentage vegetation cover:	100%
Photo:

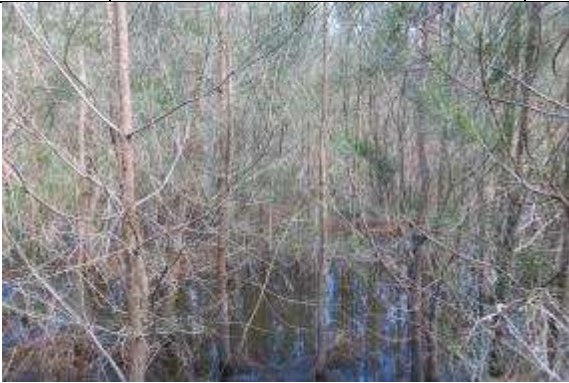
Monitoring month:	54	Months since direct seeding:	59
Date:	February 2020		
Comments:	Standing water covers this entire quadrat this month.		
Native species:	<i>Casuarina glauca</i>		
Weed species:	<i>Cynodon dactylon</i>		
Damage:	Nil		
Native dominance:	90%	Percentage vegetation cover:	100%
Photo:

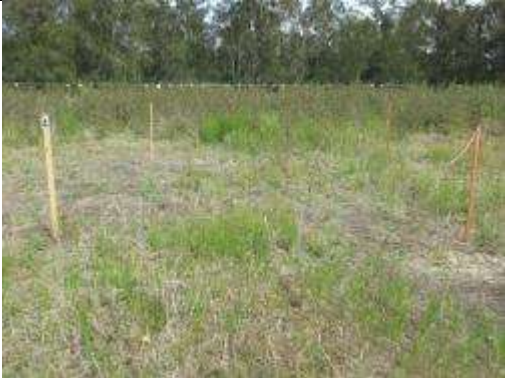
Monitoring month:	1	Months since direct seeding:	6
Date:	September 2015		
Comments:	Canopy trees were in seedling form in the quadrat. This quadrat is also performing very well.		
Native species:	<i>Juncus usitatus</i> , <i>Casuarina glauca</i> , <i>Cyperus polystachyos</i> , <i>Bolboschoenus cardwellii</i> , <i>Fimbristylis ferruginea</i> , <i>Ludwigia octovalvis</i> , <i>Persicaria decipiens</i>		
Weed species:	<i>Cynodon dactylon</i>		
Damage:	Nil		
Native dominance:	88%	Percentage vegetation cover:	50%
Photo:

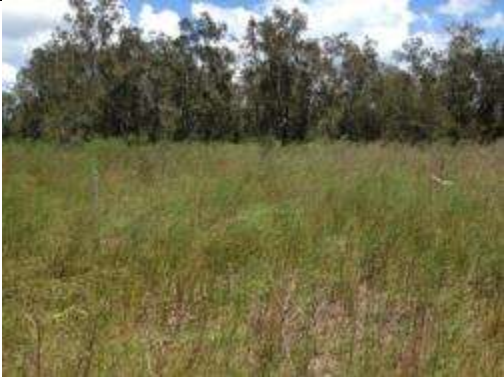
Monitoring month:	6	Months since direct seeding:	11
Date:	February 2016		
Comments:	Canopy trees remain in seedling form in this quadrat. In surrounding areas several new species were observed germinating, small clusters of Eucalyptus, also <i>Canavalia rosea</i> , <i>Acacia concurrens</i> , <i>Hibiscus diversifolium</i> , and <i>Corymbia intermedia</i> . They may be vulnerable if the area is inundated for long periods. Aster weed is proving to be an unlikely ally.		
Native species:	<i>Juncus usitatus</i> , <i>Casuarina glauca</i> , <i>Cyperus polystachyos</i> , <i>Bolboschoenus cardwellii</i> , <i>Fimbristylis ferruginea</i> , <i>Ludwigia octovalvis</i> , <i>Persicaria decipiens</i>		
Weed species:	<i>Aster subulatus</i> , <i>Cuphea carthagenesis</i> , <i>Cynodon dactylon</i>		
Damage:	Nil		
Native dominance:	70%	Percentage vegetation cover:	60%
Photo:

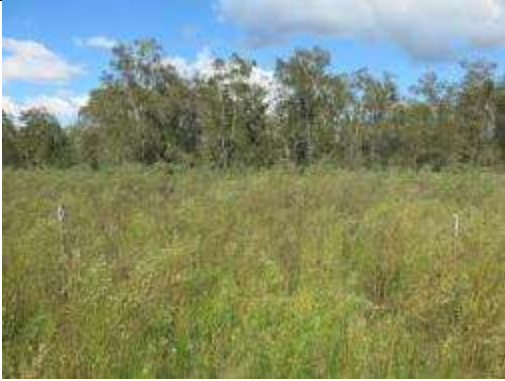
Monitoring month:	7	Months since direct seeding:	12
Date:	March 2016		
Comments:	Canopy trees remain in seedling form in the quadrat. The new terrestrial species observed last time between these quadrats have mostly yellowed, suffering from lack of oxygen due to recent rains. Of course sedges are becoming abundant, and the appropriate canopy trees being Melaleuca and Casuarina are thriving.		
Native species:	<i>Juncus usitatus</i> , <i>Casuarina glauca</i> , <i>Cyperus polystachyos</i> , <i>Bolboschoenus cardwellii</i> , <i>Fimbristylis ferruginea</i> , <i>Ludwigia octovalvis</i> , <i>Persicaria decipiens</i>		
Weed species:	<i>Aster subulatus</i> , <i>Cuphea carthagenesis</i> , <i>Cynodon dactylon</i>		
Damage:	Nil		
Native dominance:	70%	Percentage vegetation cover:	70%
Photo:

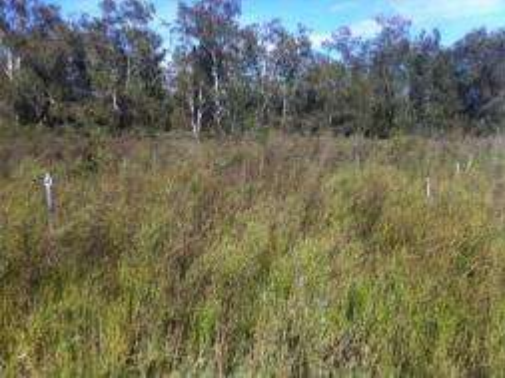
Monitoring month:	8	Months since direct seeding:	13
Date:	April 2016		
Comments:	Canopy trees remain in seedling form in the quadrat. The new terrestrial species observed last time between these quadrats have mostly yellowed, suffering from lack of oxygen due to recent rains. Sedges are becoming abundant, and the appropriate canopy trees being Melaleuca and Casuarina are thriving. Percentage cover and native dominance remain strong.		
Native species:	<i>Juncus usitatus</i> , <i>Casuarina glauca</i> , <i>Cyperus polystachyos</i> , <i>Bolboschoenus cardwellii</i> , <i>Fimbristylis ferruginea</i> , <i>Ludwigia octovalvis</i> , <i>Persicaria decipiens</i>		
Weed species:	<i>Aster subulatus</i> , <i>Cuphea carthagenesis</i> , <i>Cynodon dactylon</i>		
Damage:	Nil		
Native dominance:	70%	Percentage vegetation cover:	70%
Photo:

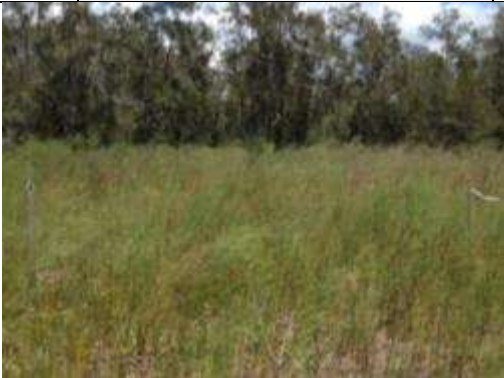
Monitoring month:	9	Months since direct seeding:	14
Date:	May 2016		
Comments:	Canopy trees remain in seedling form in the quadrat. Native diversity and species dominance within this quadrat are both moderate to high for the area.		
Native species:	<i>Juncus usitatus</i> , <i>Casuarina glauca</i> , <i>Cyperus polystachyos</i> , <i>Bolboschoenus cardwellii</i> , <i>Fimbristylis ferruginea</i> , <i>Ludwigia octovalvis</i> , <i>Persicaria decipiens</i>		
Weed species:	<i>Aster subulatus</i> , <i>Cuphea carthagenesis</i> , <i>Cynodon dactylon</i>		
Damage:	Nil		
Native dominance:	70%	Percentage vegetation cover:	70%
Photo:

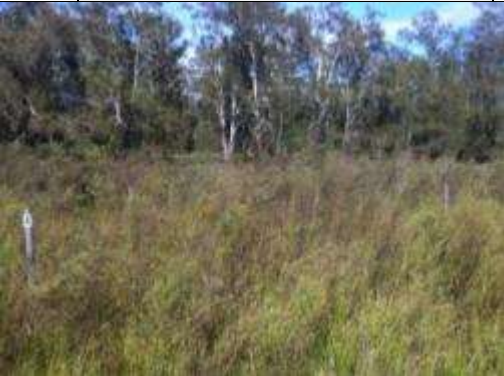
Monitoring month:	10	Months since direct seeding:	15
Date:	June 2016		
Comments:	Native grass and sedge species continue to progress well. Casuarina seedlings are prospering, however growth will slow over the winter period.		
Native species:	<i>Juncus usitatus</i> , <i>Casuarina glauca</i> , <i>Cyperus polystachyos</i> , <i>Bolboschoenus cardwellii</i> , <i>Fimbristylis ferruginea</i> , <i>Ludwigia octovalvis</i> , <i>Persicaria decipiens</i>		
Weed species:	<i>Aster subulatus</i> , <i>Cuphea carthagenesis</i> , <i>Cynodon dactylon</i>		
Damage:	Nil		
Native dominance:	70%	Percentage vegetation cover:	75%
Photo:

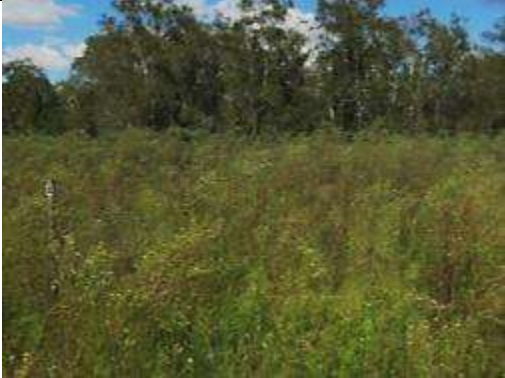
Monitoring month:	11	Months since direct seeding:	16
Date:	July 2016		
Comments:	Growth within this quadrat has slowed during the winter period. Aster die-off is evident.		
Native species:	<i>Juncus usitatus, Casuarina glauca, Cyperus polystachyos, Bolboschoenus cardwellii, Fimbristylis ferruginea, Ludwigia octovalvis, Persicaria decipiens</i>		
Weed species:	<i>Aster subulatus, Cuphea carthagenesis, Cynodon dactylon</i>		
Damage:	Nil		
Native dominance :	70%	Percentage vegetation cover:	70%
Photo:

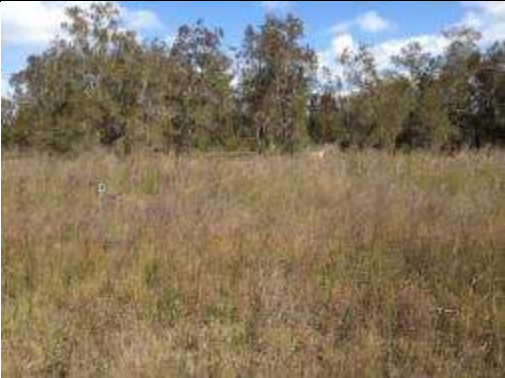
Monitoring month:	12	Months since direct seeding:	17
Date:	August 2016		
Comments:	Canopy trees that were in seedling form in this quadrant are now over 1m high. There has been no change in native dominance, however vegetation cover has increased by 10%.		
Native species:	<i>Juncus usitatus, Casuarina glauca, Cyperus polystachyos, Bolboschoenus cardwellii, Fimbristylis ferruginea, Ludwigia octovalvis, Persicaria decipiens</i>		
Weed species:	<i>Aster subulatus, Cuphea carthagenesis, Cynodon dactylon</i>		
Damage:	Nil		
Native dominance:	70%	Percentage vegetation cover:	80%
Photo:

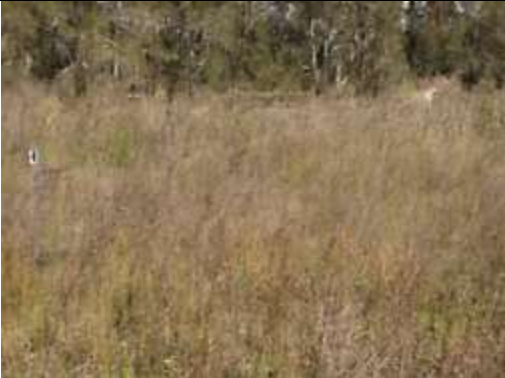
Monitoring month:	13	Months since direct seeding:	18
Date:	September 2016		
Comments:	Casuarina seedlings within this quadrat continue to prosper.		
Native species:	<i>Juncus usitatus</i> , <i>Casuarina glauca</i> , <i>Cyperus polystachyos</i> , <i>Bolboschoenus cardwellii</i> , <i>Fimbristylis ferruginea</i> , <i>Ludwigia octovalvis</i> , <i>Persicaria decipiens</i>		
Weed species:	<i>Aster subulatus</i> , <i>Cuphea carthagenesis</i> , <i>Cynodon dactylon</i>		
Damage:	Nil		
Native dominance:	70%	Percentage vegetation cover:	80%
Photo:

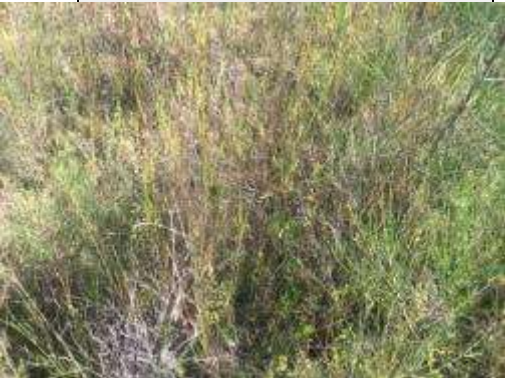
Monitoring month:	14	Months since direct seeding:	19
Date:	October 2016		
Comments:	Casuarina seedlings continue to show new growth. Native dominance continues to increase.		
Native species:	<i>Juncus usitatus</i> , <i>Casuarina glauca</i> , <i>Cyperus polystachyos</i> , <i>Bolboschoenus cardwellii</i> , <i>Fimbristylis ferruginea</i> , <i>Ludwigia octovalvis</i> , <i>Persicaria decipiens</i>		
Weed species:	<i>Aster subulatus</i> , <i>Cuphea carthagenesis</i> , <i>Cynodon dactylon</i>		
Damage:	Nil		
Native dominance:	75%	Percentage vegetation cover:	80%
Photo:

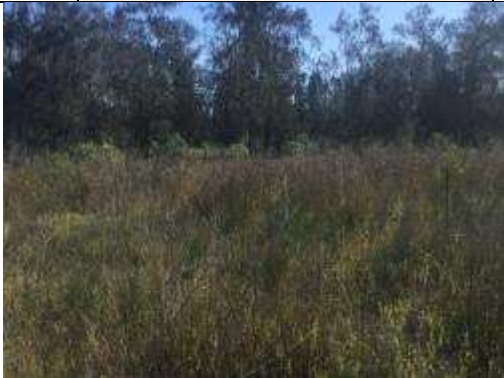
Monitoring month:	15	Months since direct seeding:	20
Date:	November 2016		
Comments:	Native species continue to dominate within this quadrat this month. Sedges and rushes also continue to grow well.		
Native species:	<i>Juncus usitatus</i> , <i>Casuarina glauca</i> , <i>Cyperus polystachyos</i> , <i>Bolboschoenus cardwellii</i> , <i>Fimbristylis ferruginea</i> , <i>Ludwigia octovalvis</i> , <i>Persicaria decipiens</i>		
Weed species:	<i>Aster subulatus</i> , <i>Cuphea carthagenesis</i> , <i>Cynodon dactylon</i>		
Damage:	Nil		
Native dominance:	80%	Percentage vegetation cover:	80%
Photo:

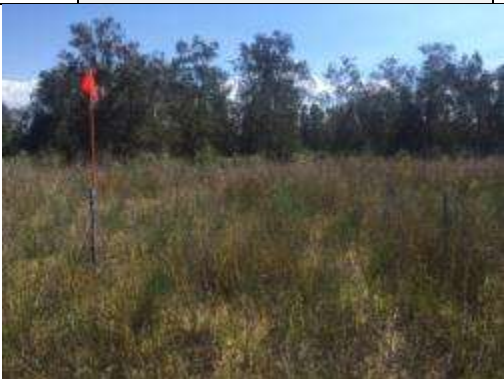
Monitoring month:	16	Months since direct seeding:	21
Date:	December 2016		
Comments:	A high visibility flag and extended pole was added to the quadrat stake this month for ease of identification. Groundsel has been identified within this quadrat this month.		
Native species:	<i>Juncus usitatus</i> , <i>Casuarina glauca</i> , <i>Cyperus polystachyos</i> , <i>Bolboschoenus cardwellii</i> , <i>Fimbristylis ferruginea</i> , <i>Ludwigia octovalvis</i> , <i>Persicaria decipiens</i>		
Weed species:	<i>Aster subulatus</i> , <i>Cuphea carthagenesis</i> , <i>Cynodon dactylon</i> , <i>Baccharis halimifolia</i> *		
Damage:	Nil		
Native dominance:	80%	Percentage vegetation cover:	80%
Photo:

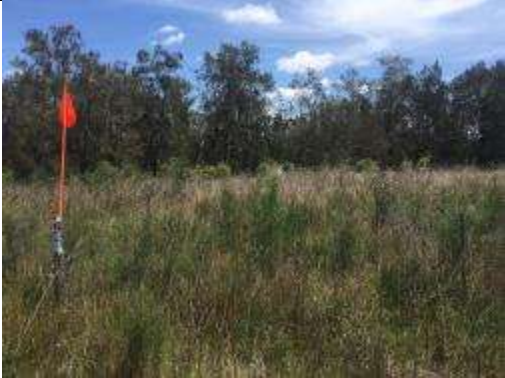
Monitoring month:	17	Months since direct seeding:	22
Date:	January 2017		
Comments:	Groundsel treatment has been successful within this quadrat. Casuarinas continue to grow well, with most individuals reaching approximately 1.5m in height.		
Native species:	<i>Juncus usitatus</i> , <i>Casuarina glauca</i> , <i>Cyperus polystachyos</i> , <i>Bolboschoenus cardwellii</i> , <i>Fimbristylis ferruginea</i> , <i>Ludwigia octovalvis</i> , <i>Persicaria decipiens</i>		
Weed species:	<i>Aster subulatus</i> , <i>Cuphea carthagenesis</i> , <i>Cynodon dactylon</i>		
Damage:	Nil		
Native dominance:	85%	Percentage vegetation cover:	90%
Photo:

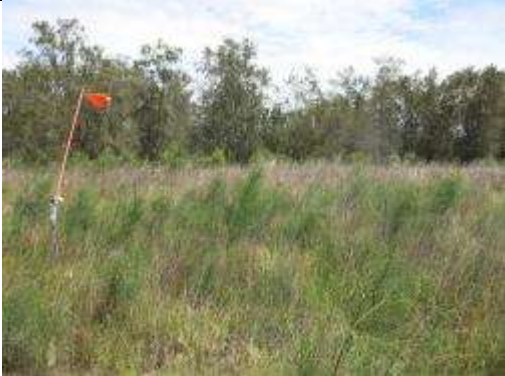
Monitoring month:	18	Months since direct seeding:	23
Date:	February 2017		
Comments:	Casuarinas continue to grow well and dominate within this quadrat. Aster has died off from this quadrat this month.		
Native species:	<i>Juncus usitatus</i> , <i>Casuarina glauca</i> , <i>Cyperus polystachyos</i> , <i>Bolboschoenus cardwellii</i> , <i>Fimbristylis ferruginea</i> , <i>Ludwigia octovalvis</i> , <i>Persicaria decipiens</i>		
Weed species:	<i>Cuphea carthagenesis</i> , <i>Cynodon dactylon</i>		
Damage:	Nil		
Native dominance:	85%	Percentage vegetation cover:	90%
Photo:

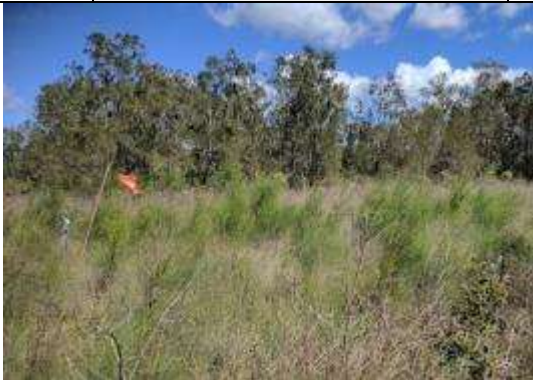
Photo:

Monitoring month:	19	Months since direct seeding:	24
Date:	March 2017 (NB: monitoring event occurred early April due to inaccessibility)		
Comments:	During the last half of this month, the NWCP received significant rainfall. Access to the area was limited. Much of the area is waterlogged (approximately 2cm of water covering quadrat) and functioning as the wetland it is designed to be. Casuarinas continue to grow well and dominate within this quadrat, approximately 1.8m high.		
Native species:	<i>Juncus usitatus</i> , <i>Casuarina glauca</i> , <i>Cyperus polystachyos</i> , <i>Bolboschoenus cardwellii</i> , <i>Fimbristylis ferruginea</i> , <i>Ludwigia octovalvis</i> , <i>Persicaria decipiens</i>		
Weed species:	<i>Cuphea carthagenesis</i> , <i>Cynodon dactylon</i>		
Damage:	Nil - large weather event associated with Ex-Tropical Cyclone Debbie did not result in any damage		
Native dominance:	85%	Percentage vegetation cover:	90%

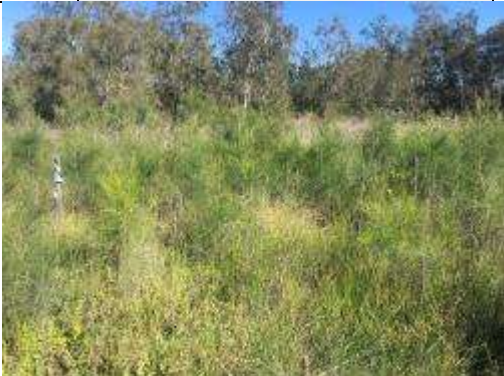
Monitoring month:	20	Months since direct seeding:	25
Date:	April 2017		
Comments:	Much of the area is still waterlogged and functioning as the wetland it is designed to be. Casuarinas continue to grow well, approximately 2m high.		
Native species:	<i>Juncus usitatus</i> , <i>Casuarina glauca</i> , <i>Cyperus polystachyos</i> , <i>Bolboschoenus cardwellii</i> , <i>Fimbristylis ferruginea</i> , <i>Ludwigia octovalvis</i> , <i>Persicaria decipiens</i>		
Weed species:	<i>Cuphea carthagenesis</i> , <i>Cynodon dactylon</i>		
Damage:	Nil		
Native dominance:	85%	Percentage vegetation cover:	90%
Photo:

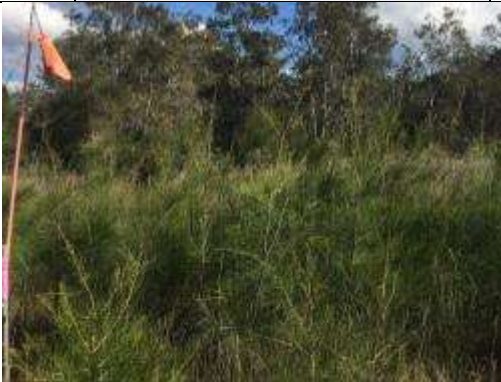
Monitoring month:	21	Months since direct seeding:	26
Date:	May 2017		
Comments:	Casuarinas continue to grow well and dominate within this quadrat, approximately 2m high.		
Native species:	<i>Juncus usitatus</i> , <i>Casuarina glauca</i> , <i>Cyperus polystachyos</i> , <i>Bolboschoenus cardwellii</i> , <i>Fimbristylis ferruginea</i> , <i>Ludwigia octovalvis</i> , <i>Persicaria decipiens</i>		
Weed species:	<i>Cuphea carthagenesis</i> , <i>Cynodon dactylon</i>		
Damage:	Nil		
Native dominance:	85%	Percentage vegetation cover:	95%
Photo:

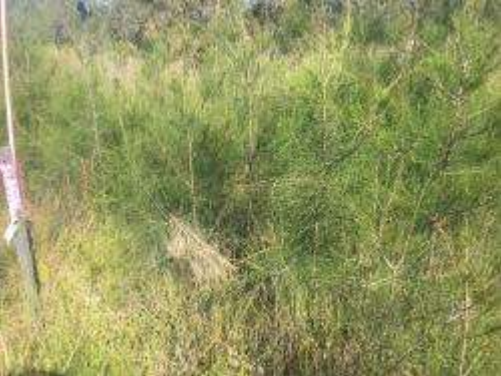
Monitoring month:	22	Months since direct seeding:	27
Date:	June 2017		
Comments:	No significant changes this month. It is anticipated growth will slow moving into the colder months.		
Native species:	<i>Juncus usitatus</i> , <i>Casuarina glauca</i> , <i>Cyperus polystachyos</i> , <i>Bolboschoenus cardwellii</i> , <i>Fimbristylis ferruginea</i> , <i>Ludwigia octovalvis</i> , <i>Persicaria decipiens</i>		
Weed species:	<i>Cuphea carthagenesis</i> , <i>Cynodon dactylon</i>		
Damage:	Nil		
Native dominance:	85%	Percentage vegetation cover:	95%
Photo:

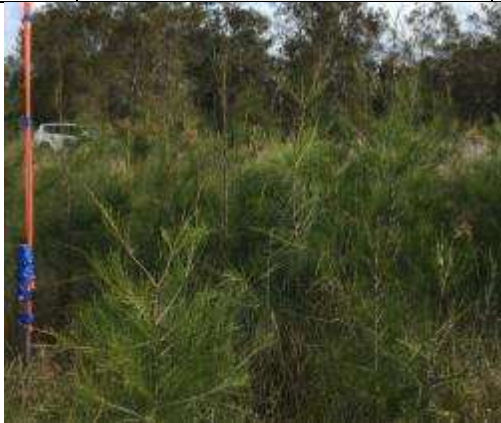
Monitoring month:	23	Months since direct seeding:	28
Date:	July 2017		
Comments:	An additional length of conduit was added to the flagging pole this month due to the increasing height of vegetation. Vegetation health is steady.		
Native species:	<i>Juncus usitatus</i> , <i>Casuarina glauca</i> , <i>Cyperus polystachyos</i> , <i>Bolboschoenus cardwellii</i> , <i>Fimbristylis ferruginea</i> , <i>Ludwigia octovalvis</i> , <i>Persicaria decipiens</i>		
Weed species:	<i>Cuphea carthagenesis</i> , <i>Cynodon dactylon</i>		
Damage:	Nil		
Native dominance:	85%	Percentage vegetation cover:	95%
Photo:

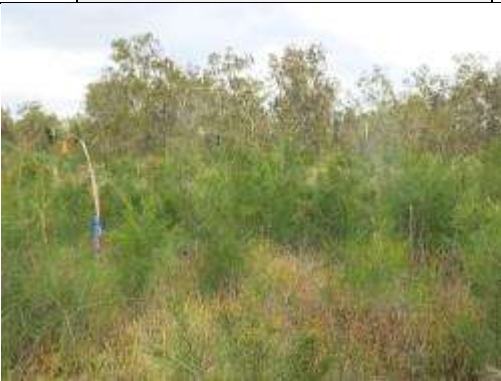
Monitoring month:	24	Months since direct seeding:	29
Date:	August 2017		
Comments:	A new species, <i>Gahnia aspera</i> , was also identified in good numbers within the surrounds of this quadrat.		
Native species:	<i>Juncus usitatus</i> , <i>Casuarina glauca</i> , <i>Cyperus polystachyos</i> , <i>Bolboschoenus cardwellii</i> , <i>Fimbristylis ferruginea</i> , <i>Ludwigia octovalvis</i> , <i>Persicaria decipiens</i>		
Weed species:	<i>Cuphea carthagenesis</i> , <i>Cynodon dactylon</i>		
Damage:	Nil		
Native dominance:	85%	Percentage vegetation cover:	95%
Photo:

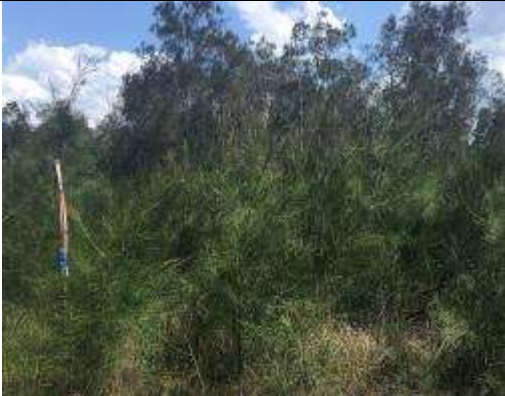
Monitoring month:	25	Months since direct seeding:	30
Date:	September 2017		
Comments:	Vegetation health and casuarina growth is steady.		
Native species:	<i>Juncus usitatus</i> , <i>Casuarina glauca</i> , <i>Cyperus polystachyos</i> , <i>Bolboschoenus cardwellii</i> , <i>Fimbristylis ferruginea</i> , <i>Ludwigia octovalvis</i> , <i>Persicaria decipiens</i>		
Weed species:	<i>Cuphea carthagenesis</i> , <i>Cynodon dactylon</i>		
Damage:	Nil		
Native dominance:	85%	Percentage vegetation cover:	95%
Photo:

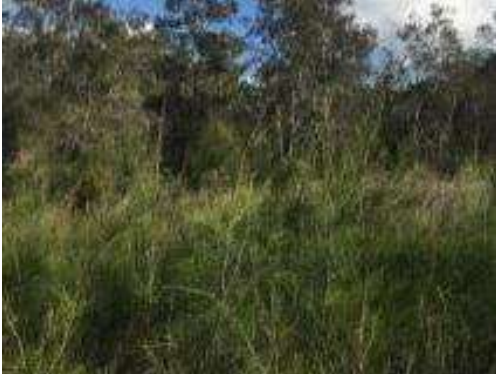
Monitoring month:	26	Months since direct seeding:	31
Date:	October 2017		
Comments:	Vegetation health and casuarina growth is steady. Groundsel recorded within the area again.		
Native species:	<i>Juncus usitatus</i> , <i>Casuarina glauca</i> , <i>Cyperus polystachyos</i> , <i>Bolboschoenus cardwellii</i> , <i>Fimbristylis ferruginea</i> , <i>Ludwigia octovalvis</i> , <i>Persicaria decipiens</i>		
Weed species:	<i>Cuphea carthagenesis</i> , <i>Cynodon dactylon</i> , <i>Baccharis halimifolia</i> *		
Damage:	Nil		
Native dominance:	85%	Percentage vegetation cover:	95%
Photo:

* Weed species requires complete eradication to meet the Desired Environmental Outcomes.

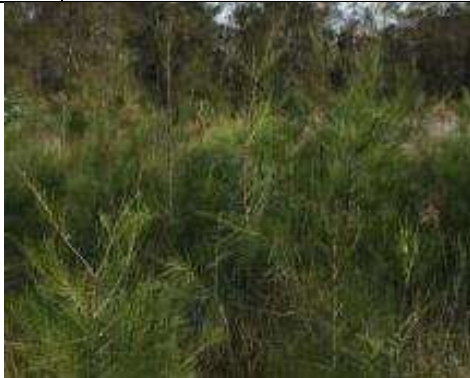
Monitoring month:	27	Months since direct seeding:	32
Date:	November 2017		
Comments:	Some rainfall was received in the latter part of this month assisting in the growth of vegetation. Groundsel still recorded but not increasing in density.		
Native species:	<i>Juncus usitatus</i> , <i>Casuarina glauca</i> , <i>Cyperus polystachyos</i> , <i>Bolboschoenus cardwellii</i> , <i>Fimbristylis ferruginea</i> , <i>Ludwigia octovalvis</i> , <i>Persicaria decipiens</i>		
Weed species:	<i>Cuphea carthagenesis</i> , <i>Cynodon dactylon</i> , <i>Baccharis halimifolia</i> *		
Damage:	Nil		
Native dominance:	85%	Percentage vegetation cover:	95%
Photo:

* Weed species requires complete eradication to meet the Desired Environmental Outcomes.

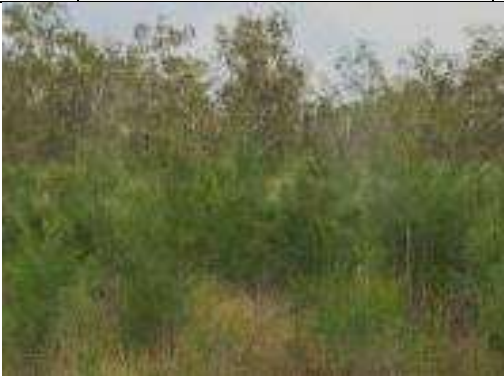
Monitoring month:	28	Months since direct seeding:	33
Date:	December 2017		
Comments:	Vegetation health and casuarina growth is steady. Treatment of groundsel will be required, however access is an issue due to rain and waterlogging.		
Native species:	<i>Juncus usitatus</i> , <i>Casuarina glauca</i> , <i>Cyperus polystachyos</i> , <i>Bolboschoenus cardwellii</i> , <i>Fimbristylis ferruginea</i> , <i>Ludwigia octovalvis</i> , <i>Persicaria decipiens</i>		
Weed species:	<i>Cuphea carthagenesis</i> , <i>Cynodon dactylon</i> , <i>Baccharis halimifolia</i> *		
Damage:	Nil		
Native dominance:	85%	Percentage vegetation cover:	95%
Photo:

* Weed species requires complete eradication to meet the Desired Environmental Outcomes.

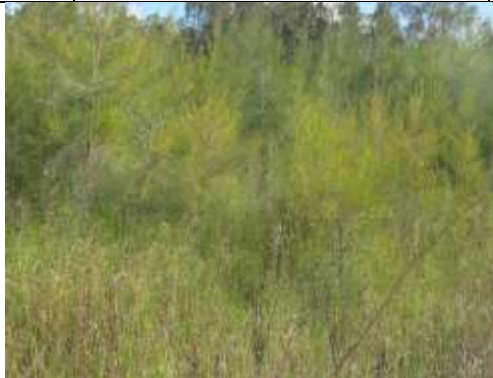
Monitoring month:	29	Months since direct seeding:	34
Date:	January 2018		
Comments:	Vegetation health and casuarina growth is steady. Treatment of groundsel commenced this month.		
Native species:	<i>Juncus usitatus</i> , <i>Casuarina glauca</i> , <i>Cyperus polystachyos</i> , <i>Bolboschoenus cardwellii</i> , <i>Fimbristylis ferruginea</i> , <i>Ludwigia octovalvis</i> , <i>Persicaria decipiens</i>		
Weed species:	<i>Cuphea carthagenesis</i> , <i>Cynodon dactylon</i> , <i>Baccharis halimifolia</i> *		
Damage:	Nil		
Native dominance:	85%	Percentage vegetation cover:	95%
Photo:

* Weed species requires complete eradication to meet the Desired Environmental Outcomes.
