North-West Conservation Park - Rehabilitation Monitoring

Lot 1 RP48903

North-West Conservation Park
Gainsborough Greens

March 2020

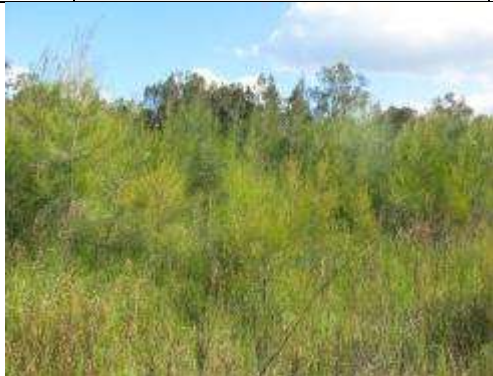
Monitoring month:	30	Months since direct seeding:	35
Date:	February 2018		
Comments:	Native vegetation biomass continues to increase. Groundsel removal throughout entire NWCP continues this month		
Native species:	<i>Juncus usitatus</i> , <i>Casuarina glauca</i> , <i>Cyperus polystachyos</i> , <i>Bolboschoenus cardwellii</i> , <i>Fimbristylis ferruginea</i> , <i>Ludwigia octovalvis</i> , <i>Persicaria decipiens</i>		
Weed species:	<i>Cuphea carthagenesis</i> , <i>Cynodon dactylon</i> , <i>Baccharis halimifolia</i> *		
Damage:	Nil		
Native dominance:	85%	Percentage vegetation cover:	95%
Photo:

* Weed species requires complete eradication to meet the Desired Environmental Outcomes.

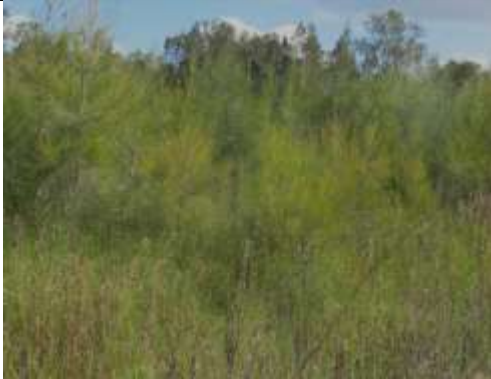
Monitoring month:	31	Months since direct seeding:	36
Date:	March 2018		
Comments:	A significant amount of rain fell at the end of last month resulting in standing water for approximately 3 weeks. This has assisted with natural weed treatment. Canopy growth and shading has also assisted in a reduction of weed growth. Groundsel treatment has been successful and the weed removed from this quadrat.		
Native species:	<i>Juncus usitatus</i> , <i>Casuarina glauca</i> , <i>Cyperus polystachyos</i> , <i>Bolboschoenus cardwellii</i> , <i>Fimbristylis ferruginea</i> , <i>Ludwigia octovalvis</i> , <i>Persicaria decipiens</i>		
Weed species:	<i>Cuphea carthagenesis</i> , <i>Cynodon dactylon</i>		
Damage:	Nil		
Native dominance:	85%	Percentage vegetation cover:	95%
Photo:

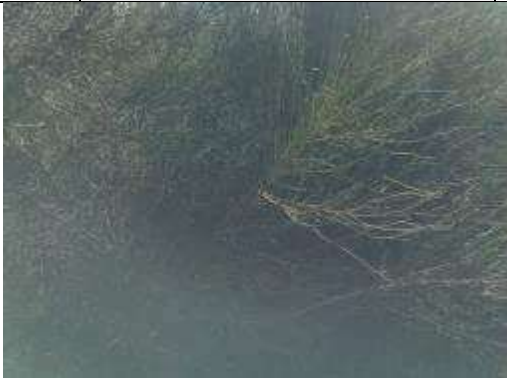
Monitoring month:	32	Months since direct seeding:	37
Date:	April 2018		
Comments:	Vegetation health and casuarina growth is steady.		
Native species:	<i>Juncus usitatus</i> , <i>Casuarina glauca</i> , <i>Cyperus polystachyos</i> , <i>Bolboschoenus cardwellii</i> , <i>Fimbristylis ferruginea</i> , <i>Ludwigia octovalvis</i> , <i>Persicaria decipiens</i>		
Weed species:	<i>Cuphea carthagenesis</i> , <i>Cynodon dactylon</i>		
Damage:	Nil		
Native dominance:	85%	Percentage vegetation cover:	95%
Photo:

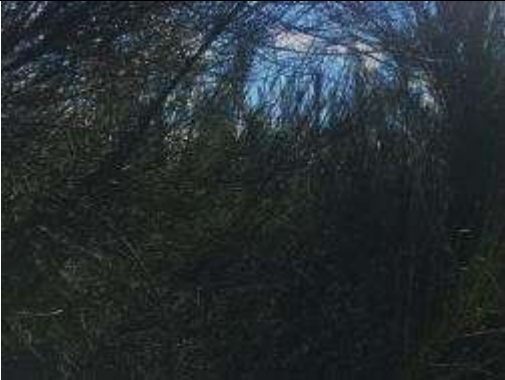
Monitoring month:	33	Months since direct seeding:	38
Date:	May 2018		
Comments:	Native vegetation biomass continues to increase.		
Native species:	<i>Juncus usitatus</i> , <i>Casuarina glauca</i> , <i>Cyperus polystachyos</i> , <i>Bolboschoenus cardwellii</i> , <i>Fimbristylis ferruginea</i> , <i>Ludwigia octovalvis</i> , <i>Persicaria decipiens</i>		
Weed species:	<i>Cuphea carthagenesis</i> , <i>Cynodon dactylon</i>		
Damage:	Nil		
Native dominance:	85%	Percentage vegetation cover:	95%
Photo:

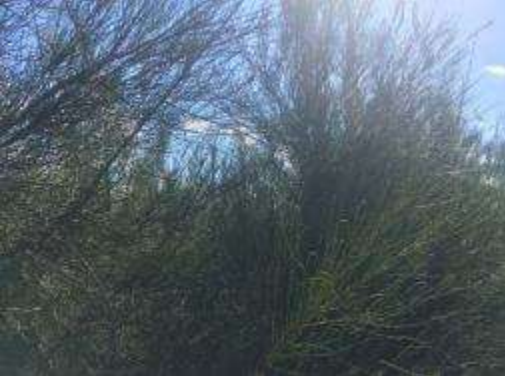
Monitoring month:	34	Months since direct seeding:	39
Date:	June 2018		
Comments:	No significant changes this month due to the slowing down of the growing season.		
Native species:	<i>Juncus usitatus</i> , <i>Casuarina glauca</i> , <i>Cyperus polystachyos</i> , <i>Bolboschoenus cardwellii</i> , <i>Fimbristylis ferruginea</i> , <i>Ludwigia octovalvis</i> , <i>Persicaria decipiens</i>		
Weed species:	<i>Cuphea carthagenesis</i> , <i>Cynodon dactylon</i>		
Damage:	Nil		
Native dominance:	85%	Percentage vegetation cover:	95%
Photo:

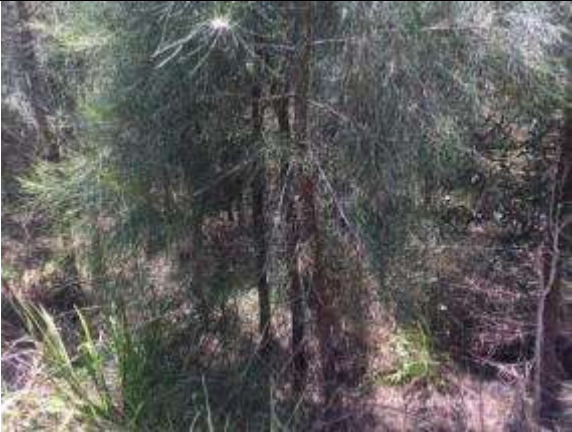
Monitoring month:	35	Months since direct seeding:	40
Date:	July 2018		
Comments:	Species diversity is declining due to the allelopathic properties of <i>Casuarina glauca</i> .		
Native species:	<i>Juncus usitatus</i> , <i>Casuarina glauca</i> , <i>Cyperus polystachyos</i> , <i>Bolboschoenus cardwellii</i> , <i>Fimbristylis ferruginea</i>		
Weed species:	<i>Cynodon dactylon</i>		
Damage:	Nil		
Native dominance:	95%	Percentage vegetation cover:	95%
Photo:

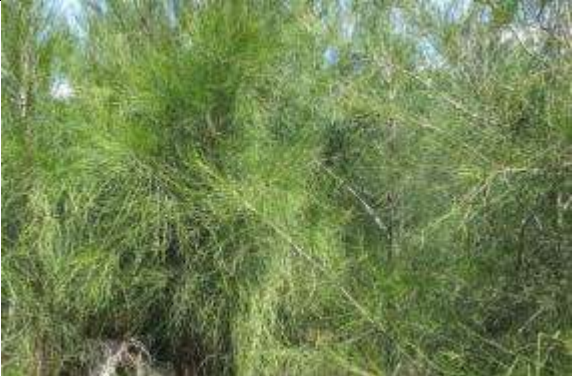
Monitoring month:	36	Months since direct seeding:	41
Date:	August 2018		
Comments:	A decline in diversity was notable this month due to the developing dominance of <i>Casuarina glauca</i> .		
Native species:	<i>Juncus usitatus</i> , <i>Casuarina glauca</i> , <i>Bolboschoenus cardwellii</i>		
Weed species:	<i>Cynodon dactylon</i>		
Damage:	Nil		
Native dominance:	95%	Percentage vegetation cover:	95%
Photo:

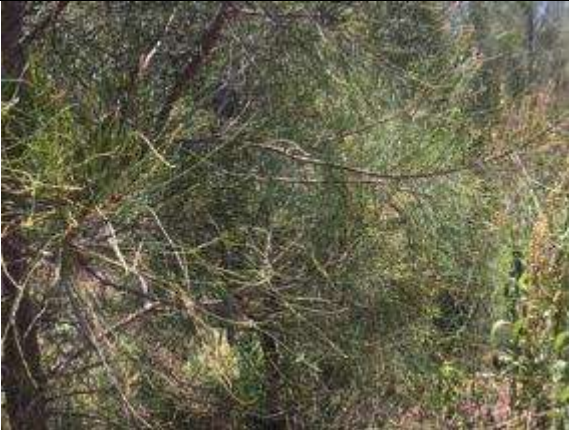
Monitoring month:	37	Months since direct seeding:	42
Date:	September 2018		
Comments:	No significant changes this month however the surrounding area continues to develop well with <i>Juncus krausii</i> copses strengthening in areas of high sodium soils.		
Native species:	<i>Juncus usitatus</i> , <i>Casuarina glauca</i> , <i>Bolboschoenus cardwellii</i>		
Weed species:	<i>Cynodon dactylon</i>		
Damage:	Nil		
Native dominance:	95%	Percentage vegetation cover:	95%
Photo:

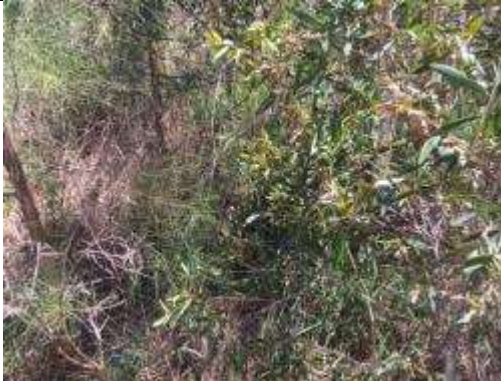
Monitoring month:	38	Months since direct seeding:	43
Date:	October 2018		
Comments:	Rainfall occurred throughout the area during this month which has assisted with the increase in biomass.		
Native species:	<i>Juncus usitatus</i> , <i>Casuarina glauca</i> , <i>Bolboschoenus cardwellii</i>		
Weed species:	<i>Cynodon dactylon</i>		
Damage:	Nil		
Native dominance:	95%	Percentage vegetation cover:	95%
Photo:

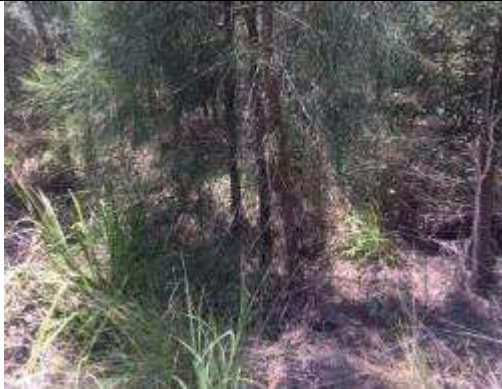
Monitoring month:	39	Months since direct seeding:	44
Date:	November 2018		
Comments:	Rapidly increasing temperatures were experienced this month resulting in the exponential growth of vegetation.		
Native species:	<i>Juncus usitatus, Casuarina glauca, Bolboschoenus cardwellii</i>		
Weed species:	<i>Cynodon dactylon</i>		
Damage:	Nil		
Native dominance:	95%	Percentage vegetation cover:	95%
Photo:

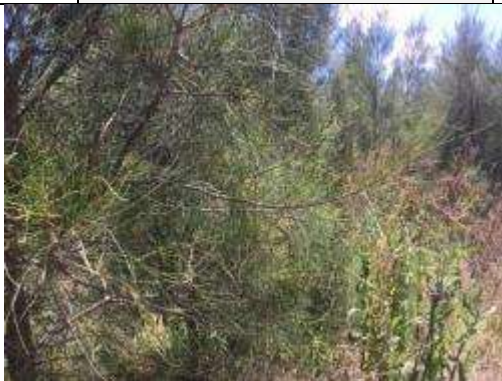
Monitoring month:	40	Months since direct seeding:	45
Date:	December 2018		
Comments:	Vegetation growth was steady this month.		
Native species:	<i>Juncus usitatus, Casuarina glauca, Bolboschoenus cardwellii</i>		
Weed species:	<i>Cynodon dactylon</i>		
Damage:	Nil		
Native dominance:	95%	Percentage vegetation cover:	95%
Photo:

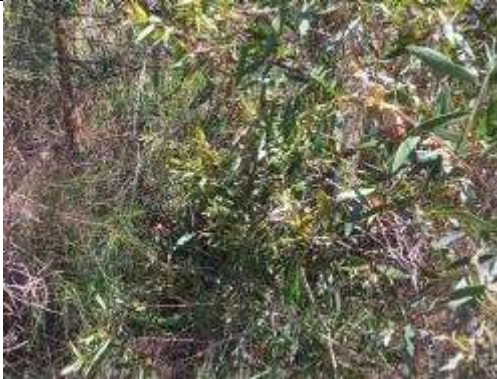
Monitoring month:	41	Months since direct seeding:	46
Date:	January 2019		
Comments:	No significant changes occurred this month.		
Native species:	<i>Juncus usitatus, Casuarina glauca, Bolboschoenus cardwellii</i>		
Weed species:	<i>Cynodon dactylon</i>		
Damage:	Nil		
Native dominance:	95%	Percentage vegetation cover:	95%
Photo:

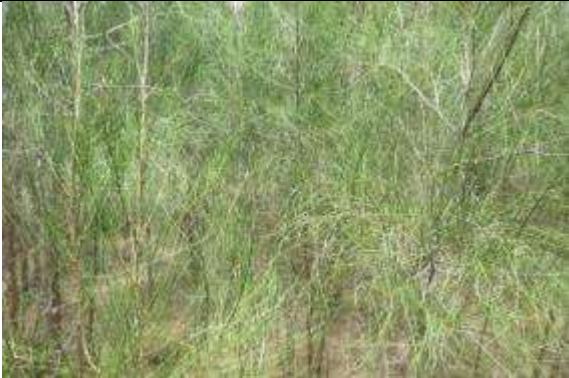
Monitoring month:	42	Months since direct seeding:	47
Date:	February 2019		
Comments:	Vegetation growth was steady this month.		
Native species:	<i>Juncus usitatus, Casuarina glauca, Bolboschoenus cardwellii</i>		
Weed species:	<i>Cynodon dactylon</i>		
Damage:	Nil		
Native dominance:	95%	Percentage vegetation cover:	95%
Photo:

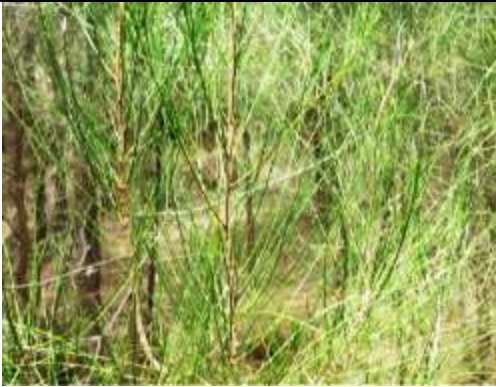
Monitoring month:	43	Months since direct seeding:	48
Date:	March 2019		
Comments:	Casuarinas continue to increase in biomass.		
Native species:	<i>Juncus usitatus</i> , <i>Casuarina glauca</i> , <i>Bolboschoenus cardwellii</i>		
Weed species:	<i>Cynodon dactylon</i>		
Damage:	Nil		
Native dominance:	95%	Percentage vegetation cover:	95%
Photo:

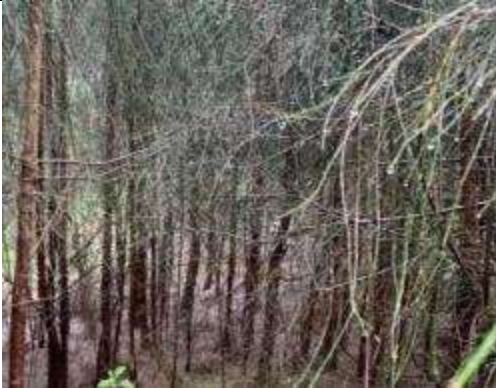
Monitoring month:	44	Months since direct seeding:	49
Date:	April 2019		
Comments:	Rainfall events increased late last month and continued this month giving the NWCP a much needed watering.		
Native species:	<i>Juncus usitatus</i> , <i>Casuarina glauca</i> , <i>Bolboschoenus cardwellii</i>		
Weed species:	<i>Cynodon dactylon</i>		
Damage:	Nil		
Native dominance:	95%	Percentage vegetation cover:	100%
Photo:

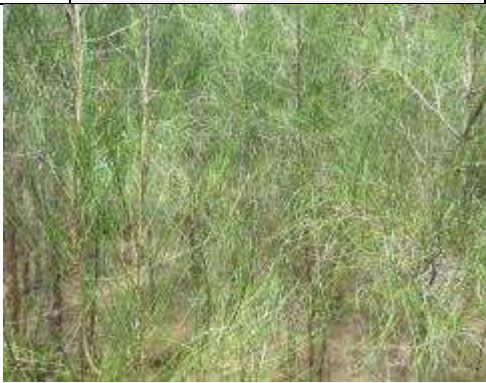
Monitoring month:	45	Months since direct seeding:	50
Date:	May 2019		
Comments:	Casuarinas continue to increase in biomass.		
Native species:	<i>Juncus usitatus</i> , <i>Casuarina glauca</i> , <i>Bolboschoenus cardwellii</i>		
Weed species:	<i>Cynodon dactylon</i>		
Damage:	Nil		
Native dominance:	95%	Percentage vegetation cover:	100%
Photo:

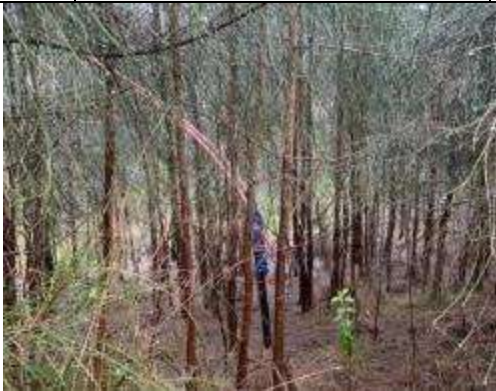
Monitoring month:	46	Months since direct seeding:	51
Date:	June 2019		
Comments:	Rainfall over the past few months has increased plant growth and vigour.		
Native species:	<i>Juncus usitatus</i> , <i>Casuarina glauca</i> , <i>Bolboschoenus cardwellii</i>		
Weed species:	<i>Cynodon dactylon</i>		
Damage:	Nil		
Native dominance:	95%	Percentage vegetation cover:	100%
Photo:

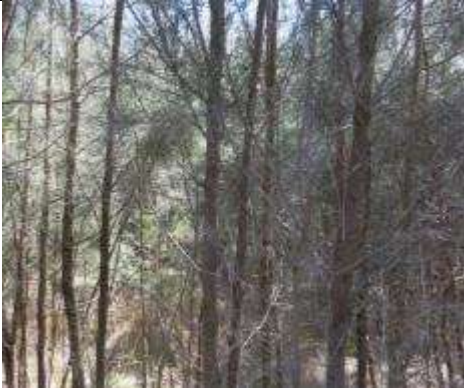
Monitoring month:	47	Months since direct seeding:	52
Date:	July 2019		
Comments:	Growth of this quadrat and the surrounds is steady.		
Native species:	<i>Juncus usitatus</i> , <i>Casuarina glauca</i> , <i>Bolboschoenus cardwellii</i>		
Weed species:	<i>Cynodon dactylon</i>		
Damage:	Nil		
Native dominance:	95%	Percentage vegetation cover:	100%
Photo:

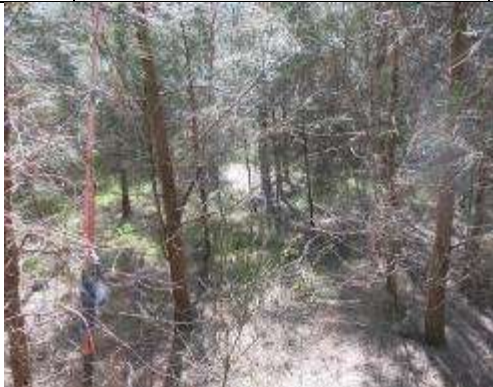
Monitoring month:	48	Months since direct seeding:	53
Date:	August 2019		
Comments:	<i>Eucalyptus tereticornis</i> is becoming more notable within the surrounding area.		
Native species:	<i>Juncus usitatus</i> , <i>Casuarina glauca</i> , <i>Bolboschoenus cardwellii</i>		
Weed species:	<i>Cynodon dactylon</i>		
Damage:	Nil		
Native dominance:	95%	Percentage vegetation cover:	100%
Photo:

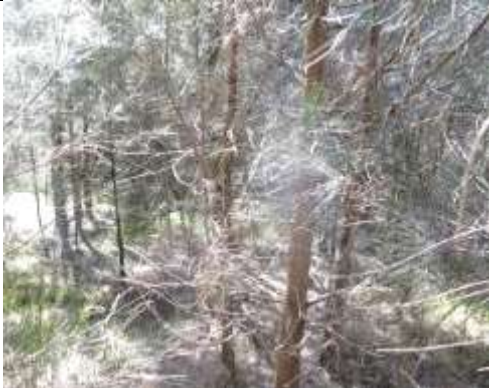
Monitoring month:	49	Months since direct seeding:	54
Date:	September 2019		
Comments:	Allelopathic properties of the casuarina leaf litter is still supressing species diversity.		
Native species:	<i>Juncus usitatus, Casuarina glauca, Bolboschoenus cardwellii</i>		
Weed species:	<i>Cynodon dactylon</i>		
Damage:	Nil		
Native dominance:	95%	Percentage vegetation cover:	100%
Photo:

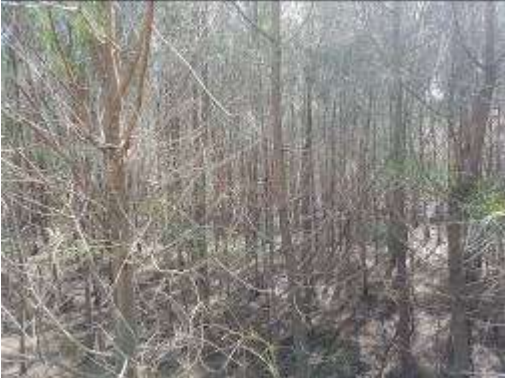
Monitoring month:	50	Months since direct seeding:	55
Date:	October 2019		
Comments:	Extended drought conditions are starting to take their toll with the extreme slowing of plant growth.		
Native species:	<i>Juncus usitatus, Casuarina glauca, Bolboschoenus cardwellii</i>		
Weed species:	<i>Nil</i>		
Damage:	Nil		
Native dominance:	100%	Percentage vegetation cover:	100%
Photo:

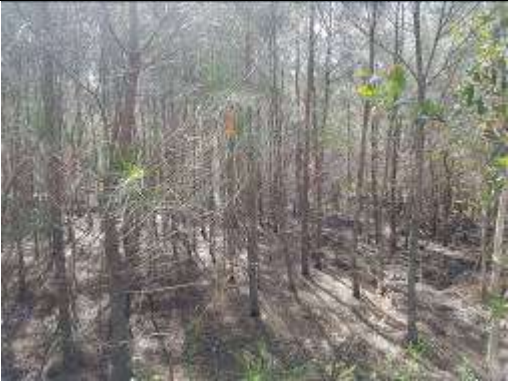
Monitoring month:	51	Months since direct seeding:	56
Date:	November 2019		
Comments:	Growth steady.		
Native species:	<i>Casuarina glauca</i> , <i>Bolboschoenus cardwellii</i>		
Weed species:	Nil		
Damage:	Nil		
Native dominance:	100%	Percentage vegetation cover:	100%
Photo:

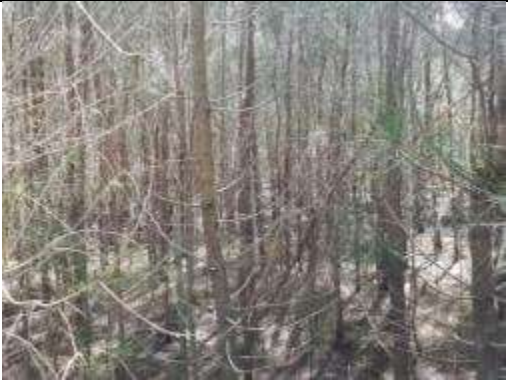
Monitoring month:	52	Months since direct seeding:	57
Date:	December 2019		
Comments:	Vegetation community maturing.		
Native species:	<i>Casuarina glauca</i> , <i>Bolboschoenus cardwellii</i>		
Weed species:	Nil		
Damage:	Nil		
Native dominance:	100%	Percentage vegetation cover:	100%
Photo:

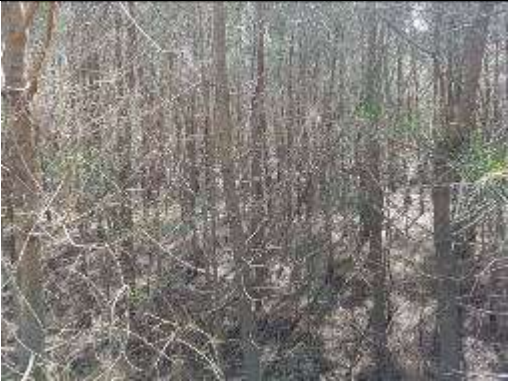
Monitoring month:	53	Months since direct seeding:	58
Date:	January 2020		
Comments:	Quadrat continues to mature.		
Native species:	<i>Casuarina glauca</i> , <i>Bolboschoenus cardwellii</i>		
Weed species:	Nil		
Damage:	Nil		
Native dominance:	100%	Percentage vegetation cover:	100%
Photo:

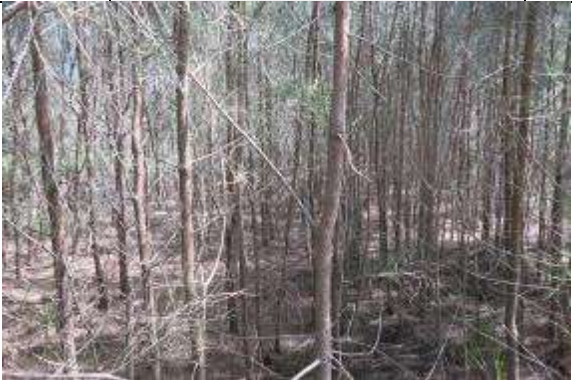
Monitoring month:	54	Months since direct seeding:	59
Date:	February 2020		
Comments:	No significant changes this month. Elevation of this quadrat is slightly higher therefore not subject to standing water.		
Native species:	<i>Casuarina glauca</i> , <i>Bolboschoenus cardwellii</i>		
Weed species:	Nil		
Damage:	Nil		
Native dominance:	100%	Percentage vegetation cover:	100%
Photo:

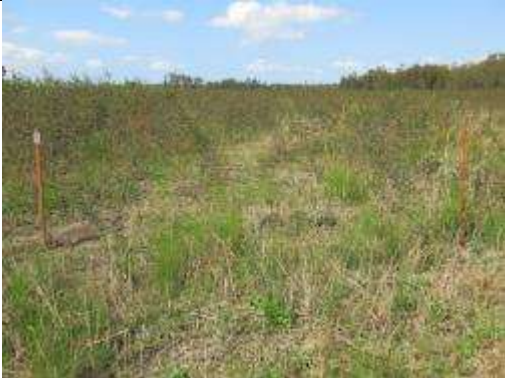
Monitoring month:	1	Months since direct seeding:	6
Date:	September 2015		
Comments:	Some plants exceeded 1 metre in height. <i>Melaleuca quinquenervia</i> was common here. Excellent plant diversity recorded here.		
Native species:	<i>Juncus usitatus</i> , <i>Cyperus polystachyos</i> , <i>Bolboschoenus cardwellii</i> , <i>Fimbristylis ferruginea</i> , <i>Ludwigia octovalvis</i> , <i>Melaleuca quinquenervia</i> , <i>Persicaria attenuata</i>		
Weed species:	<i>Cynodon dactylon</i>		
Damage:	Nil		
Native dominance:	88%	Percentage vegetation cover:	60%
Photo:

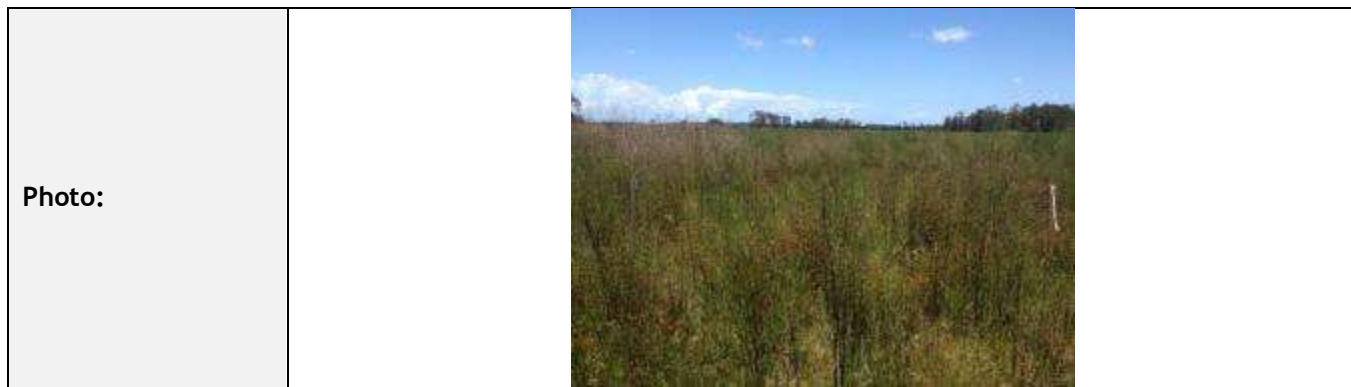
Monitoring month:	6	Months since direct seeding:	11
Date:	February 2016		
Comments:	Some plants now exceeding 1.3 metres in height. <i>Melaleuca quinquenervia</i> remains most common here. In surrounding areas several new species were observed germinating, small clusters of Eucalyptus, also <i>Canavalia rosea</i> , <i>Acacia concurrens</i> , <i>Acacia hubbardiana</i> , <i>Acacia falcata</i> , <i>Hibiscus diversifolium</i> , <i>Corymbia intermedia</i> , and <i>Eucalyptus teriticornis</i> . They may be vulnerable if the area is inundated for long periods. These are dormant seed as this area was not over-seeded in October. A promising sign for elsewhere onsite.		
Native species:	<i>Juncus usitatus</i> , <i>Cyperus polystachyos</i> , <i>Bolboschoenus cardwellii</i> , <i>Fimbristylis ferruginea</i> , <i>Ludwigia octovalvis</i> , <i>Melaleuca quinquenervia</i> , <i>Persicaria attenuata</i>		
Weed species:	<i>Aster subulatus</i> , <i>Cuphea carthagenesis</i> , <i>Cynodon dactylon</i>

Damage:	Nil		
Native dominance:	70%	Percentage vegetation cover:	80%

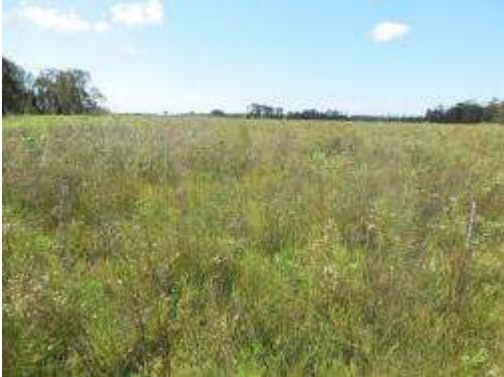
Monitoring month:	7	Months since direct seeding:	12
Date:	March 2016		
Comments:	Some plants of <i>Melaleuca quinquenervia</i> and <i>Casuarina glauca</i> exceeded 1.5 metres in height, these were common here. The new terrestrial species observed last time between these quadrats have mostly yellowed, suffering from lack of oxygen due to recent rains. Seven canopy trees were counted within 1 square metre being <i>Melaleuca quinquenervia</i> and <i>Casuarina glauca</i> . Myrtle Rust is also obvious on <i>Melaleuca</i> in the surrounds.		
Native species:	<i>Juncus usitatus</i> , <i>Cyperus polystachyos</i> , <i>Bolboschoenus cardwellii</i> , <i>Fimbristylis ferruginea</i> , <i>Ludwigia octovalvis</i> , <i>Melaleuca quinquenervia</i> , <i>Persicaria attenuata</i>		
Weed species:	<i>Aster subulatus</i> , <i>Cuphea carthagenesis</i> , <i>Cynodon dactylon</i>		
Damage:	Nil		
Native dominance:	70%	Percentage vegetation cover:	80%

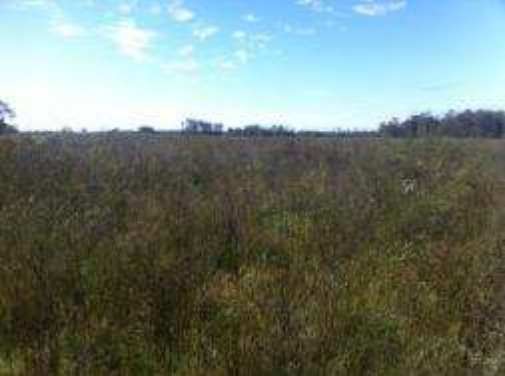
Monitoring month:	8	Months since direct seeding:	13
Date:	April 2016		
Comments:	Some plants of <i>Melaleuca quinquenervia</i> and <i>Casuarina glauca</i> exceeded 1.5 metres in height. As per Quadrat 4, the new terrestrial species observed last time between these quadrats have mostly yellowed, suffering from lack of oxygen due to recent rains. Canopy trees, <i>Melaleuca quinquenervia</i> and <i>Casuarina glauca</i> are progressing. Myrtle Rust is also obvious on <i>Melaleuca</i> in the surrounds.		
Native species:	<i>Juncus usitatus</i> , <i>Cyperus polystachyos</i> , <i>Bolboschoenus cardwellii</i> , <i>Fimbristylis ferruginea</i> , <i>Ludwigia octovalvis</i> , <i>Melaleuca quinquenervia</i> , <i>Persicaria attenuata</i>		
Weed species:	<i>Aster subulatus</i> , <i>Cuphea carthagenesis</i> , <i>Cynodon dactylon</i>		
Damage:	Nil		
Native dominance:	70%	Percentage vegetation cover:	80%
Photo:

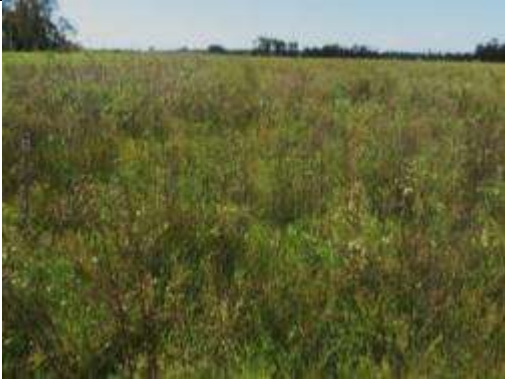
Monitoring month:	9	Months since direct seeding:	14
Date:	May 2016		
Comments:	<i>Melaleuca quinquenervia</i> and <i>Casuarina glauca</i> seedlings exceed 1.5 metres in height. New species emerging in the surrounding areas are still not evident within this quadrat.		
Native species:	<i>Juncus usitatus</i> , <i>Cyperus polystachyos</i> , <i>Bolboschoenus cardwellii</i> , <i>Fimbristylis ferruginea</i> , <i>Ludwigia octovalvis</i> , <i>Melaleuca quinquenervia</i> , <i>Persicaria attenuata</i>		
Weed species:	<i>Aster subulatus</i> , <i>Cuphea carthagenesis</i> , <i>Cynodon dactylon</i>		
Damage:	Nil		
Native dominance:	70%	Percentage vegetation cover:	80%
Photo:

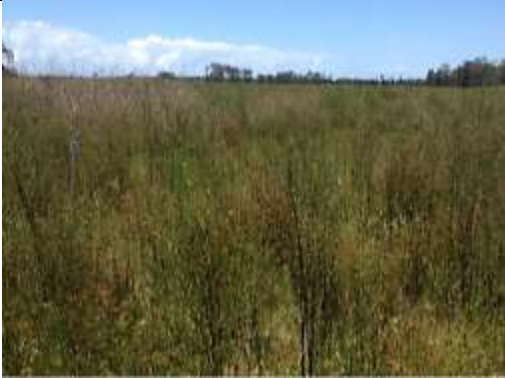
Monitoring month:	10	Months since direct seeding:	15
Date:	June 2016		
Comments:	Native canopy seedlings still progressing well. Some Aster die-back is starting to show due to the decrease in temperature.		
Native species:	<i>Juncus usitatus</i> , <i>Cyperus polystachyos</i> , <i>Bolboschoenus cardwellii</i> , <i>Fimbristylis ferruginea</i> , <i>Ludwigia octovalvis</i> , <i>Melaleuca quinquenervia</i> , <i>Persicaria attenuata</i>		
Weed species:	<i>Aster subulatus</i> , <i>Cuphea carthagenesis</i> , <i>Cynodon dactylon</i>		
Damage:	Nil		
Native dominance:	75%	Percentage vegetation cover:	80%
Photo:

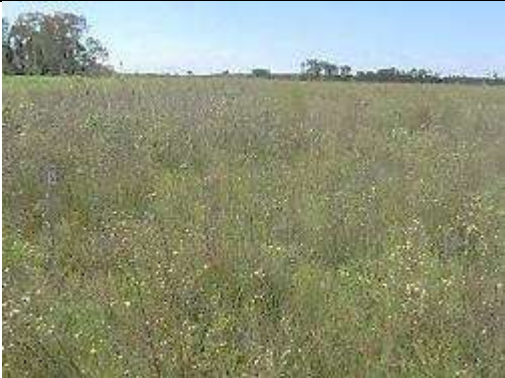
Monitoring month:	11	Months since direct seeding:	16
Date:	July 2016		
Comments:	Growth of vegetation has slowed over this month as species enter winter dormancy. With the standard reduction in Aster due to the winter period, native dominance has increase, despite overall growth of vegetation not increasing.		
Native species:	<i>Juncus usitatus</i> , <i>Cyperus polystachyos</i> , <i>Bolboschoenus cardwellii</i> , <i>Fimbristylis ferruginea</i> , <i>Ludwigia octovalvis</i> , <i>Melaleuca quinquenervia</i> , <i>Persicaria attenuata</i>		
Weed species:	<i>Aster subulatus</i> , <i>Cuphea carthagenesis</i> , <i>Cynodon dactylon</i>		
Damage:	Nil		
Native dominance:	80%	Percentage vegetation cover:	80%
Photo:

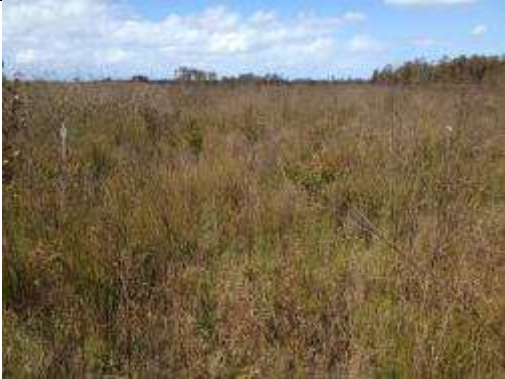
Monitoring month:	12	Months since direct seeding:	17
Date:	August 2016		
Comments:	Melaleuca and Casuarina are forming impressive thickets in areas between quadrants 4, 5, 6 and 7. Despite the changes surrounding the quadrants, no significant change is noted within this quadrat. Canopy trees, <i>Melaleuca quinquenervia</i> and <i>Casuarina glauca</i> are still progressing. Myrtle Rust is also obvious on Melaleuca in the surrounds.		
Native species:	<i>Juncus usitatus</i> , <i>Cyperus polystachyos</i> , <i>Bolboschoenus cardwellii</i> , <i>Fimbristylis ferruginea</i> , <i>Ludwigia octovalvis</i> , <i>Melaleuca quinquenervia</i> , <i>Persicaria attenuata</i>		
Weed species:	<i>Aster subulatus</i> , <i>Cuphea carthagenesis</i> , <i>Cynodon dactylon</i>		
Damage:	Nil		
Native dominance:	80%	Percentage vegetation cover:	80%
Photo:

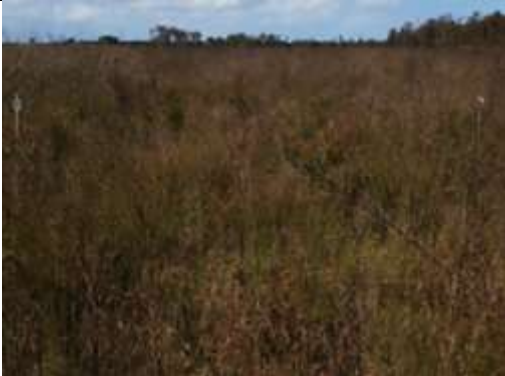
Monitoring month:	13	Months since direct seeding:	18
Date:	September 2016		
Comments:	No significant change is noted within this quadrat. Canopy trees, <i>Melaleuca quinquenervia</i> and <i>Casuarina glauca</i> are still progressing. Myrtle Rust is also obvious on Melaleuca in the surrounds.		
Native species:	<i>Juncus usitatus</i> , <i>Cyperus polystachyos</i> , <i>Bolboschoenus cardwellii</i> , <i>Fimbristylis ferruginea</i> , <i>Ludwigia octovalvis</i> , <i>Melaleuca quinquenervia</i> , <i>Persicaria attenuata</i>		
Weed species:	<i>Aster subulatus</i> , <i>Cuphea carthagenesis</i> , <i>Cynodon dactylon</i>		
Damage:	Nil		
Native dominance:	80%	Percentage vegetation cover:	80%
Photo:

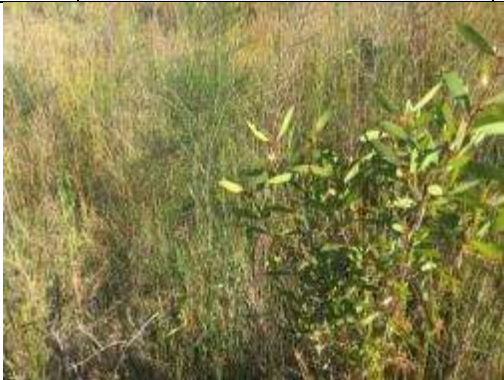
Monitoring month:	14	Months since direct seeding:	19
Date:	October 2016		
Comments:	Melaleuca and Casuarina seedlings continue to grow well. Myrtle Rust is still obvious on Melaleuca in the surrounds, however is yet to spread into this quadrat.		
Native species:	<i>Juncus usitatus</i> , <i>Cyperus polystachyos</i> , <i>Bolboschoenus cardwellii</i> , <i>Fimbristylis ferruginea</i> , <i>Ludwigia octovalvis</i> , <i>Melaleuca quinquenervia</i> , <i>Persicaria attenuata</i>		
Weed species:	<i>Aster subulatus</i> , <i>Cuphea carthagenesis</i> , <i>Cynodon dactylon</i>		
Damage:	Nil		
Native dominance:	80%	Percentage vegetation cover:	80%
Photo:

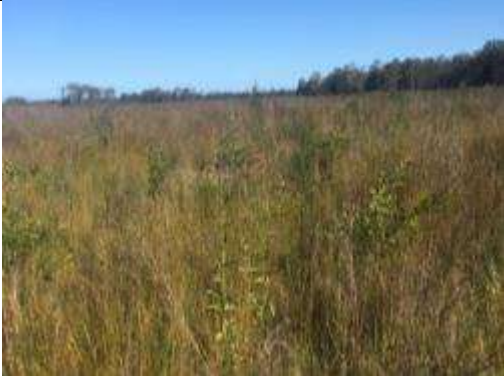
Monitoring month:	15	Months since direct seeding:	20
Date:	November 2016		
Comments:	Melaleuca and Casuarina seedlings continue to grow well. No other notable changes have occurred this month.		
Native species:	<i>Juncus usitatus</i> , <i>Cyperus polystachyos</i> , <i>Bolboschoenus cardwellii</i> , <i>Fimbristylis ferruginea</i> , <i>Ludwigia octovalvis</i> , <i>Melaleuca quinquenervia</i> , <i>Persicaria attenuata</i>		
Weed species:	<i>Aster subulatus</i> , <i>Cuphea carthagenesis</i> , <i>Cynodon dactylon</i>		
Damage:	Nil		
Native dominance:	80%	Percentage vegetation cover:	85%
Photo:

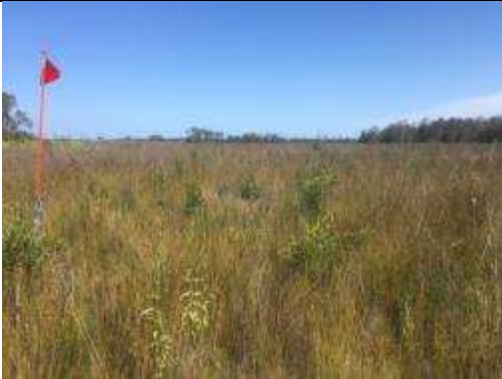
Monitoring month:	16	Months since direct seeding:	21
Date:	December 2016		
Comments:	A high visibility flag and extended pole was added to the quadrat stake this month for ease of identification. Groundsel has been identified within this quadrat this month. Melaleucas continue to gain height.		
Native species:	<i>Juncus usitatus</i> , <i>Cyperus polystachyos</i> , <i>Bolboschoenus cardwellii</i> , <i>Fimbristylis ferruginea</i> , <i>Ludwigia octovalvis</i> , <i>Melaleuca quinquenervia</i> , <i>Persicaria attenuata</i>		
Weed species:	<i>Aster subulatus</i> , <i>Cuphea carthagenesis</i> , <i>Cynodon dactylon</i> , <i>Baccharis halimifolia</i>*		
Damage:	Nil		
Native dominance:	80%	Percentage vegetation cover:	85%
Photo:

* Weed species requires complete eradication to meet the Desired Environmental Outcomes.

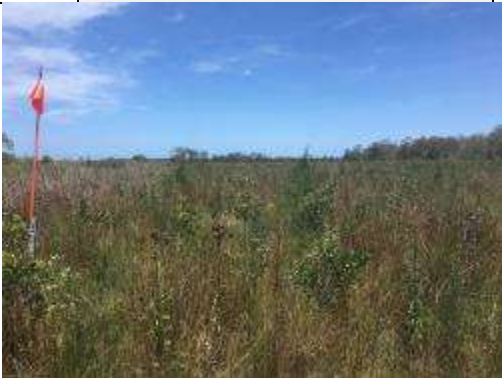
Monitoring month:	17	Months since direct seeding:	22
Date:	January 2017		
Comments:	Native vegetation continues to prosper this month with Casuarinas reaching up to approximately 1.5m and Melaleucas averaging 1.3m in height.		
Native species:	<i>Juncus usitatus</i> , <i>Cyperus polystachyos</i> , <i>Bolboschoenus cardwellii</i> , <i>Fimbristylis ferruginea</i> , <i>Ludwigia octovalvis</i> , <i>Melaleuca quinquenervia</i> , <i>Persicaria attenuata</i> , <i>Casuarina glauca</i>		
Weed species:	<i>Aster subulatus</i> , <i>Cuphea carthagenesis</i> , <i>Cynodon dactylon</i> , <i>Baccharis halimifolia</i>*		
Damage:	Nil		
Native dominance:	85%	Percentage vegetation cover:	90%
Photo:

* Weed species requires complete eradication to meet the Desired Environmental Outcomes.

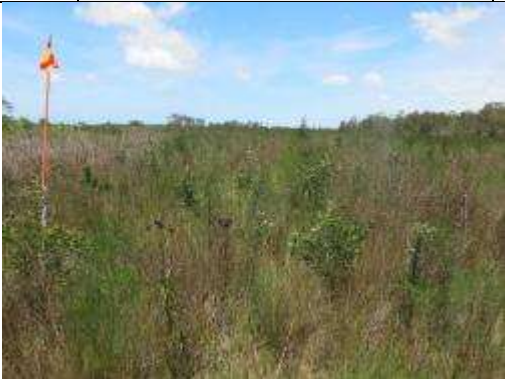
Monitoring month:	18	Months since direct seeding:	23
Date:	February 2017		
Comments:	Native vegetation continues to prosper this month with Casuarinas reaching up to approximately 1.5m and Melaleucas averaging 1.3m in height.		
Native species:	<i>Juncus usitatus</i> , <i>Cyperus polystachyos</i> , <i>Bolboschoenus cardwellii</i> , <i>Fimbristylis ferruginea</i> , <i>Ludwigia octovalvis</i> , <i>Melaleuca quinquenervia</i> , <i>Persicaria attenuata</i> , <i>Casuarina glauca</i>		
Weed species:	<i>Cuphea carthagenesis</i> , <i>Cynodon dactylon</i>		
Damage:	Nil		
Native dominance:	85%	Percentage vegetation cover:	90%
Photo:

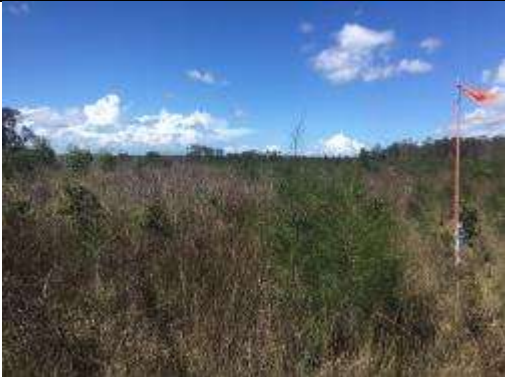
Monitoring month:	19	Months since direct seeding:	24
Date:	March 2017 (NB: monitoring event occurred early April due to inaccessibility)		
Comments:	During the last half of this month, the NWCP received significant rainfall. Access to the area was limited. Much of the area is waterlogged (approximately 4cm of water covering quadrat) and functioning as the wetland it is designed to be. Correct angle for photo was not achievable due to water. Casuarinas reaching up to approximately 2.5m and Melaleucas averaging 1.5m in height.		
Native species:	<i>Juncus usitatus</i> , <i>Cyperus polystachyos</i> , <i>Bolboschoenus cardwellii</i> , <i>Fimbristylis ferruginea</i> , <i>Ludwigia octovalvis</i> , <i>Melaleuca quinquenervia</i> , <i>Persicaria attenuata</i> , <i>Casuarina glauca</i>		
Weed species:	<i>Cuphea carthagenesis</i> , <i>Cynodon dactylon</i>		
Damage:	Nil - large weather event associated with Ex-Tropical Cyclone Debbie did not result in any damage

Native dominance:	85%	Percentage vegetation cover:	90%
Photo:

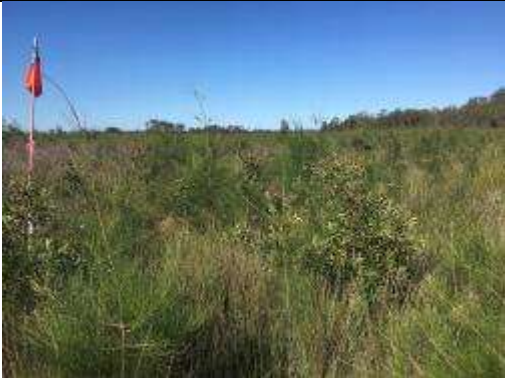
Monitoring month:	20	Months since direct seeding:	25
Date:	April 2017		
Comments:	Much of the area is still waterlogged and functioning as the wetland it is designed to be. Casuarinas and Melaleucas continue to grow well.		
Native species:	<i>Juncus usitatus</i> , <i>Cyperus polystachyos</i> , <i>Bolboschoenus cardwellii</i> , <i>Fimbristylis ferruginea</i> , <i>Ludwigia octovalvis</i> , <i>Melaleuca quinquenervia</i> , <i>Persicaria attenuata</i> , <i>Casuarina glauca</i>		
Weed species:	<i>Cuphea carthagenesis</i> , <i>Cynodon dactylon</i>		
Damage:	Nil		
Native dominance:	85%	Percentage vegetation cover:	90%
Photo:

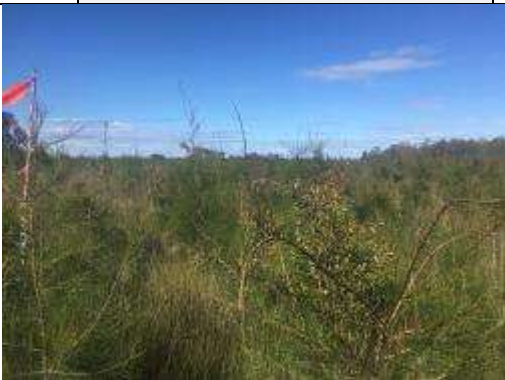
Monitoring month:	21	Months since direct seeding:	26
Date:	May 2017		
Comments:	Canopy species continue to reach above groundcovers. Casuarinas reaching up to approximately 3m and Melaleucas averaging 2m in height.		
Native species:	<i>Juncus usitatus</i> , <i>Cyperus polystachyos</i> , <i>Bolboschoenus cardwellii</i> , <i>Fimbristylis ferruginea</i> , <i>Ludwigia octovalvis</i> , <i>Melaleuca quinquenervia</i> , <i>Persicaria attenuata</i> , <i>Casuarina glauca</i>		
Weed species:	<i>Cuphea carthagenesis</i> , <i>Cynodon dactylon</i>		
Damage:	Nil		
Native dominance:	85%	Percentage vegetation cover:	90%
Photo:

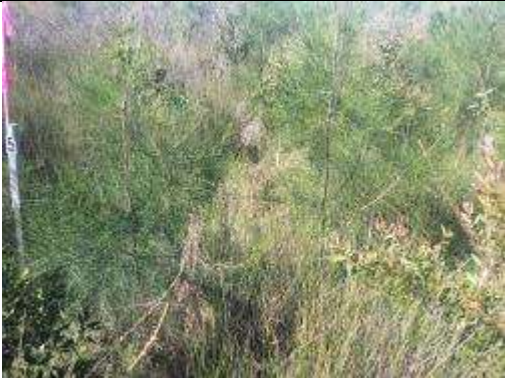
Monitoring month:	22	Months since direct seeding:	27
Date:	June 2017		
Comments:	No significant changes this month. It is anticipated growth will slow moving into the colder months.		
Native species:	<i>Juncus usitatus</i> , <i>Cyperus polystachyos</i> , <i>Bolboschoenus cardwellii</i> , <i>Fimbristylis ferruginea</i> , <i>Ludwigia octovalvis</i> , <i>Melaleuca quinquenervia</i> , <i>Persicaria attenuata</i> , <i>Casuarina glauca</i>		
Weed species:	<i>Cuphea carthagenesis</i> , <i>Cynodon dactylon</i>		
Damage:	Nil		
Native dominance:	85%	Percentage vegetation cover:	90%
Photo:

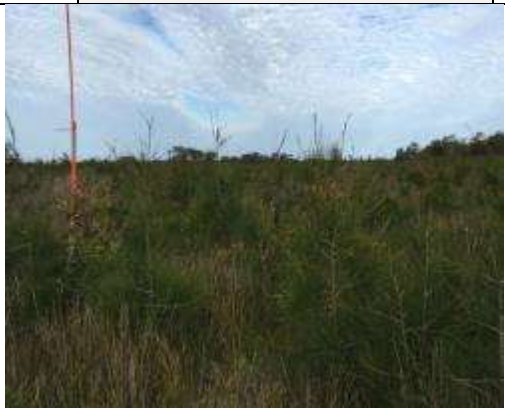
Monitoring month:	23	Months since direct seeding:	28
Date:	July 2017		
Comments:	An additional length of conduit was added to the flagging pole this month due to the increasing height of vegetation. Vegetation health is steady.		
Native species:	<i>Juncus usitatus</i> , <i>Cyperus polystachyos</i> , <i>Bolboschoenus cardwellii</i> , <i>Fimbristylis ferruginea</i> , <i>Ludwigia octovalvis</i> , <i>Melaleuca quinquenervia</i> , <i>Persicaria attenuata</i> , <i>Casuarina glauca</i>		
Weed species:	<i>Cuphea carthagenesis</i> , <i>Cynodon dactylon</i>		
Damage:	Nil		
Native dominance:	85%	Percentage vegetation cover:	90%
Photo:

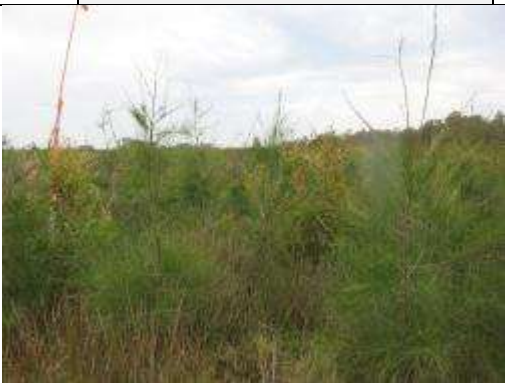
Monitoring month:	24	Months since direct seeding:	29
Date:	August 2017		
Comments:	Melaleuca growth is notable this month, becoming co-dominant with the casuarinas.		
Native species:	<i>Juncus usitatus</i> , <i>Cyperus polystachyos</i> , <i>Bolboschoenus cardwellii</i> , <i>Fimbristylis ferruginea</i> , <i>Ludwigia octovalvis</i> , <i>Melaleuca quinquenervia</i> , <i>Persicaria attenuata</i> , <i>Casuarina glauca</i>		
Weed species:	<i>Cuphea carthagenesis</i> , <i>Cynodon dactylon</i>		
Damage:	Nil		
Native dominance:	90%	Percentage vegetation cover:	90%
Photo:

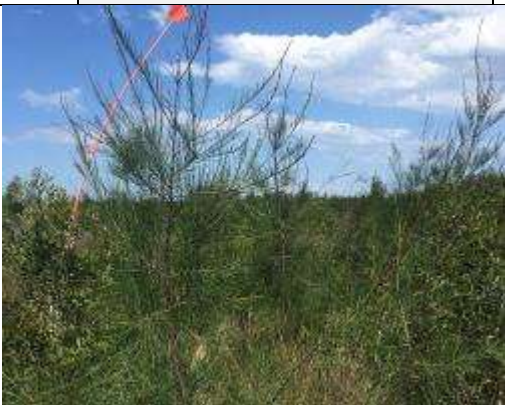
Monitoring month:	25	Months since direct seeding:	30
Date:	September 2017		
Comments:	Melaleuca and casuarina continue to grow well.		
Native species:	<i>Juncus usitatus</i> , <i>Cyperus polystachyos</i> , <i>Bolboschoenus cardwellii</i> , <i>Fimbristylis ferruginea</i> , <i>Ludwigia octovalvis</i> , <i>Melaleuca quinquenervia</i> , <i>Persicaria attenuata</i> , <i>Casuarina glauca</i>		
Weed species:	<i>Cuphea carthagenesis</i> , <i>Cynodon dactylon</i>		
Damage:	Nil		
Native dominance:	90%	Percentage vegetation cover:	90%
Photo:

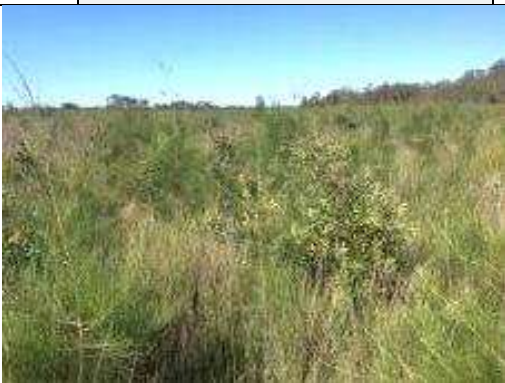
Monitoring month:	26	Months since direct seeding:	31
Date:	October 2017		
Comments:	Melaleuca and casuarina continue to grow well.		
Native species:	<i>Juncus usitatus</i> , <i>Cyperus polystachyos</i> , <i>Bolboschoenus cardwellii</i> , <i>Fimbristylis ferruginea</i> , <i>Ludwigia octovalvis</i> , <i>Melaleuca quinquenervia</i> , <i>Persicaria attenuata</i> , <i>Casuarina glauca</i>		
Weed species:	<i>Cuphea carthagenesis</i> , <i>Cynodon dactylon</i>		
Damage:	Nil		
Native dominance:	90%	Percentage vegetation cover:	90%
Photo:

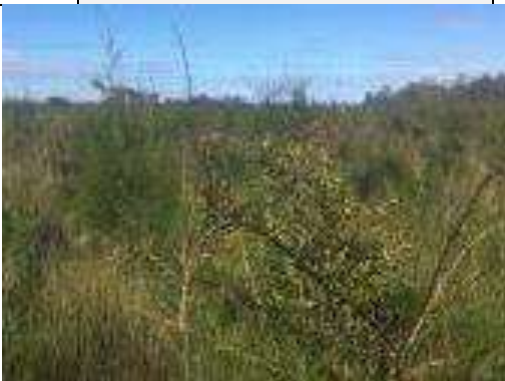
Monitoring month:	27	Months since direct seeding:	32
Date:	November 2017		
Comments:	Increasing temperatures and scattered rain events have provided good growing conditions for all vegetation. Groundsel was recorded again within the vicinity of this quadrat.		
Native species:	<i>Juncus usitatus</i> , <i>Cyperus polystachyos</i> , <i>Bolboschoenus cardwellii</i> , <i>Fimbristylis ferruginea</i> , <i>Ludwigia octovalvis</i> , <i>Melaleuca quinquenervia</i> , <i>Persicaria attenuata</i> , <i>Casuarina glauca</i>		
Weed species:	<i>Cuphea carthagenesis</i> , <i>Cynodon dactylon</i> , <i>Baccharis halimifolia</i> *		
Damage:	Nil		
Native dominance:	90%	Percentage vegetation cover:	90%
Photo:

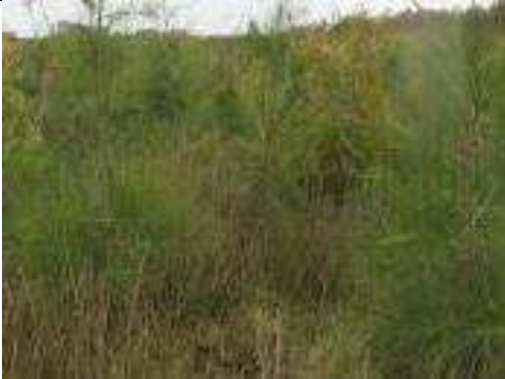
Monitoring month:	28	Months since direct seeding:	33
Date:	December 2017		
Comments:	Rainfall and increasing temperatures promoted vegetative growth across this quadrat and overall NWCP. Groundsel will require treatment in the coming months, however no possible this month due to waterlogging.		
Native species:	<i>Juncus usitatus</i> , <i>Cyperus polystachyos</i> , <i>Bolboschoenus cardwellii</i> , <i>Fimbristylis ferruginea</i> , <i>Ludwigia octovalvis</i> , <i>Melaleuca quinquenervia</i> , <i>Persicaria attenuata</i> , <i>Casuarina glauca</i>		
Weed species:	<i>Cuphea carthagenesis</i> , <i>Cynodon dactylon</i> , <i>Baccharis halimifolia</i> *		
Damage:	Nil		
Native dominance:	90%	Percentage vegetation cover:	90%
Photo:

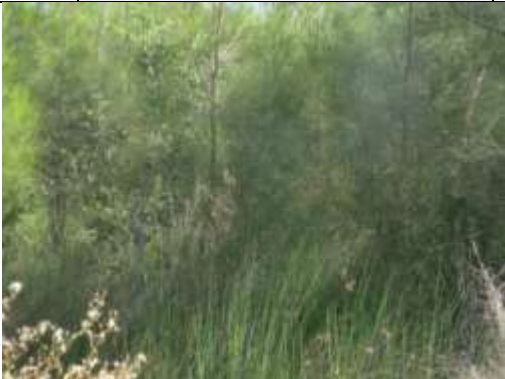
Monitoring month:	29	Months since direct seeding:	34
Date:	January 2018		
Comments:	Growth of casuarina seedlings very evident this month, adding a significant amount of biomass to this quadrat. A small amount of Myrtle Rust is still evident in the surrounding area, but not causing significant degradation.		
Native species:	<i>Juncus usitatus</i> , <i>Cyperus polystachyos</i> , <i>Bolboschoenus cardwellii</i> , <i>Fimbristylis ferruginea</i> , <i>Ludwigia octovalvis</i> , <i>Melaleuca quinquenervia</i> , <i>Persicaria attenuata</i> , <i>Casuarina glauca</i>		
Weed species:	<i>Cuphea carthagenesis</i> , <i>Cynodon dactylon</i> , <i>Baccharis halimifolia</i> *		
Damage:	Nil		
Native dominance:	90%	Percentage vegetation cover:	90%
Photo:

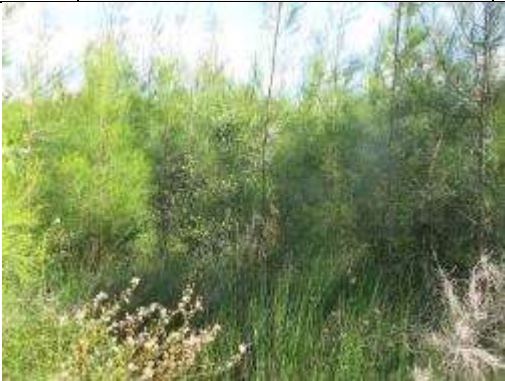
Monitoring month:	30	Months since direct seeding:	35
Date:	February 2018		
Comments:	Melaleuca and casuarina continue to grow well. Treatment of groundsel continued this month.		
Native species:	<i>Juncus usitatus</i> , <i>Cyperus polystachyos</i> , <i>Bolboschoenus cardwellii</i> , <i>Fimbristylis ferruginea</i> , <i>Ludwigia octovalvis</i> , <i>Melaleuca quinquenervia</i> , <i>Persicaria attenuata</i> , <i>Casuarina glauca</i>		
Weed species:	<i>Cuphea carthagenesis</i> , <i>Cynodon dactylon</i> , <i>Baccharis halimifolia</i> *		
Damage:	Nil		
Native dominance:	90%	Percentage vegetation cover:	90%
Photo:

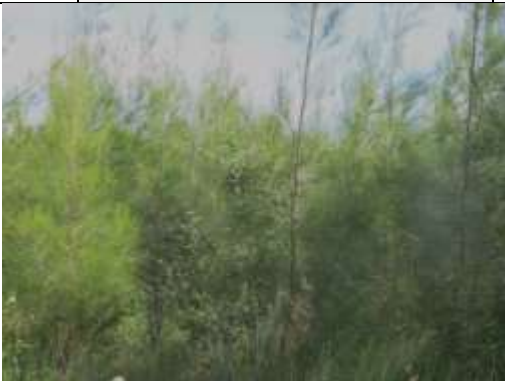
Monitoring month:	31	Months since direct seeding:	36
Date:	March 2018		
Comments:	A significant amount of rain fell at the end of last month resulting in standing water for approximately 3 weeks. This has acted as a natural weed control for a number of the weed species. Canopy growth and shading has also assisted in a reduction of weed growth.		
Native species:	<i>Juncus usitatus</i> , <i>Cyperus polystachyos</i> , <i>Bolboschoenus cardwellii</i> , <i>Fimbristylis ferruginea</i> , <i>Ludwigia octovalvis</i> , <i>Melaleuca quinquenervia</i> , <i>Persicaria attenuata</i> , <i>Casuarina glauca</i>		
Weed species:	<i>Cuphea carthagenesis</i> , <i>Cynodon dactylon</i>		
Damage:	Nil		
Native dominance:	90%	Percentage vegetation cover:	90%
Photo:

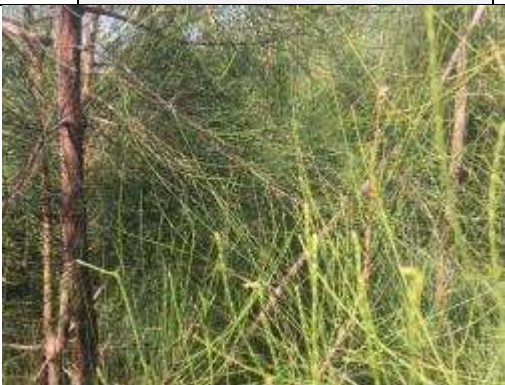
Monitoring month:	32	Months since direct seeding:	37
Date:	April 2018		
Comments:	Melaleuca and casuarina continue to add height and biomass.		
Native species:	<i>Juncus usitatus</i> , <i>Cyperus polystachyos</i> , <i>Bolboschoenus cardwellii</i> , <i>Fimbristylis ferruginea</i> , <i>Ludwigia octovalvis</i> , <i>Melaleuca quinquenervia</i> , <i>Persicaria attenuata</i> , <i>Casuarina glauca</i>		
Weed species:	<i>Cuphea carthagenesis</i> , <i>Cynodon dactylon</i>		
Damage:	Nil		
Native dominance:	90%	Percentage vegetation cover:	90%
Photo:

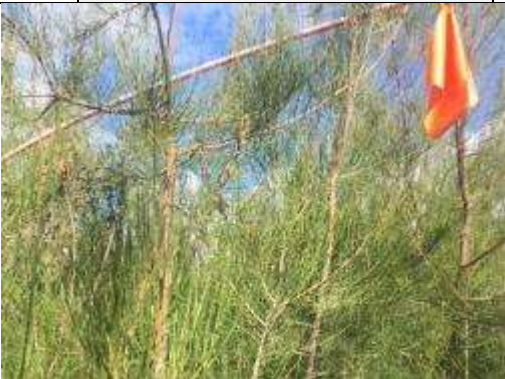
Monitoring month:	33	Months since direct seeding:	38
Date:	May 2018		
Comments:	Melaleuca and casuarina continue to grow well.		
Native species:	<i>Juncus usitatus</i> , <i>Cyperus polystachyos</i> , <i>Bolboschoenus cardwellii</i> , <i>Fimbristylis ferruginea</i> , <i>Ludwigia octovalvis</i> , <i>Melaleuca quinquenervia</i> , <i>Persicaria attenuata</i> , <i>Casuarina glauca</i>		
Weed species:	<i>Cuphea carthagenesis</i> , <i>Cynodon dactylon</i>		
Damage:	Nil		
Native dominance:	90%	Percentage vegetation cover:	90%
Photo:

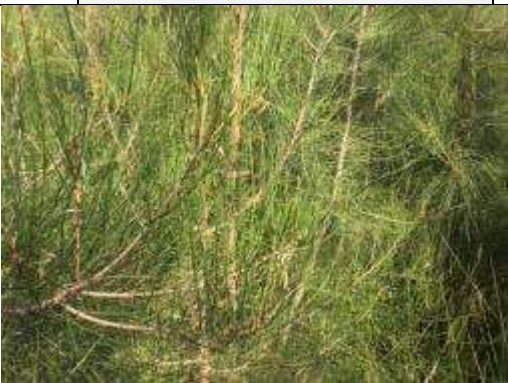
Monitoring month:	34	Months since direct seeding:	39
Date:	June 2018		
Comments:	No significant changes this month due to the slowing down of the growing season.		
Native species:	<i>Juncus usitatus</i> , <i>Cyperus polystachyos</i> , <i>Bolboschoenus cardwellii</i> , <i>Fimbristylis ferruginea</i> , <i>Ludwigia octovalvis</i> , <i>Melaleuca quinquenervia</i> , <i>Persicaria attenuata</i> , <i>Casuarina glauca</i>		
Weed species:	<i>Cuphea carthagenesis</i> , <i>Cynodon dactylon</i>		
Damage:	Nil		
Native dominance:	90%	Percentage vegetation cover:	90%
Photo:

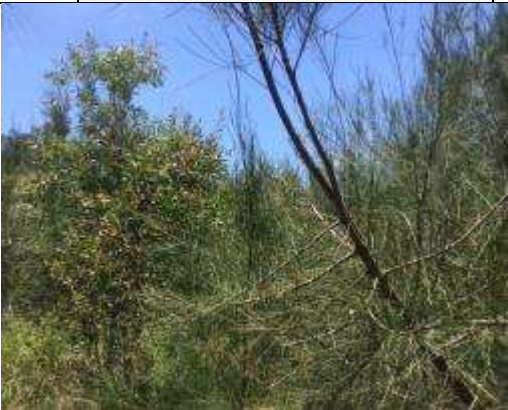
Monitoring month:	35	Months since direct seeding:	40
Date:	July 2018		
Comments:	Species diversity is declining due to the allelopathic properties of <i>Casuarina glauca</i> .		
Native species:	<i>Juncus usitatus</i> , <i>Cyperus polystachyos</i> , <i>Bolboschoenus cardwellii</i> , <i>Ludwigia octovalvis</i> , <i>Melaleuca quinquenervia</i> , <i>Casuarina glauca</i>		
Weed species:	<i>Cynodon dactylon</i>		
Damage:	Nil		
Native dominance:	90%	Percentage vegetation cover:	90%
Photo:

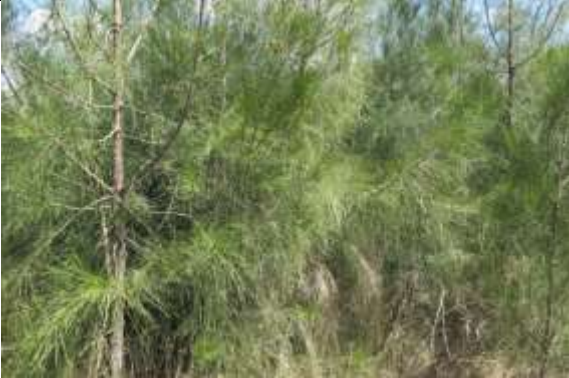
Monitoring month:	36	Months since direct seeding:	41
Date:	August 2018		
Comments:	A decline in diversity was notable this month due to the developing dominance of <i>Casuarina glauca</i> .		
Native species:	<i>Juncus usitatus</i> , <i>Bolboschoenus cardwellii</i> , <i>Ludwigia octovalvis</i> , <i>Melaleuca quinquenervia</i> , <i>Casuarina glauca</i>		
Weed species:	<i>Cynodon dactylon</i>		
Damage:	Nil		
Native dominance:	95%	Percentage vegetation cover:	90%
Photo:

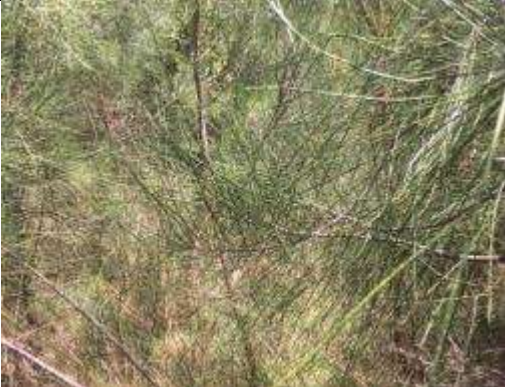
Monitoring month:	37	Months since direct seeding:	42
Date:	September 2018		
Comments:	No significant changes this month. Myrtle rust still observed within the surrounding area.		
Native species:	<i>Juncus usitatus</i> , <i>Bolboschoenus cardwellii</i> , <i>Ludwigia octovalvis</i> , <i>Melaleuca quinquenervia</i> , <i>Casuarina glauca</i>		
Weed species:	<i>Cynodon dactylon</i>		
Damage:	Nil		
Native dominance:	95%	Percentage vegetation cover:	90%
Photo:

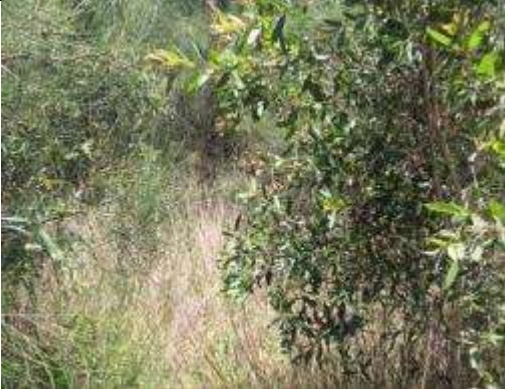
Monitoring month:	38	Months since direct seeding:	43
Date:	October 2018		
Comments:	Rainfall occurred throughout the area during this month which has assisted with the increase in biomass.		
Native species:	<i>Juncus usitatus</i> , <i>Bolboschoenus cardwellii</i> , <i>Ludwigia octovalvis</i> , <i>Melaleuca quinquenervia</i> , <i>Casuarina glauca</i>		
Weed species:	<i>Cynodon dactylon</i>		
Damage:	Nil		
Native dominance:	95%	Percentage vegetation cover:	90%
Photo:

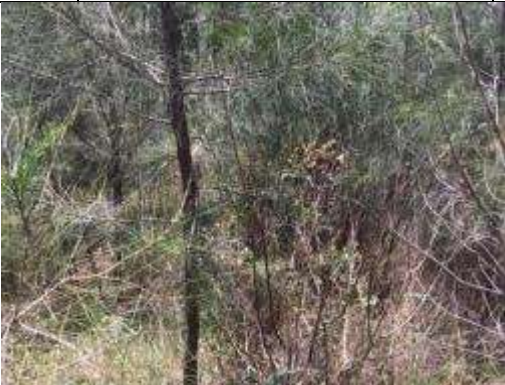
Monitoring month:	39	Months since direct seeding:	44
Date:	November 2018		
Comments:	Rapidly increasing temperatures were experienced this month resulting in the exponential growth of vegetation.		
Native species:	<i>Juncus usitatus</i> , <i>Bolboschoenus cardwellii</i> , <i>Ludwigia octovalvis</i> , <i>Melaleuca quinquenervia</i> , <i>Casuarina glauca</i>		
Weed species:	<i>Cynodon dactylon</i>		
Damage:	Nil		
Native dominance:	95%	Percentage vegetation cover:	90%
Photo:

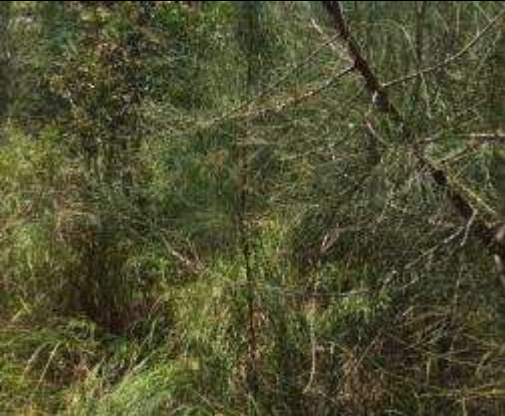
Monitoring month:	40	Months since direct seeding:	45
Date:	December 2018		
Comments:	Vegetation growth was steady this month.		
Native species:	<i>Juncus usitatus</i> , <i>Bolboschoenus cardwellii</i> , <i>Ludwigia octovalvis</i> , <i>Melaleuca quinquenervia</i> , <i>Casuarina glauca</i>		
Weed species:	<i>Cynodon dactylon</i>		
Damage:	Nil		
Native dominance:	95%	Percentage vegetation cover:	90%
Photo:

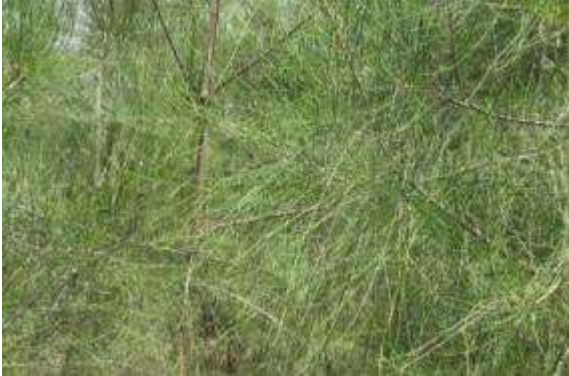
Monitoring month:	41	Months since direct seeding:	46
Date:	January 2019		
Comments:	Casuarinas continue to add biomass.		
Native species:	<i>Juncus usitatus</i> , <i>Bolboschoenus cardwellii</i> , <i>Ludwigia octovalvis</i> , <i>Melaleuca quinquenervia</i> , <i>Casuarina glauca</i>		
Weed species:	<i>Cynodon dactylon</i>		
Damage:	Nil		
Native dominance:	95%	Percentage vegetation cover:	90%
Photo:
