North-West Conservation Park - Rehabilitation Monitoring

Lot 1 RP48903

North-West Conservation Park
Gainsborough Greens

March 2020

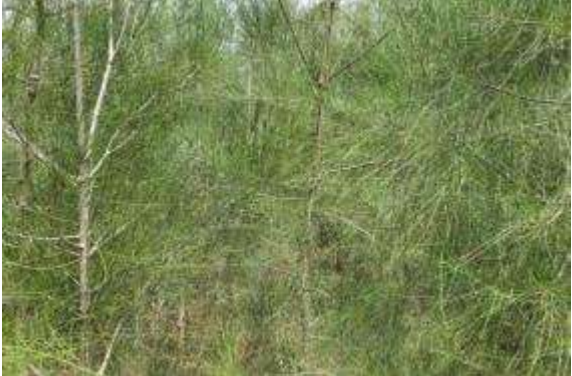
Monitoring month:	42	Months since direct seeding:	47
Date:	February 2019		
Comments:	Some native species declining in vigour due to canopy growth, but are still present.		
Native species:	<i>Juncus usitatus</i> , <i>Bolboschoenus cardwellii</i> , <i>Ludwigia octovalvis</i> , <i>Melaleuca quinquenervia</i> , <i>Casuarina glauca</i>		
Weed species:	<i>Cynodon dactylon</i>		
Damage:	Nil		
Native dominance:	95%	Percentage vegetation cover:	90%
Photo:

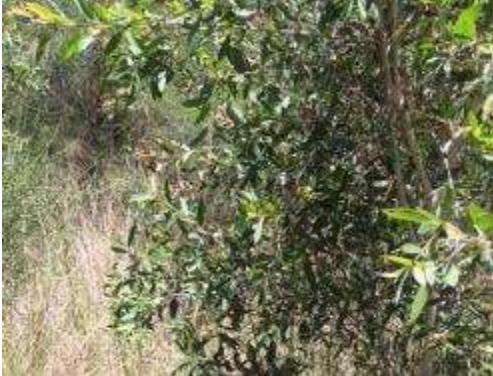
Monitoring month:	43	Months since direct seeding:	48
Date:	March 2019		
Comments:	No significant changes this month.		
Native species:	<i>Juncus usitatus</i> , <i>Bolboschoenus cardwellii</i> , <i>Ludwigia octovalvis</i> , <i>Melaleuca quinquenervia</i> , <i>Casuarina glauca</i>		
Weed species:	<i>Cynodon dactylon</i>		
Damage:	Nil		
Native dominance:	95%	Percentage vegetation cover:	90%
Photo:

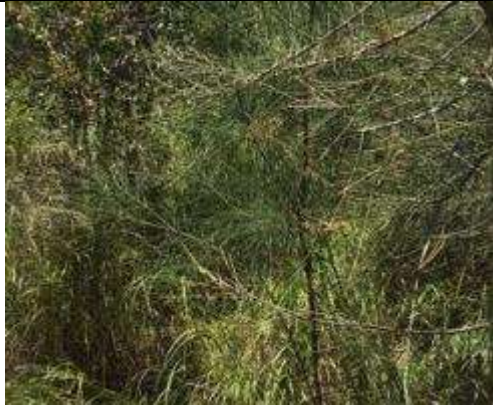
Monitoring month:	44	Months since direct seeding:	49
Date:	April 2019		
Comments:	Rainfall events increased late last month and continued this month giving the NWCP a much needed watering.		
Native species:	<i>Juncus usitatus</i> , <i>Bolboschoenus cardwellii</i> , <i>Ludwigia octovalvis</i> , <i>Melaleuca quinquenervia</i> , <i>Casuarina glauca</i>		
Weed species:	<i>Cynodon dactylon</i>		
Damage:	Nil		
Native dominance:	95%	Percentage vegetation cover:	100%
Photo:

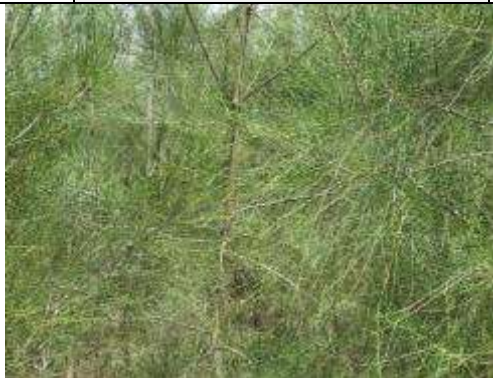
Monitoring month:	45	Months since direct seeding:	50
Date:	May 2019		
Comments:	<i>Melaleuca quinquenervia</i> and <i>Casuarina glauca</i> continue to add biomass.		
Native species:	<i>Juncus usitatus</i> , <i>Bolboschoenus cardwellii</i> , <i>Ludwigia octovalvis</i> , <i>Melaleuca quinquenervia</i> , <i>Casuarina glauca</i>		
Weed species:	<i>Cynodon dactylon</i>		
Damage:	Nil		
Native dominance:	95%	Percentage vegetation cover:	100%
Photo:

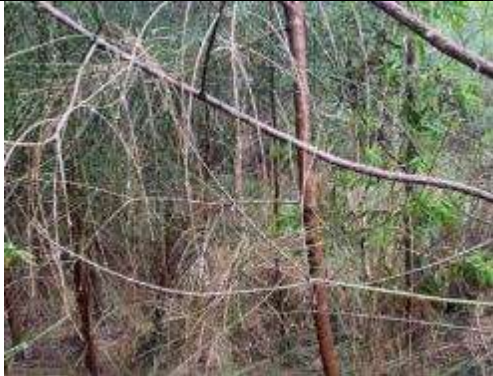
Monitoring month:	46	Months since direct seeding:	51
Date:	June 2019		
Comments:	Rainfall over the past few months has increased plant growth and vigour.		
Native species:	<i>Juncus usitatus</i> , <i>Bolboschoenus cardwellii</i> , <i>Ludwigia octovalvis</i> , <i>Melaleuca quinquenervia</i> , <i>Casuarina glauca</i>		
Weed species:	<i>Cynodon dactylon</i>		
Damage:	Nil		
Native dominance:	95%	Percentage vegetation cover:	100%
Photo:

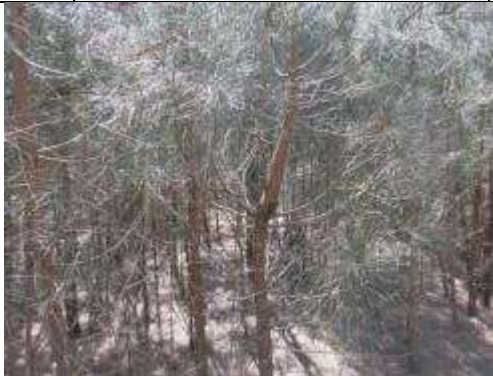
Monitoring month:	47	Months since direct seeding:	52
Date:	July 2019		
Comments:	Casuarina growth is steady throughout this quadrat and surrounding area.		
Native species:	<i>Juncus usitatus</i> , <i>Bolboschoenus cardwellii</i> , <i>Ludwigia octovalvis</i> , <i>Melaleuca quinquenervia</i> , <i>Casuarina glauca</i>		
Weed species:	<i>Cynodon dactylon</i>		
Damage:	Nil		
Native dominance:	95%	Percentage vegetation cover:	100%
Photo:

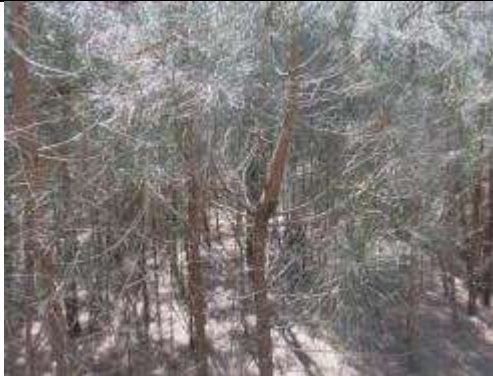
Monitoring month:	48	Months since direct seeding:	53
Date:	August 2019		
Comments:	Casuarina development continues to increase with some individuals now recorded at 9m in height.		
Native species:	<i>Juncus usitatus</i> , <i>Bolboschoenus cardwellii</i> , <i>Ludwigia octovalvis</i> , <i>Melaleuca quinquenervia</i> , <i>Casuarina glauca</i>		
Weed species:	<i>Cynodon dactylon</i>		
Damage:	Nil		
Native dominance:	95%	Percentage vegetation cover:	100%
Photo:

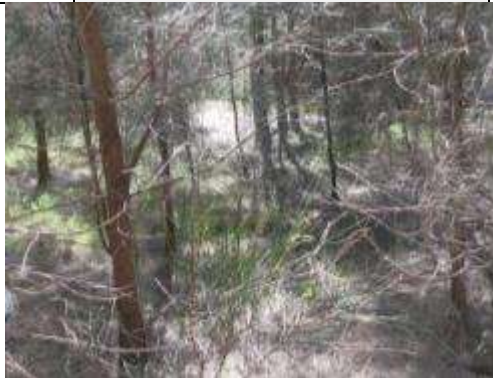
Monitoring month:	49	Months since direct seeding:	54
Date:	September 2019		
Comments:	Allelopathic properties of the casuarina leaf litter is still supressing species diversity.		
Native species:	<i>Juncus usitatus</i> , <i>Bolboschoenus cardwellii</i> , <i>Ludwigia octovalvis</i> , <i>Melaleuca quinquenervia</i> , <i>Casuarina glauca</i>		
Weed species:	<i>Cynodon dactylon</i>		
Damage:	Nil		
Native dominance:	95%	Percentage vegetation cover:	100%
Photo:

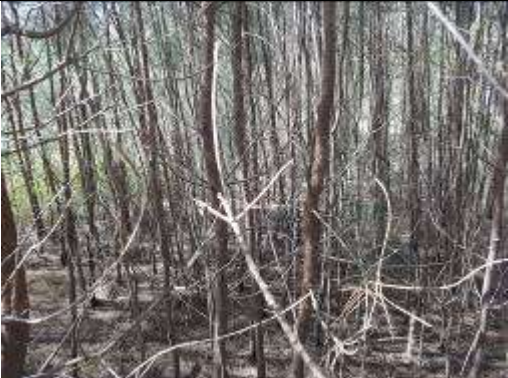
Monitoring month:	50	Months since direct seeding:	55
Date:	October 2019		
Comments:	Extended drought conditions are starting to take their toll with the extreme slowing of plant growth.		
Native species:	<i>Juncus usitatus</i> , <i>Bolboschoenus cardwellii</i> , <i>Ludwigia octovalvis</i> , <i>Melaleuca quinquenervia</i> , <i>Casuarina glauca</i>		
Weed species:	<i>Cynodon dactylon</i>		
Damage:	Nil		
Native dominance:	95%	Percentage vegetation cover:	100%
Photo:

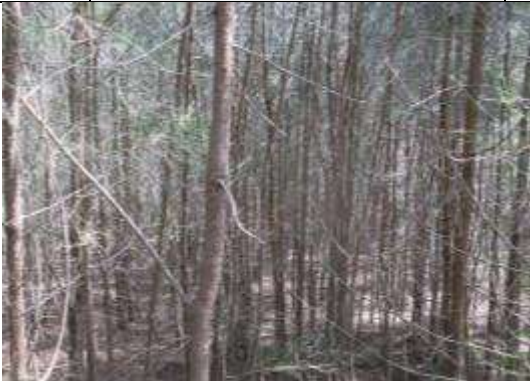
Monitoring month:	51	Months since direct seeding:	56
Date:	November 2019		
Comments:	Some wetland species have dropped out of this quad, however native dominance remains unchanged.		
Native species:	<i>Bolboschoenus cardwellii</i> , <i>Melaleuca quinquenervia</i> , <i>Casuarina glauca</i>		
Weed species:	<i>Cynodon dactylon</i>		
Damage:	Nil		
Native dominance:	95%	Percentage vegetation cover:	100%
Photo:

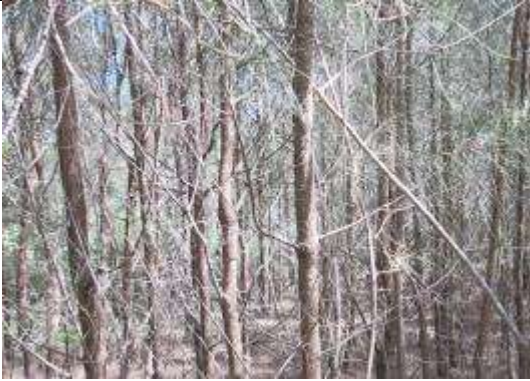
Monitoring month:	52	Months since direct seeding:	57
Date:	December 2019		
Comments:	Growth steady.		
Native species:	<i>Bolboschoenus cardwellii</i> , <i>Melaleuca quinquenervia</i> , <i>Casuarina glauca</i>		
Weed species:	<i>Cynodon dactylon</i>		
Damage:	Nil		
Native dominance:	95%	Percentage vegetation cover:	100%
Photo:

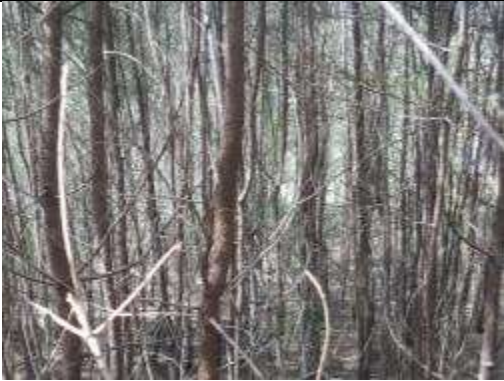
Monitoring month:	53	Months since direct seeding:	58
Date:	January 2020		
Comments:	No significant changes to report.		
Native species:	<i>Bolboschoenus cardwellii</i> , <i>Melaleuca quinquenervia</i> , <i>Casuarina glauca</i>		
Weed species:	<i>Cynodon dactylon</i>		
Damage:	Nil		
Native dominance:	95%	Percentage vegetation cover:	100%
Photo:

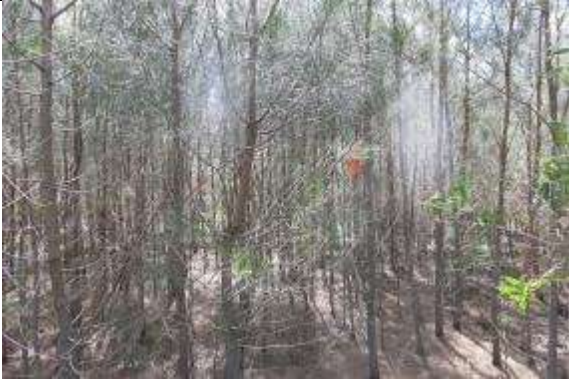
Monitoring month:	54	Months since direct seeding:	59
Date:	February 2020		
Comments:	Ongoing signs of maturing.		
Native species:	<i>Bolboschoenus cardwellii</i> , <i>Melaleuca quinquenervia</i> , <i>Casuarina glauca</i>		
Weed species:	<i>Cynodon dactylon</i>		
Damage:	Nil		
Native dominance:	95%	Percentage vegetation cover:	100%
Photo:

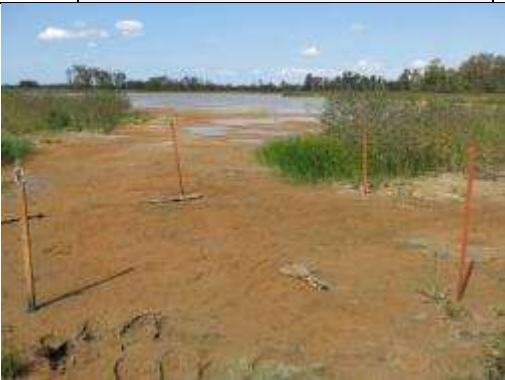
Monitoring month:	1	Months since direct seeding:	6
Date:	September 2015		
Comments:	The water having recently receded from this area results in a poor cover at the moment. However, It is assumed that <i>Bolboschoenus carwellii</i> in the background will advance to inhabit the area quickly.		
Native species:	<i>Juncus usitatus, Typha orientalis</i>		
Weed species:	<i>Nymphaea sp.</i>		
Damage:	Nil		
Native dominance:	Unable to determine	Percentage vegetation cover:	1%
Photo:

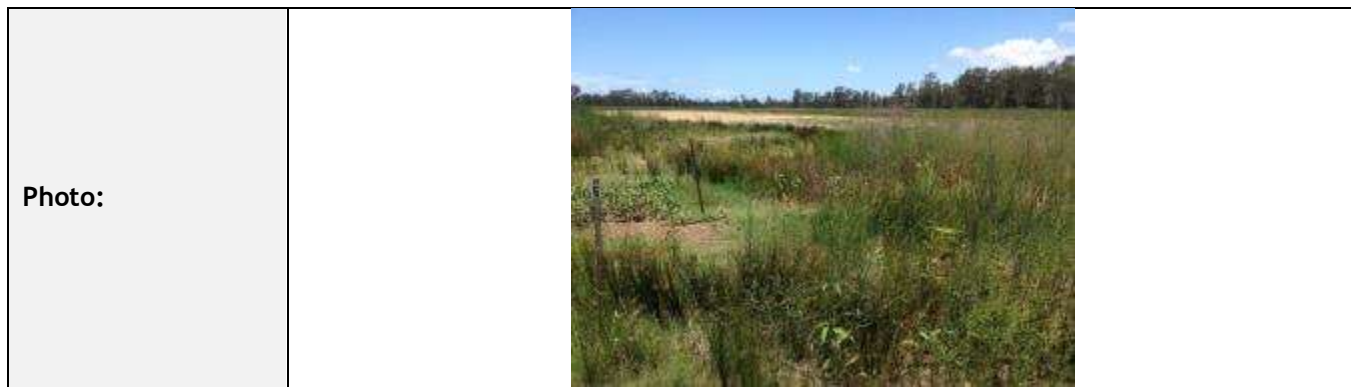
Monitoring month:	6	Months since direct seeding:	11
Date:	February 2016		
Comments:	This quadrat has changed from 1% cover to 80% cover in just six months. A remarkable result! There are significant numbers of canopy trees in the surrounding area to this quadrat. Although it looks like the weed species Aster is a dominant plant in the area, it is of no concern. It will die of its own accord within the next 4 months.		
Native species:	<i>Juncus usitatus</i> , <i>Typha orientalis</i> , <i>Casuarina glauca</i> , <i>Cyperus polystachyos</i> , <i>Ludwigia octovalvis</i> , <i>Bolboschoenus cardwellii</i> .		
Weed species:	<i>Centella asiatica</i> , <i>Cuphea carthagenesis</i> , <i>Aster subulatus</i> , <i>Paspalum dilatatum</i> , <i>Nymphaea sp.</i> , <i>Cynodon dactylon</i>		
Damage:	Nil		
Native dominance:	58%	Percentage vegetation cover:	80%

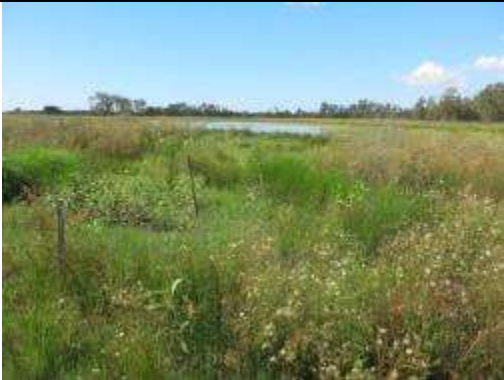
Monitoring month:	7	Months since direct seeding:	12
Date:	March 2016		
Comments:	This quadrat has changed from 1% cover to 95% cover in 8 months. The quadrat has a thin layer of water covering it. This will have the effect of being a good weed control agent. There are significant numbers of canopy trees in the surrounding area to this quadrat. Although it looks like the weed species Aster is a dominant plant in the area, it is beginning to decline.		
Native species:	<i>Juncus usitatus, Typha orientalis, Casuarina glauca, Cyperus polystachyos, Ludwigia octovalvis, Bolboschoenus cardwellii, Persicaria attenuata</i>		
Weed species:	<i>Centella asiatica, Cuphea carthagenesis, Aster subulatus, Paspalum dilatatum, Nymphaea sp., Cynodon dactylon</i>		
Damage:	Nil		
Native dominance:	61%	Percentage vegetation cover:	95%
Photo:

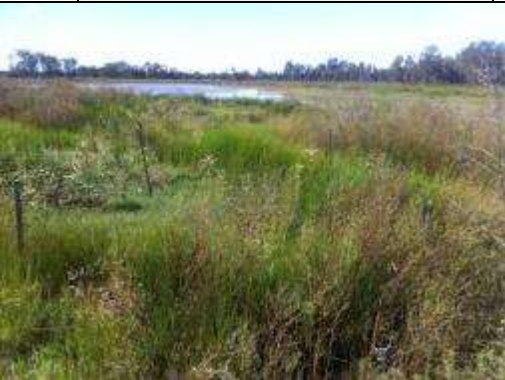
Monitoring month:	8	Months since direct seeding:	13
Date:	April 2016		
Comments:	The quadrat has a thin layer of water covering it. This will have the effect of being a good weed control agent. There are significant numbers of canopy trees in the surrounding area to this quadrat. Although it looks like the weed species Aster is a dominant plant in the area, it is beginning to decline.		
Native species:	<i>Juncus usitatus</i> , <i>Typha orientalis</i> , <i>Casuarina glauca</i> , <i>Cyperus polystachyos</i> , <i>Ludwigia octovalvis</i> , <i>Bolboschoenus cardwellii</i> , <i>Persicaria attenuata</i>		
Weed species:	<i>Centella asiatica</i> , <i>Cuphea carthagenesis</i> , <i>Aster subulatus</i> , <i>Paspalum dilatatum</i> , <i>Nymphaea sp.</i> , <i>Cynodon dactylon</i>		
Damage:	Nil		
Native dominance:	61%	Percentage vegetation cover:	95%
Photo:

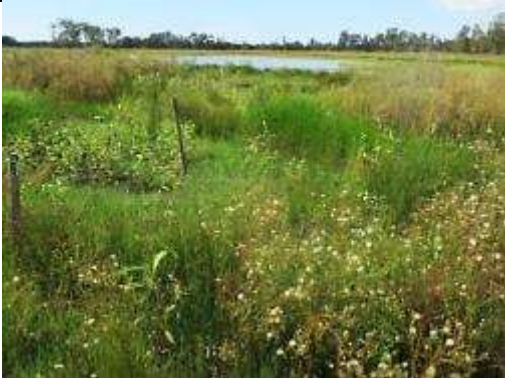
Monitoring month:	9	Months since direct seeding:	14
Date:	May 2016		
Comments:	There is still a thin layer of water covering it acting as a weed control agent. Aster growth is still declining, and is anticipated to continue this decline into winter.		
Native species:	<i>Juncus usitatus</i> , <i>Typha orientalis</i> , <i>Casuarina glauca</i> , <i>Cyperus polystachyos</i> , <i>Ludwigia octovalvis</i> , <i>Bolboschoenus cardwellii</i> , <i>Persicaria attenuata</i>		
Weed species:	<i>Centella asiatica</i> , <i>Cuphea carthagenesis</i> , <i>Aster subulatus</i> , <i>Paspalum dilatatum</i> , <i>Nymphaea sp.</i> , <i>Cynodon dactylon</i>		
Damage:	Nil		
Native dominance:	65%	Percentage vegetation cover:	95%
Photo:

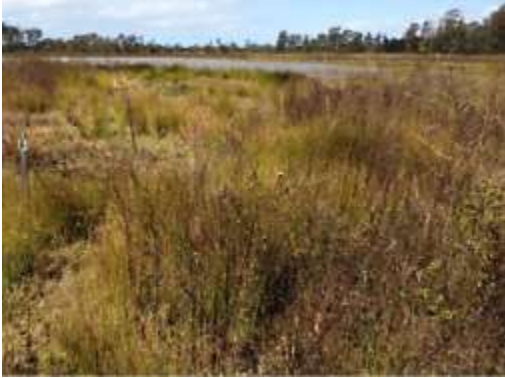
Monitoring month:	10	Months since direct seeding:	15
Date:	June 2016		
Comments:	Aster die-off is notable this month. Waterlogging, whilst assisting weed control, is also impacting upon growth of native canopy species. However, many native sedges are prospering.		
Native species:	<i>Juncus usitatus</i> , <i>Typha orientalis</i> , <i>Casuarina glauca</i> , <i>Cyperus polystachyos</i> , <i>Ludwigia octovalvis</i> , <i>Bolboschoenus cardwellii</i> , <i>Persicaria attenuata</i>		
Weed species:	<i>Centella asiatica</i> , <i>Cuphea carthagenesis</i> , <i>Aster subulatus</i> , <i>Paspalum dilatatum</i> , <i>Nymphaea sp.</i> , <i>Cynodon dactylon</i>		
Damage:	Nil		
Native dominance:	65%	Percentage vegetation cover:	95%
Photo:

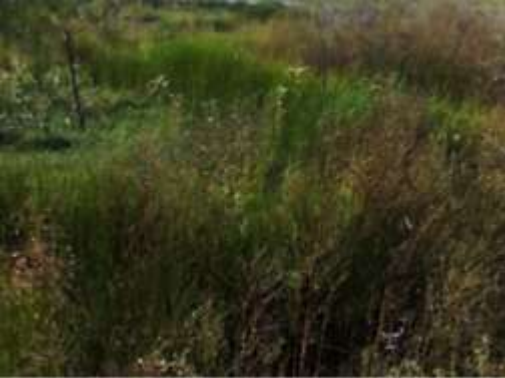
Monitoring month:	11	Months since direct seeding:	16
Date:	July 2016		
Comments:	No significant changes have occurred during this month.		
Native species:	<i>Juncus usitatus</i> , <i>Typha orientalis</i> , <i>Casuarina glauca</i> , <i>Cyperus polystachyos</i> , <i>Ludwigia octovalvis</i> , <i>Bolboschoenus cardwellii</i> , <i>Persicaria attenuata</i>		
Weed species:	<i>Centella asiatica</i> , <i>Cuphea carthagenesis</i> , <i>Aster subulatus</i> , <i>Paspalum dilatatum</i> , <i>Nymphaea sp.</i> , <i>Cynodon dactylon</i>		
Damage:	Nil		
Native dominance:	60%	Percentage vegetation cover:	95%
Photo:

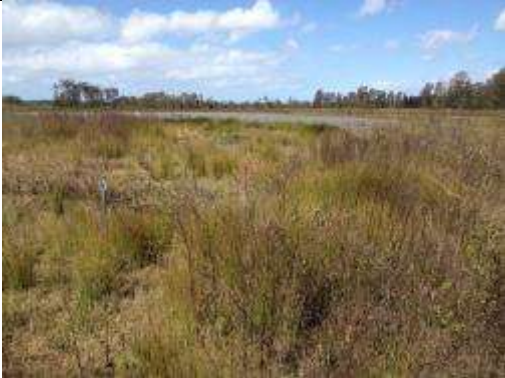
Monitoring month:	12	Months since direct seeding:	17
Date:	August 2016		
Comments:	This quadrat has retained native dominance during the entire monitoring phase to date, and continues to do so with many species of sedges in the area. There are significant numbers of canopy trees in the surrounding area to this quadrant.		
Native species:	<i>Juncus usitatus</i> , <i>Typha orientalis</i> , <i>Casuarina glauca</i> , <i>Cyperus polystachyos</i> , <i>Ludwigia octovalvis</i> , <i>Bolboschoenus cardwellii</i> , <i>Persicaria attenuata</i>		
Weed species:	<i>Centella asiatica</i> , <i>Cuphea carthagenesis</i> , <i>Aster subulatus</i> , <i>Paspalum dilatatum</i> , <i>Nymphaea sp.</i> , <i>Cynodon dactylon</i>		
Damage:	Nil		
Native dominance:	60%	Percentage vegetation cover:	95%
Photo:

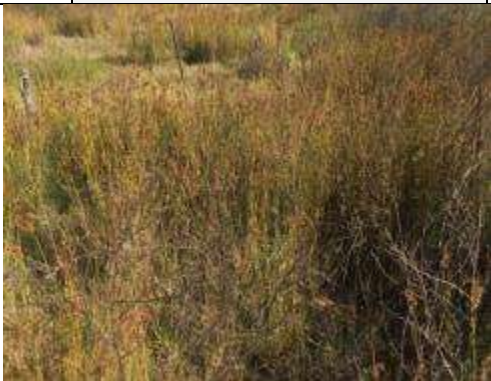
Monitoring month:	13	Months since direct seeding:	18
Date:	September 2016		
Comments:	Native sedges and rushes are continuing to prosper this month adding to the native dominance within this quadrat.		
Native species:	<i>Juncus usitatus</i> , <i>Typha orientalis</i> , <i>Casuarina glauca</i> , <i>Cyperus polystachyos</i> , <i>Ludwigia octovalvis</i> , <i>Bolboschoenus cardwellii</i> , <i>Persicaria attenuata</i>		
Weed species:	<i>Centella asiatica</i> , <i>Cuphea carthagenesis</i> , <i>Aster subulatus</i> , <i>Paspalum dilatatum</i> , <i>Nymphaea sp.</i> , <i>Cynodon dactylon</i>		
Damage:	Nil		
Native dominance:	60%	Percentage vegetation cover:	95%
Photo:

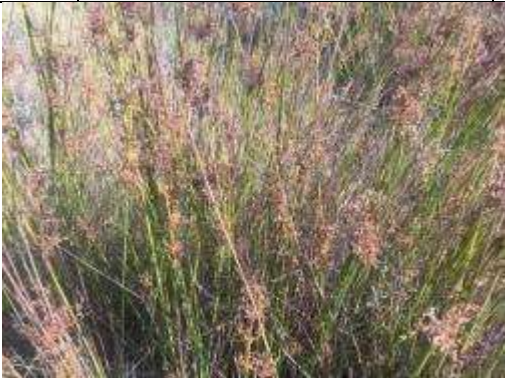
Monitoring month:	14	Months since direct seeding:	19
Date:	October 2016		
Comments:	No significant changes have been recorded this month.		
Native species:	<i>Juncus usitatus</i> , <i>Typha orientalis</i> , <i>Casuarina glauca</i> , <i>Cyperus polystachyos</i> , <i>Ludwigia octovalvis</i> , <i>Bolboschoenus cardwellii</i> , <i>Persicaria attenuata</i>		
Weed species:	<i>Centella asiatica</i> , <i>Cuphea carthagenesis</i> , <i>Aster subulatus</i> , <i>Paspalum dilatatum</i> , <i>Nymphaea sp.</i> , <i>Cynodon dactylon</i>		
Damage:	Nil		
Native dominance:	60%	Percentage vegetation cover:	95%
Photo:

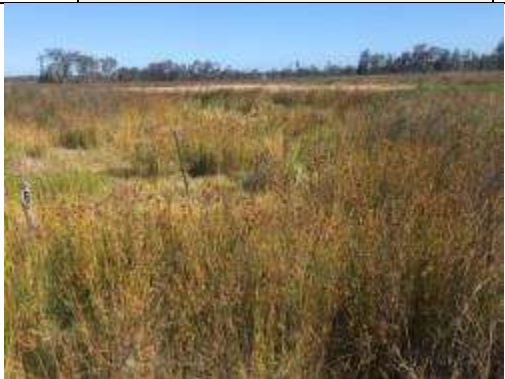
Monitoring month:	15	Months since direct seeding:	20
Date:	November 2016		
Comments:	Native sedges and rushes continue to grow well within this area, with <i>Juncus</i> still remaining the dominant species.		
Native species:	<i>Juncus usitatus</i> , <i>Typha orientalis</i> , <i>Casuarina glauca</i> , <i>Cyperus polystachyos</i> , <i>Ludwigia octovalvis</i> , <i>Bolboschoenus cardwellii</i> , <i>Persicaria attenuata</i>		
Weed species:	<i>Centella asiatica</i> , <i>Cuphea carthagenesis</i> , <i>Aster subulatus</i> , <i>Paspalum dilatatum</i> , <i>Nymphaea sp.</i> , <i>Cynodon dactylon</i>		
Damage:	Nil		
Native dominance:	65%	Percentage vegetation cover:	95%
Photo:

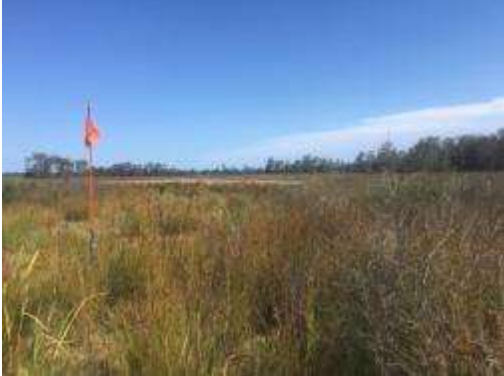
Monitoring month:	16	Months since direct seeding:	21
Date:	December 2016		
Comments:	A high visibility flag and extended pole was added to the quadrat stake this month for ease of identification. <i>Juncus</i> continues to flourish.		
Native species:	<i>Juncus usitatus</i> , <i>Typha orientalis</i> , <i>Casuarina glauca</i> , <i>Cyperus polystachyos</i> , <i>Ludwigia octovalvis</i> , <i>Bolboschoenus cardwellii</i> , <i>Persicaria attenuata</i>		
Weed species:	<i>Centella asiatica</i> , <i>Cuphea carthagenesis</i> , <i>Aster subulatus</i> , <i>Paspalum dilatatum</i> , <i>Nymphaea sp.</i> , <i>Cynodon dactylon</i>		
Damage:	Nil		
Native dominance:	65%	Percentage vegetation cover:	95%
Photo:

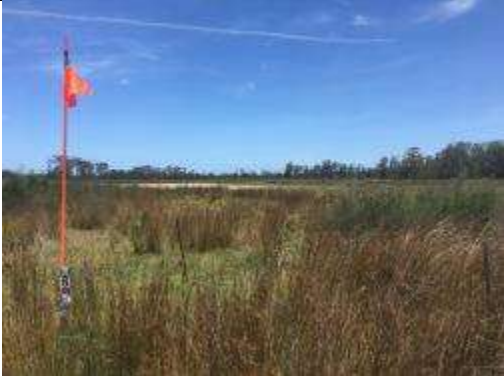
Monitoring month:	17	Months since direct seeding:	22
Date:	January 2017		
Comments:	<i>Juncus</i> continues to flourish, however <i>Cynodon dactylon</i> still dominates.		
Native species:	<i>Juncus usitatus</i> , <i>Typha orientalis</i> , <i>Casuarina glauca</i> , <i>Cyperus polystachyos</i> , <i>Ludwigia octovalvis</i> , <i>Bolboschoenus cardwellii</i> , <i>Persicaria attenuata</i>		
Weed species:	<i>Centella asiatica</i> , <i>Cuphea carthagenesis</i> , <i>Aster subulatus</i> , <i>Paspalum dilatatum</i> , <i>Nymphaea sp.</i> , <i>Cynodon dactylon</i>		
Damage:	Nil		
Native dominance:	60%	Percentage vegetation cover:	95%
Photo:

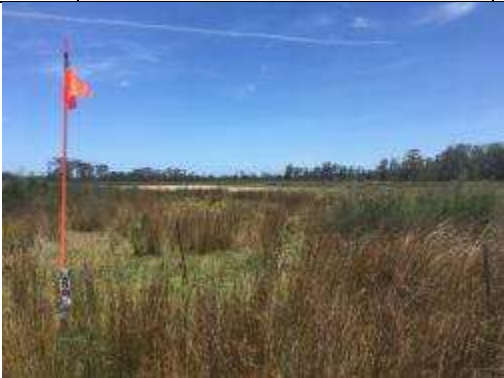
Monitoring month:	18	Months since direct seeding:	23
Date:	February 2017		
Comments:	Native sedge species continue to dominate this quadrat.		
Native species:	<i>Juncus usitatus</i> , <i>Typha orientalis</i> , <i>Casuarina glauca</i> , <i>Cyperus polystachyos</i> , <i>Ludwigia octovalvis</i> , <i>Bolboschoenus cardwellii</i> , <i>Persicaria attenuata</i>		
Weed species:	<i>Centella asiatica</i> , <i>Cuphea carthagenesis</i> , <i>Aster subulatus</i> , <i>Paspalum dilatatum</i> , <i>Nymphaea sp.</i> , <i>Cynodon dactylon</i>		
Damage:	Nil		
Native dominance:	65%	Percentage vegetation cover:	95%
Photo:

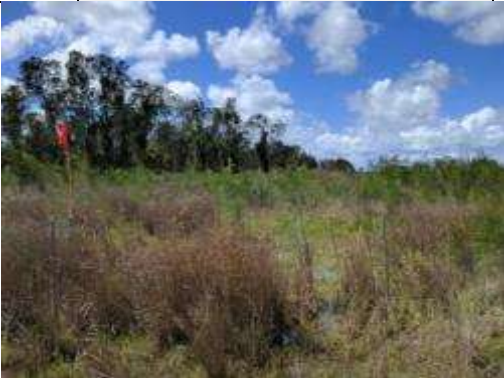
Monitoring month:	19	Months since direct seeding:	24
Date:	March 2017 (NB: monitoring event occurred early April due to inaccessibility)		
Comments:	During the last half of this month, the NWCP received significant rainfall. Access to the area was limited. Much of the area is waterlogged and functioning as the wetland it is designed to be. The correct angle of the photo was not achievable due to this waterlogging. Native sedge species continue to dominate this quadrat.		
Native species:	<i>Juncus usitatus</i> , <i>Typha orientalis</i> , <i>Casuarina glauca</i> , <i>Cyperus polystachyos</i> , <i>Ludwigia octovalvis</i> , <i>Bolboschoenus cardwellii</i> , <i>Persicaria attenuata</i>		
Weed species:	<i>Centella asiatica</i> , <i>Cuphea carthagenesis</i> , <i>Aster subulatus</i> , <i>Paspalum dilatatum</i> , <i>Nymphaea sp.</i> , <i>Cynodon dactylon</i>		
Damage:	Nil - large weather event associated with Ex-Tropical Cyclone Debbie did not result in any damage

Native dominance:	65%	Percentage vegetation cover:	95%
Photo:

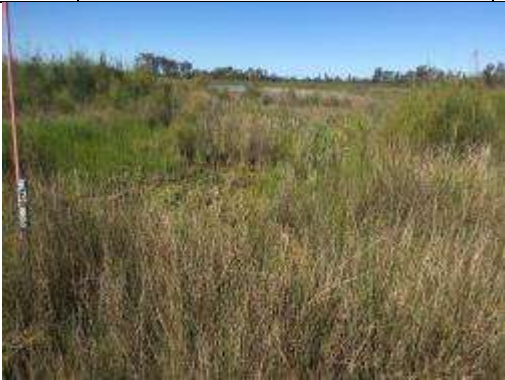
Monitoring month:	20	Months since direct seeding:	25
Date:	April 2017		
Comments:	Native sedge species continue to dominate this quadrat.		
Native species:	<i>Juncus usitatus</i> , <i>Typha orientalis</i> , <i>Casuarina glauca</i> , <i>Cyperus polystachyos</i> , <i>Ludwigia octovalvis</i> , <i>Bolboschoenus cardwellii</i> , <i>Persicaria attenuata</i>		
Weed species:	<i>Centella asiatica</i> , <i>Cuphea carthagenesis</i> , <i>Aster subulatus</i> , <i>Paspalum dilatatum</i> , <i>Nymphaea sp.</i> , <i>Cynodon dactylon</i>		
Damage:	Nil		
Native dominance:	65%	Percentage vegetation cover:	95%
Photo:

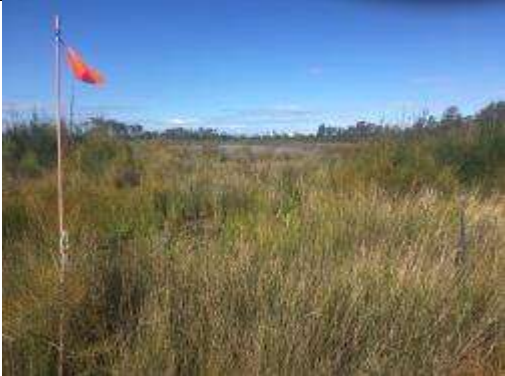
Monitoring month:	21	Months since direct seeding:	26
Date:	May 2017		
Comments:	Native sedge species continue to dominate this quadrat.		
Native species:	<i>Juncus usitatus</i> , <i>Typha orientalis</i> , <i>Casuarina glauca</i> , <i>Cyperus polystachyos</i> , <i>Ludwigia octovalvis</i> , <i>Bolboschoenus cardwellii</i> , <i>Persicaria attenuata</i>		
Weed species:	<i>Centella asiatica</i> , <i>Cuphea carthagenesis</i> , <i>Aster subulatus</i> , <i>Paspalum dilatatum</i> , <i>Nymphaea sp.</i> , <i>Cynodon dactylon</i>		
Damage:	Nil		
Native dominance:	65%	Percentage vegetation cover:	95%
Photo:

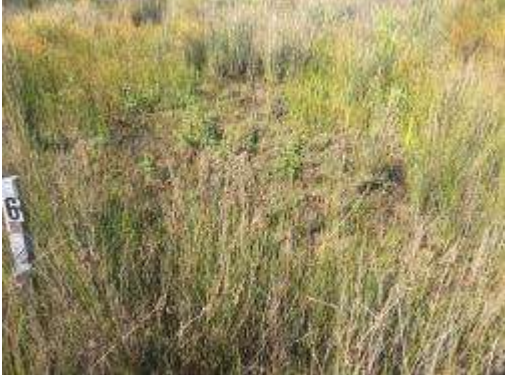
Monitoring month:	22	Months since direct seeding:	27
Date:	June 2017		
Comments:	No significant changes this month. It is anticipated growth will slow moving into the colder months.		
Native species:	<i>Juncus usitatus</i> , <i>Typha orientalis</i> , <i>Casuarina glauca</i> , <i>Cyperus polystachyos</i> , <i>Ludwigia octovalvis</i> , <i>Bolboschoenus cardwellii</i> , <i>Persicaria attenuata</i>		
Weed species:	<i>Centella asiatica</i> , <i>Cuphea carthagenesis</i> , <i>Aster subulatus</i> , <i>Paspalum dilatatum</i> , <i>Nymphaea sp.</i> , <i>Cynodon dactylon</i>		
Damage:	Nil		
Native dominance:	65%	Percentage vegetation cover:	95%
Photo:

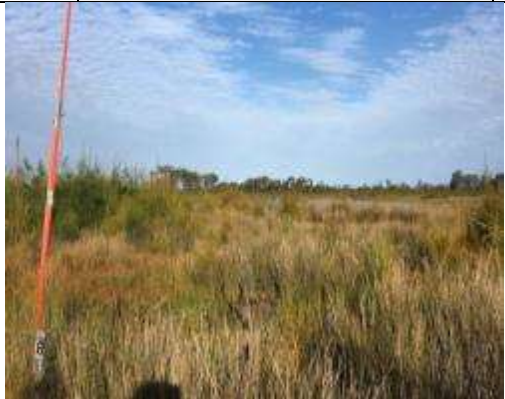
Monitoring month:	23	Months since direct seeding:	28
Date:	July 2017		
Comments:	An additional length of conduit was added to the flagging pole this month due to the increasing height of vegetation. Vegetation health is steady.		
Native species:	<i>Juncus usitatus</i> , <i>Typha orientalis</i> , <i>Casuarina glauca</i> , <i>Cyperus polystachyos</i> , <i>Ludwigia octovalvis</i> , <i>Bolboschoenus cardwellii</i> , <i>Persicaria attenuata</i>		
Weed species:	<i>Centella asiatica</i> , <i>Cuphea carthagenesis</i> , <i>Aster subulatus</i> , <i>Paspalum dilatatum</i> , <i>Nymphaea sp.</i> , <i>Cynodon dactylon</i>		
Damage:	Nil		
Native dominance:	65%	Percentage vegetation cover:	95%
Photo:

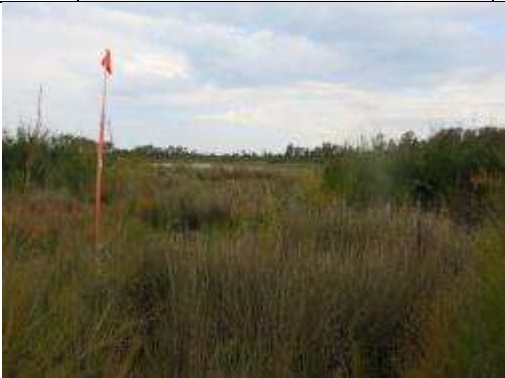
Monitoring month:	24	Months since direct seeding:	29
Date:	August 2017		
Comments:	Weed growth remains minimal within this quadrat.		
Native species:	<i>Juncus usitatus</i> , <i>Typha orientalis</i> , <i>Casuarina glauca</i> , <i>Cyperus polystachyos</i> , <i>Ludwigia octovalvis</i> , <i>Bolboschoenus cardwellii</i> , <i>Persicaria attenuata</i>		
Weed species:	<i>Centella asiatica</i> , <i>Cuphea carthagenesis</i> , <i>Aster subulatus</i> , <i>Paspalum dilatatum</i> , <i>Nymphaea sp.</i> , <i>Cynodon dactylon</i>		
Damage:	Nil		
Native dominance:	70%	Percentage vegetation cover:	95%
Photo:

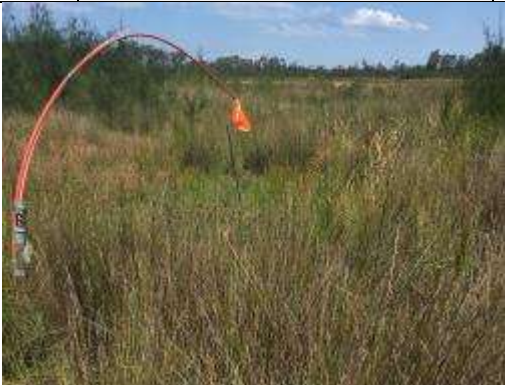
Monitoring month:	25	Months since direct seeding:	30
Date:	September 2017		
Comments:	Vegetation growth is steady.		
Native species:	<i>Juncus usitatus</i> , <i>Typha orientalis</i> , <i>Casuarina glauca</i> , <i>Cyperus polystachyos</i> , <i>Ludwigia octovalvis</i> , <i>Bolboschoenus cardwellii</i> , <i>Persicaria attenuata</i>		
Weed species:	<i>Centella asiatica</i> , <i>Cuphea carthagenesis</i> , <i>Aster subulatus</i> , <i>Paspalum dilatatum</i> , <i>Nymphaea sp.</i> , <i>Cynodon dactylon</i>		
Damage:	Nil		
Native dominance:	70%	Percentage vegetation cover:	95%
Photo:

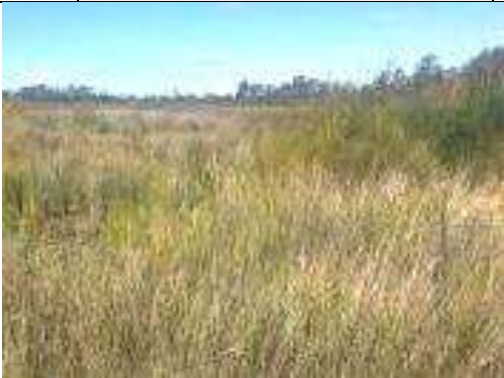
Monitoring month:	26	Months since direct seeding:	31
Date:	October 2017		
Comments:	Vegetation growth is steady.		
Native species:	<i>Juncus usitatus</i> , <i>Typha orientalis</i> , <i>Casuarina glauca</i> , <i>Cyperus polystachyos</i> , <i>Ludwigia octovalvis</i> , <i>Bolboschoenus cardwellii</i> , <i>Persicaria attenuata</i>		
Weed species:	<i>Centella asiatica</i> , <i>Cuphea carthagenesis</i> , <i>Aster subulatus</i> , <i>Paspalum dilatatum</i> , <i>Nymphaea sp.</i> , <i>Cynodon dactylon</i>		
Damage:	Nil		
Native dominance:	70%	Percentage vegetation cover:	95%
Photo:

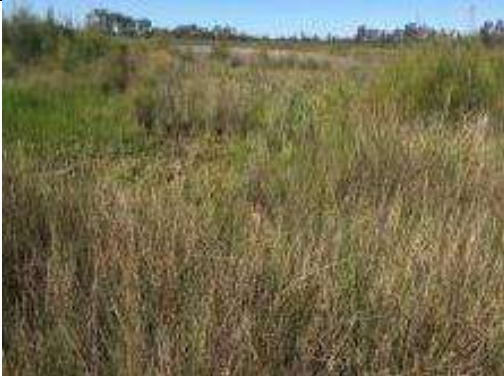
Monitoring month:	27	Months since direct seeding:	32
Date:	November 2017		
Comments:	Frequent small rainfall events occurred during this month, increasing the waterlogging of this quadrat. These conditions are favourable for the species within this area.		
Native species:	<i>Juncus usitatus</i> , <i>Typha orientalis</i> , <i>Casuarina glauca</i> , <i>Cyperus polystachyos</i> , <i>Ludwigia octovalvis</i> , <i>Bolboschoenus cardwellii</i> , <i>Persicaria attenuata</i>		
Weed species:	<i>Centella asiatica</i> , <i>Cuphea carthagenesis</i> , <i>Aster subulatus</i> , <i>Paspalum dilatatum</i> , <i>Nymphaea sp.</i> , <i>Cynodon dactylon</i>		
Damage:	Nil		
Native dominance:	70%	Percentage vegetation cover:	95%
Photo:

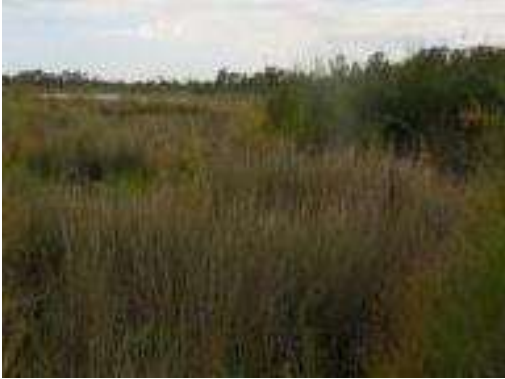
Monitoring month:	28	Months since direct seeding:	33
Date:	December 2017		
Comments:	Similar conditions to the previous month whereby frequent small rainfall events occurred, increasing the waterlogging of this quadrat. These conditions are favourable for the species within this area.		
Native species:	<i>Juncus usitatus</i> , <i>Typha orientalis</i> , <i>Casuarina glauca</i> , <i>Cyperus polystachyos</i> , <i>Ludwigia octovalvis</i> , <i>Bolboschoenus cardwellii</i> , <i>Persicaria attenuata</i>		
Weed species:	<i>Centella asiatica</i> , <i>Cuphea carthagenesis</i> , <i>Aster subulatus</i> , <i>Paspalum dilatatum</i> , <i>Nymphaea sp.</i> , <i>Cynodon dactylon</i>		
Damage:	Nil		
Native dominance:	80%	Percentage vegetation cover:	95%
Photo:

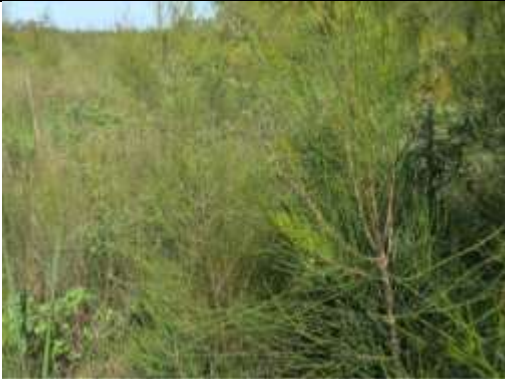
Monitoring month:	29	Months since direct seeding:	34
Date:	January 2017		
Comments:	Vegetation growth is steady. Casuarina seedlings are becoming noticeable over the top of tall reeds and sedges.		
Native species:	<i>Juncus usitatus</i> , <i>Typha orientalis</i> , <i>Casuarina glauca</i> , <i>Cyperus polystachyos</i> , <i>Ludwigia octovalvis</i> , <i>Bolboschoenus cardwellii</i> , <i>Persicaria attenuata</i>		
Weed species:	<i>Centella asiatica</i> , <i>Cuphea carthagenesis</i> , <i>Aster subulatus</i> , <i>Paspalum dilatatum</i> , <i>Nymphaea sp.</i> , <i>Cynodon dactylon</i>		
Damage:	Nil		
Native dominance:	85%	Percentage vegetation cover:	95%
Photo:

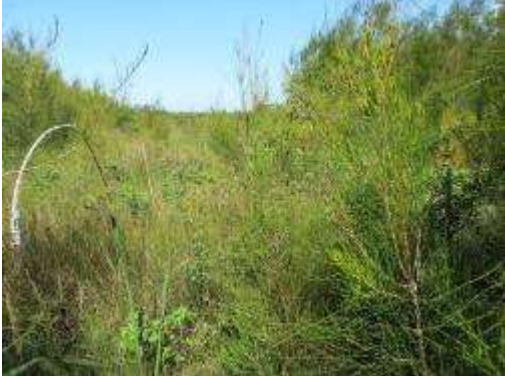
Monitoring month:	30	Months since direct seeding:	35
Date:	February 2018		
Comments:	This quadrat continues to grow in complexity, with both sedge/cyperus wetland vegetation and casuarina canopy growing strongly.		
Native species:	<i>Juncus usitatus</i> , <i>Typha orientalis</i> , <i>Casuarina glauca</i> , <i>Cyperus polystachyos</i> , <i>Ludwigia octovalvis</i> , <i>Bolboschoenus cardwellii</i> , <i>Persicaria attenuata</i>		
Weed species:	<i>Centella asiatica</i> , <i>Cuphea carthagenesis</i> , <i>Aster subulatus</i> , <i>Paspalum dilatatum</i> , <i>Nymphaea sp.</i> , <i>Cynodon dactylon</i>		
Damage:	Nil		
Native dominance:	85%	Percentage vegetation cover:	95%
Photo:

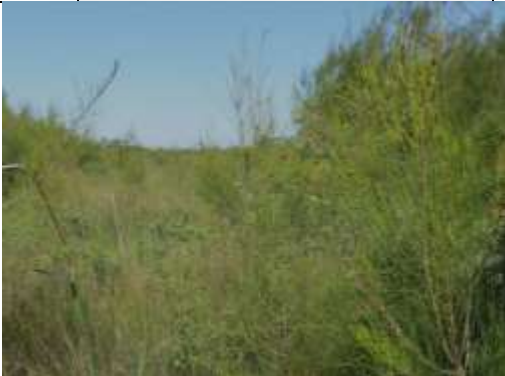
Monitoring month:	31	Months since direct seeding:	36
Date:	March 2018		
Comments:	A significant amount of rain fell at the end of last month resulting in standing water for approximately 3 weeks. This has acted as a natural weed control for a number of the weed species. Canopy growth and shading has also assisted in a reduction of weed growth.		
Native species:	<i>Juncus usitatus</i> , <i>Typha orientalis</i> , <i>Casuarina glauca</i> , <i>Cyperus polystachyos</i> , <i>Ludwigia octovalvis</i> , <i>Bolboschoenus cardwellii</i> , <i>Persicaria attenuata</i>		
Weed species:	<i>Centella asiatica</i> , <i>Cuphea carthagenesis</i> , <i>Aster subulatus</i> , <i>Paspalum dilatatum</i> , <i>Nymphaea sp.</i> , <i>Cynodon dactylon</i>		
Damage:	Nil		
Native dominance:	90%	Percentage vegetation cover:	95%
Photo:

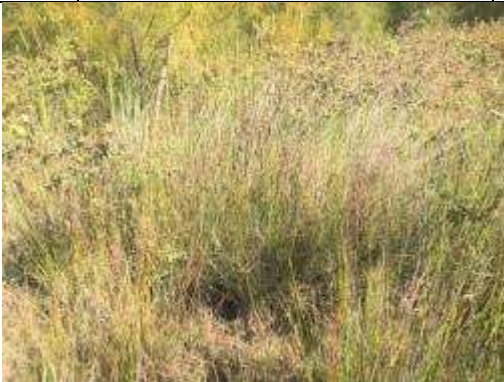
Monitoring month:	32	Months since direct seeding:	37
Date:	April 2018		
Comments:	Vegetation growth is steady.		
Native species:	<i>Juncus usitatus</i> , <i>Typha orientalis</i> , <i>Casuarina glauca</i> , <i>Cyperus polystachyos</i> , <i>Ludwigia octovalvis</i> , <i>Bolboschoenus cardwellii</i> , <i>Persicaria attenuata</i>		
Weed species:	<i>Centella asiatica</i> , <i>Cuphea carthagenesis</i> , <i>Aster subulatus</i> , <i>Paspalum dilatatum</i> , <i>Nymphaea sp.</i> , <i>Cynodon dactylon</i>		
Damage:	Nil		
Native dominance:	90%	Percentage vegetation cover:	95%
Photo:

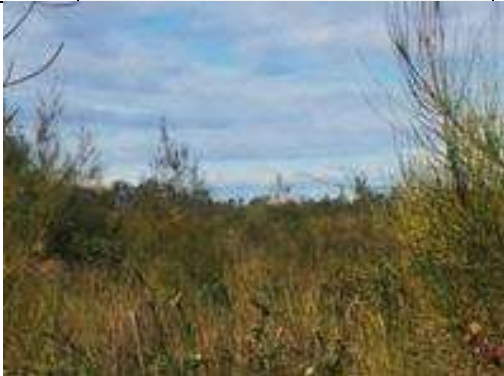
Monitoring month:	33	Months since direct seeding:	38
Date:	May 2018		
Comments:	both sedge/cyperus wetland vegetation and casuarina canopy growing strongly.		
Native species:	<i>Juncus usitatus</i> , <i>Typha orientalis</i> , <i>Casuarina glauca</i> , <i>Cyperus polystachyos</i> , <i>Ludwigia octovalvis</i> , <i>Bolboschoenus cardwellii</i> , <i>Persicaria attenuata</i>		
Weed species:	<i>Centella asiatica</i> , <i>Cuphea carthagenesis</i> , <i>Aster subulatus</i> , <i>Paspalum dilatatum</i> , <i>Nymphaea sp.</i> , <i>Cynodon dactylon</i>		
Damage:	Nil		
Native dominance:	90%	Percentage vegetation cover:	95%
Photo:

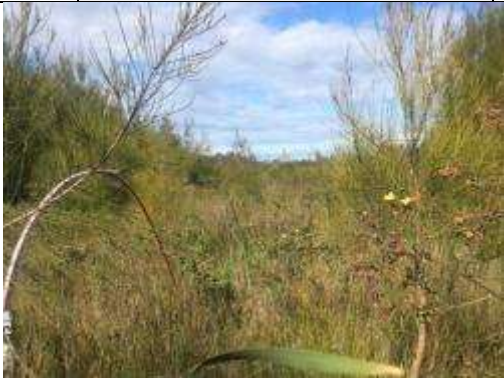
Monitoring month:	34	Months since direct seeding:	39
Date:	June 2018		
Comments:	No significant changes this month due to the slowing down of the growing season.		
Native species:	<i>Juncus usitatus</i> , <i>Typha orientalis</i> , <i>Casuarina glauca</i> , <i>Cyperus polystachyos</i> , <i>Ludwigia octovalvis</i> , <i>Bolboschoenus cardwellii</i> , <i>Persicaria attenuata</i>		
Weed species:	<i>Centella asiatica</i> , <i>Cuphea carthagenesis</i> , <i>Aster subulatus</i> , <i>Paspalum dilatatum</i> , <i>Nymphaea sp.</i> , <i>Cynodon dactylon</i>		
Damage:	Nil		
Native dominance:	90%	Percentage vegetation cover:	95%
Photo:

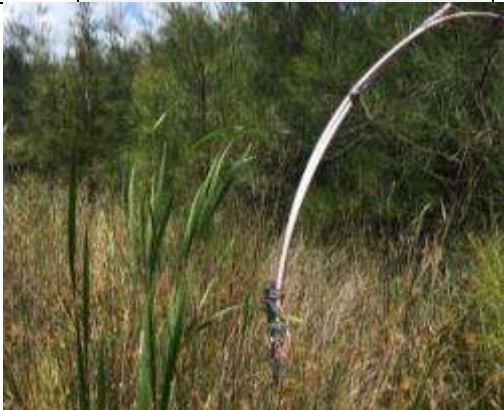
Monitoring month:	35	Months since direct seeding:	40
Date:	July 2018		
Comments:	Native diversity has slightly reduced however this is expected given the slower growing season. Weed diversity has also decreased.		
Native species:	<i>Juncus usitatus</i> , <i>Typha orientalis</i> , <i>Casuarina glauca</i> , <i>Bolboschoenus cardwellii</i>		
Weed species:	<i>Cuphea carthagenesis</i> , <i>Aster subulatus</i> , <i>Paspalum dilatatum</i> , <i>Cynodon dactylon</i>		
Damage:	Nil		
Native dominance:	90%	Percentage vegetation cover:	95%
Photo:

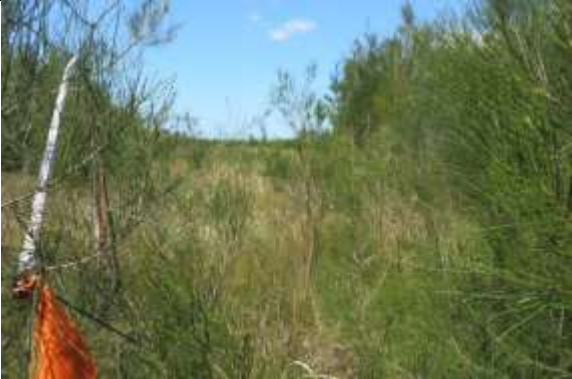
Monitoring month:	36	Months since direct seeding:	41
Date:	August 2018		
Comments:	Weed diversity has significantly reduced again this month.		
Native species:	<i>Juncus usitatus, Typha orientalis, Casuarina glauca, Bolboschoenus cardwellii</i>		
Weed species:	<i>Cynodon dactylon</i>		
Damage:	Nil		
Native dominance:	95%	Percentage vegetation cover:	95%
Photo:

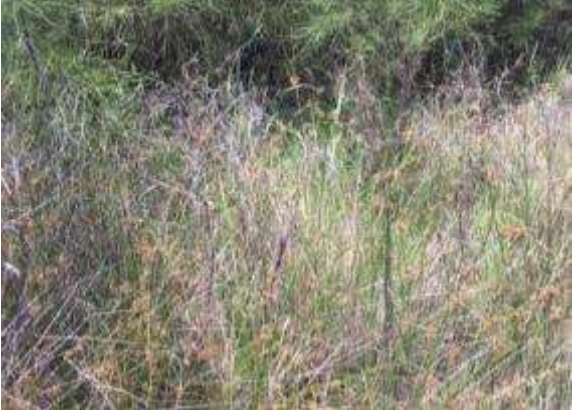
Monitoring month:	37	Months since direct seeding:	42
Date:	September 2018		
Comments:	Weed presence remains relatively low again this month.		
Native species:	<i>Juncus usitatus, Typha orientalis, Casuarina glauca, Bolboschoenus cardwellii</i>		
Weed species:	<i>Cynodon dactylon</i>		
Damage:	Nil		
Native dominance:	95%	Percentage vegetation cover:	95%
Photo:

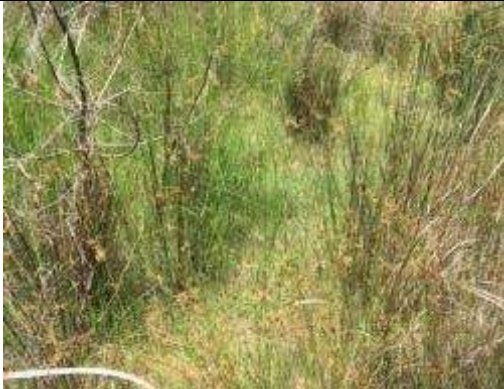
Monitoring month:	38	Months since direct seeding:	43
Date:	October 2018		
Comments:	Rainfall occurred throughout the area during this month which has assisted with the increase in biomass.		
Native species:	<i>Juncus usitatus, Typha orientalis, Casuarina glauca, Bolboschoenus cardwellii</i>		
Weed species:	<i>Cynodon dactylon</i>		
Damage:	Nil		
Native dominance:	95%	Percentage vegetation cover:	95%
Photo:

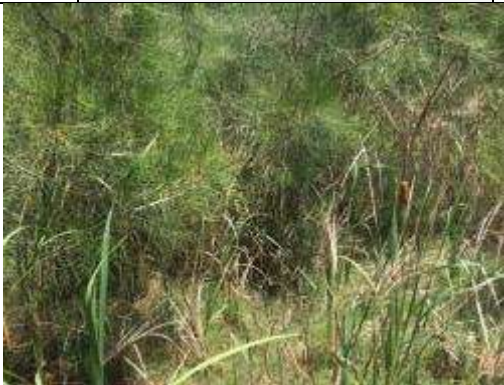
Monitoring month:	39	Months since direct seeding:	44
Date:	November 2018		
Comments:	Rapidly increasing temperatures were experienced this month resulting in the exponential growth of vegetation.		
Native species:	<i>Juncus usitatus, Typha orientalis, Casuarina glauca, Bolboschoenus cardwellii</i>		
Weed species:	<i>Cynodon dactylon</i>		
Damage:	Nil		
Native dominance:	95%	Percentage vegetation cover:	95%
Photo:

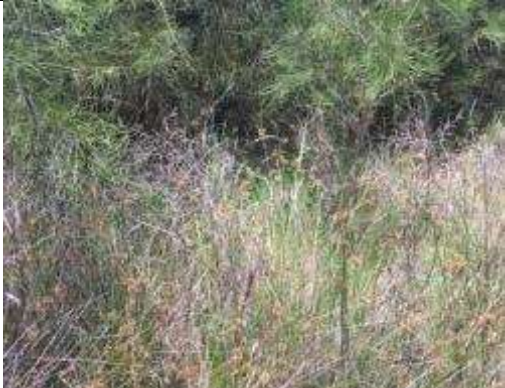
Monitoring month:	40	Months since direct seeding:	45
Date:	December 2018		
Comments:	Vegetation growth was steady this month.		
Native species:	<i>Juncus usitatus, Typha orientalis, Casuarina glauca, Bolboschoenus cardwellii</i>		
Weed species:	<i>Cynodon dactylon</i>		
Damage:	Nil		
Native dominance:	95%	Percentage vegetation cover:	95%
Photo:

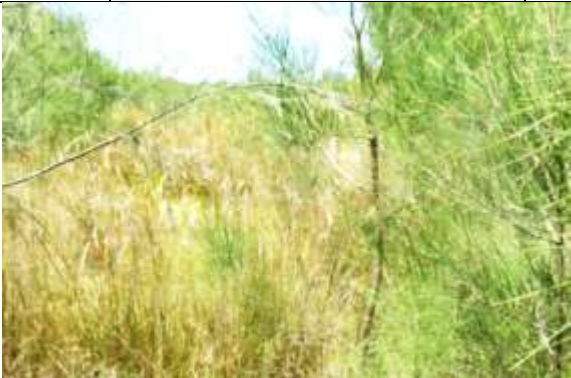
Monitoring month:	41	Months since direct seeding:	46
Date:	January 2019		
Comments:	Casuarinas continue to add biomass this month.		
Native species:	<i>Juncus usitatus, Typha orientalis, Casuarina glauca, Bolboschoenus cardwellii</i>		
Weed species:	<i>Cynodon dactylon</i>		
Damage:	Nil		
Native dominance:	95%	Percentage vegetation cover:	95%
Photo:

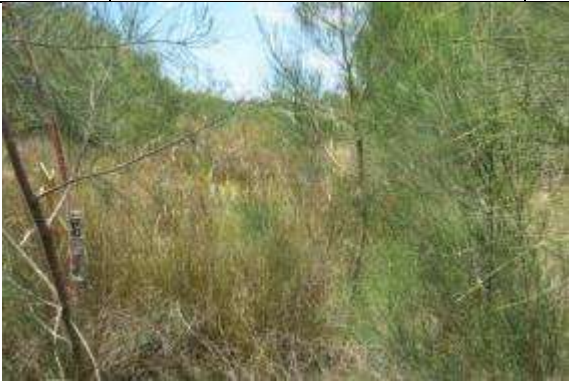
Monitoring month:	42	Months since direct seeding:	47
Date:	February 2019		
Comments:	One individual specimen of <i>Ludwigia octovalvis</i> has been recorded within the bounds of this quadrat. This is a new species record for this quadrat, but not for the NWCP on the whole.		
Native species:	<i>Juncus usitatus</i> , <i>Typha orientalis</i> , <i>Casuarina glauca</i> , <i>Bolboschoenus cardwellii</i> , <i>Ludwigia octovalvis</i>		
Weed species:	<i>Cynodon dactylon</i>		
Damage:	Nil		
Native dominance:	95%	Percentage vegetation cover:	95%
Photo:

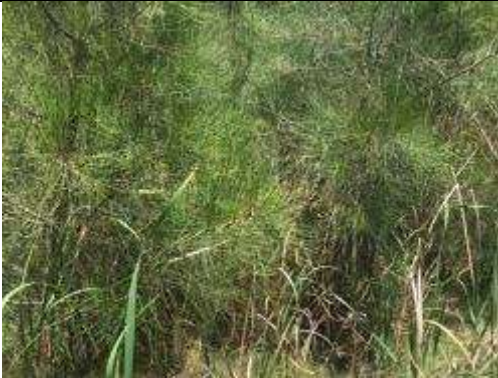
Monitoring month:	43	Months since direct seeding:	48
Date:	March 2019		
Comments:	No significant changes this month.		
Native species:	<i>Juncus usitatus</i> , <i>Typha orientalis</i> , <i>Casuarina glauca</i> , <i>Bolboschoenus cardwellii</i>		
Weed species:	<i>Cynodon dactylon</i>		
Damage:	Nil		
Native dominance:	95%	Percentage vegetation cover:	95%
Photo:

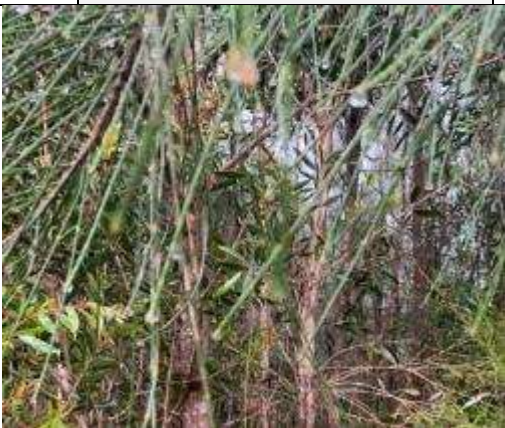
Monitoring month:	44	Months since direct seeding:	49
Date:	April 2019		
Comments:	Rainfall events increased late last month and continued this month giving the NWCP a much needed watering.		
Native species:	<i>Juncus usitatus, Typha orientalis, Casuarina glauca, Bolboschoenus cardwellii</i>		
Weed species:	<i>Cynodon dactylon</i>		
Damage:	Nil		
Native dominance:	95%	Percentage vegetation cover:	95%
Photo:

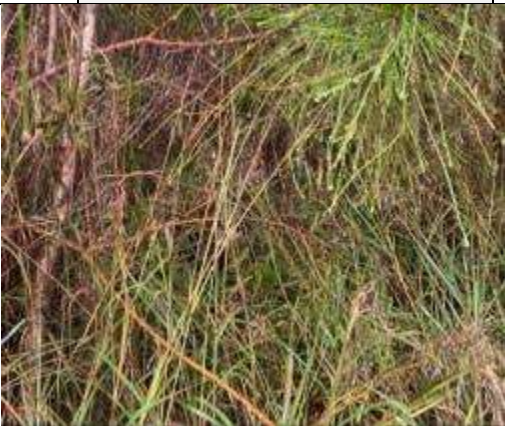
Monitoring month:	45	Months since direct seeding:	50
Date:	May 2019		
Comments:	<i>Casuarina glauca</i> continues to add biomass.		
Native species:	<i>Juncus usitatus, Typha orientalis, Casuarina glauca, Bolboschoenus cardwellii</i>		
Weed species:	<i>Cynodon dactylon</i>		
Damage:	Nil		
Native dominance:	95%	Percentage vegetation cover:	95%
Photo:

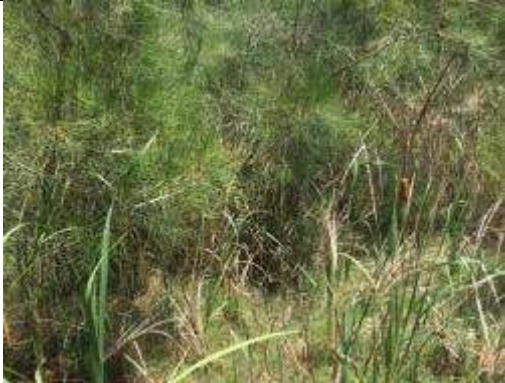
Monitoring month:	46	Months since direct seeding:	51
Date:	June 2019		
Comments:	Rainfall over the past few months has increased plant growth and vigour.		
Native species:	<i>Juncus usitatus</i> , <i>Typha orientalis</i> , <i>Casuarina glauca</i> , <i>Bolboschoenus cardwellii</i>		
Weed species:	<i>Cynodon dactylon</i>		
Damage:	Nil		
Native dominance:	95%	Percentage vegetation cover:	95%
Photo:

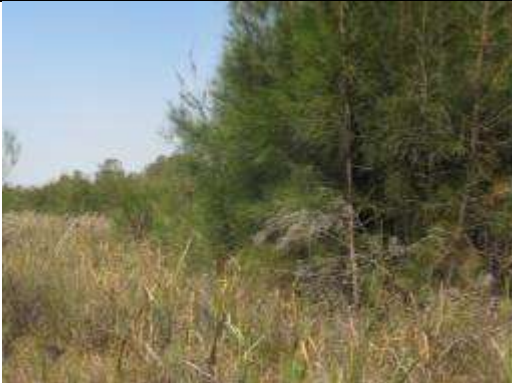
Monitoring month:	47	Months since direct seeding:	52
Date:	July 2019		
Comments:	Growth is steady.		
Native species:	<i>Juncus usitatus</i> , <i>Typha orientalis</i> , <i>Casuarina glauca</i> , <i>Bolboschoenus cardwellii</i>		
Weed species:	<i>Cynodon dactylon</i>		
Damage:	Nil		
Native dominance:	95%	Percentage vegetation cover:	95%
Photo:

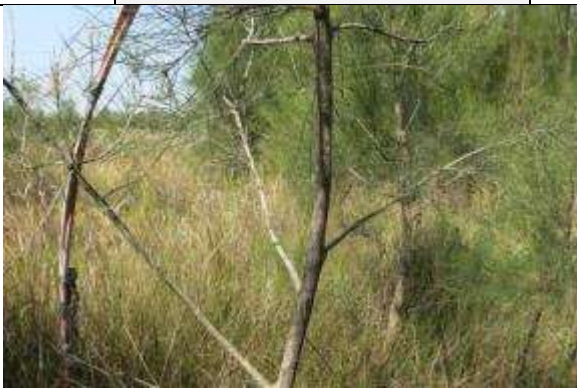
Monitoring month:	48	Months since direct seeding:	53
Date:	August 2019		
Comments:	Within the surrounding area, <i>Melaleuca quinquenervia</i> was recorded setting seed for the first time.		
Native species:	<i>Juncus usitatus</i> , <i>Typha orientalis</i> , <i>Casuarina glauca</i> , <i>Bolboschoenus cardwellii</i>		
Weed species:	<i>Cynodon dactylon</i>		
Damage:	Nil		
Native dominance:	95%	Percentage vegetation cover:	95%
Photo:

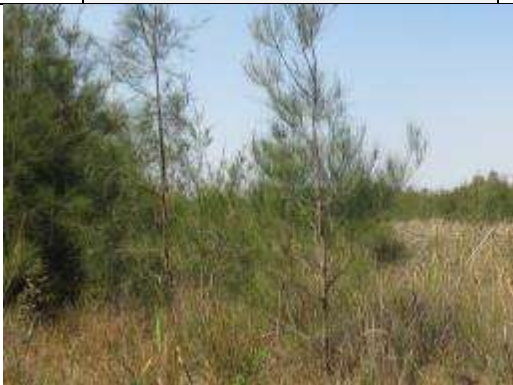
Monitoring month:	49	Months since direct seeding:	54
Date:	September 2019		
Comments:	Casuarina copses are starting to extend outwards, closing gaps between each stand.		
Native species:	<i>Juncus usitatus</i> , <i>Typha orientalis</i> , <i>Casuarina glauca</i> , <i>Bolboschoenus cardwellii</i>		
Weed species:	<i>Cynodon dactylon</i>		
Damage:	Nil		
Native dominance:	95%	Percentage vegetation cover:	95%
Photo:

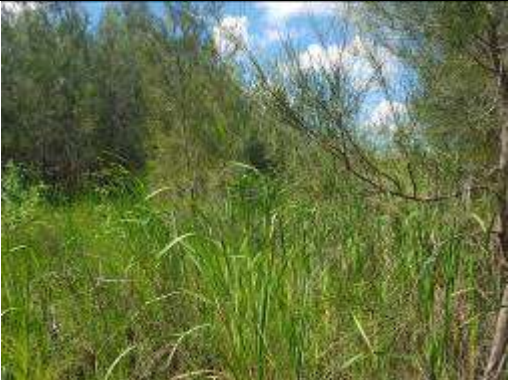
Monitoring month:	50	Months since direct seeding:	55
Date:	October 2019		
Comments:	Extended drought conditions are starting to take their toll with the extreme slowing of plant growth.		
Native species:	<i>Juncus usitatus, Typha orientalis, Casuarina glauca, Bolboschoenus cardwellii</i>		
Weed species:	<i>Cynodon dactylon</i>		
Damage:	Nil		
Native dominance:	95%	Percentage vegetation cover:	95%
Photo:

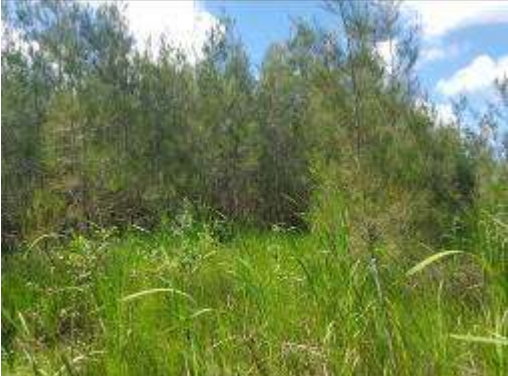
Monitoring month:	51	Months since direct seeding:	56
Date:	November 2019		
Comments:	Casuarina copses are continuing to spread, closing gaps between each stand.		
Native species:	<i>Juncus usitatus, Typha orientalis, Casuarina glauca, Bolboschoenus cardwellii</i>		
Weed species:	<i>Cynodon dactylon</i>		
Damage:	Nil		
Native dominance:	95%	Percentage vegetation cover:	95%
Photo:

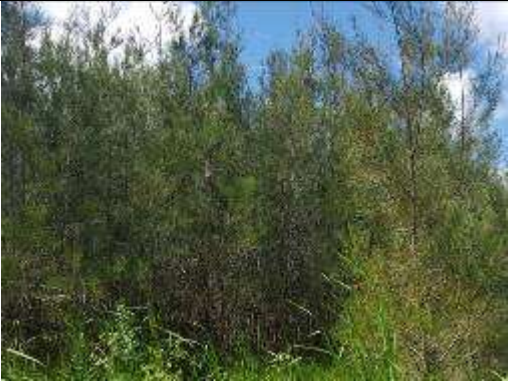
Monitoring month:	52	Months since direct seeding:	57
Date:	December 2019		
Comments:	Vegetation growth steady.		
Native species:	<i>Juncus usitatus, Typha orientalis, Casuarina glauca, Bolboschoenus cardwellii</i>		
Weed species:	<i>Cynodon dactylon</i>		
Damage:	Nil		
Native dominance:	95%	Percentage vegetation cover:	95%
Photo:

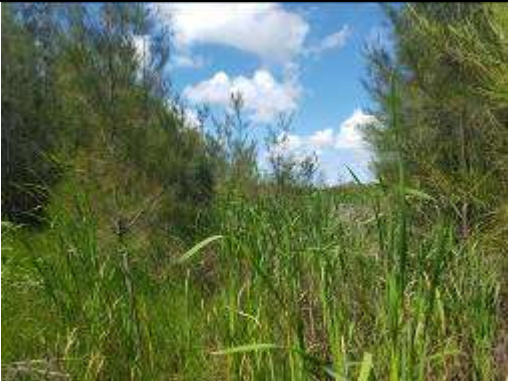
Monitoring month:	53	Months since direct seeding:	58
Date:	January 2020		
Comments:	Recent rainfall has increased vigour of wetland species.		
Native species:	<i>Juncus usitatus, Typha orientalis, Casuarina glauca, Bolboschoenus cardwellii</i>		
Weed species:	<i>Cynodon dactylon</i>		
Damage:	Nil		
Native dominance:	95%	Percentage vegetation cover:	95%
Photo:

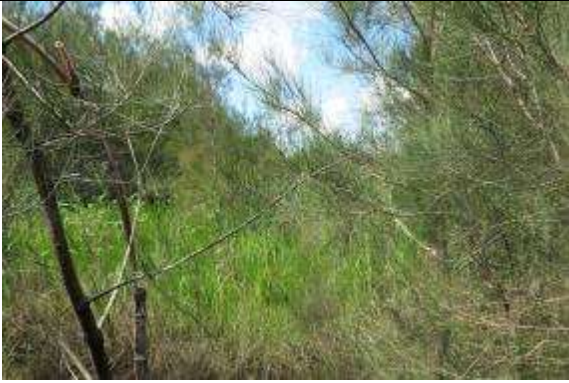
Monitoring month:	54	Months since direct seeding:	59
Date:	February 2020		
Comments:	Quadrat remains weed free, with the exception of couch.		
Native species:	<i>Juncus usitatus</i> , <i>Typha orientalis</i> , <i>Casuarina glauca</i> , <i>Bolboschoenus cardwellii</i> , <i>Ludwigia octovalvis</i>		
Weed species:	<i>Cynodon dactylon</i>		
Damage:	Nil		
Native dominance:	95%	Percentage vegetation cover:	95%
Photo:
