North-West Conservation Park - Rehabilitation Monitoring

Lot 1 RP48903

North-West Conservation Park
Gainsborough Greens

March 2020

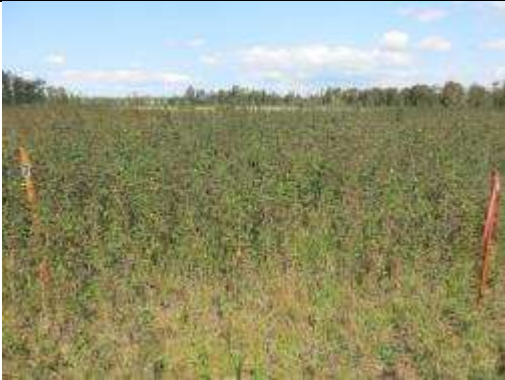
4.7 Quadrat 7

Monitoring month:	1	Months since direct seeding:	6
Date:	September 2015		
Comments:	Very heavily dominated by Ludwigia, with one individual canopy species, <i>Melaleuca quinquenervia</i> . Reasonable diversity, exotic presence recorded at the outer perimeter of the quadrat.		
Native species:	<i>Ludwigia octovalvis</i> , <i>Juncus usitatus</i> , <i>Cyperus exaltatus</i> , <i>Melaleuca quinquenervia</i>		
Weed species:	<i>Cuphea carthagenesis</i> , <i>Cynodon dactylon</i>		
Damage:	Nil		
Native dominance:	83%	Percentage vegetation cover:	90%
Photo:

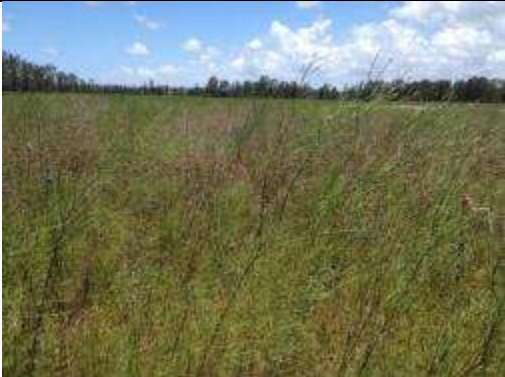
Monitoring month:	6	Months since direct seeding:	11
Date:	February 2016		
Comments:	The overall number of canopy trees has improved in this quadrat. This is representative of the surrounding area also. As per quadrat 6, it appears weeds are dominating in the picture but on-ground natives make up approximately 75% of coverage.		
Native species:	<i>Ludwigia octovalvis</i> , <i>Casuarina glauca</i> , <i>Juncus usitatus</i> , <i>Cyperus exaltatus</i> , <i>Melaleuca quinquenervia</i>		
Weed species:	<i>Cuphea carthagenesis</i> , <i>Aster subulatus</i> , <i>Cynodon dactylon</i>		
Damage:	Nil		
Native dominance:	75%	Percentage vegetation cover:	100%
Photo:

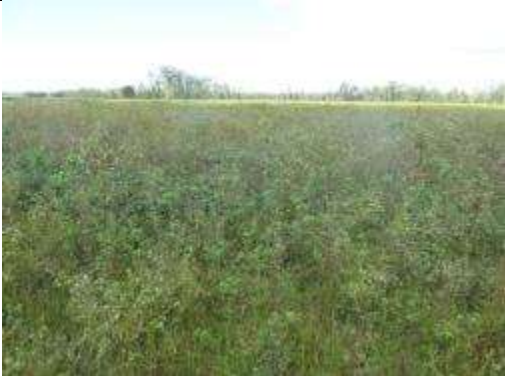
Monitoring month:	7	Months since direct seeding:	12
Date:	March 2016		
Comments:	Upon the first visit, one canopy tree was identified, upon the second visit 6 canopy trees were identified. Now there are significant numbers present. This is representative of the surrounding area also, and an upwards trend common over much of the site. There are significant numbers of canopy trees in the surrounding area. A vigorous response from the sedges to recent rain is evident around this area.		
Native species:	<i>Ludwigia octovalvis</i> , <i>Casuarina glauca</i> , <i>Juncus usitatus</i> , <i>Cyperus exaltatus</i> , <i>Melaleuca quinquenervia</i>		
Weed species:	<i>Cuphea carthagenesis</i> , <i>Aster subulatus</i> , <i>Paspalum dilatatum</i> , <i>Cynodon dactylon</i>		
Damage:	Nil		
Native dominance:	66%	Percentage vegetation cover:	100%
Photo:

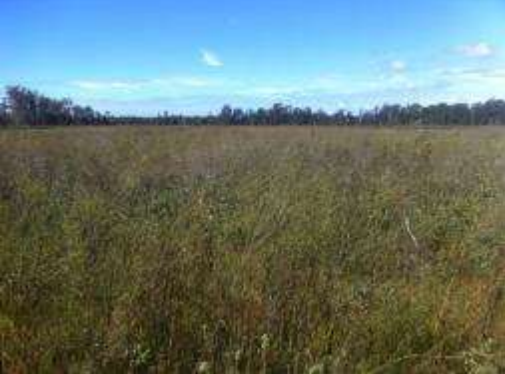
Monitoring month:	8	Months since direct seeding:	13
Date:	April 2016		
Comments:	A significant number of canopy species are present. This is representative of the surrounding area also, and an upwards trend common over much of the site. There are significant numbers of canopy trees in the surrounding area. A vigorous response from the sedges to recent rain is evident around this area.		
Native species:	<i>Ludwigia octovalvis</i> , <i>Casuarina glauca</i> , <i>Juncus usitatus</i> , <i>Cyperus exaltatus</i> , <i>Melaleuca quinquenervia</i>		
Weed species:	<i>Cuphea carthagenesis</i> , <i>Aster subulatus</i> , <i>Paspalum dilatatum</i> , <i>Cynodon dactylon</i>		
Damage:	Nil		
Native dominance:	66%	Percentage vegetation cover:	100%
Photo:

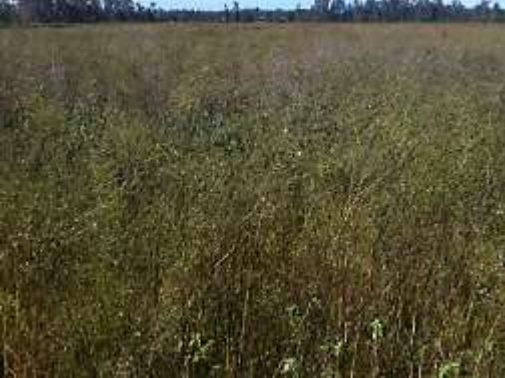
Monitoring month:	9	Months since direct seeding:	14
Date:	May 2016		
Comments:	Growth conditions have favoured native sedges this month.		
Native species:	<i>Ludwigia octovalvis</i> , <i>Casuarina glauca</i> , <i>Juncus usitatus</i> , <i>Cyperus exaltatus</i> , <i>Melaleuca quinquenervia</i>		
Weed species:	<i>Cuphea carthagenesis</i> , <i>Aster subulatus</i> , <i>Paspalum dilatatum</i> , <i>Cynodon dactylon</i>		
Damage:	Nil		
Native dominance:	66%	Percentage vegetation cover:	100%
Photo:

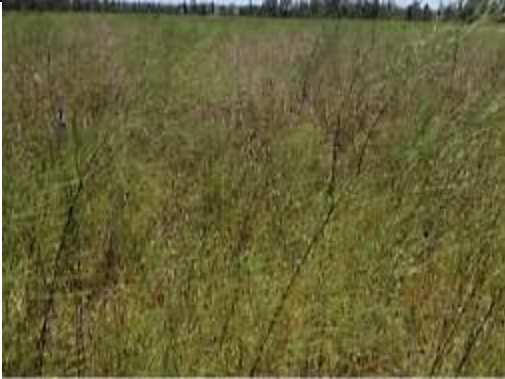
Monitoring month:	10	Months since direct seeding:	15
Date:	June 2016		
Comments:	As per similar quadrats, Aster is starting to show signs of die-back for the winter months.		
Native species:	<i>Ludwigia octovalvis</i> , <i>Casuarina glauca</i> , <i>Juncus usitatus</i> , <i>Cyperus exaltatus</i> , <i>Melaleuca quinquenervia</i>		
Weed species:	<i>Cuphea carthagenesis</i> , <i>Aster subulatus</i> , <i>Paspalum dilatatum</i> , <i>Cynodon dactylon</i>		
Damage:	Nil		
Native dominance:	65%	Percentage vegetation cover:	100%
Photo:

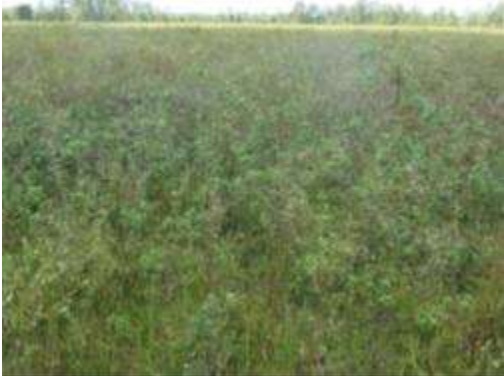
Monitoring month:	11	Months since direct seeding:	16
Date:	July 2016		
Comments:	No significant differences were recorded this month.		
Native species:	<i>Ludwigia octovalvis</i> , <i>Casuarina glauca</i> , <i>Juncus usitatus</i> , <i>Cyperus exaltatus</i> , <i>Melaleuca quinquenervia</i>		
Weed species:	<i>Cuphea carthagenesis</i> , <i>Aster subulatus</i> , <i>Paspalum dilatatum</i> , <i>Cynodon dactylon</i>		
Damage:	Nil		
Native dominance:	65%	Percentage vegetation cover:	100%
Photo:

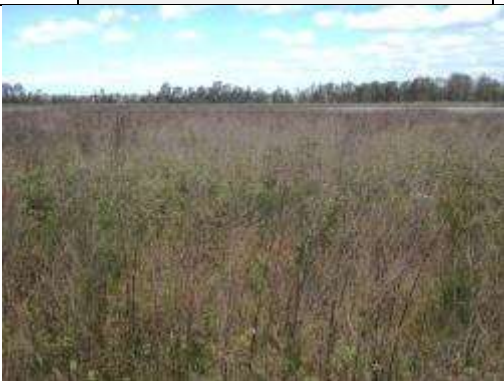
Monitoring month:	12	Months since direct seeding:	17
Date:	August 2016		
Comments:	Native canopy vegetation continues to increase in diversity within this quadrat. During month 1, 6 individuals were identified, now there are significant numbers present. This is also representative of the surrounding area, and an overall upwards trend common over much of the site.		
Native species:	<i>Ludwigia octovalvis</i> , <i>Casuarina glauca</i> , <i>Juncus usitatus</i> , <i>Cyperus exaltatus</i> , <i>Melaleuca quinquenervia</i>		
Weed species:	<i>Cuphea carthagenesis</i> , <i>Aster subulatus</i> , <i>Paspalum dilatatum</i> , <i>Cynodon dactylon</i>		
Damage:	Nil		
Native dominance:	66%	Percentage vegetation cover:	100%
Photo:

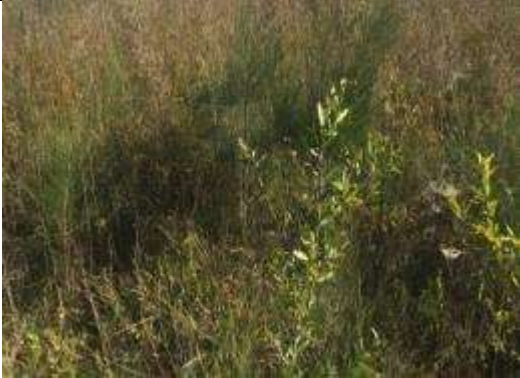
Monitoring month:	13	Months since direct seeding:	18
Date:	September 2016		
Comments:	Melaleuca and Casuarina seedlings continue to grow and prosper this month. Native dominance has also increased with this spike in growth.		
Native species:	<i>Ludwigia octovalvis</i> , <i>Casuarina glauca</i> , <i>Juncus usitatus</i> , <i>Cyperus exaltatus</i> , <i>Melaleuca quinquenervia</i>		
Weed species:	<i>Cuphea carthagenesis</i> , <i>Aster subulatus</i> , <i>Paspalum dilatatum</i> , <i>Cynodon dactylon</i>		
Damage:	Nil		
Native dominance:	70%	Percentage vegetation cover:	100%
Photo:

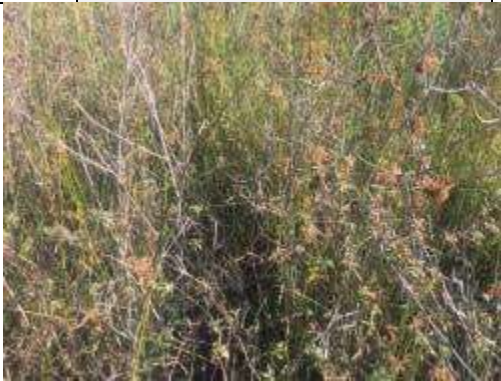
Monitoring month:	14	Months since direct seeding:	19
Date:	October 2016		
Comments:	Cypress and sedge growth continues to increase this month.		
Native species:	<i>Ludwigia octovalvis</i> , <i>Casuarina glauca</i> , <i>Juncus usitatus</i> , <i>Cyperus exaltatus</i> , <i>Melaleuca quinquenervia</i>		
Weed species:	<i>Cuphea carthagenesis</i> , <i>Aster subulatus</i> , <i>Paspalum dilatatum</i> , <i>Cynodon dactylon</i>		
Damage:	Nil		
Native dominance:	70%	Percentage vegetation cover:	100%
Photo:

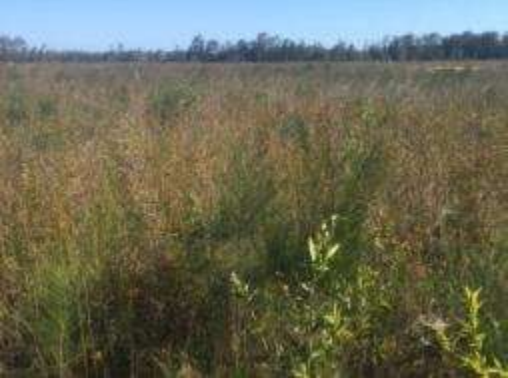
Monitoring month:	15	Months since direct seeding:	20
Date:	November 2016		
Comments:	Melaleuca and Casuarina seedlings continue to grow and prosper this month, with many emerging over the height of Juncus plants.		
Native species:	<i>Ludwigia octovalvis</i> , <i>Casuarina glauca</i> , <i>Juncus usitatus</i> , <i>Cyperus exaltatus</i> , <i>Melaleuca quinquenervia</i>		
Weed species:	<i>Cuphea carthagenesis</i> , <i>Aster subulatus</i> , <i>Paspalum dilatatum</i> , <i>Cynodon dactylon</i>		
Damage:	Nil		
Native dominance:	70%	Percentage vegetation cover:	100%
Photo:

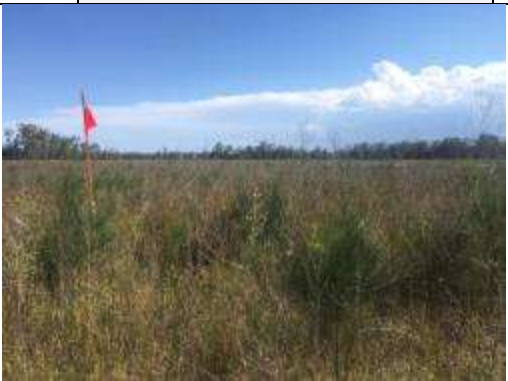
Monitoring month:	16	Months since direct seeding:	21
Date:	December 2016		
Comments:	A high visibility flag and extended pole was added to the quadrat stake this month for ease of identification. Melaleuca and Casuarina seedlings continue to grow and prosper this month.		
Native species:	<i>Ludwigia octovalvis</i> , <i>Casuarina glauca</i> , <i>Juncus usitatus</i> , <i>Cyperus exaltatus</i> , <i>Melaleuca quinquenervia</i>		
Weed species:	<i>Cuphea carthagenesis</i> , <i>Aster subulatus</i> , <i>Paspalum dilatatum</i> , <i>Cynodon dactylon</i>		
Damage:	Nil		
Native dominance:	70%	Percentage vegetation cover:	100%
Photo:

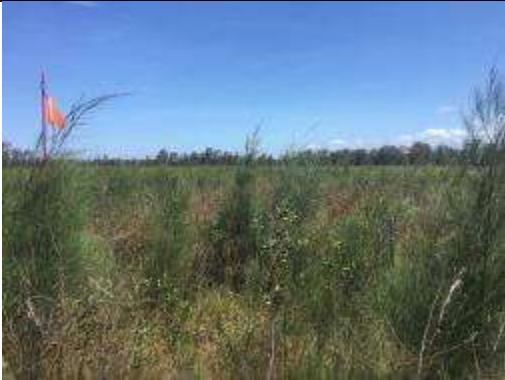
Monitoring month:	17	Months since direct seeding:	22
Date:	January 2017		
Comments:	Melaleuca and Casuarina seedlings continue to grow and prosper this month, with Casuarinas up to approximately 2m in height and Melaleucas averaging approximately 1.2m in height.		
Native species:	<i>Ludwigia octovalvis</i> , <i>Casuarina glauca</i> , <i>Juncus usitatus</i> , <i>Cyperus exaltatus</i> , <i>Melaleuca quinquenervia</i>		
Weed species:	<i>Cuphea carthagenesis</i> , <i>Aster subulatus</i> , <i>Paspalum dilatatum</i> , <i>Cynodon dactylon</i>		
Damage:	Nil		
Native dominance:	75%	Percentage vegetation cover:	100%
Photo:

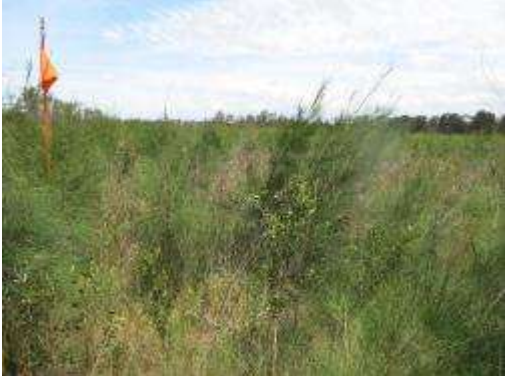
Monitoring month:	18	Months since direct seeding:	23
Date:	February 2017		
Comments:	Melaleuca and Casuarina seedlings continue to grow and prosper this month, with Casuarinas up to approximately 2m in height and Melaleucas averaging approximately 1.2m in height.		
Native species:	<i>Ludwigia octovalvis</i> , <i>Casuarina glauca</i> , <i>Juncus usitatus</i> , <i>Cyperus exaltatus</i> , <i>Melaleuca quinquenervia</i>		
Weed species:	<i>Cuphea carthagenesis</i> , <i>Paspalum dilatatum</i> , <i>Cynodon dactylon</i> , <i>Conyza sumatrensis</i>		
Damage:	Nil		
Native dominance:	75%	Percentage vegetation cover:	100%
Photo:

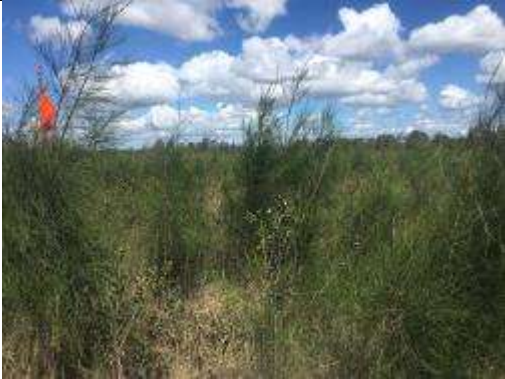
Monitoring month:	19	Months since direct seeding:	24
Date:	March 2017 (NB: monitoring event occurred early April due to inaccessibility)		
Comments:	During the last half of this month, the NWCP received significant rainfall. Access to the area was limited. Much of the area is waterlogged and functioning as the wetland it is designed to be. Melaleuca and Casuarina seedlings continue to grow and prosper, with Casuarinas up to approximately 3m and Melaleucas approximately 1.5m in height.		
Native species:	<i>Ludwigia octovalvis</i> , <i>Casuarina glauca</i> , <i>Juncus usitatus</i> , <i>Cyperus exaltatus</i> , <i>Melaleuca quinquenervia</i>		
Weed species:	<i>Cuphea carthagenesis</i> , <i>Paspalum dilatatum</i> , <i>Cynodon dactylon</i> , <i>Conyza sumatrensis</i>		
Damage:	Nil		
Native dominance:	75%	Percentage vegetation cover:	100%
Photo:

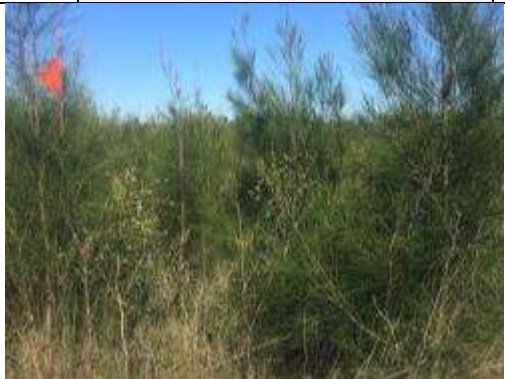
Monitoring month:	20	Months since direct seeding:	25
Date:	April 2017		
Comments:	Much of the area is still waterlogged and functioning as the wetland it is designed to be. Melaleucas and Casuarinas continue to grow well.		
Native species:	<i>Ludwigia octovalvis</i> , <i>Casuarina glauca</i> , <i>Juncus usitatus</i> , <i>Cyperus exaltatus</i> , <i>Melaleuca quinquenervia</i>		
Weed species:	<i>Cuphea carthagenesis</i> , <i>Paspalum dilatatum</i> , <i>Cynodon dactylon</i> , <i>Conyza sumatrensis</i>		
Damage:	Nil		
Native dominance:	75%	Percentage vegetation cover:	100%
Photo:

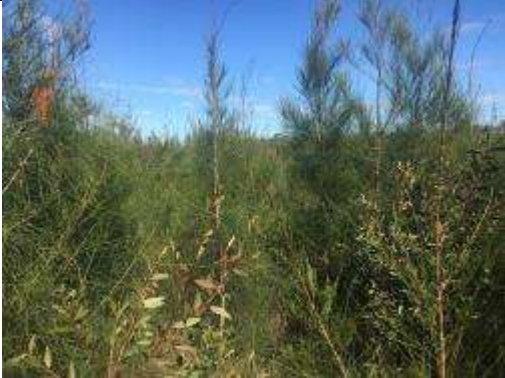
Monitoring month:	21	Months since direct seeding:	26
Date:	May 2017		
Comments:	Melaleuca and Casuarina seedlings continue to grow and prosper, with Casuarinas up to approximately 3.5m and Melaleucas approximately 2m in height.		
Native species:	<i>Ludwigia octovalvis</i> , <i>Casuarina glauca</i> , <i>Juncus usitatus</i> , <i>Cyperus exaltatus</i> , <i>Melaleuca quinquenervia</i>		
Weed species:	<i>Cuphea carthagenesis</i> , <i>Paspalum dilatatum</i> , <i>Cynodon dactylon</i> , <i>Conyza sumatrensis</i>		
Damage:	Nil		
Native dominance:	75%	Percentage vegetation cover:	100%
Photo:

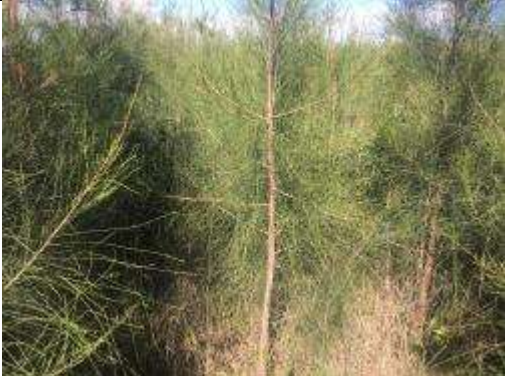
Monitoring month:	22	Months since direct seeding:	27
Date:	June 2017		
Comments:	No significant changes this month. It is anticipated growth will slow moving into the colder months.		
Native species:	<i>Ludwigia octovalvis</i> , <i>Casuarina glauca</i> , <i>Juncus usitatus</i> , <i>Cyperus exaltatus</i> , <i>Melaleuca quinquenervia</i>		
Weed species:	<i>Cuphea carthagenesis</i> , <i>Paspalum dilatatum</i> , <i>Cynodon dactylon</i> , <i>Conyza sumatrensis</i>		
Damage:	Nil		
Native dominance:	75%	Percentage vegetation cover:	100%
Photo:

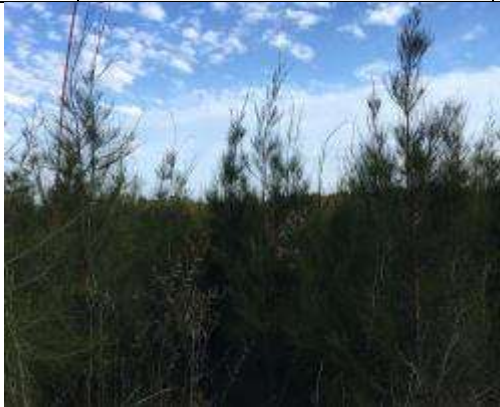
Monitoring month:	23	Months since direct seeding:	28
Date:	July 2017		
Comments:	An additional length of conduit was added to the flagging pole this month due to the increasing height of vegetation. Vegetation health is steady.		
Native species:	<i>Ludwigia octovalvis</i> , <i>Casuarina glauca</i> , <i>Juncus usitatus</i> , <i>Cyperus exaltatus</i> , <i>Melaleuca quinquenervia</i>		
Weed species:	<i>Cuphea carthagenesis</i> , <i>Paspalum dilatatum</i> , <i>Cynodon dactylon</i> , <i>Conyza sumatrensis</i>		
Damage:	Nil		
Native dominance:	75%	Percentage vegetation cover:	100%
Photo:

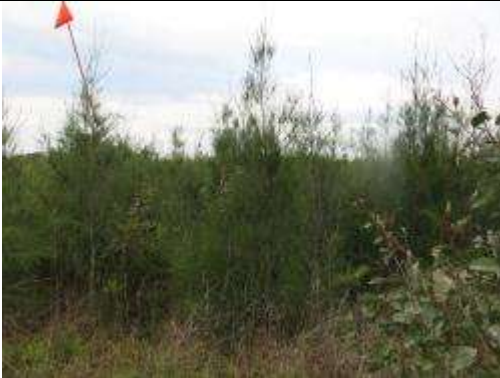
Monitoring month:	24	Months since direct seeding:	29
Date:	August 2017		
Comments:	Biomass of casuarinas has increased significantly, which has in turn increased shading. This has resulted in the eradication of <i>Conyza sumatrensis</i>		
Native species:	<i>Ludwigia octovalvis</i> , <i>Casuarina glauca</i> , <i>Juncus usitatus</i> , <i>Cyperus exaltatus</i> , <i>Melaleuca quinquenervia</i>		
Weed species:	<i>Cuphea carthagenesis</i> , <i>Paspalum dilatatum</i> , <i>Cynodon dactylon</i>		
Damage:	Nil		
Native dominance:	75%	Percentage vegetation cover:	100%
Photo:

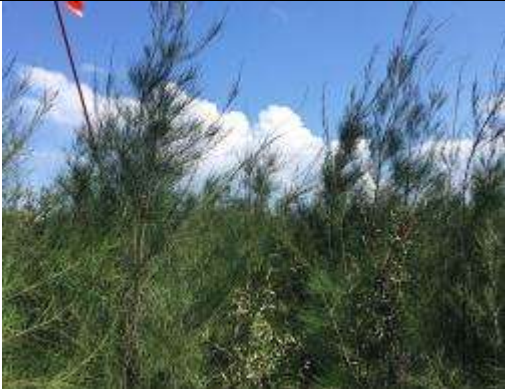
Monitoring month:	25	Months since direct seeding:	30
Date:	September 2017		
Comments:	Vegetation health and growth is steady.		
Native species:	<i>Ludwigia octovalvis</i> , <i>Casuarina glauca</i> , <i>Juncus usitatus</i> , <i>Cyperus exaltatus</i> , <i>Melaleuca quinquenervia</i>		
Weed species:	<i>Cuphea carthagenesis</i> , <i>Paspalum dilatatum</i> , <i>Cynodon dactylon</i> , <i>Conyza sumatrensis</i>		
Damage:	Nil		
Native dominance:	75%	Percentage vegetation cover:	100%
Photo:

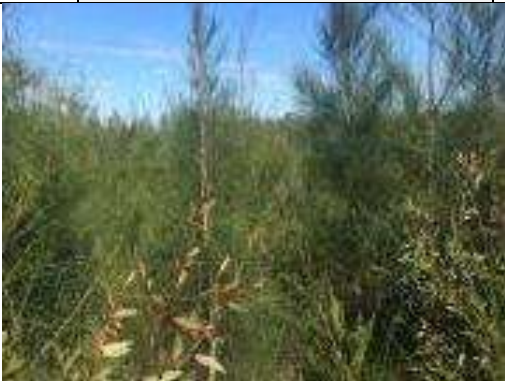
Monitoring month:	26	Months since direct seeding:	31
Date:	October 2017		
Comments:	Vegetation health and growth is steady.		
Native species:	<i>Ludwigia octovalvis</i> , <i>Casuarina glauca</i> , <i>Juncus usitatus</i> , <i>Cyperus exaltatus</i> , <i>Melaleuca quinquenervia</i>		
Weed species:	<i>Cuphea carthagenesis</i> , <i>Paspalum dilatatum</i> , <i>Cynodon dactylon</i> , <i>Conyza sumatrensis</i>		
Damage:	Nil		
Native dominance:	75%	Percentage vegetation cover:	100%
Photo:

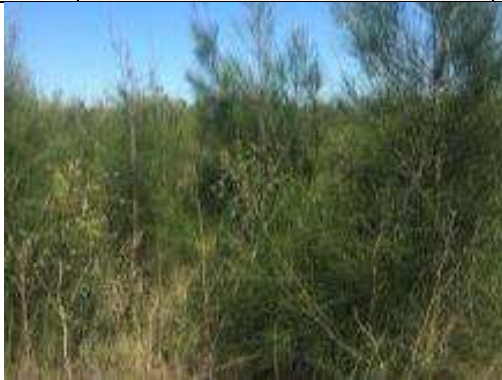
Monitoring month:	27	Months since direct seeding:	32
Date:	November 2017		
Comments:	Rainfall and increasing temperatures have driven an increase in biomass of casuarina and melaleuca.		
Native species:	<i>Ludwigia octovalvis</i> , <i>Casuarina glauca</i> , <i>Juncus usitatus</i> , <i>Cyperus exaltatus</i> , <i>Melaleuca quinquenervia</i>		
Weed species:	<i>Cuphea carthagenesis</i> , <i>Paspalum dilatatum</i> , <i>Cynodon dactylon</i> , <i>Conyza sumatrensis</i>		
Damage:	Nil		
Native dominance:	75%	Percentage vegetation cover:	100%
Photo:

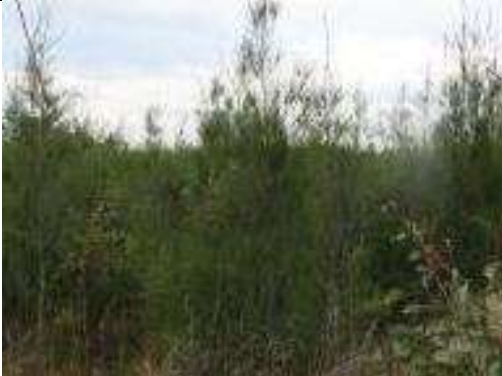
Monitoring month:	28	Months since direct seeding:	33
Date:	December 2017		
Comments:	Rainfall events of the previous month and this month have resulted in waterlogging. This has assisted the growth of melaleucas.		
Native species:	<i>Ludwigia octovalvis</i> , <i>Casuarina glauca</i> , <i>Juncus usitatus</i> , <i>Cyperus exaltatus</i> , <i>Melaleuca quinquenervia</i>		
Weed species:	<i>Cuphea carthagenesis</i> , <i>Paspalum dilatatum</i> , <i>Cynodon dactylon</i> , <i>Conyza sumatrensis</i>		
Damage:	Nil		
Native dominance:	75%	Percentage vegetation cover:	100%
Photo:

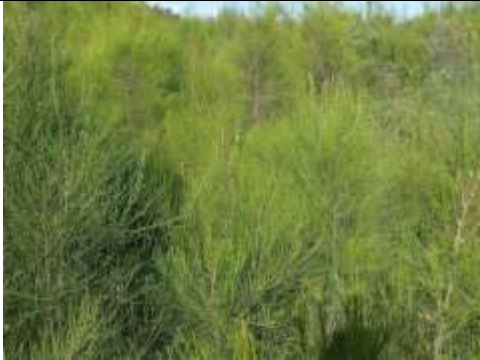
Monitoring month:	29	Months since direct seeding:	34
Date:	January 2018		
Comments:	Casuarinas have added significant biomass and continue to close in the canopy.		
Native species:	<i>Ludwigia octovalvis</i> , <i>Casuarina glauca</i> , <i>Juncus usitatus</i> , <i>Cyperus exaltatus</i> , <i>Melaleuca quinquenervia</i>		
Weed species:	<i>Cuphea carthagenesis</i> , <i>Paspalum dilatatum</i> , <i>Cynodon dactylon</i> , <i>Conyza sumatrensis</i>		
Damage:	Nil		
Native dominance:	80%	Percentage vegetation cover:	100%
Photo:

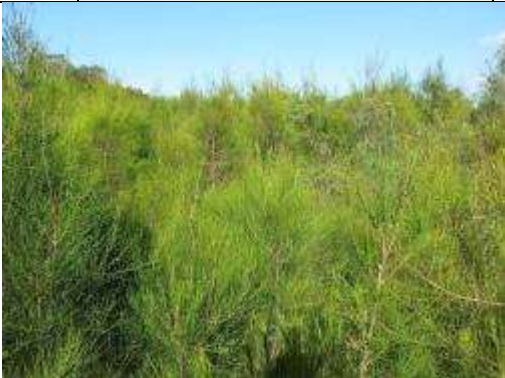
Monitoring month:	30	Months since direct seeding:	35
Date:	February 2018		
Comments:	Vegetation health and growth is steady.		
Native species:	<i>Ludwigia octovalvis</i> , <i>Casuarina glauca</i> , <i>Juncus usitatus</i> , <i>Cyperus exaltatus</i> , <i>Melaleuca quinquenervia</i>		
Weed species:	<i>Cuphea carthagenesis</i> , <i>Paspalum dilatatum</i> , <i>Cynodon dactylon</i> , <i>Conyza sumatrensis</i>		
Damage:	Nil		
Native dominance:	80%	Percentage vegetation cover:	100%
Photo:

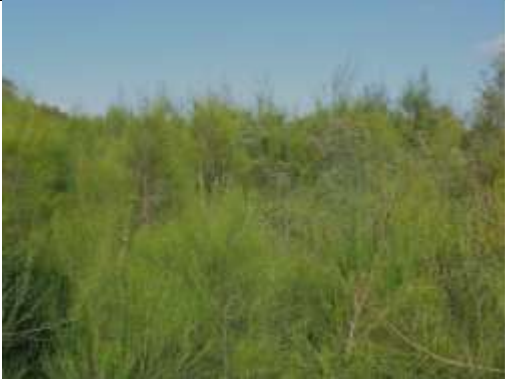
Monitoring month:	31	Months since direct seeding:	36
Date:	March 2018		
Comments:	A significant amount of rain fell at the end of last month resulting in standing water for approximately 3 weeks. This has acted as a natural weed control for a number of the weed species. Canopy growth and shading has also assisted in a reduction of weed growth. One weed species not present this month.		
Native species:	<i>Ludwigia octovalvis</i> , <i>Casuarina glauca</i> , <i>Juncus usitatus</i> , <i>Cyperus exaltatus</i> , <i>Melaleuca quinquenervia</i>		
Weed species:	<i>Cuphea carthagenesis</i> , <i>Paspalum dilatatum</i> , <i>Cynodon dactylon</i>		
Damage:	Nil		
Native dominance:	85%	Percentage vegetation cover:	100%
Photo:

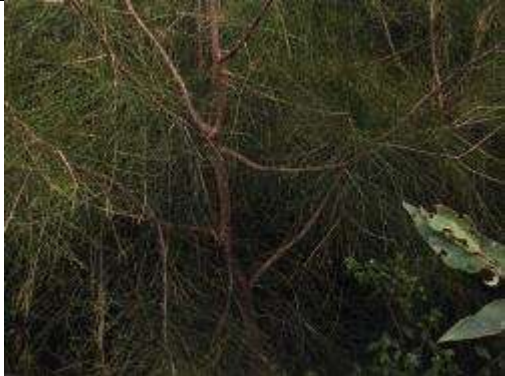
Monitoring month:	32	Months since direct seeding:	37
Date:	April 2018		
Comments:	Vegetation health and growth is steady.		
Native species:	<i>Ludwigia octovalvis</i> , <i>Casuarina glauca</i> , <i>Juncus usitatus</i> , <i>Cyperus exaltatus</i> , <i>Melaleuca quinquenervia</i>		
Weed species:	<i>Cuphea carthagenesis</i> , <i>Paspalum dilatatum</i> , <i>Cynodon dactylon</i>		
Damage:	Nil		
Native dominance:	85%	Percentage vegetation cover:	100%
Photo:

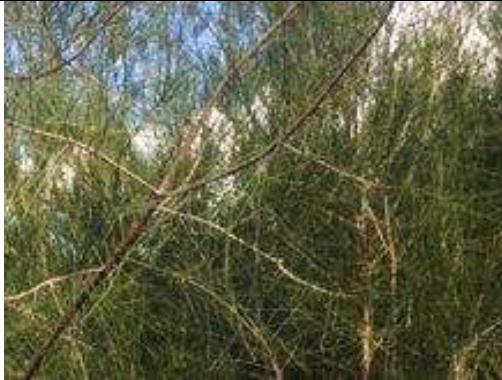
Monitoring month:	33	Months since direct seeding:	38
Date:	May 2018		
Comments:	Casuarinas have added significant biomass and continue to close in the canopy.		
Native species:	<i>Ludwigia octovalvis</i> , <i>Casuarina glauca</i> , <i>Juncus usitatus</i> , <i>Cyperus exaltatus</i> , <i>Melaleuca quinquenervia</i>		
Weed species:	<i>Cuphea carthagenesis</i> , <i>Paspalum dilatatum</i> , <i>Cynodon dactylon</i>		
Damage:	Nil		
Native dominance:	85%	Percentage vegetation cover:	100%
Photo:

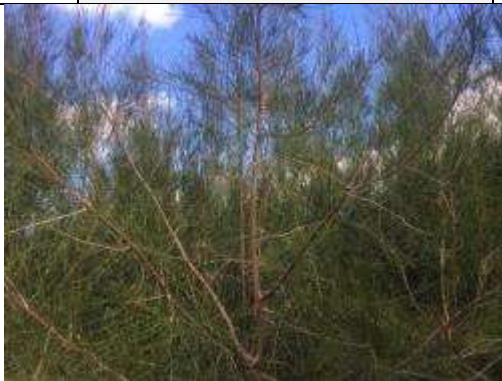
Monitoring month:	34	Months since direct seeding:	39
Date:	June 2018		
Comments:	No significant changes this month due to the slowing down of the growing season.		
Native species:	<i>Ludwigia octovalvis</i> , <i>Casuarina glauca</i> , <i>Juncus usitatus</i> , <i>Cyperus exaltatus</i> , <i>Melaleuca quinquenervia</i>		
Weed species:	<i>Cuphea carthagenesis</i> , <i>Paspalum dilatatum</i> , <i>Cynodon dactylon</i>		
Damage:	Nil		
Native dominance:	85%	Percentage vegetation cover:	100%
Photo:

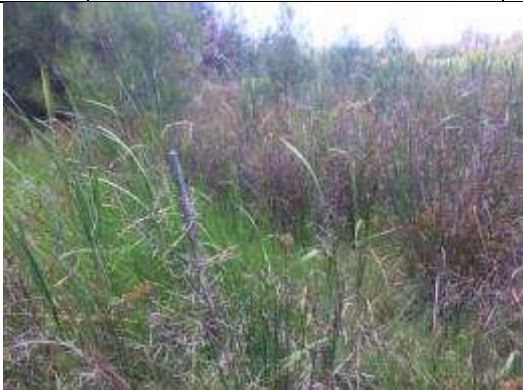
Monitoring month:	35	Months since direct seeding:	40
Date:	July 2018		
Comments:	An alternate route was identified to gain access into this quadrat beyond the thicket of <i>Casuarina glauca</i> . Quadrat is dominated by wetland groundcovers. Species composition, native dominance and vegetation cover statistics remain unchanged.		
Native species:	<i>Ludwigia octovalvis</i> , <i>Casuarina glauca</i> , <i>Juncus usitatus</i> , <i>Carex apressa</i> , <i>Cyperus exaltatus</i> , <i>Melaleuca quinquenervia</i>		
Weed species:	<i>Cynodon dactylon</i>		
Damage:	Nil		
Native dominance:	95%	Percentage vegetation cover:	100%
Photo:

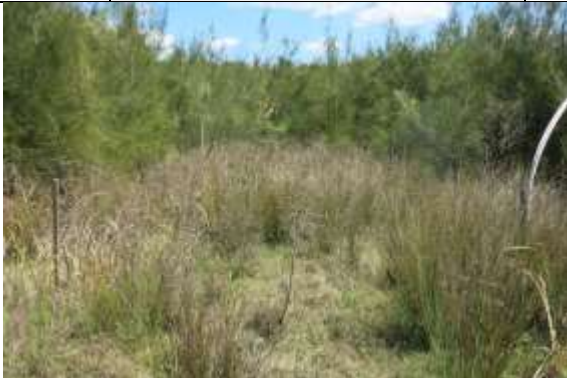
Monitoring month:	36	Months since direct seeding:	41
Date:	August 2018		
Comments:	<i>Casuarina glauca</i> was recorded flowering and seeding within the surrounding areas for the first time since monitoring commenced.		
Native species:	<i>Ludwigia octovalvis</i> , <i>Casuarina glauca</i> , <i>Juncus usitatus</i> , <i>Carex apressa</i> , <i>Cyperus exaltatus</i> , <i>Melaleuca quinquenervia</i>		
Weed species:	<i>Cynodon dactylon</i>		
Damage:	Nil		
Native dominance:	95%	Percentage vegetation cover:	100%
Photo:

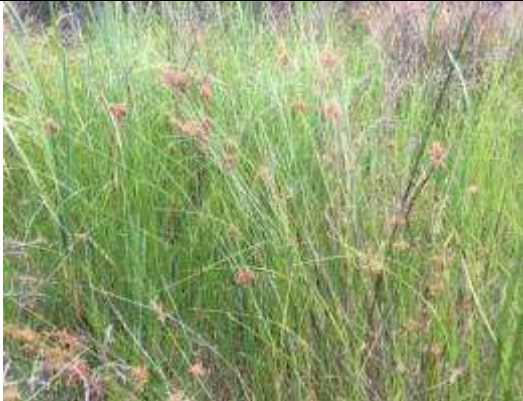
Monitoring month:	37	Months since direct seeding:	42
Date:	September 2018		
Comments:	<i>Melaleuca quinquenervia</i> in the surrounding area is struggling with Myrtle Rust.		
Native species:	<i>Ludwigia octovalvis</i> , <i>Casuarina glauca</i> , <i>Juncus usitatus</i> , <i>Carex apressa</i> , <i>Cyperus exaltatus</i> , <i>Melaleuca quinquenervia</i>		
Weed species:	<i>Cynodon dactylon</i>		
Damage:	Nil		
Native dominance:	95%	Percentage vegetation cover:	100%
Photo:

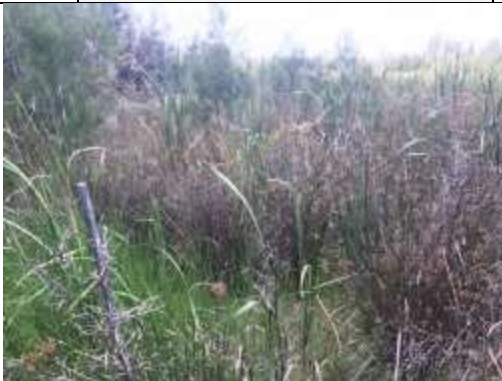
Monitoring month:	38	Months since direct seeding:	43
Date:	October 2018		
Comments:	Rainfall occurred throughout the area during this month which has assisted with the increase in biomass.		
Native species:	<i>Ludwigia octovalvis</i> , <i>Casuarina glauca</i> , <i>Juncus usitatus</i> , <i>Carex apressa</i> , <i>Cyperus exaltatus</i> , <i>Melaleuca quinquenervia</i>		
Weed species:	<i>Cynodon dactylon</i>		
Damage:	Nil		
Native dominance:	95%	Percentage vegetation cover:	100%
Photo:

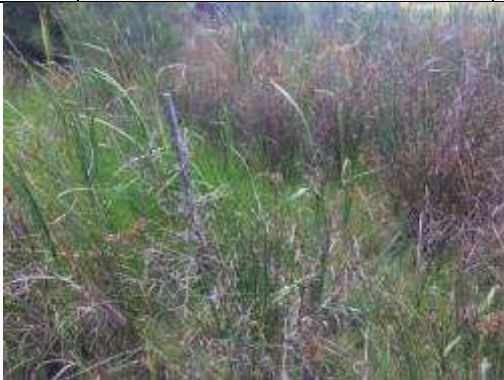
Monitoring month:	39	Months since direct seeding:	44
Date:	November 2018		
Comments:	Rapidly increasing temperatures were experienced this month resulting in the exponential growth of vegetation.		
Native species:	<i>Ludwigia octovalvis</i> , <i>Casuarina glauca</i> , <i>Juncus usitatus</i> , <i>Carex apressa</i> , <i>Cyperus exaltatus</i> , <i>Melaleuca quinquenervia</i>		
Weed species:	<i>Cynodon dactylon</i>		
Damage:	Nil		
Native dominance:	95%	Percentage vegetation cover:	100%
Photo:

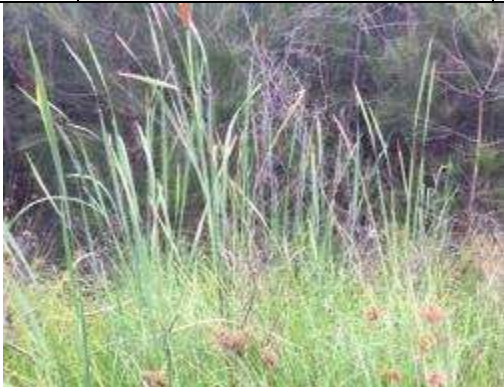
Monitoring month:	40	Months since direct seeding:	45
Date:	December 2018		
Comments:	Vegetation growth was steady this month.		
Native species:	<i>Ludwigia octovalvis</i> , <i>Casuarina glauca</i> , <i>Juncus usitatus</i> , <i>Carex apressa</i> , <i>Cyperus exaltatus</i> , <i>Melaleuca quinquenervia</i>		
Weed species:	<i>Cynodon dactylon</i>		
Damage:	Nil		
Native dominance:	95%	Percentage vegetation cover:	100%
Photo:

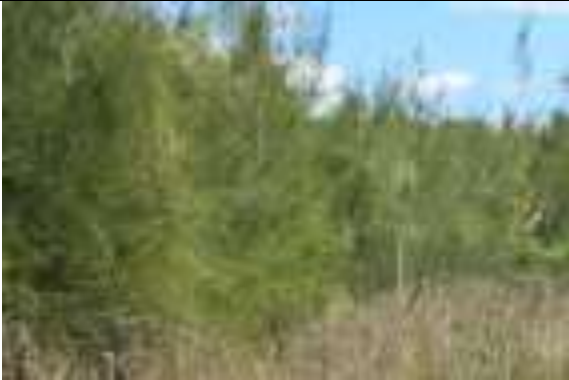
Monitoring month:	41	Months since direct seeding:	46
Date:	January 2019		
Comments:	Access to this quadrat is becoming extremely difficult		
Native species:	<i>Ludwigia octovalvis</i> , <i>Casuarina glauca</i> , <i>Juncus usitatus</i> , <i>Carex apressa</i> , <i>Cyperus exaltatus</i> , <i>Melaleuca quinquenervia</i>		
Weed species:	<i>Cynodon dactylon</i>		
Damage:	Nil		
Native dominance:	95%	Percentage vegetation cover:	100%
Photo:

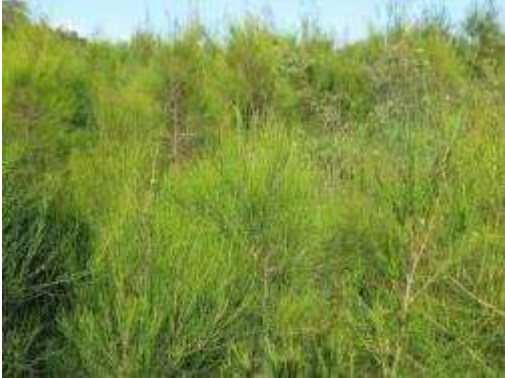
Monitoring month:	42	Months since direct seeding:	47
Date:	February 2019		
Comments:	Vegetation growth was steady this month.		
Native species:	<i>Ludwigia octovalvis</i> , <i>Casuarina glauca</i> , <i>Juncus usitatus</i> , <i>Carex apressa</i> , <i>Cyperus exaltatus</i> , <i>Melaleuca quinquenervia</i>		
Weed species:	<i>Cynodon dactylon</i>		
Damage:	Nil		
Native dominance:	95%	Percentage vegetation cover:	100%
Photo:

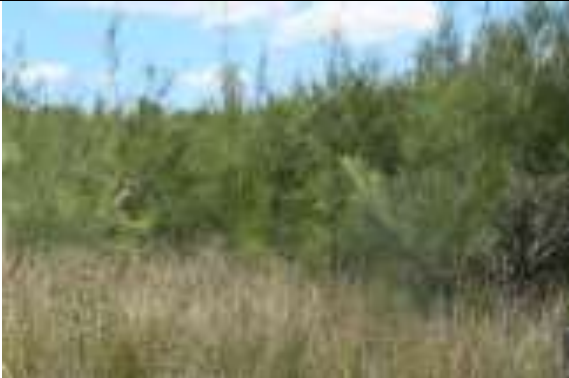
Monitoring month:	43	Months since direct seeding:	48
Date:	March 2019		
Comments:	Casuarinas in surrounding areas continue to close in the canopy.		
Native species:	<i>Ludwigia octovalvis</i> , <i>Casuarina glauca</i> , <i>Juncus usitatus</i> , <i>Carex apressa</i> , <i>Cyperus exaltatus</i> , <i>Melaleuca quinquenervia</i>		
Weed species:	<i>Cynodon dactylon</i>		
Damage:	Nil		
Native dominance:	95%	Percentage vegetation cover:	100%
Photo:

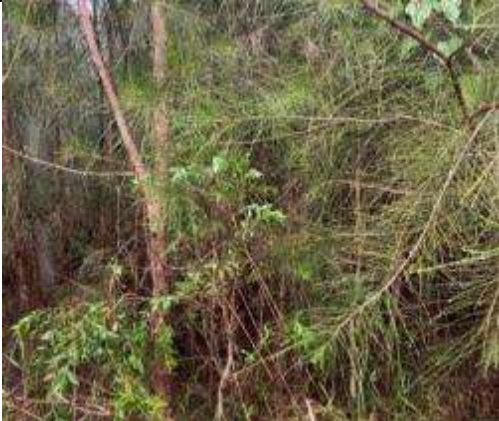
Monitoring month:	44	Months since direct seeding:	49
Date:	April 2019		
Comments:	Rainfall events increased late last month and continued this month giving the NWCP a much needed watering.		
Native species:	<i>Ludwigia octovalvis</i> , <i>Casuarina glauca</i> , <i>Juncus usitatus</i> , <i>Carex apressa</i> , <i>Cyperus exaltatus</i> , <i>Melaleuca quinquenervia</i>		
Weed species:	<i>Cynodon dactylon</i>		
Damage:	Nil		
Native dominance:	95%	Percentage vegetation cover:	100%
Photo:

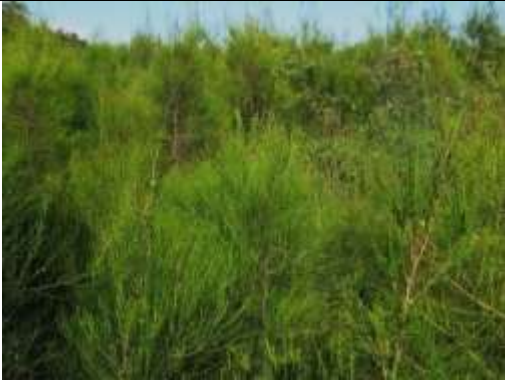
Monitoring month:	45	Months since direct seeding:	50
Date:	May 2019		
Comments:	<i>Casuarina glauca</i> continues to add biomass.		
Native species:	<i>Ludwigia octovalvis</i> , <i>Casuarina glauca</i> , <i>Juncus usitatus</i> , <i>Carex apressa</i> , <i>Cyperus exaltatus</i> , <i>Melaleuca quinquenervia</i>		
Weed species:	<i>Cynodon dactylon</i>		
Damage:	Nil		
Native dominance:	95%	Percentage vegetation cover:	100%
Photo:

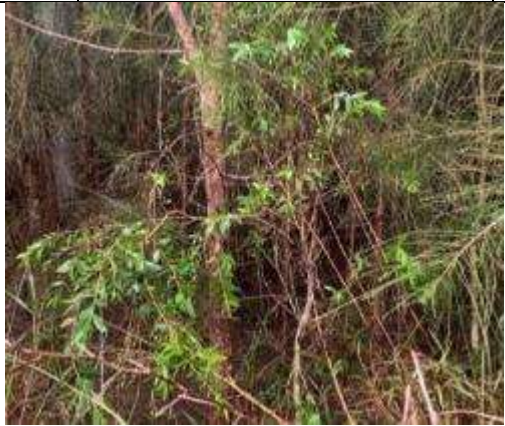
Monitoring month:	46	Months since direct seeding:	51
Date:	June 2019		
Comments:	Rainfall over the past few months has increased plant growth and vigour.		
Native species:	<i>Ludwigia octovalvis</i> , <i>Casuarina glauca</i> , <i>Juncus usitatus</i> , <i>Carex apressa</i> , <i>Cyperus exaltatus</i> , <i>Melaleuca quinquenervia</i>		
Weed species:	<i>Cynodon dactylon</i>		
Damage:	Nil		
Native dominance:	95%	Percentage vegetation cover:	100%
Photo:

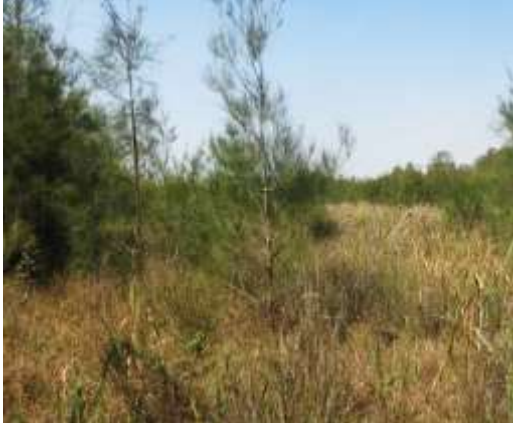
Monitoring month:	47	Months since direct seeding:	52
Date:	July 2019		
Comments:	Casuarina copses are starting to extend outwards, closing gaps between each stand.		
Native species:	<i>Ludwigia octovalvis</i> , <i>Casuarina glauca</i> , <i>Juncus usitatus</i> , <i>Carex apressa</i> , <i>Cyperus exaltatus</i> , <i>Melaleuca quinquenervia</i>		
Weed species:	<i>Cynodon dactylon</i>		
Damage:	Nil		
Native dominance:	95%	Percentage vegetation cover:	100%
Photo:

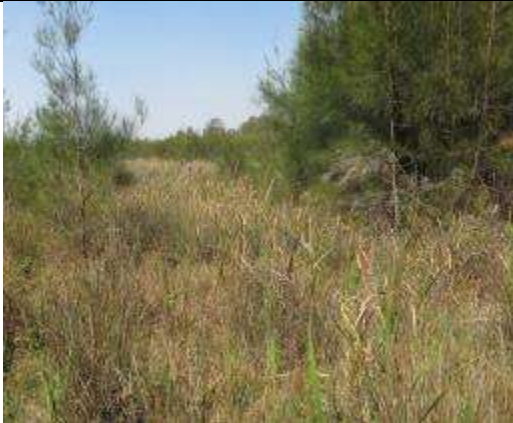
Monitoring month:	48	Months since direct seeding:	53
Date:	August 2019		
Comments:	Myrtle rust is still notable in the surrounding area, however this presence is declining.		
Native species:	<i>Ludwigia octovalvis</i> , <i>Casuarina glauca</i> , <i>Juncus usitatus</i> , <i>Carex apressa</i> , <i>Cyperus exaltatus</i> , <i>Melaleuca quinquenervia</i>		
Weed species:	<i>Cynodon dactylon</i>		
Damage:	Nil		
Native dominance:	95%	Percentage vegetation cover:	100%
Photo:

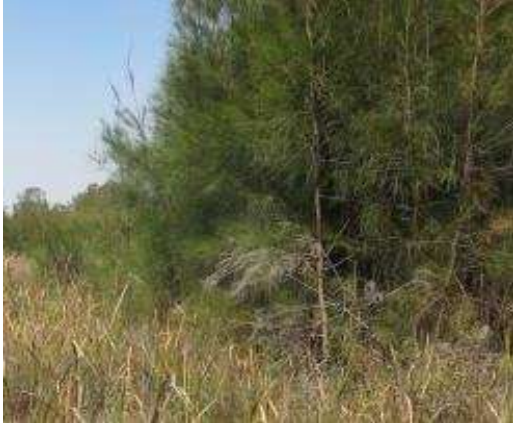
Monitoring month:	49	Months since direct seeding:	54
Date:	September 2019		
Comments:	Allelopathic properties of the casuarina leaf litter is still supressing species diversity.		
Native species:	<i>Ludwigia octovalvis</i> , <i>Casuarina glauca</i> , <i>Juncus usitatus</i> , <i>Carex apressa</i> , <i>Cyperus exaltatus</i> , <i>Melaleuca quinquenervia</i>		
Weed species:	<i>Cynodon dactylon</i>		
Damage:	Nil		
Native dominance:	95%	Percentage vegetation cover:	100%
Photo:

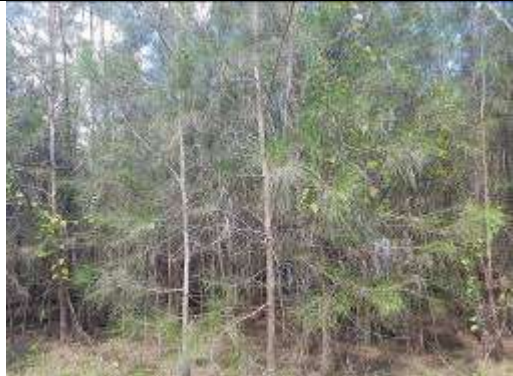
Monitoring month:	50	Months since direct seeding:	55
Date:	October 2019		
Comments:	Extended drought conditions are starting to take their toll with the extreme slowing of plant growth.		
Native species:	<i>Ludwigia octovalvis</i> , <i>Casuarina glauca</i> , <i>Juncus usitatus</i> , <i>Carex apressa</i> , <i>Cyperus exaltatus</i> , <i>Melaleuca quinquenervia</i>		
Weed species:	<i>Cynodon dactylon</i>		
Damage:	Nil		
Native dominance:	95%	Percentage vegetation cover:	100%
Photo:

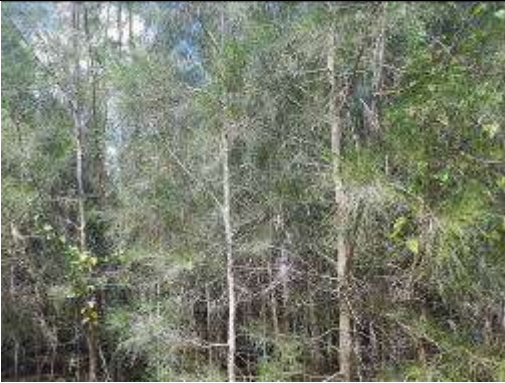
Monitoring month:	51	Months since direct seeding:	56
Date:	November 2019		
Comments:	Myrtle rust on melaleuca was minimal within the immediate area to this quadrat.		
Native species:	<i>Ludwigia octovalvis</i> , <i>Casuarina glauca</i> , <i>Juncus usitatus</i> , <i>Carex apressa</i> , <i>Cyperus exaltatus</i> , <i>Melaleuca quinquenervia</i>		
Weed species:	<i>Cynodon dactylon</i>		
Damage:	Nil		
Native dominance:	95%	Percentage vegetation cover:	100%
Photo:

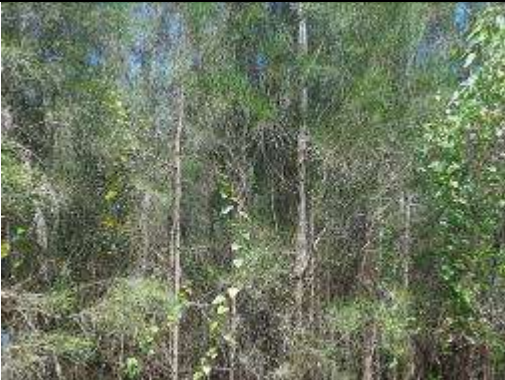
Monitoring month:	52	Months since direct seeding:	57
Date:	December 2019		
Comments:	Growth is steady.		
Native species:	<i>Ludwigia octovalvis</i> , <i>Casuarina glauca</i> , <i>Juncus usitatus</i> , <i>Carex apressa</i> , <i>Cyperus exaltatus</i> , <i>Melaleuca quinquenervia</i>		
Weed species:	<i>Cynodon dactylon</i>		
Damage:	Nil		
Native dominance:	95%	Percentage vegetation cover:	100%
Photo:

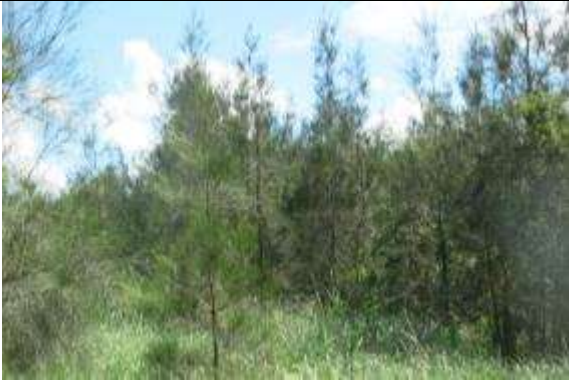
Monitoring month:	53	Months since direct seeding:	58
Date:	January 2020		
Comments:	Recent rain has assisted in the health of wetland understorey species.		
Native species:	<i>Ludwigia octovalvis</i> , <i>Casuarina glauca</i> , <i>Juncus usitatus</i> , <i>Carex apressa</i> , <i>Cyperus exaltatus</i> , <i>Melaleuca quinquenervia</i>		
Weed species:	<i>Cynodon dactylon</i>		
Damage:	Nil		
Native dominance:	95%	Percentage vegetation cover:	100%
Photo:

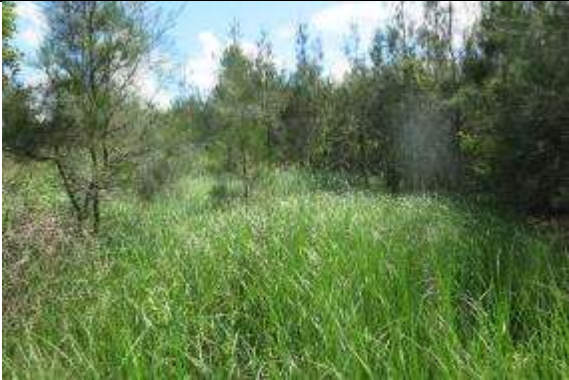
Monitoring month:	54	Months since direct seeding:	59
Date:	February 2020		
Comments:	Wetland species are flourishing.		
Native species:	<i>Ludwigia octovalvis</i> , <i>Casuarina glauca</i> , <i>Juncus usitatus</i> , <i>Carex apressa</i> , <i>Cyperus exaltatus</i> , <i>Melaleuca quinquenervia</i>		
Weed species:	<i>Cynodon dactylon</i>		
Damage:	Nil		
Native dominance:	95%	Percentage vegetation cover:	100%
Photo:

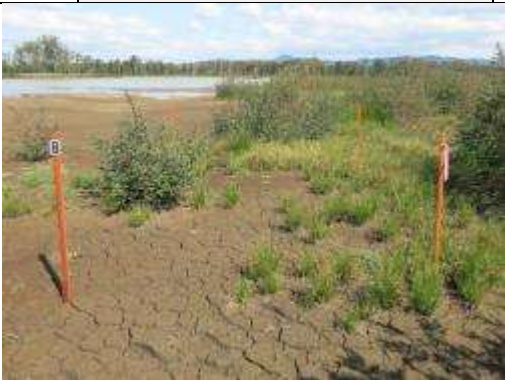
Monitoring month:	1	Months since direct seeding:	6
Date:	September 2015		
Comments:	This is a typical example of an ephemeral clay pan wetland. Water has receded now for approximately 1 month. Clay crust has formed with moist soil material below the crust. Weeds are not present.		
Native species:	<i>Ludwigia octovalvis</i> , <i>Juncus prismatacarpa</i> , <i>Fimbristylis ferruginea</i>		
Weed species:	<i>Cynodon dactylon</i>		
Damage:	Nil		
Native dominance:	100%	Percentage vegetation cover:	30%
Photo:

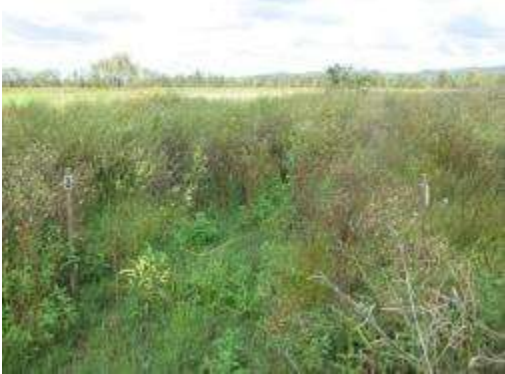
Monitoring month:	7	Months since direct seeding:	12
Date:	March 2016		
Comments:	This area has developed well in the last 8 month period. There are significant numbers of canopy trees in the surrounding area. <i>Capillipedium spiciergum</i> is seeding prolifically in this area.		
Native species:	<i>Ludwigia octovalvis</i> , <i>Juncus prismatacarpa</i> , <i>Fimbristylis ferruginea</i> , <i>Cyperus polystachyos</i> , <i>Juncus usitatus</i> , <i>Persicaria sp.</i>		
Weed species:	<i>Cuphea carthagenesis</i> , <i>Aster subulatus</i> , <i>Cynodon dactylon</i>		
Damage:	Nil		
Native dominance:	66%	Percentage vegetation cover:	100%
Photo:

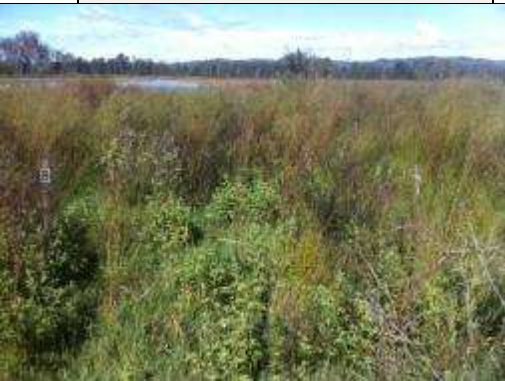
Monitoring month:	8	Months since direct seeding:	13
Date:	April 2016		
Comments:	There are significant numbers of canopy trees in the surrounding area. <i>Capillipedium spiciergum</i> is seeding prolifically in this area.		
Native species:	<i>Ludwigia octovalvis</i> , <i>Juncus prismatacarpa</i> , <i>Fimbristylis ferruginea</i> , <i>Cyperus polystachyos</i> , <i>Juncus usitatus</i> , <i>Persicaria sp.</i>		
Weed species:	<i>Cuphea carthagenesis</i> , <i>Aster subulatus</i> , <i>Cynodon dactylon</i>		
Damage:	Nil		
Native dominance:	66%	Percentage vegetation cover:	100%
Photo:

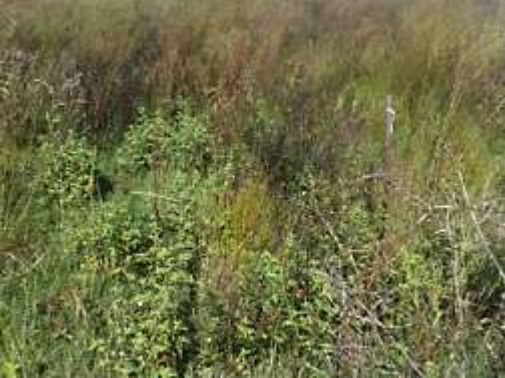
Monitoring month:	9	Months since direct seeding:	14
Date:	May 2016		
Comments:	Sedges and rushes continue to perform well within this quadrat. There has been no change in native dominance.		
Native species:	<i>Ludwigia octovalvis</i> , <i>Juncus prismatacarpa</i> , <i>Fimbristylis ferruginea</i> , <i>Cyperus polystachyos</i> , <i>Juncus usitatus</i> , <i>Persicaria sp.</i>		
Weed species:	<i>Cuphea carthagenesis</i> , <i>Aster subulatus</i> , <i>Cynodon dactylon</i>		
Damage:	Nil		
Native dominance:	66%	Percentage vegetation cover:	100%
Photo:

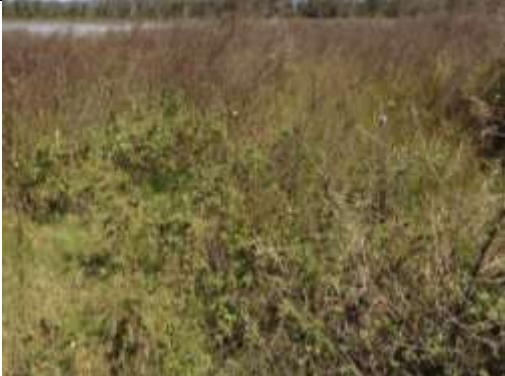
Monitoring month:	10	Months since direct seeding:	15
Date:	June 2016		
Comments:	Aster is commencing winter dormancy, however not significant enough to alter the native dominance. Minimal growth is anticipated over this period.		
Native species:	<i>Ludwigia octovalvis</i> , <i>Juncus prismatacarpa</i> , <i>Fimbristylis ferruginea</i> , <i>Cyperus polystachyos</i> , <i>Juncus usitatus</i> , <i>Persicaria sp.</i>		
Weed species:	<i>Cuphea carthagenesis</i> , <i>Aster subulatus</i> , <i>Cynodon dactylon</i>		
Damage:	Nil		
Native dominance:	66%	Percentage vegetation cover:	100%
Photo:

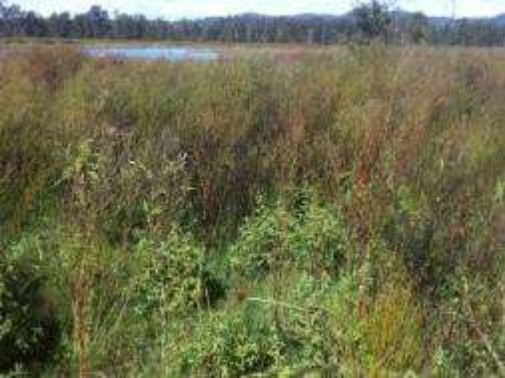
Monitoring month:	11	Months since direct seeding:	16
Date:	July 2016		
Comments:	No significant change has been recorded this month.		
Native species:	<i>Ludwigia octovalvis</i> , <i>Juncus prismatacarpa</i> , <i>Fimbristylis ferruginea</i> , <i>Cyperus polystachyos</i> , <i>Juncus usitatus</i> , <i>Persicaria sp.</i>		
Weed species:	<i>Cuphea carthagenesis</i> , <i>Aster subulatus</i> , <i>Cynodon dactylon</i>		
Damage:	Nil		
Native dominance:	66%	Percentage vegetation cover:	100%
Photo:

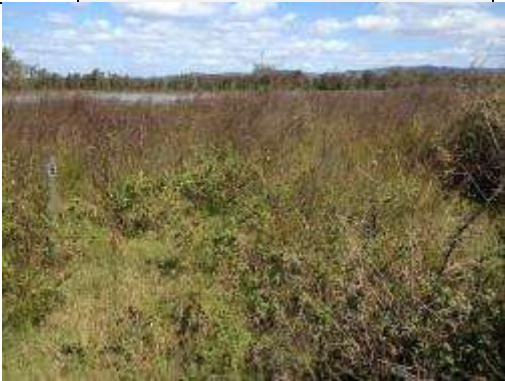
Monitoring month:	12	Months since direct seeding:	17
Date:	August 2016		
Comments:	This quadrat still remains relatively weed free. The first canopy tree within the quadrat was recorded this month, indicating canopy trees are still emerging.		
Native species:	<i>Ludwigia octovalvis</i> , <i>Juncus prismatacarpa</i> , <i>Fimbristylis ferruginea</i> , <i>Cyperus polystachyos</i> , <i>Juncus usitatus</i> , <i>Persicaria sp.</i> , <i>Casuarina glauca</i>		
Weed species:	<i>Cuphea carthagenesis</i> , <i>Aster subulatus</i> , <i>Cynodon dactylon</i>		
Damage:	Nil		
Native dominance:	66%	Percentage vegetation cover:	100%
Photo:

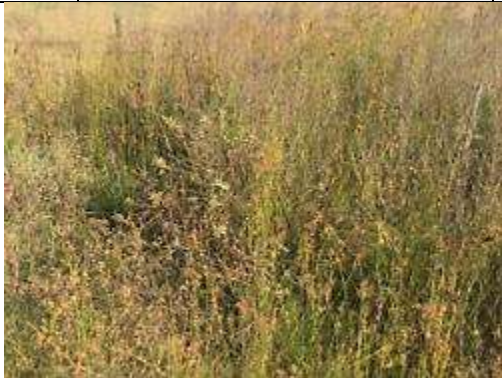
Monitoring month:	13	Months since direct seeding:	18
Date:	September 2016		
Comments:	With the increase of temperatures, <i>Juncus</i> and rushes have grown significantly. This has increased the native dominance within this quadrat.		
Native species:	<i>Ludwigia octovalvis</i> , <i>Juncus prismatacarpa</i> , <i>Fimbristylis ferruginea</i> , <i>Cyperus polystachyos</i> , <i>Juncus usitatus</i> , <i>Persicaria sp.</i> , <i>Casuarina glauca</i>		
Weed species:	<i>Cuphea carthagenesis</i> , <i>Aster subulatus</i> , <i>Cynodon dactylon</i>		
Damage:	Nil		
Native dominance:	70%	Percentage vegetation cover:	100%
Photo:

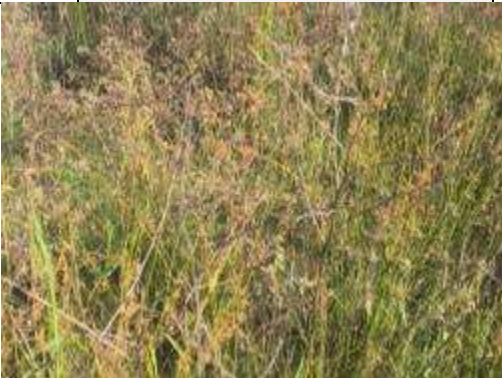
Monitoring month:	14	Months since direct seeding:	19
Date:	October 2016		
Comments:	No significant change recorded for this month.		
Native species:	<i>Ludwigia octovalvis</i> , <i>Juncus prismatacarpa</i> , <i>Fimbristylis ferruginea</i> , <i>Cyperus polystachyos</i> , <i>Juncus usitatus</i> , <i>Persicaria sp.</i> , <i>Casuarina glauca</i>		
Weed species:	<i>Cuphea carthagenesis</i> , <i>Aster subulatus</i> , <i>Cynodon dactylon</i>		
Damage:	Nil		
Native dominance:	70%	Percentage vegetation cover:	100%
Photo:

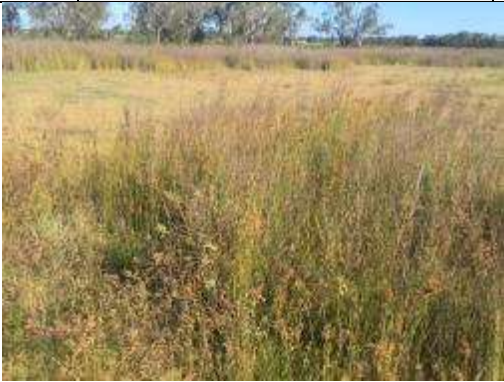
Monitoring month:	15	Months since direct seeding:	20
Date:	November 2016		
Comments:	Wetland species, such as <i>Juncus</i> , have continued to remain healthy. No significant changes have been recorded.		
Native species:	<i>Ludwigia octovalvis</i> , <i>Juncus prismatacarpa</i> , <i>Fimbristylis ferruginea</i> , <i>Cyperus polystachyos</i> , <i>Juncus usitatus</i> , <i>Persicaria sp.</i> , <i>Casuarina glauca</i>		
Weed species:	<i>Cuphea carthagenesis</i> , <i>Aster subulatus</i> , <i>Cynodon dactylon</i>		
Damage:	Nil		
Native dominance:	70%	Percentage vegetation cover:	100%
Photo:

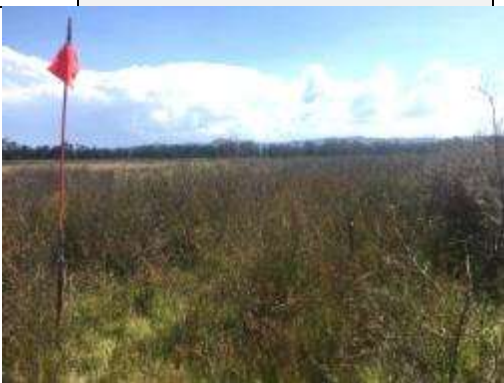
Monitoring month:	16	Months since direct seeding:	21
Date:	December 2016		
Comments:	A high visibility flag and extended pole was added to the quadrat stake this month for ease of identification. Wetland species, such as <i>Juncus</i> , have continued to remain healthy.		
Native species:	<i>Ludwigia octovalvis</i> , <i>Juncus prismatacarpa</i> , <i>Fimbristylis ferruginea</i> , <i>Cyperus polystachyos</i> , <i>Juncus usitatus</i> , <i>Persicaria sp.</i> , <i>Casuarina glauca</i>		
Weed species:	<i>Cuphea carthagenesis</i> , <i>Aster subulatus</i> , <i>Cynodon dactylon</i>		
Damage:	Nil		
Native dominance:	70%	Percentage vegetation cover:	100%
Photo:

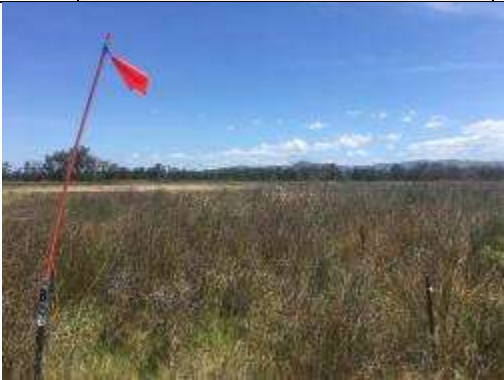
Monitoring month:	17	Months since direct seeding:	22
Date:	January 2017		
Comments:	Wetland species, such as <i>Juncus</i> , have continued to remain healthy. <i>Casuarinas</i> average approximately 1.2m in height. <i>Cynodon dactylon</i> continues to dominate.		
Native species:	<i>Ludwigia octovalvis</i> , <i>Juncus prismatacarpa</i> , <i>Fimbristylis ferruginea</i> , <i>Cyperus polystachyos</i> , <i>Juncus usitatus</i> , <i>Persicaria sp.</i> , <i>Casuarina glauca</i>		
Weed species:	<i>Cuphea carthagenesis</i> , <i>Aster subulatus</i> , <i>Cynodon dactylon</i>		
Damage:	Nil		
Native dominance:	65%	Percentage vegetation cover:	100%
Photo:

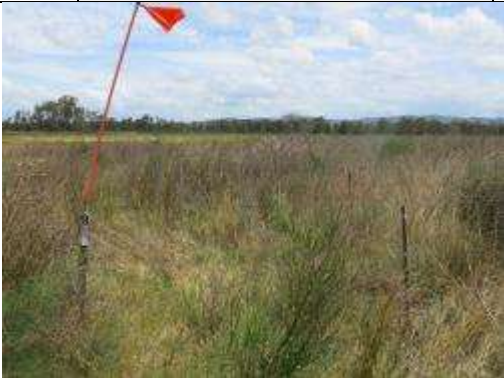
Monitoring month:	18	Months since direct seeding:	23
Date:	February 2017		
Comments:	There are no significant changes to this quadrat this month.		
Native species:	<i>Ludwigia octovalvis</i> , <i>Juncus prismatacarpa</i> , <i>Fimbristylis ferruginea</i> , <i>Cyperus polystachyos</i> , <i>Juncus usitatus</i> , <i>Persicaria sp.</i> , <i>Casuarina glauca</i>		
Weed species:	<i>Cuphea carthagenesis</i> , <i>Aster subulatus</i> , <i>Cynodon dactylon</i>		
Damage:	Yes - evidence of tyre tracks through quadrat. It is anticipated that this quadrat will recover quickly from this disturbance.		
Native dominance:	70%	Percentage vegetation cover:	100%
Photo:
