North-West Conservation Park - Rehabilitation Monitoring

Lot 1 RP48903

North-West Conservation Park
Gainsborough Greens

March 2020

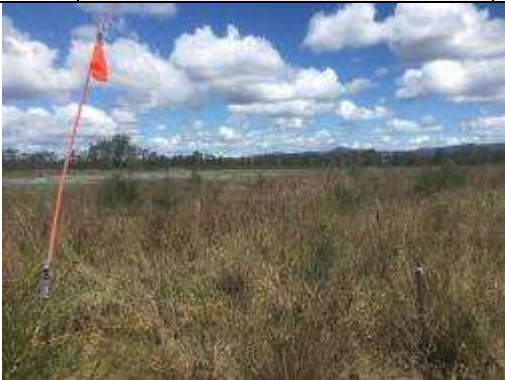
Photo:

Monitoring month:	19	Months since direct seeding:	24
Date:	March 2017 (NB: monitoring event occurred early April due to inaccessibility)		
Comments:	During the last half of this month, the NWCP received significant rainfall. Access to the area was limited. Much of the area is waterlogged (approximately 8cm of water covering quadrat) and functioning as the wetland it is designed to be. Casuarinas up to approximately 1.5m in height.		
Native species:	<i>Ludwigia octovalvis</i> , <i>Juncus prismatacarpa</i> , <i>Fimbristylis ferruginea</i> , <i>Cyperus polystachyos</i> , <i>Juncus usitatus</i> , <i>Persicaria sp.</i> , <i>Casuarina glauca</i>		
Weed species:	<i>Cuphea carthagenesis</i> , <i>Aster subulatus</i> , <i>Cynodon dactylon</i>		
Damage:	Nil - large weather event associated with Ex-Tropical Cyclone Debbie did not result in any damage. Recovering well from tyre track disturbance.		
Native dominance:	70%	Percentage vegetation cover:	100%

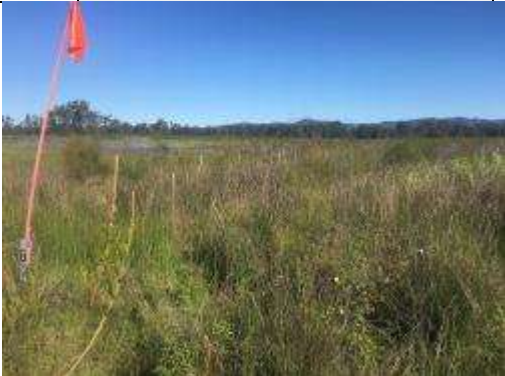
Monitoring month:	20	Months since direct seeding:	25
Date:	April 2017		
Comments:	Much of the area is still waterlogged and functioning as the wetland it is designed to be.		
Native species:	<i>Ludwigia octovalvis</i> , <i>Juncus prismatacarpa</i> , <i>Fimbristylis ferruginea</i> , <i>Cyperus polystachyos</i> , <i>Juncus usitatus</i> , <i>Persicaria sp.</i> , <i>Casuarina glauca</i>		
Weed species:	<i>Cuphea carthagenesis</i> , <i>Aster subulatus</i> , <i>Cynodon dactylon</i>		
Damage:	Nil		
Native dominance:	70%	Percentage vegetation cover:	100%
Photo:

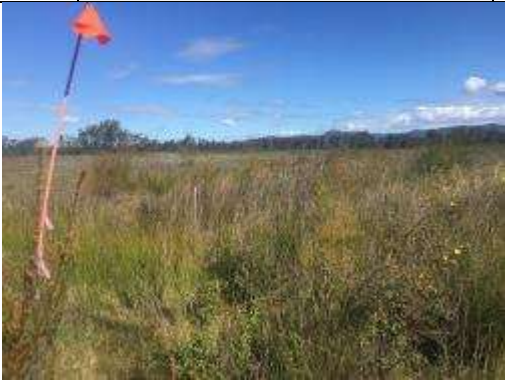
Monitoring month:	21	Months since direct seeding:	26
Date:	May 2017		
Comments:	Quadrat still dominated by sedges and groundcovers. Casuarinas up to approximately 1.5m in height.		
Native species:	<i>Ludwigia octovalvis</i> , <i>Juncus prismatacarpa</i> , <i>Fimbristylis ferruginea</i> , <i>Cyperus polystachyos</i> , <i>Juncus usitatus</i> , <i>Persicaria sp.</i> , <i>Casuarina glauca</i>		
Weed species:	<i>Cuphea carthagenesis</i> , <i>Aster subulatus</i> , <i>Cynodon dactylon</i>		
Damage:	Nil		
Native dominance:	70%	Percentage vegetation cover:	100%
Photo:

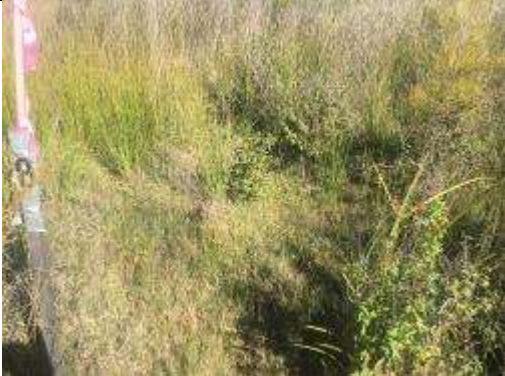
Monitoring month:	22	Months since direct seeding:	27
Date:	June 2017		
Comments:	No significant changes this month. It is anticipated growth will slow moving into the colder months.		
Native species:	<i>Ludwigia octovalvis</i> , <i>Juncus prismatacarpa</i> , <i>Fimbristylis ferruginea</i> , <i>Cyperus polystachyos</i> , <i>Juncus usitatus</i> , <i>Persicaria sp.</i> , <i>Casuarina glauca</i>		
Weed species:	<i>Cuphea carthagenesis</i> , <i>Aster subulatus</i> , <i>Cynodon dactylon</i>		
Damage:	Nil		
Native dominance:	70%	Percentage vegetation cover:	100%
Photo:

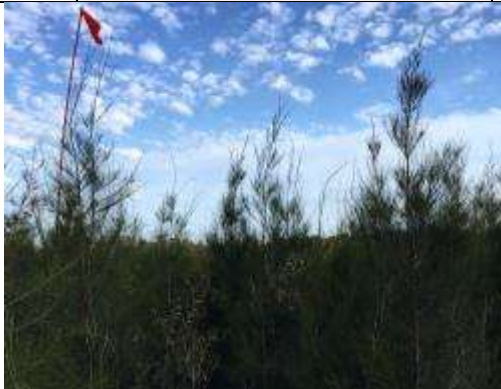
Monitoring month:	23	Months since direct seeding:	28
Date:	July 2017		
Comments:	An additional length of conduit was added to the flagging pole this month due to the increasing height of vegetation. Vegetation health is steady.		
Native species:	<i>Ludwigia octovalvis</i> , <i>Juncus prismatacarpa</i> , <i>Fimbristylis ferruginea</i> , <i>Cyperus polystachyos</i> , <i>Juncus usitatus</i> , <i>Persicaria sp.</i> , <i>Casuarina glauca</i>		
Weed species:	<i>Cuphea carthagenesis</i> , <i>Aster subulatus</i> , <i>Cynodon dactylon</i>		
Damage:	Nil		
Native dominance:	70%	Percentage vegetation cover:	100%
Photo:

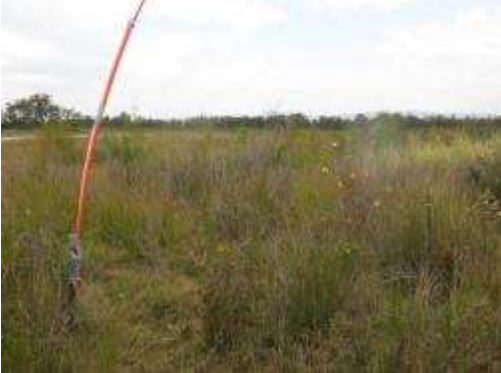
Monitoring month:	24	Months since direct seeding:	29
Date:	August 2017		
Comments:	Quadrat remains stable.		
Native species:	<i>Ludwigia octovalvis</i> , <i>Juncus prismatacarpa</i> , <i>Fimbristylis ferruginea</i> , <i>Cyperus polystachyos</i> , <i>Juncus usitatus</i> , <i>Persicaria sp.</i> , <i>Casuarina glauca</i>		
Weed species:	<i>Cuphea carthagenesis</i> , <i>Aster subulatus</i> , <i>Cynodon dactylon</i>		
Damage:	Nil		
Native dominance:	70%	Percentage vegetation cover:	100%
Photo:

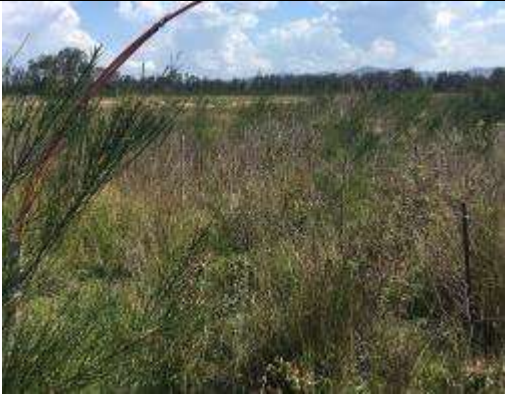
Monitoring month:	25	Months since direct seeding:	30
Date:	September 2017		
Comments:	Vegetation growth is steady.		
Native species:	<i>Ludwigia octovalvis</i> , <i>Juncus prismatacarpa</i> , <i>Fimbristylis ferruginea</i> , <i>Cyperus polystachyos</i> , <i>Juncus usitatus</i> , <i>Persicaria sp.</i> , <i>Casuarina glauca</i>		
Weed species:	<i>Cuphea carthagenesis</i> , <i>Aster subulatus</i> , <i>Cynodon dactylon</i>		
Damage:	Nil		
Native dominance:	70%	Percentage vegetation cover:	100%
Photo:

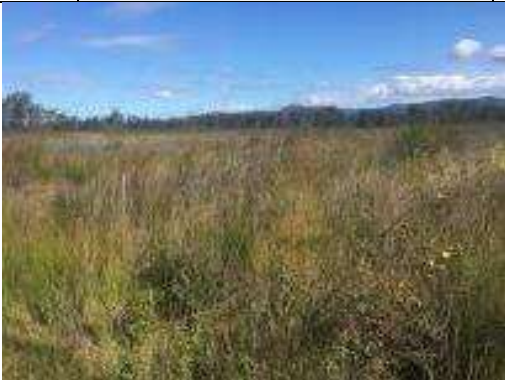
Monitoring month:	26	Months since direct seeding:	31
Date:	October 2017		
Comments:	No significant changes this month.		
Native species:	<i>Ludwigia octovalvis</i> , <i>Juncus prismatacarpa</i> , <i>Fimbristylis ferruginea</i> , <i>Cyperus polystachyos</i> , <i>Juncus usitatus</i> , <i>Persicaria sp.</i> , <i>Casuarina glauca</i>		
Weed species:	<i>Cuphea carthagenesis</i> , <i>Aster subulatus</i> , <i>Cynodon dactylon</i>		
Damage:	Nil		
Native dominance:	70%	Percentage vegetation cover:	100%
Photo:

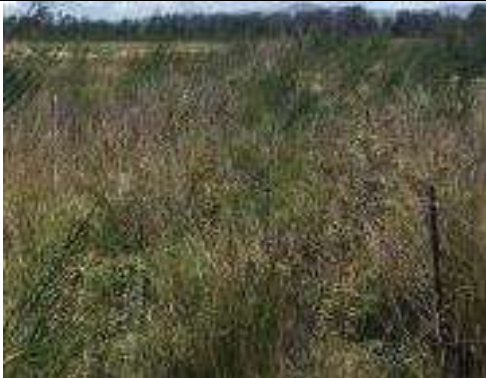
Monitoring month:	27	Months since direct seeding:	32
Date:	November 2017		
Comments:	Rainfall and increasing temperatures has boosted vegetative growth.		
Native species:	<i>Ludwigia octovalvis</i> , <i>Juncus prismatacarpa</i> , <i>Fimbristylis ferruginea</i> , <i>Cyperus polystachyos</i> , <i>Juncus usitatus</i> , <i>Persicaria sp.</i> , <i>Casuarina glauca</i>		
Weed species:	<i>Cuphea carthagenesis</i> , <i>Aster subulatus</i> , <i>Cynodon dactylon</i>		
Damage:	Nil		
Native dominance:	70%	Percentage vegetation cover:	100%
Photo:

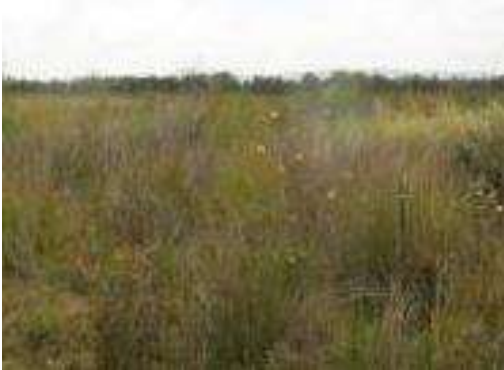
Monitoring month:	28	Months since direct seeding:	33
Date:	December 2017		
Comments:	Moderate rainfall has been received during this month, increasing waterlogging.		
Native species:	<i>Ludwigia octovalvis</i> , <i>Juncus prismatacarpa</i> , <i>Fimbristylis ferruginea</i> , <i>Cyperus polystachyos</i> , <i>Juncus usitatus</i> , <i>Persicaria sp.</i> , <i>Casuarina glauca</i>		
Weed species:	<i>Cuphea carthagenesis</i> , <i>Aster subulatus</i> , <i>Cynodon dactylon</i>		
Damage:	Nil		
Native dominance:	75%	Percentage vegetation cover:	100%
Photo:

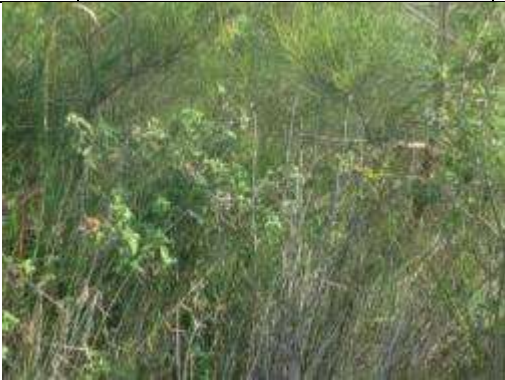
Monitoring month:	29	Months since direct seeding:	34
Date:	January 2018		
Comments:	Casuarina seedlings are now clearly evident over the tops of rushes/sedges this month and are now growing rapidly		
Native species:	<i>Ludwigia octovalvis</i> , <i>Juncus prismatacarpa</i> , <i>Fimbristylis ferruginea</i> , <i>Cyperus polystachyos</i> , <i>Juncus usitatus</i> , <i>Persicaria sp.</i> , <i>Casuarina glauca</i>		
Weed species:	<i>Cuphea carthagenesis</i> , <i>Aster subulatus</i> , <i>Cynodon dactylon</i>		
Damage:	Nil		
Native dominance:	75%	Percentage vegetation cover:	100%
Photo:

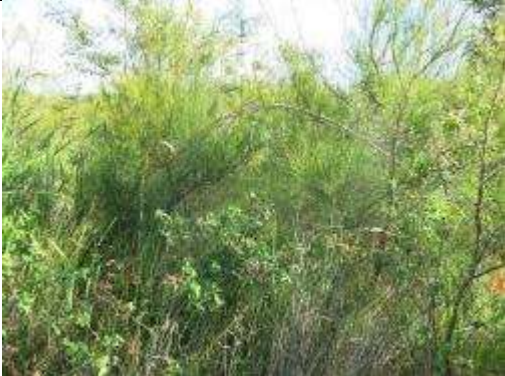
Monitoring month:	30	Months since direct seeding:	35
Date:	February 2018		
Comments:	Casuarina canopy is continuing to form and shade out weed species. Aster not present within this quadrat this month.		
Native species:	<i>Ludwigia octovalvis</i> , <i>Juncus prismatacarpa</i> , <i>Fimbristylis ferruginea</i> , <i>Cyperus polystachyos</i> , <i>Juncus usitatus</i> , <i>Persicaria sp.</i> , <i>Casuarina glauca</i>		
Weed species:	<i>Cuphea carthagenesis</i> , <i>Cynodon dactylon</i>		
Damage:	Nil		
Native dominance:	85%	Percentage vegetation cover:	100%
Photo:

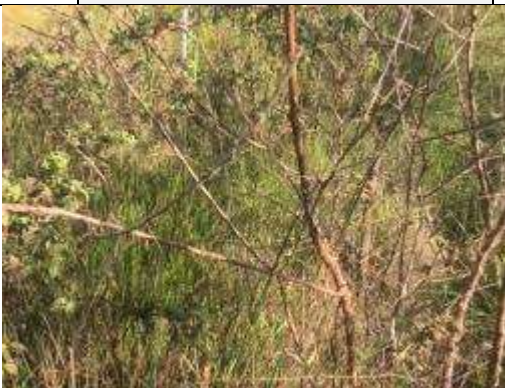
Monitoring month:	32	Months since direct seeding:	37
Date:	April 2018		
Comments:	Native plant growth and biomass continues to increase.		
Native species:	<i>Ludwigia octovalvis</i> , <i>Juncus prismatacarpa</i> , <i>Fimbristylis ferruginea</i> , <i>Cyperus polystachyos</i> , <i>Juncus usitatus</i> , <i>Persicaria sp.</i> , <i>Casuarina glauca</i> , <i>Carex appressa</i> , <i>Leersia hexandra</i> , <i>Cyperus exaltatus</i>		
Weed species:	<i>Cuphea carthagenesis</i> , <i>Cynodon dactylon</i>		
Damage:	Nil		
Native dominance:	85%	Percentage vegetation cover:	100%
Photo:

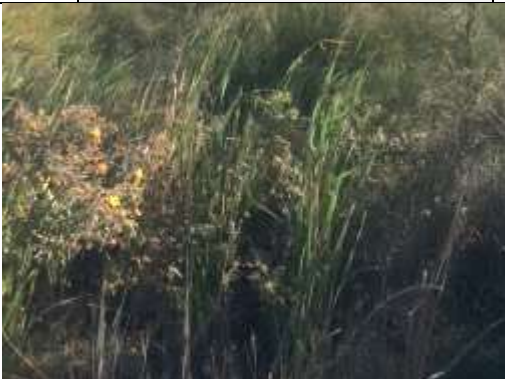
Monitoring month:	33	Months since direct seeding:	38
Date:	May 2018		
Comments:	Casuarina canopy is continuing to form and shade out weed species.		
Native species:	<i>Ludwigia octovalvis</i> , <i>Juncus prismatacarpa</i> , <i>Fimbristylis ferruginea</i> , <i>Cyperus polystachyos</i> , <i>Juncus usitatus</i> , <i>Persicaria sp.</i> , <i>Casuarina glauca</i> , <i>Carex appressa</i> , <i>Leersia hexandra</i> , <i>Cyperus exaltatus</i>		
Weed species:	<i>Cuphea carthagenesis</i> , <i>Cynodon dactylon</i>		
Damage:	Nil		
Native dominance:	85%	Percentage vegetation cover:	100%
Photo:

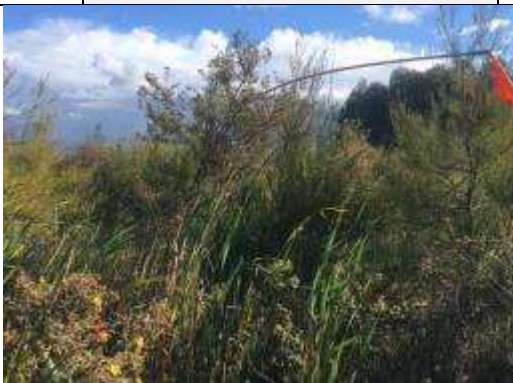
Monitoring month:	34	Months since direct seeding:	39
Date:	June 2018		
Comments:	No significant changes this month due to the slowing down of the growing season.		
Native species:	<i>Ludwigia octovalvis</i> , <i>Juncus prismatacarpa</i> , <i>Fimbristylis ferruginea</i> , <i>Cyperus polystachyos</i> , <i>Juncus usitatus</i> , <i>Persicaria sp.</i> , <i>Casuarina glauca</i> , <i>Carex appressa</i> , <i>Leersia hexandra</i> , <i>Cyperus exaltatus</i>		
Weed species:	<i>Cuphea carthagenesis</i> , <i>Cynodon dactylon</i>		
Damage:	Nil		
Native dominance:	85%	Percentage vegetation cover:	100%
Photo:

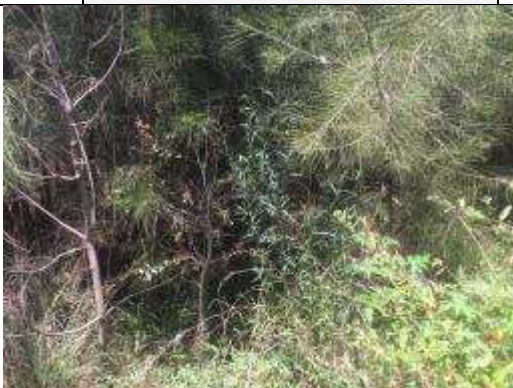
Monitoring month:	35	Months since direct seeding:	40
Date:	July 2018		
Comments:	Some native species have dropped out of this quadrat due to a combination of competition and winter; however native abundance is increasing despite the decline in diversity.		
Native species:	<i>Ludwigia octovalvis</i> , <i>Fimbristylis ferruginea</i> , , <i>Juncus usitatus</i> , <i>Persicaria sp.</i> , <i>Casuarina glauca</i> , <i>Carex appressa</i> , <i>Cyperus exaltatus</i>		
Weed species:	<i>Cynodon dactylon</i>		
Damage:	Nil		
Native dominance:	90%	Percentage vegetation cover:	100%
Photo:

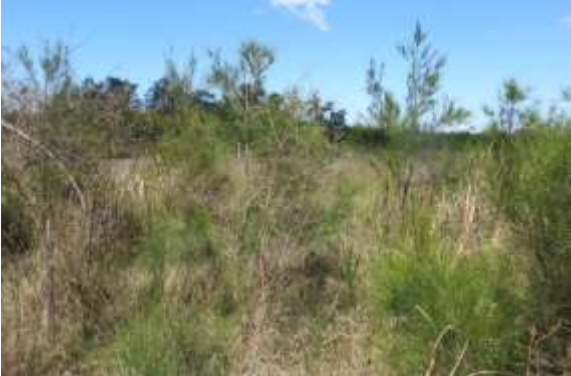
Monitoring month:	36	Months since direct seeding:	41
Date:	August 2018		
Comments:	Some additional native species have dropped out of this quadrat due to a combination of competition and winter; however native abundance is increase despite the decline in diversity.		
Native species:	<i>Fimbristylis ferruginea, Juncus usitatus, Casuarina glauca, Carex appressa</i>		
Weed species:	<i>Cynodon dactylon</i>		
Damage:	Nil		
Native dominance:	95%	Percentage vegetation cover:	100%
Photo:

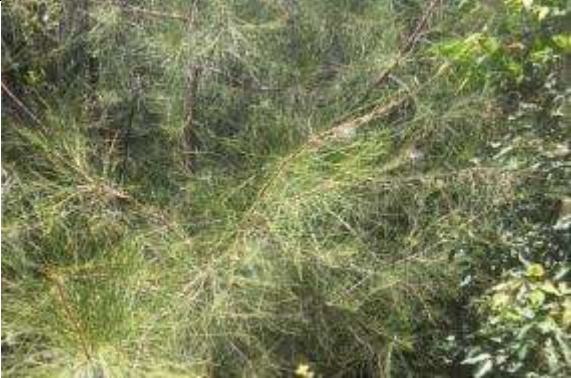
Monitoring month:	37	Months since direct seeding:	42
Date:	September 2018		
Comments:	Vegetation growth steady.		
Native species:	<i>Fimbristylis ferruginea, Juncus usitatus, Casuarina glauca, Carex appressa</i>		
Weed species:	<i>Cynodon dactylon</i>		
Damage:	Nil		
Native dominance:	95%	Percentage vegetation cover:	100%
Photo:

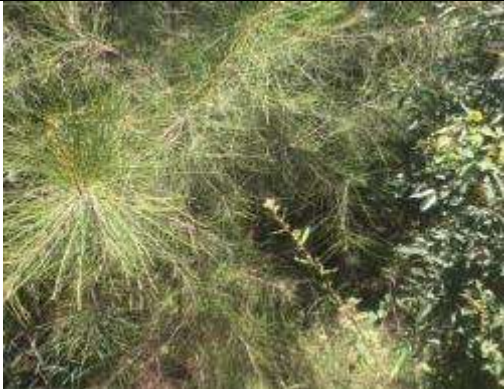
Monitoring month:	38	Months since direct seeding:	43
Date:	October 2018		
Comments:	Rainfall occurred throughout the area during this month which has assisted with the increase in biomass.		
Native species:	<i>Fimbristylis ferruginea, Juncus usitatus, Casuarina glauca, Carex appressa</i>		
Weed species:	<i>Cynodon dactylon</i>		
Damage:	Nil		
Native dominance:	95%	Percentage vegetation cover:	100%
Photo:

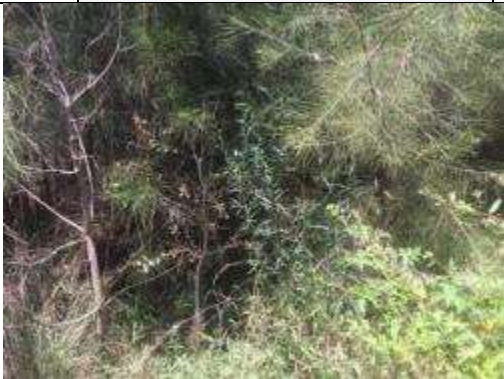
Monitoring month:	39	Months since direct seeding:	44
Date:	November 2018		
Comments:	Rapidly increasing temperatures were experienced this month resulting in the exponential growth of vegetation.		
Native species:	<i>Fimbristylis ferruginea, Juncus usitatus, Casuarina glauca, Carex appressa</i>		
Weed species:	<i>Cynodon dactylon</i>		
Damage:	Nil		
Native dominance:	95%	Percentage vegetation cover:	100%
Photo:

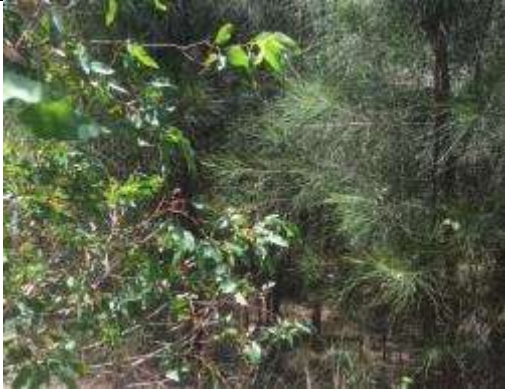
Monitoring month:	40	Months since direct seeding:	45
Date:	December 2018		
Comments:	Vegetation growth was steady this month.		
Native species:	<i>Fimbristylis ferruginea</i> , <i>Juncus usitatus</i> , <i>Casuarina glauca</i> , <i>Carex appressa</i>		
Weed species:	<i>Cynodon dactylon</i>		
Damage:	Nil		
Native dominance:	95%	Percentage vegetation cover:	100%
Photo:

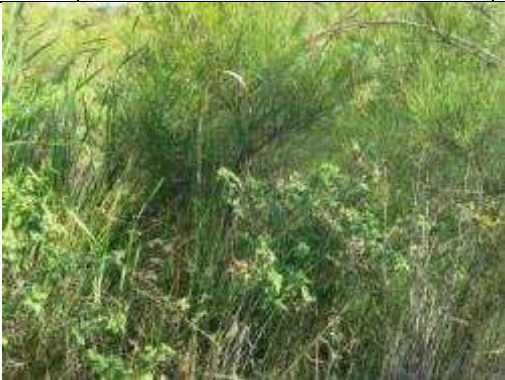
Monitoring month:	41	Months since direct seeding:	46
Date:	January 2019		
Comments:	Biomass continues to increase.		
Native species:	<i>Fimbristylis ferruginea</i> , <i>Juncus usitatus</i> , <i>Casuarina glauca</i> , <i>Carex appressa</i>		
Weed species:	<i>Cynodon dactylon</i>		
Damage:	Nil		
Native dominance:	95%	Percentage vegetation cover:	100%
Photo:

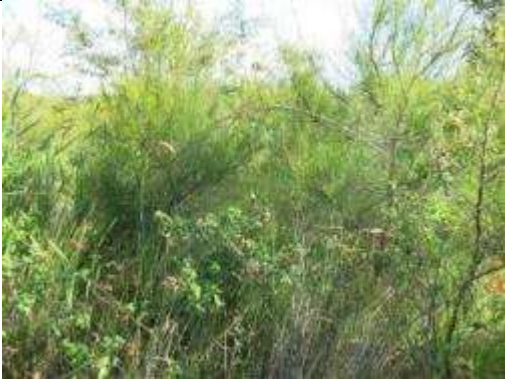
Monitoring month:	42	Months since direct seeding:	47
Date:	February 2019		
Comments:	Vegetation growth was steady this month.		
Native species:	<i>Fimbristylis ferruginea</i> , <i>Juncus usitatus</i> , <i>Casuarina glauca</i> , <i>Carex appressa</i>		
Weed species:	<i>Cynodon dactylon</i>		
Damage:	Nil		
Native dominance:	95%	Percentage vegetation cover:	100%
Photo:

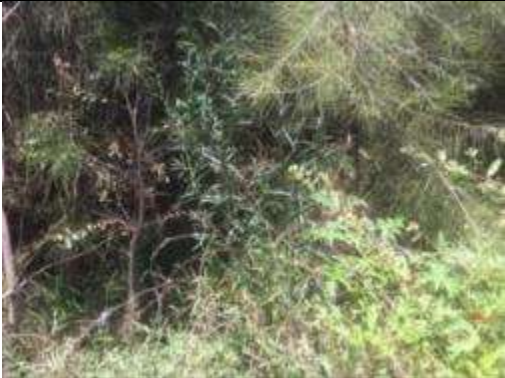
Monitoring month:	43	Months since direct seeding:	48
Date:	March 2019		
Comments:	No significant changes this month.		
Native species:	<i>Fimbristylis ferruginea</i> , <i>Juncus usitatus</i> , <i>Casuarina glauca</i> , <i>Carex appressa</i>		
Weed species:	<i>Cynodon dactylon</i>		
Damage:	Nil		
Native dominance:	95%	Percentage vegetation cover:	100%
Photo:

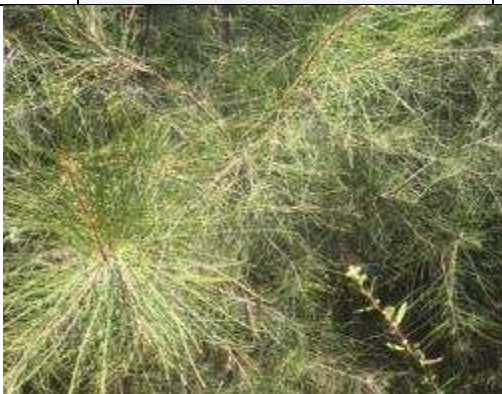
Monitoring month:	44	Months since direct seeding:	49
Date:	April 2019		
Comments:	Rainfall events increased late last month and continued this month giving the NWCP a much needed watering.		
Native species:	<i>Fimbristylis ferruginea</i> , <i>Juncus usitatus</i> , <i>Casuarina glauca</i> , <i>Carex appressa</i>		
Weed species:	<i>Cynodon dactylon</i>		
Damage:	Nil		
Native dominance:	95%	Percentage vegetation cover:	100%
Photo:

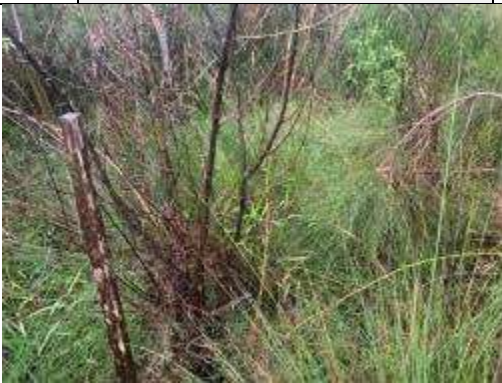
Monitoring month:	45	Months since direct seeding:	50
Date:	May 2019		
Comments:	<i>Casuarina glauca</i> continues to add biomass.		
Native species:	<i>Fimbristylis ferruginea</i> , <i>Juncus usitatus</i> , <i>Casuarina glauca</i> , <i>Carex appressa</i>		
Weed species:	<i>Cynodon dactylon</i>		
Damage:	Nil		
Native dominance:	95%	Percentage vegetation cover:	100%
Photo:

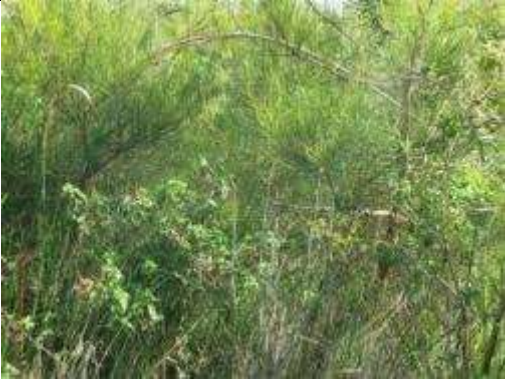
Monitoring month:	46	Months since direct seeding:	51
Date:	June 2019		
Comments:	Rainfall over the past few months has increased plant growth and vigour.		
Native species:	<i>Fimbristylis ferruginea</i> , <i>Juncus usitatus</i> , <i>Casuarina glauca</i> , <i>Carex appressa</i>		
Weed species:	<i>Cynodon dactylon</i>		
Damage:	Nil		
Native dominance:	95%	Percentage vegetation cover:	100%
Photo:

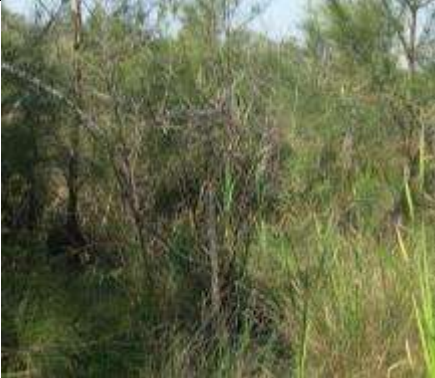
Monitoring month:	47	Months since direct seeding:	52
Date:	July 2019		
Comments:	Growth of casuarina biomass continues to suppress the growth of less prolific groundcover species.		
Native species:	<i>Juncus usitatus</i> , <i>Casuarina glauca</i> , <i>Carex appressa</i>		
Weed species:	<i>Cynodon dactylon</i>		
Damage:	Nil		
Native dominance:	95%	Percentage vegetation cover:	100%
Photo:

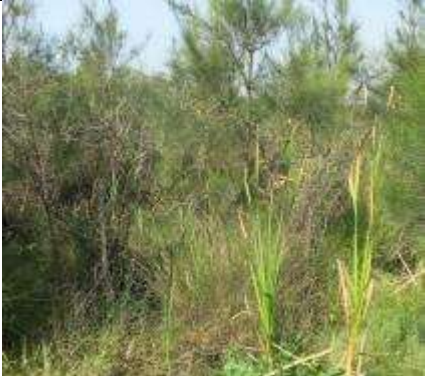
Monitoring month:	48	Months since direct seeding:	53
Date:	August 2019		
Comments:	Vegetation continues to mature.		
Native species:	<i>Juncus usitatus</i> , <i>Casuarina glauca</i> , <i>Carex appressa</i>		
Weed species:	<i>Cynodon dactylon</i>		
Damage:	Nil		
Native dominance:	95%	Percentage vegetation cover:	100%
Photo:

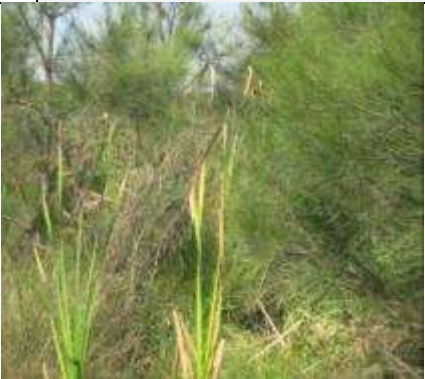
Monitoring month:	49	Months since direct seeding:	54
Date:	September 2019		
Comments:	Allelopathic properties of the casuarina leaf litter is starting to result in a marginal decline in couch density.		
Native species:	<i>Juncus usitatus</i> , <i>Casuarina glauca</i> , <i>Carex appressa</i>		
Weed species:	<i>Cynodon dactylon</i>		
Damage:	Nil		
Native dominance:	95%	Percentage vegetation cover:	100%
Photo:

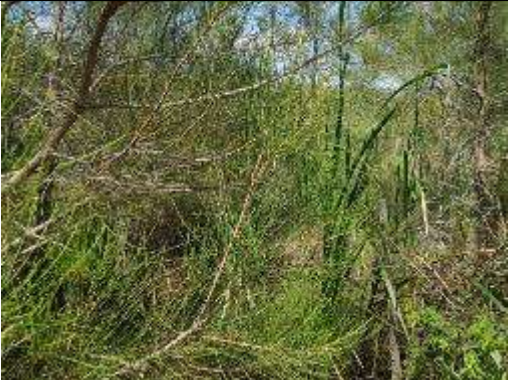
Monitoring month:	50	Months since direct seeding:	55
Date:	October 2019		
Comments:	Extended drought conditions are starting to take their toll with the extreme slowing of plant growth.		
Native species:	<i>Juncus usitatus, Casuarina glauca, Carex appressa</i>		
Weed species:	<i>Cynodon dactylon</i>		
Damage:	Nil		
Native dominance:	95%	Percentage vegetation cover:	100%
Photo:

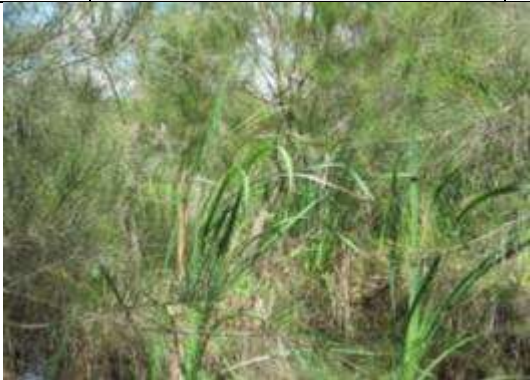
Monitoring month:	51	Months since direct seeding:	56
Date:	November 2019		
Comments:	No significant changes to report.		
Native species:	<i>Juncus usitatus, Casuarina glauca, Carex appressa</i>		
Weed species:	<i>Cynodon dactylon</i>		
Damage:	Nil		
Native dominance:	95%	Percentage vegetation cover:	100%
Photo:

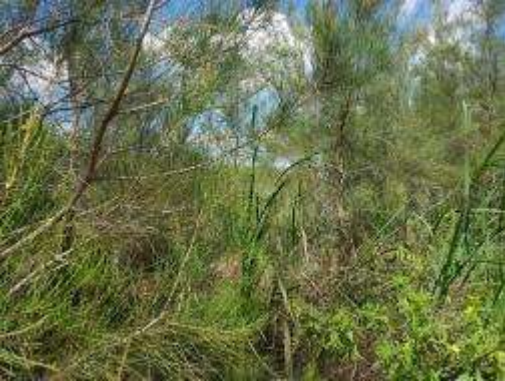
Monitoring month:	52	Months since direct seeding:	57
Date:	December 2019		
Comments:	Vegetation growth steady.		
Native species:	<i>Juncus usitatus, Casuarina glauca, Carex appressa</i>		
Weed species:	<i>Cynodon dactylon</i>		
Damage:	Nil		
Native dominance:	95%	Percentage vegetation cover:	100%
Photo:

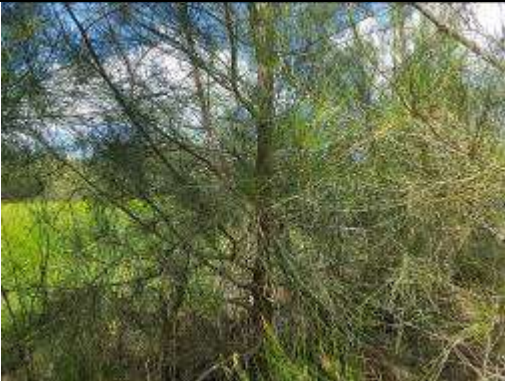
Monitoring month:	53	Months since direct seeding:	58
Date:	January 2020		
Comments:	Recent rain has assisted wetland plant health.		
Native species:	<i>Juncus usitatus, Casuarina glauca, Carex appressa</i>		
Weed species:	<i>Cynodon dactylon</i>		
Damage:	Nil		
Native dominance:	95%	Percentage vegetation cover:	100%
Photo:

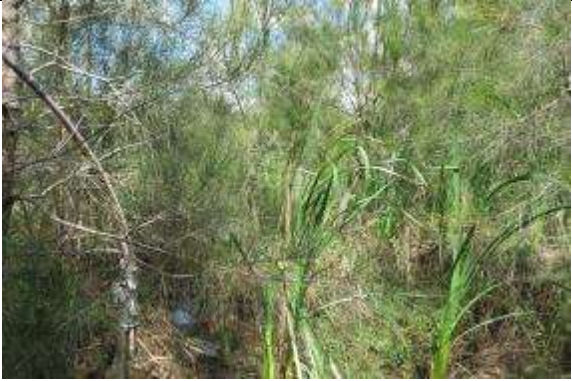
Monitoring month:	54	Months since direct seeding:	59
Date:	February 2020		
Comments:	Positive signs of maturation continue.		
Native species:	<i>Juncus usitatus, Casuarina glauca, Carex appressa</i>		
Weed species:	<i>Cynodon dactylon</i>		
Damage:	Nil		
Native dominance:	95%	Percentage vegetation cover:	100%
Photo:

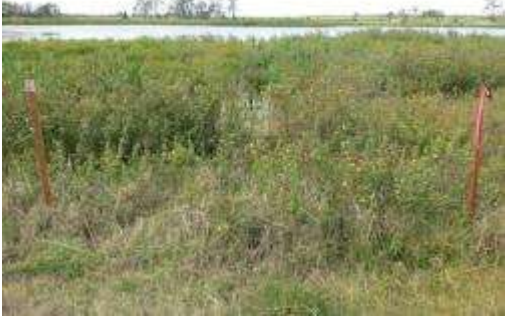
4.9 Quadrat 9

Monitoring month:	1	Months since direct seeding:	6
Date:	September 2015		
Comments:	This is an interesting quadrat due the drop in contour from the fore ground to the background. Although not easily seen in the photo, it highlights how water has limited weed growth at the lower contours, creating a specialist environment favouring the native sedges in comparison to the fore ground, where weed species are dominant.		
Native species:	<i>Ludwigia octovalvis</i> , <i>Juncus usitatus</i> , <i>Eleocharis dulcis</i> , <i>Persicaria decipiens</i> , <i>Cyperus polystachyos</i> , <i>Cyperus exaltatus</i> , <i>Typha orientalis</i>		
Weed species:	<i>Cuphea carthagenesis</i> , <i>Cynodon dactylon</i>		
Damage:	Nil		
Native dominance:	89%	Percentage vegetation cover:	50%
Photo:

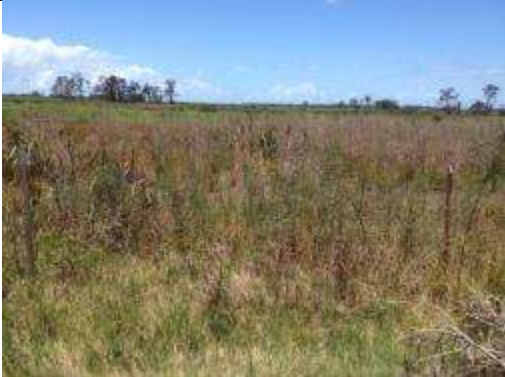
Monitoring month:	6	Months since direct seeding:	11
Date:	February 2016		
Comments:	There has been an increase in canopy species in this quadrat from one, to two species. This area will benefit well from the next inundation event and is clearly now suffering the effects of extended drying and lack of rain.		
Native species:	<i>Ludwigia octovalvis</i> , <i>Juncus usitatus</i> , <i>Eleocharis dulcis</i> , <i>Persicaria decipiens</i> , <i>Cyperus polystachyos</i> , <i>Cyperus exaltatus</i> , <i>Casuarina glauca</i> , <i>Melaleuca quinquenervia</i> , <i>Typha orientalis</i>		
Weed species:	<i>Cuphea carthagenesis</i> , <i>Aster subulatus</i> , <i>Cynodon dactylon</i>		
Damage:	Nil		
Native dominance:	66%	Percentage vegetation cover:	100%
Photo:

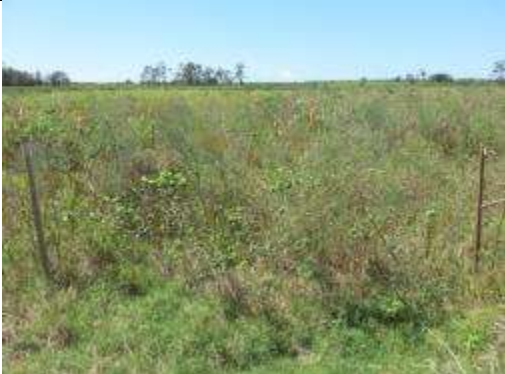
Monitoring month:	7	Months since direct seeding:	12
Date:	March 2016		
Comments:	Rain events over the past month have improved the health of this quadrat. Native dominance still remains strong.		
Native species:	<i>Ludwigia octovalvis</i> , <i>Juncus usitatus</i> , <i>Eleocharis dulcis</i> , <i>Persicaria decipiens</i> , <i>Persicaria attenuata</i> , <i>Cyperus polystachyos</i> , <i>Cyperus exaltatus</i> , <i>Casuarina glauca</i> , <i>Melaleuca quinquenervia</i> , <i>Typha orientalis</i>		
Weed species:	<i>Cuphea carthagenesis</i> , <i>Aster subulatus</i> , <i>Paspalum dilatatum</i> , <i>Cynodon dactylon</i>		
Damage:	Nil		
Native dominance:	71%	Percentage vegetation cover:	100%
Photo:

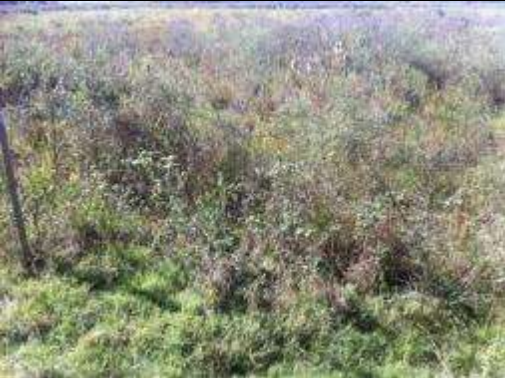
Monitoring month:	8	Months since direct seeding:	13
Date:	April 2016		
Comments:	Rain events over the past month have improved the health of this quadrat. Native dominance still remains strong.		
Native species:	<i>Ludwigia octovalvis</i> , <i>Juncus usitatus</i> , <i>Eleocharis dulcis</i> , <i>Persicaria decipiens</i> , <i>Persicaria attenuata</i> , <i>Cyperus polystachyos</i> , <i>Cyperus exaltatus</i> , <i>Casuarina glauca</i> , <i>Melaleuca quinquenervia</i> , <i>Typha orientalis</i>		
Weed species:	<i>Cuphea carthagenesis</i> , <i>Aster subulatus</i> , <i>Paspalum dilatatum</i> , <i>Cynodon dactylon</i>		
Damage:	Nil		
Native dominance:	71%	Percentage vegetation cover:	100%
Photo:

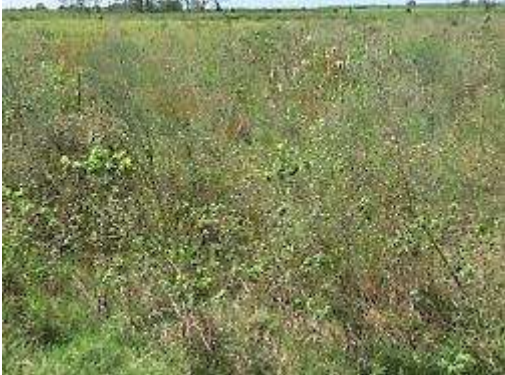
Monitoring month:	9	Months since direct seeding:	14
Date:	May 2016		
Comments:	Typha growth is slowly increasing. It is anticipated that this species will soon dominate this quadrat.		
Native species:	<i>Ludwigia octovalvis</i> , <i>Juncus usitatus</i> , <i>Eleocharis dulcis</i> , <i>Persicaria decipiens</i> , <i>Persicaria attenuata</i> , <i>Cyperus polystachyos</i> , <i>Cyperus exaltatus</i> , <i>Casuarina glauca</i> , <i>Melaleuca quinquenervia</i> , <i>Typha orientalis</i>		
Weed species:	<i>Cuphea carthagenesis</i> , <i>Aster subulatus</i> , <i>Paspalum dilatatum</i> , <i>Cynodon dactylon</i>		
Damage:	Nil		
Native dominance:	71%	Percentage vegetation cover:	100%
Photo:

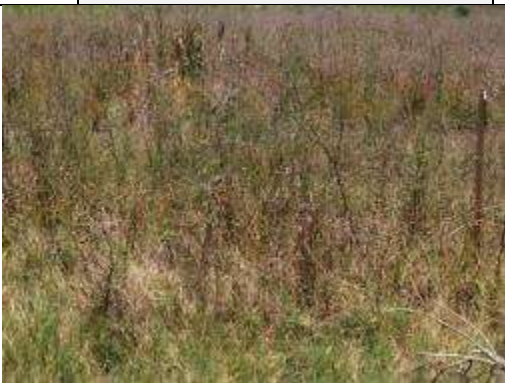
Monitoring month:	10	Months since direct seeding:	15
Date:	June 2016		
Comments:	Aster has started to die-off for the winter period.		
Native species:	<i>Ludwigia octovalvis</i> , <i>Juncus usitatus</i> , <i>Eleocharis dulcis</i> , <i>Persicaria decipiens</i> , <i>Persicaria attenuata</i> , <i>Cyperus polystachyos</i> , <i>Cyperus exaltatus</i> , <i>Casuarina glauca</i> , <i>Melaleuca quinquenervia</i> , <i>Typha orientalis</i>		
Weed species:	<i>Cuphea carthagenesis</i> , <i>Aster subulatus</i> , <i>Paspalum dilatatum</i> , <i>Cynodon dactylon</i>		
Damage:	Nil		
Native dominance:	71%	Percentage vegetation cover:	100%
Photo:

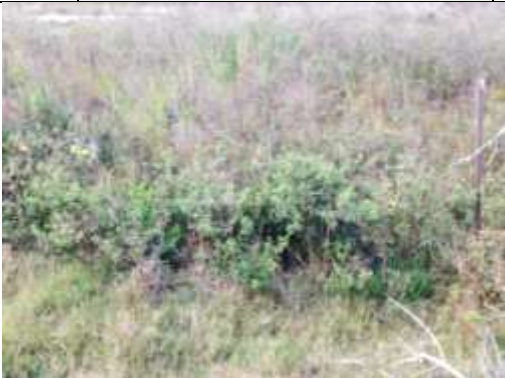
Monitoring month:	11	Months since direct seeding:	16
Date:	July 2016		
Comments:	Ludwigia has grown significantly this month, becoming more dominant. This however has not changed the overall native dominance.		
Native species:	<i>Ludwigia octovalvis</i> , <i>Juncus usitatus</i> , <i>Eleocharis dulcis</i> , <i>Persicaria decipiens</i> , <i>Persicaria attenuata</i> , <i>Cyperus polystachyos</i> , <i>Cyperus exaltatus</i> , <i>Casuarina glauca</i> , <i>Melaleuca quinquenervia</i> , <i>Typha orientalis</i>		
Weed species:	<i>Cuphea carthagenesis</i> , <i>Aster subulatus</i> , <i>Paspalum dilatatum</i> , <i>Cynodon dactylon</i>		
Damage:	Nil		
Native dominance:	71%	Percentage vegetation cover:	100%
Photo:

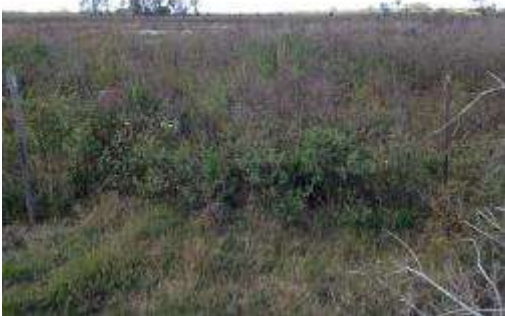
Monitoring month:	12	Months since direct seeding:	17
Date:	August 2016		
Comments:	This area will benefit well from the next inundation event.		
Native species:	<i>Ludwigia octovalvis</i> , <i>Juncus usitatus</i> , <i>Eleocharis dulcis</i> , <i>Persicaria decipiens</i> , <i>Persicaria attenuata</i> , <i>Cyperus polystachyos</i> , <i>Cyperus exaltatus</i> , <i>Casuarina glauca</i> , <i>Melaleuca quinquenervia</i> , <i>Typha orientalis</i>		
Weed species:	<i>Cuphea carthagenesis</i> , <i>Aster subulatus</i> , <i>Paspalum dilatatum</i> , <i>Cynodon dactylon</i>		
Damage:	Nil		
Native dominance:	71%	Percentage vegetation cover:	100%
Photo:

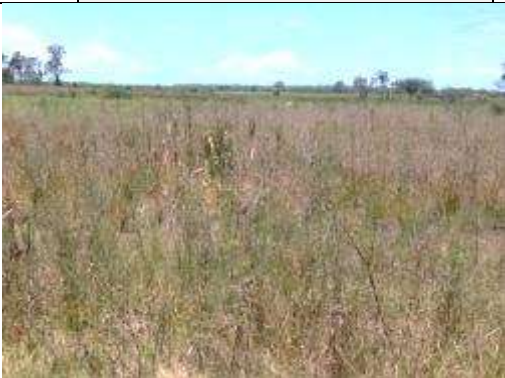
Monitoring month:	13	Months since direct seeding:	18
Date:	September 2016		
Comments:	No significant changes have been recorded this month.		
Native species:	<i>Ludwigia octovalvis</i> , <i>Juncus usitatus</i> , <i>Eleocharis dulcis</i> , <i>Persicaria decipiens</i> , <i>Persicaria attenuata</i> , <i>Cyperus polystachyos</i> , <i>Cyperus exaltatus</i> , <i>Casuarina glauca</i> , <i>Melaleuca quinquenervia</i> , <i>Typha orientalis</i>		
Weed species:	<i>Cuphea carthagenesis</i> , <i>Aster subulatus</i> , <i>Paspalum dilatatum</i> , <i>Cynodon dactylon</i>		
Damage:	Nil		
Native dominance:	75%	Percentage vegetation cover:	100%
Photo:

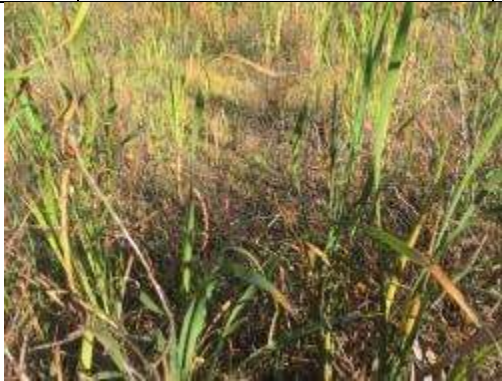
Monitoring month:	14	Months since direct seeding:	19
Date:	October 2016		
Comments:	Typha growth has increased this month and is clearly the dominant native species within this quadrat.		
Native species:	<i>Ludwigia octovalvis, Juncus usitatus, Eleocharis dulcis, Persicaria decipiens, Persicaria attenuata, Cyperus polystachyos, Cyperus exaltatus, Casuarina glauca, Melaleuca quinquenervia, Typha orientalis</i>		
Weed species:	<i>Cuphea carthagenesis, Aster subulatus, Paspalum dilatatum, Cynodon dactylon</i>		
Damage:	Nil		
Native dominance:	75%	Percentage vegetation cover:	100%
Photo:

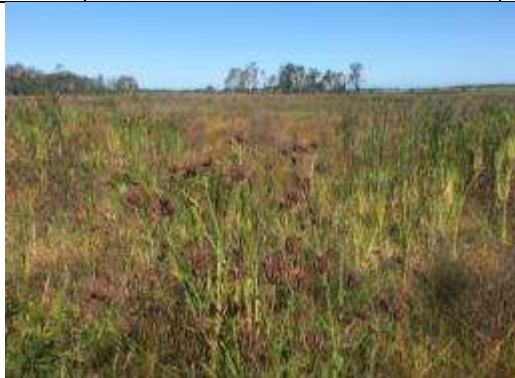
Monitoring month:	15	Months since direct seeding:	20
Date:	November 2016		
Comments:	No significant changes have been recorded this month.		
Native species:	<i>Ludwigia octovalvis, Juncus usitatus, Eleocharis dulcis, Persicaria decipiens, Persicaria attenuata, Cyperus polystachyos, Cyperus exaltatus, Casuarina glauca, Melaleuca quinquenervia, Typha orientalis</i>		
Weed species:	<i>Cuphea carthagenesis, Aster subulatus, Paspalum dilatatum, Cynodon dactylon</i>		
Damage:	Nil		
Native dominance:	75%	Percentage vegetation cover:	100%
Photo:

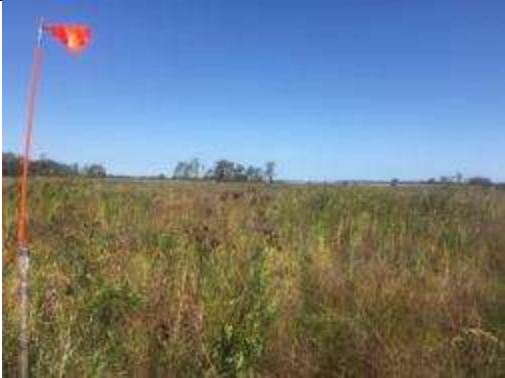
Monitoring month:	16	Months since direct seeding:	21
Date:	December 2016		
Comments:	A high visibility flag and extended pole was added to the quadrat stake this month for ease of identification. Typha continues to grow well, competing for dominance.		
Native species:	<i>Ludwigia octovalvis, Juncus usitatus, Eleocharis dulcis, Persicaria decipiens, Persicaria attenuata, Cyperus polystachyos, Cyperus exaltatus, Casuarina glauca, Melaleuca quinquenervia, Typha orientalis</i>		
Weed species:	<i>Cuphea carthagenesis, Aster subulatus, Paspalum dilatatum, Cynodon dactylon, Verbena bonariensis</i>		
Damage:	Nil		
Native dominance:	75%	Percentage vegetation cover:	100%
Photo:

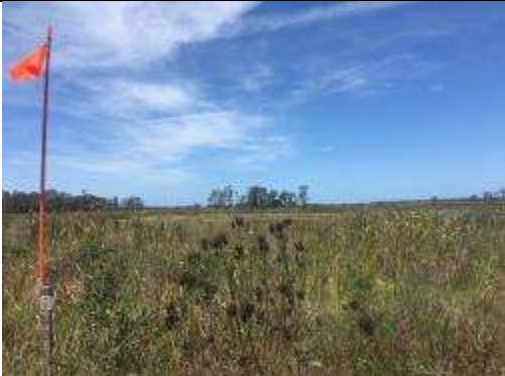
Monitoring month:	17	Months since direct seeding:	22
Date:	January 2017		
Comments:	Typha continues to grow well, competing for dominance. Melaleuca and casuarina individuals continue to grow well, averaging 1m in height.		
Native species:	<i>Ludwigia octovalvis, Juncus usitatus, Eleocharis dulcis, Persicaria decipiens, Persicaria attenuata, Cyperus polystachyos, Cyperus exaltatus, Casuarina glauca, Melaleuca quinquenervia, Typha orientalis</i>		
Weed species:	<i>Cuphea carthagenesis, Aster subulatus, Paspalum dilatatum, Cynodon dactylon, Verbena bonariensis</i>		
Damage:	Nil		
Native dominance:	75%	Percentage vegetation cover:	100%
Photo:

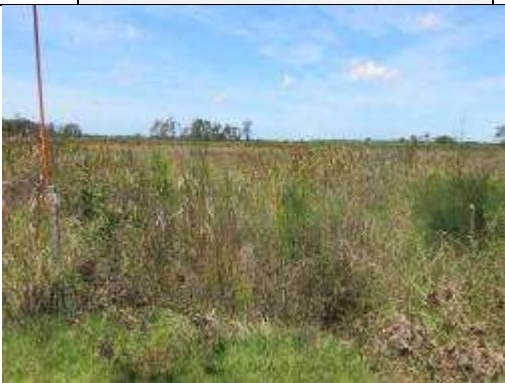
Monitoring month:	18	Months since direct seeding:	23
Date:	February 2017		
Comments:	There has been no significant change within this quadrat this month.		
Native species:	<i>Ludwigia octovalvis</i> , <i>Juncus usitatus</i> , <i>Eleocharis dulcis</i> , <i>Persicaria decipiens</i> , <i>Persicaria attenuata</i> , <i>Cyperus polystachyos</i> , <i>Cyperus exaltatus</i> , <i>Casuarina glauca</i> , <i>Melaleuca quinquenervia</i> , <i>Typha orientalis</i>		
Weed species:	<i>Cuphea carthagenesis</i> , <i>Aster subulatus</i> , <i>Paspalum dilatatum</i> , <i>Cynodon dactylon</i>		
Damage:	Nil		
Native dominance:	75%	Percentage vegetation cover:	100%
Photo:

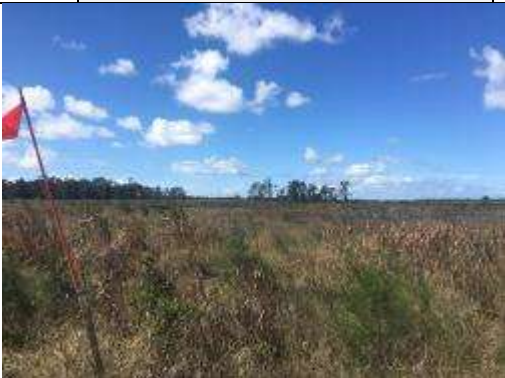
Monitoring month:	19	Months since direct seeding:	24
Date:	March 2017 (NB: monitoring event occurred early April due to inaccessibility)		
Comments:	During the last half of this month, the NWCP received significant rainfall. Access to the area was limited. Much of the area is waterlogged (approximately 15cm of water covering quadrat) and functioning as the wetland it is designed to be. Casuarinas and Melaleucas approximately 1.5m in height.		
Native species:	<i>Ludwigia octovalvis</i> , <i>Juncus usitatus</i> , <i>Eleocharis dulcis</i> , <i>Persicaria decipiens</i> , <i>Persicaria attenuata</i> , <i>Cyperus polystachyos</i> , <i>Cyperus exaltatus</i> , <i>Casuarina glauca</i> , <i>Melaleuca quinquenervia</i> , <i>Typha orientalis</i>		
Weed species:	<i>Cuphea carthagenesis</i> , <i>Aster subulatus</i> , <i>Paspalum dilatatum</i> , <i>Cynodon dactylon</i>		
Damage:	Nil - large weather event associated with Ex-Tropical Cyclone Debbie did not result in any damage

Native dominance:	75%	Percentage vegetation cover:	100%
Photo:

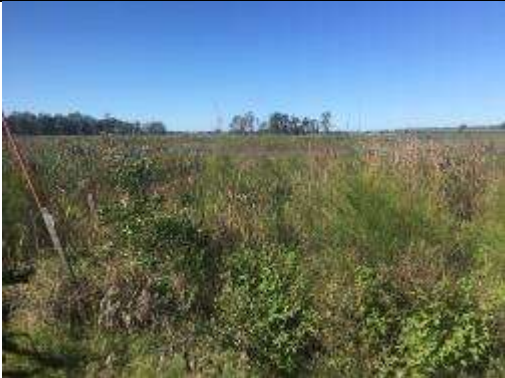
Monitoring month:	20	Months since direct seeding:	25
Date:	April 2017		
Comments:	Much of the area is still waterlogged and functioning as the wetland it is designed to be. Quadrat dominated by sedges and groundcovers.		
Native species:	<i>Ludwigia octovalvis</i> , <i>Juncus usitatus</i> , <i>Eleocharis dulcis</i> , <i>Persicaria decipiens</i> , <i>Persicaria attenuata</i> , <i>Cyperus polystachyos</i> , <i>Cyperus exaltatus</i> , <i>Casuarina glauca</i> , <i>Melaleuca quinquenervia</i> , <i>Typha orientalis</i>		
Weed species:	<i>Cuphea carthagenesis</i> , <i>Aster subulatus</i> , <i>Paspalum dilatatum</i> , <i>Cynodon dactylon</i>		
Damage:	Nil		
Native dominance:	75%	Percentage vegetation cover:	100%
Photo:

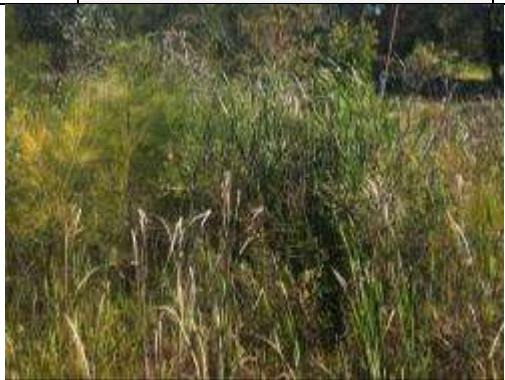
Monitoring month:	21	Months since direct seeding:	26
Date:	May 2017		
Comments:	Sedges and groundcovers continue to dominate. Casuarinas and Melaleucas approximately 1.5m in height.		
Native species:	<i>Ludwigia octovalvis</i> , <i>Juncus usitatus</i> , <i>Eleocharis dulcis</i> , <i>Persicaria decipiens</i> , <i>Persicaria attenuata</i> , <i>Cyperus polystachyos</i> , <i>Cyperus exaltatus</i> , <i>Casuarina glauca</i> , <i>Melaleuca quinquenervia</i> , <i>Typha orientalis</i>		
Weed species:	<i>Cuphea carthagenesis</i> , <i>Aster subulatus</i> , <i>Paspalum dilatatum</i> , <i>Cynodon dactylon</i>		
Damage:	Nil		
Native dominance:	75%	Percentage vegetation cover:	100%
Photo:

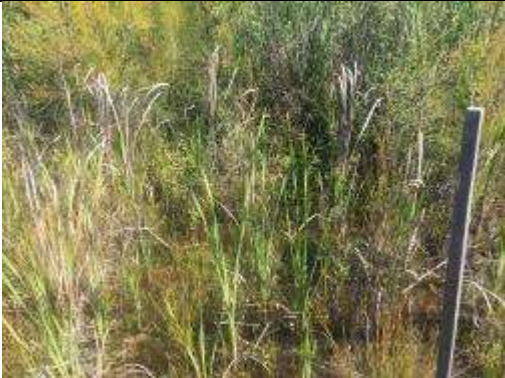
Monitoring month:	22	Months since direct seeding:	27
Date:	June 2017		
Comments:	No significant changes this month. It is anticipated growth will slow moving into the colder months.		
Native species:	<i>Ludwigia octovalvis, Juncus usitatus, Eleocharis dulcis, Persicaria decipiens, Persicaria attenuata, Cyperus polystachyos, Cyperus exaltatus, Casuarina glauca, Melaleuca quinquenervia, Typha orientalis</i>		
Weed species:	<i>Cuphea carthagenesis, Aster subulatus, Paspalum dilatatum, Cynodon dactylon</i>		
Damage:	Nil		
Native dominance:	75%	Percentage vegetation cover:	100%
Photo:

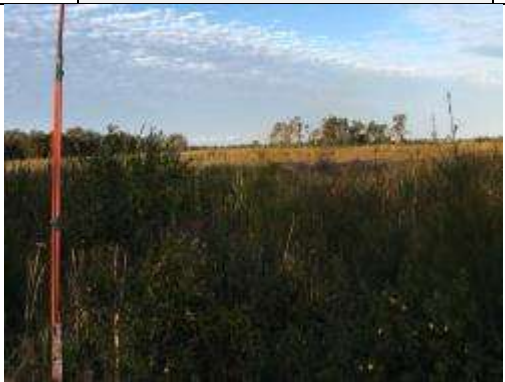
Monitoring month:	23	Months since direct seeding:	28
Date:	July 2017		
Comments:	An additional length of conduit was added to the flagging pole this month due to the increasing height of vegetation. Vegetation health is steady.		
Native species:	<i>Ludwigia octovalvis, Juncus usitatus, Eleocharis dulcis, Persicaria decipiens, Persicaria attenuata, Cyperus polystachyos, Cyperus exaltatus, Casuarina glauca, Melaleuca quinquenervia, Typha orientalis</i>		
Weed species:	<i>Cuphea carthagenesis, Aster subulatus, Paspalum dilatatum, Cynodon dactylon</i>		
Damage:	Nil		
Native dominance:	75%	Percentage vegetation cover:	100%
Photo:

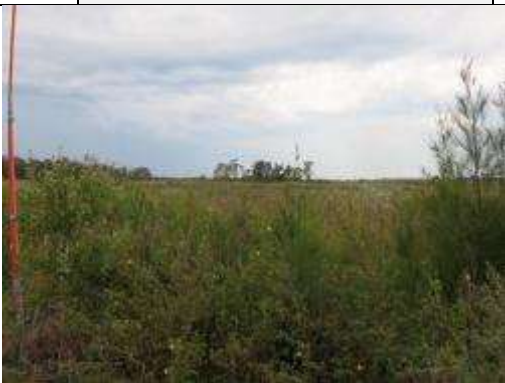
Monitoring month:	24	Months since direct seeding:	29
Date:	August 2017		
Comments:	Vegetation growth is stable.		
Native species:	<i>Ludwigia octovalvis</i> , <i>Juncus usitatus</i> , <i>Eleocharis dulcis</i> , <i>Persicaria decipiens</i> , <i>Persicaria attenuata</i> , <i>Cyperus polystachyos</i> , <i>Cyperus exaltatus</i> , <i>Casuarina glauca</i> , <i>Melaleuca quinquenervia</i> , <i>Typha orientalis</i>		
Weed species:	<i>Cuphea carthagenesis</i> , <i>Aster subulatus</i> , <i>Paspalum dilatatum</i> , <i>Cynodon dactylon</i>		
Damage:	Nil		
Native dominance:	75%	Percentage vegetation cover:	100%
Photo:

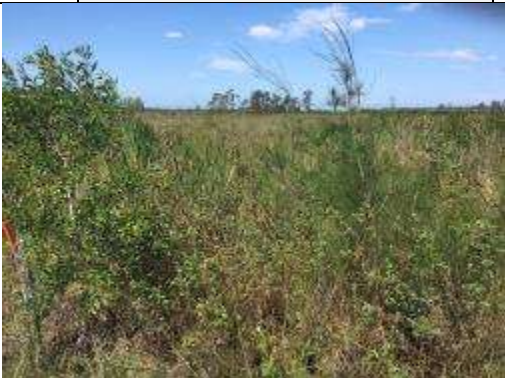
Monitoring month:	25	Months since direct seeding:	30
Date:	September 2017		
Comments:	Casuarinas continue to increase in biomass.		
Native species:	<i>Ludwigia octovalvis</i> , <i>Juncus usitatus</i> , <i>Eleocharis dulcis</i> , <i>Persicaria decipiens</i> , <i>Persicaria attenuata</i> , <i>Cyperus polystachyos</i> , <i>Cyperus exaltatus</i> , <i>Casuarina glauca</i> , <i>Melaleuca quinquenervia</i> , <i>Typha orientalis</i>		
Weed species:	<i>Cuphea carthagenesis</i> , <i>Aster subulatus</i> , <i>Paspalum dilatatum</i> , <i>Cynodon dactylon</i>		
Damage:	Nil		
Native dominance:	75%	Percentage vegetation cover:	100%
Photo:

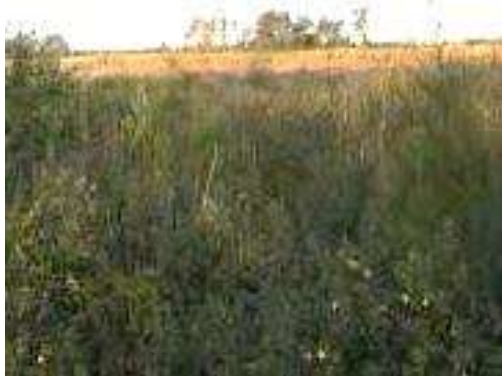
Monitoring month:	26	Months since direct seeding:	31
Date:	October 2017		
Comments:	No significant changes this month.		
Native species:	<i>Ludwigia octovalvis</i> , <i>Juncus usitatus</i> , <i>Eleocharis dulcis</i> , <i>Persicaria decipiens</i> , <i>Persicaria attenuata</i> , <i>Cyperus polystachyos</i> , <i>Cyperus exaltatus</i> , <i>Casuarina glauca</i> , <i>Melaleuca quinquenervia</i> , <i>Typha orientalis</i>		
Weed species:	<i>Cuphea carthagenesis</i> , <i>Aster subulatus</i> , <i>Paspalum dilatatum</i> , <i>Cynodon dactylon</i>		
Damage:	Nil		
Native dominance:	75%	Percentage vegetation cover:	100%
Photo:

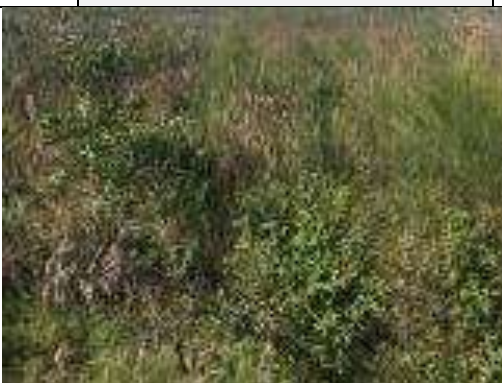
Monitoring month:	27	Months since direct seeding:	32
Date:	November 2017		
Comments:	A number of scattered rainfall events occurred this month. This assisted in the growth of sedge and wetland species that dominate this quadrat.		
Native species:	<i>Ludwigia octovalvis</i> , <i>Juncus usitatus</i> , <i>Eleocharis dulcis</i> , <i>Persicaria decipiens</i> , <i>Persicaria attenuata</i> , <i>Cyperus polystachyos</i> , <i>Cyperus exaltatus</i> , <i>Casuarina glauca</i> , <i>Melaleuca quinquenervia</i> , <i>Typha orientalis</i>		
Weed species:	<i>Cuphea carthagenesis</i> , <i>Aster subulatus</i> , <i>Paspalum dilatatum</i> , <i>Cynodon dactylon</i>		
Damage:	Nil		
Native dominance:	75%	Percentage vegetation cover:	100%
Photo:

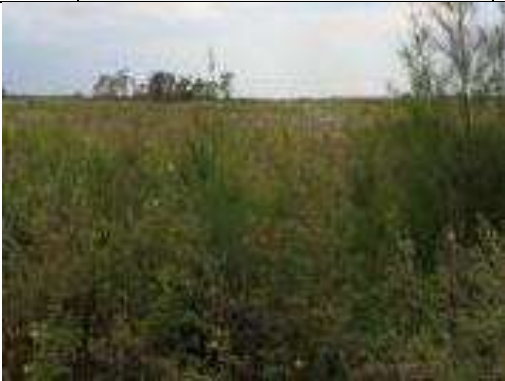
Monitoring month:	28	Months since direct seeding:	33
Date:	December 2017		
Comments:	Further rain events occurred this month resulting in the increasing biomass of casuarinas and sedges/rushes.		
Native species:	<i>Ludwigia octovalvis, Juncus usitatus, Eleocharis dulcis, Persicaria decipiens, Persicaria attenuata, Cyperus polystachyos, Cyperus exaltatus, Casuarina glauca, Melaleuca quinquenervia, Typha orientalis</i>		
Weed species:	<i>Cuphea carthagenesis, Aster subulatus, Paspalum dilatatum, Cynodon dactylon</i>		
Damage:	Nil		
Native dominance:	75%	Percentage vegetation cover:	100%
Photo:

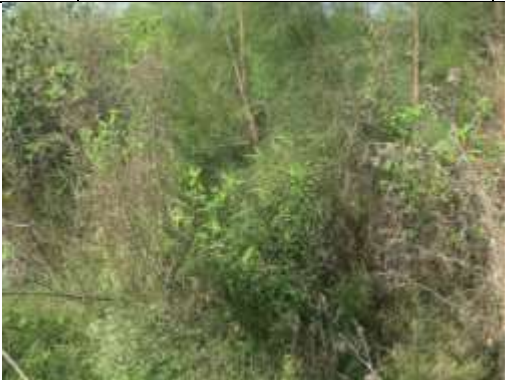
Monitoring month:	29	Months since direct seeding:	34
Date:	January 2018		
Comments:	Vegetation growth is stable.		
Native species:	<i>Ludwigia octovalvis, Juncus usitatus, Eleocharis dulcis, Persicaria decipiens, Persicaria attenuata, Cyperus polystachyos, Cyperus exaltatus, Casuarina glauca, Melaleuca quinquenervia, Typha orientalis</i>		
Weed species:	<i>Cuphea carthagenesis, Aster subulatus, Paspalum dilatatum, Cynodon dactylon</i>		
Damage:	Nil		
Native dominance:	75%	Percentage vegetation cover:	100%
Photo:

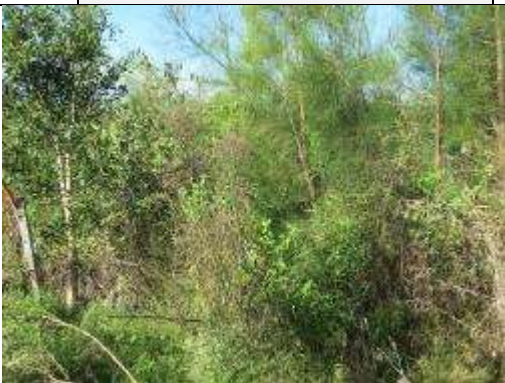
Monitoring month:	30	Months since direct seeding:	35
Date:	February 2018		
Comments:	Native vegetation continues to add biomass, outcompeting weed species.		
Native species:	<i>Ludwigia octovalvis</i> , <i>Juncus usitatus</i> , <i>Eleocharis dulcis</i> , <i>Persicaria decipiens</i> , <i>Persicaria attenuata</i> , <i>Cyperus polystachyos</i> , <i>Cyperus exaltatus</i> , <i>Casuarina glauca</i> , <i>Melaleuca quinquenervia</i> , <i>Typha orientalis</i>		
Weed species:	<i>Cuphea carthagenesis</i> , <i>Aster subulatus</i> , <i>Paspalum dilatatum</i> , <i>Cynodon dactylon</i>		
Damage:	Nil		
Native dominance:	75%	Percentage vegetation cover:	100%
Photo:

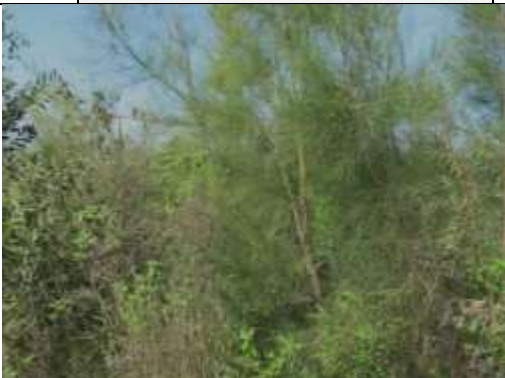
Monitoring month:	31	Months since direct seeding:	36
Date:	March 2018		
Comments:	A significant amount of rain fell at the end of last month resulting in standing water for approximately 3 weeks. This has acted as a natural weed control for a number of the weed species. Canopy growth and shading has also assisted in a reduction of weed growth, including the displacement of 2 weed species.		
Native species:	<i>Ludwigia octovalvis</i> , <i>Juncus usitatus</i> , <i>Eleocharis dulcis</i> , <i>Persicaria decipiens</i> , <i>Persicaria attenuata</i> , <i>Cyperus polystachyos</i> , <i>Cyperus exaltatus</i> , <i>Casuarina glauca</i> , <i>Melaleuca quinquenervia</i> , <i>Typha orientalis</i>		
Weed species:	<i>Cuphea carthagenesis</i> , <i>Cynodon dactylon</i>		
Damage:	Nil		
Native dominance:	80%	Percentage vegetation cover:	100%
Photo:

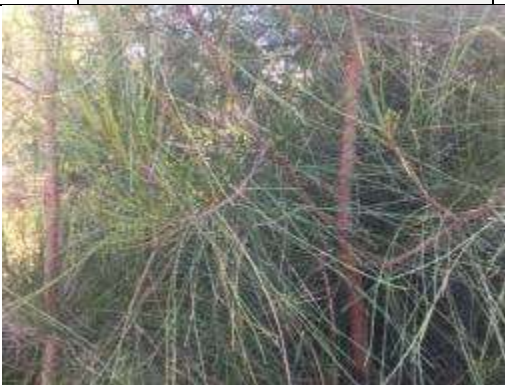
Monitoring month:	32	Months since direct seeding:	37
Date:	April 2018		
Comments:	Vegetation growth is stable.		
Native species:	<i>Ludwigia octovalvis</i> , <i>Juncus usitatus</i> , <i>Eleocharis dulcis</i> , <i>Persicaria decipiens</i> , <i>Persicaria attenuata</i> , <i>Cyperus polystachyos</i> , <i>Cyperus exaltatus</i> , <i>Casuarina glauca</i> , <i>Melaleuca quinquenervia</i> , <i>Typha orientalis</i>		
Weed species:	<i>Cuphea carthagenesis</i> , <i>Cynodon dactylon</i>		
Damage:	Nil		
Native dominance:	80%	Percentage vegetation cover:	100%
Photo:

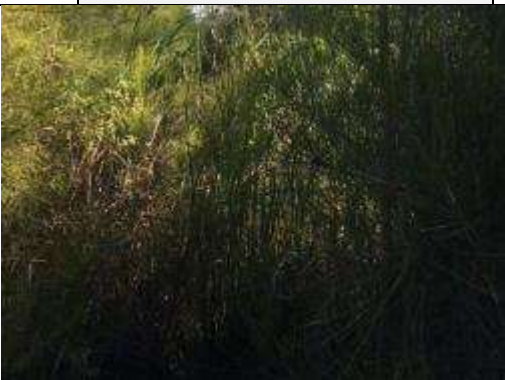
Monitoring month:	33	Months since direct seeding:	38
Date:	May 2018		
Comments:	Native vegetation continues to add biomass, outcompeting weed species.		
Native species:	<i>Ludwigia octovalvis</i> , <i>Juncus usitatus</i> , <i>Eleocharis dulcis</i> , <i>Persicaria decipiens</i> , <i>Persicaria attenuata</i> , <i>Cyperus polystachyos</i> , <i>Cyperus exaltatus</i> , <i>Casuarina glauca</i> , <i>Melaleuca quinquenervia</i> , <i>Typha orientalis</i>		
Weed species:	<i>Cuphea carthagenesis</i> , <i>Cynodon dactylon</i>		
Damage:	Nil		
Native dominance:	80%	Percentage vegetation cover:	100%
Photo:
