North-West Conservation Park - Rehabilitation Monitoring

Lot 1 RP48903

North-West Conservation Park
Gainsborough Greens

March 2020

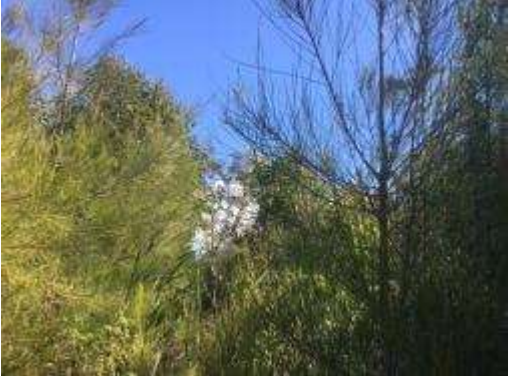
Monitoring month:	34	Months since direct seeding:	39
Date:	June 2018		
Comments:	No significant changes this month due to the slowing down of the growing season.		
Native species:	<i>Ludwigia octovalvis</i> , <i>Juncus usitatus</i> , <i>Eleocharis dulcis</i> , <i>Persicaria decipiens</i> , <i>Persicaria attenuata</i> , <i>Cyperus polystachyos</i> , <i>Cyperus exaltatus</i> , <i>Casuarina glauca</i> , <i>Melaleuca quinquenervia</i> , <i>Typha orientalis</i>		
Weed species:	<i>Cuphea carthagenesis</i> , <i>Cynodon dactylon</i>		
Damage:	Nil		
Native dominance:	80%	Percentage vegetation cover:	100%
Photo:

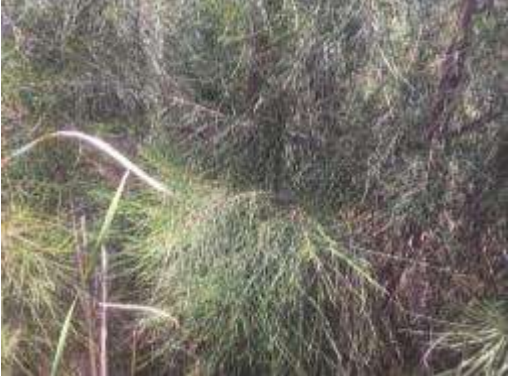
Monitoring month:	35	Months since direct seeding:	40
Date:	July 2018		
Comments:	Vegetative development continues to displace weed species.		
Native species:	<i>Ludwigia octovalvis</i> , <i>Juncus usitatus</i> , <i>Eleocharis dulcis</i> , <i>Cyperus polystachyos</i> , <i>Cyperus exaltatus</i> , <i>Casuarina glauca</i> , <i>Melaleuca quinquenervia</i> , <i>Typha orientalis</i>		
Weed species:	<i>Cynodon dactylon</i>		
Damage:	Nil		
Native dominance:	85%	Percentage vegetation cover:	100%
Photo:

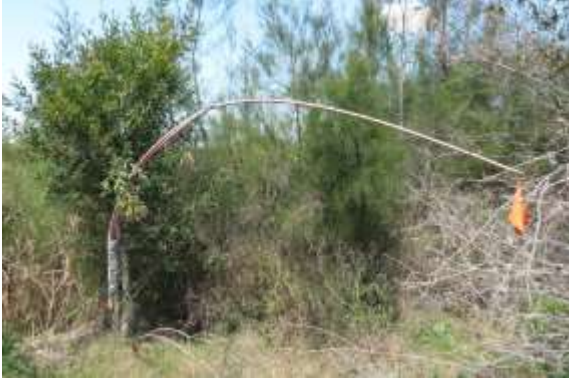
Monitoring month:	36	Months since direct seeding:	41
Date:	August 2018		
Comments:	Species diversity is declining, however native dominance remains high.		
Native species:	<i>Ludwigia octovalvis</i> , <i>Juncus usitatus</i> , <i>Eleocharis dulcis</i> , <i>Cyperus exaltatus</i> , <i>Casuarina glauca</i> , <i>Melaleuca quinquenervia</i> , <i>Typha orientalis</i>		
Weed species:	<i>Cynodon dactylon</i>		
Damage:	Nil		
Native dominance:	85%	Percentage vegetation cover:	100%
Photo:

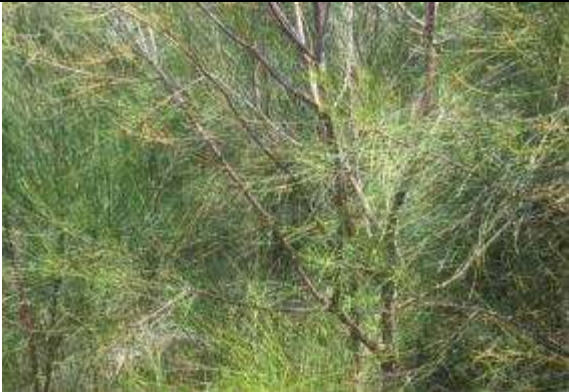
Monitoring month:	37	Months since direct seeding:	42
Date:	September 2018		
Comments:	Within the surrounding area, casuarinas are noted to be in seed. Once these trees set viable seed, a second cohort will commence development.		
Native species:	<i>Ludwigia octovalvis</i> , <i>Juncus usitatus</i> , <i>Eleocharis dulcis</i> , <i>Cyperus exaltatus</i> , <i>Casuarina glauca</i> , <i>Melaleuca quinquenervia</i> , <i>Typha orientalis</i>		
Weed species:	<i>Cynodon dactylon</i>		
Damage:	Nil		
Native dominance:	90%	Percentage vegetation cover:	100%
Photo:

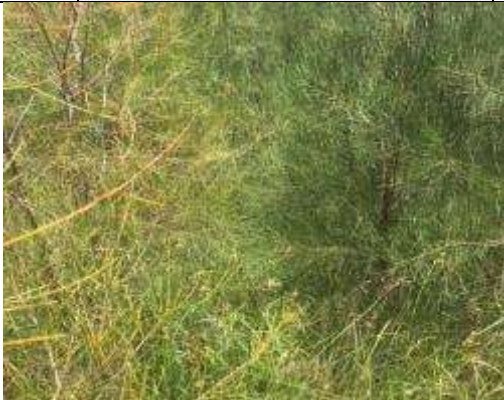
Monitoring month:	38	Months since direct seeding:	43
Date:	October 2018		
Comments:	Rainfall occurred throughout the area during this month which has assisted with the increase in biomass.		
Native species:	<i>Ludwigia octovalvis, Juncus usitatus, Eleocharis dulcis, Cyperus exaltatus, Casuarina glauca, Melaleuca quinquenervia, Typha orientalis</i>		
Weed species:	<i>Cynodon dactylon</i>		
Damage:	Nil		
Native dominance:	90%	Percentage vegetation cover:	100%
Photo:

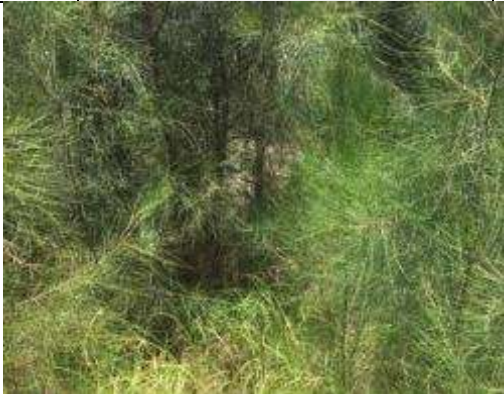
Monitoring month:	39	Months since direct seeding:	44
Date:	November 2018		
Comments:	Rapidly increasing temperatures were experienced this month resulting in the exponential growth of vegetation.		
Native species:	<i>Ludwigia octovalvis, Juncus usitatus, Eleocharis dulcis, Cyperus exaltatus, Casuarina glauca, Melaleuca quinquenervia, Typha orientalis</i>		
Weed species:	<i>Cynodon dactylon</i>		
Damage:	Nil		
Native dominance:	90%	Percentage vegetation cover:	100%
Photo:

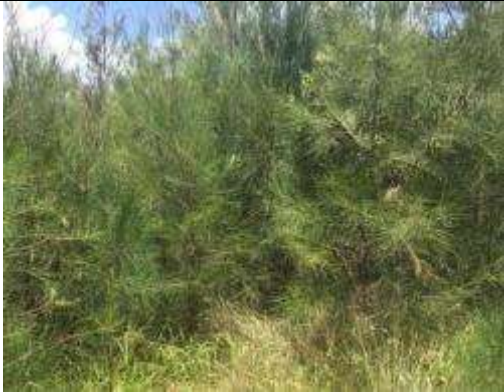
Monitoring month:	40	Months since direct seeding:	45
Date:	December 2018		
Comments:	Vegetation growth was steady this month.		
Native species:	<i>Ludwigia octovalvis</i> , <i>Juncus usitatus</i> , <i>Eleocharis dulcis</i> , <i>Cyperus exaltatus</i> , <i>Casuarina glauca</i> , <i>Melaleuca quinquenervia</i> , <i>Typha orientalis</i>		
Weed species:	<i>Cynodon dactylon</i>		
Damage:	Nil		
Native dominance:	90%	Percentage vegetation cover:	100%
Photo:

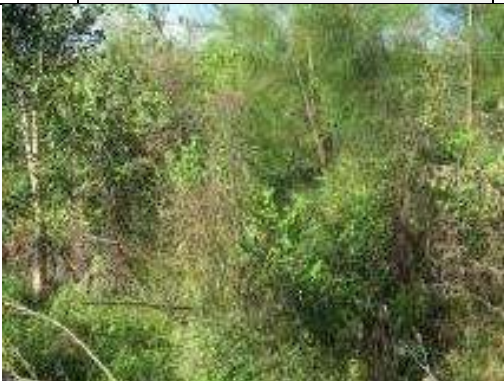
Monitoring month:	41	Months since direct seeding:	46
Date:	January 2019		
Comments:	The closing canopy within this area continues to result in a decline in abundance of groundcover species. This will eventually plateau.		
Native species:	<i>Ludwigia octovalvis</i> , <i>Juncus usitatus</i> , <i>Eleocharis dulcis</i> , <i>Cyperus exaltatus</i> , <i>Casuarina glauca</i> , <i>Melaleuca quinquenervia</i> , <i>Typha orientalis</i>		
Weed species:	<i>Cynodon dactylon</i>		
Damage:	Nil		
Native dominance:	90%	Percentage vegetation cover:	100%
Photo:

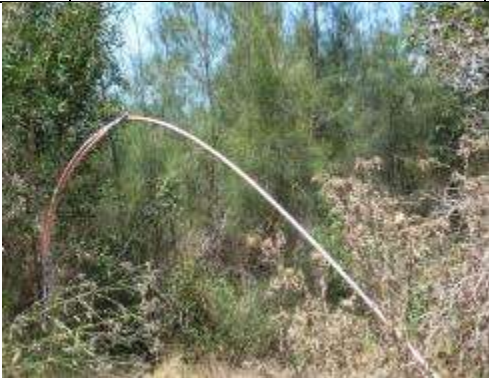
Monitoring month:	42	Months since direct seeding:	47
Date:	February 2019		
Comments:	Diversity of this quadrat is still low compared to 12 months ago, however biomass is still increasing.		
Native species:	<i>Ludwigia octovalvis, Juncus usitatus, Eleocharis dulcis, Cyperus exaltatus, Casuarina glauca, Melaleuca quinquenervia, Typha orientalis</i>		
Weed species:	<i>Cynodon dactylon</i>		
Damage:	Nil		
Native dominance:	90%	Percentage vegetation cover:	100%
Photo:

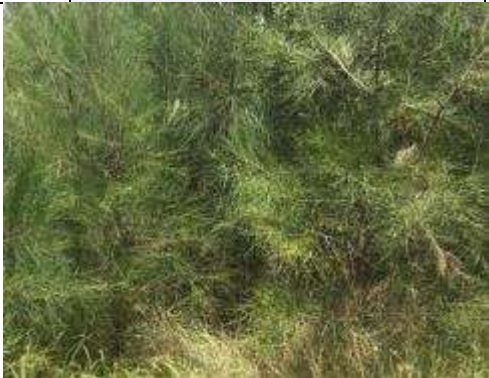
Monitoring month:	43	Months since direct seeding:	48
Date:	March 2019		
Comments:	No significant changes occurred this month.		
Native species:	<i>Ludwigia octovalvis, Juncus usitatus, Eleocharis dulcis, Cyperus exaltatus, Casuarina glauca, Melaleuca quinquenervia, Typha orientalis</i>		
Weed species:	<i>Cynodon dactylon</i>		
Damage:	Nil		
Native dominance:	90%	Percentage vegetation cover:	100%
Photo:

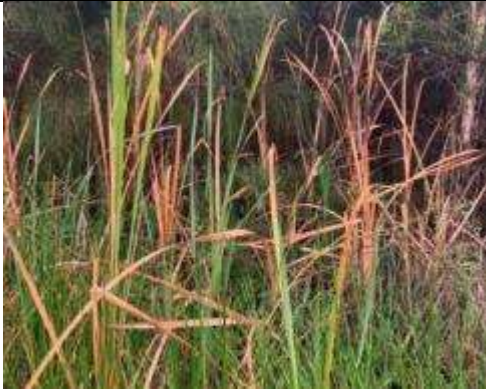
Monitoring month:	44	Months since direct seeding:	49
Date:	April 2019		
Comments:	Rainfall events increased late last month and continued this month giving the NWCP a much needed watering.		
Native species:	<i>Ludwigia octovalvis</i> , <i>Juncus usitatus</i> , <i>Eleocharis dulcis</i> , <i>Cyperus exaltatus</i> , <i>Casuarina glauca</i> , <i>Melaleuca quinquenervia</i> , <i>Typha orientalis</i>		
Weed species:	<i>Cynodon dactylon</i>		
Damage:	Nil		
Native dominance:	90%	Percentage vegetation cover:	100%
Photo:

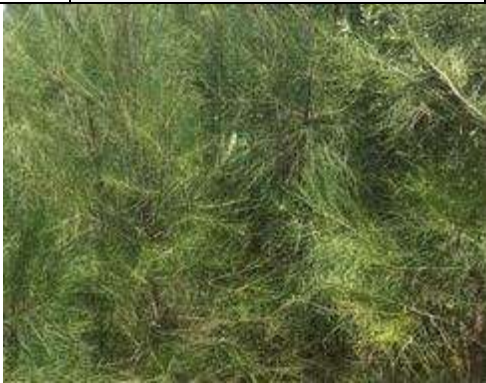
Monitoring month:	45	Months since direct seeding:	50
Date:	May 2019		
Comments:	<i>Casuarina glauca</i> continues to add biomass.		
Native species:	<i>Ludwigia octovalvis</i> , <i>Juncus usitatus</i> , <i>Eleocharis dulcis</i> , <i>Cyperus exaltatus</i> , <i>Casuarina glauca</i> , <i>Melaleuca quinquenervia</i> , <i>Typha orientalis</i>		
Weed species:	<i>Cynodon dactylon</i>		
Damage:	Nil		
Native dominance:	90%	Percentage vegetation cover:	100%
Photo:

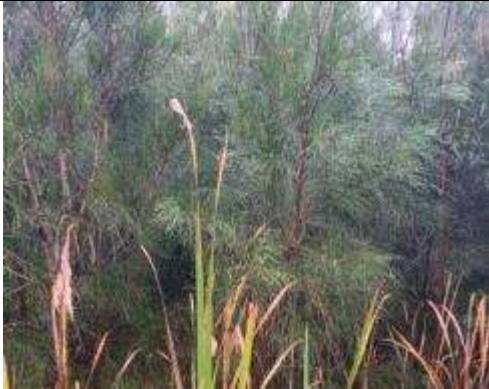
Monitoring month:	46	Months since direct seeding:	51
Date:	June 2019		
Comments:	Rainfall over the past few months has increased plant growth and vigour.		
Native species:	<i>Ludwigia octovalvis</i> , <i>Juncus usitatus</i> , <i>Eleocharis dulcis</i> , <i>Cyperus exaltatus</i> , <i>Casuarina glauca</i> , <i>Melaleuca quinquenervia</i> , <i>Typha orientalis</i>		
Weed species:	<i>Cynodon dactylon</i>		
Damage:	Nil		
Native dominance:	90%	Percentage vegetation cover:	100%
Photo:

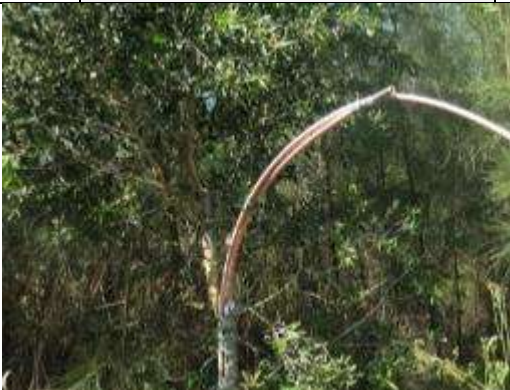
Monitoring month:	47	Months since direct seeding:	52
Date:	July 2019		
Comments:	Vegetation growth is steady.		
Native species:	<i>Ludwigia octovalvis</i> , <i>Juncus usitatus</i> , <i>Eleocharis dulcis</i> , <i>Cyperus exaltatus</i> , <i>Casuarina glauca</i> , <i>Melaleuca quinquenervia</i> , <i>Typha orientalis</i>		
Weed species:	<i>Cynodon dactylon</i>		
Damage:	Nil		
Native dominance:	90%	Percentage vegetation cover:	100%
Photo:

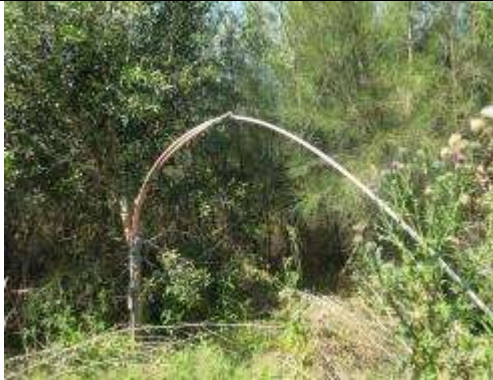
Monitoring month:	48	Months since direct seeding:	53
Date:	August 2019		
Comments:	Native dominance is increasing marginally.		
Native species:	<i>Ludwigia octovalvis</i> , <i>Juncus usitatus</i> , <i>Eleocharis dulcis</i> , <i>Cyperus exaltatus</i> , <i>Casuarina glauca</i> , <i>Melaleuca quinquenervia</i> , <i>Typha orientalis</i>		
Weed species:	<i>Cynodon dactylon</i>		
Damage:	Nil		
Native dominance:	95%	Percentage vegetation cover:	100%
Photo:

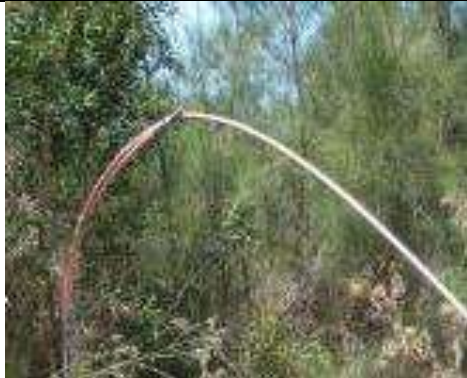
Monitoring month:	49	Months since direct seeding:	54
Date:	September 2019		
Comments:	Vegetative development continues to displace weed species.		
Native species:	<i>Ludwigia octovalvis</i> , <i>Juncus usitatus</i> , <i>Eleocharis dulcis</i> , <i>Cyperus exaltatus</i> , <i>Casuarina glauca</i> , <i>Melaleuca quinquenervia</i> , <i>Typha orientalis</i>		
Weed species:	<i>Cynodon dactylon</i>		
Damage:	Nil		
Native dominance:	95%	Percentage vegetation cover:	100%
Photo:

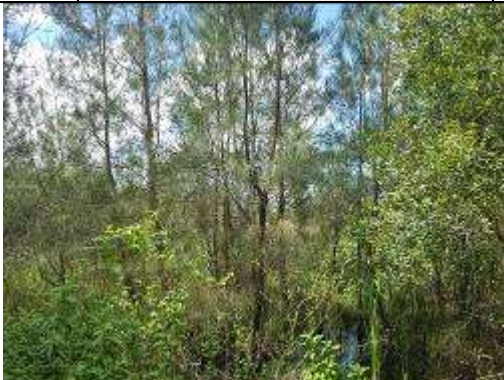
Monitoring month:	50	Months since direct seeding:	55
Date:	October 2019		
Comments:	Extended drought conditions are starting to take their toll with the extreme slowing of plant growth.		
Native species:	<i>Ludwigia octovalvis, Juncus usitatus, Eleocharis dulcis, Cyperus exaltatus, Casuarina glauca, Melaleuca quinquenervia, Typha orientalis</i>		
Weed species:	<i>Cynodon dactylon</i>		
Damage:	Nil		
Native dominance:	95%	Percentage vegetation cover:	100%
Photo:

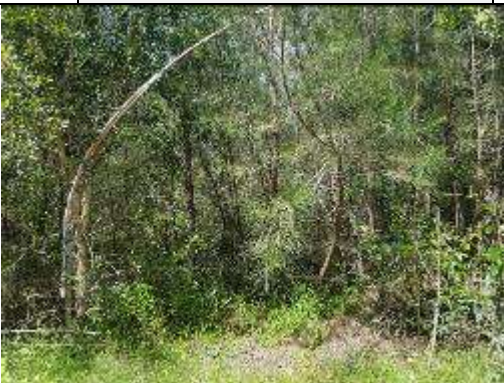
Monitoring month:	51	Months since direct seeding:	56
Date:	November 2019		
Comments:	Extended dry conditions are impacting wetland groundcover species.		
Native species:	<i>Ludwigia octovalvis, Juncus usitatus, Eleocharis dulcis, Casuarina glauca, Melaleuca quinquenervia, Typha orientalis</i>		
Weed species:	<i>Cynodon dactylon</i>		
Damage:	Nil		
Native dominance:	95%	Percentage vegetation cover:	100%
Photo:

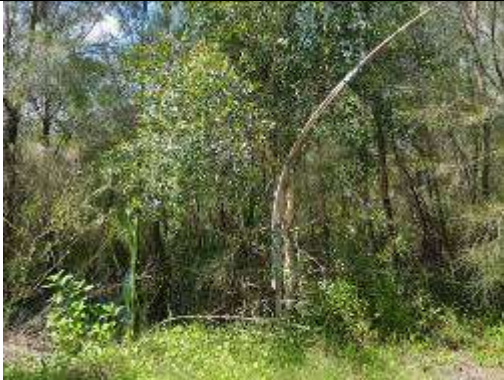
Monitoring month:	52	Months since direct seeding:	57
Date:	December 2019		
Comments:	Casuarina continues to add biomass.		
Native species:	<i>Ludwigia octovalvis, Juncus usitatus, Eleocharis dulcis, Casuarina glauca, Melaleuca quinquenervia, Typha orientalis</i>		
Weed species:	<i>Cynodon dactylon</i>		
Damage:	Nil		
Native dominance:	95%	Percentage vegetation cover:	100%
Photo:

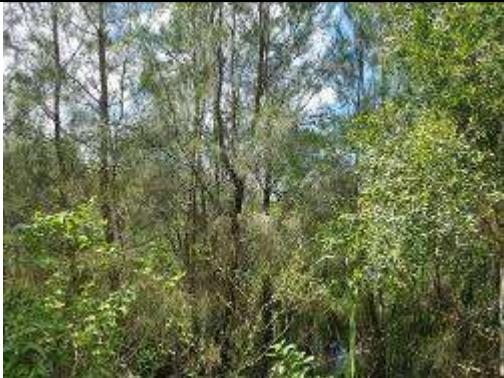
Monitoring month:	53	Months since direct seeding:	58
Date:	January 2020		
Comments:	Vegetation growth steady.		
Native species:	<i>Ludwigia octovalvis, Juncus usitatus, Eleocharis dulcis, Casuarina glauca, Melaleuca quinquenervia, Typha orientalis</i>		
Weed species:	<i>Cynodon dactylon</i>		
Damage:	Nil		
Native dominance:	95%	Percentage vegetation cover:	100%
Photo:

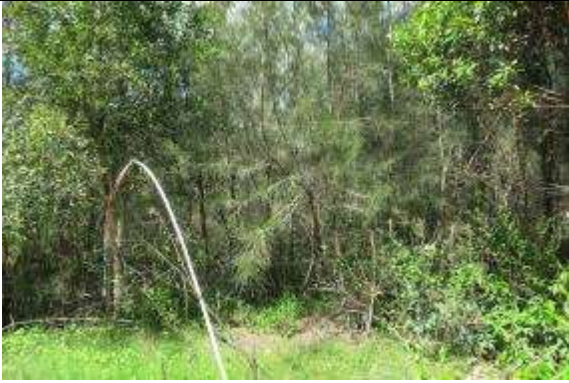
Monitoring month:	54	Months since direct seeding:	59
Date:	February 2020		
Comments:	Quadrat is showing signs of inundation.		
Native species:	<i>Ludwigia octovalvis</i> , <i>Juncus usitatus</i> , <i>Eleocharis dulcis</i> , <i>Casuarina glauca</i> , <i>Melaleuca quinquenervia</i> , <i>Typha orientalis</i>		
Weed species:	<i>Cynodon dactylon</i>		
Damage:	Nil		
Native dominance:	95%	Percentage vegetation cover:	100%
Photo:

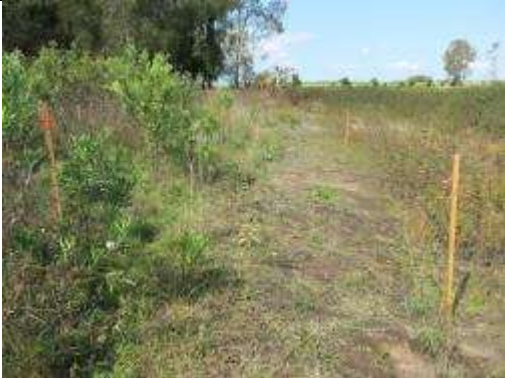
4.10 Quadrat 10

Monitoring month:	1	Months since direct seeding:	6
Date:	September 2015		
Comments:	This is one of two dry and sloping quadrats where the contour highlights the impact of improved drainage on terrestrial plant success. This is evident both in diversity and structure, where 5 canopy species are present. The area is also surrounded with <i>Mimosa pudica</i> *, a weed of concern in these drier environments.		
Native species:	<i>Corymbia citriodora</i> , <i>Capillipedium spicigerum</i> , <i>Acacia fimbriata</i> , <i>Acacia hubbardiana</i> , <i>Acacia concurrens</i> , <i>Acacia lieocalyx</i> , <i>Allocasurina littoralis</i> , <i>Cyperus polystachyos</i> , <i>Dodonaea viscosa</i> , <i>Pultenaea villosa</i> , <i>Parsonsia straminia</i>		
Weed species:	<i>Mimosa pudica</i> *, <i>Gomphocarpus physocarpus</i> , <i>Axonopus sp.</i> , <i>Brachiaria decumbens</i> , <i>Cynodon dactylon</i>		
Damage:	Nil		
Native dominance:	76%	Percentage vegetation cover:	50%

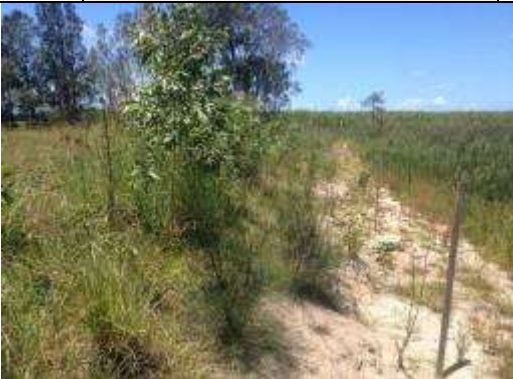
Monitoring month:	6	Months since direct seeding:	11
Date:	February 2016		
Comments:	This is one of two dry and sloping quadrats where the contour highlights the impact of improved drainage on terrestrial plant success. This is evident both in diversity and structure, where 5 canopy species are present. There has been an increase in diversity in this quadrat by three species. The area is also surrounded with <i>Mimosa pudica</i> , a weed of concern in these drier environments. The growth within this quadrat is quite representative of this contour zone around the entire site. Although the diversity is highest in this area. Other areas of the same contour are expected to change as the benefits of shading increases. The tallest tree measured at 3.2 metres in this quadrat. An increase in cover in this area is not expected due to the severity of scalping, with no surface organics left by machinery.

Native species:	<i>Corymbia citriodora, Capillipedium spicigerum, Acacia fimbriata, Acacia hubbardiana, Acacia concurrens, Acacia lieocalyx, Allocasurina littoralis, Cyperus polystachyos, Dodonaea viscosa, Pultenaea villosa, Parsonsia straminia, Melaleuca viminalis, Melaleuca salignus, Eucalyptus crebra</i>		
Weed species:	<i>Mimosa pudica*</i> , <i>Gomphocarpus physocarpus, Axonopus sp., Brachiaria decumbens, Cynodon dactylon</i>		
Damage:	Nil		
Native dominance:	80%	Percentage vegetation cover:	50%
Photo:

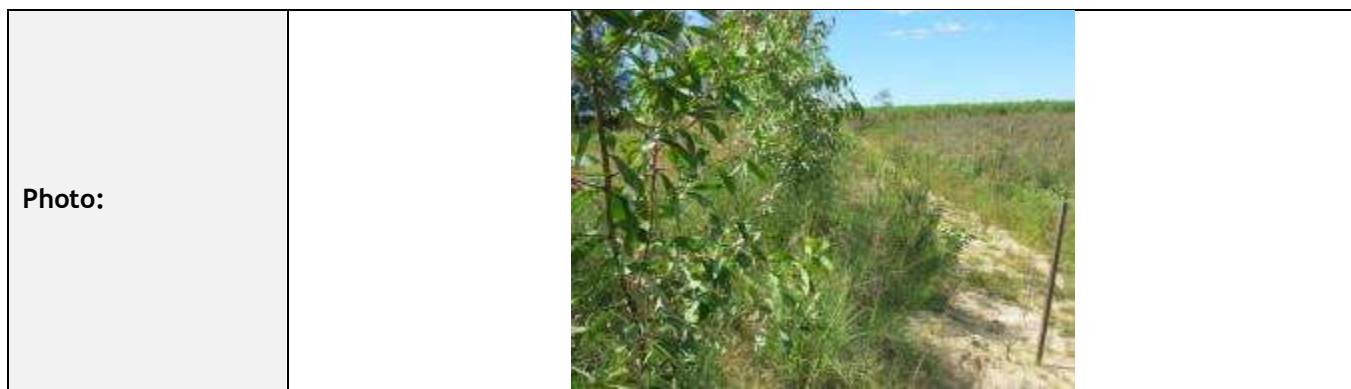
Monitoring month:	7	Months since direct seeding:	12
Date:	March 2016		
Comments:	The growth within this quadrat is quite representative of this contour zone around the entire site. Although the diversity is highest in this area, change has been noted in other areas of the same contour as the benefits of shading increases. The tallest tree previously measured at 3.2 metres in this quadrat. This time the growth has been impressive, now growing up to 4 metres.		
Native species:	<i>Corymbia citriodora, Capillipedium spicigerum, Acacia fimbriata, Acacia hubbardiana, Acacia concurrens, Acacia lieocalyx, Allocasurina littoralis, Cyperus polystachyos, Dodonaea viscosa, Pultenaea villosa, Parsonsia straminia, Melaleuca viminalis, Melaleuca salignus, Eucalyptus crebra</i>		
Weed species:	<i>Mimosa pudica*</i> , <i>Gomphocarpus physocarpus, Axonopus sp., Brachiaria decumbens, Cynodon dactylon</i>		
Damage:	Nil

Native dominance:	90%	Percentage vegetation cover:	50%

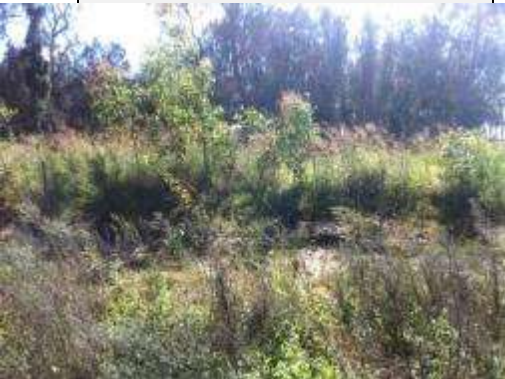
Monitoring month:	8	Months since direct seeding:	13
Date:	April 2016		
Comments:	The growth within this quadrat is quite representative of this contour zone around the entire site. Although the diversity is highest in this area, change has been noted in other areas of the same contour as the benefits of shading increases.		
Native species:	<i>Corymbia citriodora, Capillipedium spicigerum, Acacia fimbriata, Acacia hubbardiana, Acacia concurrens, Acacia lieocalyx, Allocasurina littoralis, Cyperus polystachyos, Dodonaea viscosa, Pultenaea villosa, Parsonsia straminia, Melaleuca viminalis, Melaleuca salignus, Eucalyptus crebra</i>		
Weed species:	<i>Mimosa pudica*</i> , <i>Gomphocarpus physocarpus, Axonopus sp., Brachiaria decumbens, Cynodon dactylon</i>		
Damage:	Nil		
Native dominance:	90%	Percentage vegetation cover:	50%
Photo:

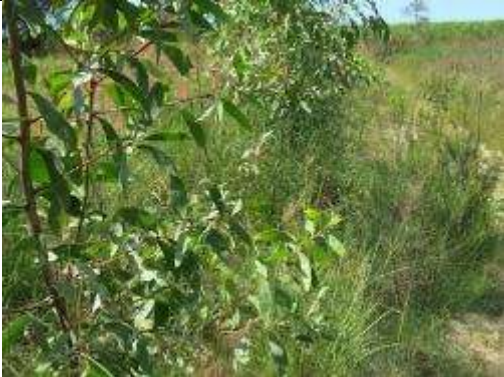
Monitoring month:	9	Months since direct seeding:	14
Date:	May 2016		
Comments:	No significant change has been recorded this month.		
Native species:	<i>Corymbia citriodora</i> , <i>Capillipedium spicigerum</i> , <i>Acacia fimbriata</i> , <i>Acacia hubbardiana</i> , <i>Acacia concurrens</i> , <i>Acacia lieocalyx</i> , <i>Allocasurina littoralis</i> , <i>Cyperus polystachyos</i> , <i>Dodonaea viscosa</i> , <i>Pultenaea villosa</i> , <i>Parsonsia straminia</i> , <i>Melaleuca viminalis</i> , <i>Melaleuca salignus</i> , <i>Eucalyptus crebra</i> , <i>Hovea acutifolia</i>		
Weed species:	<i>Mimosa pudica</i> *, <i>Gomphocarpus physocarpus</i> , <i>Axonopus sp.</i> , <i>Brachiaria decumbens</i> , <i>Cynodon dactylon</i>		
Damage:	Nil		
Native dominance:	90%	Percentage vegetation cover:	50%
Photo:

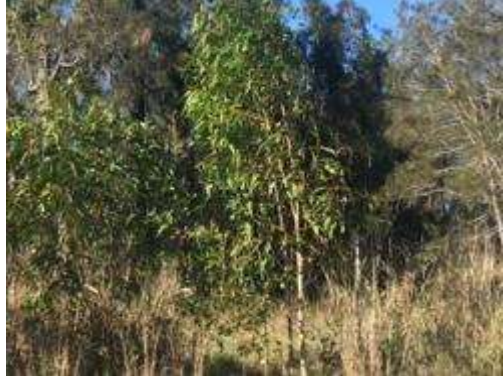
Monitoring month:	10	Months since direct seeding:	15
Date:	June 2016		
Comments:	It is anticipated that growth of vegetation within this quadrat will slow over the winter period.		
Native species:	<i>Corymbia citriodora</i> , <i>Capillipedium spicigerum</i> , <i>Acacia fimbriata</i> , <i>Acacia hubbardiana</i> , <i>Acacia concurrens</i> , <i>Acacia lieocalyx</i> , <i>Allocasurina littoralis</i> , <i>Cyperus polystachyos</i> , <i>Dodonaea viscosa</i> , <i>Pultenaea villosa</i> , <i>Parsonsia straminia</i> , <i>Melaleuca viminalis</i> , <i>Melaleuca salignus</i> , <i>Eucalyptus crebra</i> , <i>Hovea acutifolia</i>		
Weed species:	<i>Mimosa pudica</i> *, <i>Gomphocarpus physocarpus</i> , <i>Axonopus sp.</i> , <i>Brachiaria decumbens</i> , <i>Cynodon dactylon</i>		
Damage:	Nil		
Native dominance:	90%	Percentage vegetation cover:	50%
Photo:

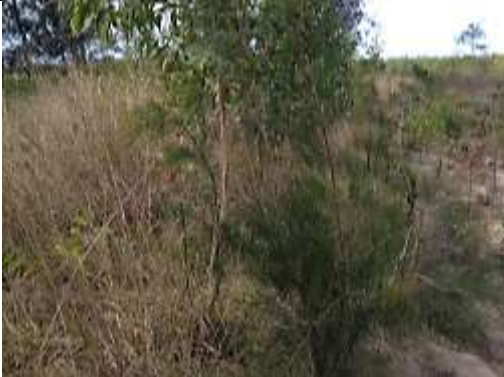
Monitoring month:	11	Months since direct seeding:	16
Date:	July 2016		
Comments:	Winter effects are evident, however vegetation health is good for this time of year.		
Native species:	<i>Corymbia citriodora</i> , <i>Capillipedium spicigerum</i> , <i>Acacia fimbriata</i> , <i>Acacia hubbardiana</i> , <i>Acacia concurrens</i> , <i>Acacia lieocalyx</i> , <i>Allocasurina littoralis</i> , <i>Cyperus polystachyos</i> , <i>Dodonaea viscosa</i> , <i>Pultenaea villosa</i> , <i>Parsonsia straminia</i> , <i>Melaleuca viminalis</i> , <i>Melaleuca salignus</i> , <i>Eucalyptus crebra</i> , <i>Hovea acutifolia</i>		
Weed species:	<i>Mimosa pudica</i> *, <i>Gomphocarpus physocarpus</i> , <i>Axonopus sp.</i> , <i>Brachiaria decumbens</i> , <i>Cynodon dactylon</i>		
Damage:	Nil		
Native dominance:	90%	Percentage vegetation cover:	50%
Photo:

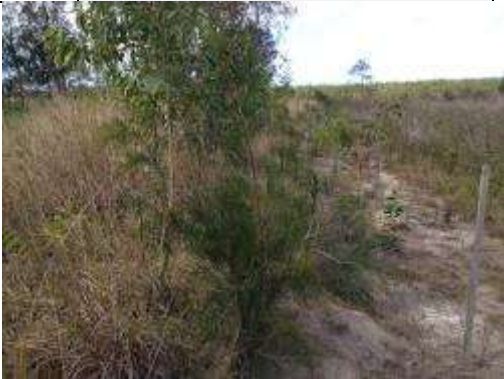
Monitoring month:	12	Months since direct seeding:	17
Date:	August 2016		
Comments:	This is one of two dry, sloping quadrats where the contour highlights the impact of improved drainage on terrestrial plant success. This is evident in diversity & structure.		
Native species:	<i>Corymbia citriodora</i> , <i>Capillipedium spicigerum</i> , <i>Acacia fimbriata</i> , <i>Acacia hubbardiana</i> , <i>Acacia concurrens</i> , <i>Acacia lieocalyx</i> , <i>Allocasurina littoralis</i> , <i>Cyperus polystachyos</i> , <i>Dodonaea viscosa</i> , <i>Pultenaea villosa</i> , <i>Parsonsia straminia</i> , <i>Melaleuca viminalis</i> , <i>Melaleuca salignus</i> , <i>Eucalyptus crebra</i> , <i>Hovea acutifolia</i>		
Weed species:	<i>Mimosa pudica</i> *, <i>Gomphocarpus physocarpus</i> , <i>Axonopus sp.</i> , <i>Brachiaria decumbens</i> , <i>Cynodon dactylon</i>		
Damage:	Nil		
Native dominance:	90%	Percentage vegetation cover:	50%

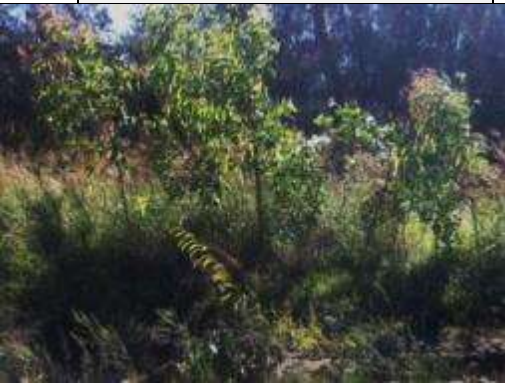
Monitoring month:	13	Months since direct seeding:	18
Date:	September 2016		
Comments:	The growth within this quadrant is quite representative of the broader site, with some Eucalyptus reaching 5m or more. <i>Capillipedium spicigerum</i> is still a dominant grass in the background even though dormant over this period.		
Native species:	<i>Corymbia citriodora</i> , <i>Capillipedium spicigerum</i> , <i>Cynodon dactylon</i> , <i>Acacia fimbriata</i> , <i>Acacia hubbardiana</i> , <i>Acacia concurrens</i> , <i>Acacia lieocalyx</i> , <i>Allocasurina littoralis</i> , <i>Cyperus polystachyos</i> , <i>Dodonaea viscosa</i> , <i>Pultenaea villosa</i> , <i>Parsonsia straminia</i> , <i>Melaleuca viminalis</i> , <i>Melaleuca salignus</i> , <i>Eucalyptus crebra</i> , <i>Hovea acutifolia</i>		
Weed species:	<i>Mimosa pudica</i> *, <i>Gomphocarpus physocarpus</i> , <i>Axonopus sp.</i> , <i>Brachiaria decumbens</i>

Damage:	Nil		
Native dominance:	90%	Percentage vegetation cover:	50%
Photo:

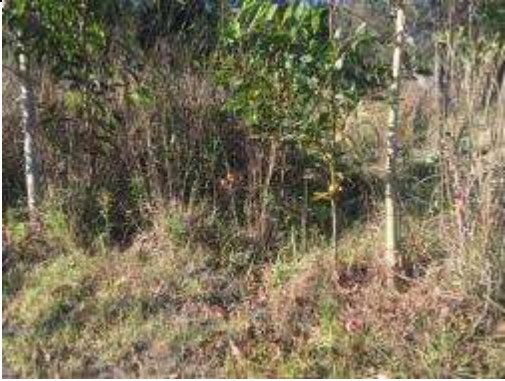
Monitoring month:	14	Months since direct seeding:	19
Date:	October 2016		
Comments:	No significant changes have been recorded this month.		
Native species:	<i>Corymbia citriodora</i> , <i>Capillipedium spicigerum</i> , <i>Acacia fimbriata</i> , <i>Acacia hubbardiana</i> , <i>Acacia concurrens</i> , <i>Acacia lieocalyx</i> , <i>Allocasurina littoralis</i> , <i>Cyperus polystachyos</i> , <i>Dodonaea viscosa</i> , <i>Pultenaea villosa</i> , <i>Parsonsia straminia</i> , <i>Melaleuca viminalis</i> , <i>Melaleuca salignus</i> , <i>Eucalyptus crebra</i> , <i>Hovea acutifolia</i>		
Weed species:	<i>Mimosa pudica</i> *, <i>Gomphocarpus physocarpus</i> , <i>Axonopus sp.</i> , <i>Brachiaria decumbens</i> , <i>Cynodon dactylon</i>		
Damage:	Nil		
Native dominance:	90%	Percentage vegetation cover:	50%
Photo:

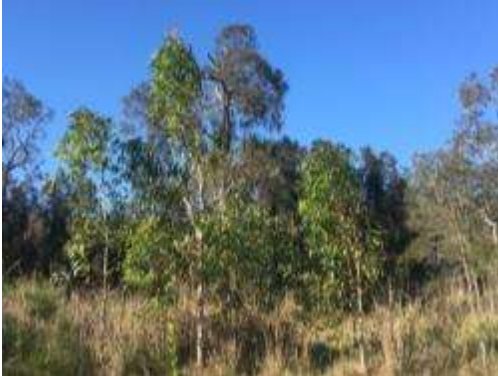
Monitoring month:	15	Months since direct seeding:	20
Date:	November 2016		
Comments:	Growth of canopy vegetation is evident this month, with juvenile eucalypts growing well. <i>Capillipedium spicigerum</i> is still a dominant grass within this quadrat.		
Native species:	<i>Corymbia citriodora</i> , <i>Capillipedium spicigerum</i> , <i>Acacia fimbriata</i> , <i>Acacia hubbardiana</i> , <i>Acacia concurrens</i> , <i>Acacia lieocalyx</i> , <i>Allocasurina littoralis</i> , <i>Cyperus polystachyos</i> , <i>Dodonaea viscosa</i> , <i>Pultenaea villosa</i> , <i>Parsonsia straminia</i> , <i>Melaleuca viminalis</i> , <i>Melaleuca salignus</i> , <i>Eucalyptus crebra</i> , <i>Hovea acutifolia</i>		
Weed species:	<i>Mimosa pudica</i> *, <i>Gomphocarpus physocarpus</i> , <i>Axonopus sp.</i> , <i>Brachiaria decumbens</i> , <i>Cynodon dactylon</i>		
Damage:	Nil		
Native dominance:	90%	Percentage vegetation cover:	50%

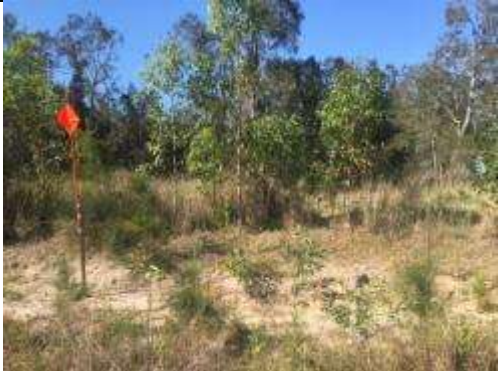
Monitoring month:	16	Months since direct seeding:	21
Date:	December 2016		
Comments:	A high visibility flag and extended pole was added to the quadrat stake this month for ease of identification. No other significant changes were noted.		
Native species:	<i>Corymbia citriodora</i> , <i>Capillipedium spicigerum</i> , <i>Acacia fimbriata</i> , <i>Acacia hubbardiana</i> , <i>Acacia concurrens</i> , <i>Acacia lieocalyx</i> , <i>Allocasurina littoralis</i> , <i>Cyperus polystachyos</i> , <i>Dodonaea viscosa</i> , <i>Pultenaea villosa</i> , <i>Parsonsia straminia</i> , <i>Melaleuca viminalis</i> , <i>Melaleuca salignus</i> , <i>Eucalyptus crebra</i> , <i>Hovea acutifolia</i>		
Weed species:	<i>Mimosa pudica</i> *, <i>Gomphocarpus physocarpus</i> , <i>Axonopus sp.</i> , <i>Brachiaria decumbens</i> , <i>Cynodon dactylon</i>		
Damage:	Nil		
Native dominance:	90%	Percentage vegetation cover:	50%
Photo:

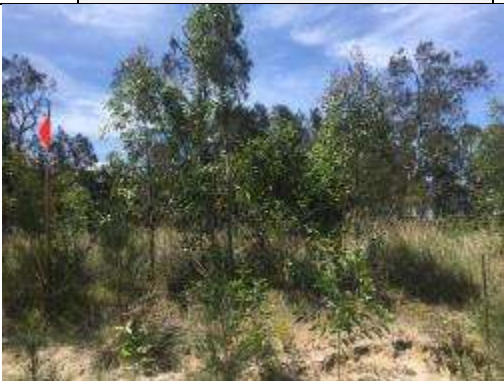
Monitoring month:	17	Months since direct seeding:	22
Date:	January 2017		
Comments:	Canopy eucalypts continue to grow, averaging approximately 2.5m-4m in height.		
Native species:	<i>Corymbia citriodora</i> , <i>Capillipedium spicigerum</i> , <i>Acacia fimbriata</i> , <i>Acacia hubbardiana</i> , <i>Acacia concurrens</i> , <i>Acacia lieocalyx</i> , <i>Allocasurina littoralis</i> , <i>Cyperus polystachyos</i> , <i>Dodonaea viscosa</i> , <i>Pultenaea villosa</i> , <i>Parsonsia straminia</i> , <i>Melaleuca viminalis</i> , <i>Melaleuca salignus</i> , <i>Eucalyptus crebra</i> , <i>Hovea acutifolia</i>		
Weed species:	<i>Mimosa pudica</i> *, <i>Gomphocarpus physocarpus</i> , <i>Axonopus sp.</i> , <i>Brachiaria decumbens</i> , <i>Cynodon dactylon</i>		
Damage:	Nil		
Native dominance:	90%	Percentage vegetation cover:	55%
Photo:

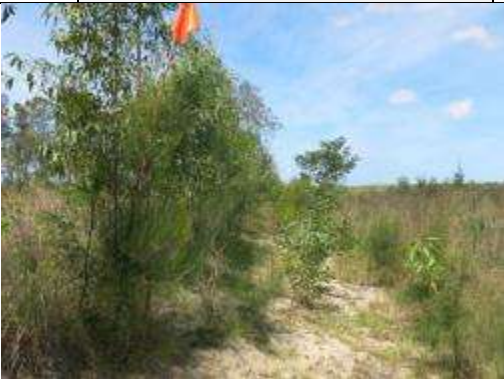
Monitoring month:	18	Months since direct seeding:	23
Date:	February 2017		
Comments:	Canopy eucalypts continue to grow, averaging approximately 2.5m-4m in height.		
Native species:	<i>Corymbia citriodora</i> , <i>Capillipedium spicigerum</i> , <i>Acacia fimbriata</i> , <i>Acacia hubbardiana</i> , <i>Acacia concurrens</i> , <i>Acacia lieocalyx</i> , <i>Allocasurina littoralis</i> , <i>Cyperus polystachyos</i> , <i>Dodonaea viscosa</i> , <i>Pultenaea villosa</i> , <i>Parsonsia straminia</i> , <i>Melaleuca viminalis</i> , <i>Melaleuca salignus</i> , <i>Eucalyptus crebra</i> , <i>Hovea acutifolia</i>		
Weed species:	<i>Mimosa pudica</i> *, <i>Gomphocarpus physocarpus</i> , <i>Axonopus sp.</i> , <i>Brachiaria decumbens</i> , <i>Cynodon dactylon</i>		
Damage:	Nil		
Native dominance:	90%	Percentage vegetation cover:	55%
Photo:

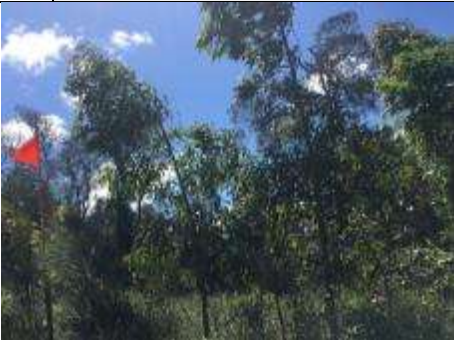
Monitoring month:	19	Months since direct seeding:	24
Date:	March 2017 (NB: monitoring event occurred early April due to inaccessibility)		
Comments:	During the last half of this month, the NWCP received significant rainfall. Access to the area was limited. Despite being on the upper margins of this area, this quadrat was still high in moisture. Canopy eucalypts continue to grow, approximately 4.5m.		
Native species:	<i>Corymbia citriodora</i> , <i>Capillipedium spicigerum</i> , <i>Acacia fimbriata</i> , <i>Acacia hubbardiana</i> , <i>Acacia concurrens</i> , <i>Acacia lieocalyx</i> , <i>Allocasurina littoralis</i> , <i>Cyperus polystachyos</i> , <i>Dodonaea viscosa</i> , <i>Pultenaea villosa</i> , <i>Parsonsia straminia</i> , <i>Melaleuca viminalis</i> , <i>Melaleuca salignus</i> , <i>Eucalyptus crebra</i> , <i>Hovea acutifolia</i>		
Weed species:	<i>Mimosa pudica</i> *, <i>Gomphocarpus physocarpus</i> , <i>Axonopus sp.</i> , <i>Brachiaria decumbens</i> , <i>Cynodon dactylon</i>

Damage:	Nil - large weather event associated with Ex-Tropical Cyclone Debbie did not result in any damage		
Native dominance:	90%	Percentage vegetation cover:	55%
Photo:

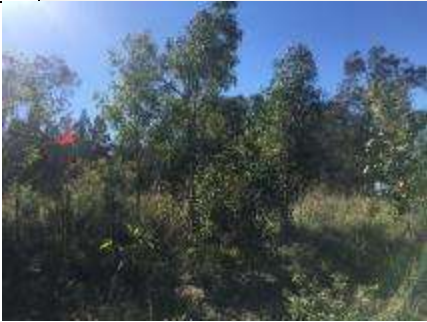
Monitoring month:	20	Months since direct seeding:	25
Date:	April 2017		
Comments:	Soil moisture within the higher elevation areas was reduced back to average levels. Canopy eucalypts continue to grow, averaging approximately 4.5m.		
Native species:	<i>Corymbia citriodora</i> , <i>Capillipedium spicigerum</i> , <i>Acacia fimbriata</i> , <i>Acacia hubbardiana</i> , <i>Acacia concurrens</i> , <i>Acacia lieocalyx</i> , <i>Allocasurina littoralis</i> , <i>Cyperus polystachyos</i> , <i>Dodonaea viscosa</i> , <i>Pultenaea villosa</i> , <i>Parsonsia straminia</i> , <i>Melaleuca viminalis</i> , <i>Melaleuca salignus</i> , <i>Eucalyptus crebra</i> , <i>Hovea acutifolia</i>		
Weed species:	<i>Mimosa pudica</i> *, <i>Gomphocarpus physocarpus</i> , <i>Axonopus sp.</i> , <i>Brachiaria decumbens</i> , <i>Cynodon dactylon</i>		
Damage:	Nil		
Native dominance:	90%	Percentage vegetation cover:	55%
Photo:

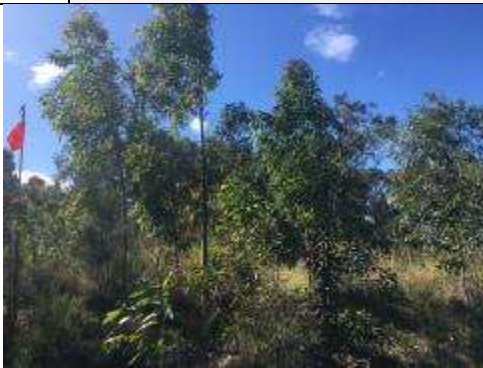
Monitoring month:	21	Months since direct seeding:	26
Date:	May 2017		
Comments:	Canopy eucalypts continue to grow, averaging approximately 4.5m.		
Native species:	<i>Corymbia citriodora</i> , <i>Capillipedium spicigerum</i> , <i>Acacia fimbriata</i> , <i>Acacia hubbardiana</i> , <i>Acacia concurrens</i> , <i>Acacia lieocalyx</i> , <i>Allocasurina littoralis</i> , <i>Cyperus polystachyos</i> , <i>Dodonaea viscosa</i> , <i>Pultenaea villosa</i> , <i>Parsonsia straminia</i> , <i>Melaleuca viminalis</i> , <i>Melaleuca salignus</i> , <i>Eucalyptus crebra</i> , <i>Hovea acutifolia</i>		
Weed species:	<i>Mimosa pudica</i> *, <i>Gomphocarpus physocarpus</i> , <i>Axonopus sp.</i> , <i>Brachiaria decumbens</i> , <i>Cynodon dactylon</i>		
Damage:	Nil		
Native dominance:	90%	Percentage vegetation cover:	55%
Photo:

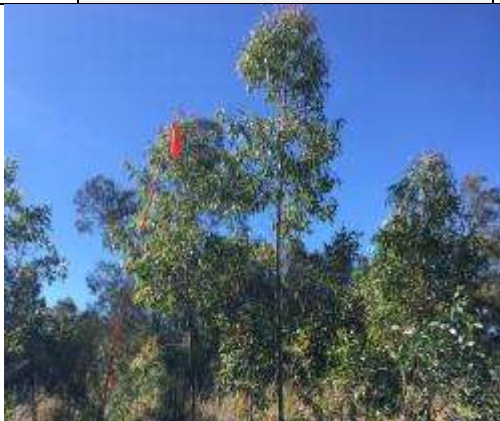
Monitoring month:	23	Months since direct seeding:	28
Date:	July 2017		
Comments:	An additional length of conduit was added to the flagging pole this month due to the increasing height of vegetation. Weed treatment has controlled Mimosa.		
Native species:	<i>Corymbia citriodora</i> , <i>Capillipedium spicigerum</i> , <i>Acacia fimbriata</i> , <i>Acacia hubbardiana</i> , <i>Acacia concurrens</i> , <i>Acacia lieocalyx</i> , <i>Allocasurina littoralis</i> , <i>Cyperus polystachyos</i> , <i>Dodonaea viscosa</i> , <i>Pultenaea villosa</i> , <i>Parsonsia straminia</i> , <i>Melaleuca viminalis</i> , <i>Melaleuca salignus</i> , <i>Eucalyptus crebra</i> , <i>Hovea acutifolia</i>		
Weed species:	<i>Gomphocarpus physocarpus</i> , <i>Axonopus sp.</i> , <i>Brachiaria decumbens</i> , <i>Cynodon dactylon</i>		
Damage:	Nil		
Native dominance:	90%	Percentage vegetation cover:	55%
Photo:

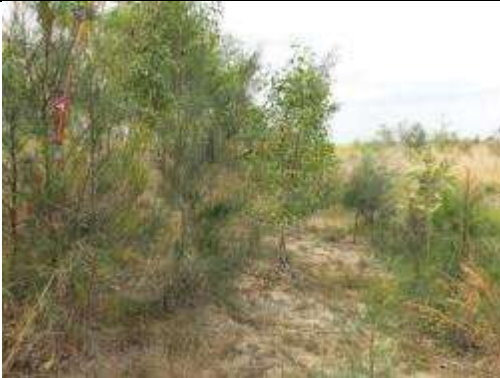
Monitoring month:	24	Months since direct seeding:	29
Date:	August 2017		
Comments:	Height and biomass of vegetation continues to increase.		
Native species:	<i>Corymbia citriodora</i> , <i>Capillipedium spicigerum</i> , <i>Acacia fimbriata</i> , <i>Acacia hubbardiana</i> , <i>Acacia concurrens</i> , <i>Acacia lieocalyx</i> , <i>Allocasurina littoralis</i> , <i>Cyperus polystachyos</i> , <i>Dodonaea viscosa</i> , <i>Pultenaea villosa</i> , <i>Parsonsia straminia</i> , <i>Melaleuca viminalis</i> , <i>Melaleuca salignus</i> , <i>Eucalyptus crebra</i> , <i>Hovea acutifolia</i>		
Weed species:	<i>Gomphocarpus physocarpus</i> , <i>Axonopus sp.</i> , <i>Brachiaria decumbens</i> , <i>Cynodon dactylon</i>		
Damage:	Nil		
Native dominance:	90%	Percentage vegetation cover:	55%
Photo:

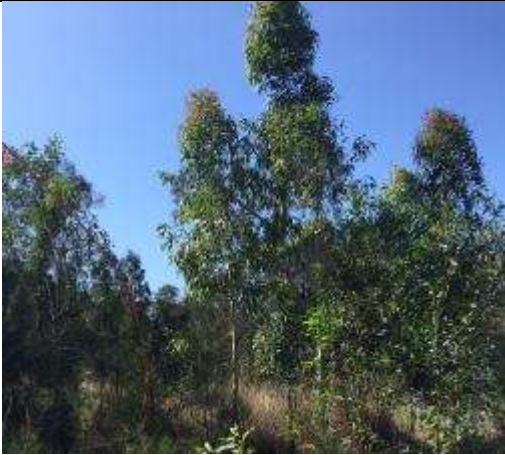
Monitoring month:	25	Months since direct seeding:	30
Date:	September 2017		
Comments:	Vegetation growth remains steady.		
Native species:	<i>Corymbia citriodora, Capillipedium spicigerum, Acacia fimbriata, Acacia hubbardiana, Acacia concurrens, Acacia lieocalyx, Allocasurina littoralis, Cyperus polystachyos, Dodonaea viscosa, Pultenaea villosa, Parsonsia straminia, Melaleuca viminalis, Melaleuca salignus, Eucalyptus crebra, Hovea acutifolia</i>		
Weed species:	<i>Gomphocarpus physocarpus, Axonopus sp., Brachiaria decumbens, Cynodon dactylon</i>		
Damage:	Nil		
Native dominance:	90%	Percentage vegetation cover:	55%
Photo:

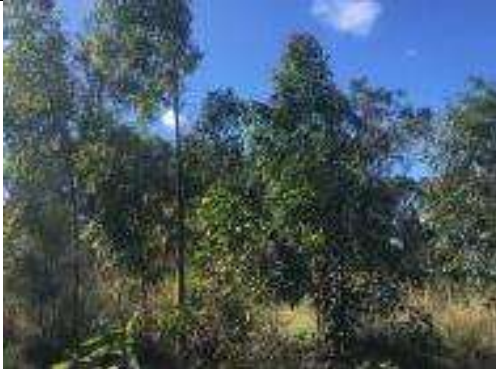
Monitoring month:	26	Months since direct seeding:	31
Date:	October 2017		
Comments:	No significant changes this month		
Native species:	<i>Corymbia citriodora, Capillipedium spicigerum, Acacia fimbriata, Acacia hubbardiana, Acacia concurrens, Acacia lieocalyx, Allocasurina littoralis, Cyperus polystachyos, Dodonaea viscosa, Pultenaea villosa, Parsonsia straminia, Melaleuca viminalis, Melaleuca salignus, Eucalyptus crebra, Hovea acutifolia</i>		
Weed species:	<i>Gomphocarpus physocarpus, Axonopus sp., Brachiaria decumbens, Cynodon dactylon</i>		
Damage:	Nil		
Native dominance:	90%	Percentage vegetation cover:	55%
Photo:

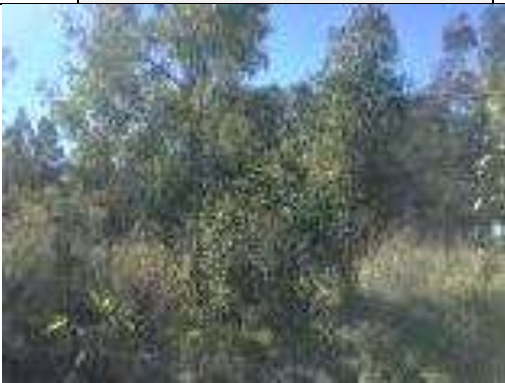
Monitoring month:	27	Months since direct seeding:	32
Date:	November 2017		
Comments:	A number of small rainfall events and warming temperatures are assisting with increasing the biomass of vegetation within this quadrat.		
Native species:	<i>Corymbia citriodora</i> , <i>Capillipedium spicigerum</i> , <i>Acacia fimbriata</i> , <i>Acacia hubbardiana</i> , <i>Acacia concurrens</i> , <i>Acacia lieocalyx</i> , <i>Allocasurina littoralis</i> , <i>Cyperus polystachyos</i> , <i>Dodonaea viscosa</i> , <i>Pultenaea villosa</i> , <i>Parsonsia straminia</i> , <i>Melaleuca viminalis</i> , <i>Melaleuca salignus</i> , <i>Eucalyptus crebra</i> , <i>Hovea acutifolia</i>		
Weed species:	<i>Gomphocarpus physocarpus</i> , <i>Axonopus sp.</i> , <i>Brachiaria decumbens</i> , <i>Cynodon dactylon</i>		
Damage:	Nil		
Native dominance:	90%	Percentage vegetation cover:	55%
Photo:

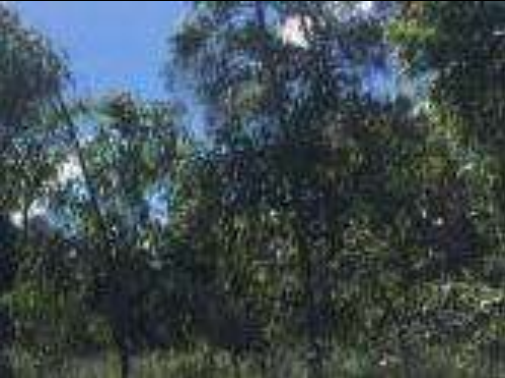
Monitoring month:	28	Months since direct seeding:	33
Date:	December 2017		
Comments:	Vegetation growth remains steady.		
Native species:	<i>Corymbia citriodora</i> , <i>Capillipedium spicigerum</i> , <i>Acacia fimbriata</i> , <i>Acacia hubbardiana</i> , <i>Acacia concurrens</i> , <i>Acacia lieocalyx</i> , <i>Allocasurina littoralis</i> , <i>Cyperus polystachyos</i> , <i>Dodonaea viscosa</i> , <i>Pultenaea villosa</i> , <i>Parsonsia straminia</i> , <i>Melaleuca viminalis</i> , <i>Melaleuca salignus</i> , <i>Eucalyptus crebra</i> , <i>Hovea acutifolia</i>		
Weed species:	<i>Gomphocarpus physocarpus</i> , <i>Axonopus sp.</i> , <i>Brachiaria decumbens</i> , <i>Cynodon dactylon</i>		
Damage:	Nil		
Native dominance:	90%	Percentage vegetation cover:	55%
Photo:

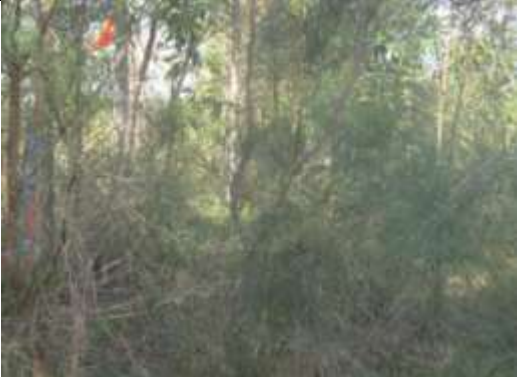
Monitoring month:	29	Months since direct seeding:	34
Date:	January 2017		
Comments:	Vegetation growth remains steady.		
Native species:	<i>Corymbia citriodora</i> , <i>Capillipedium spicigerum</i> , <i>Acacia fimbriata</i> , <i>Acacia hubbardiana</i> , <i>Acacia concurrens</i> , <i>Acacia lieocalyx</i> , <i>Allocasurina littoralis</i> , <i>Cyperus polystachyos</i> , <i>Dodonaea viscosa</i> , <i>Pultenaea villosa</i> , <i>Parsonsia straminia</i> , <i>Melaleuca viminalis</i> , <i>Melaleuca salignus</i> , <i>Eucalyptus crebra</i> , <i>Hovea acutifolia</i>		
Weed species:	<i>Gomphocarpus physocarpus</i> , <i>Axonopus sp.</i> , <i>Brachiaria decumbens</i> , <i>Cynodon dactylon</i>		
Damage:	Nil		
Native dominance:	90%	Percentage vegetation cover:	55%
Photo:

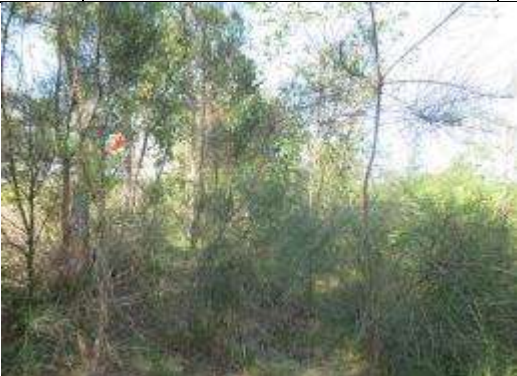
Monitoring month:	30	Months since direct seeding:	35
Date:	February 2018		
Comments:	Due to the location of this quadrat, it is quite dry and will benefit greatly from the next large rain event.		
Native species:	<i>Corymbia citriodora</i> , <i>Capillipedium spicigerum</i> , <i>Acacia fimbriata</i> , <i>Acacia hubbardiana</i> , <i>Acacia concurrens</i> , <i>Acacia lieocalyx</i> , <i>Allocasurina littoralis</i> , <i>Cyperus polystachyos</i> , <i>Dodonaea viscosa</i> , <i>Pultenaea villosa</i> , <i>Parsonsia straminia</i> , <i>Melaleuca viminalis</i> , <i>Melaleuca salignus</i> , <i>Eucalyptus crebra</i> , <i>Hovea acutifolia</i>		
Weed species:	<i>Gomphocarpus physocarpus</i> , <i>Axonopus sp.</i> , <i>Brachiaria decumbens</i> , <i>Cynodon dactylon</i>		
Damage:	Nil		
Native dominance:	90%	Percentage vegetation cover:	55%
Photo:

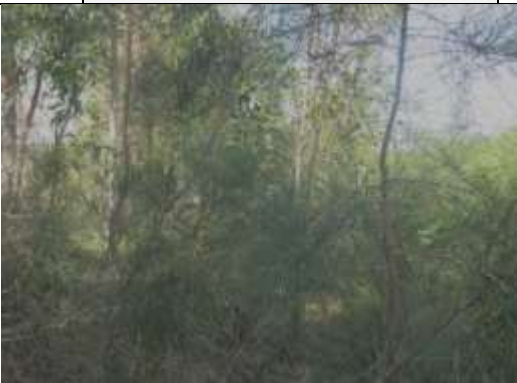
Monitoring month:	31	Months since direct seeding:	36
Date:	March 2018		
Comments:	Canopy is continuing to close. The native grass <i>Capillipedium spicigerum</i> continues to out compete the weed grass species.		
Native species:	<i>Corymbia citriodora</i> , <i>Capillipedium spicigerum</i> , <i>Acacia fimbriata</i> , <i>Acacia hubbardiana</i> , <i>Acacia concurrens</i> , <i>Acacia lieocalyx</i> , <i>Allocasurina littoralis</i> , <i>Cyperus polystachyos</i> , <i>Dodonaea viscosa</i> , <i>Pultenaea villosa</i> , <i>Parsonsia straminia</i> , <i>Melaleuca viminalis</i> , <i>Melaleuca salignus</i> , <i>Eucalyptus crebra</i> , <i>Hovea acutifolia</i>		
Weed species:	<i>Gomphocarpus physocarpus</i> , <i>Axonopus sp.</i> , <i>Brachiaria decumbens</i> , <i>Cynodon dactylon</i>		
Damage:	Nil		
Native dominance:	90%	Percentage vegetation cover:	55%
Photo:

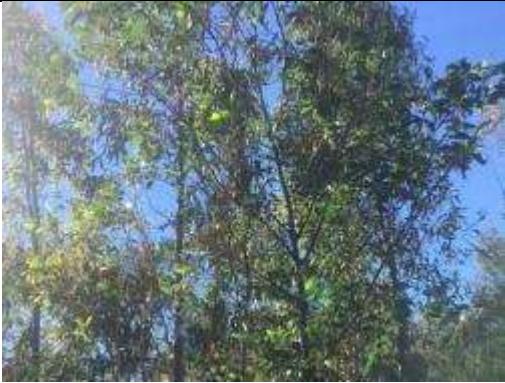
Monitoring month:	32	Months since direct seeding:	37
Date:	April 2018		
Comments:	Height and biomass of vegetation continues to increase.		
Native species:	<i>Corymbia citriodora</i> , <i>Capillipedium spicigerum</i> , <i>Acacia fimbriata</i> , <i>Acacia hubbardiana</i> , <i>Acacia concurrens</i> , <i>Acacia lieocalyx</i> , <i>Allocasurina littoralis</i> , <i>Cyperus polystachyos</i> , <i>Dodonaea viscosa</i> , <i>Pultenaea villosa</i> , <i>Parsonsia straminia</i> , <i>Melaleuca viminalis</i> , <i>Melaleuca salignus</i> , <i>Eucalyptus crebra</i> , <i>Hovea acutifolia</i>		
Weed species:	<i>Gomphocarpus physocarpus</i> , <i>Axonopus sp.</i> , <i>Brachiaria decumbens</i> , <i>Cynodon dactylon</i>		
Damage:	Nil		
Native dominance:	90%	Percentage vegetation cover:	55%
Photo:

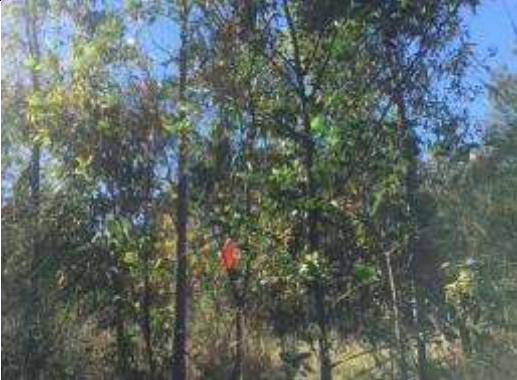
Monitoring month:	33	Months since direct seeding:	38
Date:	May 2018		
Comments:	Vegetation growth remains steady.		
Native species:	<i>Corymbia citriodora</i> , <i>Capillipedium spicigerum</i> , <i>Acacia fimbriata</i> , <i>Acacia hubbardiana</i> , <i>Acacia concurrens</i> , <i>Acacia lieocalyx</i> , <i>Allocasurina littoralis</i> , <i>Cyperus polystachyos</i> , <i>Dodonaea viscosa</i> , <i>Pultenaea villosa</i> , <i>Parsonsia straminia</i> , <i>Melaleuca viminalis</i> , <i>Melaleuca salignus</i> , <i>Eucalyptus crebra</i> , <i>Hovea acutifolia</i>		
Weed species:	<i>Gomphocarpus physocarpus</i> , <i>Axonopus sp.</i> , <i>Brachiaria decumbens</i> , <i>Cynodon dactylon</i>		
Damage:	Nil		
Native dominance:	90%	Percentage vegetation cover:	55%
Photo:

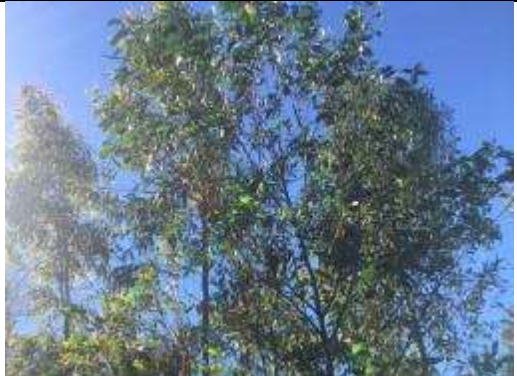
Monitoring month:	34	Months since direct seeding:	39
Date:	June 2018		
Comments:	No significant changes this month due to the slowing down of the growing season.		
Native species:	<i>Corymbia citriodora</i> , <i>Capillipedium spicigerum</i> , <i>Acacia fimbriata</i> , <i>Acacia hubbardiana</i> , <i>Acacia concurrens</i> , <i>Acacia lieocalyx</i> , <i>Allocasurina littoralis</i> , <i>Cyperus polystachyos</i> , <i>Dodonaea viscosa</i> , <i>Pultenaea villosa</i> , <i>Parsonsia straminia</i> , <i>Melaleuca viminalis</i> , <i>Melaleuca salignus</i> , <i>Eucalyptus crebra</i> , <i>Hovea acutifolia</i>		
Weed species:	<i>Gomphocarpus physocarpus</i> , <i>Axonopus sp.</i> , <i>Brachiaria decumbens</i> , <i>Cynodon dactylon</i>		
Damage:	Nil		
Native dominance:	90%	Percentage vegetation cover:	60%
Photo:

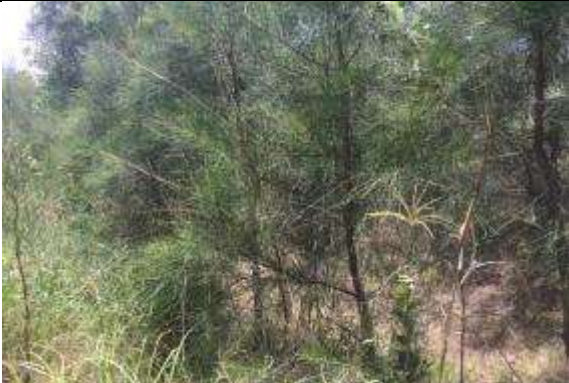
Monitoring month:	35	Months since direct seeding:	40
Date:	July 2018		
Comments:	Winter has notably impacted weed abundance and diversity.		
Native species:	<i>Corymbia citriodora</i> , <i>Capillipedium spicigerum</i> , <i>Acacia fimbriata</i> , <i>Acacia hubbardiana</i> , <i>Acacia concurrens</i> , <i>Acacia lieocalyx</i> , <i>Allocasurina littoralis</i> , <i>Cyperus polystachyos</i> , <i>Dodonaea viscosa</i> , <i>Pultenaea villosa</i> , <i>Parsonsia straminia</i> , <i>Melaleuca viminalis</i> , <i>Melaleuca salignus</i> , <i>Eucalyptus crebra</i> , <i>Hovea acutifolia</i>		
Weed species:	<i>Cynodon dactylon</i>		
Damage:	Nil		
Native dominance:	90%	Percentage vegetation cover:	70%
Photo:

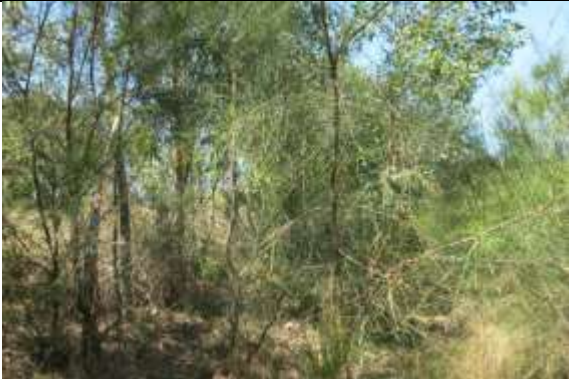
Monitoring month:	36	Months since direct seeding:	41
Date:	August 2018		
Comments:	<i>Corymbia citriodora</i> recorded with mature seed. Many species in flower and seed within this quadrat and surrounding area.		
Native species:	<i>Corymbia citriodora</i> , <i>Capillipedium spicigerum</i> , <i>Acacia fimbriata</i> , <i>Acacia hubbardiana</i> , <i>Acacia concurrens</i> , <i>Acacia lieocalyx</i> , <i>Allocasurina littoralis</i> , <i>Cyperus polystachyos</i> , <i>Dodonaea viscosa</i> , <i>Pultenaea villosa</i> , <i>Parsonsia straminia</i> , <i>Melaleuca viminalis</i> , <i>Melaleuca salignus</i> , <i>Eucalyptus crebra</i> , <i>Hovea acutifolia</i>		
Weed species:	<i>Cynodon dactylon</i>		
Damage:	Nil		
Native dominance:	90%	Percentage vegetation cover:	70%
Photo:

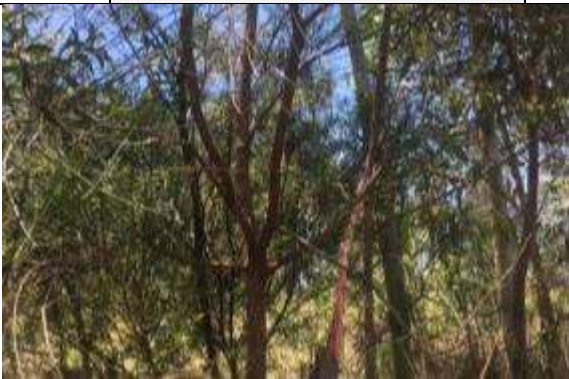
Monitoring month:	37	Months since direct seeding:	42
Date:	September 2018		
Comments:	This quadrat is progressively transitioning towards a grassy woodland structure with dominance of native grasses in the understorey.		
Native species:	<i>Corymbia citriodora</i> , <i>Capillipedium spicigerum</i> , <i>Acacia fimbriata</i> , <i>Acacia hubbardiana</i> , <i>Acacia concurrens</i> , <i>Acacia lieocalyx</i> , <i>Allocasurina littoralis</i> , <i>Cyperus polystachyos</i> , <i>Dodonaea viscosa</i> , <i>Pultenaea villosa</i> , <i>Parsonsia straminia</i> , <i>Melaleuca viminalis</i> , <i>Melaleuca salignus</i> , <i>Eucalyptus crebra</i> , <i>Hovea acutifolia</i>		
Weed species:	<i>Cynodon dactylon</i>		
Damage:	Nil		
Native dominance:	90%	Percentage vegetation cover:	70%
Photo:

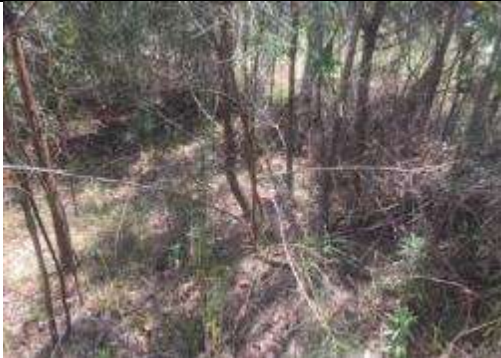
Monitoring month:	38	Months since direct seeding:	43
Date:	October 2018		
Comments:	Rainfall occurred throughout the area during this month which has assisted with the increase in biomass.		
Native species:	<i>Corymbia citriodora</i> , <i>Capillipedium spicigerum</i> , <i>Acacia fimbriata</i> , <i>Acacia hubbardiana</i> , <i>Acacia concurrens</i> , <i>Acacia lieocalyx</i> , <i>Allocasurina littoralis</i> , <i>Cyperus polystachyos</i> , <i>Dodonaea viscosa</i> , <i>Pultenaea villosa</i> , <i>Parsonsia straminia</i> , <i>Melaleuca viminalis</i> , <i>Melaleuca salignus</i> , <i>Eucalyptus crebra</i> , <i>Hovea acutifolia</i>		
Weed species:	<i>Cynodon dactylon</i>		
Damage:	Nil		
Native dominance:	90%	Percentage vegetation cover:	70%
Photo:

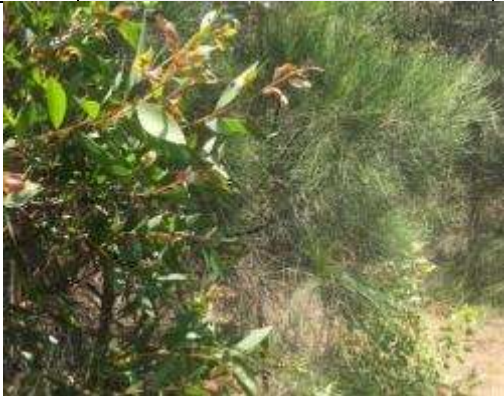
Monitoring month:	40	Months since direct seeding:	45
Date:	December 2018		
Comments:	Vegetation growth was steady this month.		
Native species:	<i>Corymbia citriodora, Capillipedium spicigerum, Acacia fimbriata, Acacia hubbardiana, Acacia concurrens, Acacia lieocalyx, Allocasurina littoralis, Cyperus polystachyos, Dodonaea viscosa, Pultenaea villosa, Parsonsia straminia, Melaleuca viminalis, Melaleuca salignus, Eucalyptus crebra, Hovea acutifolia</i>		
Weed species:	<i>Cynodon dactylon</i>		
Damage:	Nil		
Native dominance:	90%	Percentage vegetation cover:	70%
Photo:
