North-West Conservation Park - Rehabilitation Monitoring

Lot 1 RP48903

North-West Conservation Park
Gainsborough Greens

March 2020

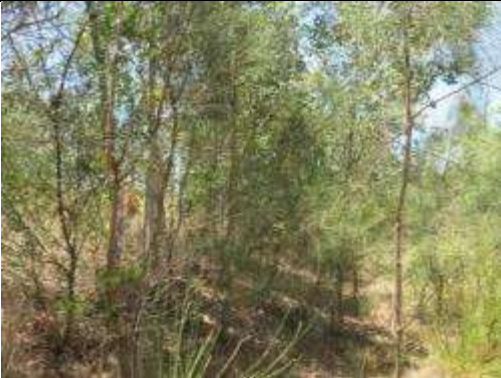
Monitoring month:	42	Months since direct seeding:	47
Date:	February 2019		
Comments:	<i>Corymbia citriodora</i> recorded with mature seed.		
Native species:	<i>Corymbia citriodora</i> , <i>Capillipedium spicigerum</i> , <i>Acacia fimbriata</i> , <i>Acacia hubbardiana</i> , <i>Acacia concurrens</i> , <i>Acacia lieocalyx</i> , <i>Allocasurina littoralis</i> , <i>Cyperus polystachyos</i> , <i>Dodonaea viscosa</i> , <i>Pultenaea villosa</i> , <i>Parsonsia straminia</i> , <i>Melaleuca viminalis</i> , <i>Melaleuca salignus</i> , <i>Eucalyptus crebra</i> , <i>Hovea acutifolia</i>		
Weed species:	<i>Cynodon dactylon</i>		
Damage:	Nil		
Native dominance:	90%	Percentage vegetation cover:	70%
Photo:

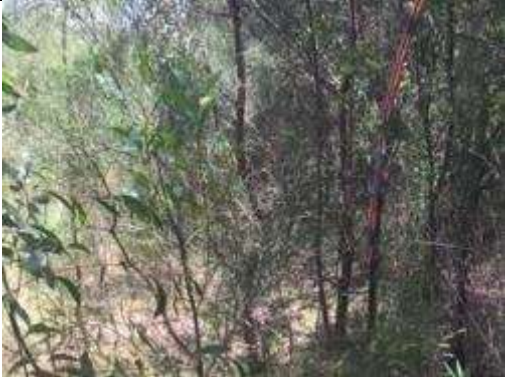
Monitoring month:	43	Months since direct seeding:	48
Date:	March 2019		
Comments:	No significant changes occurred this month.		
Native species:	<i>Corymbia citriodora</i> , <i>Capillipedium spicigerum</i> , <i>Acacia fimbriata</i> , <i>Acacia hubbardiana</i> , <i>Acacia concurrens</i> , <i>Acacia lieocalyx</i> , <i>Allocasurina littoralis</i> , <i>Cyperus polystachyos</i> , <i>Dodonaea viscosa</i> , <i>Pultenaea villosa</i> , <i>Parsonsia straminia</i> , <i>Melaleuca viminalis</i> , <i>Melaleuca salignus</i> , <i>Eucalyptus crebra</i> , <i>Hovea acutifolia</i>		
Weed species:	<i>Cynodon dactylon</i>		
Damage:	Nil		
Native dominance:	90%	Percentage vegetation cover:	70%
Photo:

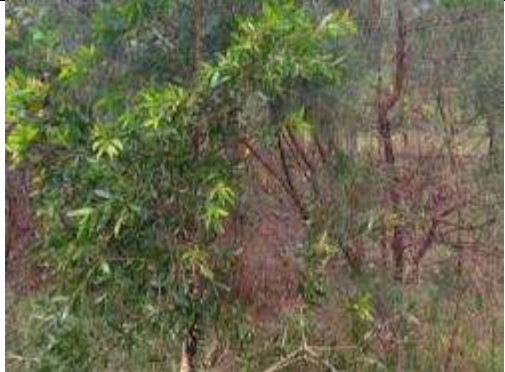
Monitoring month:	44	Months since direct seeding:	49
Date:	April 2019		
Comments:	Rainfall events increased late last month and continued this month giving the NWCP a much needed watering.		
Native species:	<i>Corymbia citriodora</i> , <i>Capillipedium spicigerum</i> , <i>Acacia fimbriata</i> , <i>Acacia hubbardiana</i> , <i>Acacia concurrens</i> , <i>Acacia lieocalyx</i> , <i>Allocasurina littoralis</i> , <i>Cyperus polystachyos</i> , <i>Dodonaea viscosa</i> , <i>Pultenaea villosa</i> , <i>Parsonsia straminia</i> , <i>Melaleuca viminalis</i> , <i>Melaleuca salignus</i> , <i>Eucalyptus crebra</i> , <i>Hovea acutifolia</i>		
Weed species:	<i>Cynodon dactylon</i>		
Damage:	Nil		
Native dominance:	95%	Percentage vegetation cover:	75%
Photo:

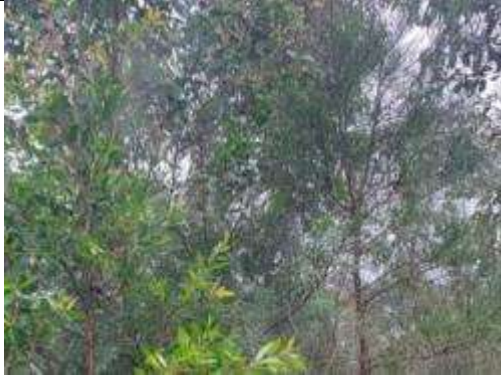
Monitoring month:	45	Months since direct seeding:	50
Date:	May 2019		
Comments:	No significant changes occurred this month.		
Native species:	<i>Corymbia citriodora</i> , <i>Capillipedium spicigerum</i> , <i>Acacia fimbriata</i> , <i>Acacia hubbardiana</i> , <i>Acacia concurrens</i> , <i>Acacia lieocalyx</i> , <i>Allocasurina littoralis</i> , <i>Cyperus polystachyos</i> , <i>Dodonaea viscosa</i> , <i>Pultenaea villosa</i> , <i>Parsonsia straminia</i> , <i>Melaleuca viminalis</i> , <i>Melaleuca salignus</i> , <i>Eucalyptus crebra</i> , <i>Hovea acutifolia</i>		
Weed species:	<i>Cynodon dactylon</i>		
Damage:	Nil		
Native dominance:	95%	Percentage vegetation cover:	80%
Photo:

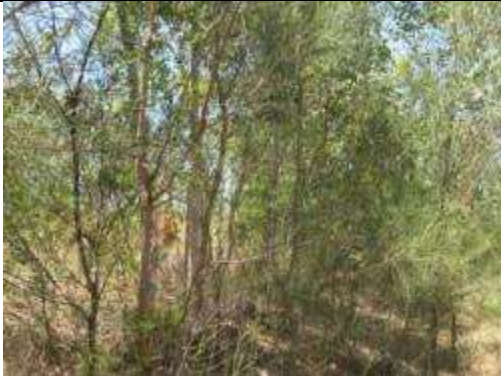
Monitoring month:	46	Months since direct seeding:	51
Date:	June 2019		
Comments:	Rainfall over the past few months has increased plant growth and vigour.		
Native species:	<i>Corymbia citriodora</i> , <i>Capillipedium spicigerum</i> , <i>Acacia fimbriata</i> , <i>Acacia hubbardiana</i> , <i>Acacia concurrens</i> , <i>Acacia lieocalyx</i> , <i>Allocasurina littoralis</i> , <i>Cyperus polystachyos</i> , <i>Dodonaea viscosa</i> , <i>Pultenaea villosa</i> , <i>Parsonsia straminia</i> , <i>Melaleuca viminalis</i> , <i>Melaleuca salignus</i> , <i>Eucalyptus crebra</i> , <i>Hovea acutifolia</i>		
Weed species:	<i>Cynodon dactylon</i>		
Damage:	Nil		
Native dominance:	95%	Percentage vegetation cover:	80%
Photo:

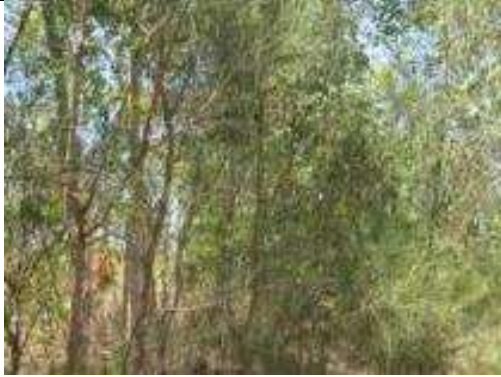
Monitoring month:	47	Months since direct seeding:	52
Date:	July 2019		
Comments:	Vegetation growth is steady.		
Native species:	<i>Corymbia citriodora</i> , <i>Capillipedium spicigerum</i> , <i>Acacia fimbriata</i> , <i>Acacia hubbardiana</i> , <i>Acacia concurrens</i> , <i>Acacia lieocalyx</i> , <i>Allocasurina littoralis</i> , <i>Cyperus polystachyos</i> , <i>Dodonaea viscosa</i> , <i>Pultenaea villosa</i> , <i>Parsonsia straminia</i> , <i>Melaleuca viminalis</i> , <i>Melaleuca salignus</i> , <i>Eucalyptus crebra</i> , <i>Hovea acutifolia</i>		
Weed species:	<i>Cynodon dactylon</i>		
Damage:	Nil		
Native dominance:	95%	Percentage vegetation cover:	80%
Photo:

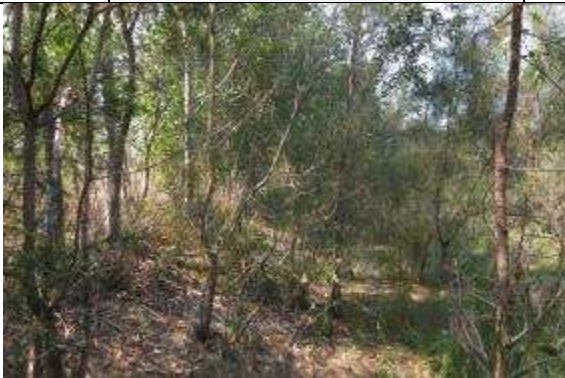
Monitoring month:	48	Months since direct seeding:	53
Date:	August 2019		
Comments:	Leaf litter has now reached complete soil coverage, providing soil enrichment.		
Native species:	<i>Corymbia citriodora</i> , <i>Capillipedium spicigerum</i> , <i>Acacia fimbriata</i> , <i>Acacia hubbardiana</i> , <i>Acacia concurrens</i> , <i>Acacia lieocalyx</i> , <i>Allocasurina littoralis</i> , <i>Cyperus polystachyos</i> , <i>Dodonaea viscosa</i> , <i>Pultenaea villosa</i> , <i>Parsonsia straminia</i> , <i>Melaleuca viminalis</i> , <i>Melaleuca salignus</i> , <i>Eucalyptus crebra</i> , <i>Hovea acutifolia</i>		
Weed species:	<i>Cynodon dactylon</i>		
Damage:	Nil		
Native dominance:	95%	Percentage vegetation cover:	80%
Photo:

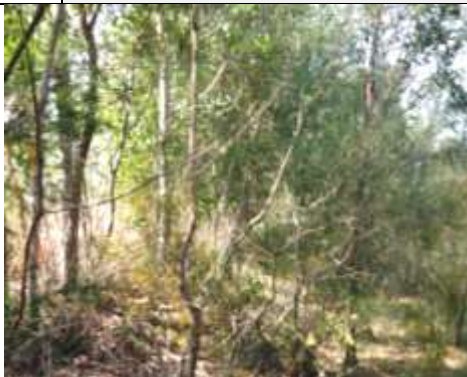
Monitoring month:	49	Months since direct seeding:	54
Date:	September 2019		
Comments:	<i>Leptospermum polygalifolium</i> is flowering in the surrounding area for the second time.		
Native species:	<i>Corymbia citriodora</i> , <i>Capillipedium spicigerum</i> , <i>Acacia fimbriata</i> , <i>Acacia hubbardiana</i> , <i>Acacia concurrens</i> , <i>Acacia lieocalyx</i> , <i>Allocasurina littoralis</i> , <i>Cyperus polystachyos</i> , <i>Dodonaea viscosa</i> , <i>Pultenaea villosa</i> , <i>Parsonsia straminia</i> , <i>Melaleuca viminalis</i> , <i>Melaleuca salignus</i> , <i>Eucalyptus crebra</i> , <i>Hovea acutifolia</i>		
Weed species:	<i>Cynodon dactylon</i>		
Damage:	Nil		
Native dominance:	95%	Percentage vegetation cover:	80%
Photo:

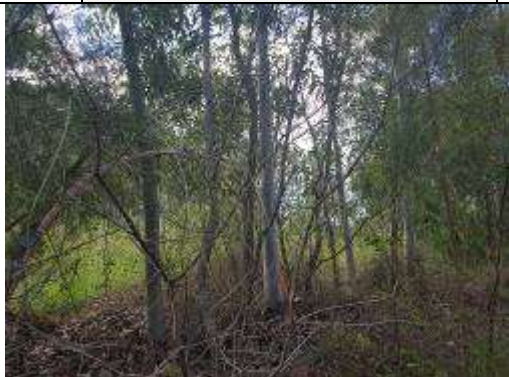
Monitoring month:	50	Months since direct seeding:	55
Date:	October 2019		
Comments:	Extended drought conditions are starting to take their toll with the extreme slowing of plant growth.		
Native species:	<i>Corymbia citriodora</i> , <i>Capillipedium spicigerum</i> , <i>Acacia fimbriata</i> , <i>Acacia hubbardiana</i> , <i>Acacia concurrens</i> , <i>Acacia lieocalyx</i> , <i>Allocasurina littoralis</i> , <i>Cyperus polystachyos</i> , <i>Dodonaea viscosa</i> , <i>Pultenaea villosa</i> , <i>Parsonsia straminia</i> , <i>Melaleuca viminalis</i> , <i>Melaleuca salignus</i> , <i>Eucalyptus crebra</i> , <i>Hovea acutifolia</i>		
Weed species:	<i>Cynodon dactylon</i>		
Damage:	Nil		
Native dominance:	95%	Percentage vegetation cover:	80%
Photo:

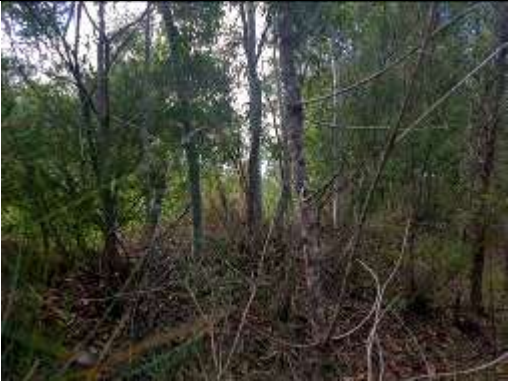
Monitoring month:	51	Months since direct seeding:	56
Date:	November 2019		
Comments:	No significant changes.		
Native species:	<i>Corymbia citriodora</i> , <i>Capillipedium spicigerum</i> , <i>Acacia fimbriata</i> , <i>Acacia hubbardiana</i> , <i>Acacia concurrens</i> , <i>Acacia lieocalyx</i> , <i>Allocasurina littoralis</i> , <i>Cyperus polystachyos</i> , <i>Dodonaea viscosa</i> , <i>Pultenaea villosa</i> , <i>Parsonsia straminia</i> , <i>Melaleuca viminalis</i> , <i>Melaleuca salignus</i> , <i>Eucalyptus crebra</i> , <i>Hovea acutifolia</i>		
Weed species:	<i>Cynodon dactylon</i>		
Damage:	Nil		
Native dominance:	95%	Percentage vegetation cover:	80%
Photo:

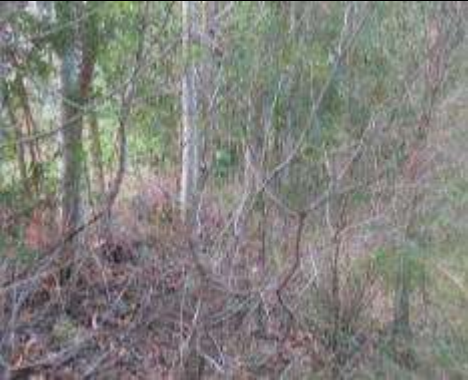
Monitoring month:	52	Months since direct seeding:	57
Date:	December 2019		
Comments:	Quadrat continues to mature.		
Native species:	<i>Corymbia citriodora</i> , <i>Capillipedium spicigerum</i> , <i>Acacia fimbriata</i> , <i>Acacia hubbardiana</i> , <i>Acacia concurrens</i> , <i>Acacia lieocalyx</i> , <i>Allocasurina littoralis</i> , <i>Cyperus polystachyos</i> , <i>Dodonaea viscosa</i> , <i>Pultenaea villosa</i> , <i>Parsonsia straminia</i> , <i>Melaleuca viminalis</i> , <i>Melaleuca salignus</i> , <i>Eucalyptus crebra</i> , <i>Hovea acutifolia</i>		
Weed species:	<i>Cynodon dactylon</i>		
Damage:	Nil		
Native dominance:	95%	Percentage vegetation cover:	80%
Photo:

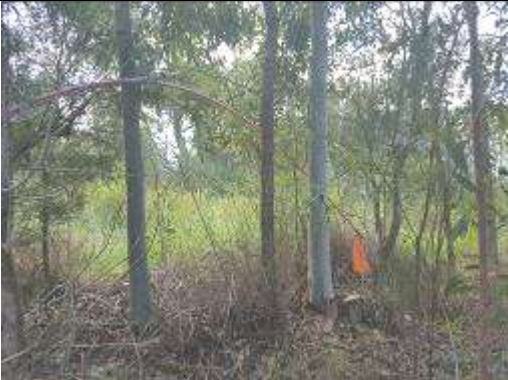
Monitoring month:	53	Months since direct seeding:	58
Date:	January 2020		
Comments:	Biomass continues to increase.		
Native species:	<i>Corymbia citriodora</i> , <i>Capillipedium spicigerum</i> , <i>Acacia fimbriata</i> , <i>Acacia hubbardiana</i> , <i>Acacia concurrens</i> , <i>Acacia lieocalyx</i> , <i>Allocasurina littoralis</i> , <i>Cyperus polystachyos</i> , <i>Dodonaea viscosa</i> , <i>Pultenaea villosa</i> , <i>Parsonsia straminia</i> , <i>Melaleuca viminalis</i> , <i>Melaleuca salignus</i> , <i>Eucalyptus crebra</i> , <i>Hovea acutifolia</i>		
Weed species:	<i>Cynodon dactylon</i>		
Damage:	Nil		
Native dominance:	95%	Percentage vegetation cover:	80%
Photo:

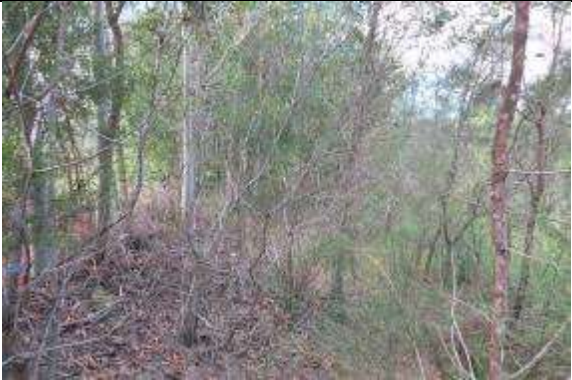
Monitoring month:	54	Months since direct seeding:	59
Date:	February 2020		
Comments:	Leaf litter now covers the entire quadrat.		
Native species:	<i>Corymbia citriodora</i> , <i>Capillipedium spicigerum</i> , <i>Acacia fimbriata</i> , <i>Acacia hubbardiana</i> , <i>Acacia concurrens</i> , <i>Acacia lieocalyx</i> , <i>Allocasurina littoralis</i> , <i>Cyperus polystachyos</i> , <i>Dodonaea viscosa</i> , <i>Pultenaea villosa</i> , <i>Parsonsia straminia</i> , <i>Melaleuca viminalis</i> , <i>Melaleuca salignus</i> , <i>Eucalyptus crebra</i> , <i>Hovea acutifolia</i>		
Weed species:	<i>Cynodon dactylon</i>		
Damage:	Nil		
Native dominance:	95%	Percentage vegetation cover:	80%
Photo:

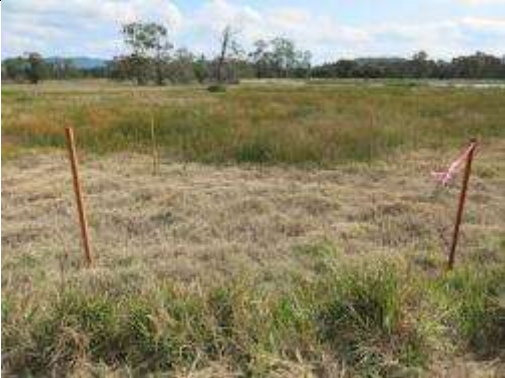
4.11 Quadrat 11

Monitoring month:	1	Months since direct seeding:	6
Date:	September 2015		
Comments:	This is the only quadrat that has been left undisturbed. The quadrat and areas seen in the background were previously dominated by weeds prior to being slashed. Slashing works avoided small isolated stands of <i>Cynodon</i> and <i>Eleocharis</i> . This effort, coupled with flood rains has created a remarkable result with native plant communities now dominating the entire site.		
Native species:	<i>Eleocharis dulcis</i>		
Weed species:	<i>Cynodon dactylon</i>		
Damage:	Nil		
Native dominance:	80%	Percentage vegetation cover:	100%
Photo:

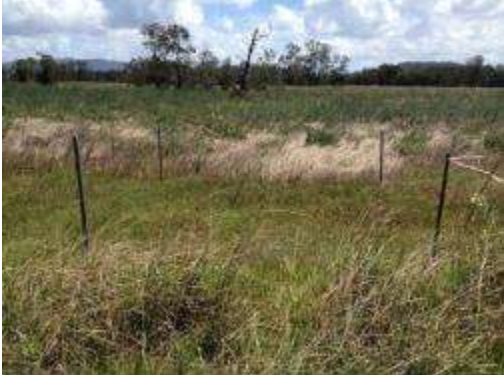
Monitoring month:	6	Months since direct seeding:	11
Date:	February 2016		
Comments:	No new weed species identified and natives continue to dominate. In the background you can see clumping weed species, particularly Aster and Milk Thistle. It's evident with the absence of water logging, weed species can behave differently than when the area is inundated. Inundation on this site is actually an asset towards weed control.		
Native species:	<i>Eleocharis dulcis, Cyperus polystachyos</i>		
Weed species:	<i>Aster subulatus, Cynodon dactylon, Sonchus oleraceus</i>		
Damage:	Nil		
Native dominance:	75%	Percentage vegetation cover:	100%
Photo:

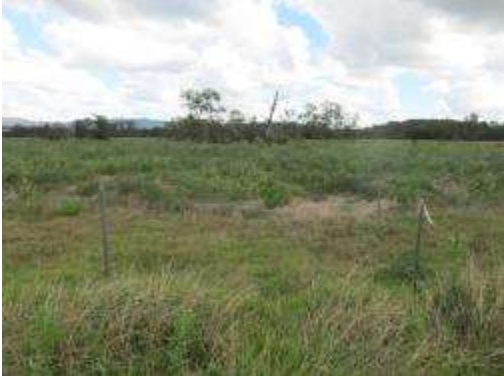
Monitoring month:	7	Months since direct seeding:	12
Date:	March 2016		
Comments:	No new weed species identified and natives continue to dominate. Inundation on this site has been an asset towards weed control.		
Native species:	<i>Eleocharis dulcis</i> , <i>Cyperus polystachyos</i>		
Weed species:	<i>Aster subulatus</i> , <i>Cynodon dactylon</i> , <i>Sonchus oleraceus</i>		
Damage:	Nil		
Native dominance:	75%	Percentage vegetation cover:	100%
Photo:

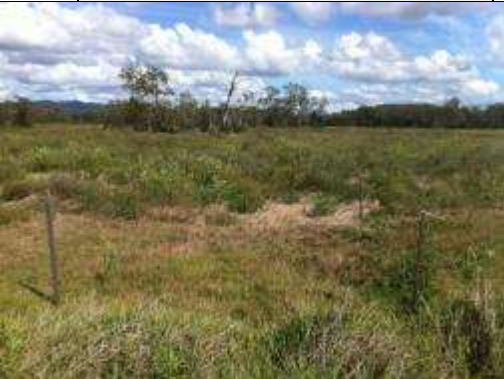
Monitoring month:	8	Months since direct seeding:	13
Date:	April 2016		
Comments:	No new weed species identified and natives continue to dominate. Inundation on this site has been an asset towards weed control.		
Native species:	<i>Eleocharis dulcis</i> , <i>Cyperus polystachyos</i>		
Weed species:	<i>Aster subulatus</i> , <i>Cynodon dactylon</i> , <i>Sonchus oleraceus</i>		
Damage:	Nil		
Native dominance:	75%	Percentage vegetation cover:	100%
Photo:

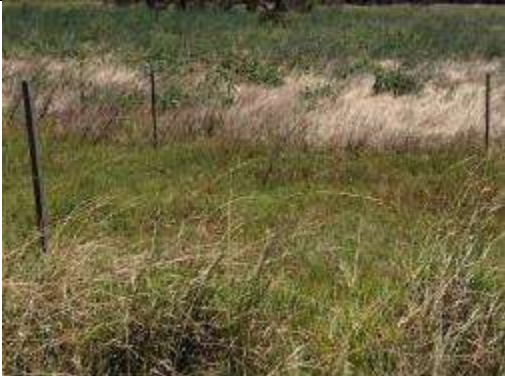
Monitoring month:	9	Months since direct seeding:	14
Date:	May 2016		
Comments:	No significant changes recorded this month.		
Native species:	<i>Eleocharis dulcis</i> , <i>Cyperus polystachyos</i>		
Weed species:	<i>Aster subulatus</i> , <i>Cynodon dactylon</i> , <i>Sonchus oleraceus</i>		
Damage:	Nil		
Native dominance:	70%	Percentage vegetation cover:	100%
Photo:

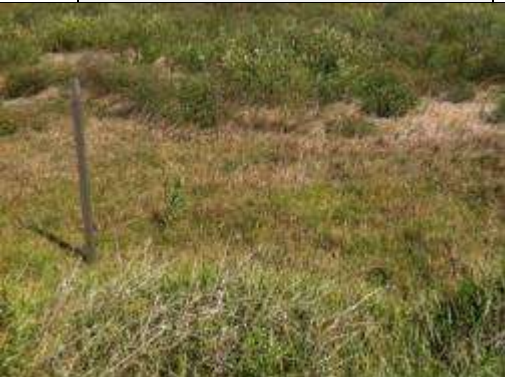
Monitoring month:	10	Months since direct seeding:	15
Date:	June 2016		
Comments:	Native dominance is slightly lower this month due to the onset of cooler temperatures.		
Native species:	<i>Eleocharis dulcis</i> , <i>Cyperus polystachyos</i>		
Weed species:	<i>Aster subulatus</i> , <i>Cynodon dactylon</i> , <i>Sonchus oleraceus</i>		
Damage:	Nil		
Native dominance:	65%	Percentage vegetation cover:	100%
Photo:

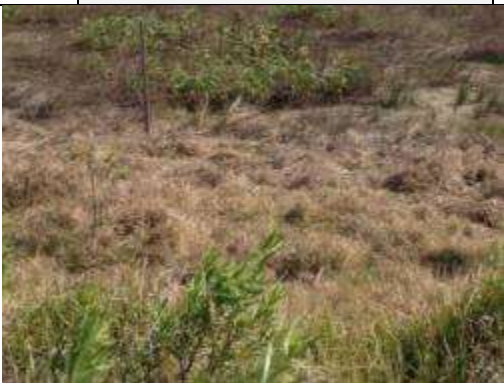
Monitoring month:	11	Months since direct seeding:	16
Date:	July 2016		
Comments:	Wintering is extremely notable this month with the significant die-off of Aster. <i>Gomphocarpus physocarpus</i> has been identified within the quadrat for the first time this month.		
Native species:	<i>Eleocharis dulcis</i> , <i>Cyperus polystachyos</i>		
Weed species:	<i>Aster subulatus</i> , <i>Cynodon dactylon</i> , <i>Sonchus oleraceus</i> , <i>Gomphocarpus physocarpus</i>		
Damage:	Nil		
Native dominance:	65%	Percentage vegetation cover:	100%
Photo:

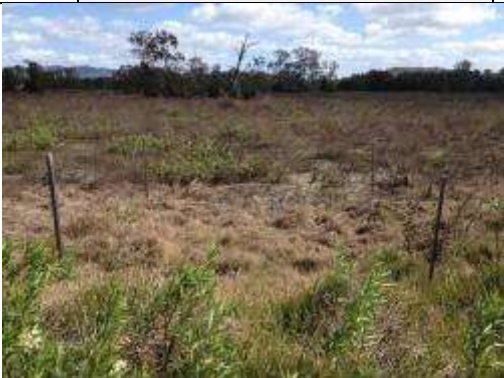
Monitoring month:	12	Months since direct seeding:	17
Date:	August 2016		
Comments:	There is an ongoing change in abundance and dominance of different species within this quadrat. <i>Persicaria attenuata</i> located in the surrounding area can be seen taking advantage of the lack of competition, spreading rapidly.		
Native species:	<i>Eleocharis dulcis</i> , <i>Cyperus polystachyos</i> , <i>Elaeocharis equisetina</i>		
Weed species:	<i>Aster subulatus</i> , <i>Cynodon dactylon</i> , <i>Sonchus oleraceus</i> , <i>Gomphocarpus physocarpus</i>		
Damage:	Nil		
Native dominance:	65%	Percentage vegetation cover:	100%
Photo:

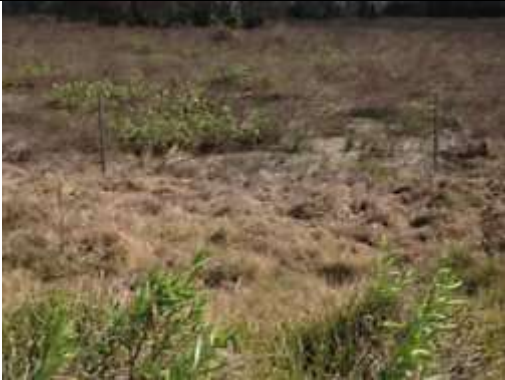
Monitoring month:	13	Months since direct seeding:	18
Date:	September 2016		
Comments:	<i>Cynodon dactylon</i> continues to grow and is moving closer to taking over dominance within this quadrat.		
Native species:	<i>Eleocharis dulcis</i> , <i>Cyperus polystachyos</i> , <i>Elaeocharis equisetina</i>		
Weed species:	<i>Aster subulatus</i> , <i>Cynodon dactylon</i> , <i>Sonchus oleraceus</i> , <i>Gomphocarpus physocarpus</i>		
Damage:	Nil		
Native dominance:	65%	Percentage vegetation cover:	100%
Photo:

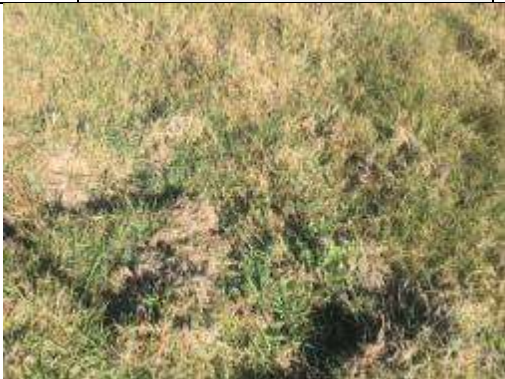
Monitoring month:	14	Months since direct seeding:	19
Date:	October 2016		
Comments:	<i>Cynodon dactylon</i> continues to edge closer to dominance.		
Native species:	<i>Eleocharis dulcis</i> , <i>Cyperus polystachyos</i> , <i>Elaeocharis equisetina</i>		
Weed species:	<i>Aster subulatus</i> , <i>Cynodon dactylon</i> , <i>Sonchus oleraceus</i> , <i>Gomphocarpus physocarpus</i>		
Damage:	Nil		
Native dominance:	50%	Percentage vegetation cover:	100%
Photo:

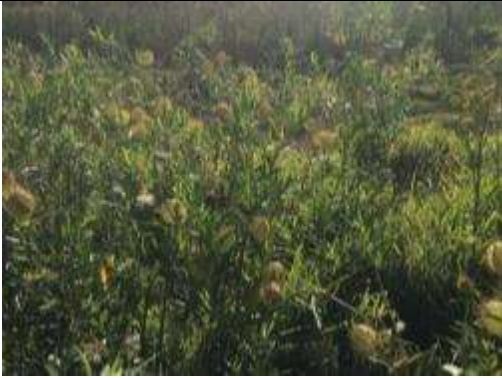
Monitoring month:	15	Months since direct seeding:	20
Date:	November 2016		
Comments:	<i>Gomphocarpus physocarpus</i> is becoming dominant in the surrounding areas and encroaching further into the quadrat.		
Native species:	<i>Eleocharis dulcis</i> , <i>Cyperus polystachyos</i> , <i>Elaeocharis equisetina</i>		
Weed species:	<i>Aster subulatus</i> , <i>Cynodon dactylon</i> , <i>Sonchus oleraceus</i> , <i>Gomphocarpus physocarpus</i>		
Damage:	Nil		
Native dominance:	50%	Percentage vegetation cover:	100%
Photo:

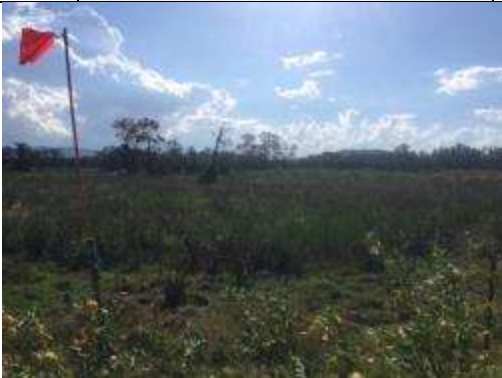
Monitoring month:	16	Months since direct seeding:	21
Date:	December 2016		
Comments:	A high visibility flag and extended pole was added to the quadrat stake this month for ease of identification. No other significant changes were recorded this month.		
Native species:	<i>Eleocharis dulcis</i> , <i>Cyperus polystachyos</i> , <i>Elaeocharis equisetina</i>		
Weed species:	<i>Aster subulatus</i> , <i>Cynodon dactylon</i> , <i>Sonchus oleraceus</i> , <i>Gomphocarpus physocarpus</i>		
Damage:	Nil		
Native dominance:	45%	Percentage vegetation cover:	100%
Photo:

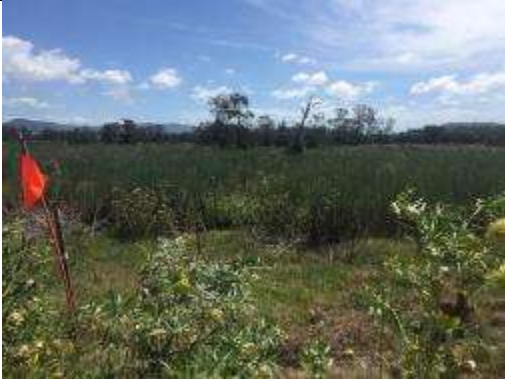
Monitoring month:	17	Months since direct seeding:	22
Date:	January 2017		
Comments:	<i>Cynodon dactylon</i> continues to dominate within this quadrat.		
Native species:	<i>Eleocharis dulcis</i> , <i>Cyperus polystachyos</i> , <i>Elaeocharis equisetina</i>		
Weed species:	<i>Aster subulatus</i> , <i>Cynodon dactylon</i> , <i>Sonchus oleraceus</i> , <i>Gomphocarpus physocarpus</i>		
Damage:	Nil		
Native dominance:	45%	Percentage vegetation cover:	100%
Photo:

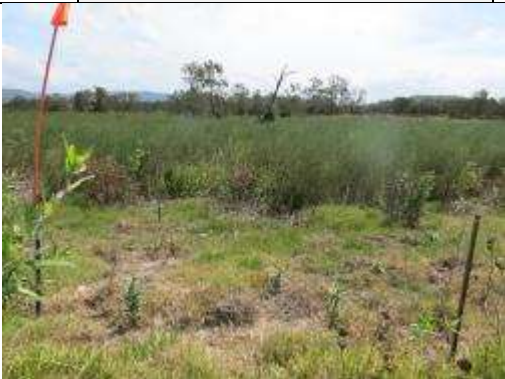
Monitoring month:	18	Months since direct seeding:	23
Date:	February 2017		
Comments:	No significant change recorded within this quadrat. Aster continues to spread behind this quadrat.		
Native species:	<i>Eleocharis dulcis</i> , <i>Cyperus polystachyos</i> , <i>Elaeocharis equisetina</i>		
Weed species:	<i>Aster subulatus</i> , <i>Cynodon dactylon</i> , <i>Sonchus oleraceus</i> , <i>Gomphocarpus physocarpus</i>		
Damage:	Nil		
Native dominance:	45%	Percentage vegetation cover:	100%
Photo:

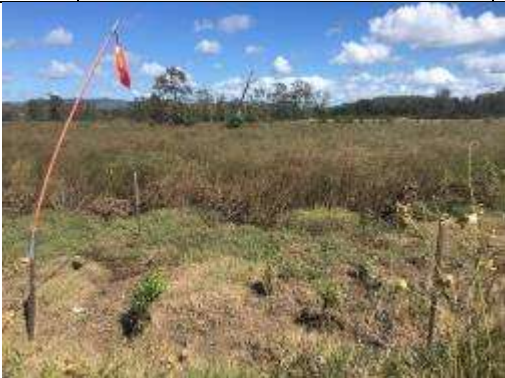
Photo:

Monitoring month:	19	Months since direct seeding:	24
Date:	March 2017 (NB: monitoring event occurred early April due to inaccessibility)		
Comments:	During the last half of this month, the NWCP received significant rainfall. Access to the area was limited. Much of the area is waterlogged and functioning as the wetland it is designed to be. No significant change recorded within this quadrat. Waterlogging is evident within this quadrant. Aster continues to spread in the background, however this annual will commence senescence soon.		
Native species:	<i>Eleocharis dulcis</i> , <i>Cyperus polystachyos</i> , <i>Elaeocharis equisetina</i>		
Weed species:	<i>Aster subulatus</i> , <i>Cynodon dactylon</i> , <i>Sonchus oleraceus</i> , <i>Gomphocarpus physocarpus</i>		
Damage:	Nil - large weather event associated with Ex-Tropical Cyclone Debbie did not result in any damage		
Native dominance:	45%	Percentage vegetation cover:	100%

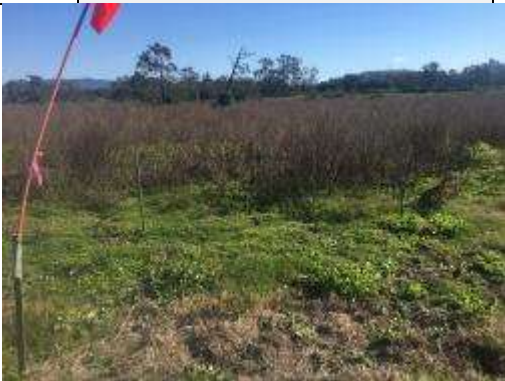
Monitoring month:	20	Months since direct seeding:	25
Date:	April 2017		
Comments:	Minor waterlogging is still evident within this quadrant. Aster has moved into the senescence stage of its lifecycle.		
Native species:	<i>Eleocharis dulcis</i> , <i>Cyperus polystachyos</i> , <i>Elaeocharis equisetina</i>		
Weed species:	<i>Aster subulatus</i> , <i>Cynodon dactylon</i> , <i>Sonchus oleraceus</i> , <i>Gomphocarpus physocarpus</i>		
Damage:	Nil		
Native dominance:	45%	Percentage vegetation cover:	100%
Photo:

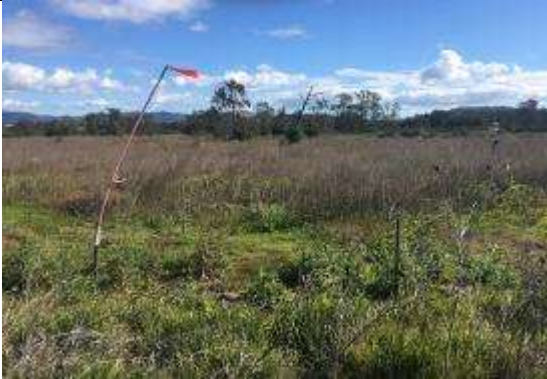
Monitoring month:	21	Months since direct seeding:	26
Date:	May 2017		
Comments:	Growth conditions remain unchanged, with this quadrat continuing to underwhelm.		
Native species:	<i>Eleocharis dulcis</i> , <i>Cyperus polystachyos</i> , <i>Elaeocharis equisetina</i>		
Weed species:	<i>Aster subulatus</i> , <i>Cynodon dactylon</i> , <i>Sonchus oleraceus</i> , <i>Gomphocarpus physocarpus</i>		
Damage:	Nil		
Native dominance:	45%	Percentage vegetation cover:	100%
Photo:

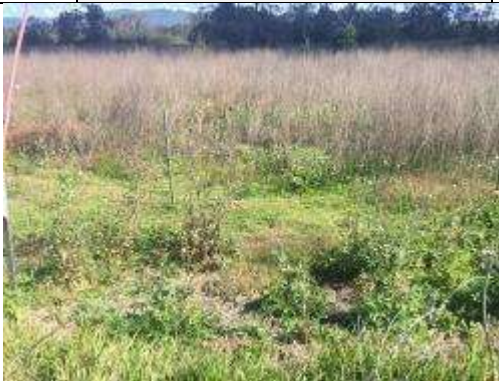
Monitoring month:	22	Months since direct seeding:	27
Date:	June 2017		
Comments:	No significant changes this month. It is anticipated growth will slow moving into the colder months.		
Native species:	<i>Eleocharis dulcis</i> , <i>Cyperus polystachyos</i> , <i>Elaeocharis equisetina</i>		
Weed species:	<i>Aster subulatus</i> , <i>Cynodon dactylon</i> , <i>Sonchus oleraceus</i> , <i>Gomphocarpus physocarpus</i>		
Damage:	Nil		
Native dominance:	45%	Percentage vegetation cover:	100%
Photo:

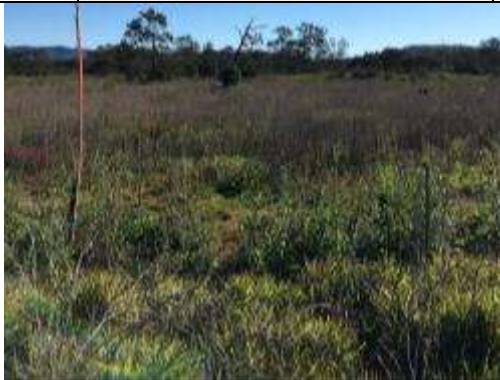
Monitoring month:	23	Months since direct seeding:	28
Date:	July 2017		
Comments:	An additional length of conduit was added to the flagging pole this month due to the increasing height of vegetation. Vegetation health is steady.		
Native species:	<i>Eleocharis dulcis</i> , <i>Cyperus polystachyos</i> , <i>Elaeocharis equisetina</i>		
Weed species:	<i>Aster subulatus</i> , <i>Cynodon dactylon</i> , <i>Sonchus oleraceus</i> , <i>Gomphocarpus physocarpus</i>		
Damage:	Nil		
Native dominance:	45%	Percentage vegetation cover:	100%
Photo:

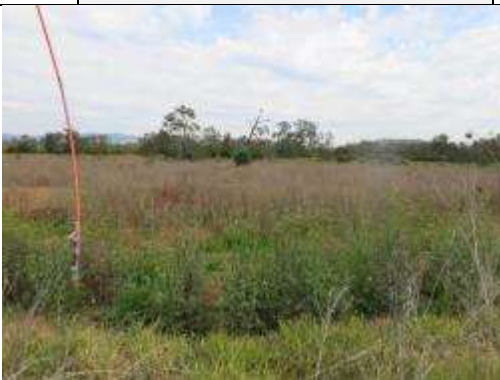
Monitoring month:	24	Months since direct seeding:	29
Date:	August 2017		
Comments:	An outbreak of Common Sow Thistle, a common pasture weed, has occurred across the quadrat this month. This weed is not of concern and will be controlled with the next large rain/flooding event.		
Native species:	<i>Eleocharis dulcis</i> , <i>Cyperus polystachyos</i> , <i>Elaeocharis equisetina</i>		
Weed species:	<i>Aster subulatus</i> , <i>Cynodon dactylon</i> , <i>Sonchus oleraceus</i> , <i>Gomphocarpus physocarpus</i>		
Damage:	Nil		
Native dominance:	40%	Percentage vegetation cover:	100%
Photo:

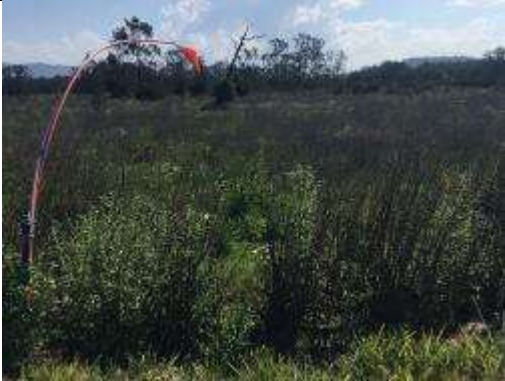
Monitoring month:	25	Months since direct seeding:	30
Date:	September 2017		
Comments:	No significant changes this month.		
Native species:	<i>Eleocharis dulcis</i> , <i>Cyperus polystachyos</i> , <i>Elaeocharis equisetina</i>		
Weed species:	<i>Aster subulatus</i> , <i>Cynodon dactylon</i> , <i>Sonchus oleraceus</i> , <i>Gomphocarpus physocarpus</i>		
Damage:	Nil		
Native dominance:	40%	Percentage vegetation cover:	100%
Photo:

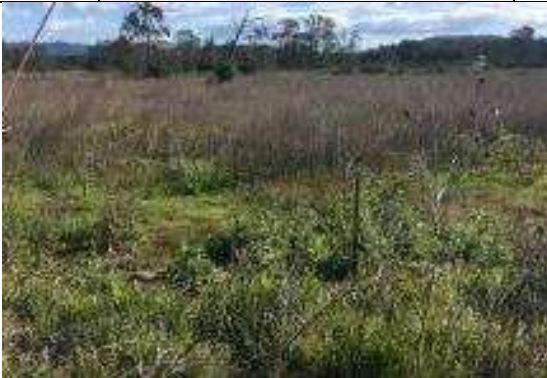
Monitoring month:	26	Months since direct seeding:	31
Date:	October 2017		
Comments:	Common Sow Thistle is still present in high numbers within this quadrat, however this is not of concern at this time.		
Native species:	<i>Eleocharis dulcis</i> , <i>Cyperus polystachyos</i> , <i>Elaeocharis equisetina</i>		
Weed species:	<i>Aster subulatus</i> , <i>Cynodon dactylon</i> , <i>Sonchus oleraceus</i> , <i>Gomphocarpus physocarpus</i>		
Damage:	Nil		
Native dominance:	40%	Percentage vegetation cover:	100%
Photo:

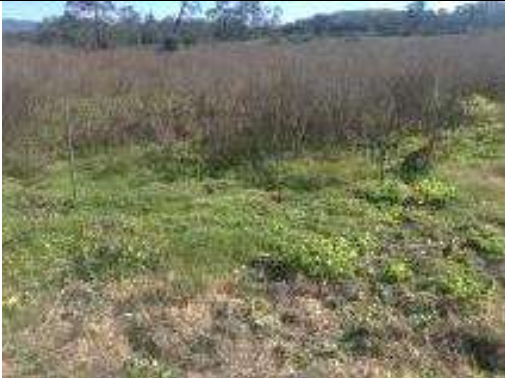
Monitoring month:	27	Months since direct seeding:	32
Date:	November 2017		
Comments:	A number of small rainfall events were received during the latter part of this month increasing vegetative growth across this quadrat.		
Native species:	<i>Eleocharis dulcis</i> , <i>Cyperus polystachyos</i> , <i>Elaeocharis equisetina</i>		
Weed species:	<i>Aster subulatus</i> , <i>Cynodon dactylon</i> , <i>Sonchus oleraceus</i> , <i>Gomphocarpus physocarpus</i>		
Damage:	Nil		
Native dominance:	40%	Percentage vegetation cover:	100%
Photo:

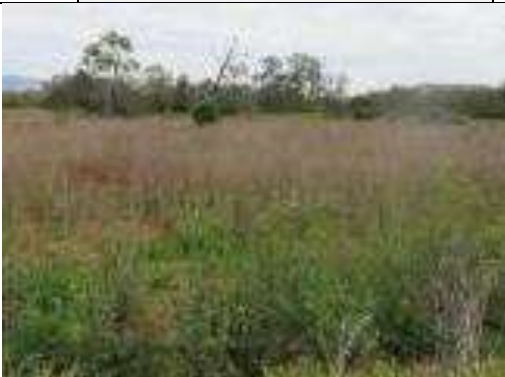
Monitoring month:	28	Months since direct seeding:	33
Date:	December 2017		
Comments:	No significant changes this month.		
Native species:	<i>Eleocharis dulcis</i> , <i>Cyperus polystachyos</i> , <i>Elaeocharis equisetina</i>		
Weed species:	<i>Aster subulatus</i> , <i>Cynodon dactylon</i> , <i>Sonchus oleraceus</i> , <i>Gomphocarpus physocarpus</i>		
Damage:	Nil		
Native dominance:	40%	Percentage vegetation cover:	100%
Photo:

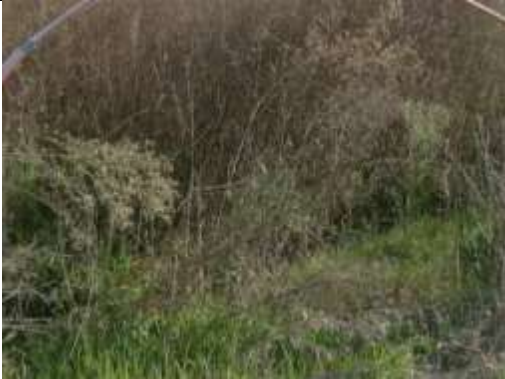
Monitoring month:	29	Months since direct seeding:	34
Date:	January 2018		
Comments:	No significant changes this month.		
Native species:	<i>Eleocharis dulcis</i> , <i>Cyperus polystachyos</i> , <i>Elaeocharis equisetina</i>		
Weed species:	<i>Aster subulatus</i> , <i>Cynodon dactylon</i> , <i>Sonchus oleraceus</i> , <i>Gomphocarpus physocarpus</i>		
Damage:	Nil		
Native dominance:	40%	Percentage vegetation cover:	100%
Photo:

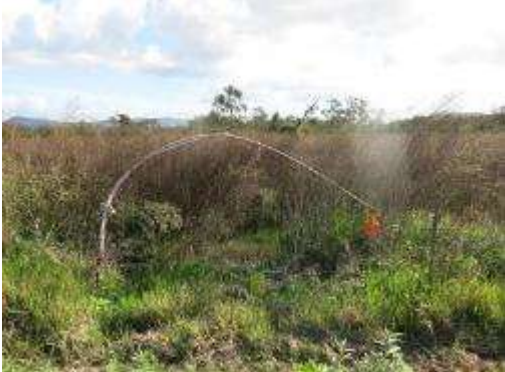
Monitoring month:	30	Months since direct seeding:	35
Date:	February 2018		
Comments:	A change in species composition and distribution of species within the quadrat is notable this month when compared to the previous monitoring.		
Native species:	<i>Eleocharis dulcis</i> , <i>Cyperus polystachyos</i> , <i>Persicaria sp.</i> , <i>Axonopus sp</i>		
Weed species:	<i>Sonchus oleraceus</i> , <i>Cynodon dactylon</i>		
Damage:	Nil		
Native dominance:	40%	Percentage vegetation cover:	100%
Photo:

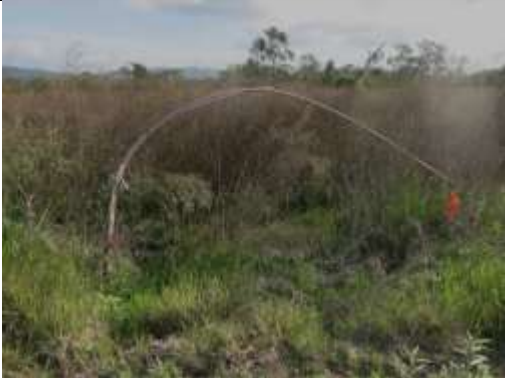
Monitoring month:	31	Months since direct seeding:	36
Date:	March 2018		
Comments:	A significant amount of rain fell at the end of last month resulting in standing water for approximately 3 weeks. This has acted as a natural weed control for a number of the weed species. Canopy growth and shading has also assisted in a reduction of weed growth.		
Native species:	<i>Eleocharis dulcis</i> , <i>Cyperus polystachyos</i> , <i>Persicaria sp.</i> , <i>Axonopus sp</i>		
Weed species:	<i>Sonchus oleraceus</i> , <i>Cynodon dactylon</i>		
Damage:	Nil		
Native dominance:	40%	Percentage vegetation cover:	100%
Photo:

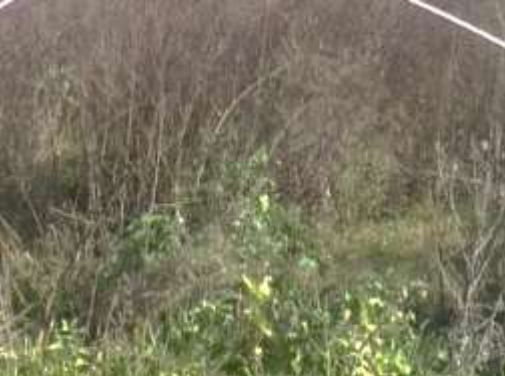
Monitoring month:	32	Months since direct seeding:	37
Date:	April 2018		
Comments:	Species density and distribution in the quadrat continues to change.		
Native species:	<i>Eleocharis dulcis</i> , <i>Cyperus polystachyos</i> , <i>Persicaria sp.</i> , <i>Axonopus sp</i>		
Weed species:	<i>Sonchus oleraceus</i> , <i>Cynodon dactylon</i>		
Damage:	Nil		
Native dominance:	40%	Percentage vegetation cover:	100%
Photo:

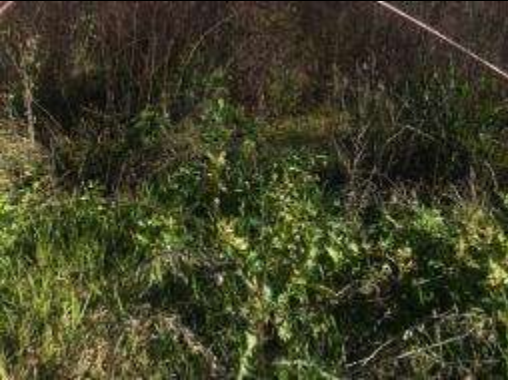
Monitoring month:	33	Months since direct seeding:	38
Date:	May 2018		
Comments:	Common Sow Thistle is still present in high numbers within this quadrat, however this is not of concern at this time.		
Native species:	<i>Eleocharis dulcis</i> , <i>Cyperus polystachyos</i> , <i>Persicaria sp.</i> , <i>Axonopus sp</i>		
Weed species:	<i>Sonchus oleraceus</i> , <i>Cynodon dactylon</i>		
Damage:	Nil		
Native dominance:	40%	Percentage vegetation cover:	100%
Photo:

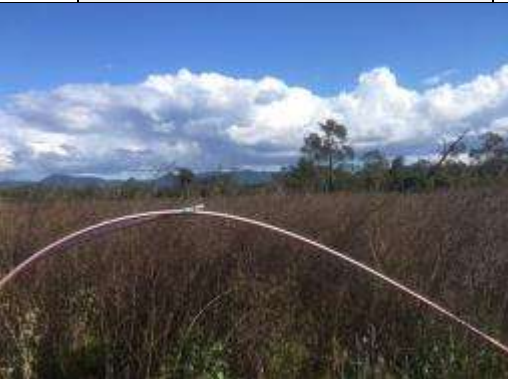
Monitoring month:	34	Months since direct seeding:	39
Date:	June 2018		
Comments:	No significant changes this month due to the slowing down of the growing season.		
Native species:	<i>Eleocharis dulcis</i> , <i>Cyperus polystachyos</i> , <i>Persicaria sp.</i> , <i>Axonopus sp</i>		
Weed species:	<i>Sonchus oleraceus</i> , <i>Cynodon dactylon</i>		
Damage:	Nil		
Native dominance:	40%	Percentage vegetation cover:	100%
Photo:

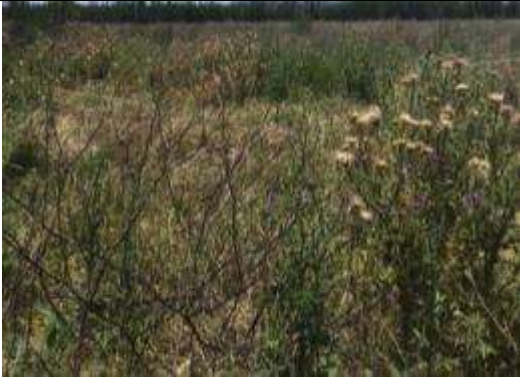
Monitoring month:	35	Months since direct seeding:	40
Date:	July 2018		
Comments:	A transition is occurring with the re-emergence of Spear Thistle within this quadrat. This species is not of concern.		
Native species:	<i>Eleocharis dulcis</i> , <i>Cyperus polystachyos</i> , <i>Axonopus sp</i>		
Weed species:	<i>Sonchus oleraceus</i> , <i>Cynodon dactylon</i> , <i>Cirsium vulgare</i>		
Damage:	Nil		
Native dominance:	40%	Percentage vegetation cover:	100%
Photo:

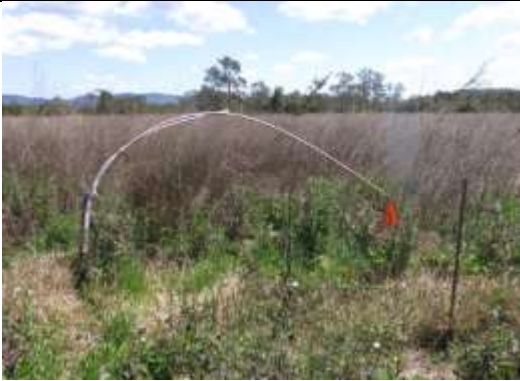
Monitoring month:	36	Months since direct seeding:	41
Date:	August 2018		
Comments:	Common Sow Thistle and Spear Thistle are codominant weed species within this quadrat due to the current season.		
Native species:	<i>Eleocharis dulcis</i> , <i>Cyperus polystachyos</i> , <i>Axonopus sp</i>		
Weed species:	<i>Sonchus oleraceus</i> , <i>Cynodon dactylon</i> , <i>Cirsium vulgare</i>		
Damage:	Nil		
Native dominance:	40%	Percentage vegetation cover:	100%
Photo:

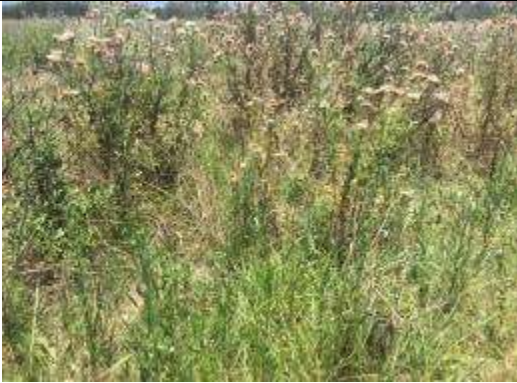
Monitoring month:	37	Months since direct seeding:	42
Date:	September 2018		
Comments:	No significant changes this month. <i>Capillipedium spicigerum</i> is still dominant and abundant within the immediate surrounds.		
Native species:	<i>Eleocharis dulcis</i> , <i>Cyperus polystachyos</i> , <i>Axonopus sp</i>		
Weed species:	<i>Sonchus oleraceus</i> , <i>Cynodon dactylon</i> , <i>Cirsium vulgare</i> , <i>Aster subulatus</i>		
Damage:	Nil		
Native dominance:	45%	Percentage vegetation cover:	100%
Photo:

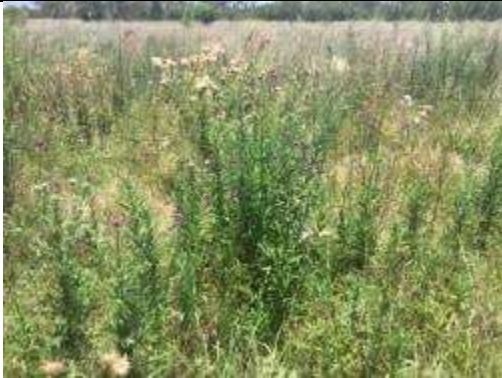
Monitoring month:	38	Months since direct seeding:	43
Date:	October 2018		
Comments:	Rainfall occurred throughout the area during this month which has assisted with the increase in biomass.		
Native species:	<i>Eleocharis dulcis</i> , <i>Cyperus polystachyos</i> , <i>Axonopus sp</i>		
Weed species:	<i>Sonchus oleraceus</i> , <i>Cynodon dactylon</i> , <i>Cirsium vulgare</i> , <i>Aster subulatus</i>		
Damage:	Nil		
Native dominance:	50%	Percentage vegetation cover:	100%
Photo:

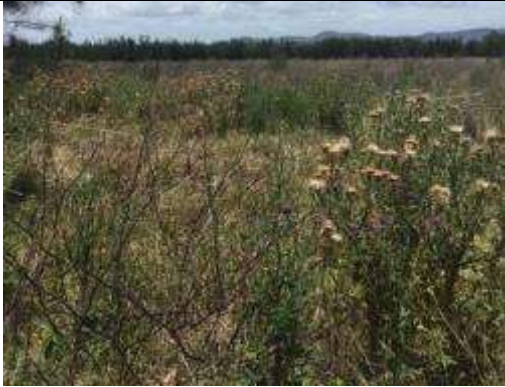
Monitoring month:	39	Months since direct seeding:	44
Date:	November 2018		
Comments:	Rapidly increasing temperatures were experienced this month resulting in the exponential growth of vegetation.		
Native species:	<i>Eleocharis dulcis</i> , <i>Cyperus polystachyos</i> , <i>Axonopus sp</i>		
Weed species:	<i>Sonchus oleraceus</i> , <i>Cynodon dactylon</i> , <i>Cirsium vulgare</i> , <i>Aster subulatus</i>		
Damage:	Nil		
Native dominance:	45%	Percentage vegetation cover:	100%
Photo:

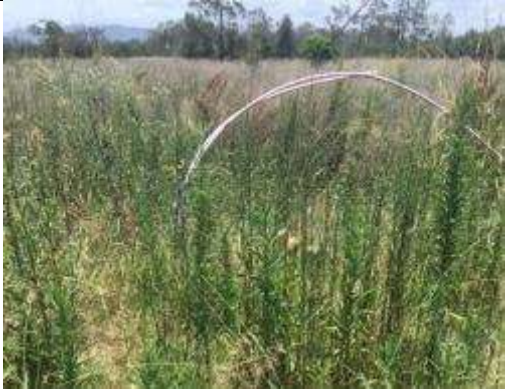
Monitoring month:	40	Months since direct seeding:	45
Date:	December 2018		
Comments:	Vegetation growth was steady this month.		
Native species:	<i>Eleocharis dulcis</i> , <i>Cyperus polystachyos</i> , <i>Axonopus sp</i>		
Weed species:	<i>Sonchus oleraceus</i> , <i>Cynodon dactylon</i> , <i>Cirsium vulgare</i> , <i>Aster subulatus</i>		
Damage:	Nil		
Native dominance:	40%	Percentage vegetation cover:	100%
Photo:

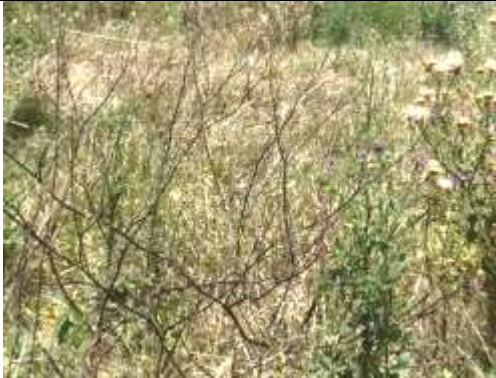
Monitoring month:	41	Months since direct seeding:	46
Date:	January 2019		
Comments:	Aster is starting to increase in biomass and is predicted to become dominant over the coming months.		
Native species:	<i>Eleocharis dulcis</i> , <i>Cyperus polystachyos</i> , <i>Axonopus sp</i>		
Weed species:	<i>Sonchus oleraceus</i> , <i>Cynodon dactylon</i> , <i>Cirsium vulgare</i> , <i>Aster subulatus</i>		
Damage:	Nil		
Native dominance:	40%	Percentage vegetation cover:	100%
Photo:

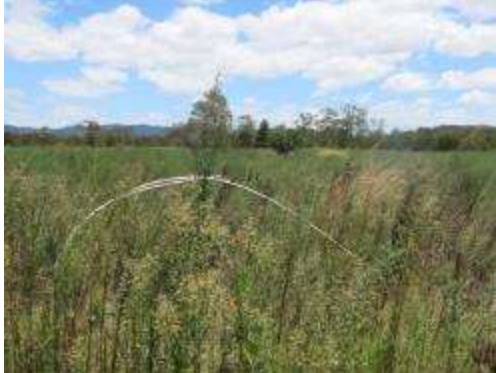
Monitoring month:	42	Months since direct seeding:	47
Date:	February 2019		
Comments:	This quadrat has rapidly transitioned due to the dominance of Aster. This will transition again with the seasonal cycle of this species.		
Native species:	<i>Eleocharis dulcis</i> , <i>Cyperus polystachyos</i> , <i>Axonopus sp</i>		
Weed species:	<i>Sonchus oleraceus</i> , <i>Cynodon dactylon</i> , <i>Cirsium vulgare</i> , <i>Aster subulatus</i>		
Damage:	Nil		
Native dominance:	40%	Percentage vegetation cover:	100%
Photo:

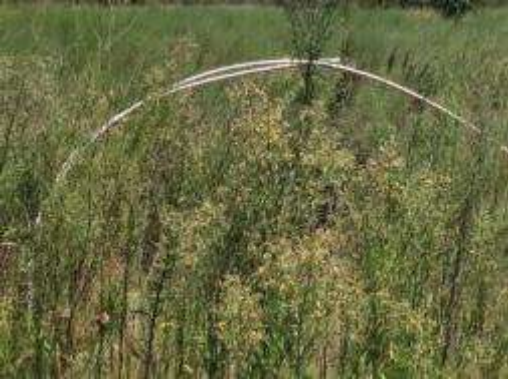
Monitoring month:	43	Months since direct seeding:	48
Date:	March 2019		
Comments:	No significant changes occurred this month.		
Native species:	<i>Eleocharis dulcis</i> , <i>Cyperus polystachyos</i> , <i>Axonopus sp</i>		
Weed species:	<i>Sonchus oleraceus</i> , <i>Cynodon dactylon</i> , <i>Cirsium vulgare</i> , <i>Aster subulatus</i>		
Damage:	Nil		
Native dominance:	40%	Percentage vegetation cover:	100%
Photo:

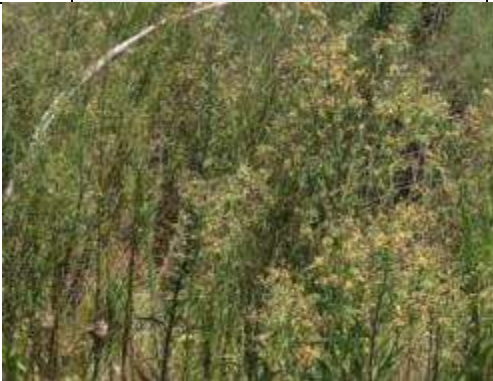
Monitoring month:	44	Months since direct seeding:	49
Date:	April 2019		
Comments:	Rainfall events increased late last month and continued this month giving the NWCP a much needed watering.		
Native species:	<i>Eleocharis dulcis</i> , <i>Cyperus polystachyos</i> , <i>Axonopus sp</i>		
Weed species:	<i>Sonchus oleraceus</i> , <i>Cynodon dactylon</i> , <i>Cirsium vulgare</i> , <i>Aster subulatus</i>		
Damage:	Nil		
Native dominance:	40%	Percentage vegetation cover:	100%
Photo:

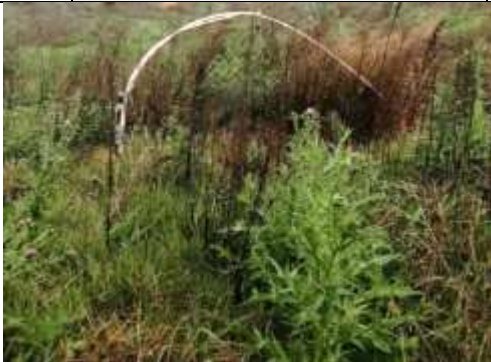
Monitoring month:	45	Months since direct seeding:	50
Date:	May 2019		
Comments:	<i>Cirsium vulgare</i> has taken the upper hand on the seasonal variation in herbaceous pasture weed dominance.		
Native species:	<i>Eleocharis dulcis</i> , <i>Cyperus polystachyos</i> , <i>Axonopus sp</i>		
Weed species:	<i>Sonchus oleraceus</i> , <i>Cynodon dactylon</i> , <i>Cirsium vulgare</i> , <i>Aster subulatus</i>		
Damage:	Nil		
Native dominance:	40%	Percentage vegetation cover:	100%
Photo:

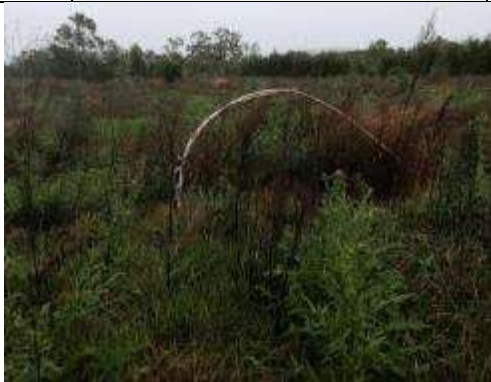
Monitoring month:	46	Months since direct seeding:	51
Date:	June 2019		
Comments:	Rainfall over the past few months has increased plant growth and vigour.		
Native species:	<i>Eleocharis dulcis</i> , <i>Cyperus polystachyos</i> , <i>Axonopus sp</i>		
Weed species:	<i>Sonchus oleraceus</i> , <i>Cynodon dactylon</i> , <i>Cirsium vulgare</i> , <i>Aster subulatus</i>		
Damage:	Nil		
Native dominance:	40%	Percentage vegetation cover:	100%
Photo:

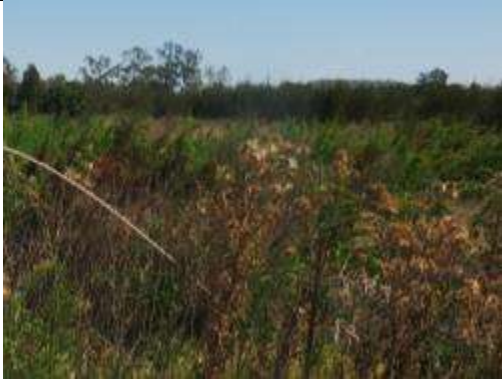
Monitoring month:	47	Months since direct seeding:	52
Date:	July 2019		
Comments:	Aster is becoming dominant once again which has reduced native abundance.		
Native species:	<i>Eleocharis dulcis</i> , <i>Cyperus polystachyos</i>		
Weed species:	<i>Sonchus oleraceus</i> , <i>Cynodon dactylon</i> , <i>Cirsium vulgare</i> , <i>Aster subulatus</i>		
Damage:	Nil		
Native dominance:	30%	Percentage vegetation cover:	100%
Photo:

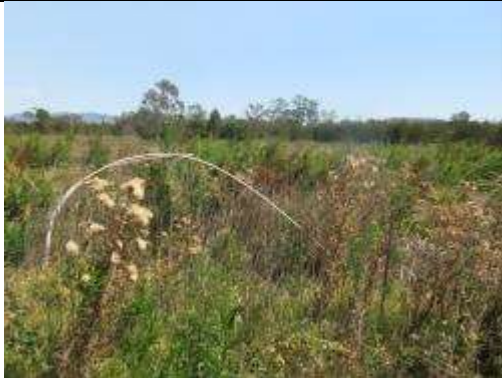
Monitoring month:	48	Months since direct seeding:	53
Date:	August 2019		
Comments:	Quadrat still struggling to gain native dominance.		
Native species:	<i>Cyperus polystachyos</i>		
Weed species:	<i>Sonchus oleraceus</i> , <i>Cynodon dactylon</i> , <i>Cirsium vulgare</i> , <i>Aster subulatus</i>		
Damage:	Nil		
Native dominance:	25%	Percentage vegetation cover:	100%
Photo:

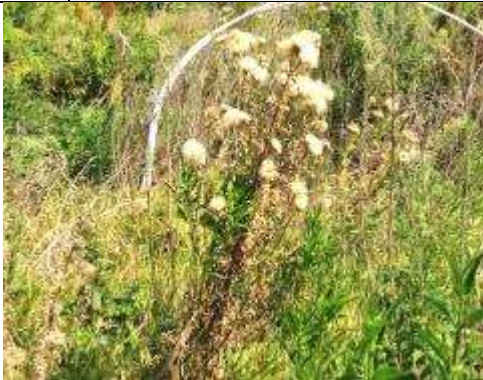
Monitoring month:	49	Months since direct seeding:	54
Date:	September 2019		
Comments:	No native improvement for this quadrat. It is anticipated this will shift once aster dominance decreases.		
Native species:	<i>Cyperus polystachyos</i>		
Weed species:	<i>Sonchus oleraceus, Cynodon dactylon, Cirsium vulgare, Aster subulatus</i>		
Damage:	Nil		
Native dominance:	25%	Percentage vegetation cover:	100%
Photo:

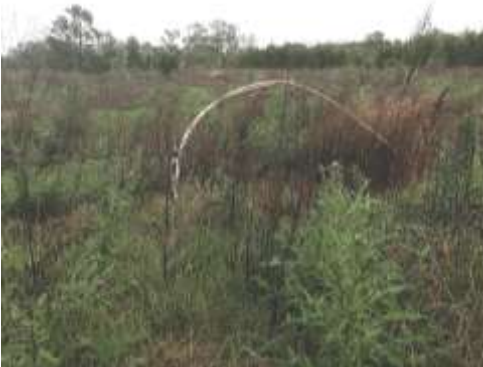
Monitoring month:	50	Months since direct seeding:	55
Date:	October 2019		
Comments:	Extended drought conditions are starting to take their toll with the extreme slowing of plant growth.		
Native species:	<i>Cyperus polystachyos</i>		
Weed species:	<i>Sonchus oleraceus, Cynodon dactylon, Cirsium vulgare, Aster subulatus</i>		
Damage:	Nil		
Native dominance:	25%	Percentage vegetation cover:	100%
Photo:

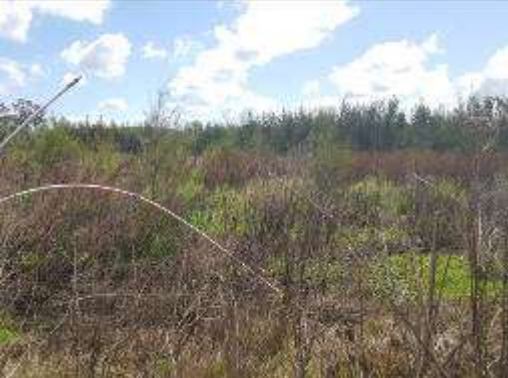
Monitoring month:	51	Months since direct seeding:	56
Date:	November 2019		
Comments:	No native improvement for this quadrat. It is anticipated this will shift once aster dominance decreases.		
Native species:	<i>Cyperus polystachyos</i>		
Weed species:	<i>Sonchus oleraceus, Cynodon dactylon, Cirsium vulgare, Aster subulatus</i>		
Damage:	Nil		
Native dominance:	25%	Percentage vegetation cover:	100%
Photo:

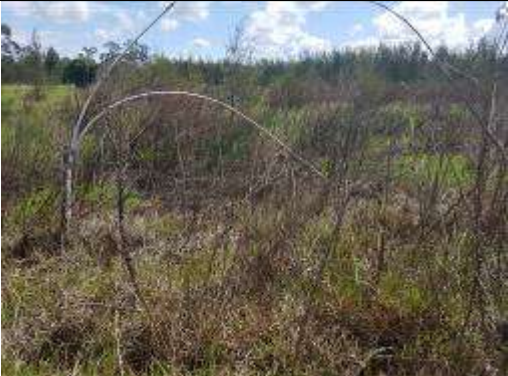
Monitoring month:	52	Months since direct seeding:	57
Date:	December 2019		
Comments:	No significant change.		
Native species:	<i>Cyperus polystachyos</i>		
Weed species:	<i>Sonchus oleraceus, Cynodon dactylon, Cirsium vulgare, Aster subulatus</i>		
Damage:	Nil		
Native dominance:	25%	Percentage vegetation cover:	100%
Photo:

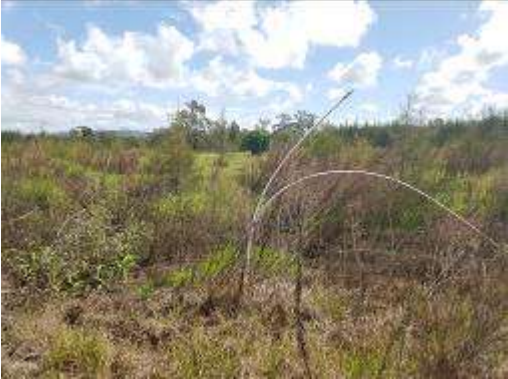
Monitoring month:	53	Months since direct seeding:	58
Date:	January 2020		
Comments:	Annual weed species dominance is transitioning due to season and water inundation.		
Native species:	<i>Cyperus polystachyos</i>		
Weed species:	<i>Sonchus oleraceus, Cynodon dactylon, Cirsium vulgare, Aster subulatus</i>		
Damage:	Nil		
Native dominance:	15%	Percentage vegetation cover:	100%
Photo:

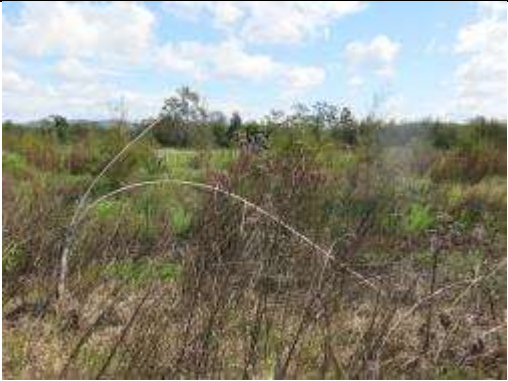
Monitoring month:	54	Months since direct seeding:	59
Date:	February 2020		
Comments:	Quadrat remains degraded.		
Native species:	<i>Cyperus polystachyos</i>		
Weed species:	<i>Cynodon dactylon, Cirsium vulgare, Aster subulatus</i>		
Damage:	Nil		
Native dominance:	5%	Percentage vegetation cover:	100%
Photo:

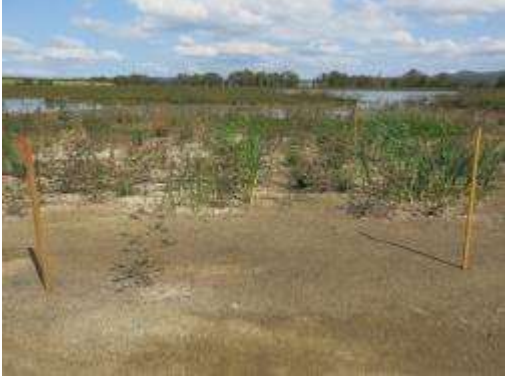
4.12 Quadrat 12

Monitoring month:	1	Months since direct seeding:	6
Date:	September 2015		
Comments:	Water has recently receded from this area. Typha may move quickly in the coming wet season to smother the development of this area. This quadrat was selected to monitor how Typha (native) and other endemic wetland species will compete in the time ahead.		
Native species:	<i>Bolboschoenus cardwellii</i> , <i>Ludwigia octovalvis</i> , <i>Microleana stipoides</i> , <i>Elaeocharis dulcis</i> , <i>Typha orientalis</i>		
Weed species:	Nil		
Damage:	Nil		
Native dominance:	100%	Percentage vegetation cover:	15%
Photo:

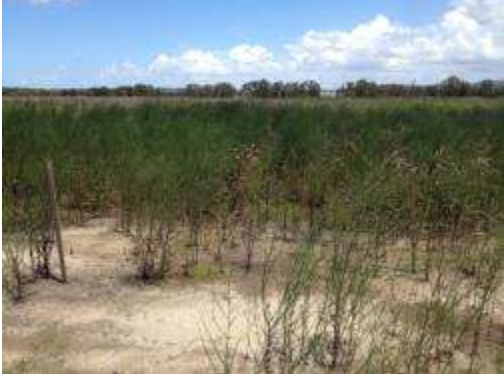
Monitoring month:	6	Months since direct seeding:	11
Date:	February 2016		
Comments:	<i>Typha</i> has not increased in abundance in this area as expected since the first monitoring. 34 canopy trees were counted within the quadrat. No canopy trees were identified six months ago when monitoring started. This is representative of the surrounding area.		
Native species:	<i>Bolboschoenus cardwellii</i> , <i>Ludwigia octovalvis</i> , <i>Microleana stipoides</i> , <i>Elaeocharis dulcis</i> , <i>Typha orientalis</i> , <i>Casuarina glauca</i>		
Weed species:	<i>Aster subulatus</i>		
Damage:	Nil		
Native dominance:	86%	Percentage vegetation cover:	30%
Photo:
