North-West Conservation Park - Rehabilitation Monitoring

Lot 1 RP48903

North-West Conservation Park
Gainsborough Greens

March 2020

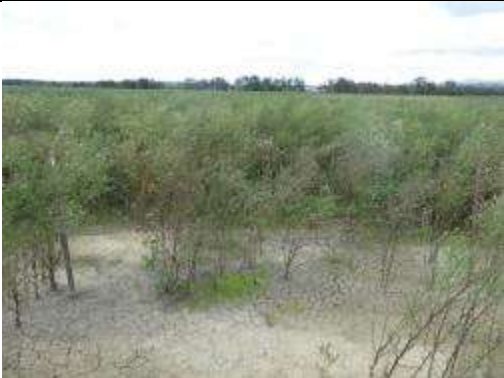
Monitoring month:	7	Months since direct seeding:	12
Date:	March 2016		
Comments:	The canopy trees are abundant within this 16 square metre quadrat. This is representative of the surrounding area also. <i>Schoenoplectus vallidus</i> , a new native sedge is common in the surrounds. <i>Pennesetum alopecerioides</i> is looking fantastic in the surrounding area. Typha has not increased in abundance in this area as was expected at the first visit. Grasses and sedges have moved into the bare areas significantly over the past 6 weeks.		
Native species:	<i>Bolboschoenus cardwellii</i> , <i>Ludwigia octovalvis</i> , <i>Microleana stipoides</i> , <i>Elaeocharis dulcis</i> , <i>Casuarina glauca</i> , <i>Typha orientalis</i>		
Weed species:	<i>Aster subulatus</i>		
Damage:	Nil		
Native dominance:	86%	Percentage vegetation cover:	50%
Photo:

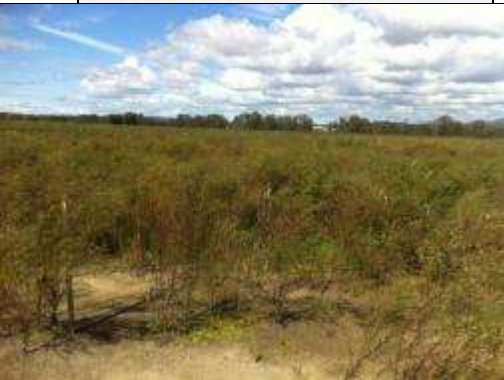
Monitoring month:	8	Months since direct seeding:	13
Date:	April 2016		
Comments:	The canopy trees are abundant within this 16 square metre quadrat. This is representative of the surrounding area also. <i>Schoenoplectus vallidus</i> , a new native sedge is common in the surrounds. <i>Pennesetum alopecerioides</i> is looking fantastic in the surrounding area. Typha has not increased in abundance in this area as was expected at the very first visit. Grasses and sedges have moved into the bare areas.		
Native species:	<i>Bolboschoenus cardwellii</i> , <i>Ludwigia octovalvis</i> , <i>Microleana stipoides</i> , <i>Elaeocharis dulcis</i> , <i>Casuarina glauca</i> , <i>Typha orientalis</i>		
Weed species:	<i>Aster subulatus</i>		
Damage:	Nil		
Native dominance:	86%	Percentage vegetation cover:	50%
Photo:

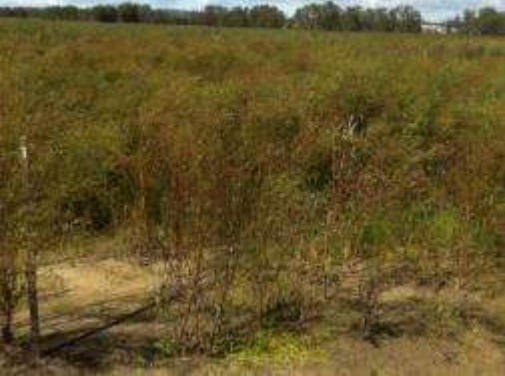
Monitoring month:	9	Months since direct seeding:	14
Date:	May 2016		
Comments:	No significant change recorded this month.		
Native species:	<i>Bolboschoenus cardwellii</i> , <i>Ludwigia octovalvis</i> , <i>Microleana stipoides</i> , <i>Elaeocharis dulcis</i> , <i>Casuarina glauca</i> , <i>Typha orientalis</i>		
Weed species:	<i>Aster subulatus</i>		
Damage:	Nil		
Native dominance:	80%	Percentage vegetation cover:	50%
Photo:

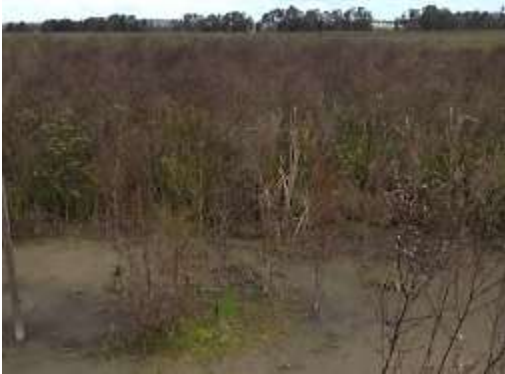
Monitoring month:	10	Months since direct seeding:	15
Date:	June 2016		
Comments:	Aster is showing signs of wintering and die-back.		
Native species:	<i>Bolboschoenus cardwellii</i> , <i>Ludwigia octovalvis</i> , <i>Microleana stipoides</i> , <i>Elaeocharis dulcis</i> , <i>Casuarina glauca</i> , <i>Typha orientalis</i>		
Weed species:	<i>Aster subulatus</i>		
Damage:	Nil		
Native dominance:	80%	Percentage vegetation cover:	50%
Photo:

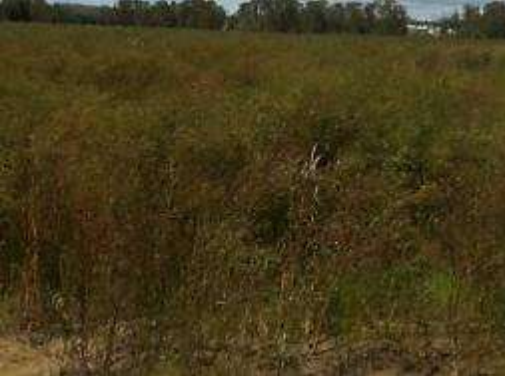
Monitoring month:	11	Months since direct seeding:	16
Date:	July 2016		
Comments:	Wintering has affected this quadrat significantly this month. In addition, <i>Baccharis halimifolia</i> * was also identified for the first time.		
Native species:	<i>Bolboschoenus cardwellii</i> , <i>Ludwigia octovalvis</i> , <i>Microleana stipoides</i> , <i>Elaeocharis dulcis</i> , <i>Casuarina glauca</i> , <i>Typha orientalis</i>		
Weed species:	<i>Aster subulatus</i> , <i>Baccharis halimifolia</i> *		
Damage:	Nil		
Native dominance:	65%	Percentage vegetation cover:	50%
Photo:

* Weed species requires complete eradication to meet the Desired Environmental Outcomes.

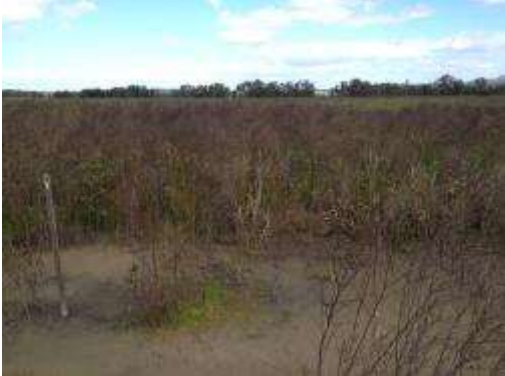
Monitoring month:	12	Months since direct seeding:	17
Date:	August 2016		
Comments:	This quadrat is abundant with canopy tree species, which is also representative of the surrounding areas. The native grass <i>Capillipedium spicigerum</i> is dormant in the surrounding area. <i>Baumea articulata</i> was also observed in the surrounds, a sedge species not identified before within the area.		
Native species:	<i>Bolboschoenus cardwellii</i> , <i>Ludwigia octovalvis</i> , <i>Microleana stipoides</i> , <i>Elaeocharis dulcis</i> , <i>Casuarina glauca</i> , <i>Typha orientalis</i>		
Weed species:	<i>Aster subulatus</i> , <i>Baccharis halimifolia</i> *		
Damage:	Nil		
Native dominance:	65%	Percentage vegetation cover:	50%
Photo:

* Weed species requires complete eradication to meet the Desired Environmental Outcomes.

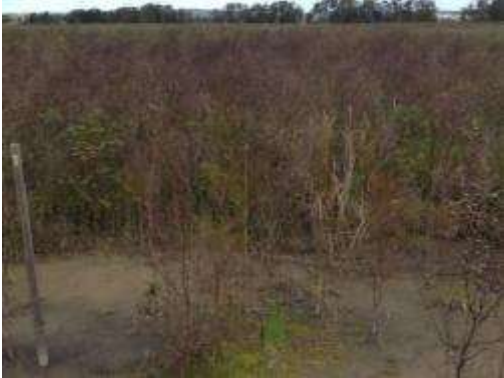
Monitoring month:	13	Months since direct seeding:	18
Date:	September 2016		
Comments:	This quadrat is slowly emerging from its winter phase.		
Native species:	<i>Bolboschoenus cardwellii</i> , <i>Ludwigia octovalvis</i> , <i>Microleana stipoides</i> , <i>Elaeocharis dulcis</i> , <i>Casuarina glauca</i> , <i>Typha orientalis</i>		
Weed species:	<i>Aster subulatus</i> , <i>Baccharis halimifolia</i> *		
Damage:	Nil		
Native dominance:	65%	Percentage vegetation cover:	60%
Photo:

* Weed species requires complete eradication to meet the Desired Environmental Outcomes.

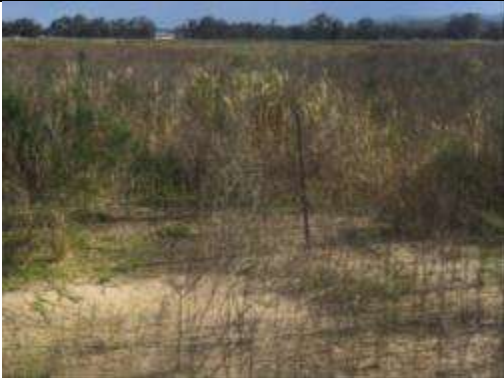
Monitoring month:	14	Months since direct seeding:	19
Date:	October 2016		
Comments:	No significant changes recorded this month.		
Native species:	<i>Bolboschoenus cardwellii</i> , <i>Ludwigia octovalvis</i> , <i>Microleana stipoides</i> , <i>Elaeocharis dulcis</i> , <i>Casuarina glauca</i> , <i>Typha orientalis</i>		
Weed species:	<i>Aster subulatus</i> , <i>Baccharis halimifolia</i> *		
Damage:	Nil		
Native dominance:	65%	Percentage vegetation cover:	60%
Photo:

* Weed species requires complete eradication to meet the Desired Environmental Outcomes.

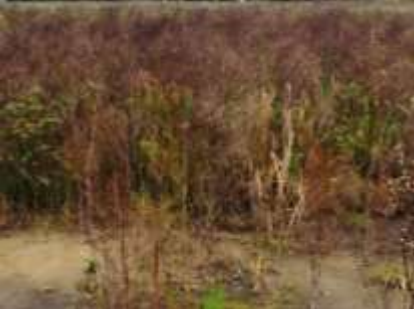
Monitoring month:	15	Months since direct seeding:	20
Date:	November 2016		
Comments:	Typha is growing well amongst other native grass species.		
Native species:	<i>Bolboschoenus cardwellii</i> , <i>Ludwigia octovalvis</i> , <i>Microleana stipoides</i> , <i>Elaeocharis dulcis</i> , <i>Casuarina glauca</i> , <i>Typha orientalis</i>		
Weed species:	<i>Aster subulatus</i> , <i>Baccharis halimifolia</i> *		
Damage:	Nil		
Native dominance:	65%	Percentage vegetation cover:	60%
Photo:

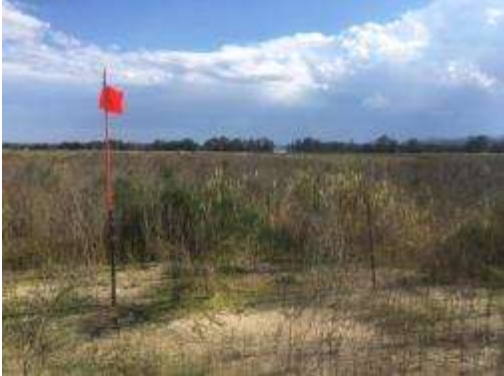
Monitoring month:	16	Months since direct seeding:	21
Date:	December 2016		
Comments:	A high visibility flag and extended pole was added to the quadrat stake this month for ease of identification. Groundsel was not identified this month. This may be a result of the growing height and density of Typha.		
Native species:	<i>Bolboschoenus cardwellii</i> , <i>Ludwigia octovalvis</i> , <i>Microleana stipoides</i> , <i>Elaeocharis dulcis</i> , <i>Casuarina glauca</i> , <i>Typha orientalis</i>		
Weed species:	<i>Aster subulatus</i>		
Damage:	Nil		
Native dominance:	70%	Percentage vegetation cover:	60%
Photo:

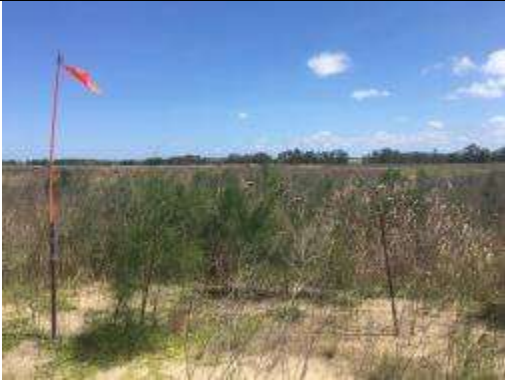
Monitoring month:	17	Months since direct seeding:	22
Date:	January 2017		
Comments:	Casuarinas continue to grow well, averaging 1.5m in height.		
Native species:	<i>Bolboschoenus cardwellii</i> , <i>Ludwigia octovalvis</i> , <i>Microleana stipoides</i> , <i>Elaeocharis dulcis</i> , <i>Casuarina glauca</i> , <i>Typha orientalis</i>		
Weed species:	<i>Aster subulatus</i>		
Damage:	Nil		
Native dominance:	70%	Percentage vegetation cover:	60%
Photo:

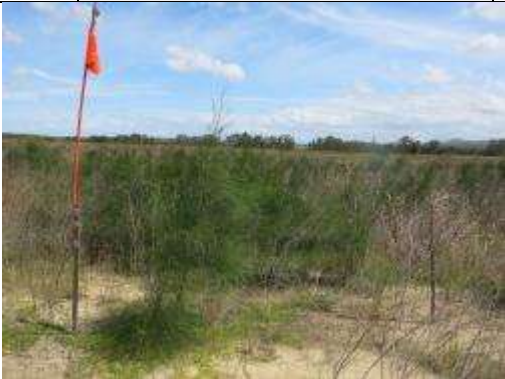
Monitoring month:	18	Months since direct seeding:	23
Date:	February 2017		
Comments:	Casuarinas continue to grow well, averaging 1.5m in height.		
Native species:	<i>Bolboschoenus cardwellii</i> , <i>Ludwigia octovalvis</i> , <i>Microleana stipoides</i> , <i>Elaeocharis dulcis</i> , <i>Casuarina glauca</i> , <i>Typha orientalis</i>		
Weed species:	<i>Paspalum dilatatum</i>		
Damage:	Nil		
Native dominance:	70%	Percentage vegetation cover:	60%
Photo:

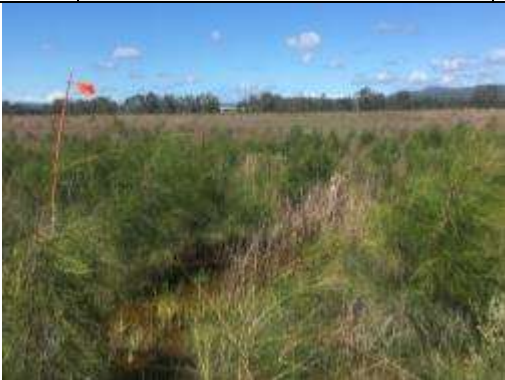
Monitoring month:	19	Months since direct seeding:	24
Date:	March 2017 (NB: monitoring event occurred early April due to inaccessibility)		
Comments:	During the last half of this month, the NWCP received significant rainfall. Access to the area was limited. Much of the area is waterlogged and functioning as the wetland it is designed to be. Previously bare areas within this quadrat are flooded this month. Waterlogging may change species diversity over the next few months.		
Native species:	<i>Bolboschoenus cardwellii</i> , <i>Ludwigia octovalvis</i> , <i>Microleana stipoides</i> , <i>Elaeocharis dulcis</i> , <i>Casuarina glauca</i> , <i>Typha orientalis</i>		
Weed species:	<i>Paspalum dilatatum</i>		
Damage:	Nil - large weather event associated with Ex-Tropical Cyclone Debbie did not result in any damage		
Native dominance:	70%	Percentage vegetation cover:	60%
Photo:

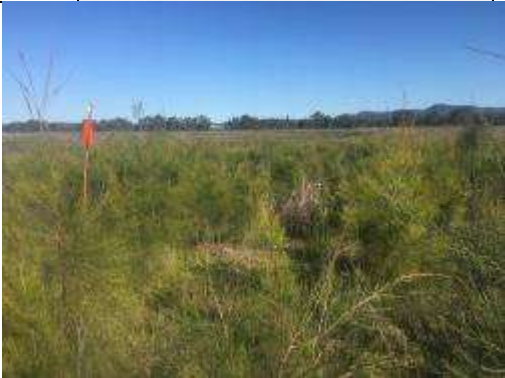
Monitoring month:	20	Months since direct seeding:	25
Date:	April 2017		
Comments:	Much of the area is still waterlogged and functioning as the wetland it is designed to be. Increased moisture has benefited this quadrat.		
Native species:	<i>Bolboschoenus cardwellii</i> , <i>Ludwigia octovalvis</i> , <i>Microleana stipoides</i> , <i>Elaeocharis dulcis</i> , <i>Casuarina glauca</i> , <i>Typha orientalis</i>		
Weed species:	<i>Paspalum dilatatum</i>		
Damage:	Nil		
Native dominance:	70%	Percentage vegetation cover:	60%
Photo:

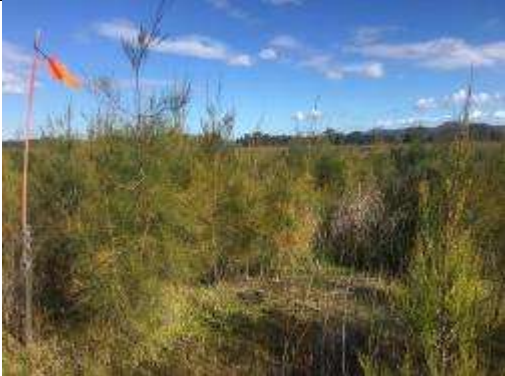
Monitoring month:	21	Months since direct seeding:	26
Date:	May 2017		
Comments:	A number of individual Casuarinas have shot up due to the rain events over the past few months. Some individuals now reaching 3m, almost doubling in height.		
Native species:	<i>Bolboschoenus cardwellii</i> , <i>Ludwigia octovalvis</i> , <i>Microleana stipoides</i> , <i>Elaeocharis dulcis</i> , <i>Casuarina glauca</i> , <i>Typha orientalis</i>		
Weed species:	<i>Paspalum dilatatum</i>		
Damage:	Nil		
Native dominance:	70%	Percentage vegetation cover:	60%
Photo:

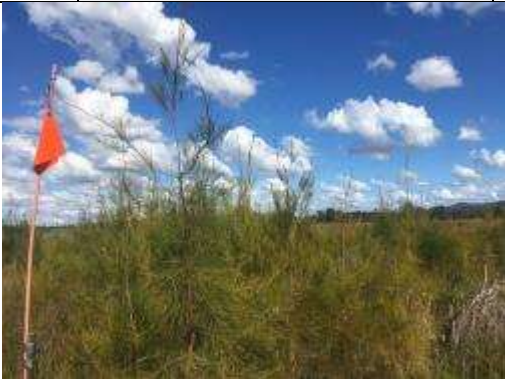
Monitoring month:	22	Months since direct seeding:	27
Date:	June 2017		
Comments:	No significant changes this month. It is anticipated growth will slow moving into the colder months.		
Native species:	<i>Bolboschoenus cardwellii</i> , <i>Ludwigia octovalvis</i> , <i>Microleana stipoides</i> , <i>Elaeocharis dulcis</i> , <i>Casuarina glauca</i> , <i>Typha orientalis</i>		
Weed species:	<i>Paspalum dilatatum</i>		
Damage:	Nil		
Native dominance:	70%	Percentage vegetation cover:	60%
Photo:

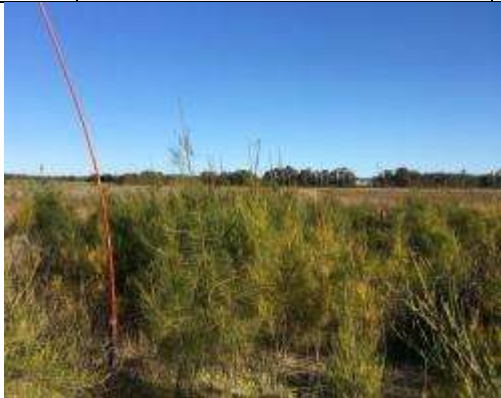
Monitoring month:	23	Months since direct seeding:	28
Date:	July 2017		
Comments:	An additional length of conduit was added to the flagging pole this month due to the increasing height of vegetation. Vegetation health is steady.		
Native species:	<i>Bolboschoenus cardwellii</i> , <i>Ludwigia octovalvis</i> , <i>Microleana stipoides</i> , <i>Elaeocharis dulcis</i> , <i>Casuarina glauca</i> , <i>Typha orientalis</i>		
Weed species:	<i>Paspalum dilatatum</i>		
Damage:	Nil		
Native dominance:	70%	Percentage vegetation cover:	65%
Photo:

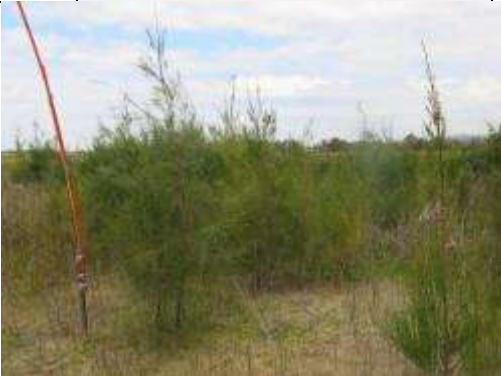
Monitoring month:	24	Months since direct seeding:	29
Date:	August 2017		
Comments:	Growth in biomass of casuarina has been steady. Quadrat is still lacking good soil coverage.		
Native species:	<i>Bolboschoenus cardwellii</i> , <i>Ludwigia octovalvis</i> , <i>Microleana stipoides</i> , <i>Elaeocharis dulcis</i> , <i>Casuarina glauca</i> , <i>Typha orientalis</i>		
Weed species:	<i>Paspalum dilatatum</i>		
Damage:	Nil		
Native dominance:	70%	Percentage vegetation cover:	70%
Photo:

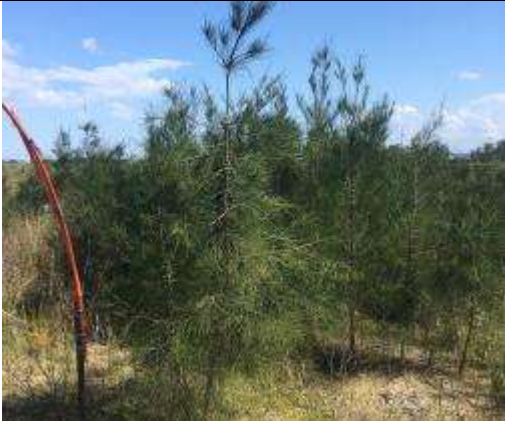
Monitoring month:	25	Months since direct seeding:	30
Date:	September 2017		
Comments:	Vegetation growth is steady.		
Native species:	<i>Bolboschoenus cardwellii</i> , <i>Ludwigia octovalvis</i> , <i>Microleana stipoides</i> , <i>Elaeocharis dulcis</i> , <i>Casuarina glauca</i> , <i>Typha orientalis</i>		
Weed species:	<i>Paspalum dilatatum</i>		
Damage:	Nil		
Native dominance:	70%	Percentage vegetation cover:	70%
Photo:

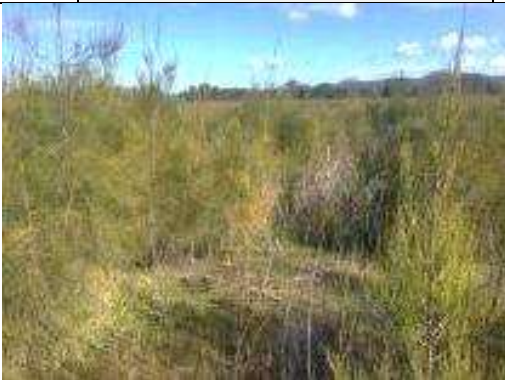
Monitoring month:	26	Months since direct seeding:	31
Date:	October 2017		
Comments:	No significant changes this month.		
Native species:	<i>Bolboschoenus cardwellii</i> , <i>Ludwigia octovalvis</i> , <i>Microleana stipoides</i> , <i>Elaeocharis dulcis</i> , <i>Casuarina glauca</i> , <i>Typha orientalis</i>		
Weed species:	<i>Paspalum dilatatum</i>		
Damage:	Nil		
Native dominance:	70%	Percentage vegetation cover:	70%
Photo:

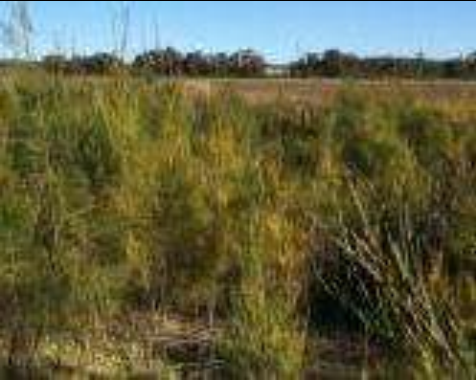
Monitoring month:	27	Months since direct seeding:	32
Date:	November 2017		
Comments:	Casuarinas continue to grow in biomass.		
Native species:	<i>Bolboschoenus cardwellii</i> , <i>Ludwigia octovalvis</i> , <i>Microleana stipoides</i> , <i>Elaeocharis dulcis</i> , <i>Casuarina glauca</i> , <i>Typha orientalis</i>		
Weed species:	<i>Paspalum dilatatum</i>		
Damage:	Nil		
Native dominance:	70%	Percentage vegetation cover:	70%
Photo:

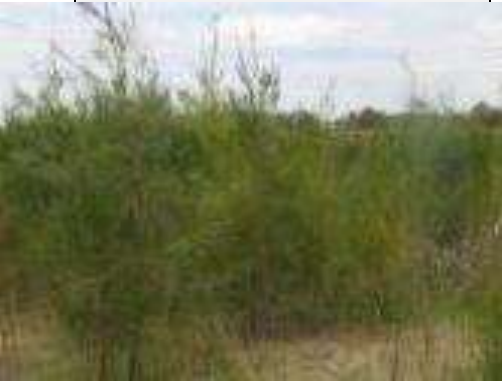
Monitoring month:	28	Months since direct seeding:	33
Date:	December 2017		
Comments:	Increasing temperatures and the rainfall events over the past two months have allowed for continued growth of casuarinas and native grasses.		
Native species:	<i>Bolboschoenus cardwellii</i> , <i>Ludwigia octovalvis</i> , <i>Microleana stipoides</i> , <i>Elaeocharis dulcis</i> , <i>Casuarina glauca</i> , <i>Typha orientalis</i>		
Weed species:	<i>Paspalum dilatatum</i>		
Damage:	Nil		
Native dominance:	70%	Percentage vegetation cover:	70%
Photo:

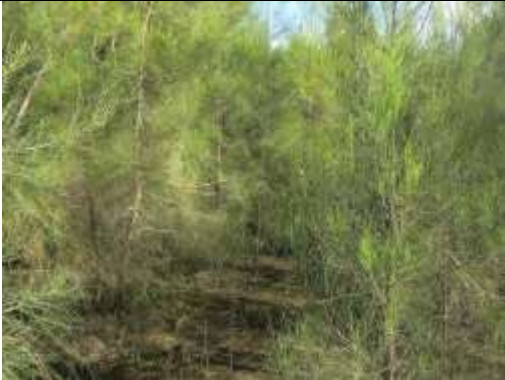
Monitoring month:	29	Months since direct seeding:	34
Date:	January 2018		
Comments:	Vegetation growth is steady.		
Native species:	<i>Bolboschoenus cardwellii</i> , <i>Ludwigia octovalvis</i> , <i>Microleana stipoides</i> , <i>Elaeocharis dulcis</i> , <i>Casuarina glauca</i> , <i>Typha orientalis</i>		
Weed species:	<i>Paspalum dilatatum</i>		
Damage:	Nil		
Native dominance:	70%	Percentage vegetation cover:	70%
Photo:

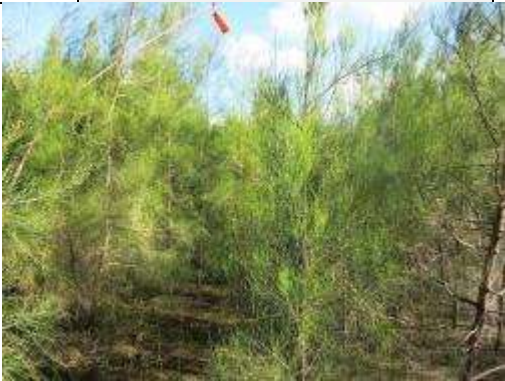
Monitoring month:	30	Months since direct seeding:	34
Date:	February 2018		
Comments:	Casuarina canopy continues to close and shade out understorey. Weed grass significantly reduced in growth.		
Native species:	<i>Bolboschoenus cardwellii</i> , <i>Ludwigia octovalvis</i> , <i>Microleana stipoides</i> , <i>Elaeocharis dulcis</i> , <i>Casuarina glauca</i> , <i>Typha orientalis</i>		
Weed species:	<i>Paspalum dilatatum</i>		
Damage:	Nil		
Native dominance:	85%	Percentage vegetation cover:	70%
Photo:

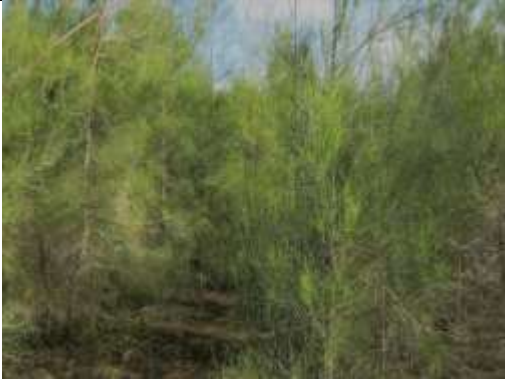
Monitoring month:	31	Months since direct seeding:	35
Date:	March 2018		
Comments:	A significant amount of rain fell at the end of last month resulting in standing water for approximately 3 weeks. This has acted as a natural weed control for a number of the weed species. Canopy growth and shading has also assisted in a reduction of weed growth.		
Native species:	<i>Bolboschoenus cardwellii</i> , <i>Ludwigia octovalvis</i> , <i>Microleana stipoides</i> , <i>Elaeocharis dulcis</i> , <i>Casuarina glauca</i> , <i>Typha orientalis</i>		
Weed species:	Nil		
Damage:	Nil		
Native dominance:	100%	Percentage vegetation cover:	70%
Photo:

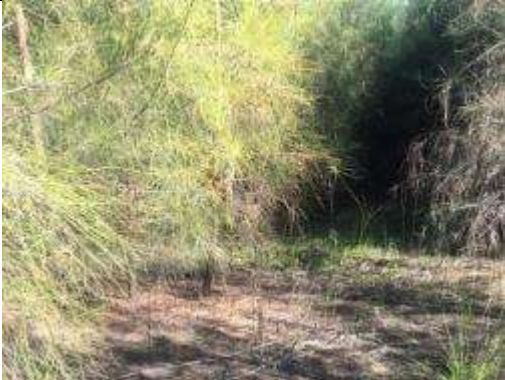
Monitoring month:	32	Months since direct seeding:	36
Date:	April 2018		
Comments:	Casuarina canopy continues to close and shade out understorey.		
Native species:	<i>Bolboschoenus cardwellii</i> , <i>Ludwigia octovalvis</i> , <i>Microleana stipoides</i> , <i>Elaeocharis dulcis</i> , <i>Casuarina glauca</i> , <i>Typha orientalis</i>		
Weed species:	Nil		
Damage:	Nil		
Native dominance:	100%	Percentage vegetation cover:	70%
Photo:

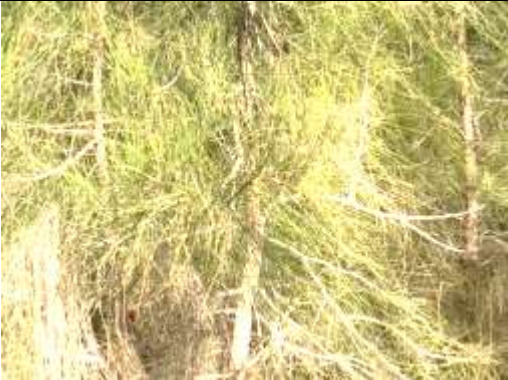
Monitoring month:	33	Months since direct seeding:	37
Date:	May 2018		
Comments:	Casuarinas continue to grow in biomass.		
Native species:	<i>Bolboschoenus cardwellii</i> , <i>Ludwigia octovalvis</i> , <i>Microleana stipoides</i> , <i>Elaeocharis dulcis</i> , <i>Casuarina glauca</i> , <i>Typha orientalis</i>		
Weed species:	Nil		
Damage:	Nil		
Native dominance:	100%	Percentage vegetation cover:	70%
Photo:

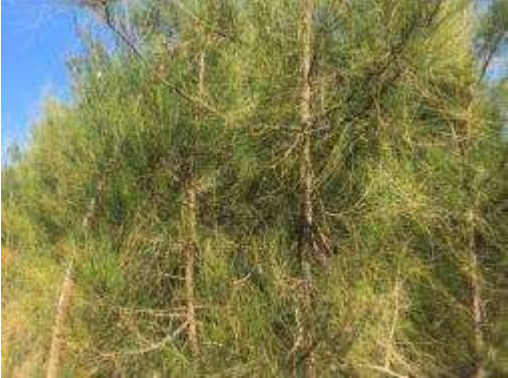
Monitoring month:	34	Months since direct seeding:	39
Date:	June 2018		
Comments:	No significant changes this month due to the slowing down of the growing season.		
Native species:	<i>Bolboschoenus cardwellii</i> , <i>Ludwigia octovalvis</i> , <i>Microleana stipoides</i> , <i>Elaeocharis dulcis</i> , <i>Casuarina glauca</i> , <i>Typha orientalis</i>		
Weed species:	Nil		
Damage:	Nil		
Native dominance:	100%	Percentage vegetation cover:	70%
Photo:

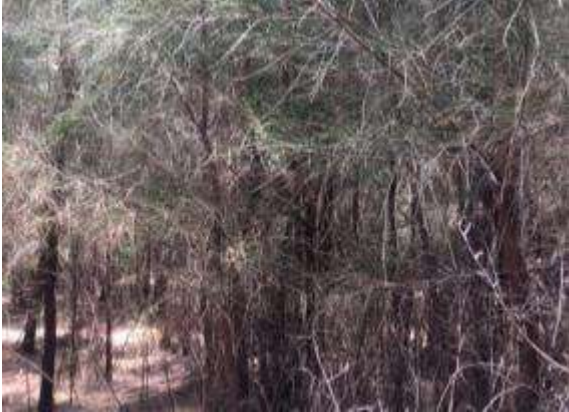
Monitoring month:	35	Months since direct seeding:	40
Date:	July 2018		
Comments:	Due to the increase in shading and organic build up, weed species are continuing to decline.		
Native species:	<i>Bolboschoenus cardwellii</i> , <i>Elaeocharis dulcis</i> , <i>Casuarina glauca</i> , <i>Typha orientalis</i>		
Weed species:	Nil		
Damage:	Nil		
Native dominance:	100%	Percentage vegetation cover:	75%
Photo:

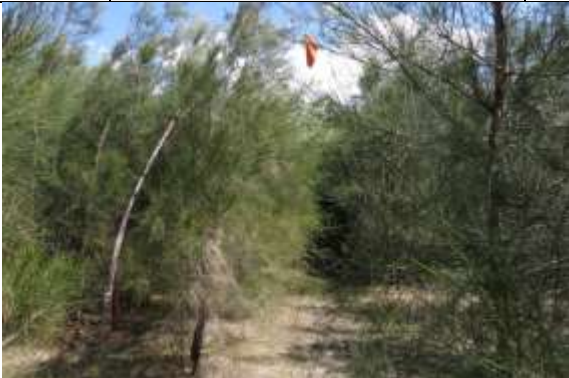
Monitoring month:	36	Months since direct seeding:	41
Date:	August 2018		
Comments:	This quadrat is developing well into an open woodland community with a sparse understorey due to inundation.		
Native species:	<i>Bolboschoenus cardwellii</i> , <i>Elaeocharis dulcis</i> , <i>Casuarina glauca</i> , <i>Typha orientalis</i>		
Weed species:	Nil		
Damage:	Nil		
Native dominance:	100%	Percentage vegetation cover:	80%
Photo:

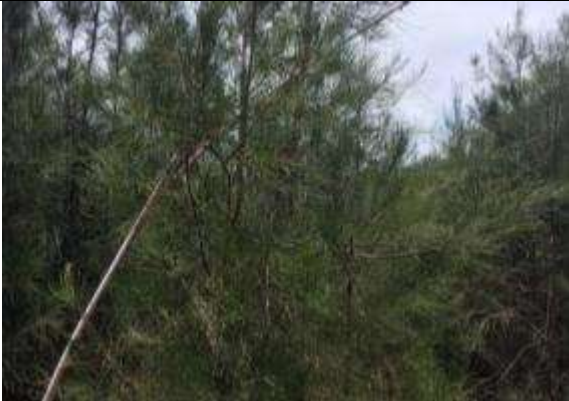
Monitoring month:	37	Months since direct seeding:	42
Date:	September 2018		
Comments:	Native diversity has declined over the past few monitoring months; however native dominance has not decreased.		
Native species:	<i>Bolboschoenus cardwellii</i> , <i>Elaeocharis dulcis</i> , <i>Casuarina glauca</i> , <i>Typha orientalis</i>		
Weed species:	Nil		
Damage:	Nil		
Native dominance:	100%	Percentage vegetation cover:	80%
Photo:

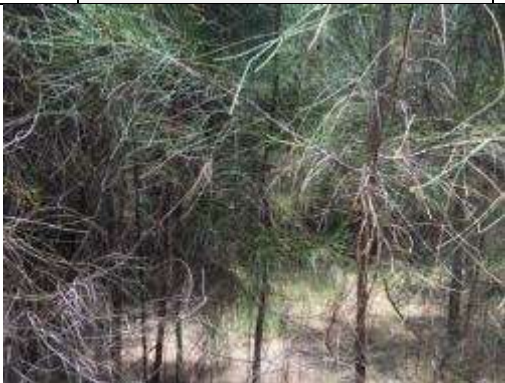
Monitoring month:	38	Months since direct seeding:	43
Date:	October 2018		
Comments:	Rainfall occurred throughout the area during this month which has assisted with the increase in biomass.		
Native species:	<i>Bolboschoenus cardwellii</i> , <i>Elaeocharis dulcis</i> , <i>Casuarina glauca</i> , <i>Typha orientalis</i>		
Weed species:	Nil		
Damage:	Nil		
Native dominance:	100%	Percentage vegetation cover:	80%
Photo:

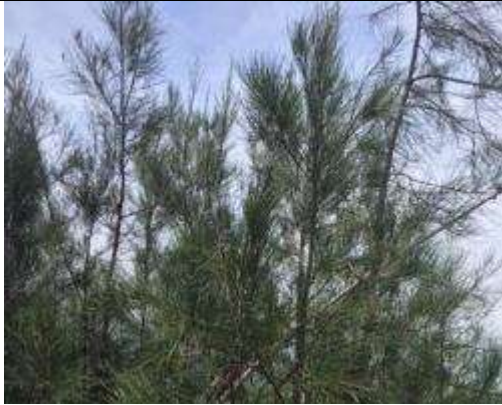
Monitoring month:	39	Months since direct seeding:	44
Date:	November 2018		
Comments:	Rapidly increasing temperatures were experienced this month resulting in the exponential growth of vegetation.		
Native species:	<i>Bolboschoenus cardwellii</i> , <i>Elaeocharis dulcis</i> , <i>Casuarina glauca</i> , <i>Typha orientalis</i>		
Weed species:	Nil		
Damage:	Nil		
Native dominance:	100%	Percentage vegetation cover:	80%
Photo:

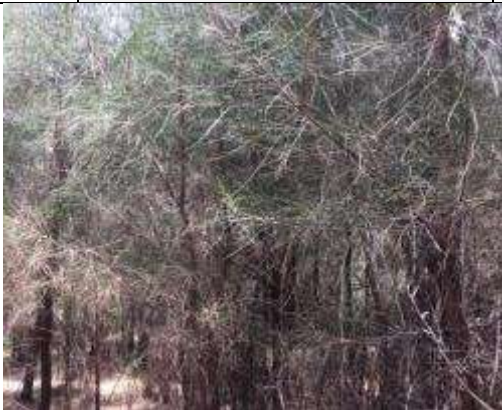
Monitoring month:	40	Months since direct seeding:	45
Date:	December 2018		
Comments:	Vegetation growth was steady this month. Typha was not identified during this monitoring event.		
Native species:	<i>Bolboschoenus cardwellii</i> , <i>Elaeocharis dulcis</i> , <i>Casuarina glauca</i>		
Weed species:	Nil		
Damage:	Nil		
Native dominance:	100%	Percentage vegetation cover:	80%
Photo:

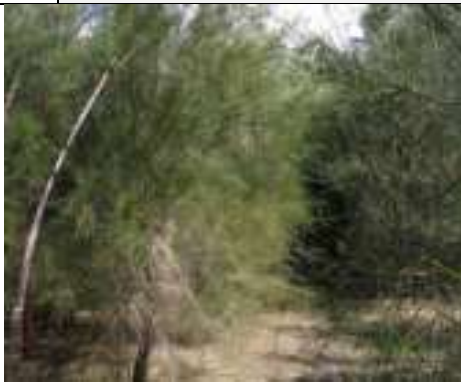
Monitoring month:	41	Months since direct seeding:	46
Date:	January 2019		
Comments:	Canopy cover continues to increase.		
Native species:	<i>Bolboschoenus cardwellii</i> , <i>Elaeocharis dulcis</i> , <i>Casuarina glauca</i>		
Weed species:	Nil		
Damage:	Nil		
Native dominance:	100%	Percentage vegetation cover:	80%
Photo:

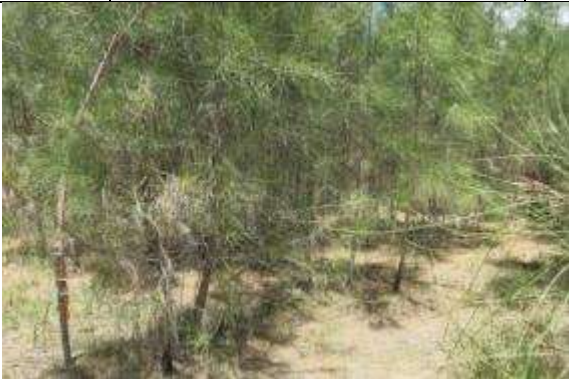
Monitoring month:	42	Months since direct seeding:	47
Date:	February 2019		
Comments:	<i>Elaeocharis dulcis</i> was not identified during this monitoring event. This could be due to the lack of rain and water inundation over the past few months.		
Native species:	<i>Bolboschoenus cardwellii</i> , <i>Casuarina glauca</i>		
Weed species:	Nil		
Damage:	Nil		
Native dominance:	100%	Percentage vegetation cover:	80%
Photo:

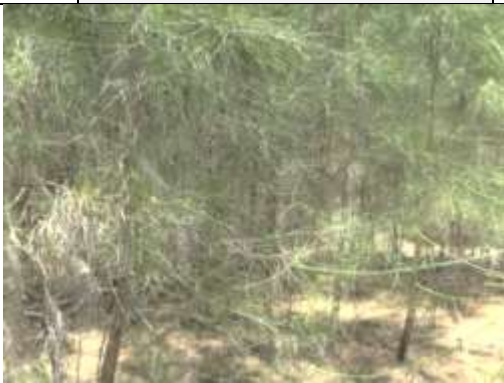
Monitoring month:	43	Months since direct seeding:	48
Date:	March 2019		
Comments:	No significant changes occurred this month.		
Native species:	<i>Bolboschoenus cardwellii</i> , <i>Elaeocharis dulcis</i> , <i>Casuarina glauca</i>		
Weed species:	Nil		
Damage:	Nil		
Native dominance:	100%	Percentage vegetation cover:	80%
Photo:

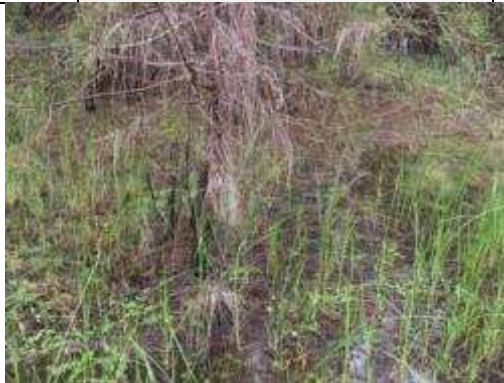
Monitoring month:	44	Months since direct seeding:	49
Date:	April 2019		
Comments:	Rainfall events increased late last month and continued this month giving the NWCP a much needed watering.		
Native species:	<i>Bolboschoenus cardwellii</i> , <i>Elaeocharis dulcis</i> , <i>Casuarina glauca</i>		
Weed species:	Nil		
Damage:	Nil		
Native dominance:	100%	Percentage vegetation cover:	80%
Photo:

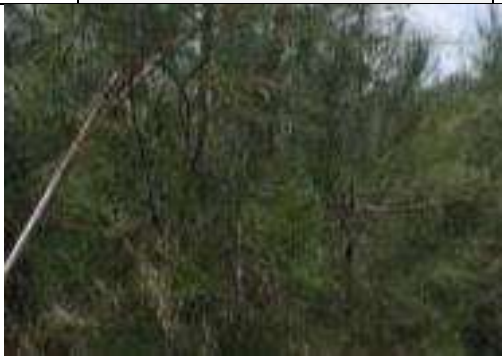
Monitoring month:	45	Months since direct seeding:	50
Date:	May 2019		
Comments:	<i>Casuarina glauca</i> continues to add biomass.		
Native species:	<i>Bolboschoenus cardwellii</i> , <i>Elaeocharis dulcis</i> , <i>Casuarina glauca</i>		
Weed species:	Nil		
Damage:	Nil		
Native dominance:	100%	Percentage vegetation cover:	80%
Photo:

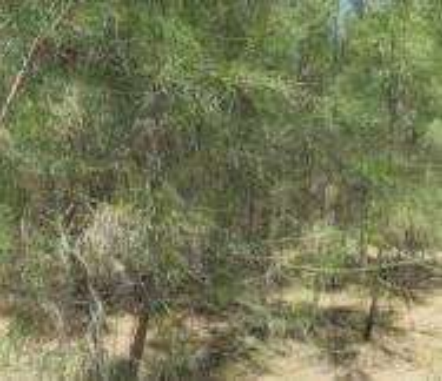
Monitoring month:	47	Months since direct seeding:	52
Date:	July 2019		
Comments:	Recent waterlogging has encouraged wetland sedge and rush growth.		
Native species:	<i>Bolboschoenus cardwellii</i> , <i>Elaeocharis dulcis</i> , <i>Casuarina glauca</i>		
Weed species:	Nil		
Damage:	Nil		
Native dominance:	100%	Percentage vegetation cover:	80%
Photo:

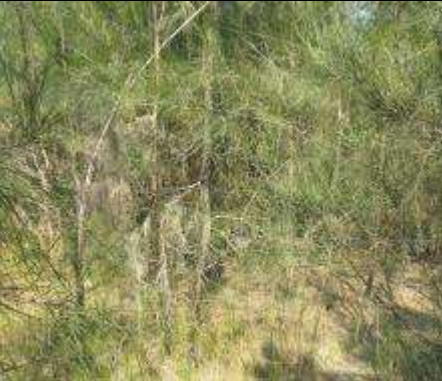
Monitoring month:	48	Months since direct seeding:	53
Date:	August 2019		
Comments:	Wetland species diversity has slowly increased.		
Native species:	<i>Bolboschoenus cardwellii</i> , <i>Elaeocharis dulcis</i> , <i>Casuarina glauca</i> , <i>Isolepis nodosa</i>		
Weed species:	Nil		
Damage:	Nil		
Native dominance:	100%	Percentage vegetation cover:	80%
Photo:

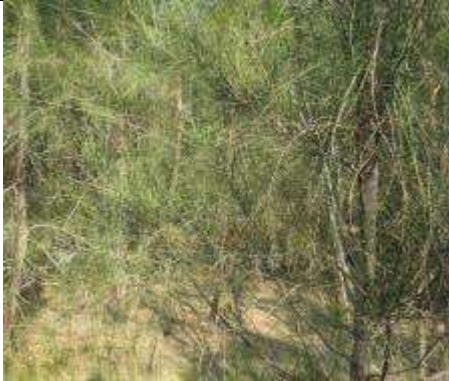
Monitoring month:	49	Months since direct seeding:	54
Date:	September 2019		
Comments:	Vegetation growth is steady.		
Native species:	<i>Bolboschoenus cardwellii</i> , <i>Elaeocharis dulcis</i> , <i>Casuarina glauca</i> , <i>Isolepis nodosa</i>		
Weed species:	Nil		
Damage:	Nil		
Native dominance:	100%	Percentage vegetation cover:	80%
Photo:

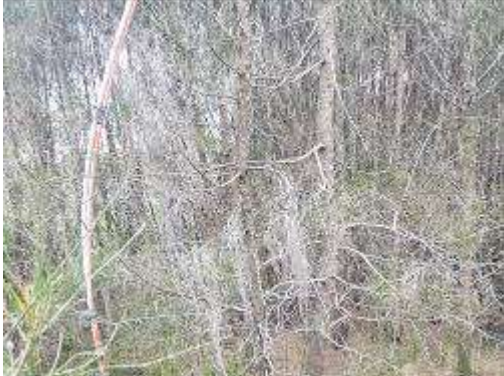
Monitoring month:	50	Months since direct seeding:	55
Date:	October 2019		
Comments:	Extended drought conditions are starting to take their toll with the extreme slowing of plant growth.		
Native species:	<i>Bolboschoenus cardwellii</i> , <i>Elaeocharis dulcis</i> , <i>Casuarina glauca</i> , <i>Isolepis nodosa</i>		
Weed species:	Nil		
Damage:	Nil		
Native dominance:	100%	Percentage vegetation cover:	80%
Photo:

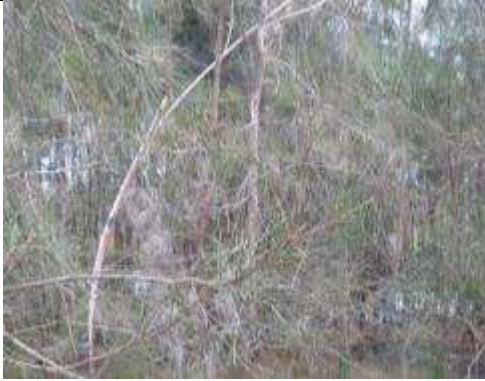
Monitoring month:	51	Months since direct seeding:	56
Date:	November 2019		
Comments:	No significant changes.		
Native species:	<i>Bolboschoenus cardwellii, Elaeocharis dulcis, Casuarina glauca, Isolepis nodosa</i>		
Weed species:	Nil		
Damage:	Nil		
Native dominance:	100%	Percentage vegetation cover:	80%
Photo:

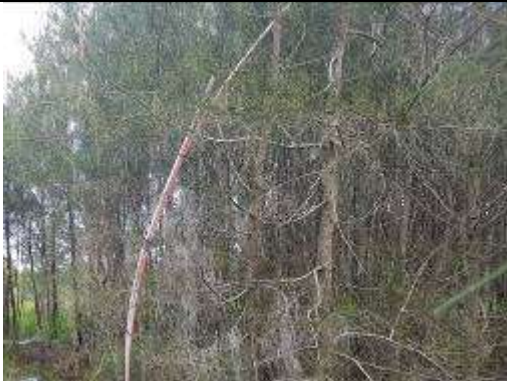
Monitoring month:	52	Months since direct seeding:	57
Date:	December 2019		
Comments:	Vegetation growth is steady.		
Native species:	<i>Bolboschoenus cardwellii, Elaeocharis dulcis, Casuarina glauca, Isolepis nodosa</i>		
Weed species:	Nil		
Damage:	Nil		
Native dominance:	100%	Percentage vegetation cover:	80%
Photo:

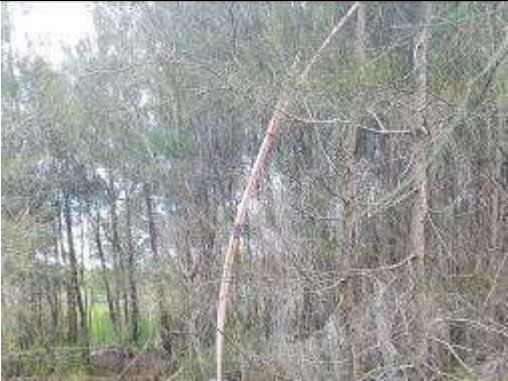
Monitoring month:	53	Months since direct seeding:	58
Date:	January 2020		
Comments:	Vegetation growth is steady.		
Native species:	<i>Bolboschoenus cardwellii</i> , <i>Elaeocharis dulcis</i> , <i>Casuarina glauca</i> , <i>Isolepis nodosa</i>		
Weed species:	Nil		
Damage:	Nil		
Native dominance:	100%	Percentage vegetation cover:	80%
Photo:

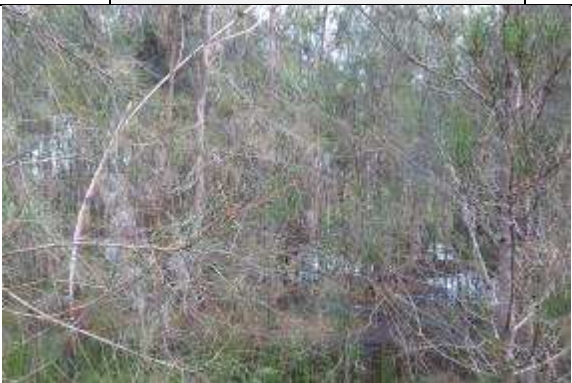
Monitoring month:	54	Months since direct seeding:	59
Date:	February 2020		
Comments:	Signs of inundation within the quadrat due to recent rain.		
Native species:	<i>Bolboschoenus cardwellii</i> , <i>Elaeocharis dulcis</i> , <i>Casuarina glauca</i> , <i>Isolepis nodosa</i> , <i>Ludwigia octovalvis</i>		
Weed species:	Nil		
Damage:	Nil		
Native dominance:	100%	Percentage vegetation cover:	80%
Photo:

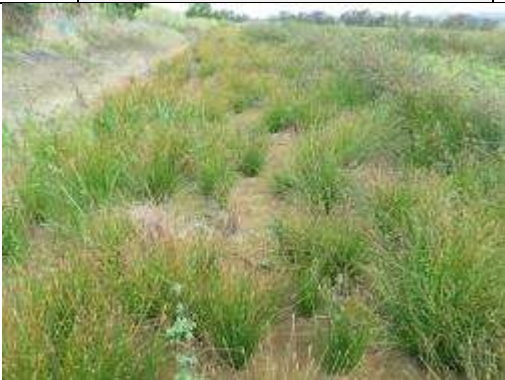
Monitoring month:	1	Months since direct seeding:	6
Date:	September 2015		
Comments:	The very specific nature of the hydrology here has quite obviously favoured <i>Eleocharis dulcis</i> . The quadrat was selected to monitor how other natives perform in competition with present Eleocharis dominance.		
Native species:	<i>Ludwigia octovalvis</i> , <i>Eleocharis dulcis</i> , <i>Bolboschoenus cardwellii</i> , <i>Juncus usitatus</i>		
Weed species:	Nil		
Damage:	Nil		
Native dominance:	100%	Percentage vegetation cover:	50%
Photo:

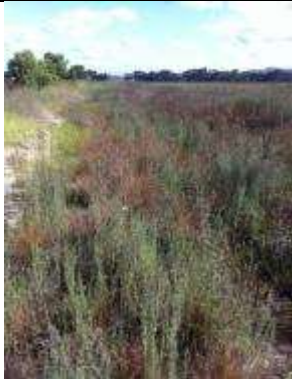
Monitoring month:	6	Months since direct seeding:	11
Date:	February 2016		
Comments:	The very specific nature of the hydrology here has quite obviously favoured <i>Eleocharis dulcis</i> . The surrounding area is lacking obvious signs of canopy trees.		
Native species:	<i>Ludwigia octovalvis</i> , <i>Eleocharis dulcis</i> , <i>Bolboschoenus cardwellii</i> , <i>Juncus usitatus</i>		
Weed species:	<i>Aster subulatus</i> , <i>Paspalum dilatatum</i> , <i>Cuphea carthagenesis</i>		
Damage:	Nil		
Native dominance:	57%	Percentage vegetation cover:	75%
Photo:

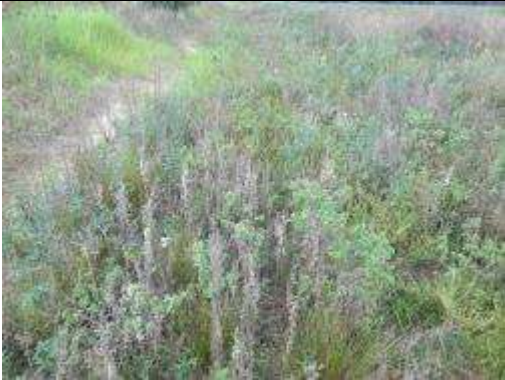
Monitoring month:	7	Months since direct seeding:	12
Date:	March 2016		
Comments:	More inundation will help the Eleocharis to recover its dominance. This surrounding area is lacking obvious signs of canopy trees.		
Native species:	<i>Ludwigia octovalvis</i> , <i>Eleocharis dulcis</i> , <i>Bolboschoenus cardwellii</i> , <i>Juncus usitatus</i>		
Weed species:	<i>Aster subulatus</i> , <i>Paspalum dilatatum</i> , <i>Cuphea carthagenesis</i>		
Damage:	Nil		
Native dominance:	57%	Percentage vegetation cover:	75%
Photo:

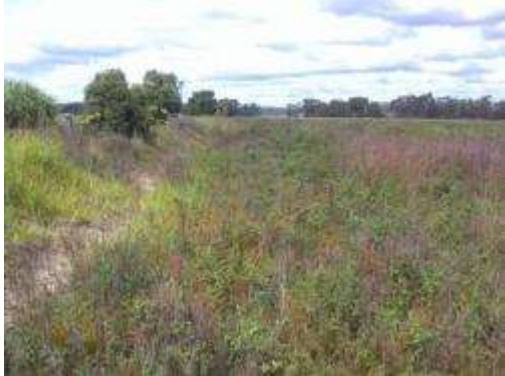
Monitoring month:	8	Months since direct seeding:	13
Date:	April 2016		
Comments:	More inundation will help the Eleocharis to recover its dominance. This surrounding area is lacking obvious signs of canopy trees.		
Native species:	<i>Ludwigia octovalvis</i> , <i>Eleocharis dulcis</i> , <i>Bolboschoenus cardwellii</i> , <i>Juncus usitatus</i>		
Weed species:	<i>Aster subulatus</i> , <i>Paspalum dilatatum</i> , <i>Cuphea carthagenesis</i>		
Damage:	Nil		
Native dominance:	57%	Percentage vegetation cover:	75%
Photo:

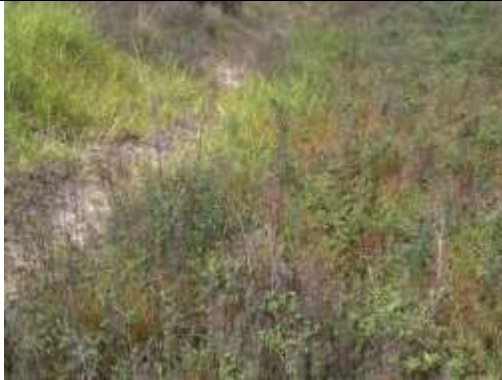
Monitoring month:	9	Months since direct seeding:	14
Date:	May 2016		
Comments:	The first <i>Casuarina</i> seedling was observed this month.		
Native species:	<i>Ludwigia octovalvis</i> , <i>Eleocharis dulcis</i> , <i>Bolboschoenus cardwellii</i> , <i>Juncus usitatus</i> , <i>Casuarina glauca</i>		
Weed species:	<i>Aster subulatus</i> , <i>Paspalum dilatatum</i> , <i>Cuphea carthagenesis</i>		
Damage:	Nil		
Native dominance:	65%	Percentage vegetation cover:	75%
Photo:

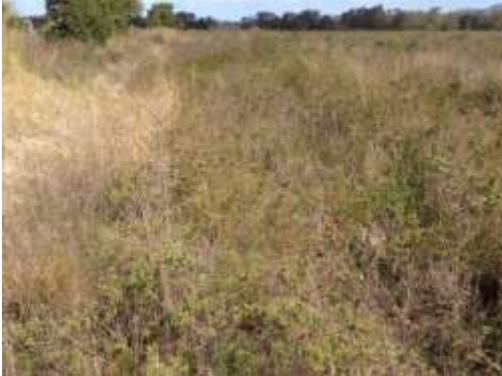
Monitoring month:	10	Months since direct seeding:	15
Date:	June 2016		
Comments:	Signs of wintering are evident this month with the di-off of <i>Aster</i> .		
Native species:	<i>Ludwigia octovalvis</i> , <i>Eleocharis dulcis</i> , <i>Bolboschoenus cardwellii</i> , <i>Juncus usitatus</i> , <i>Casuarina glauca</i>		
Weed species:	<i>Aster subulatus</i> , <i>Paspalum dilatatum</i> , <i>Cuphea carthagenesis</i>		
Damage:	Nil		
Native dominance:	65%	Percentage vegetation cover:	75%
Photo:

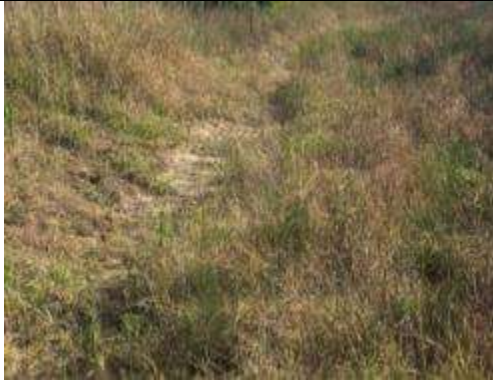
Monitoring month:	11	Months since direct seeding:	16
Date:	July 2016		
Comments:	No significant change recorded this month.		
Native species:	<i>Ludwigia octovalvis</i> , <i>Eleocharis dulcis</i> , <i>Bolboschoenus cardwellii</i> , <i>Juncus usitatus</i> , <i>Casuarina glauca</i>		
Weed species:	<i>Aster subulatus</i> , <i>Paspalum dilatatum</i> , <i>Cuphea carthagenesis</i>		
Damage:	Nil		
Native dominance:	65%	Percentage vegetation cover:	75%
Photo:

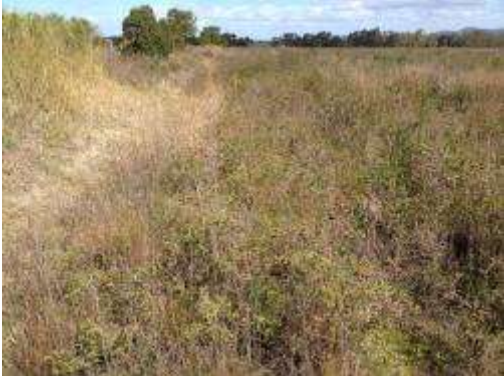
Monitoring month:	12	Months since direct seeding:	17
Date:	August 2016		
Comments:	Summer temperatures will see <i>Eleocharis</i> recover its dominance in this area.		
Native species:	<i>Ludwigia octovalvis</i> , <i>Eleocharis dulcis</i> , <i>Bolboschoenus cardwellii</i> , <i>Juncus usitatus</i> , <i>Casuarina glauca</i> , <i>Persicaria attenuata</i>		
Weed species:	<i>Aster subulatus</i> , <i>Paspalum dilatatum</i> , <i>Cuphea carthagenesis</i>		
Damage:	Nil		
Native dominance:	65%	Percentage vegetation cover:	75%
Photo:

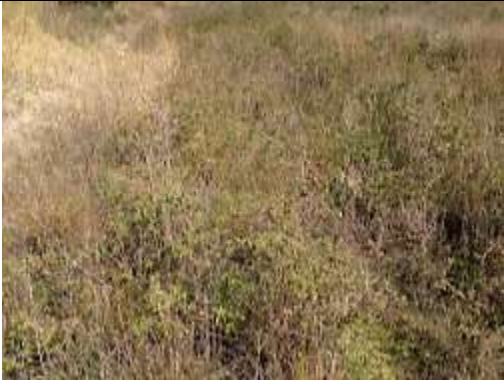
Monitoring month:	13	Months since direct seeding:	18
Date:	September 2016		
Comments:	Quadrat and surrounds are quite dry and seem to be in need of a rain event.		
Native species:	<i>Ludwigia octovalvis</i> , <i>Eleocharis dulcis</i> , <i>Bolboschoenus cardwellii</i> , <i>Juncus usitatus</i> , <i>Casuarina glauca</i> , <i>Persicaria attenuata</i>		
Weed species:	<i>Aster subulatus</i> , <i>Paspalum dilatatum</i> , <i>Cuphea carthagenesis</i>		
Damage:	Nil		
Native dominance:	65%	Percentage vegetation cover:	75%
Photo:

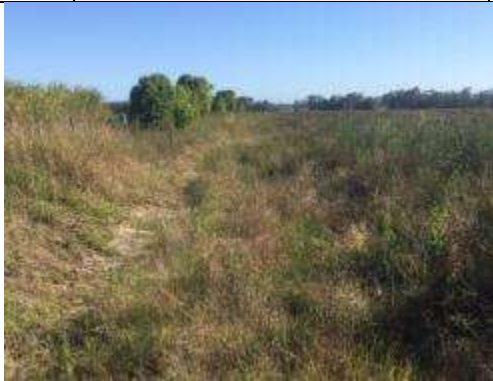
Monitoring month:	14	Months since direct seeding:	19
Date:	October 2016		
Comments:	No significant changes recorded this month.		
Native species:	<i>Ludwigia octovalvis</i> , <i>Eleocharis dulcis</i> , <i>Bolboschoenus cardwellii</i> , <i>Juncus usitatus</i> , <i>Casuarina glauca</i> , <i>Persicaria attenuata</i>		
Weed species:	<i>Aster subulatus</i> , <i>Paspalum dilatatum</i> , <i>Cuphea carthagenesis</i>		
Damage:	Nil		
Native dominance:	65%	Percentage vegetation cover:	75%
Photo:

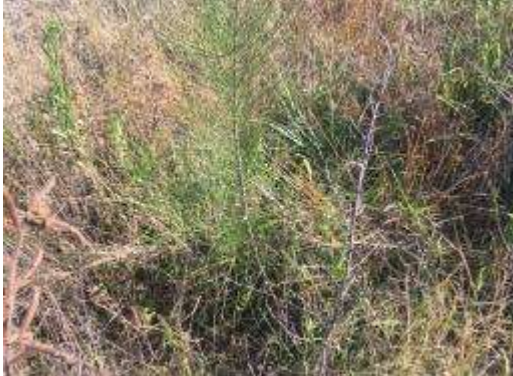
Monitoring month:	15	Months since direct seeding:	20
Date:	November 2016		
Comments:	Casuarina seedlings growing well. Some individuals up to 40cm in height.		
Native species:	<i>Ludwigia octovalvis</i> , <i>Eleocharis dulcis</i> , <i>Bolboschoenus cardwellii</i> , <i>Juncus usitatus</i> , <i>Casuarina glauca</i> , <i>Persicaria attenuata</i>		
Weed species:	<i>Aster subulatus</i> , <i>Paspalum dilatatum</i> , <i>Cuphea carthagenesis</i>		
Damage:	Nil		
Native dominance:	65%	Percentage vegetation cover:	75%
Photo:

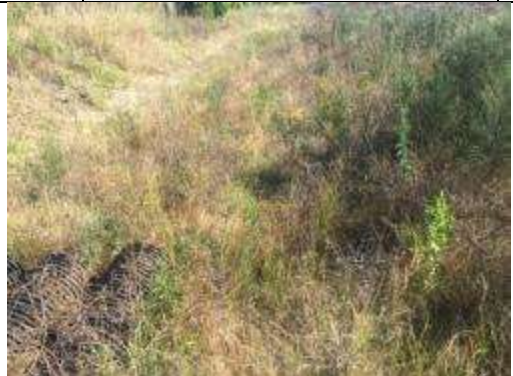
Monitoring month:	16	Months since direct seeding:	21
Date:	November 2016		
Comments:	Groundsel has been identified within this quadrat this month.		
Native species:	<i>Ludwigia octovalvis</i> , <i>Eleocharis dulcis</i> , <i>Bolboschoenus cardwellii</i> , <i>Juncus usitatus</i> , <i>Casuarina glauca</i> , <i>Persicaria attenuata</i>		
Weed species:	<i>Aster subulatus</i> , <i>Paspalum dilatatum</i> , <i>Cuphea carthagenesis</i> , <i>Baccharis halimifolia</i> *		
Damage:	Nil		
Native dominance:	65%	Percentage vegetation cover:	75%
Photo:

* Weed species requires complete eradication to meet the Desired Environmental Outcomes.

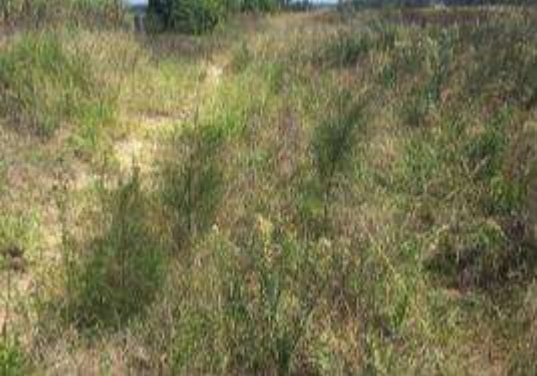
Monitoring month:	17	Months since direct seeding:	22
Date:	January 2017		
Comments:	Casuarinas continue to grow well within this quadrat, averaging approximately 1.2m in height.		
Native species:	<i>Ludwigia octovalvis</i> , <i>Eleocharis dulcis</i> , <i>Bolboschoenus cardwellii</i> , <i>Juncus usitatus</i> , <i>Casuarina glauca</i> , <i>Persicaria attenuata</i>		
Weed species:	<i>Aster subulatus</i> , <i>Paspalum dilatatum</i> , <i>Cuphea carthagenesis</i> , <i>Baccharis halimifolia</i> *		
Damage:	Nil		
Native dominance:	65%	Percentage vegetation cover:	75%
Photo:

* Weed species requires complete eradication to meet the Desired Environmental Outcomes.

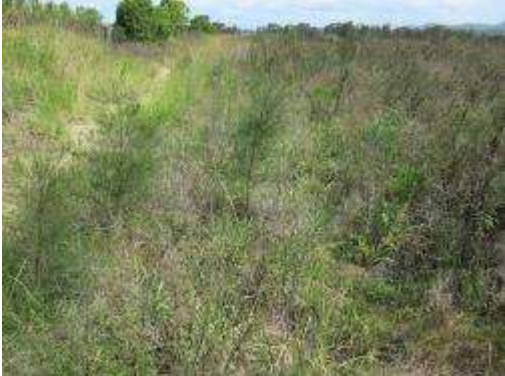
Monitoring month:	18	Months since direct seeding:	23
Date:	February 2017		
Comments:	Casuarinas continue to grow well within this quadrat, averaging approximately 1.2m in height.		
Native species:	<i>Ludwigia octovalvis</i> , <i>Eleocharis dulcis</i> , <i>Bolboschoenus cardwellii</i> , <i>Juncus usitatus</i> , <i>Casuarina glauca</i> , <i>Persicaria attenuata</i>		
Weed species:	<i>Aster subulatus</i> , <i>Paspalum dilatatum</i> , <i>Cuphea carthagenesis</i>		
Damage:	Nil		
Native dominance:	65%	Percentage vegetation cover:	75%
Photo:

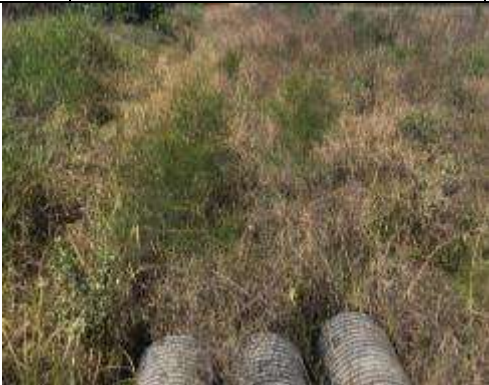
Monitoring month:	19	Months since direct seeding:	24
Date:	March 2017 (NB: monitoring event occurred early April due to inaccessibility)		
Comments:	During the last half of this month, the NWCP received significant rainfall. Access to the area was limited. Much of the area is waterlogged and functioning as the wetland it is designed to be. Casuarinas continue to grow well within this quadrat, averaging approximately 1.2m in height.		
Native species:	<i>Ludwigia octovalvis</i> , <i>Eleocharis dulcis</i> , <i>Bolboschoenus cardwellii</i> , <i>Juncus usitatus</i> , <i>Casuarina glauca</i> , <i>Persicaria attenuata</i>		
Weed species:	<i>Aster subulatus</i> , <i>Paspalum dilatatum</i> , <i>Cuphea carthagenesis</i>		
Damage:	Nil - large weather event associated with Ex-Tropical Cyclone Debbie did not result in any damage		
Native dominance:	65%	Percentage vegetation cover:	75%
Photo:

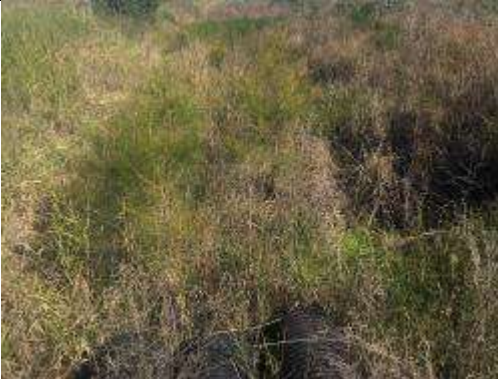
Monitoring month:	20	Months since direct seeding:	25
Date:	April 2017		
Comments:	Sedges and groundcovers still dominate this quadrat. Casuarina growth is steady.		
Native species:	<i>Ludwigia octovalvis</i> , <i>Eleocharis dulcis</i> , <i>Bolboschoenus cardwellii</i> , <i>Juncus usitatus</i> , <i>Casuarina glauca</i> , <i>Persicaria attenuata</i>		
Weed species:	<i>Aster subulatus</i> , <i>Paspalum dilatatum</i> , <i>Cuphea carthagenesis</i>		
Damage:	Nil		
Native dominance:	65%	Percentage vegetation cover:	75%
Photo:

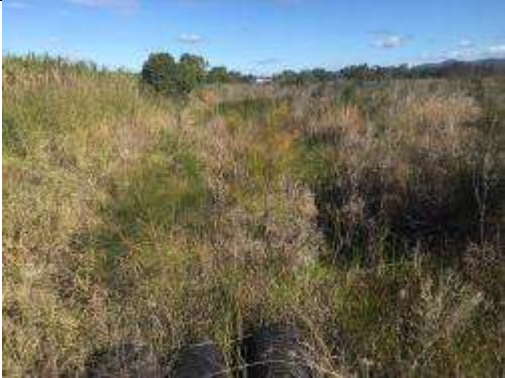
Monitoring month:	21	Months since direct seeding:	26
Date:	May 2017		
Comments:	Sedges and groundcovers still dominate this quadrat. Casuarina growth is steady, averaging approximately 2m height.		
Native species:	<i>Ludwigia octovalvis</i> , <i>Eleocharis dulcis</i> , <i>Bolboschoenus cardwellii</i> , <i>Juncus usitatus</i> , <i>Casuarina glauca</i> , <i>Persicaria attenuata</i>		
Weed species:	<i>Aster subulatus</i> , <i>Paspalum dilatatum</i> , <i>Cuphea carthagenesis</i>		
Damage:	Nil		
Native dominance:	65%	Percentage vegetation cover:	75%
Photo:

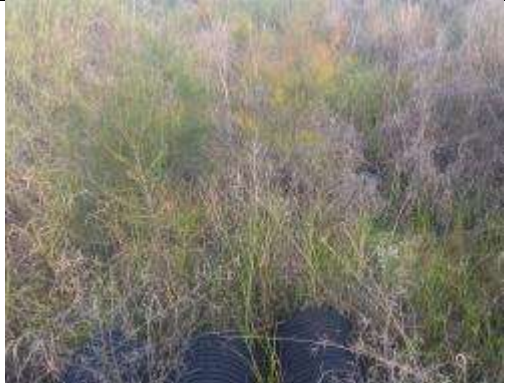
Monitoring month:	22	Months since direct seeding:	27
Date:	June 2017		
Comments:	No significant changes this month. It is anticipated growth will slow moving into the colder months.		
Native species:	<i>Ludwigia octovalvis</i> , <i>Eleocharis dulcis</i> , <i>Bolboschoenus cardwellii</i> , <i>Juncus usitatus</i> , <i>Casuarina glauca</i> , <i>Persicaria attenuata</i>		
Weed species:	<i>Aster subulatus</i> , <i>Paspalum dilatatum</i> , <i>Cuphea carthagenesis</i>		
Damage:	Nil		
Native dominance:	65%	Percentage vegetation cover:	75%
Photo:

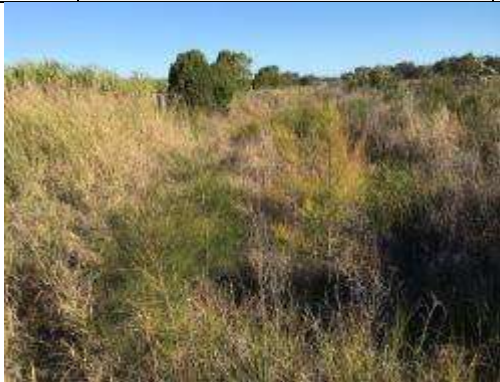
Monitoring month:	23	Months since direct seeding:	28
Date:	July 2017		
Comments:	An additional length of conduit was added to the flagging pole this month due to the increasing height of vegetation. Vegetation health is steady.		
Native species:	<i>Ludwigia octovalvis</i> , <i>Eleocharis dulcis</i> , <i>Bolboschoenus cardwellii</i> , <i>Juncus usitatus</i> , <i>Casuarina glauca</i> , <i>Persicaria attenuata</i>		
Weed species:	<i>Aster subulatus</i> , <i>Paspalum dilatatum</i> , <i>Cuphea carthagenesis</i>		
Damage:	Nil		
Native dominance:	65%	Percentage vegetation cover:	80%
Photo:

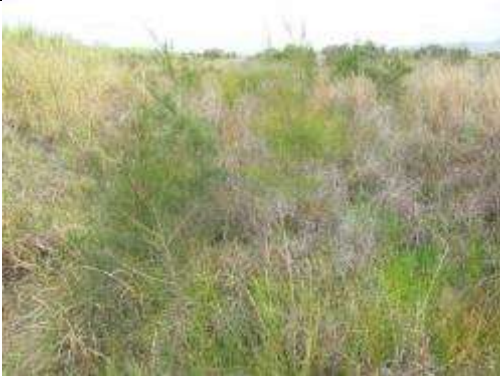
Monitoring month:	24	Months since direct seeding:	29
Date:	August 2017		
Comments:	Casuarinas continue to grow in abundance and height. Weedy grasses starting to struggle against native canopy.		
Native species:	<i>Ludwigia octovalvis</i> , <i>Eleocharis dulcis</i> , <i>Bolboschoenus cardwellii</i> , <i>Juncus usitatus</i> , <i>Casuarina glauca</i> , <i>Persicaria attenuata</i>		
Weed species:	<i>Aster subulatus</i> , <i>Paspalum dilatatum</i> , <i>Cuphea carthagenesis</i>		
Damage:	Nil		
Native dominance:	65%	Percentage vegetation cover:	80%
Photo:
