North-West Conservation Park - Rehabilitation Monitoring

Lot 1 RP48903

North-West Conservation Park
Gainsborough Greens

March 2020

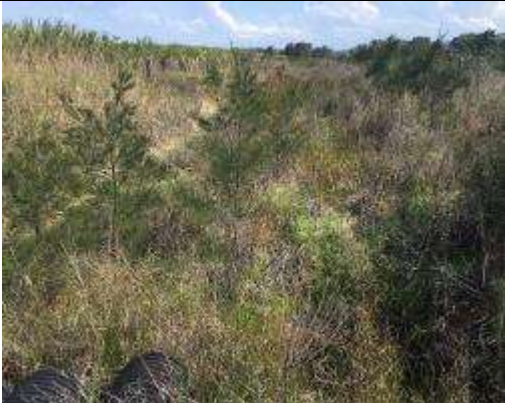
Monitoring month:	25	Months since direct seeding:	30
Date:	September 2017		
Comments:	Vegetation health is steady.		
Native species:	<i>Ludwigia octovalvis</i> , <i>Eleocharis dulcis</i> , <i>Bolboschoenus cardwellii</i> , <i>Juncus usitatus</i> , <i>Casuarina glauca</i> , <i>Persicaria attenuata</i>		
Weed species:	<i>Aster subulatus</i> , <i>Paspalum dilatatum</i> , <i>Cuphea carthagenesis</i>		
Damage:	Nil		
Native dominance:	65%	Percentage vegetation cover:	85%
Photo:

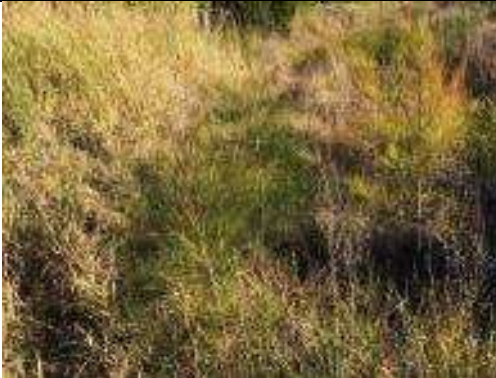
Monitoring month:	26	Months since direct seeding:	31
Date:	October 2017		
Comments:	No significant changes have occurred this month.		
Native species:	<i>Ludwigia octovalvis</i> , <i>Eleocharis dulcis</i> , <i>Bolboschoenus cardwellii</i> , <i>Juncus usitatus</i> , <i>Casuarina glauca</i> , <i>Persicaria attenuata</i>		
Weed species:	<i>Aster subulatus</i> , <i>Paspalum dilatatum</i> , <i>Cuphea carthagenesis</i>		
Damage:	Nil		
Native dominance:	65%	Percentage vegetation cover:	85%
Photo:

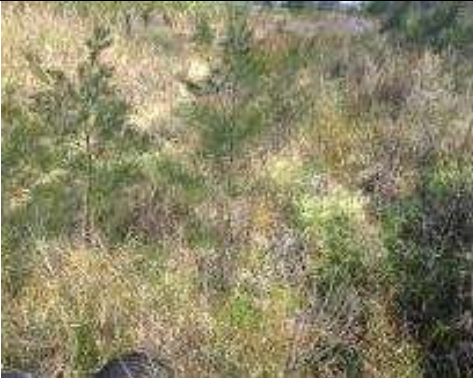
Monitoring month:	27	Months since direct seeding:	32
Date:	November 2017		
Comments:	Small rain events have promoted strong vegetative growth.		
Native species:	<i>Ludwigia octovalvis</i> , <i>Eleocharis dulcis</i> , <i>Bolboschoenus cardwellii</i> , <i>Juncus usitatus</i> , <i>Casuarina glauca</i> , <i>Persicaria attenuata</i>		
Weed species:	<i>Aster subulatus</i> , <i>Paspalum dilatatum</i> , <i>Cuphea carthagenesis</i>		
Damage:	Nil		
Native dominance:	65%	Percentage vegetation cover:	85%
Photo:

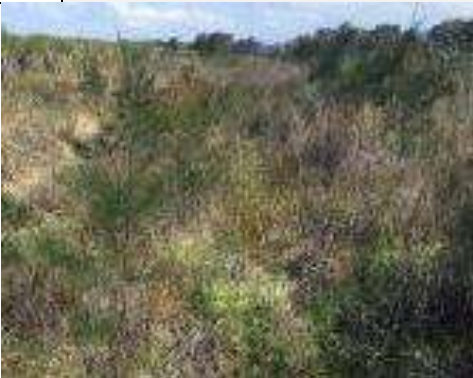
Monitoring month:	28	Months since direct seeding:	33
Date:	December 2017		
Comments:	Casuarinas have increased in biomass this month assisted by increasing temperatures and a number of small rainfall events.		
Native species:	<i>Ludwigia octovalvis</i> , <i>Eleocharis dulcis</i> , <i>Bolboschoenus cardwellii</i> , <i>Juncus usitatus</i> , <i>Casuarina glauca</i> , <i>Persicaria attenuata</i>		
Weed species:	<i>Aster subulatus</i> , <i>Paspalum dilatatum</i> , <i>Cuphea carthagenesis</i>		
Damage:	Nil		
Native dominance:	65%	Percentage vegetation cover:	85%
Photo:

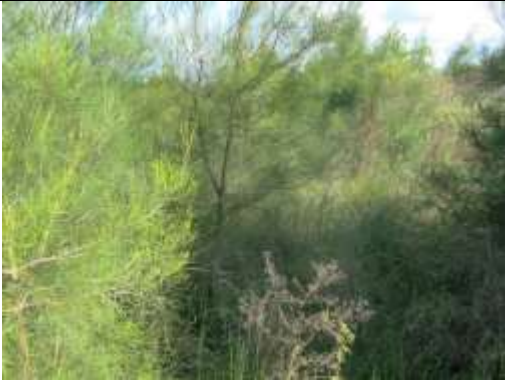
Monitoring month:	29	Months since direct seeding:	34
Date:	January 2018		
Comments:	Vegetation health is steady.		
Native species:	<i>Ludwigia octovalvis</i> , <i>Eleocharis dulcis</i> , <i>Bolboschoenus cardwellii</i> , <i>Juncus usitatus</i> , <i>Casuarina glauca</i> , <i>Persicaria attenuata</i>		
Weed species:	<i>Aster subulatus</i> , <i>Paspalum dilatatum</i> , <i>Cuphea carthagenesis</i>		
Damage:	Nil		
Native dominance:	70%	Percentage vegetation cover:	85%
Photo:

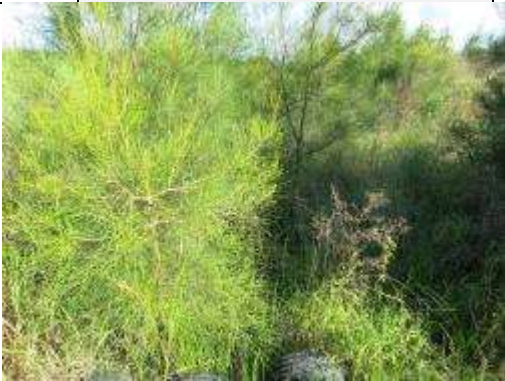
Monitoring month:	30	Months since direct seeding:	35
Date:	February 2018		
Comments:	Casuarina growth continues to close in canopy, increasing shade and decreasing weed biodiversity and biomass.		
Native species:	<i>Ludwigia octovalvis</i> , <i>Eleocharis dulcis</i> , <i>Bolboschoenus cardwellii</i> , <i>Juncus usitatus</i> , <i>Casuarina glauca</i> , <i>Persicaria attenuata</i>		
Weed species:	<i>Aster subulatus</i> , <i>Cuphea carthagenesis</i>		
Damage:	Nil		
Native dominance:	80%	Percentage vegetation cover:	85%
Photo:

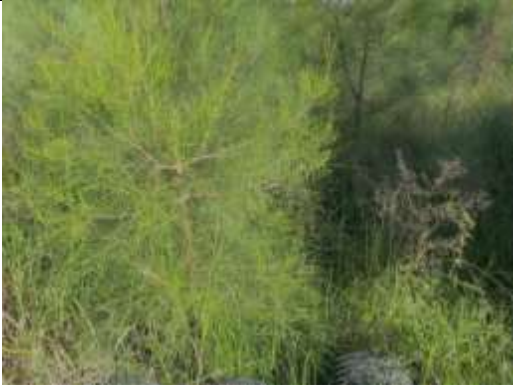
Monitoring month:	31	Months since direct seeding:	36
Date:	March 2018		
Comments:	A significant amount of rain fell at the end of last month resulting in standing water for approximately 3 weeks. This has acted as a natural weed control for a number of the weed species. Canopy growth and shading has also assisted in a reduction of weed growth.		
Native species:	<i>Ludwigia octovalvis</i> , <i>Eleocharis dulcis</i> , <i>Bolboschoenus cardwellii</i> , <i>Juncus usitatus</i> , <i>Casuarina glauca</i> , <i>Persicaria attenuata</i> , <i>Lomandra longifolia</i>		
Weed species:	Nil		
Damage:	Nil		
Native dominance:	100%	Percentage vegetation cover:	85%
Photo:

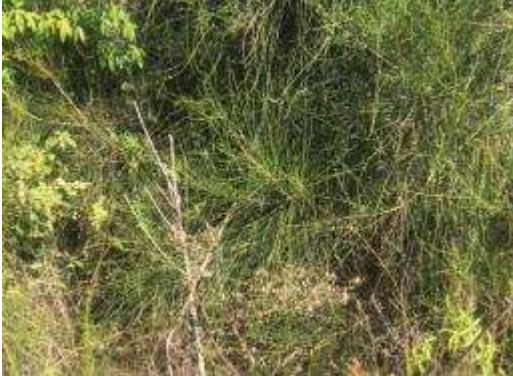
Monitoring month:	32	Months since direct seeding:	37
Date:	April 2018		
Comments:	Vegetation health is steady.		
Native species:	<i>Ludwigia octovalvis</i> , <i>Eleocharis dulcis</i> , <i>Bolboschoenus cardwellii</i> , <i>Juncus usitatus</i> , <i>Casuarina glauca</i> , <i>Persicaria attenuata</i> , <i>Lomandra longifolia</i>		
Weed species:	Nil		
Damage:	Nil		
Native dominance:	100%	Percentage vegetation cover:	85%
Photo:

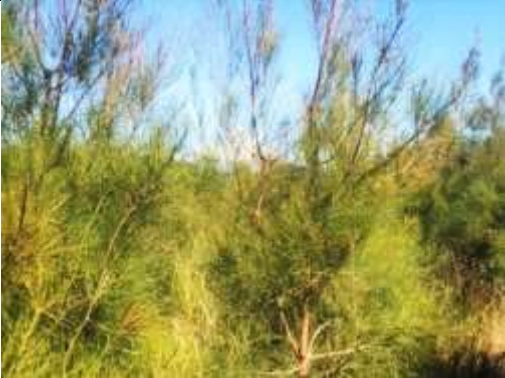
Monitoring month:	33	Months since direct seeding:	38
Date:	May 2018		
Comments:	Casuarina growth continues to close in canopy, increasing shade and decreasing weed biodiversity and biomass.		
Native species:	<i>Ludwigia octovalvis</i> , <i>Eleocharis dulcis</i> , <i>Bolboschoenus cardwellii</i> , <i>Juncus usitatus</i> , <i>Casuarina glauca</i> , <i>Persicaria attenuata</i> , <i>Lomandra longifolia</i>		
Weed species:	Nil		
Damage:	Nil		
Native dominance:	100%	Percentage vegetation cover:	85%
Photo:

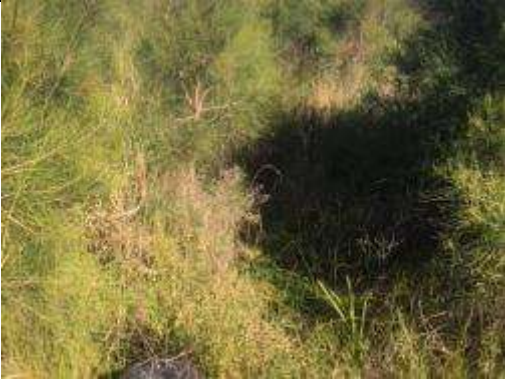
Monitoring month:	34	Months since direct seeding:	39
Date:	June 2018		
Comments:	No significant changes this month due to the slowing down of the growing season.		
Native species:	<i>Ludwigia octovalvis</i> , <i>Eleocharis dulcis</i> , <i>Bolboschoenus cardwellii</i> , <i>Juncus usitatus</i> , <i>Casuarina glauca</i> , <i>Persicaria attenuata</i> , <i>Lomandra longifolia</i>		
Weed species:	Nil		
Damage:	Nil		
Native dominance:	100%	Percentage vegetation cover:	85%
Photo:

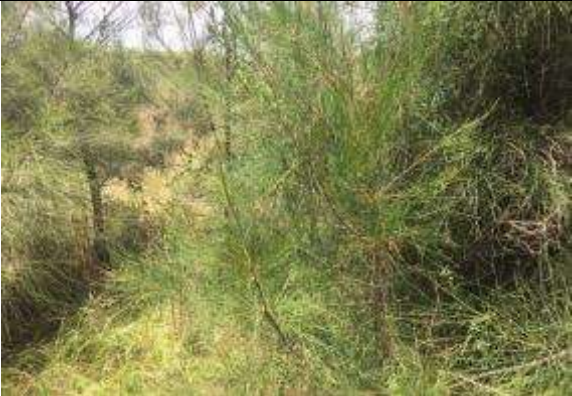
Monitoring month:	35	Months since direct seeding:	40
Date:	July 2018		
Comments:	Vegetation growth steady.		
Native species:	<i>Ludwigia octovalvis</i> , <i>Eleocharis dulcis</i> , <i>Bolboschoenus cardwellii</i> , <i>Juncus usitatus</i> , <i>Casuarina glauca</i> , <i>Persicaria attenuata</i> , <i>Lomandra longifolia</i>		
Weed species:	Nil		
Damage:	Nil		
Native dominance:	100%	Percentage vegetation cover:	85%
Photo:

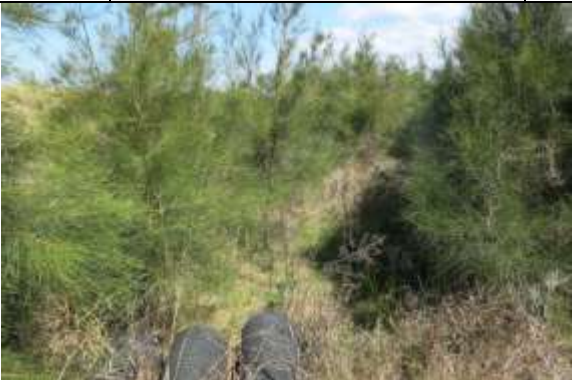
Monitoring month:	36	Months since direct seeding:	41
Date:	August 2018		
Comments:	No significant changes within the quadrat this month. Surrounding areas are progressing extremely well with the removal of Camphor Laurels.		
Native species:	<i>Ludwigia octovalvis</i> , <i>Eleocharis dulcis</i> , <i>Bolboschoenus cardwellii</i> , <i>Juncus usitatus</i> , <i>Casuarina glauca</i> , <i>Persicaria attenuata</i> , <i>Lomandra longifolia</i>		
Weed species:	Nil		
Damage:	Nil		
Native dominance:	100%	Percentage vegetation cover:	90%
Photo:

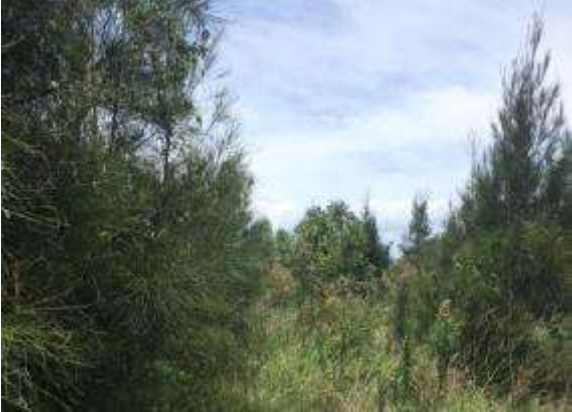
Monitoring month:	37	Months since direct seeding:	42
Date:	September 2018		
Comments:	<i>Casuarina glauca</i> continues to add biomass.		
Native species:	<i>Ludwigia octovalvis</i> , <i>Eleocharis dulcis</i> , <i>Bolboschoenus cardwellii</i> , <i>Juncus usitatus</i> , <i>Casuarina glauca</i> , <i>Persicaria attenuata</i> , <i>Lomandra longifolia</i>		
Weed species:	Nil		
Damage:	Nil		
Native dominance:	100%	Percentage vegetation cover:	90%
Photo:

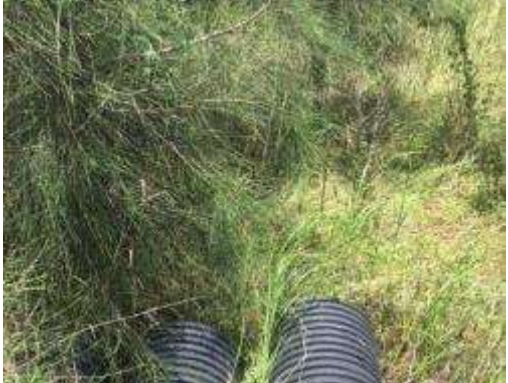
Monitoring month:	38	Months since direct seeding:	43
Date:	October 2018		
Comments:	Rainfall occurred throughout the area during this month which has assisted with the increase in biomass.		
Native species:	<i>Ludwigia octovalvis</i> , <i>Eleocharis dulcis</i> , <i>Bolboschoenus cardwellii</i> , <i>Juncus usitatus</i> , <i>Casuarina glauca</i> , <i>Persicaria attenuata</i> , <i>Lomandra longifolia</i>		
Weed species:	Nil		
Damage:	Nil		
Native dominance:	100%	Percentage vegetation cover:	90%
Photo:

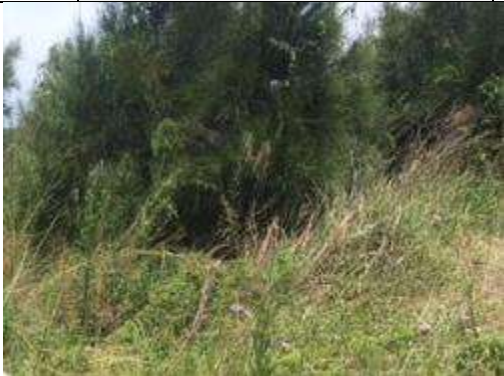
Monitoring month:	39	Months since direct seeding:	44
Date:	November 2018		
Comments:	Rapidly increasing temperatures were experienced this month resulting in the exponential growth of vegetation.		
Native species:	<i>Ludwigia octovalvis</i> , <i>Eleocharis dulcis</i> , <i>Bolboschoenus cardwellii</i> , <i>Juncus usitatus</i> , <i>Casuarina glauca</i> , <i>Persicaria attenuata</i> , <i>Lomandra longifolia</i>		
Weed species:	Nil		
Damage:	Nil		
Native dominance:	100%	Percentage vegetation cover:	90%
Photo:

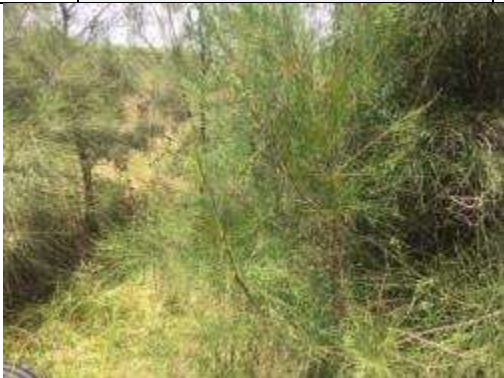
Monitoring month:	40	Months since direct seeding:	45
Date:	December 2018		
Comments:	Vegetation growth was steady this month.		
Native species:	<i>Ludwigia octovalvis</i> , <i>Eleocharis dulcis</i> , <i>Bolboschoenus cardwellii</i> , <i>Juncus usitatus</i> , <i>Casuarina glauca</i> , <i>Persicaria attenuata</i> , <i>Lomandra longifolia</i>		
Weed species:	Nil		
Damage:	Nil		
Native dominance:	100%	Percentage vegetation cover:	90%
Photo:

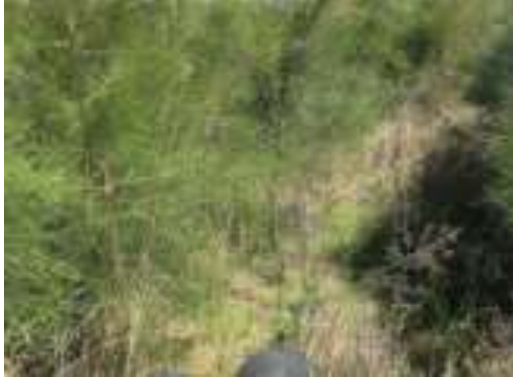
Monitoring month:	41	Months since direct seeding:	46
Date:	January 2019		
Comments:	Casuarina canopy continues to close in.		
Native species:	<i>Ludwigia octovalvis</i> , <i>Eleocharis dulcis</i> , <i>Bolboschoenus cardwellii</i> , <i>Juncus usitatus</i> , <i>Casuarina glauca</i> , <i>Persicaria attenuata</i> , <i>Lomandra longifolia</i>		
Weed species:	Nil		
Damage:	Nil		
Native dominance:	100%	Percentage vegetation cover:	90%
Photo:

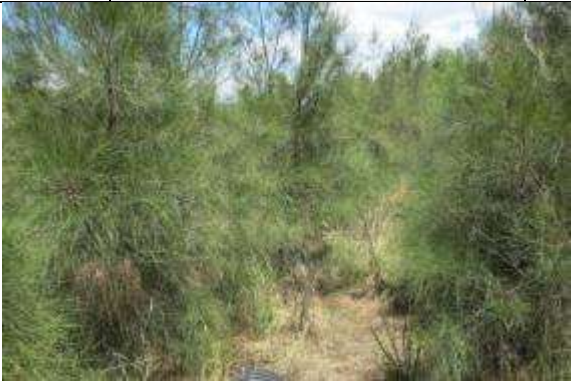
Monitoring month:	42	Months since direct seeding:	47
Date:	February 2019		
Comments:	Native groundcovers are continuing to thrive which is a positive change for the drainage line on the whole.		
Native species:	<i>Ludwigia octovalvis</i> , <i>Eleocharis dulcis</i> , <i>Bolboschoenus cardwellii</i> , <i>Juncus usitatus</i> , <i>Casuarina glauca</i> , <i>Persicaria attenuata</i> , <i>Lomandra longifolia</i>		
Weed species:	Nil		
Damage:	Nil		
Native dominance:	100%	Percentage vegetation cover:	90%
Photo:

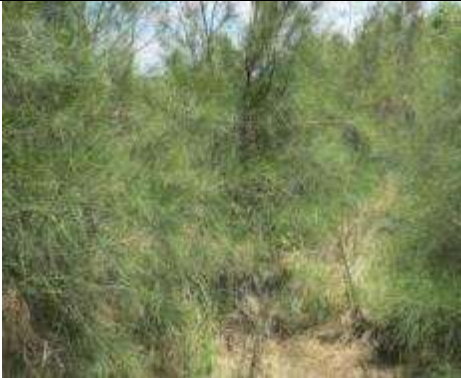
Monitoring month:	43	Months since direct seeding:	48
Date:	March 2019		
Comments:	No significant changes occurred this month.		
Native species:	<i>Ludwigia octovalvis</i> , <i>Eleocharis dulcis</i> , <i>Bolboschoenus cardwellii</i> , <i>Juncus usitatus</i> , <i>Casuarina glauca</i> , <i>Persicaria attenuata</i> , <i>Lomandra longifolia</i>		
Weed species:	Nil		
Damage:	Nil		
Native dominance:	100%	Percentage vegetation cover:	90%
Photo:

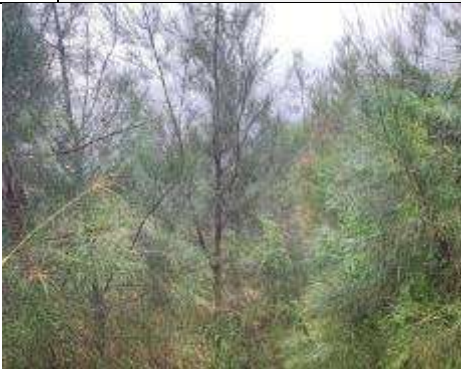
Monitoring month:	44	Months since direct seeding:	49
Date:	April 2019		
Comments:	Rainfall events increased late last month and continued this month giving the NWCP a much needed watering.		
Native species:	<i>Ludwigia octovalvis</i> , <i>Eleocharis dulcis</i> , <i>Bolboschoenus cardwellii</i> , <i>Juncus usitatus</i> , <i>Casuarina glauca</i> , <i>Persicaria attenuata</i> , <i>Lomandra longifolia</i>		
Weed species:	Nil		
Damage:	Nil		
Native dominance:	100%	Percentage vegetation cover:	90%
Photo:

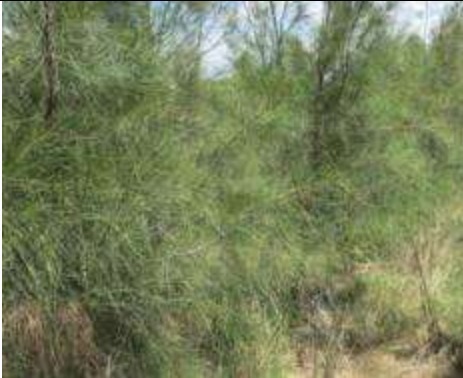
Monitoring month:	45	Months since direct seeding:	50
Date:	May 2019		
Comments:	<i>Casuarina glauca</i> continues to add biomass.		
Native species:	<i>Ludwigia octovalvis</i> , <i>Eleocharis dulcis</i> , <i>Bolboschoenus cardwellii</i> , <i>Juncus usitatus</i> , <i>Casuarina glauca</i> , <i>Persicaria attenuata</i> , <i>Lomandra longifolia</i>		
Weed species:	Nil		
Damage:	Nil		
Native dominance:	100%	Percentage vegetation cover:	90%
Photo:

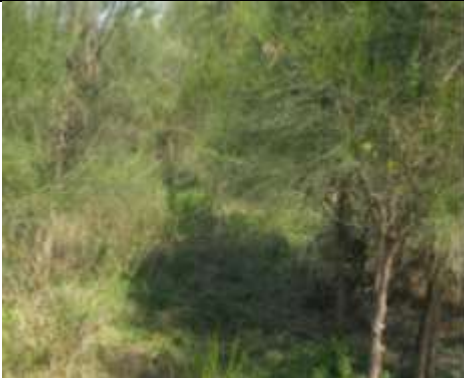
Monitoring month:	47	Months since direct seeding:	52
Date:	July 2019		
Comments:	Eucalypt growth in the surrounding area continues to add biomass, allowing for the increased abundance of native grasses such as <i>Imperata cylindrica</i> .		
Native species:	<i>Ludwigia octovalvis</i> , <i>Eleocharis dulcis</i> , <i>Bolboschoenus cardwellii</i> , <i>Juncus usitatus</i> , <i>Casuarina glauca</i> , <i>Persicaria attenuata</i> , <i>Lomandra longifolia</i>		
Weed species:	Nil		
Damage:	Nil		
Native dominance:	100%	Percentage vegetation cover:	90%
Photo:

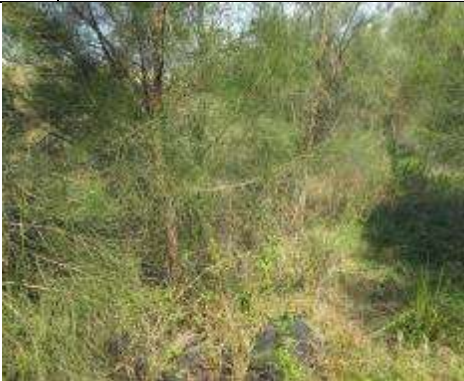
Monitoring month:	48	Months since direct seeding:	53
Date:	August 2019		
Comments:	Native dominance declined due to morning glory presence.		
Native species:	<i>Ludwigia octovalvis</i> , <i>Eleocharis dulcis</i> , <i>Bolboschoenus cardwellii</i> , <i>Juncus usitatus</i> , <i>Casuarina glauca</i> , <i>Persicaria attenuata</i> , <i>Lomandra longifolia</i>		
Weed species:	<i>Ipomoea indica</i>		
Damage:	Nil		
Native dominance:	90%	Percentage vegetation cover:	90%
Photo:

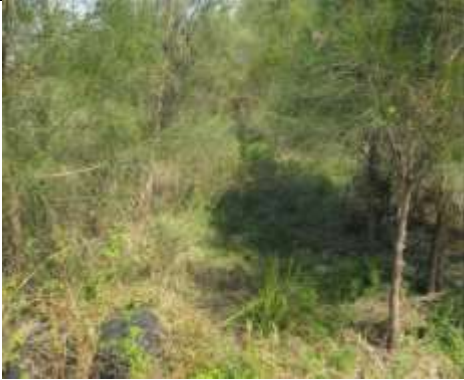
Monitoring month:	49	Months since direct seeding:	54
Date:	September 2019		
Comments:	<i>Lomandra longifolia</i> and other native groundcovers in the surrounding area are continuing to strengthen in numbers.		
Native species:	<i>Ludwigia octovalvis</i> , <i>Eleocharis dulcis</i> , <i>Bolboschoenus cardwellii</i> , <i>Juncus usitatus</i> , <i>Casuarina glauca</i> , <i>Persicaria attenuata</i> , <i>Lomandra longifolia</i>		
Weed species:	Nil		
Damage:	Nil		
Native dominance:	100%	Percentage vegetation cover:	90%
Photo:

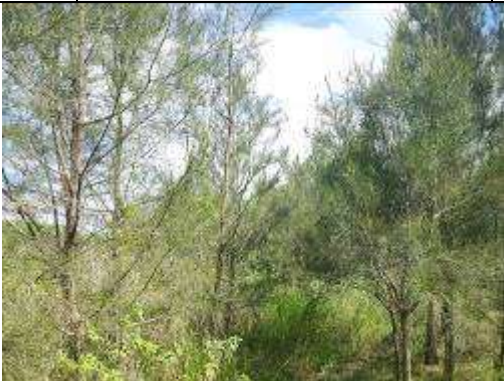
Monitoring month:	50	Months since direct seeding:	55
Date:	October 2019		
Comments:	Extended drought conditions are starting to take their toll with the extreme slowing of plant growth.		
Native species:	<i>Ludwigia octovalvis</i> , <i>Eleocharis dulcis</i> , <i>Bolboschoenus cardwellii</i> , <i>Juncus usitatus</i> , <i>Casuarina glauca</i> , <i>Persicaria attenuata</i> , <i>Lomandra longifolia</i>		
Weed species:	Nil		
Damage:	Nil		
Native dominance:	100%	Percentage vegetation cover:	90%
Photo:

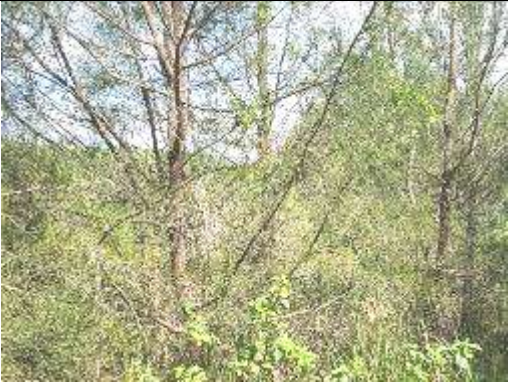
Monitoring month:	51	Months since direct seeding:	56
Date:	November 2019		
Comments:	No significant changes to report.		
Native species:	<i>Ludwigia octovalvis</i> , <i>Eleocharis dulcis</i> , <i>Bolboschoenus cardwellii</i> , <i>Juncus usitatus</i> , <i>Casuarina glauca</i> , <i>Persicaria attenuata</i> , <i>Lomandra longifolia</i>		
Weed species:	Nil		
Damage:	Nil		
Native dominance:	100%	Percentage vegetation cover:	90%
Photo:

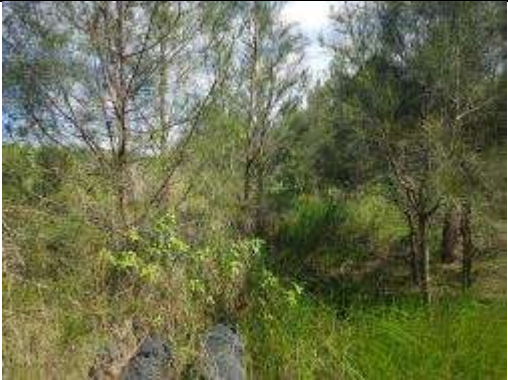
Monitoring month:	52	Months since direct seeding:	57
Date:	December 2019		
Comments:	Vegetation growth steady.		
Native species:	<i>Ludwigia octovalvis</i> , <i>Eleocharis dulcis</i> , <i>Bolboschoenus cardwellii</i> , <i>Juncus usitatus</i> , <i>Casuarina glauca</i> , <i>Persicaria attenuata</i> , <i>Lomandra longifolia</i>		
Weed species:	Nil		
Damage:	Nil		
Native dominance:	100%	Percentage vegetation cover:	90%
Photo:

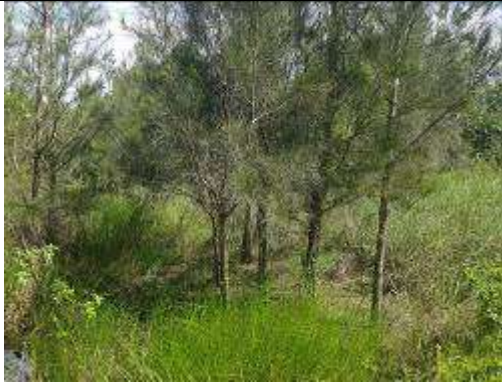
Monitoring month:	53	Months since direct seeding:	58
Date:	January 2020		
Comments:	Recent rain is increasing wetland plant vigour.		
Native species:	<i>Ludwigia octovalvis</i> , <i>Eleocharis dulcis</i> , <i>Bolboschoenus cardwellii</i> , <i>Juncus usitatus</i> , <i>Casuarina glauca</i> , <i>Persicaria attenuata</i> , <i>Lomandra longifolia</i>		
Weed species:	Nil		
Damage:	Nil		
Native dominance:	100%	Percentage vegetation cover:	90%
Photo:

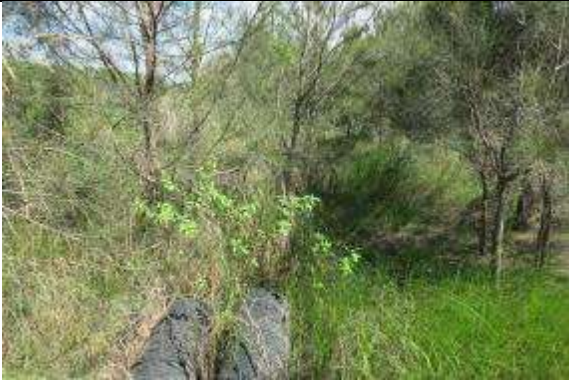
Monitoring month:	54	Months since direct seeding:	59
Date:	February 2020		
Comments:	Canopy vegetation growth and abundance is continuing to add biomass.		
Native species:	<i>Ludwigia octovalvis</i> , <i>Eleocharis dulcis</i> , <i>Bolboschoenus cardwellii</i> , <i>Juncus usitatus</i> , <i>Casuarina glauca</i> , <i>Persicaria attenuata</i> , <i>Lomandra longifolia</i>		
Weed species:	Nil		
Damage:	Nil		
Native dominance:	100%	Percentage vegetation cover:	90%
Photo:

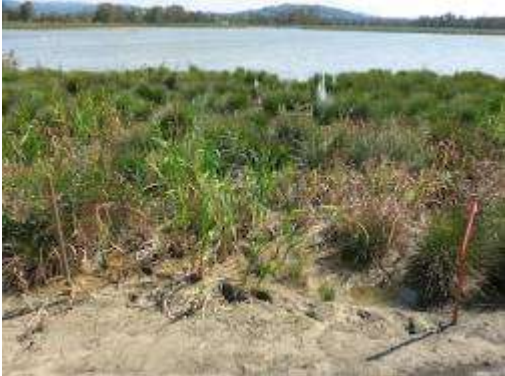
Monitoring month:	1	Months since direct seeding:	6
Date:	September 2015		
Comments:	This quadrat is dominated by native Typha. It was selected to determine how other natives are able to compete successfully (or otherwise) with the Typha.		
Native species:	<i>Elaeocharis dulcis</i> , <i>Typha orientalis</i> , <i>Ludwigia octovalvis</i>		
Weed species:	Nil		
Damage:	Nil		
Native dominance:	100%	Percentage vegetation cover:	50%
Photo:

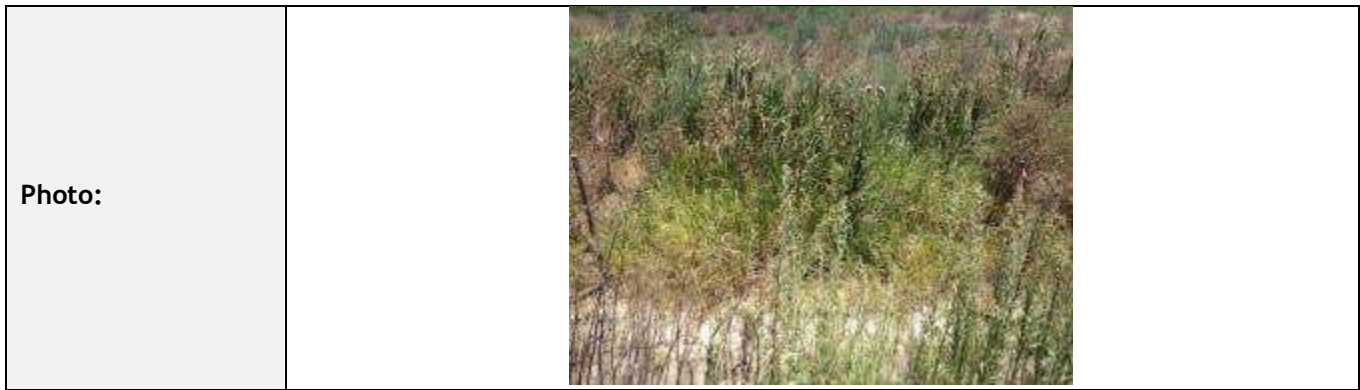
Monitoring month:	6	Months since direct seeding:	11
Date:	February 2016		
Comments:	The eastern side is the most isolated area of the project with regard to native tree recruitment potential, and an obvious lack of tree seedlings recruiting over the entire eastern side was observed. This quad reflects the lack of tree species being recorded in the eastern area. Typha continues to dominate native cover, however this dominance is finely balanced with weeds making up almost 50% of coverage. This quad is another good example of how standing water controls weeds in wetlands and the effect drying out may have on weed growth.		
Native species:	<i>Elaeocharis dulcis</i> , <i>Ludwigia octovalvis</i> , <i>Cyperus polystachyos</i> , <i>Typha orientalis</i>		
Weed species:	<i>Cirsium vulgare</i> , <i>Aster subulatus</i> , <i>Paspalum dilatatum</i>		
Damage:	Nil		
Native dominance:	57%	Percentage vegetation cover:	80%

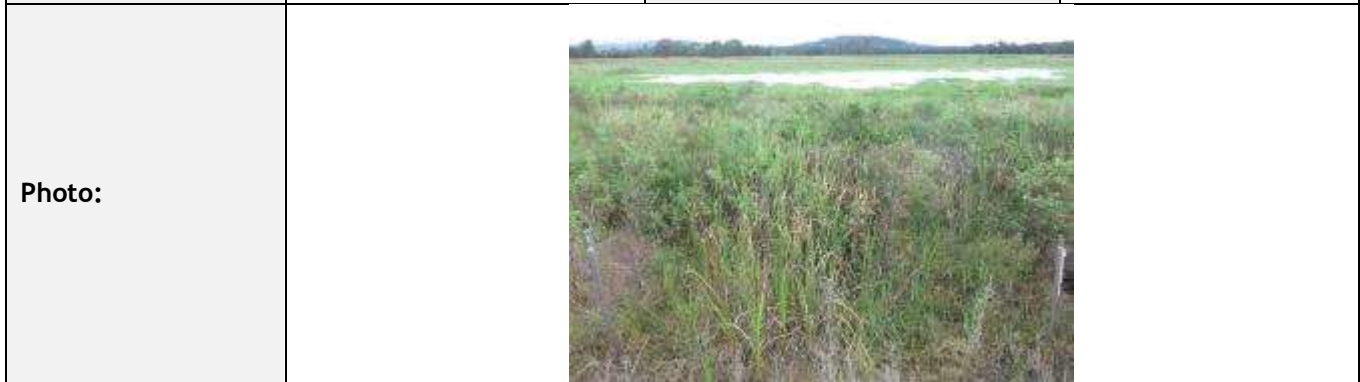
Monitoring month:	7	Months since direct seeding:	12
Date:	March 2016		
Comments:	This eastern side is the most isolated area of the project with regard to native tree recruitment potential, and an obvious lack of tree seedlings recruiting over the entire eastern side was observed.		
Native species:	<i>Elaeocharis dulcis</i> , <i>Ludwigia octovalvis</i> , <i>Cyperus polystachyos</i> , <i>Typha orientalis</i>		
Weed species:	<i>Cirsium vulgare</i> , <i>Aster subulatus</i> , <i>Paspalum dilatatum</i>		
Damage:	Nil		
Native dominance:	57%	Percentage vegetation cover:	80%

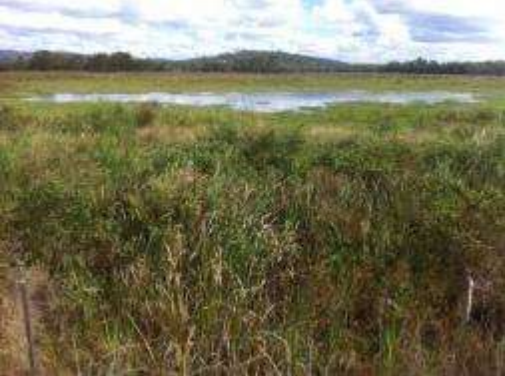
Monitoring month:	8	Months since direct seeding:	13
Date:	April 2016		
Comments:	This eastern side is the most isolated area of the project with regard to native tree recruitment potential, and an obvious lack of tree seedlings recruiting over the entire eastern side was observed.		
Native species:	<i>Elaeocharis dulcis</i> , <i>Ludwigia octovalvis</i> , <i>Cyperus polystachyos</i> , <i>Typha orientalis</i>		
Weed species:	<i>Cirsium vulgare</i> , <i>Aster subulatus</i> , <i>Paspalum dilatatum</i>		
Damage:	Nil		
Native dominance:	60%	Percentage vegetation cover:	80%
Photo:

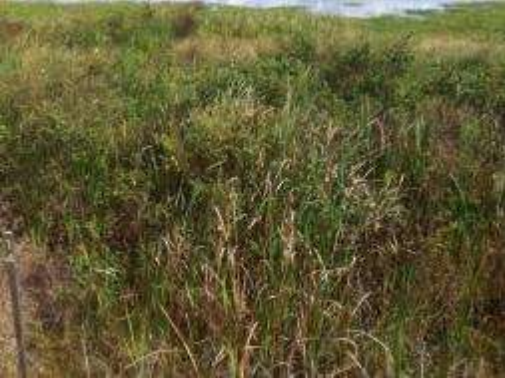
Monitoring month:	9	Months since direct seeding:	14
Date:	May 2016		
Comments:	Typha continues to grow well within this quadrat.		
Native species:	<i>Elaeocharis dulcis</i> , <i>Ludwigia octovalvis</i> , <i>Cyperus polystachyos</i> , <i>Typha orientalis</i>		
Weed species:	<i>Cirsium vulgare</i> , <i>Aster subulatus</i> , <i>Paspalum dilatatum</i>		
Damage:	Nil		
Native dominance:	60%	Percentage vegetation cover:	80%
Photo:

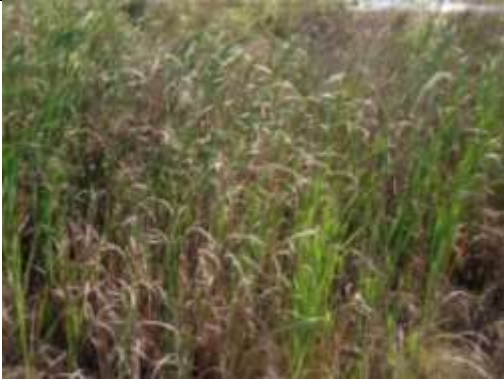
Monitoring month:	10	Months since direct seeding:	15
Date:	June 2016		
Comments:	No significant changes recorded this month.		
Native species:	<i>Elaeocharis dulcis, Ludwigia octovalvis, Cyperus polystachyos, Typha orientalis</i>		
Weed species:	<i>Cirsium vulgare, Aster subulatus, Paspalum dilatatum</i>		
Damage:	Nil		
Native dominance :	60%	Percentage vegetation cover:	80%
Photo:

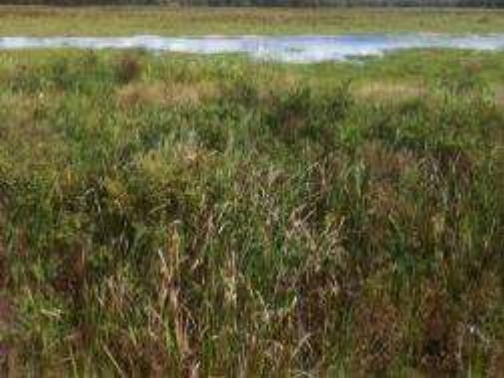
Monitoring month:	11	Months since direct seeding:	16
Date:	July 2016		
Comments:	This quadrat fared well over the winter period and continues to grow well.		
Native species:	<i>Elaeocharis dulcis, Ludwigia octovalvis, Cyperus polystachyos, Typha orientalis</i>		
Weed species:	<i>Cirsium vulgare, Aster subulatus, Paspalum dilatatum</i>		
Damage:	Nil		
Native dominance:	60%	Percentage vegetation cover:	80%
Photo:

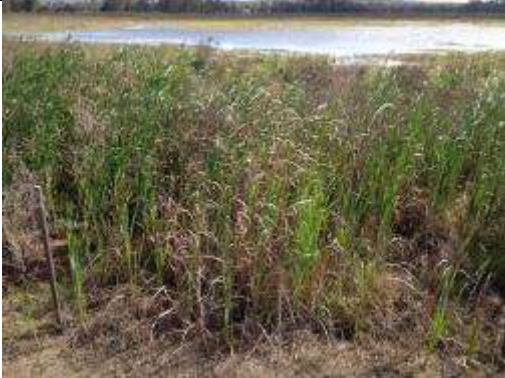
Monitoring month:	12	Months since direct seeding:	17
Date:	August 2016		
Comments:	<i>Typha</i> is becoming dominant in the area. The positive aspect to this would be its nesting habitat value for water birds over the wet season.		
Native species:	<i>Elaeocharis dulcis</i> , <i>Ludwigia octovalvis</i> , <i>Cyperus polystachyos</i> , <i>Typha orientalis</i> , <i>Carex appressa</i> , <i>Juncus usitatus</i>		
Weed species:	<i>Cirsium vulgare</i> , <i>Aster subulatus</i> , <i>Paspalum dilatatum</i>		
Damage:	Nil		
Native dominance:	65%	Percentage vegetation cover:	75%
Photo:

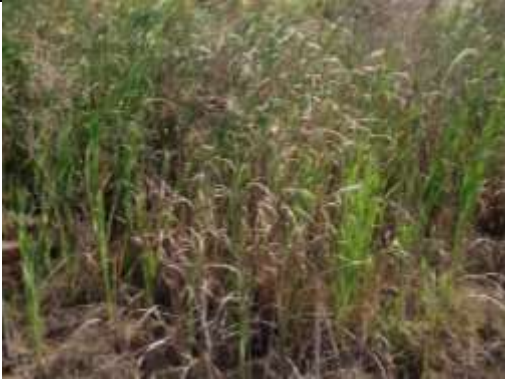
Monitoring month:	13	Months since direct seeding:	18
Date:	September 2016		
Comments:	<i>Typha</i> continues to grow well within this quadrat.		
Native species:	<i>Elaeocharis dulcis</i> , <i>Ludwigia octovalvis</i> , <i>Cyperus polystachyos</i> , <i>Typha orientalis</i> , <i>Carex appressa</i> , <i>Juncus usitatus</i>		
Weed species:	<i>Cirsium vulgare</i> , <i>Aster subulatus</i> , <i>Paspalum dilatatum</i>		
Damage:	Nil		
Native dominance:	65%	Percentage vegetation cover:	75%
Photo:

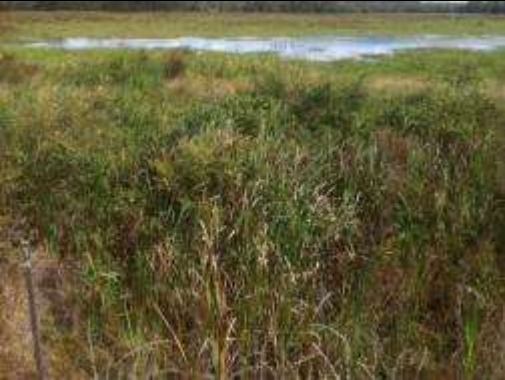
Monitoring month:	14	Months since direct seeding:	19
Date:	October 2016		
Comments:	Typha is growing strongly and is dominant over all other species.		
Native species:	<i>Elaeocharis dulcis</i> , <i>Ludwigia octovalvis</i> , <i>Cyperus polystachyos</i> , <i>Typha orientalis</i> , <i>Carex appressa</i> , <i>Juncus usitatus</i>		
Weed species:	<i>Cirsium vulgare</i> , <i>Aster subulatus</i> , <i>Paspalum dilatatum</i>		
Damage:	Nil		
Native dominance:	75%	Percentage vegetation cover:	75%
Photo:

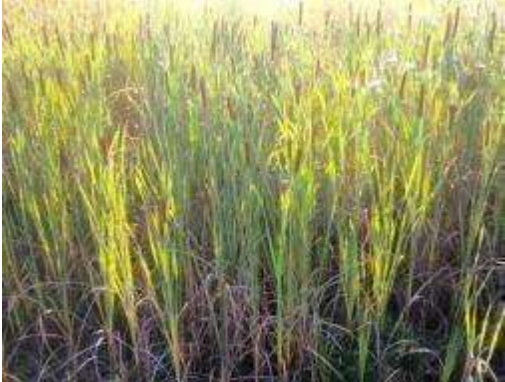
Monitoring month:	15	Months since direct seeding:	20
Date:	November 2016		
Comments:	No significant changes recorded this month.		
Native species:	<i>Elaeocharis dulcis</i> , <i>Ludwigia octovalvis</i> , <i>Cyperus polystachyos</i> , <i>Typha orientalis</i> , <i>Carex appressa</i> , <i>Juncus usitatus</i>		
Weed species:	<i>Cirsium vulgare</i> , <i>Aster subulatus</i> , <i>Paspalum dilatatum</i>		
Damage:	Nil		
Native dominance:	80%	Percentage vegetation cover:	75%
Photo:

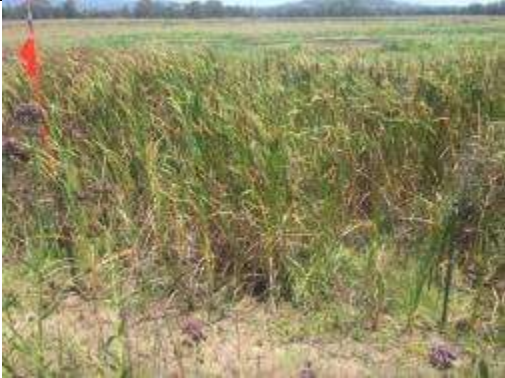
Monitoring month:	16	Months since direct seeding:	21
Date:	December 2016		
Comments:	A high visibility flag and extended pole was added to the quadrat stake this month for ease of identification. Typha continues to grow well.		
Native species:	<i>Elaeocharis dulcis</i> , <i>Ludwigia octovalvis</i> , <i>Cyperus polystachyos</i> , <i>Typha orientalis</i> , <i>Carex appressa</i> , <i>Juncus usitatus</i>		
Weed species:	<i>Cirsium vulgare</i> , <i>Aster subulatus</i> , <i>Paspalum dilatatum</i>		
Damage:	Nil		
Native dominance:	80%	Percentage vegetation cover:	75%
Photo:

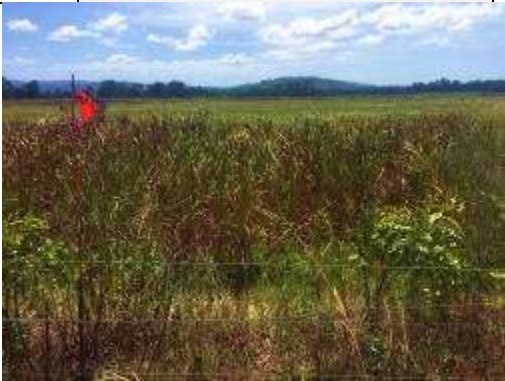
Monitoring month:	17	Months since direct seeding:	22
Date:	January 2017		
Comments:	Typha continues to grow well and dominates this quadrat.		
Native species:	<i>Elaeocharis dulcis</i> , <i>Ludwigia octovalvis</i> , <i>Cyperus polystachyos</i> , <i>Typha orientalis</i> , <i>Carex appressa</i> , <i>Juncus usitatus</i>		
Weed species:	<i>Cirsium vulgare</i> , <i>Aster subulatus</i> , <i>Paspalum dilatatum</i>		
Damage:	Nil		
Native dominance:	85%	Percentage vegetation cover:	85%
Photo:

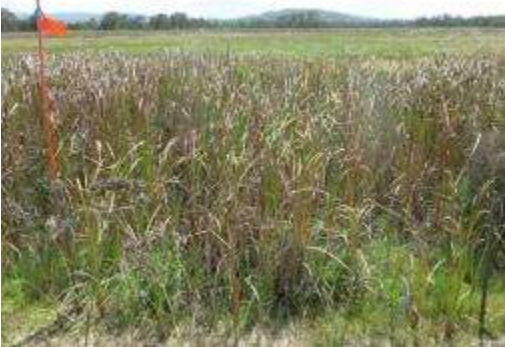
Monitoring month:	18	Months since direct seeding:	23
Date:	February 2017		
Comments:	Typha continues to dominate this quadrat.		
Native species:	<i>Elaeocharis dulcis</i> , <i>Ludwigia octovalvis</i> , <i>Cyperus polystachyos</i> , <i>Typha orientalis</i> , <i>Carex appressa</i> , <i>Juncus usitatus</i>		
Weed species:	<i>Cirsium vulgare</i> , <i>Aster subulatus</i> , <i>Paspalum dilatatum</i>		
Damage:	Nil		
Native dominance:	85%	Percentage vegetation cover:	85%
Photo:

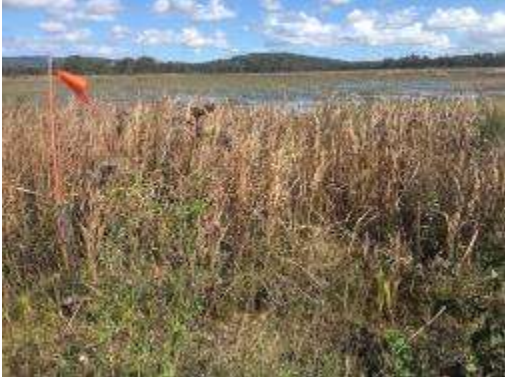
Monitoring month:	19	Months since direct seeding:	24
Date:	March 2017 (NB: monitoring event occurred early April due to inaccessibility)		
Comments:	During the last half of this month, the NWCP received significant rainfall. Access to the area was limited. Much of the area is waterlogged and functioning as the wetland it is designed to be (background of photo). Typha still continues to dominate this quadrat.		
Native species:	<i>Elaeocharis dulcis</i> , <i>Ludwigia octovalvis</i> , <i>Cyperus polystachyos</i> , <i>Typha orientalis</i> , <i>Carex appressa</i> , <i>Juncus usitatus</i>		
Weed species:	<i>Cirsium vulgare</i> , <i>Aster subulatus</i> , <i>Paspalum dilatatum</i>		
Damage:	Nil - large weather event associated with Ex-Tropical Cyclone Debbie did not result in any damage		
Native dominance:	85%	Percentage vegetation cover:	85%
Photo:

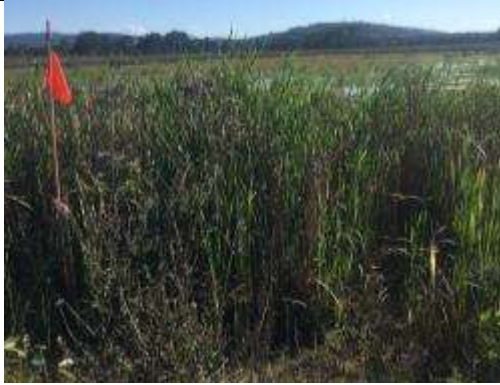
Monitoring month:	20	Months since direct seeding:	25
Date:	April 2017		
Comments:	Much of the area is still waterlogged and functioning as the wetland it is designed to be.		
Native species:	<i>Elaeocharis dulcis</i> , <i>Ludwigia octovalvis</i> , <i>Cyperus polystachyos</i> , <i>Typha orientalis</i> , <i>Carex appressa</i> , <i>Juncus usitatus</i>		
Weed species:	<i>Cirsium vulgare</i> , <i>Aster subulatus</i> , <i>Paspalum dilatatum</i>		
Damage:	Nil		
Native dominance:	85%	Percentage vegetation cover:	85%
Photo:

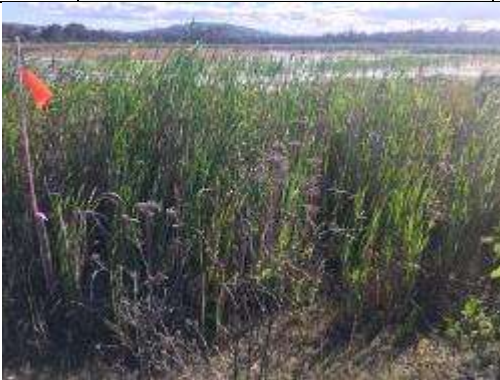
Monitoring month:	21	Months since direct seeding:	26
Date:	May 2017		
Comments:	Typha still continues to dominate this quadrat.		
Native species:	<i>Elaeocharis dulcis</i> , <i>Ludwigia octovalvis</i> , <i>Cyperus polystachyos</i> , <i>Typha orientalis</i> , <i>Carex appressa</i> , <i>Juncus usitatus</i>		
Weed species:	<i>Cirsium vulgare</i> , <i>Aster subulatus</i> , <i>Paspalum dilatatum</i>		
Damage:	Nil		
Native dominance:	85%	Percentage vegetation cover:	85%
Photo:

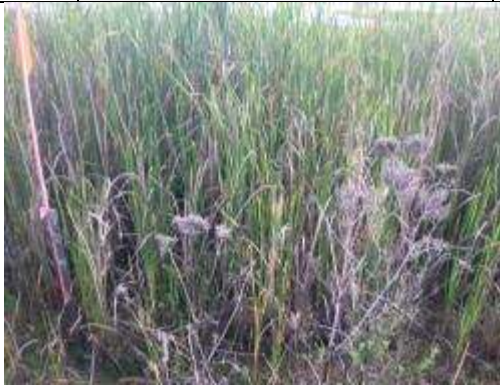
Monitoring month:	22	Months since direct seeding:	27
Date:	June 2017		
Comments:	No significant changes this month. It is anticipated growth will slow moving into the colder months.		
Native species:	<i>Elaeocharis dulcis</i> , <i>Ludwigia octovalvis</i> , <i>Cyperus polystachyos</i> , <i>Typha orientalis</i> , <i>Carex appressa</i> , <i>Juncus usitatus</i>		
Weed species:	<i>Cirsium vulgare</i> , <i>Aster subulatus</i> , <i>Paspalum dilatatum</i>		
Damage:	Nil		
Native dominance:	85%	Percentage vegetation cover:	85%
Photo:

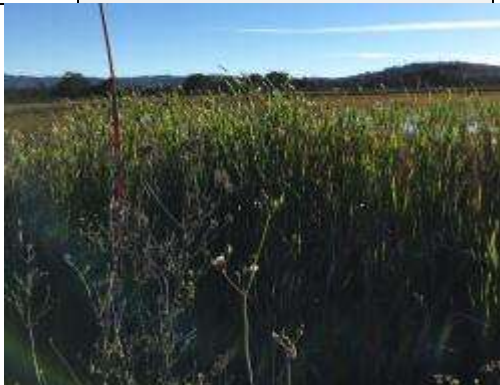
Monitoring month:	23	Months since direct seeding:	28
Date:	July 2017		
Comments:	An additional length of conduit was added to the flagging pole this month due to the increasing height of vegetation. Vegetation health is steady.		
Native species:	<i>Elaeocharis dulcis</i> , <i>Ludwigia octovalvis</i> , <i>Cyperus polystachyos</i> , <i>Typha orientalis</i> , <i>Carex appressa</i> , <i>Juncus usitatus</i>		
Weed species:	<i>Cirsium vulgare</i> , <i>Aster subulatus</i> , <i>Paspalum dilatatum</i>		
Damage:	Nil		
Native dominance:	95%	Percentage vegetation cover:	85%
Photo:

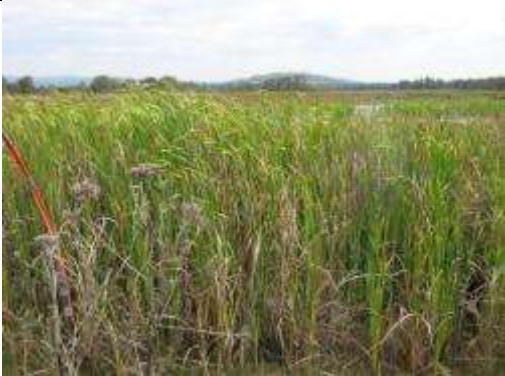
Monitoring month:	24	Months since direct seeding:	29
Date:	August 2017		
Comments:	Native dominance has reached 100%, however noted that this is primarily Typha. Diversity is decreasing due to Typha abundance.		
Native species:	<i>Elaeocharis dulcis</i> , <i>Ludwigia octovalvis</i> , <i>Cyperus polystachyos</i> , <i>Typha orientalis</i> , <i>Carex appressa</i> , <i>Juncus usitatus</i>		
Weed species:	<i>Cirsium vulgare</i> , <i>Aster subulatus</i> , <i>Paspalum dilatatum</i>		
Damage:	Nil		
Native dominance:	100%	Percentage vegetation cover:	90%
Photo:

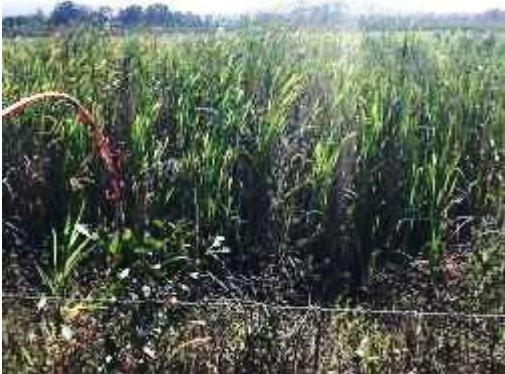
Monitoring month:	25	Months since direct seeding:	30
Date:	September 2017		
Comments:	Vegetation health is steady.		
Native species:	<i>Elaeocharis dulcis</i> , <i>Ludwigia octovalvis</i> , <i>Cyperus polystachyos</i> , <i>Typha orientalis</i> , <i>Carex appressa</i> , <i>Juncus usitatus</i>		
Weed species:	<i>Cirsium vulgare</i> , <i>Aster subulatus</i> , <i>Paspalum dilatatum</i>		
Damage:	Nil		
Native dominance:	100%	Percentage vegetation cover:	90%
Photo:

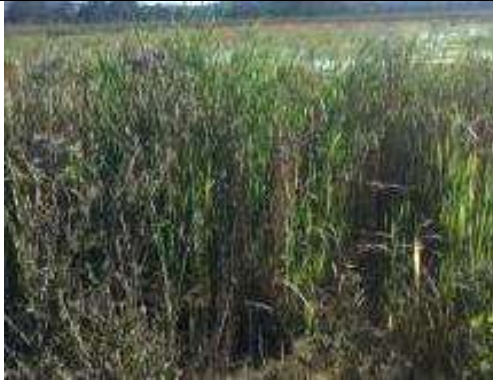
Monitoring month:	26	Months since direct seeding:	31
Date:	October 2017		
Comments:	No significant changes occurred this month.		
Native species:	<i>Elaeocharis dulcis</i> , <i>Ludwigia octovalvis</i> , <i>Cyperus polystachyos</i> , <i>Typha orientalis</i> , <i>Carex appressa</i> , <i>Juncus usitatus</i>		
Weed species:	<i>Cirsium vulgare</i> , <i>Aster subulatus</i> , <i>Paspalum dilatatum</i>		
Damage:	Nil		
Native dominance:	100%	Percentage vegetation cover:	90%
Photo:

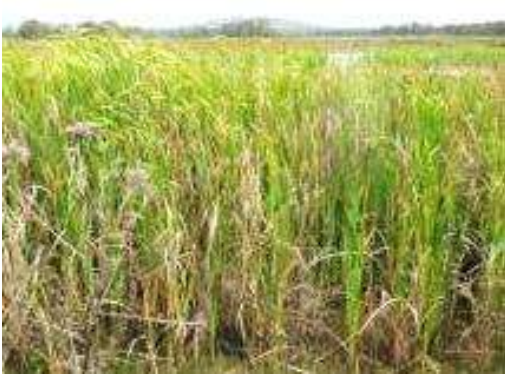
Monitoring month:	27	Months since direct seeding:	32
Date:	November 2017		
Comments:	Quadrat still dominated by dense Typha, which will soon outcompete other native and weed species.		
Native species:	<i>Elaeocharis dulcis</i> , <i>Ludwigia octovalvis</i> , <i>Cyperus polystachyos</i> , <i>Typha orientalis</i> , <i>Carex appressa</i> , <i>Juncus usitatus</i>		
Weed species:	<i>Cirsium vulgare</i> , <i>Aster subulatus</i> , <i>Paspalum dilatatum</i>		
Damage:	Nil		
Native dominance:	100%	Percentage vegetation cover:	90%
Photo:

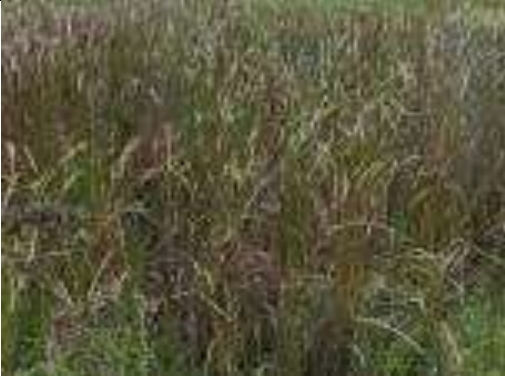
Monitoring month:	28	Months since direct seeding:	33
Date:	December 2017		
Comments:	Rain events over the past two months have increased the waterlogging of this area, promoting strong vegetation growth.		
Native species:	<i>Elaeocharis dulcis</i> , <i>Ludwigia octovalvis</i> , <i>Cyperus polystachyos</i> , <i>Typha orientalis</i> , <i>Carex appressa</i> , <i>Juncus usitatus</i>		
Weed species:	<i>Cirsium vulgare</i> , <i>Aster subulatus</i> , <i>Paspalum dilatatum</i>		
Damage:	Nil		
Native dominance:	100%	Percentage vegetation cover:	90%
Photo:

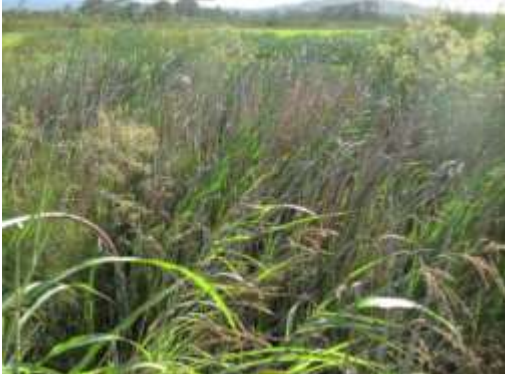
Monitoring month:	29	Months since direct seeding:	34
Date:	January 2018		
Comments:	Vegetation health is steady.		
Native species:	<i>Elaeocharis dulcis</i> , <i>Ludwigia octovalvis</i> , <i>Cyperus polystachyos</i> , <i>Typha orientalis</i> , <i>Carex appressa</i> , <i>Juncus usitatus</i>		
Weed species:	<i>Cirsium vulgare</i> , <i>Aster subulatus</i> , <i>Paspalum dilatatum</i>		
Damage:	Nil		
Native dominance:	100%	Percentage vegetation cover:	90%
Photo:

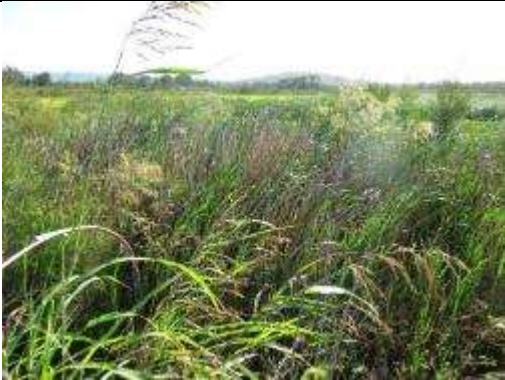
Monitoring month:	30	Months since direct seeding:	35
Date:	February 2018		
Comments:	Casuarina seedlings are becoming evident over the top of the Typha. This marks the commencement for a change in biodiversity for this quadrat. Species diversity will increase over time as the casuarina canopy forms.		
Native species:	<i>Elaeocharis dulcis</i> , <i>Ludwigia octovalvis</i> , <i>Cyperus polystachyos</i> , <i>Typha orientalis</i> , <i>Carex appressa</i> , <i>Juncus usitatus</i>		
Weed species:	<i>Cirsium vulgare</i> , <i>Aster subulatus</i> , <i>Paspalum dilatatum</i>		
Damage:	Nil		
Native dominance:	100%	Percentage vegetation cover:	90%
Photo:

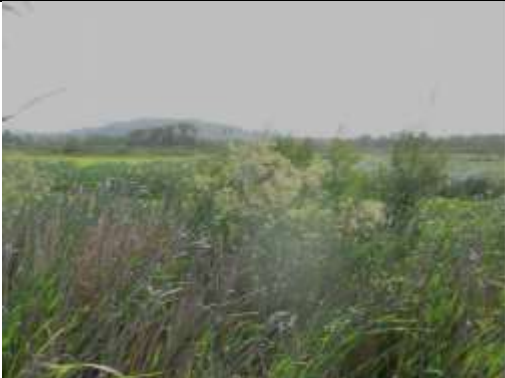
Monitoring month:	31	Months since direct seeding:	36
Date:	March 2018		
Comments:	A significant amount of rain fell at the end of last month resulting in standing water for approximately 3 weeks. This has acted as a natural weed control for a number of the weed species.		
Native species:	<i>Elaeocharis dulcis</i> , <i>Ludwigia octovalvis</i> , <i>Cyperus polystachyos</i> , <i>Typha orientalis</i> , <i>Carex appressa</i> , <i>Juncus usitatus</i>		
Weed species:	<i>Cirsium vulgare</i> , <i>Aster subulatus</i> , <i>Paspalum dilatatum</i>		
Damage:	Nil		
Native dominance:	100%	Percentage vegetation cover:	90%
Photo:

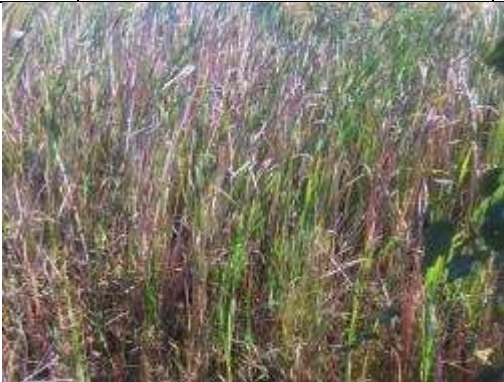
Monitoring month:	32	Months since direct seeding:	37
Date:	April 2018		
Comments:	Quadrat still dominated by dense Typha, however other natives are still increasing in density and biomass, including the addition of <i>Casuarina glauca</i> .		
Native species:	<i>Elaeocharis dulcis</i> , <i>Ludwigia octovalvis</i> , <i>Cyperus polystachyos</i> , <i>Typha orientalis</i> , <i>Carex appressa</i> , <i>Juncus usitatus</i> , <i>Casuarina glauca</i>		
Weed species:	<i>Cirsium vulgare</i> , <i>Aster subulatus</i> , <i>Paspalum dilatatum</i>		
Damage:	Nil		
Native dominance:	100%	Percentage vegetation cover:	90%
Photo:

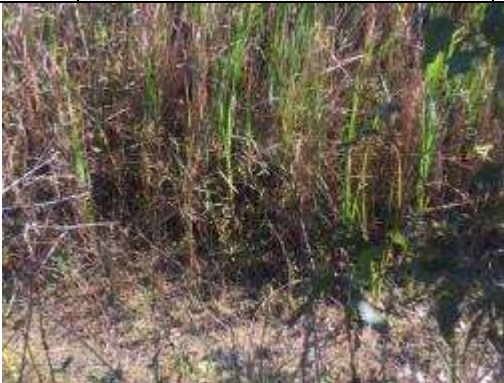
Monitoring month:	33	Months since direct seeding:	38
Date:	May 2018		
Comments:	Vegetation health is steady.		
Native species:	<i>Elaeocharis dulcis</i> , <i>Ludwigia octovalvis</i> , <i>Cyperus polystachyos</i> , <i>Typha orientalis</i> , <i>Carex appressa</i> , <i>Juncus usitatus</i> , <i>Casuarina glauca</i>		
Weed species:	<i>Cirsium vulgare</i> , <i>Aster subulatus</i> , <i>Paspalum dilatatum</i>		
Damage:	Nil		
Native dominance:	100%	Percentage vegetation cover:	95%
Photo:

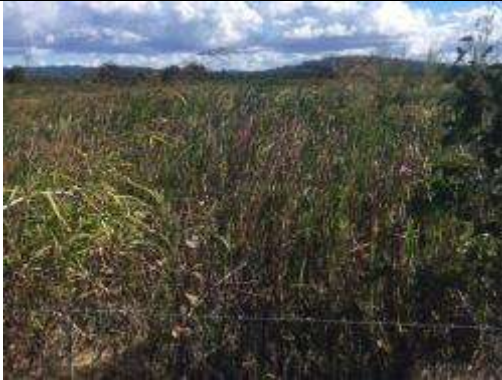
Monitoring month:	34	Months since direct seeding:	39
Date:	June 2018		
Comments:	No significant changes this month due to the slowing down of the growing season.		
Native species:	<i>Elaeocharis dulcis</i> , <i>Ludwigia octovalvis</i> , <i>Cyperus polystachyos</i> , <i>Typha orientalis</i> , <i>Carex appressa</i> , <i>Juncus usitatus</i> , <i>Casuarina glauca</i>		
Weed species:	<i>Cirsium vulgare</i> , <i>Aster subulatus</i> , <i>Paspalum dilatatum</i>		
Damage:	Nil		
Native dominance:	100%	Percentage vegetation cover:	100%
Photo:

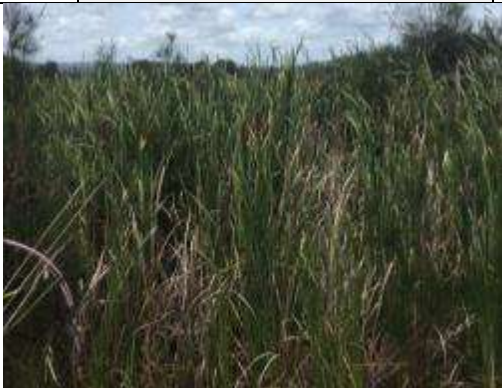
Monitoring month:	35	Months since direct seeding:	40
Date:	July 2018		
Comments:	Winter has had a notable effect on species diversity within this quadrat.		
Native species:	<i>Typha orientalis</i> , <i>Casuarina glauca</i>		
Weed species:	Nil		
Damage:	Nil		
Native dominance:	100%	Percentage vegetation cover:	100%
Photo:

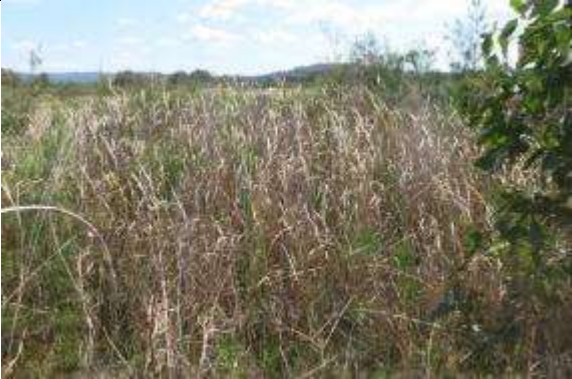
Monitoring month:	36	Months since direct seeding:	41
Date:	August 2018		
Comments:	Casuarina seedlings continue to grow well and add biomass.		
Native species:	<i>Typha orientalis</i> , <i>Casuarina glauca</i>		
Weed species:	Nil		
Damage:	Nil		
Native dominance:	100%	Percentage vegetation cover:	100%
Photo:

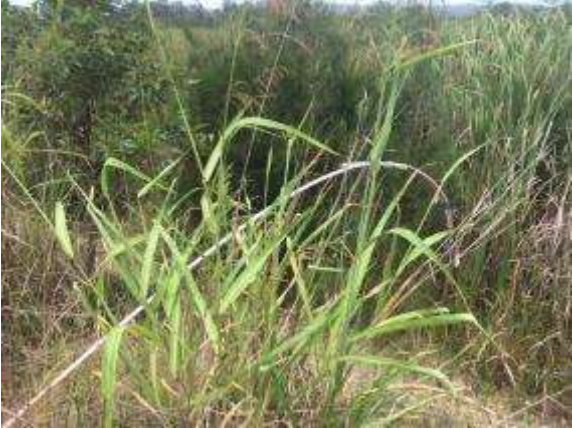
Monitoring month:	37	Months since direct seeding:	42
Date:	September 2018		
Comments:	Surrounding areas are continuing to grow well since the removal of Camphor Laurels.		
Native species:	<i>Typha orientalis</i> , <i>Casuarina glauca</i>		
Weed species:	Nil		
Damage:	Nil		
Native dominance:	100%	Percentage vegetation cover:	90%
Photo:

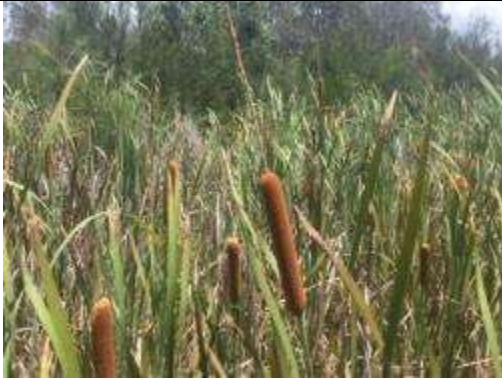
Monitoring month:	38	Months since direct seeding:	43
Date:	October 2018		
Comments:	Rainfall occurred throughout the area during this month which has assisted with the increase in biomass.		
Native species:	<i>Typha orientalis</i> , <i>Casuarina glauca</i>		
Weed species:	Nil		
Damage:	Nil		
Native dominance:	100%	Percentage vegetation cover:	90%
Photo:

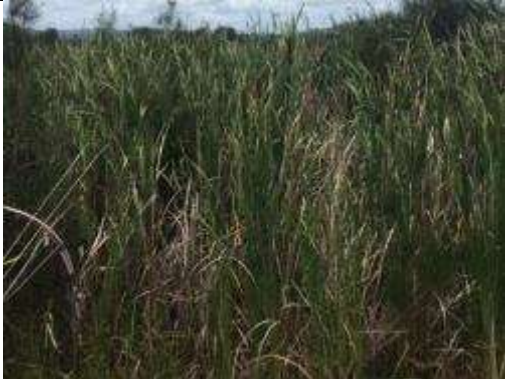
Monitoring month:	40	Months since direct seeding:	45
Date:	December 2018		
Comments:	No significant changes this month.		
Native species:	<i>Typha orientalis</i> , <i>Casuarina glauca</i>		
Weed species:	Nil		
Damage:	Nil		
Native dominance:	100%	Percentage vegetation cover:	90%
Photo:

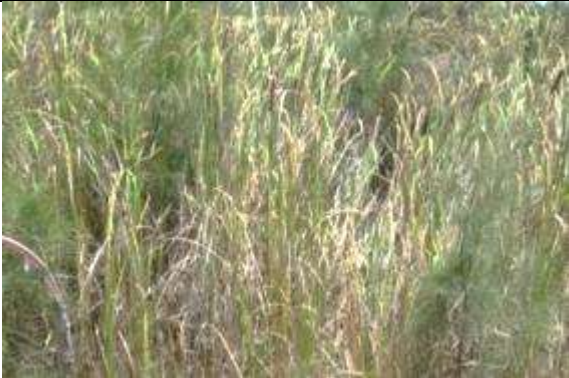
Monitoring month:	41	Months since direct seeding:	46
Date:	January 2019		
Comments:	Typha still the dominant species.		
Native species:	<i>Typha orientalis</i> , <i>Casuarina glauca</i>		
Weed species:	Nil		
Damage:	Nil		
Native dominance:	100%	Percentage vegetation cover:	100%
Photo:
