North-West Conservation Park - Rehabilitation Monitoring

Lot 1 RP48903

North-West Conservation Park
Gainsborough Greens

March 2020

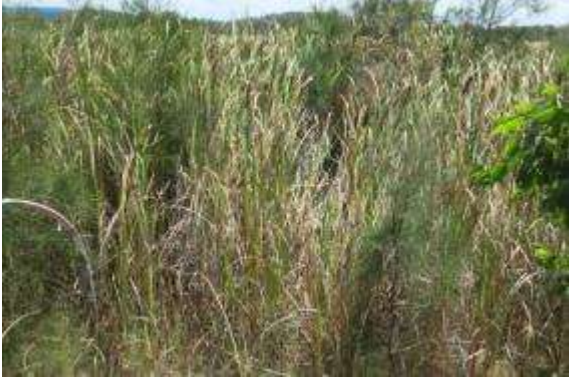
Monitoring month:	42	Months since direct seeding:	47
Date:	February 2019		
Comments:	Casuarina development is still strong.		
Native species:	<i>Typha orientalis</i> , <i>Casuarina glauca</i>		
Weed species:	Nil		
Damage:	Nil		
Native dominance:	100%	Percentage vegetation cover:	100%
Photo:

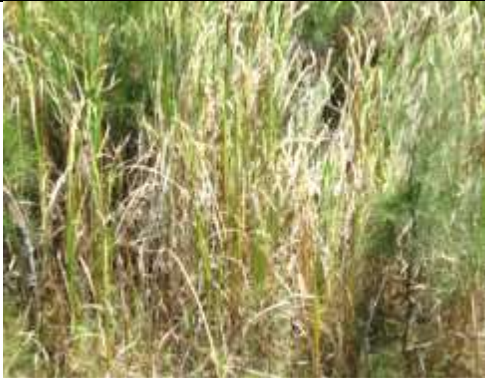
Monitoring month:	43	Months since direct seeding:	48
Date:	March 2019		
Comments:	No significant changes this month.		
Native species:	<i>Typha orientalis</i> , <i>Casuarina glauca</i>		
Weed species:	Nil		
Damage:	Nil		
Native dominance:	100%	Percentage vegetation cover:	100%
Photo:

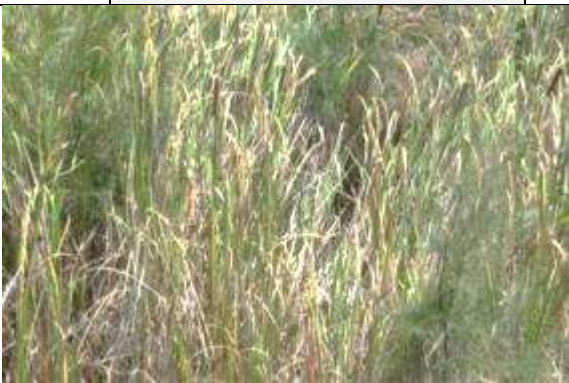
Monitoring month:	44	Months since direct seeding:	49
Date:	April 2019		
Comments:	Rainfall events increased late last month and continued this month giving the NWCP a much needed watering.		
Native species:	<i>Typha orientalis, Casuarina glauca</i>		
Weed species:	Nil		
Damage:	Nil		
Native dominance:	100%	Percentage vegetation cover:	100%
Photo:

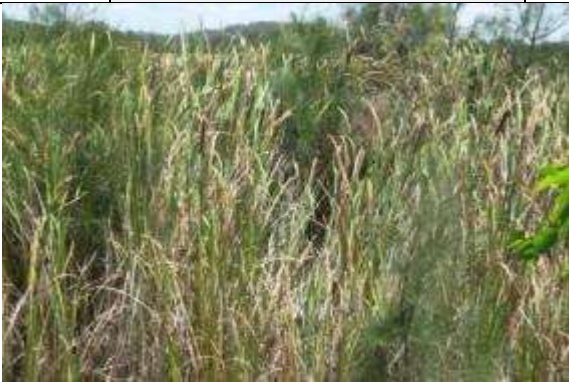
Monitoring month:	45	Months since direct seeding:	50
Date:	May 2019		
Comments:	<i>Casuarina glauca</i> continues to add biomass and will soon start outcompeting the <i>Typha</i> .		
Native species:	<i>Typha orientalis, Casuarina glauca</i>		
Weed species:	Nil		
Damage:	Nil		
Native dominance:	100%	Percentage vegetation cover:	100%
Photo:

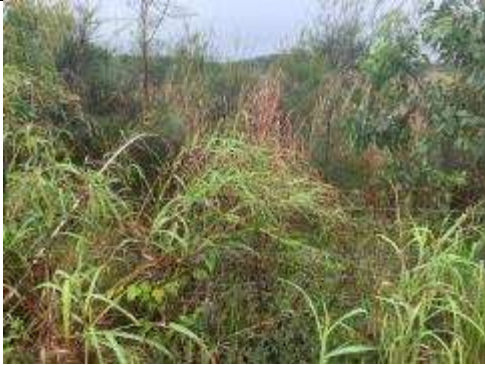
Monitoring month:	46	Months since direct seeding:	51
Date:	June 2019		
Comments:	Rainfall over the past few months has increased plant growth and vigour.		
Native species:	<i>Typha orientalis</i> , <i>Casuarina glauca</i>		
Weed species:	Nil		
Damage:	Nil		
Native dominance:	100%	Percentage vegetation cover:	100%
Photo:

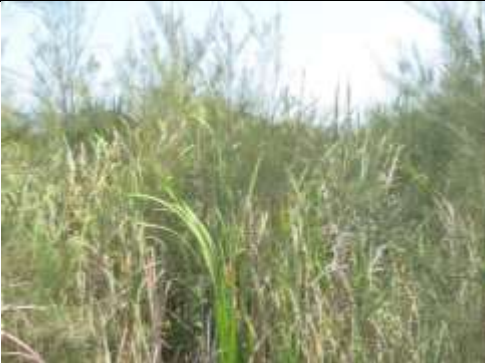
Monitoring month:	47	Months since direct seeding:	52
Date:	July 2019		
Comments:	Casuarina growth continues to increase in height over the Typha.		
Native species:	<i>Typha orientalis</i> , <i>Casuarina glauca</i>		
Weed species:	Nil		
Damage:	Nil		
Native dominance:	100%	Percentage vegetation cover:	100%
Photo:

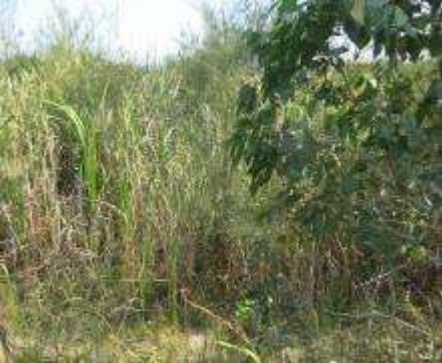
Monitoring month:	48	Months since direct seeding:	53
Date:	August 2019		
Comments:	Vegetation growth is steady.		
Native species:	<i>Typha orientalis</i> , <i>Casuarina glauca</i>		
Weed species:	Nil		
Damage:	Nil		
Native dominance:	100%	Percentage vegetation cover:	100%
Photo:

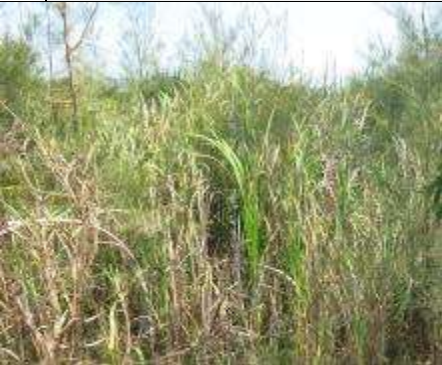
Monitoring month:	49	Months since direct seeding:	54
Date:	September 2019		
Comments:	<i>Dianella brevipedunculata</i> noted in the surrounding area for the first time for this quadrat.		
Native species:	<i>Typha orientalis</i> , <i>Casuarina glauca</i>		
Weed species:	Nil		
Damage:	Nil		
Native dominance:	100%	Percentage vegetation cover:	100%
Photo:

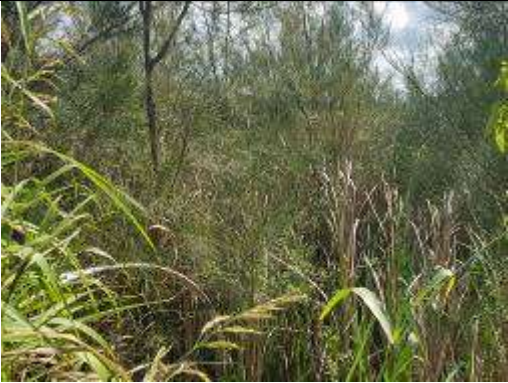
Monitoring month:	50	Months since direct seeding:	55
Date:	October 2019		
Comments:	Extended drought conditions are starting to take their toll with the extreme slowing of plant growth.		
Native species:	<i>Typha orientalis, Casuarina glauca</i>		
Weed species:	Nil		
Damage:	Nil		
Native dominance:	100%	Percentage vegetation cover:	100%
Photo:

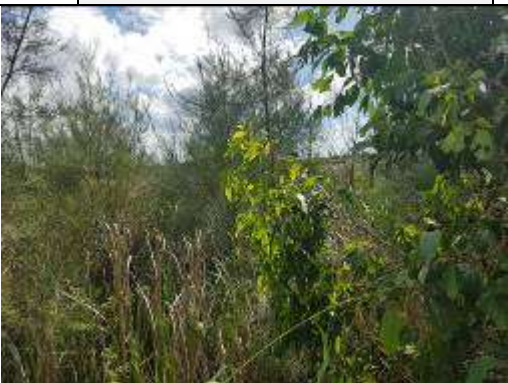
Monitoring month:	51	Months since direct seeding:	56
Date:	November 2019		
Comments:	No significant changes recorded.		
Native species:	<i>Typha orientalis, Casuarina glauca</i>		
Weed species:	Nil		
Damage:	Nil		
Native dominance:	100%	Percentage vegetation cover:	100%
Photo:

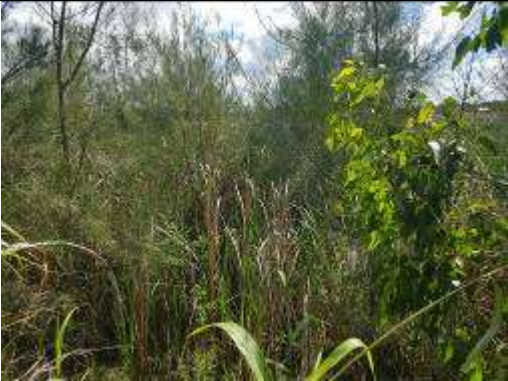
Monitoring month:	52	Months since direct seeding:	57
Date:	December 2019		
Comments:	Canopy growth continues to increase.		
Native species:	<i>Typha orientalis</i> , <i>Casuarina glauca</i>		
Weed species:	Nil		
Damage:	Nil		
Native dominance:	100%	Percentage vegetation cover:	100%
Photo:

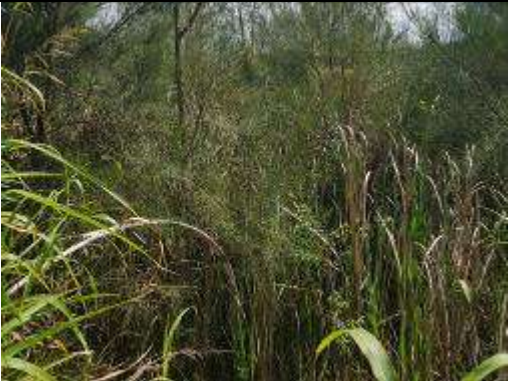
Monitoring month:	53	Months since direct seeding:	58
Date:	January 2020		
Comments:	Quadrat is continuing to transition.		
Native species:	<i>Typha orientalis</i> , <i>Casuarina glauca</i>		
Weed species:	Nil		
Damage:	Nil		
Native dominance:	100%	Percentage vegetation cover:	100%
Photo:

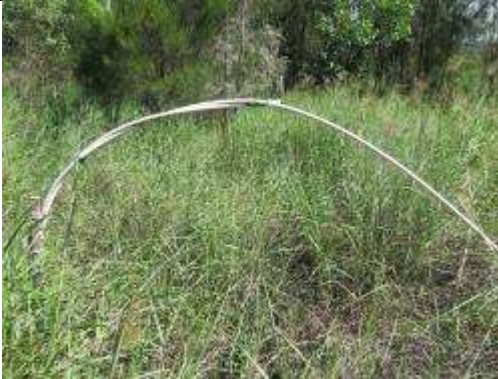
Monitoring month:	54	Months since direct seeding:	59
Date:	February 2020		
Comments:	Typha has significantly declined and is now almost entirely absent.		
Native species:	<i>Typha orientalis</i> , <i>Casuarina glauca</i>		
Weed species:	Nil		
Damage:	Nil		
Native dominance:	100%	Percentage vegetation cover:	100%
Photo:
